Re: Lead-Based Paint Inspection  
City of Lowell Community Center  
Lowell, North Carolina  
EI Project No: IHCH210085.00

**Project Site Address:** 501 W. 1<sup>st</sup> Street, Lowell, North Carolina 28098

**Inspection Date:** 8/13/2021

**Scope of Work:** Lead-Based Paint Inspection

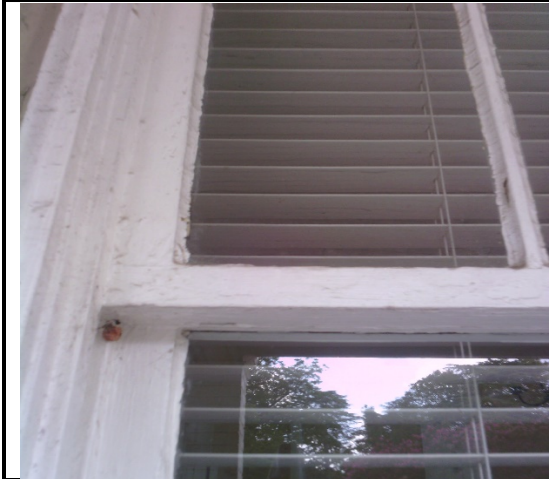
Exterior Side B Window Sash

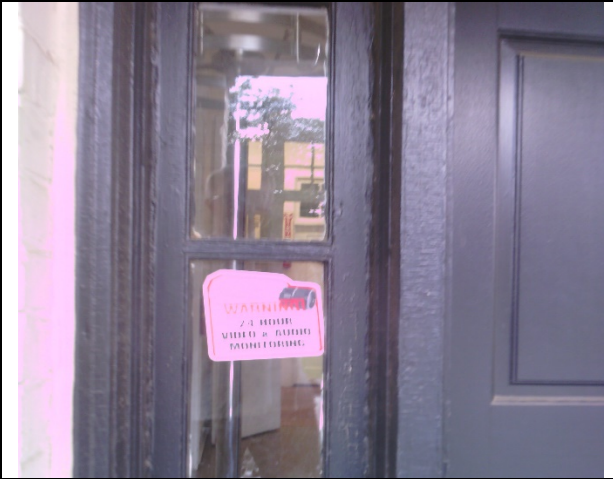
Exterior Side B Window

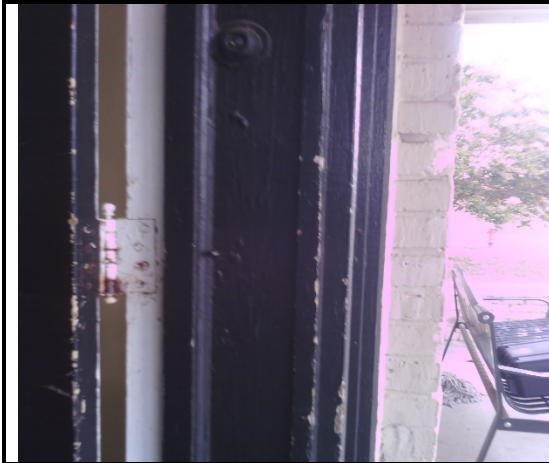
Exterior Side B Door Jamb

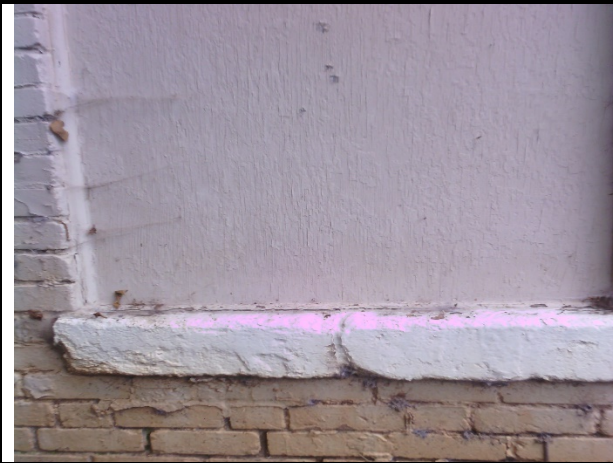
Exterior Side C Window Sill (concrete)

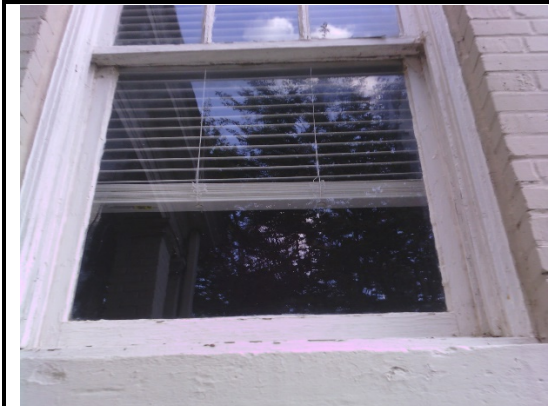
Exterior Side B Wood Trim

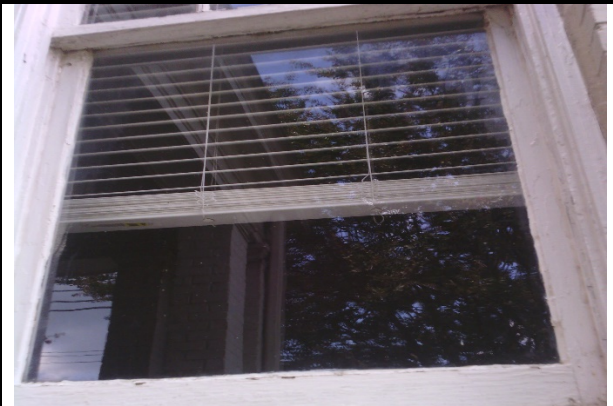
Exterior Side B Wood Trim
