APPENDIX B

PHOTOGRAPHS OF IDENTIFIED ASBESTOS-CONTAINING MATERIALS

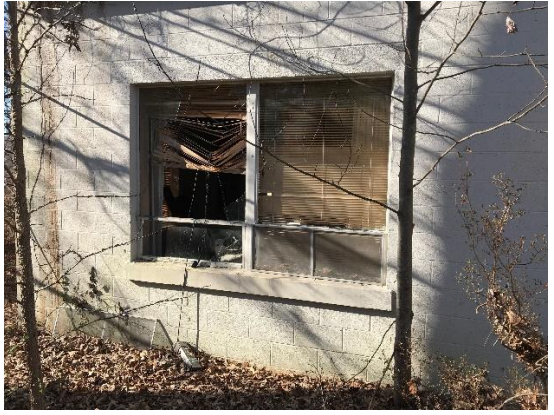
<p>HA #4</p>	<p>Window Glazing</p>	<p>HA #6</p>	<p>Door frame caulk</p>

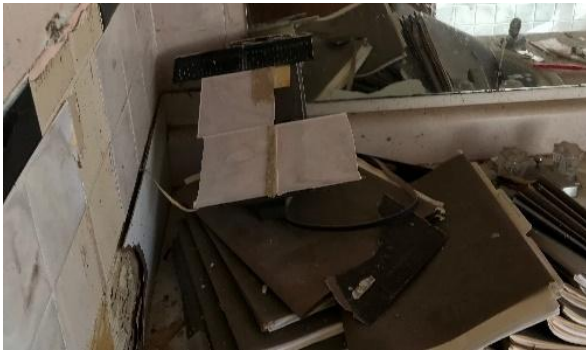
HA #19

Tan glue behind plastic
backsplash

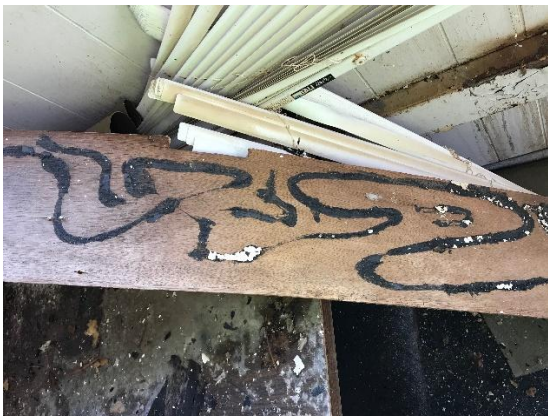
HA #19

Black mastic (on wood walls)

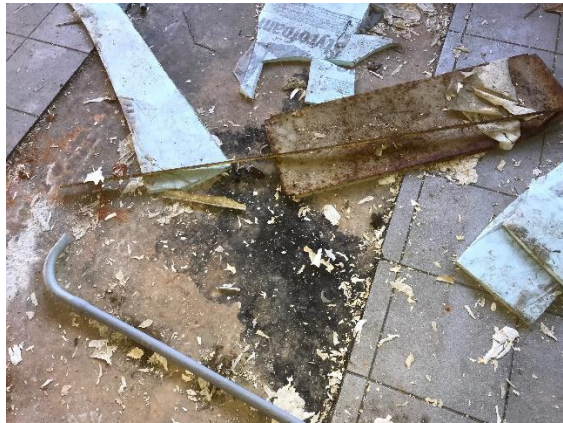
HA #21

Mastic associated with ceramic tile

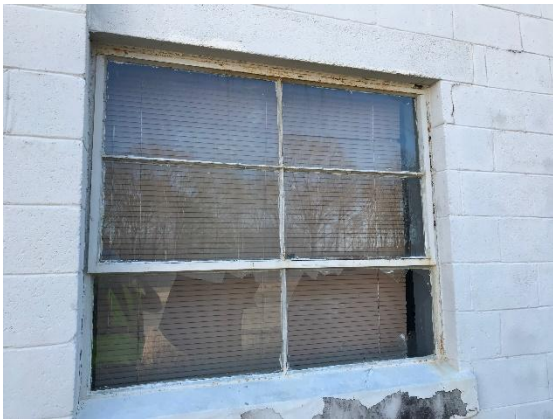
HA #25

Grey window glazing

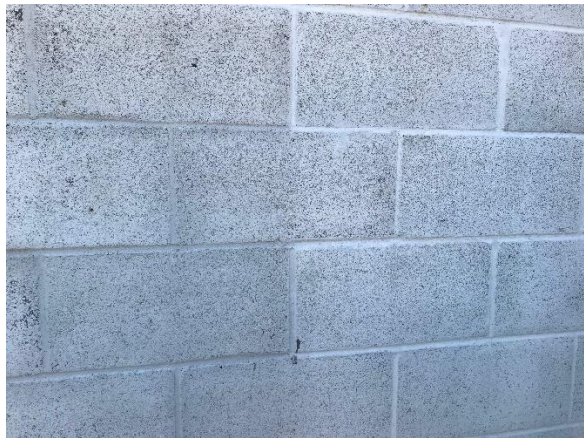
HA #26

CMU coating (exterior)

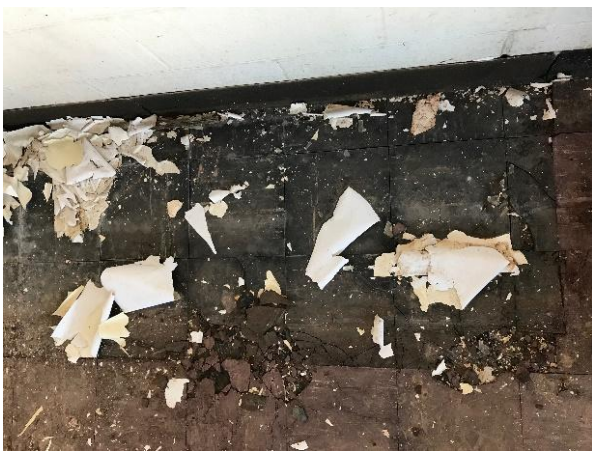
HA #27

9"x9" grey floor tile and mastic

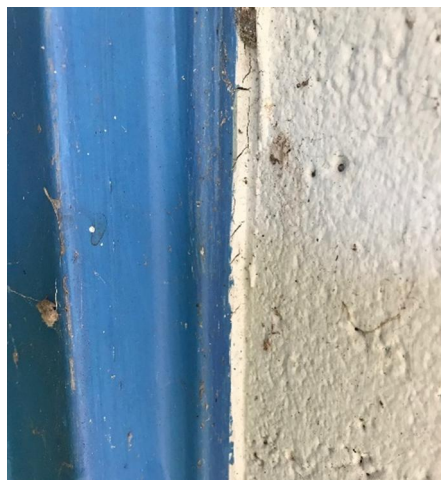
HA #28

White caulk (door frames)

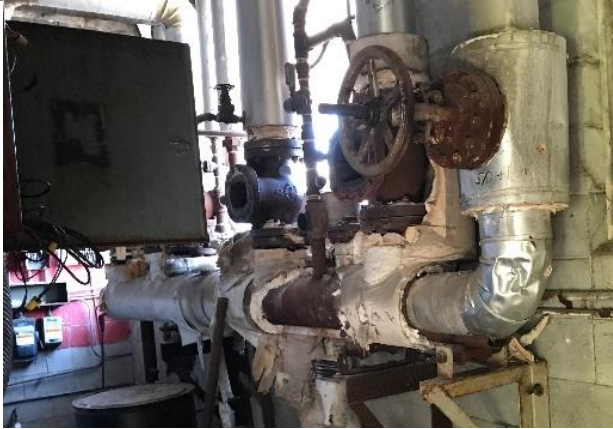
HA #10

12" header insulation

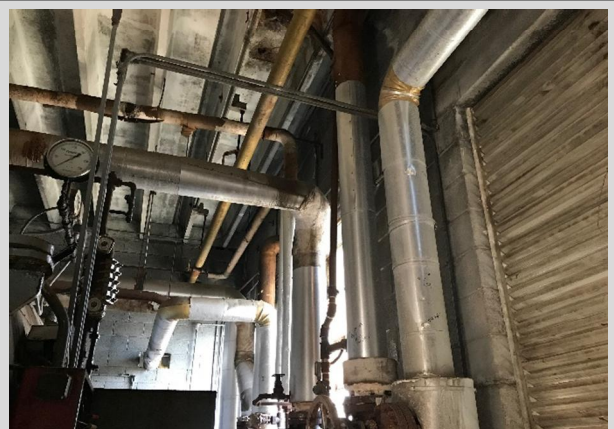
HA #11 and HA #18

6" pipe insulation

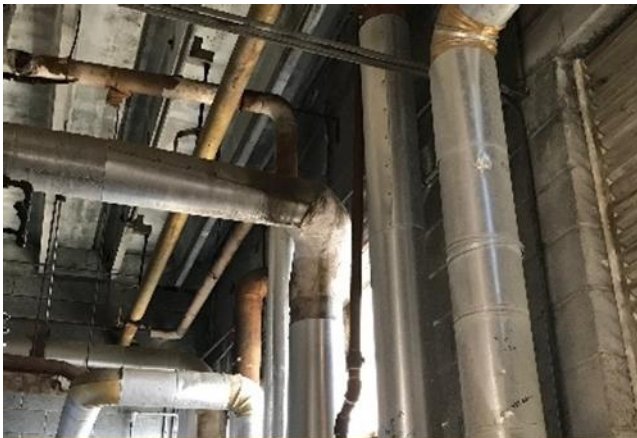
HA #12 and HA #19

6" pipe elbow insulation

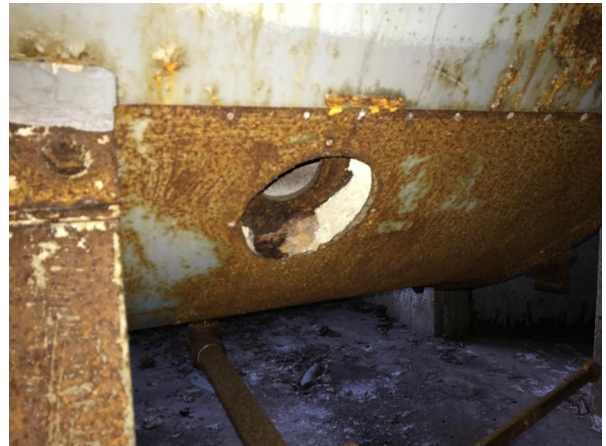
HA #15

Boiler insulation

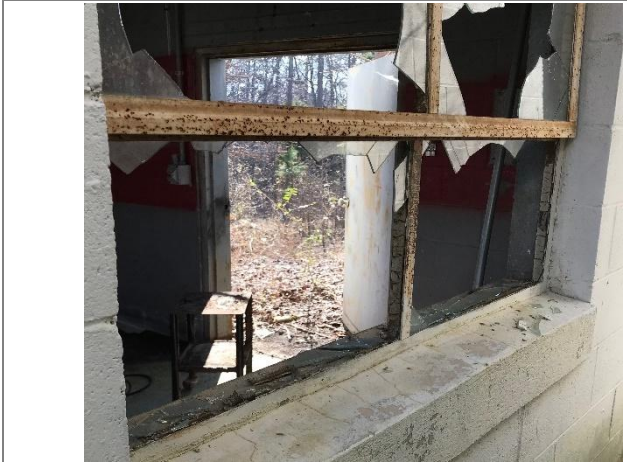
HA #1

HA No.	HOMOGENEOUS MATERIAL DESCRIPTION	GENERAL LOCATION	TYPE OF ASBESTOS *	CONDITION / CLASSIFICATION	ESTIMATED QUANTITY **
1	Window Glazing	Exterior windows	4% Chrysotile	Significantly Damaged / Friable	2 windows
3	CMU Coating	Throughout building (exterior)	3% Chrysotile	Good / Non-friable	600 ft ²
4	CMU Coating	Throughout building (interior)	3% Chrysotile	Good / Non-friable	600 ft ²

Window glazing

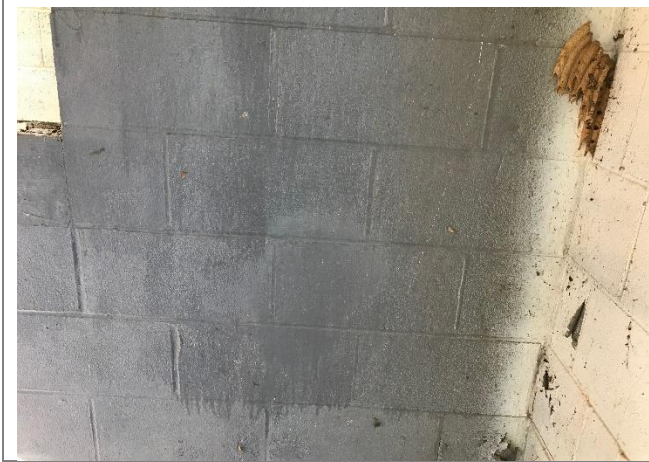
HA #4

CMU coating (interior)

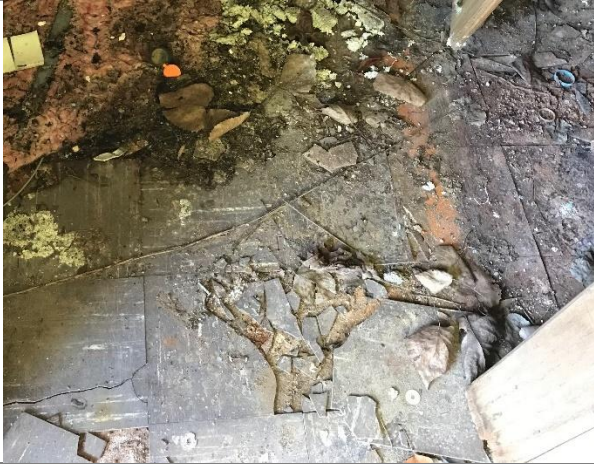
HA #1

HA No.	HOMOGENEOUS MATERIAL DESCRIPTION	GENERAL LOCATION	TYPE OF ASBESTOS *	CONDITION / CLASSIFICATION	ESTIMATED QUANTITY **
1	9"x9" Brown Floor Tile and Black Mastic	Throughout building	FT: 8% Chrysotile M: 3% Chrysotile	Significantly Damaged / Category I Non-Friable	380 ft ²
11	6" Grey Pipe Wrap	Pipe near office entrance	5% Chrysotile	Significantly Damaged / Category II Non-Friable	15 ft
16	Grey Gasket on Pipe Flange	In small building behind building 17	30% Chrysotile	Significantly Damaged / Category I Non-Friable	10 ft ²
26	Roof Flashing	Throughout Roof	Fl: 5% Chrysotile Sh: none detected	Good / Category I Non-Friable	150 ft

9"x9" Brown Floor Tile and Black Mastic

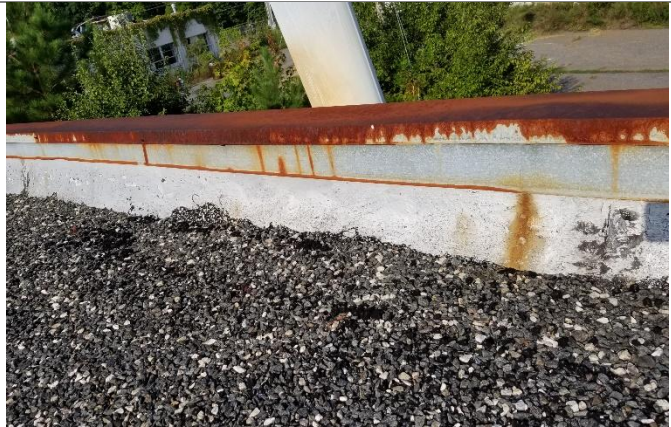
HA #1

HA No.	HOMOGENEOUS MATERIAL DESCRIPTION	GENERAL LOCATION	TYPE OF ASBESTOS *	CONDITION / CLASSIFICATION	ESTIMATED QUANTITY **
1	Roof Flashing	Roof	10% Chrysotile	Good / Category I Non-friable	350 ft

Roof Flashing

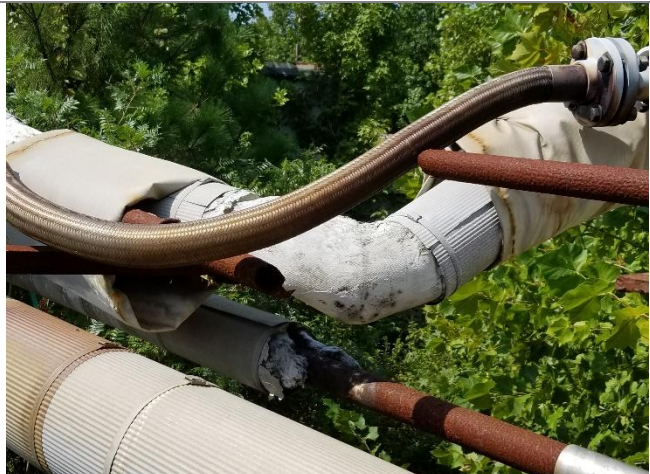
HA #4

HA No.	HOMOGENEOUS MATERIAL DESCRIPTION	GENERAL LOCATION	TYPE OF ASBESTOS *	CONDITION / CLASSIFICATION	ESTIMATED QUANTITY **
4	Corrugated metal wrap steam pipe insulation	Between buildings 6 and 8	15% Amosite	Damaged / Friable	>100 ft ‡

Corrugated Metal Wrap
Steam Pipe Insulation
