Job Name: Crompton and Knowles  
 Job Number: 71187168  
 Area: Building 7

FORMER CROMPTON AND KNOWLES SITE  
 1602 N. MAIN STREET  
 CHARLOTTE, NORTH CAROLINA

PROJECT NUMBER  
 71187168  
 SHEET  
 1-R

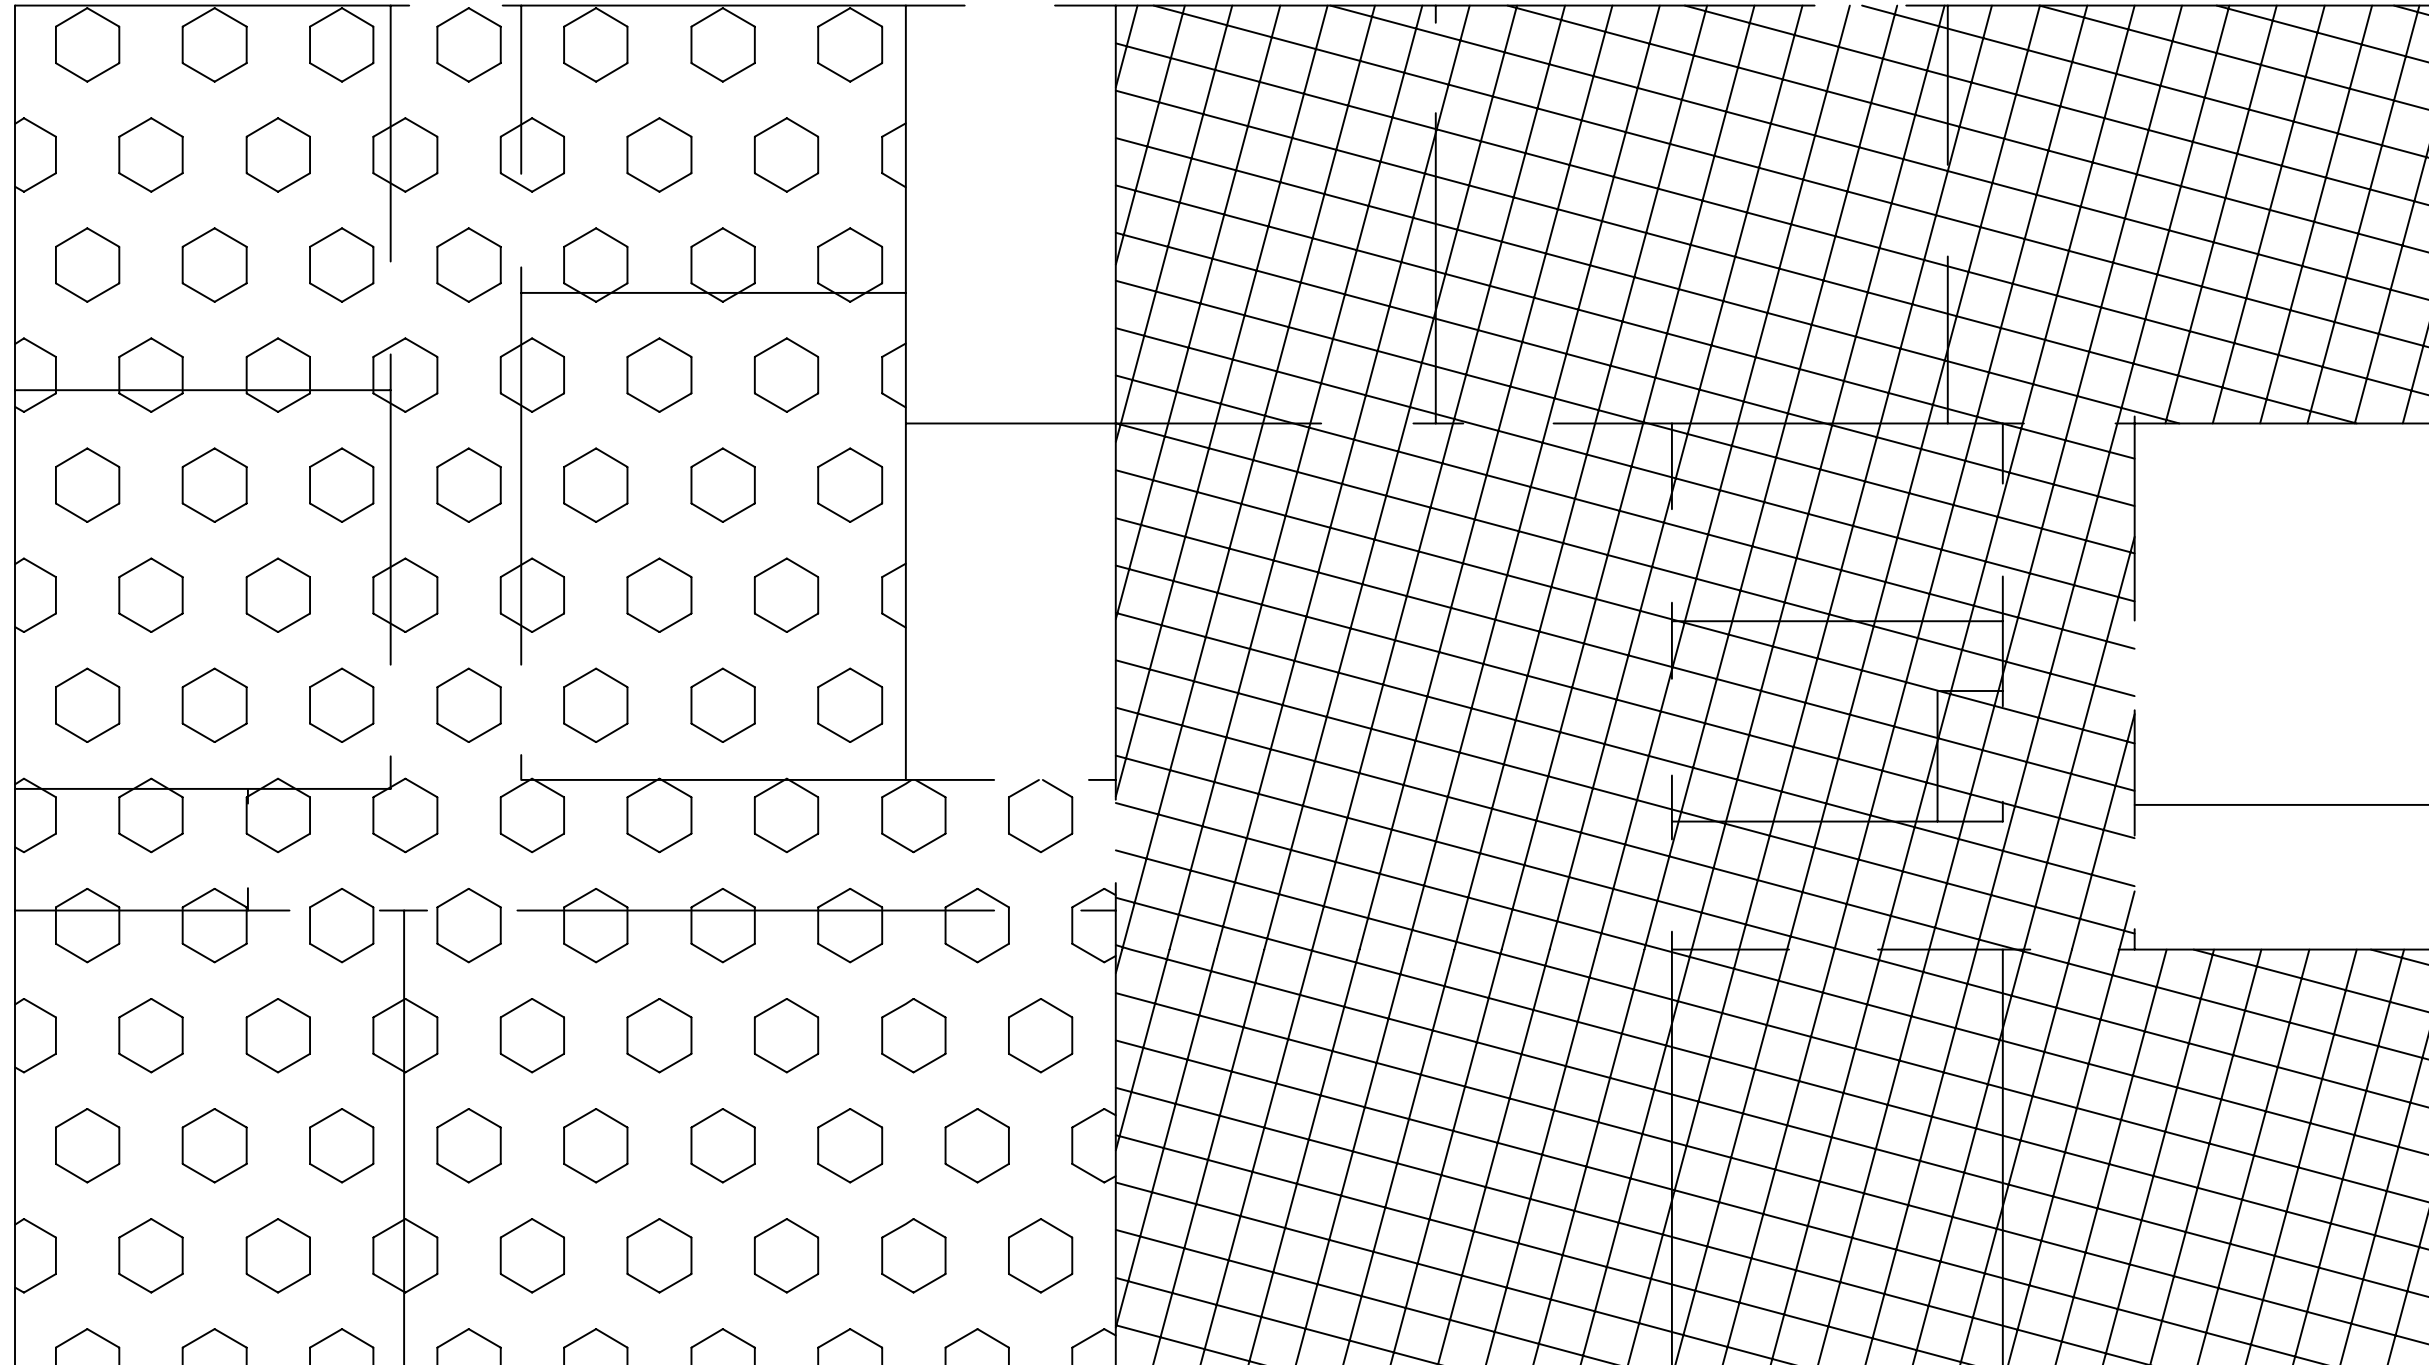
ASBESTOS-CONTAINING FLOOR TILE AND MASTIC  
 (BELOW CARPET)

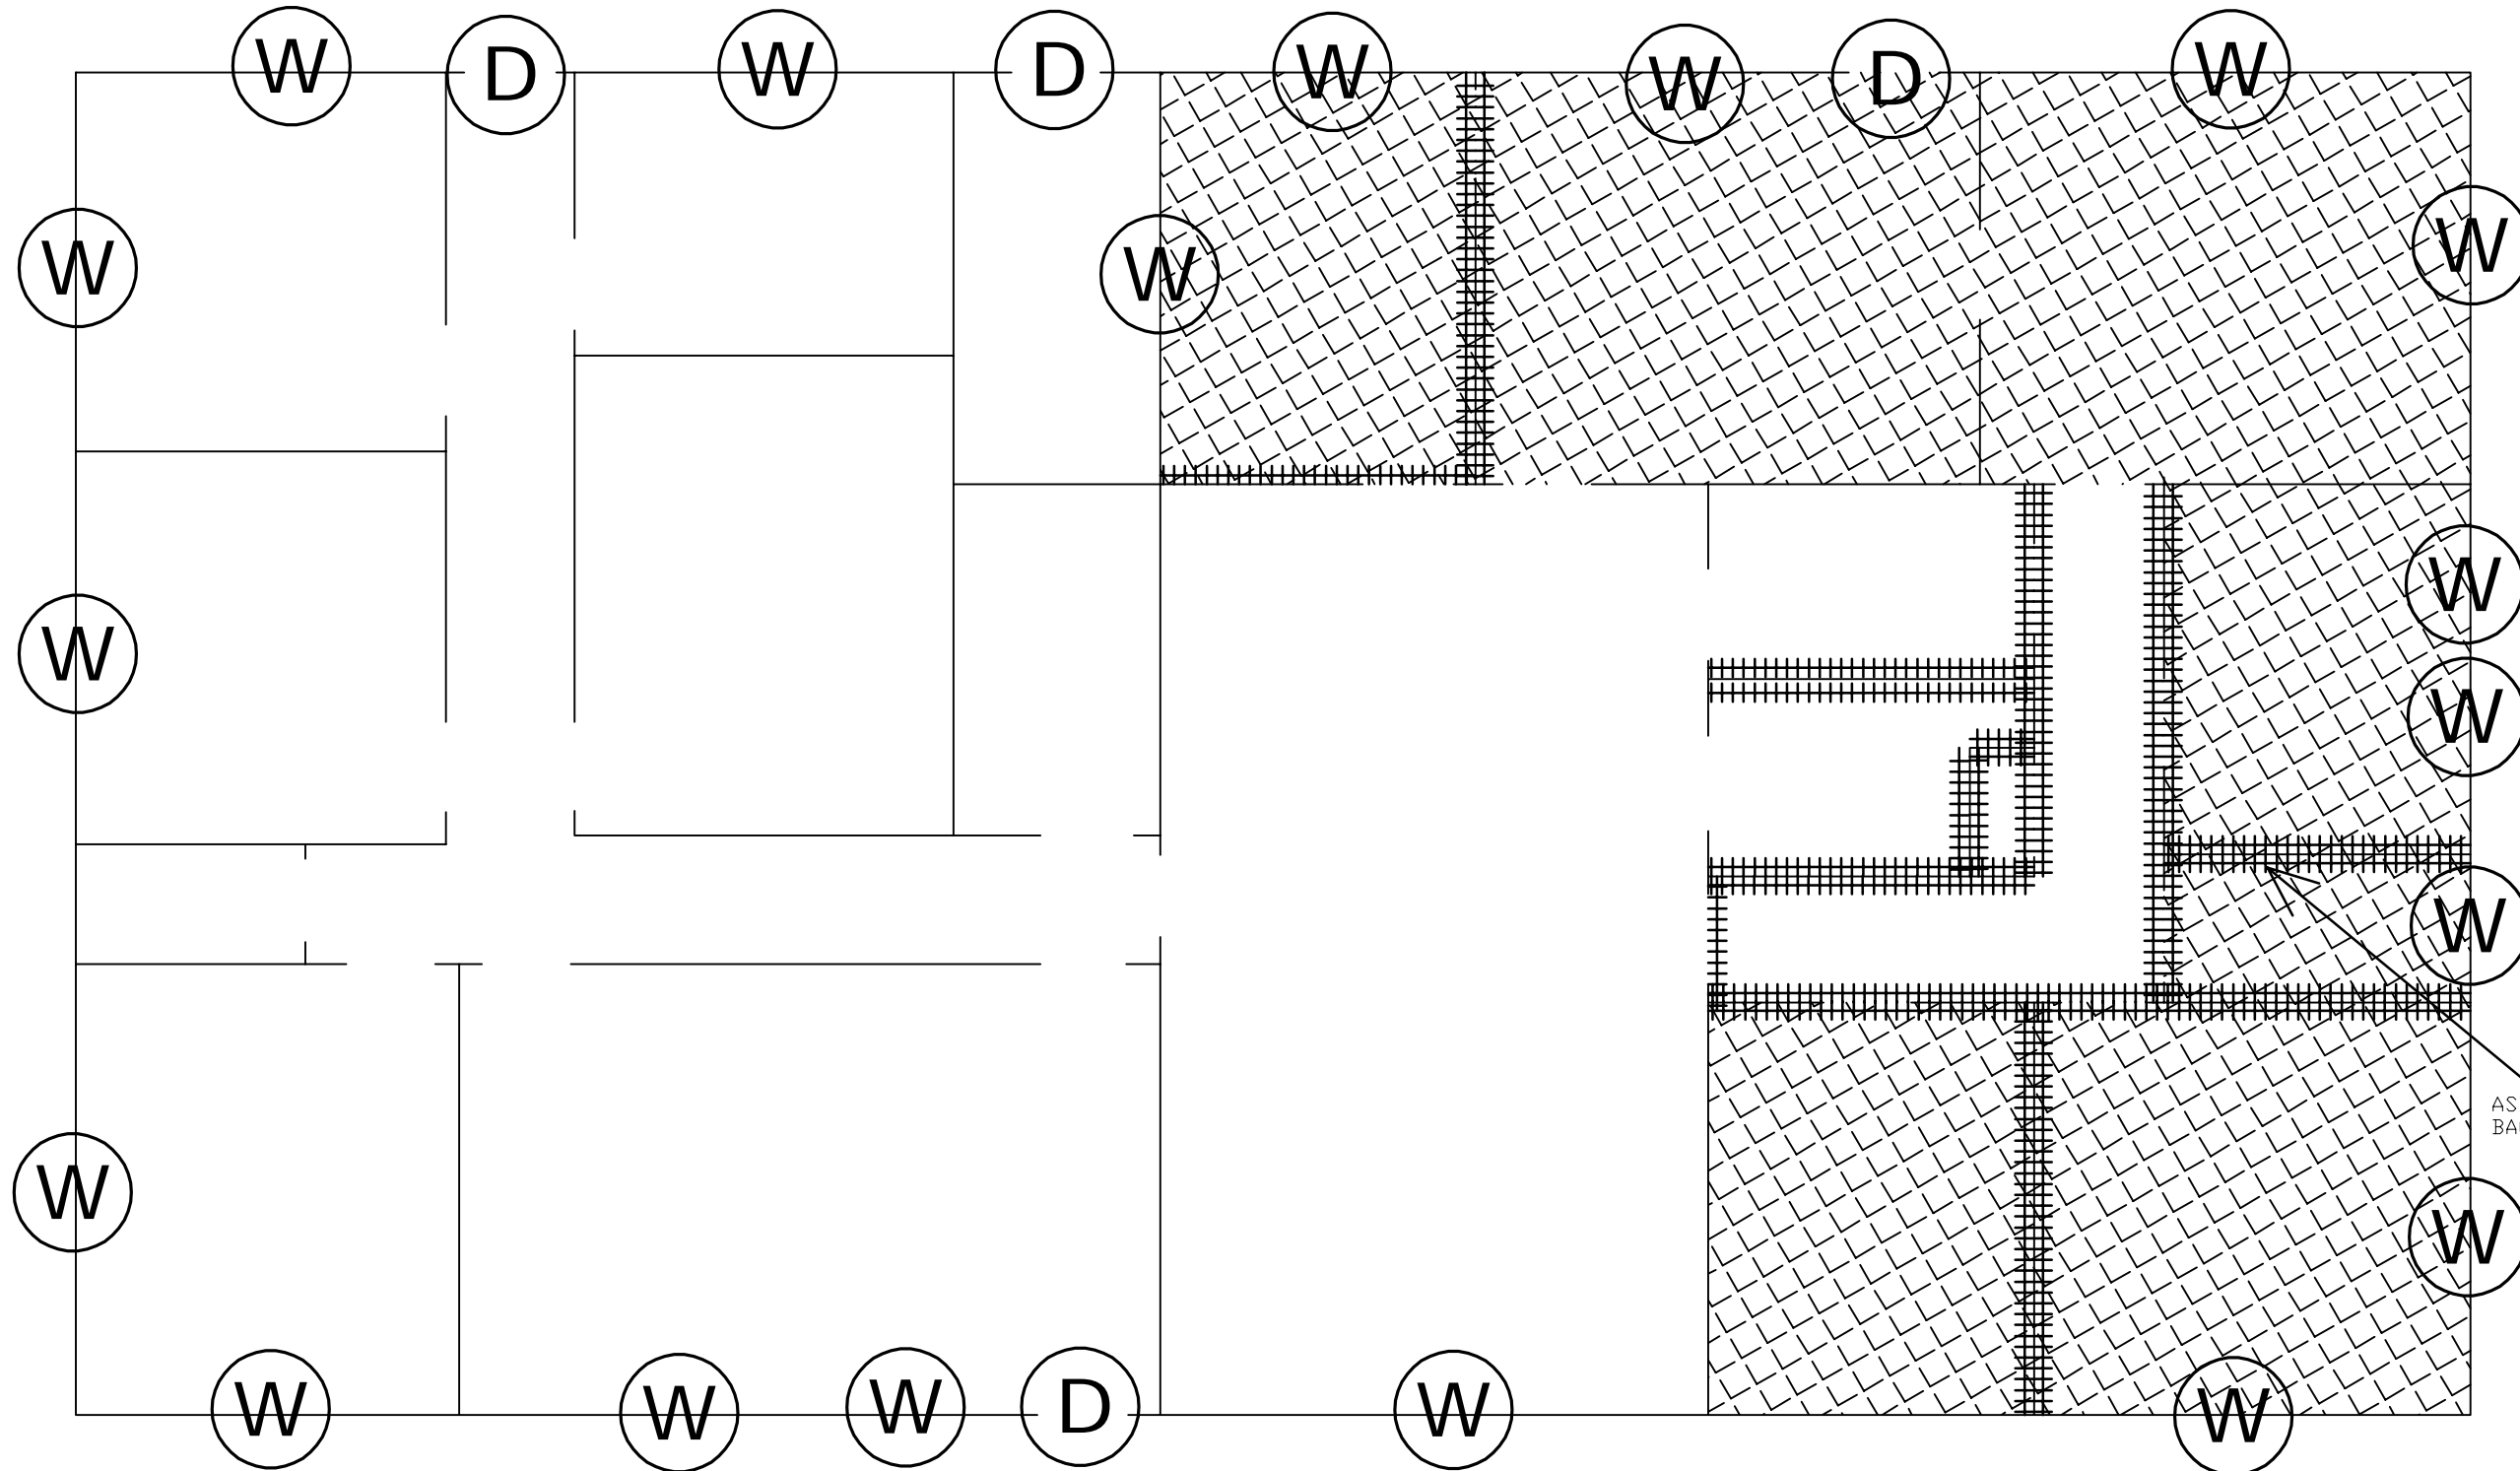
ASBESTOS-CONTAINING DOOR FRAME CAULK

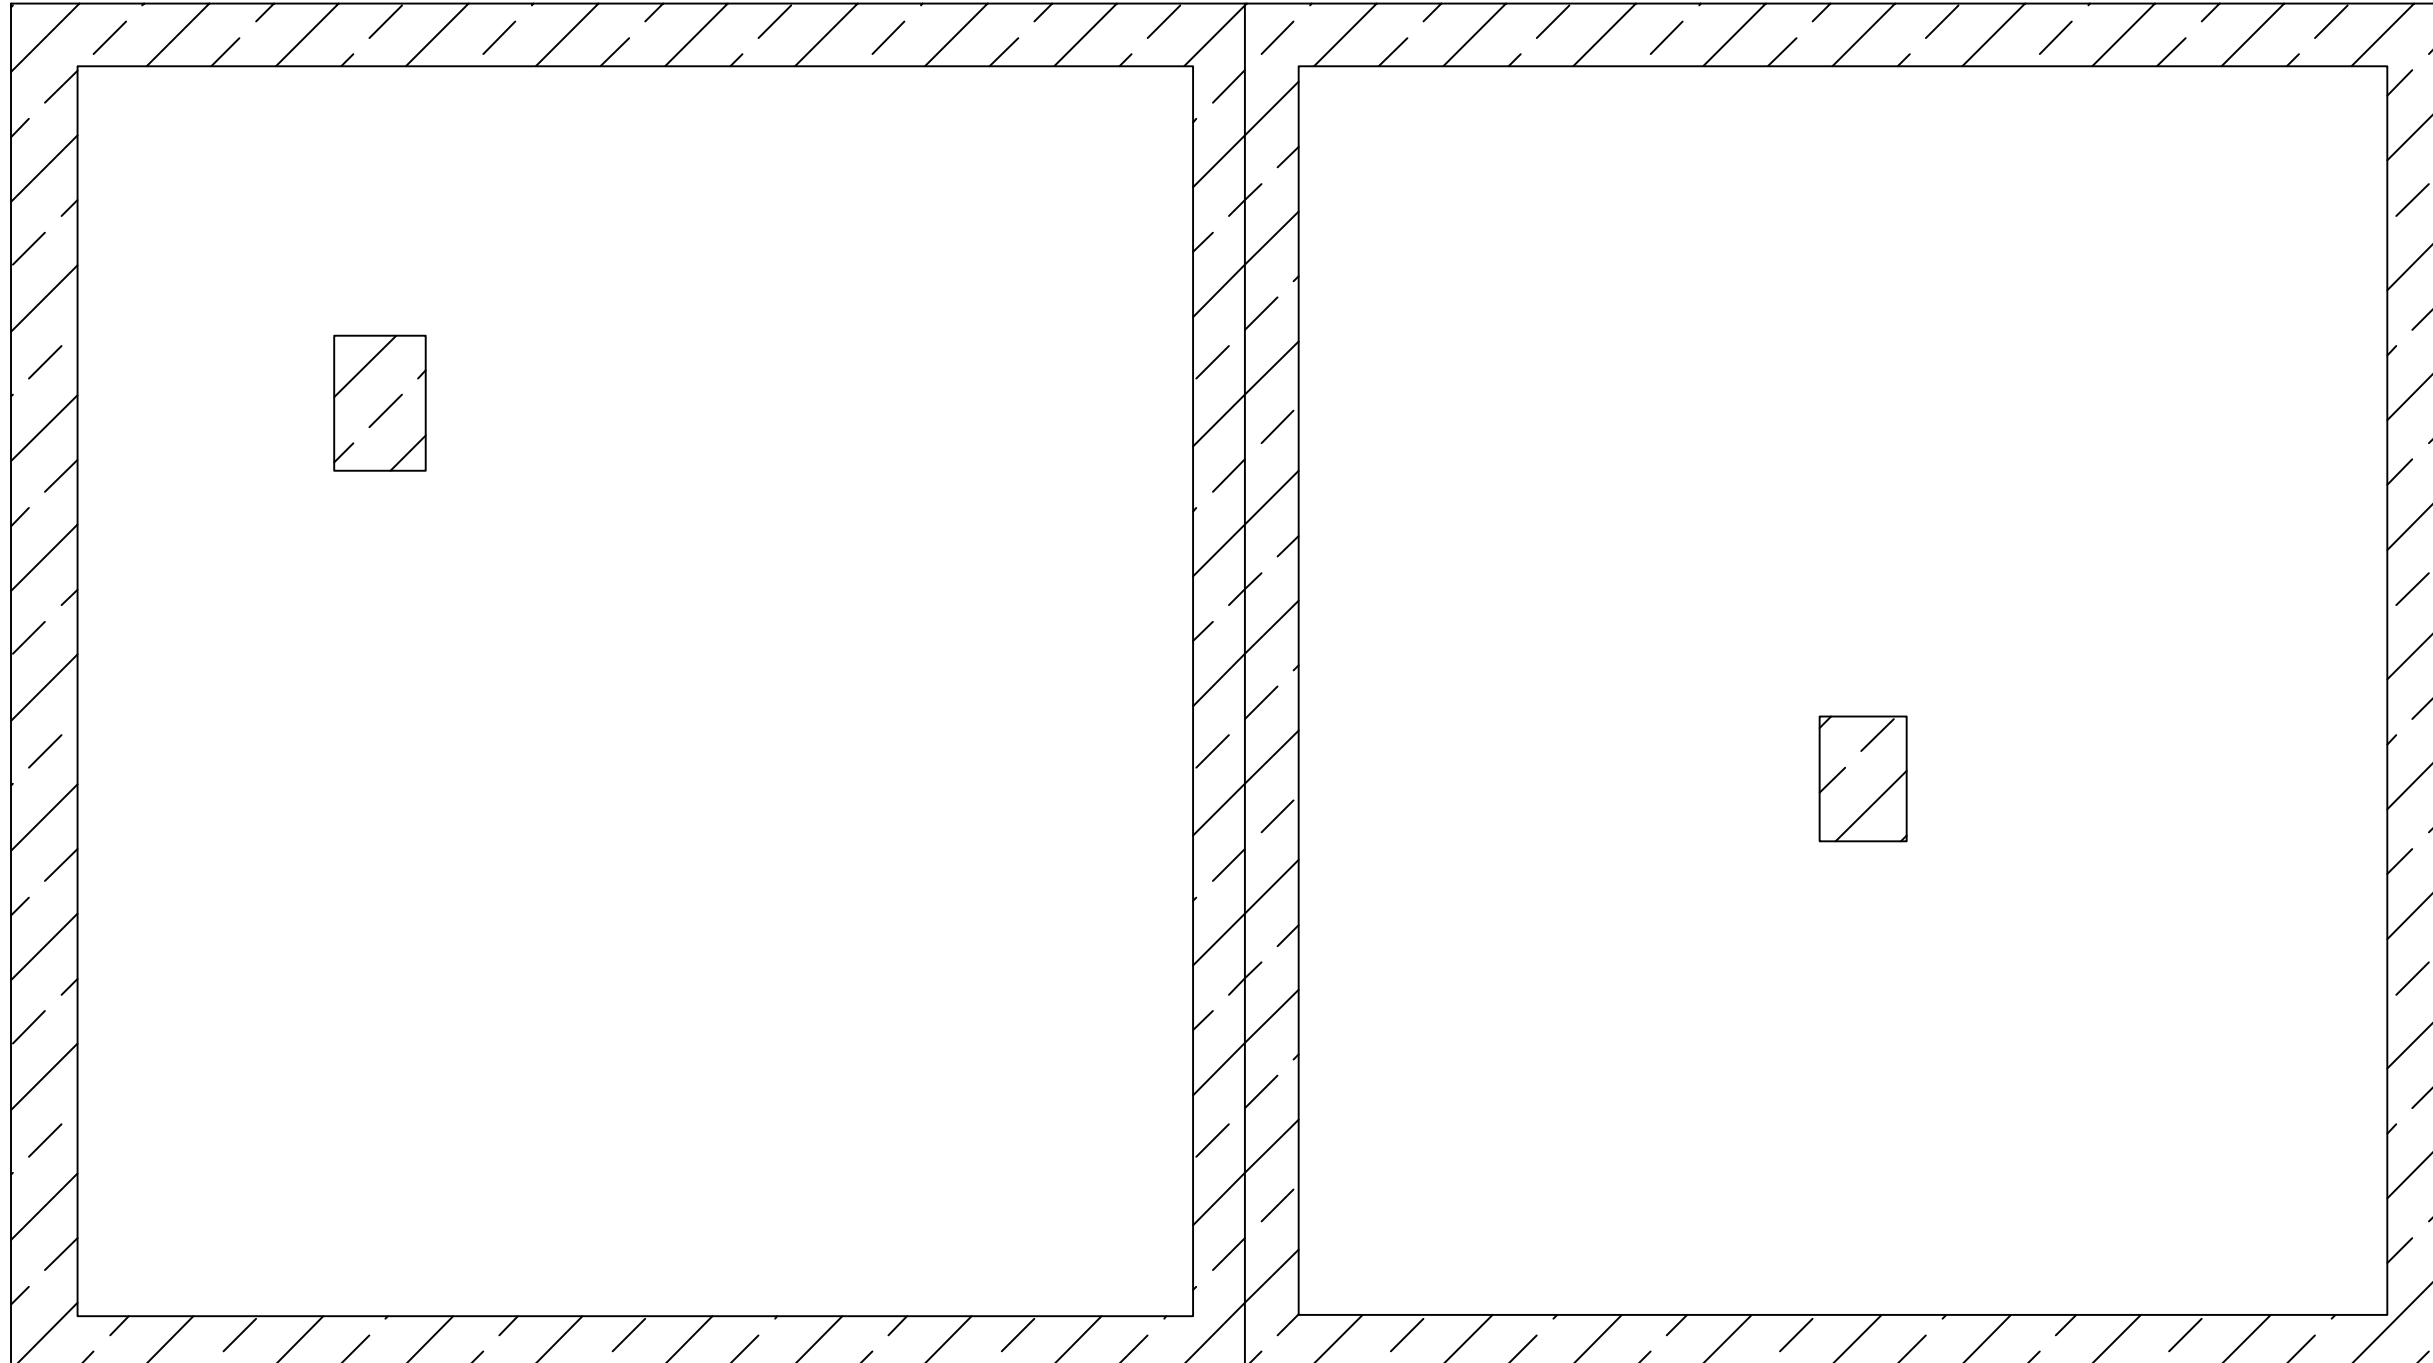
ASBESTOS-CONTAINING ROOF FLASHING, SILVER  
 COATING AND GREY ROOF CAULK

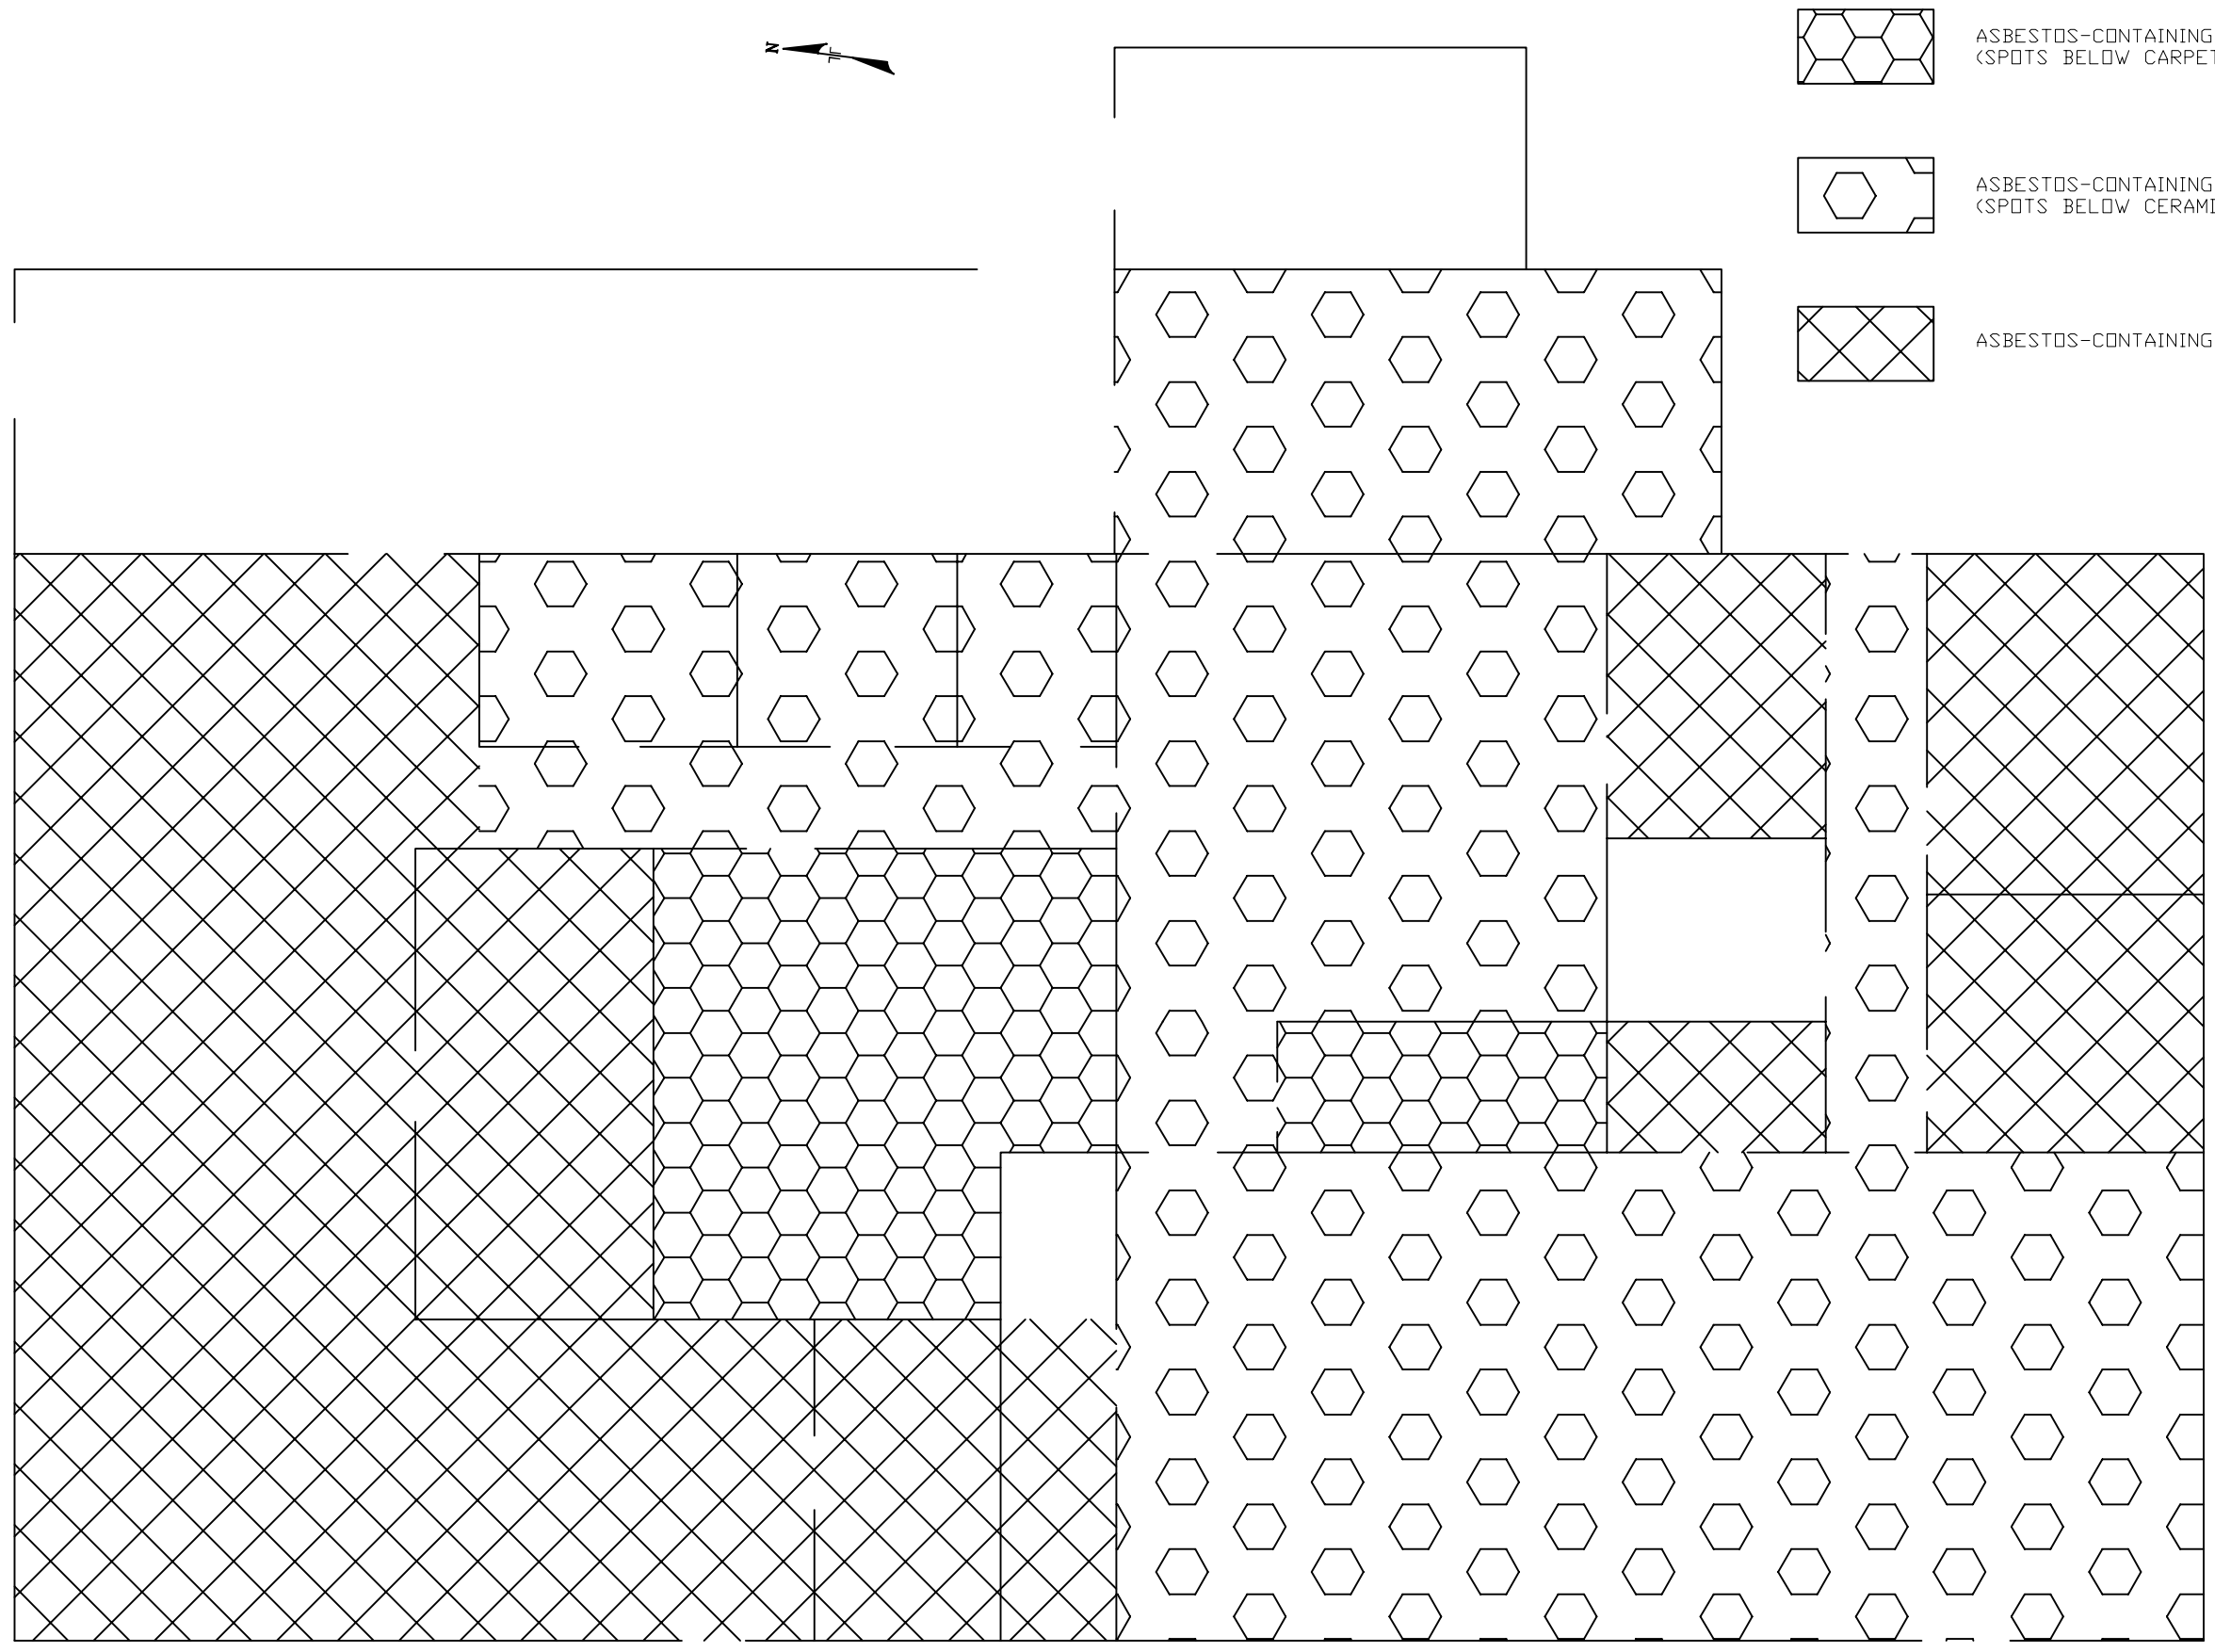
IDENTIFIED ASBESTOS-CONTAINING MATERIALS  
 BUILDING 2 - 1ST FLOOR - FLOORING

ASBESTOS-CONTAINING FLOOR MASTIC  
 (SPOTS BELOW CARPET)

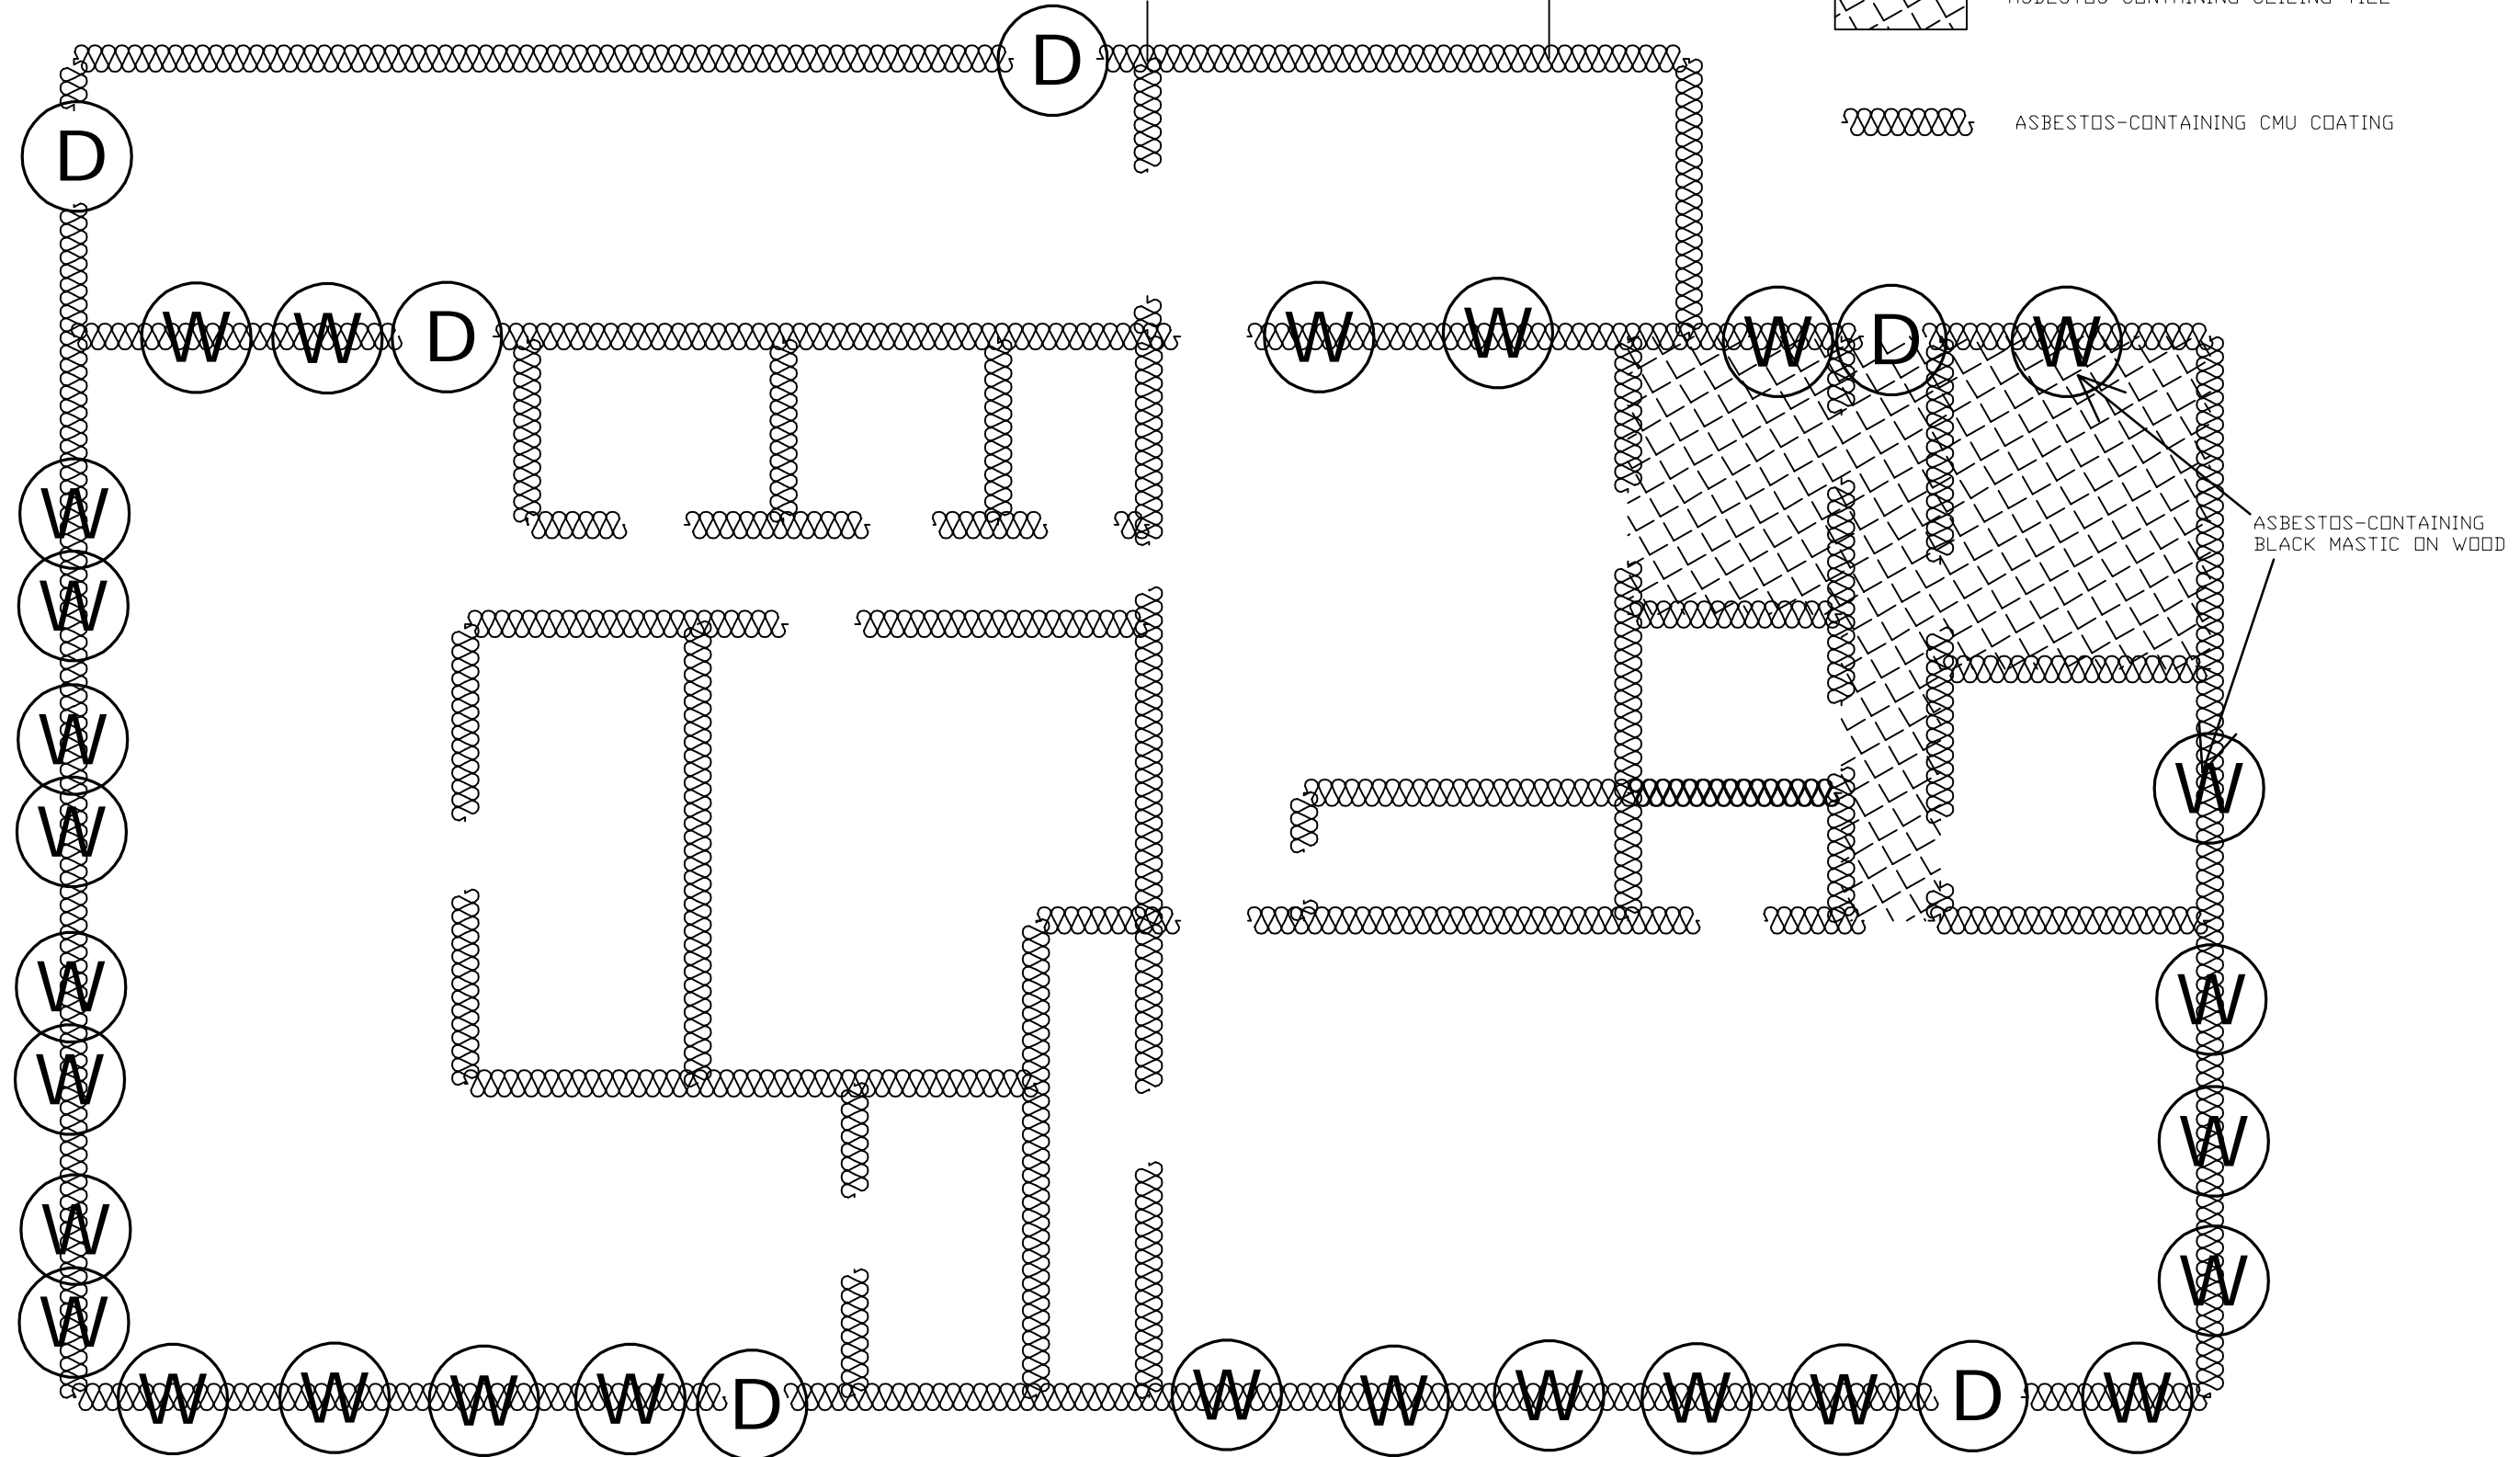
ASBESTOS-CONTAINING CMU COATING

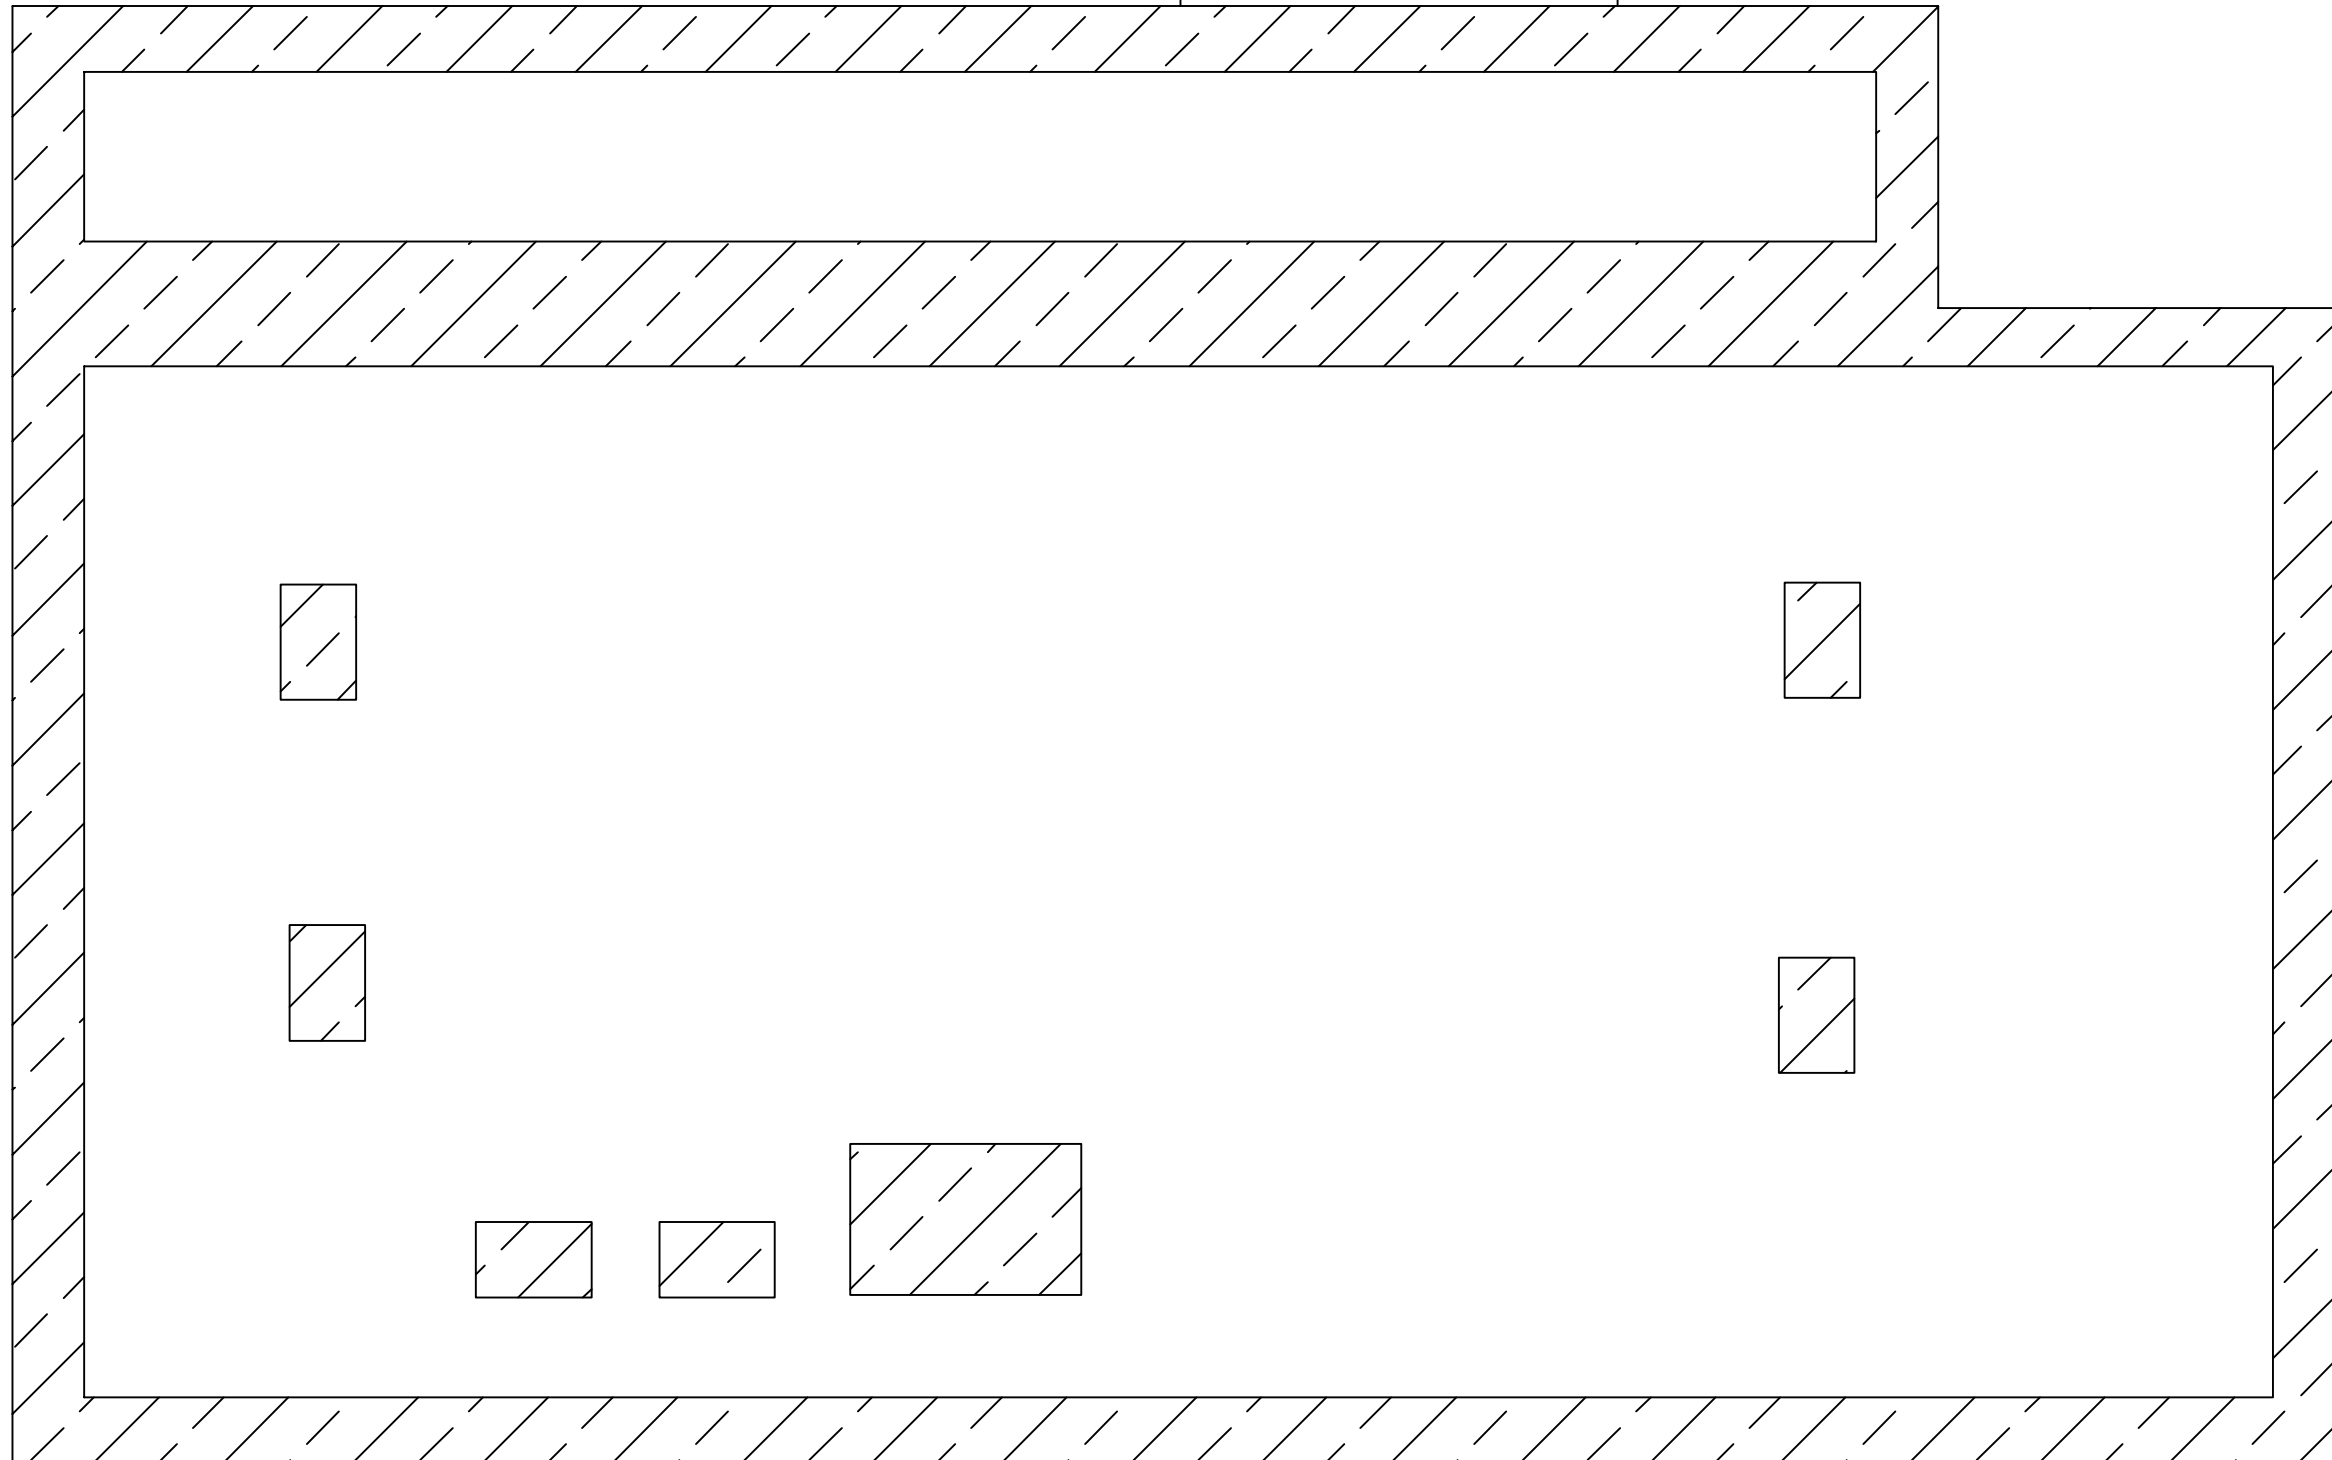
ASBESTOS-CONTAINING ROOF FLASHING, SILVER  
 ROOF COATING AND BLACK ROOF TAR
