Job Name: Crompton and Knowles  
 Job Number: 71187168  
 Area: Building 7

FORMER CROMPTON AND KNOWLES SITE  
 1602 N. MAIN STREET  
 CHARLOTTE, NORTH CAROLINA

PROJECT NUMBER  
 71187168  
 SHEET  
 1-R

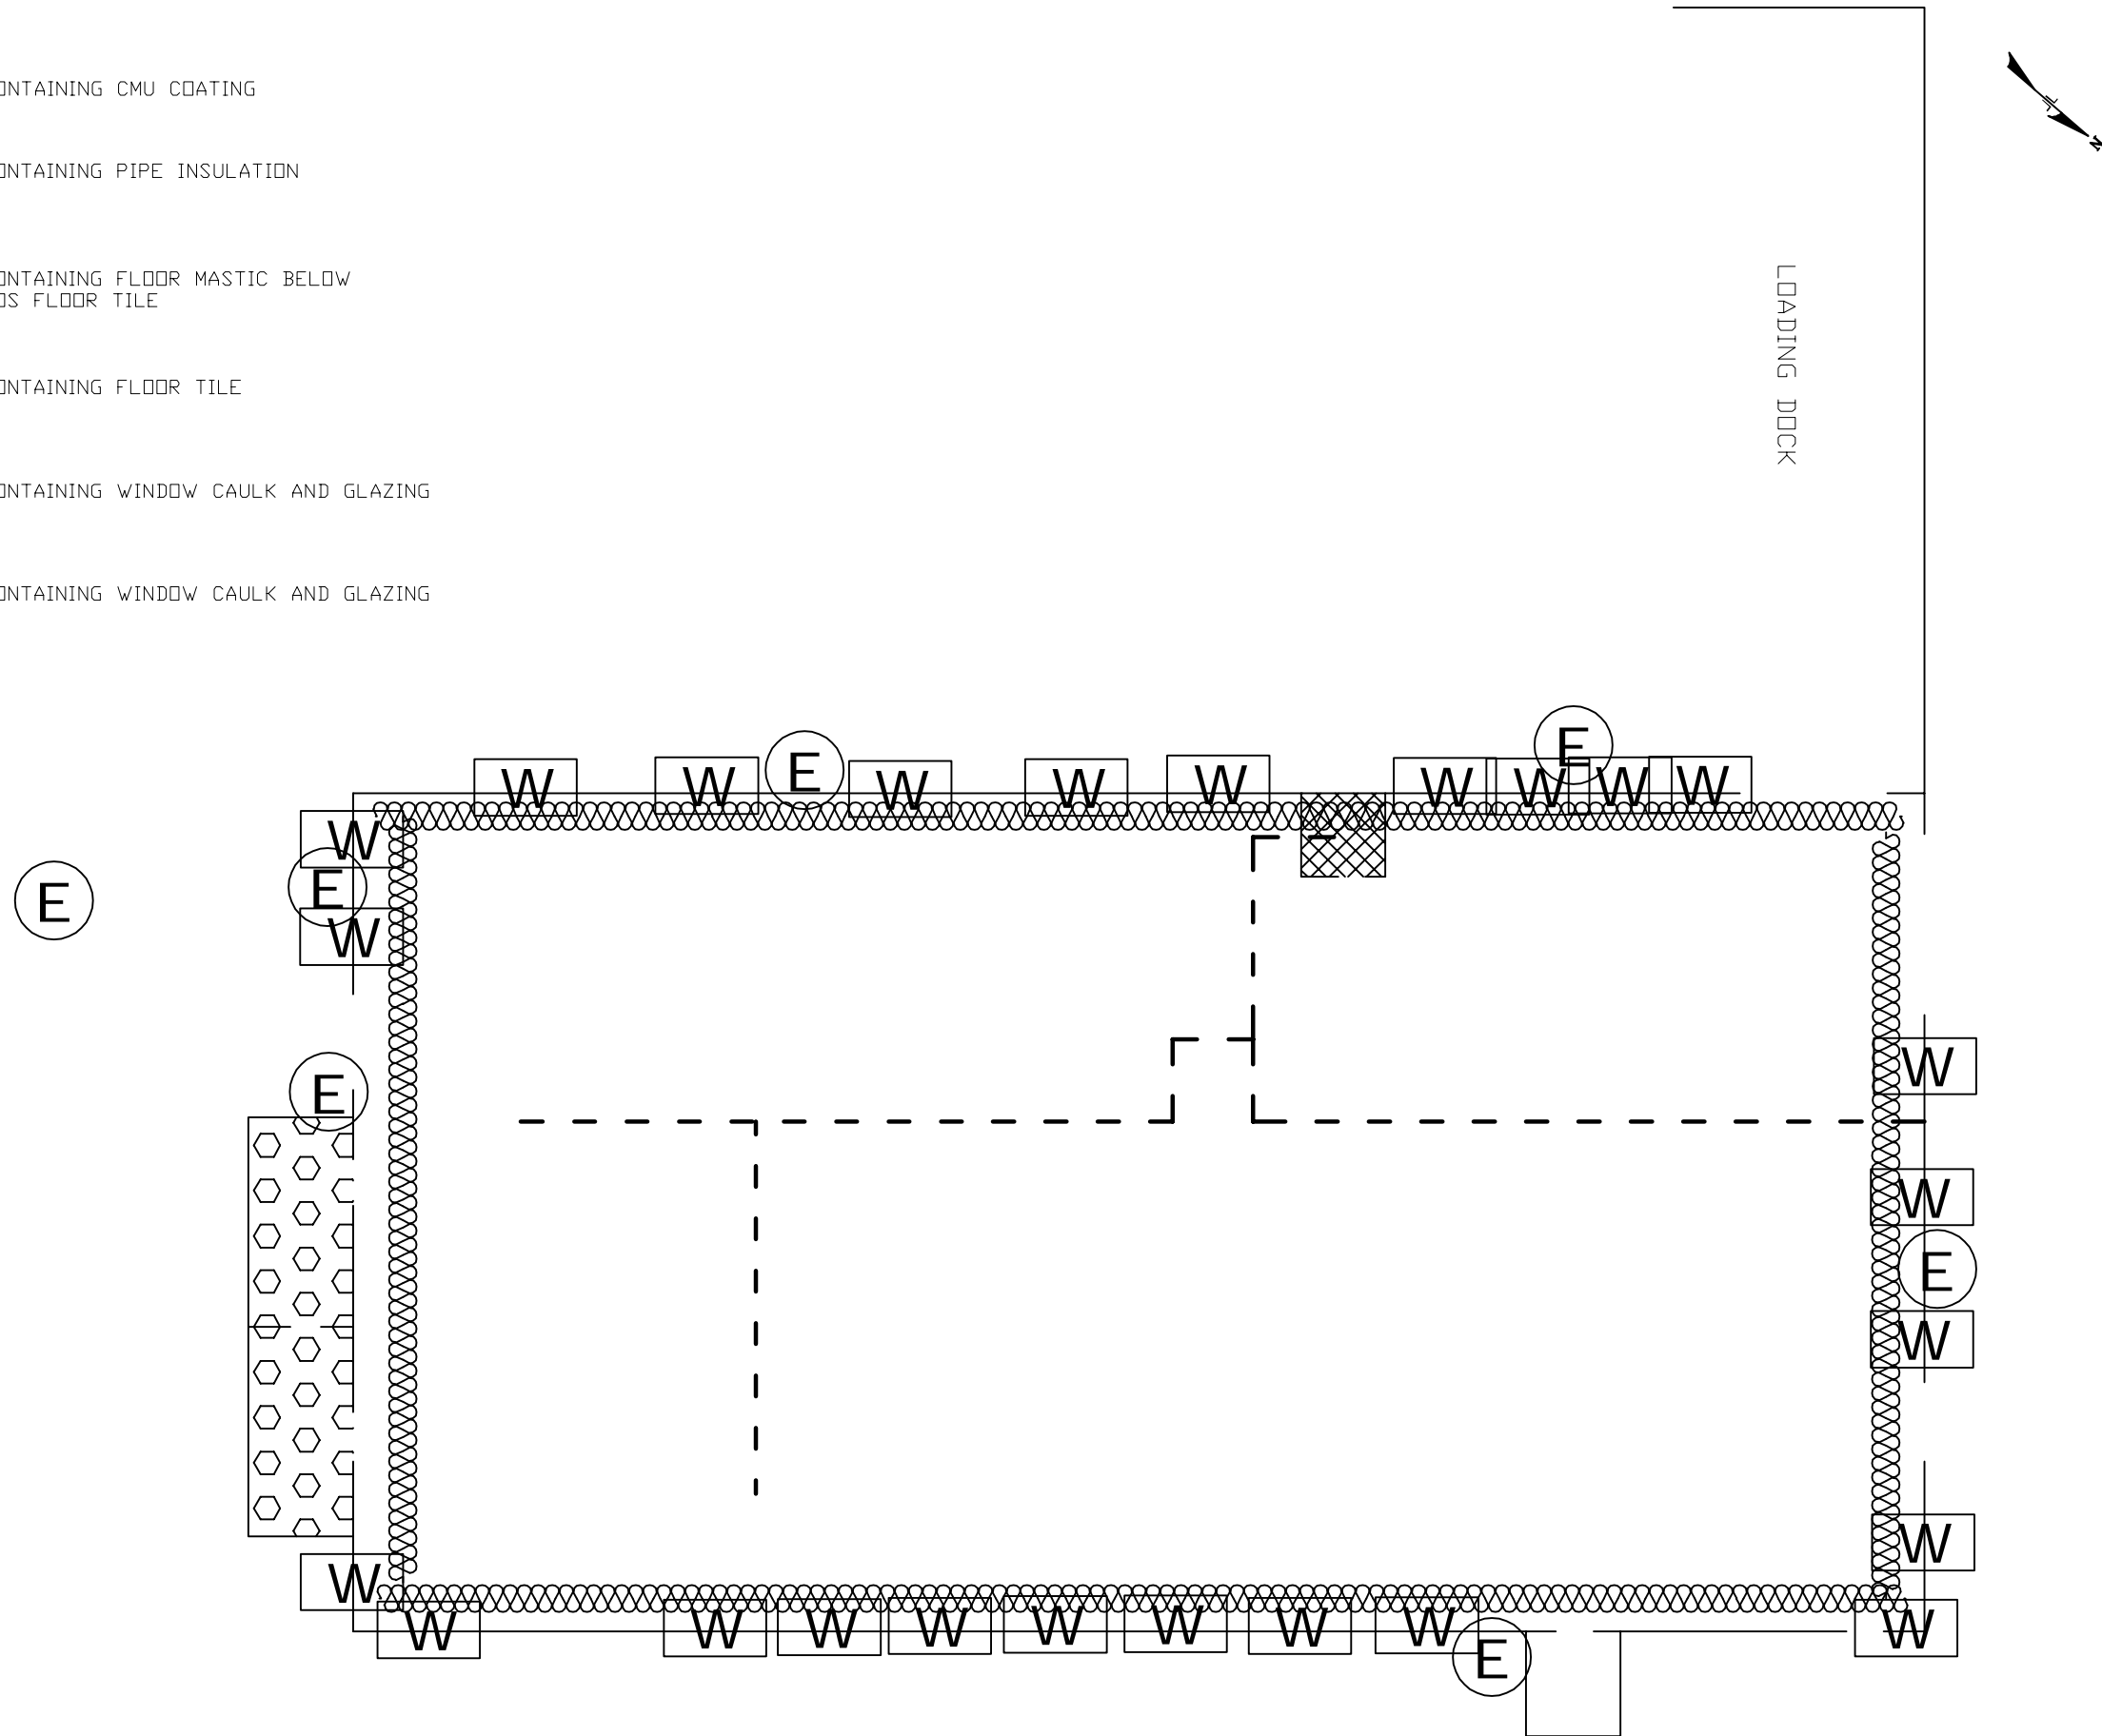
ASBESTOS-CONTAINING WINDOW CAULK AND GLAZING

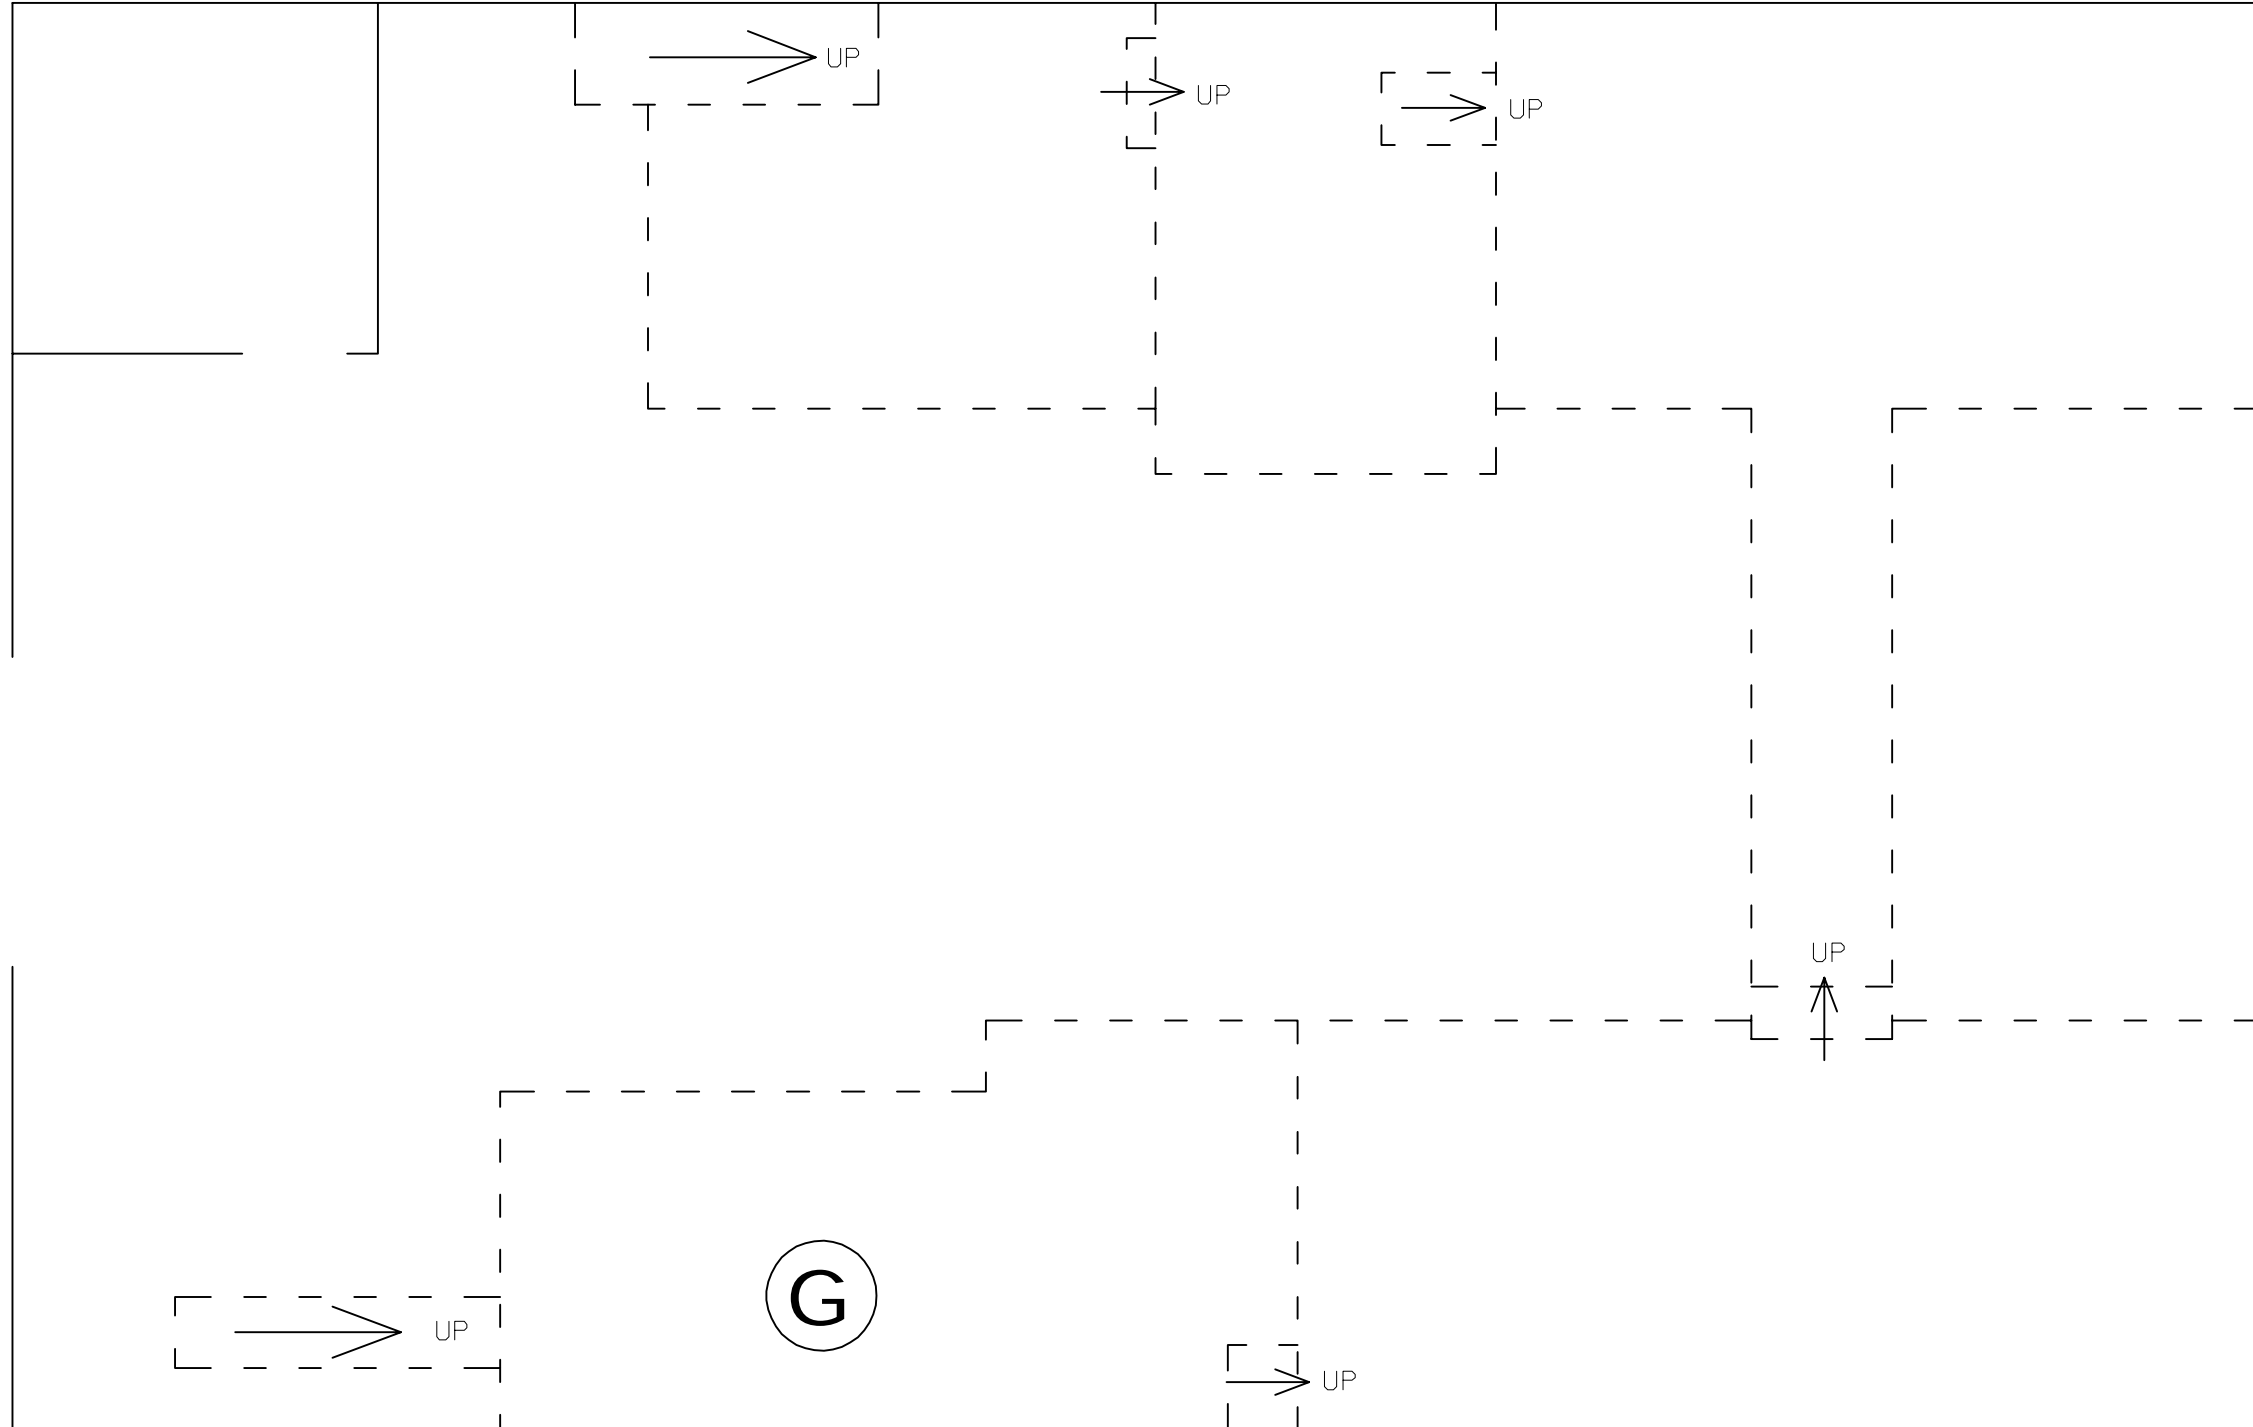
ASBESTOS-CONTAINING GASKET

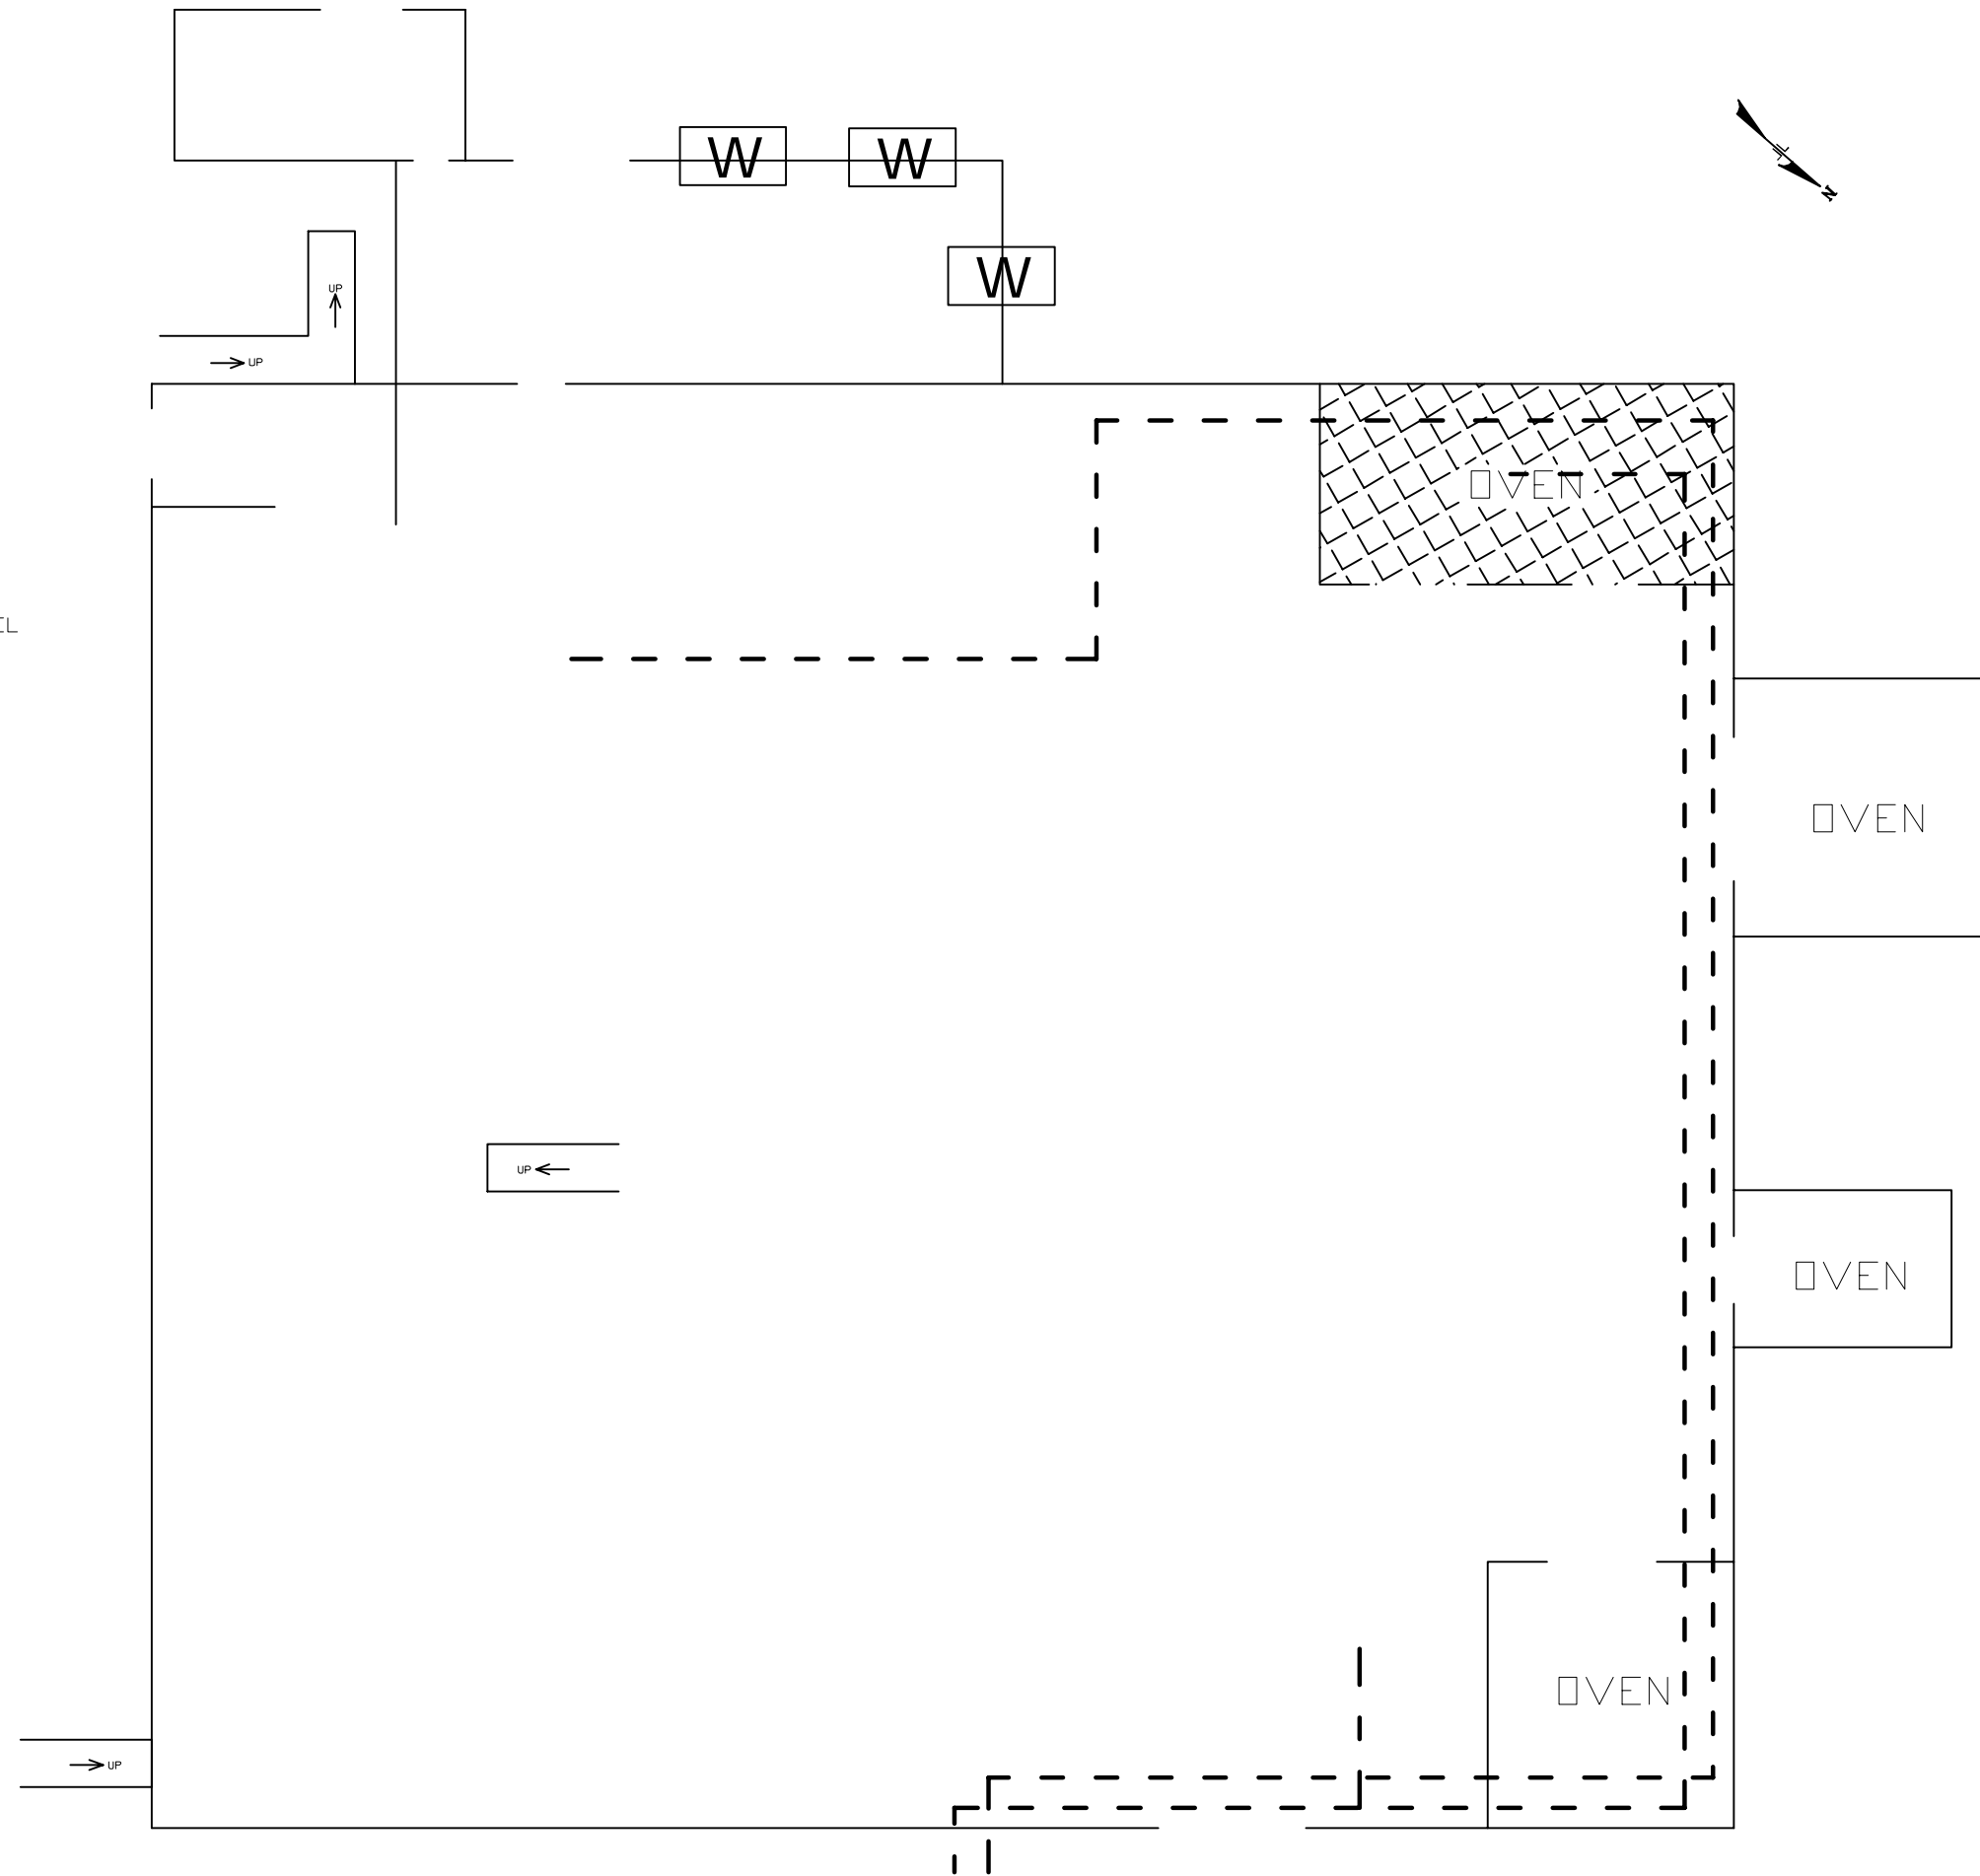
ASBESTOS-CONTAINING WINDOW GLAZING

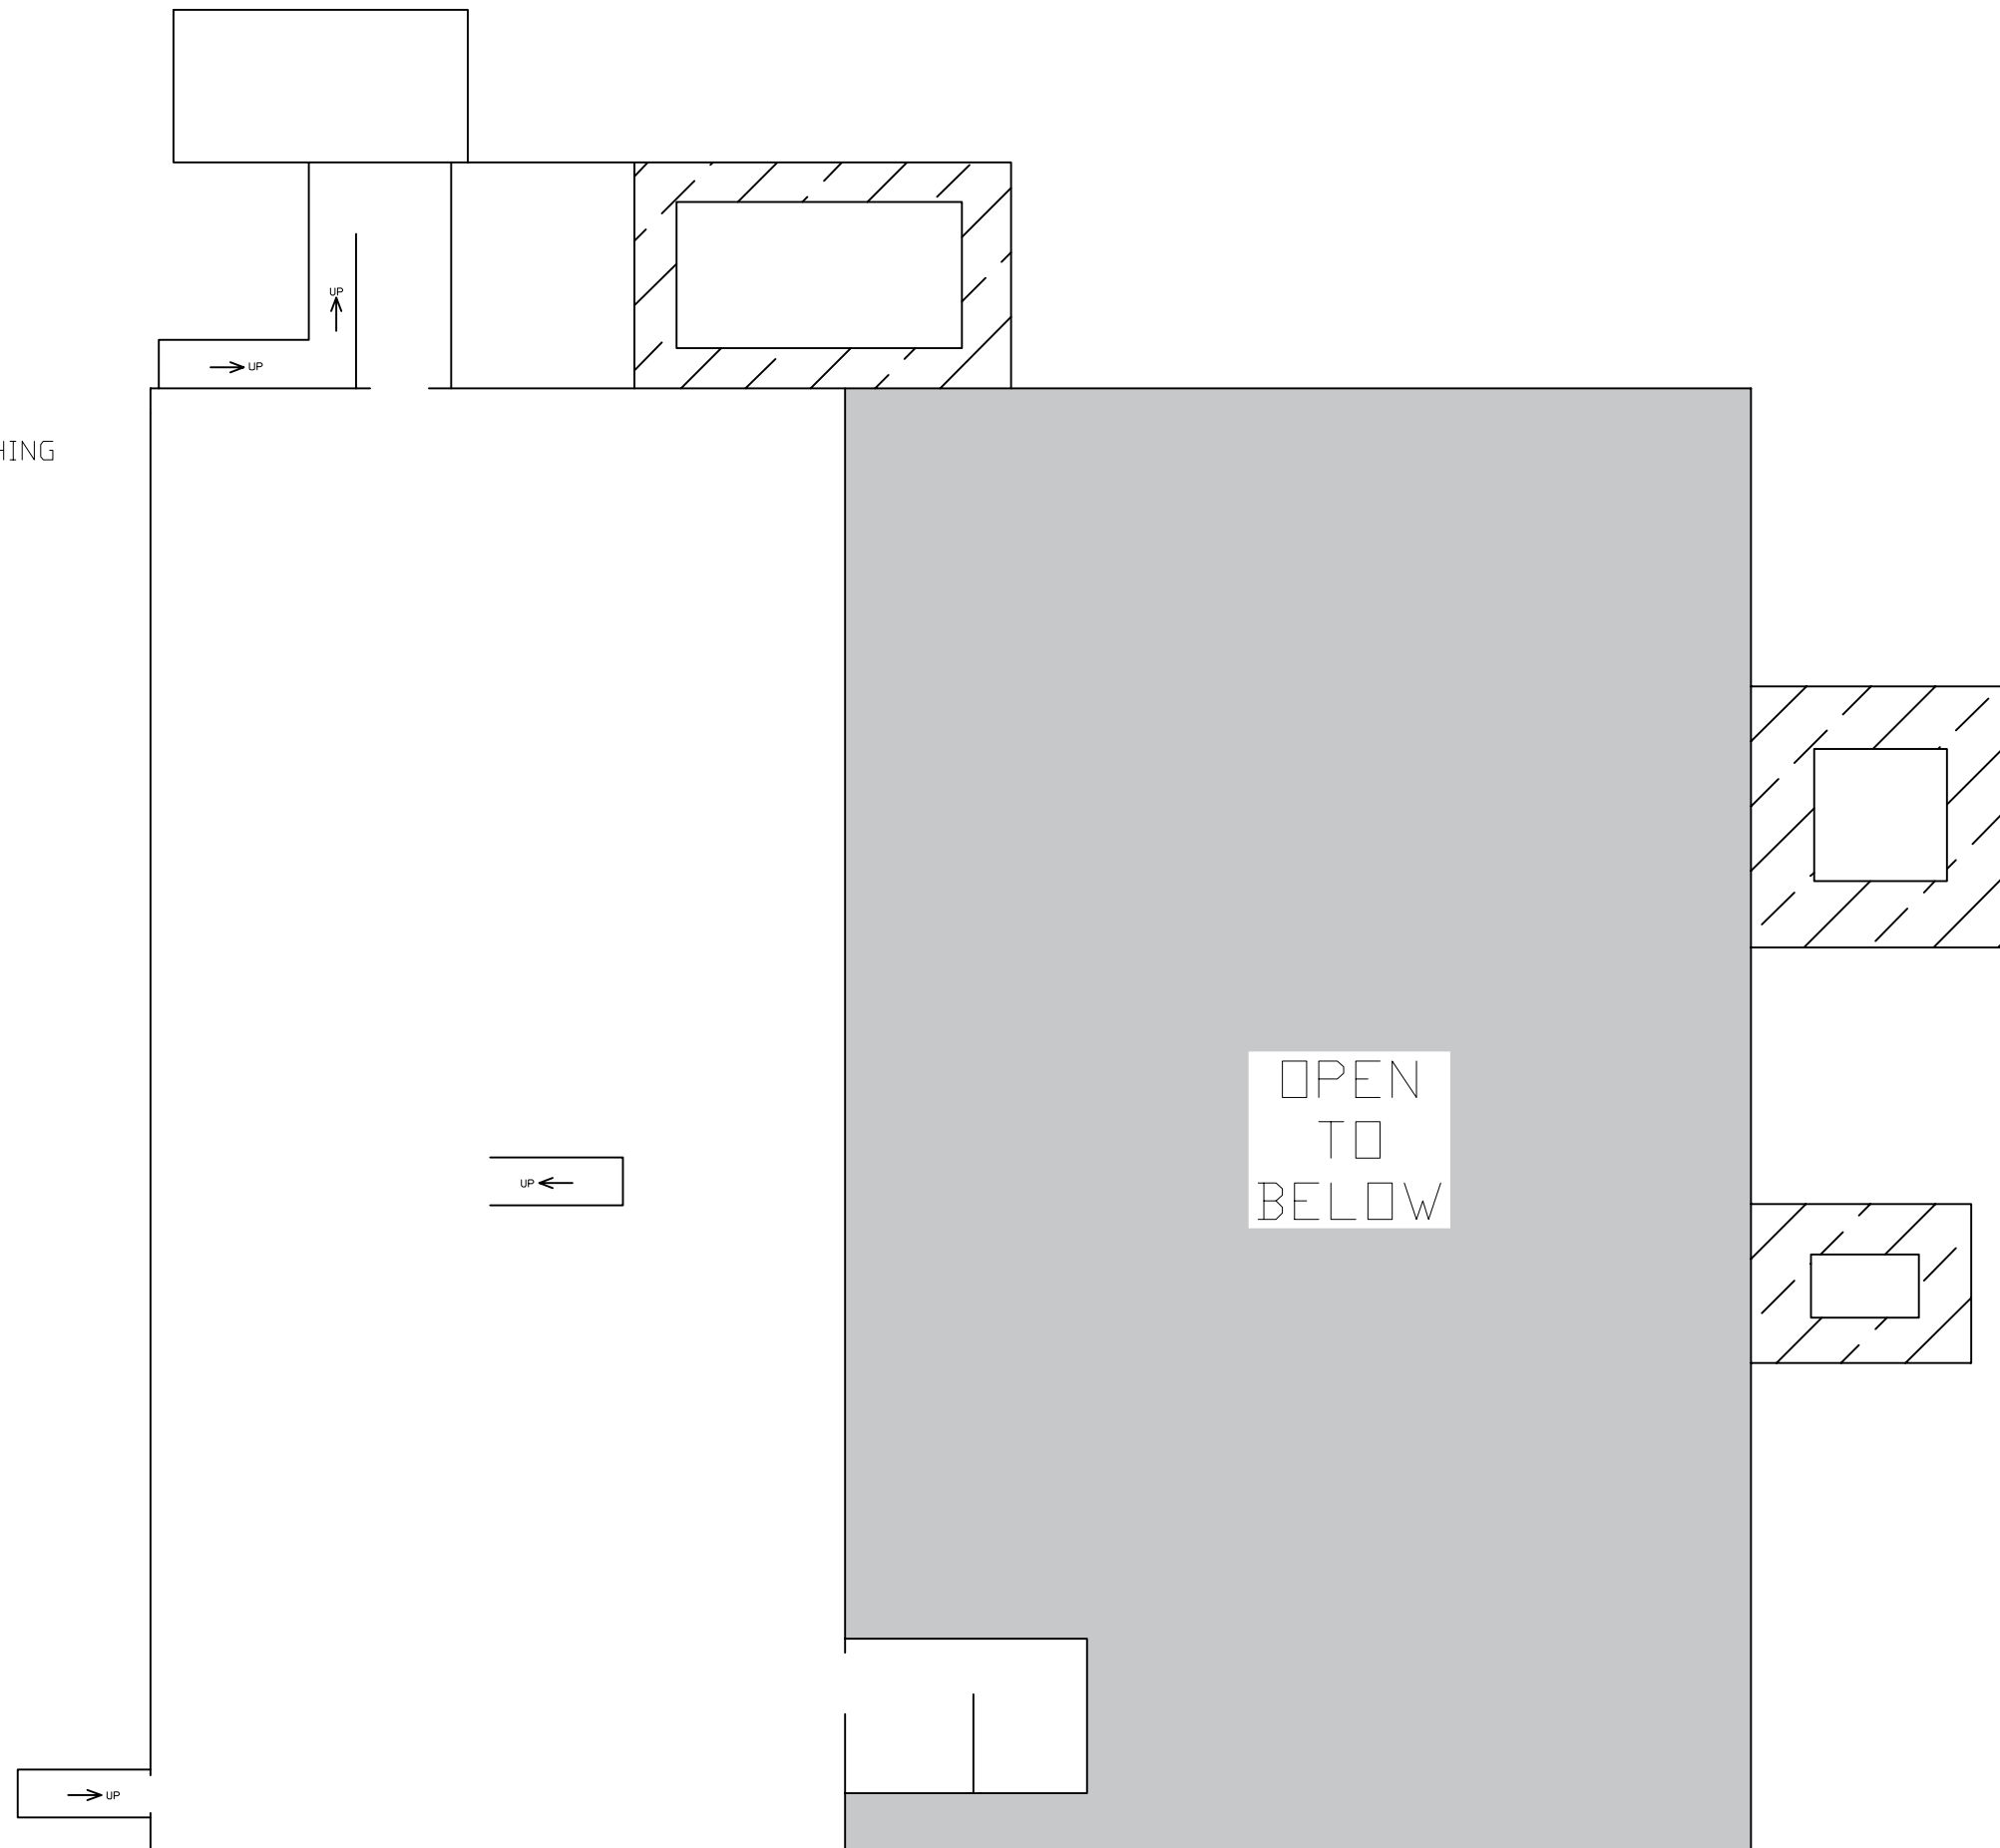
ASBESTOS-CONTAINING ROOF FLASHING

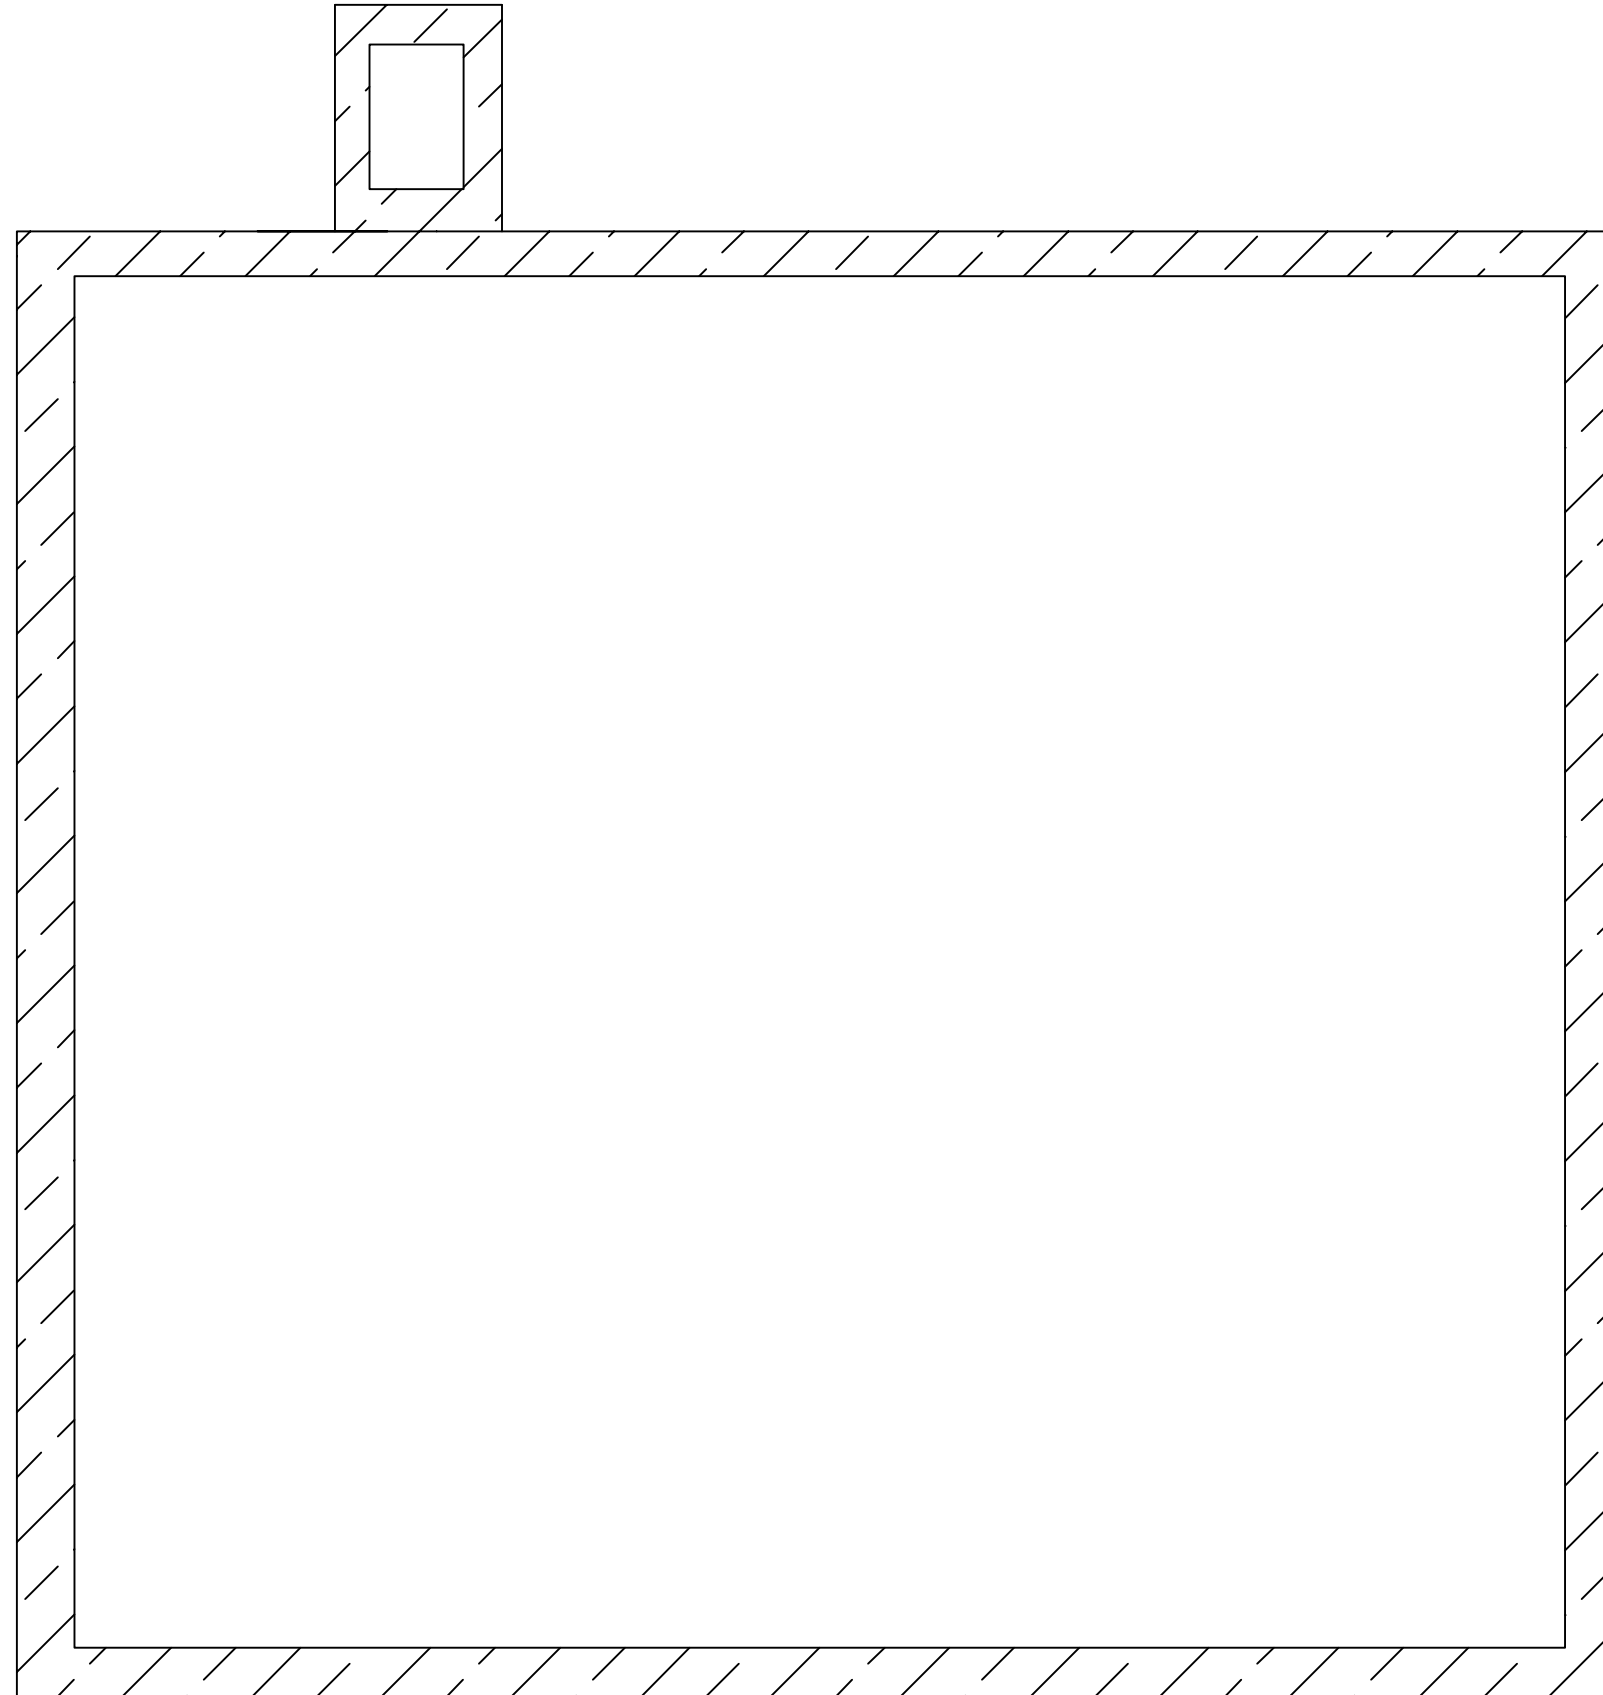
ASBESTOS-CONTAINING ROOF FLASHING

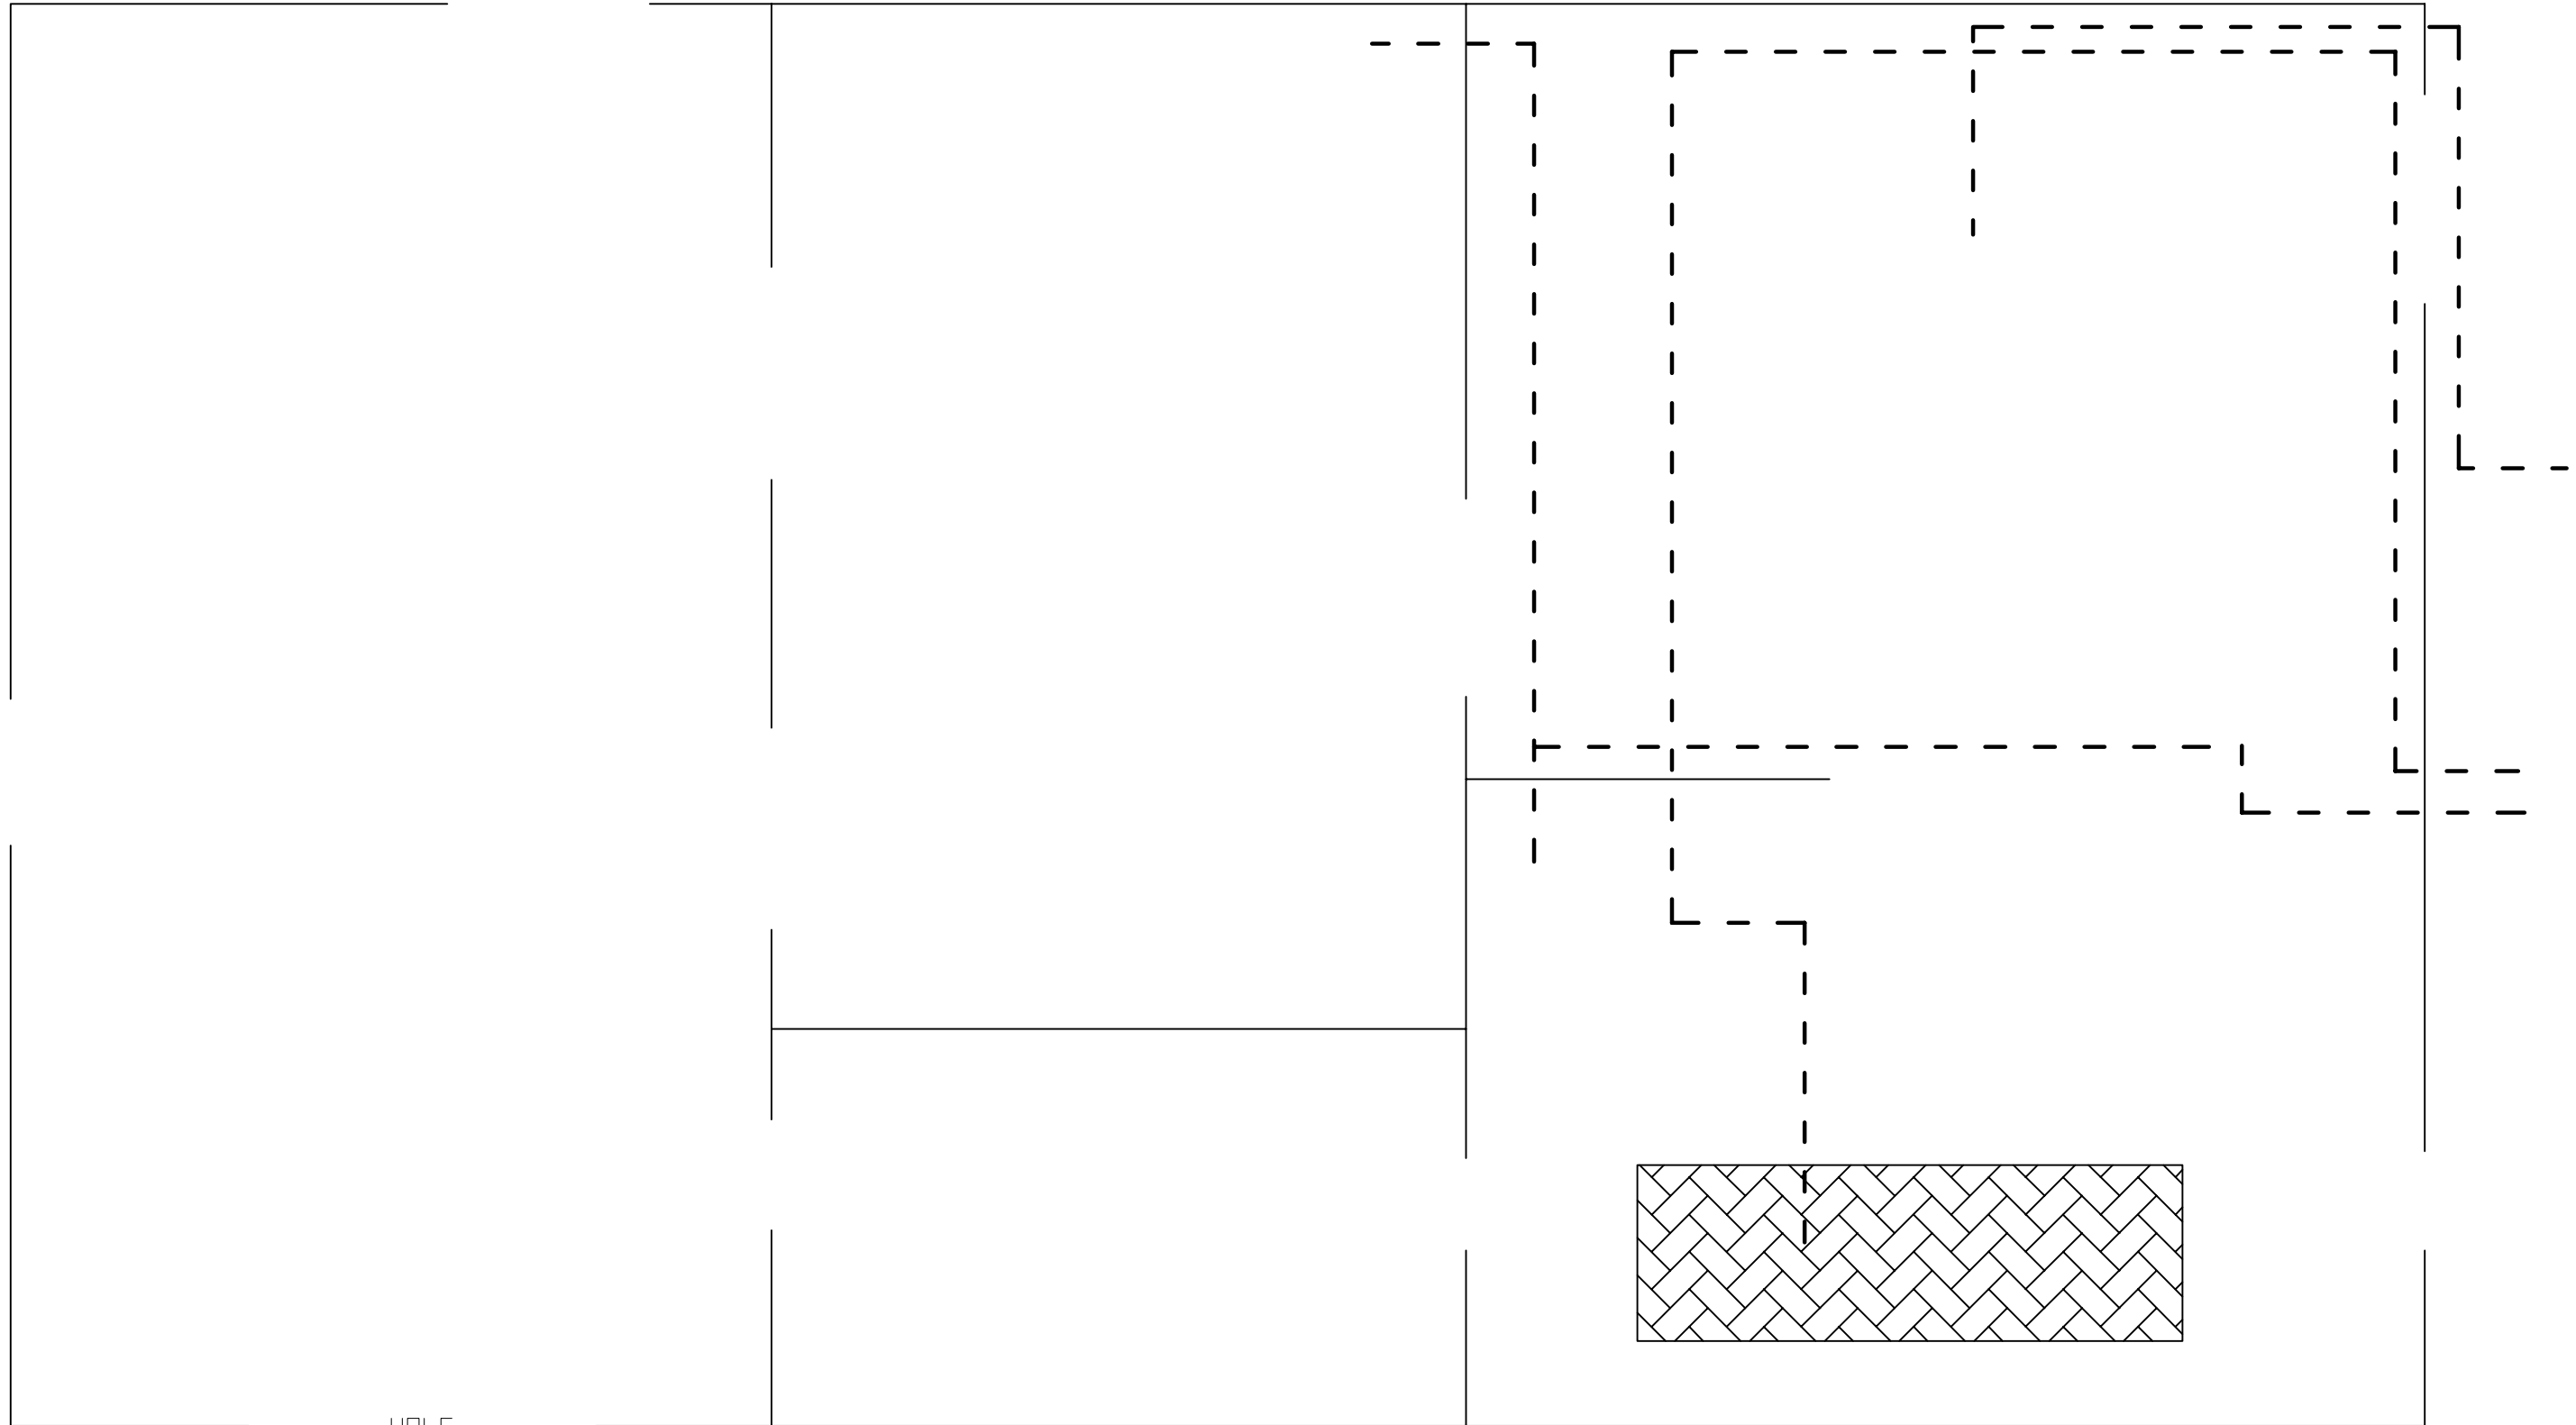
ASBESTOS-CONTAINING BOILER INSULATION
