Job Name: Crompton and Knowles  
 Job Number: 71187168  
 Area: Building 7

FORMER CROMPTON AND KNOWLES SITE  
 1602 N. MAIN STREET  
 CHARLOTTE, NORTH CAROLINA

PROJECT NUMBER  
 71187168  
 SHEET  
 1-R

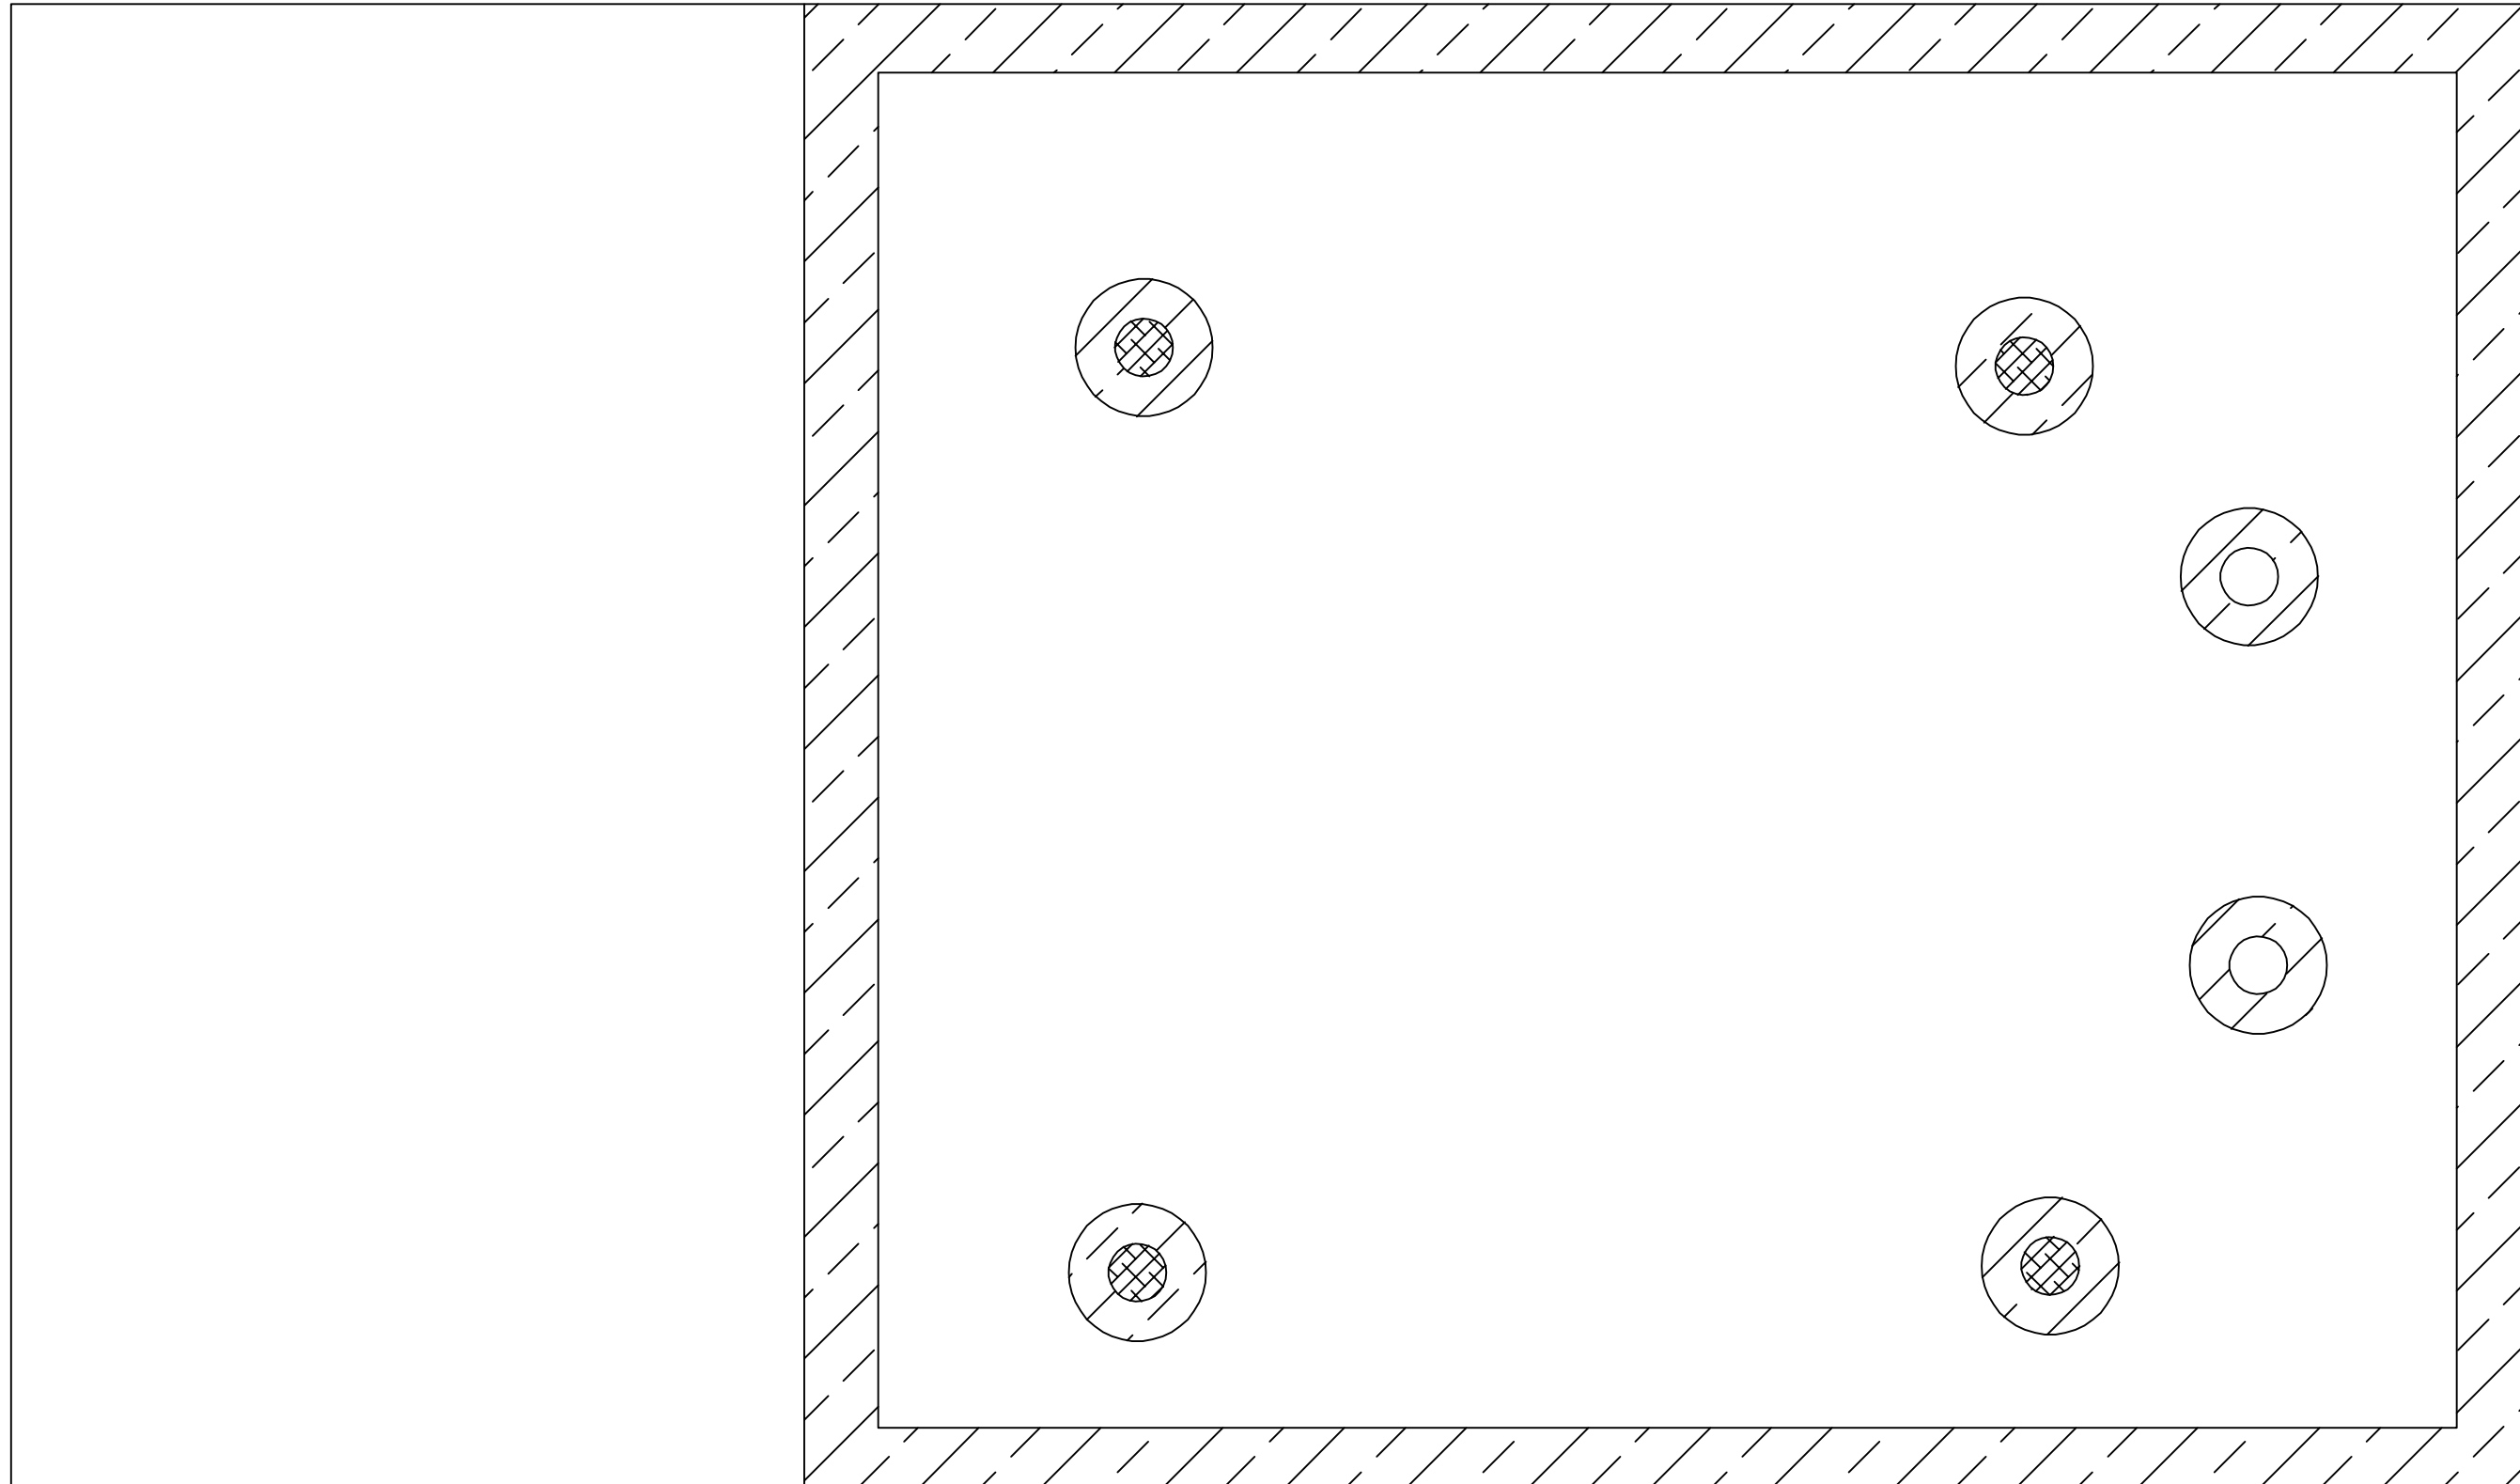
ASBESTOS-CONTAINING SILVER PAINT

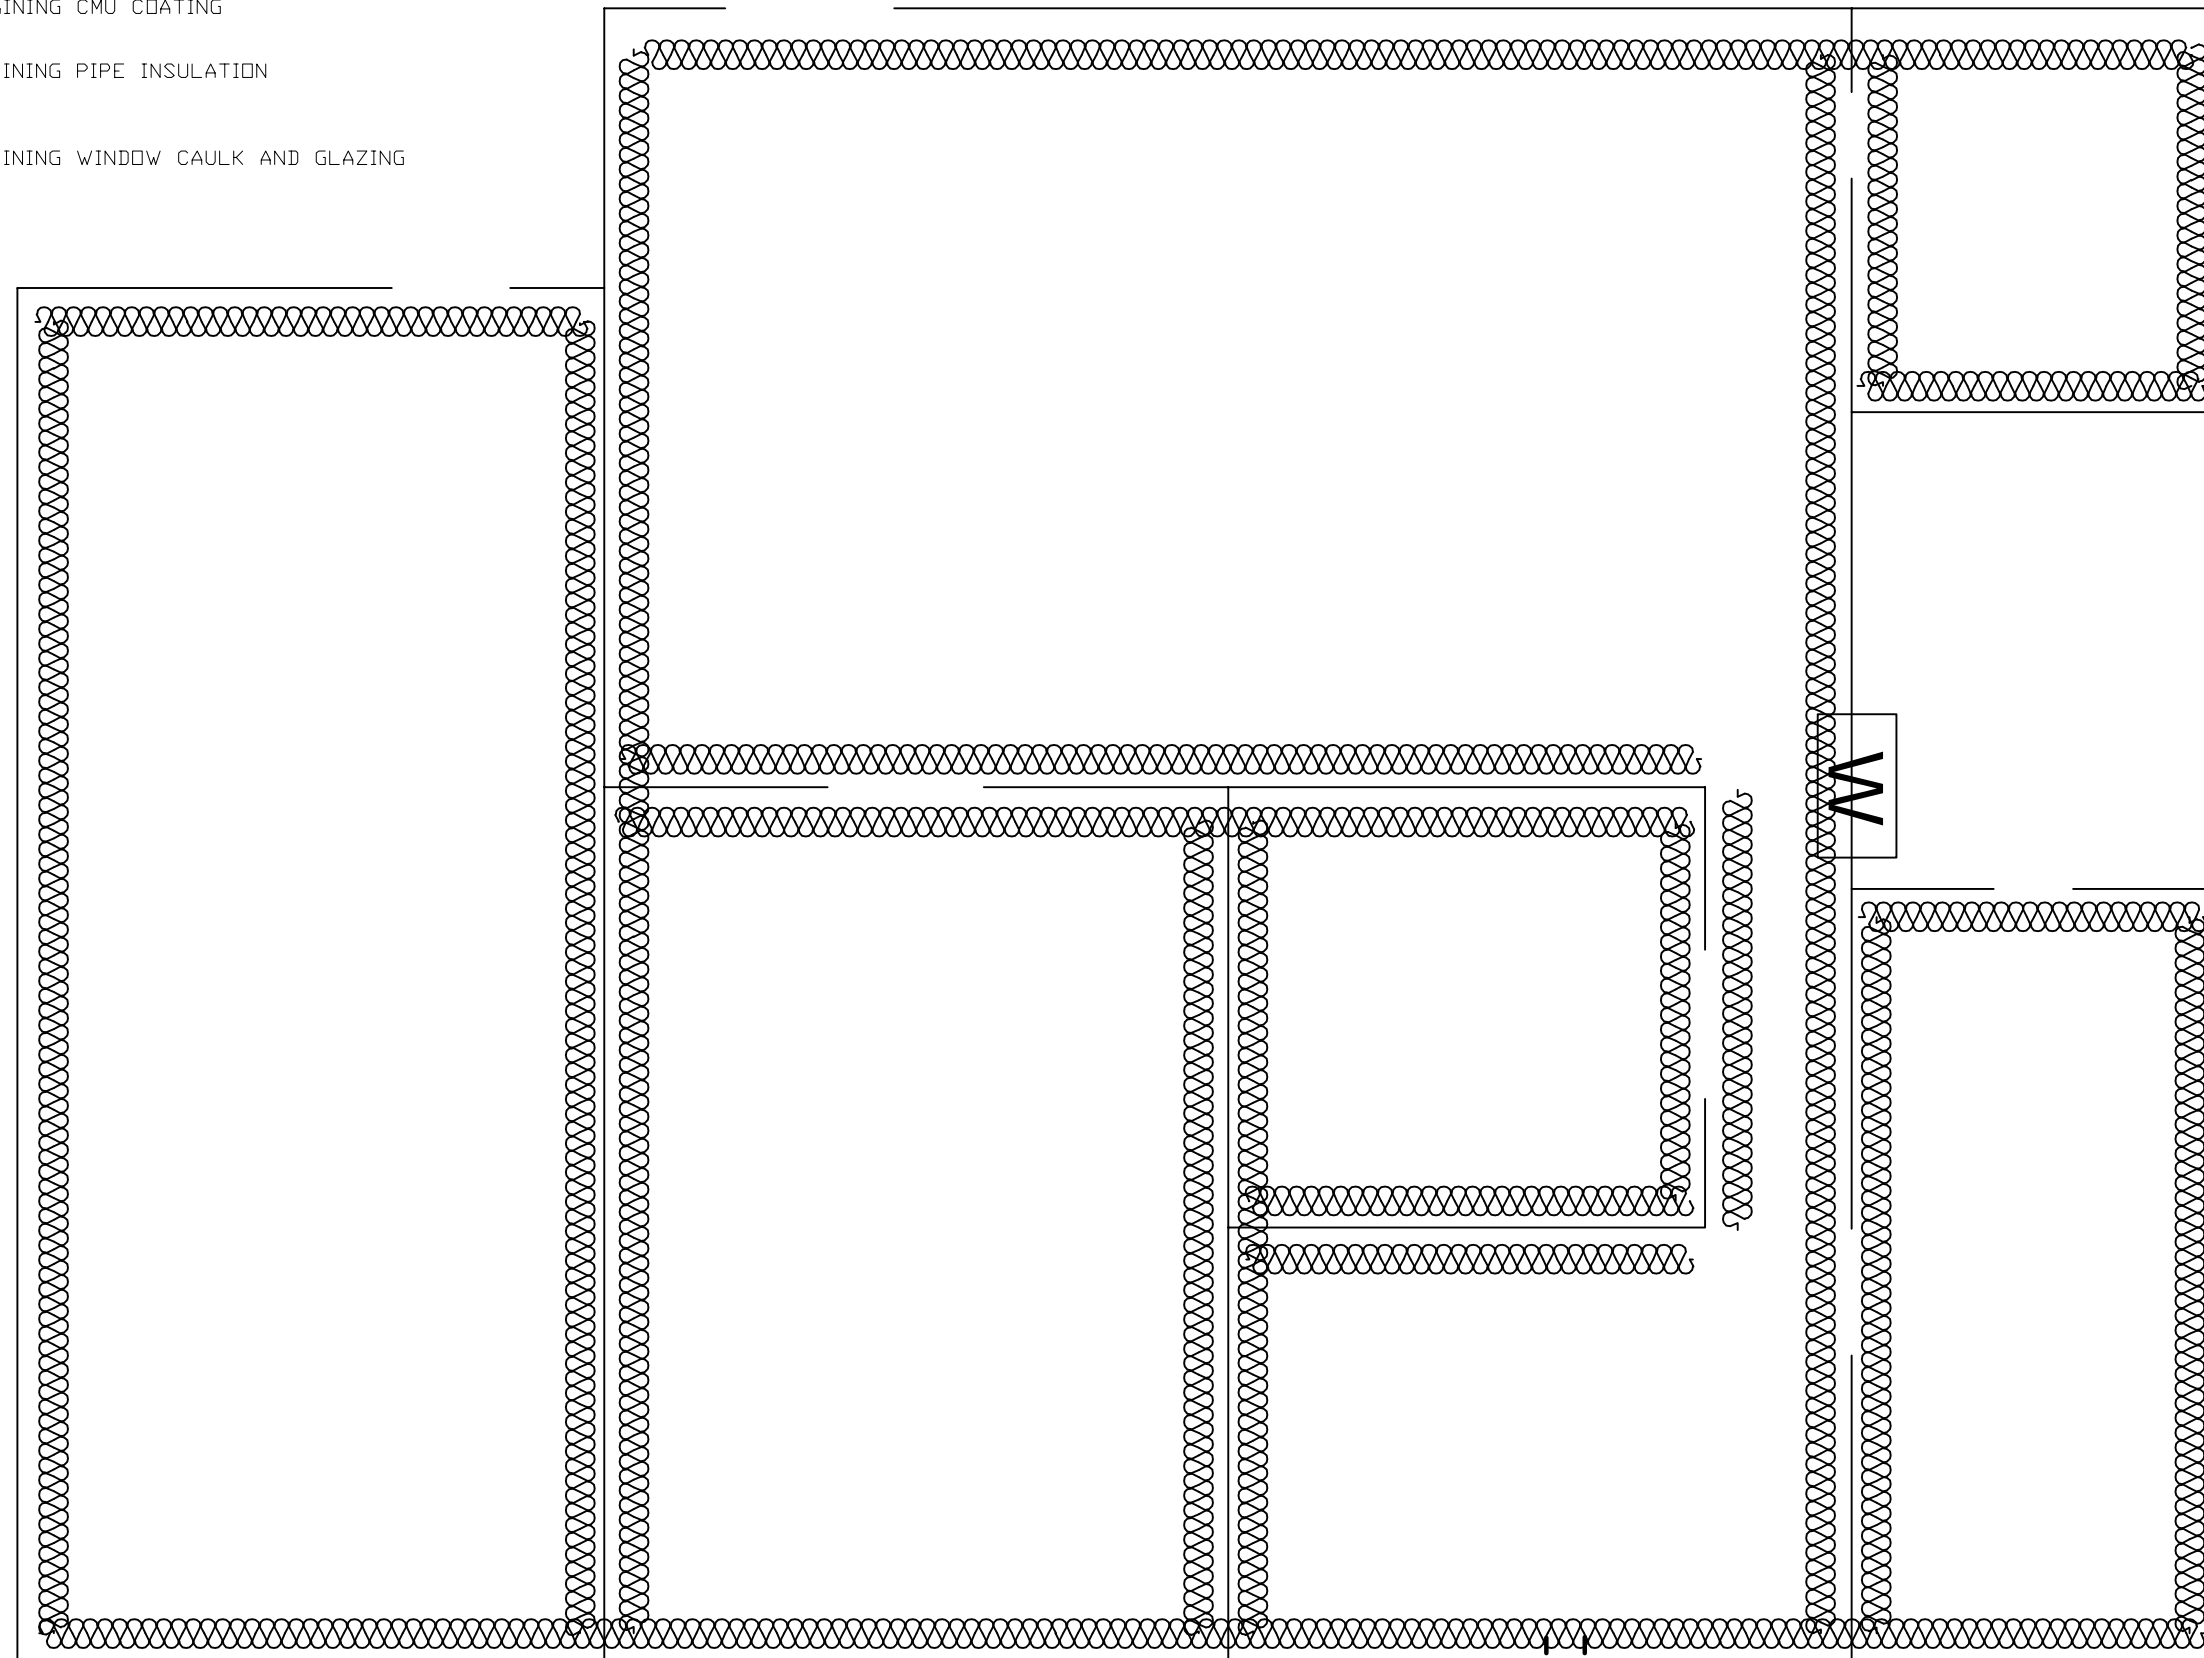
ASBESTOS-CONTAINING WINDOW CAULK AND GLAZING

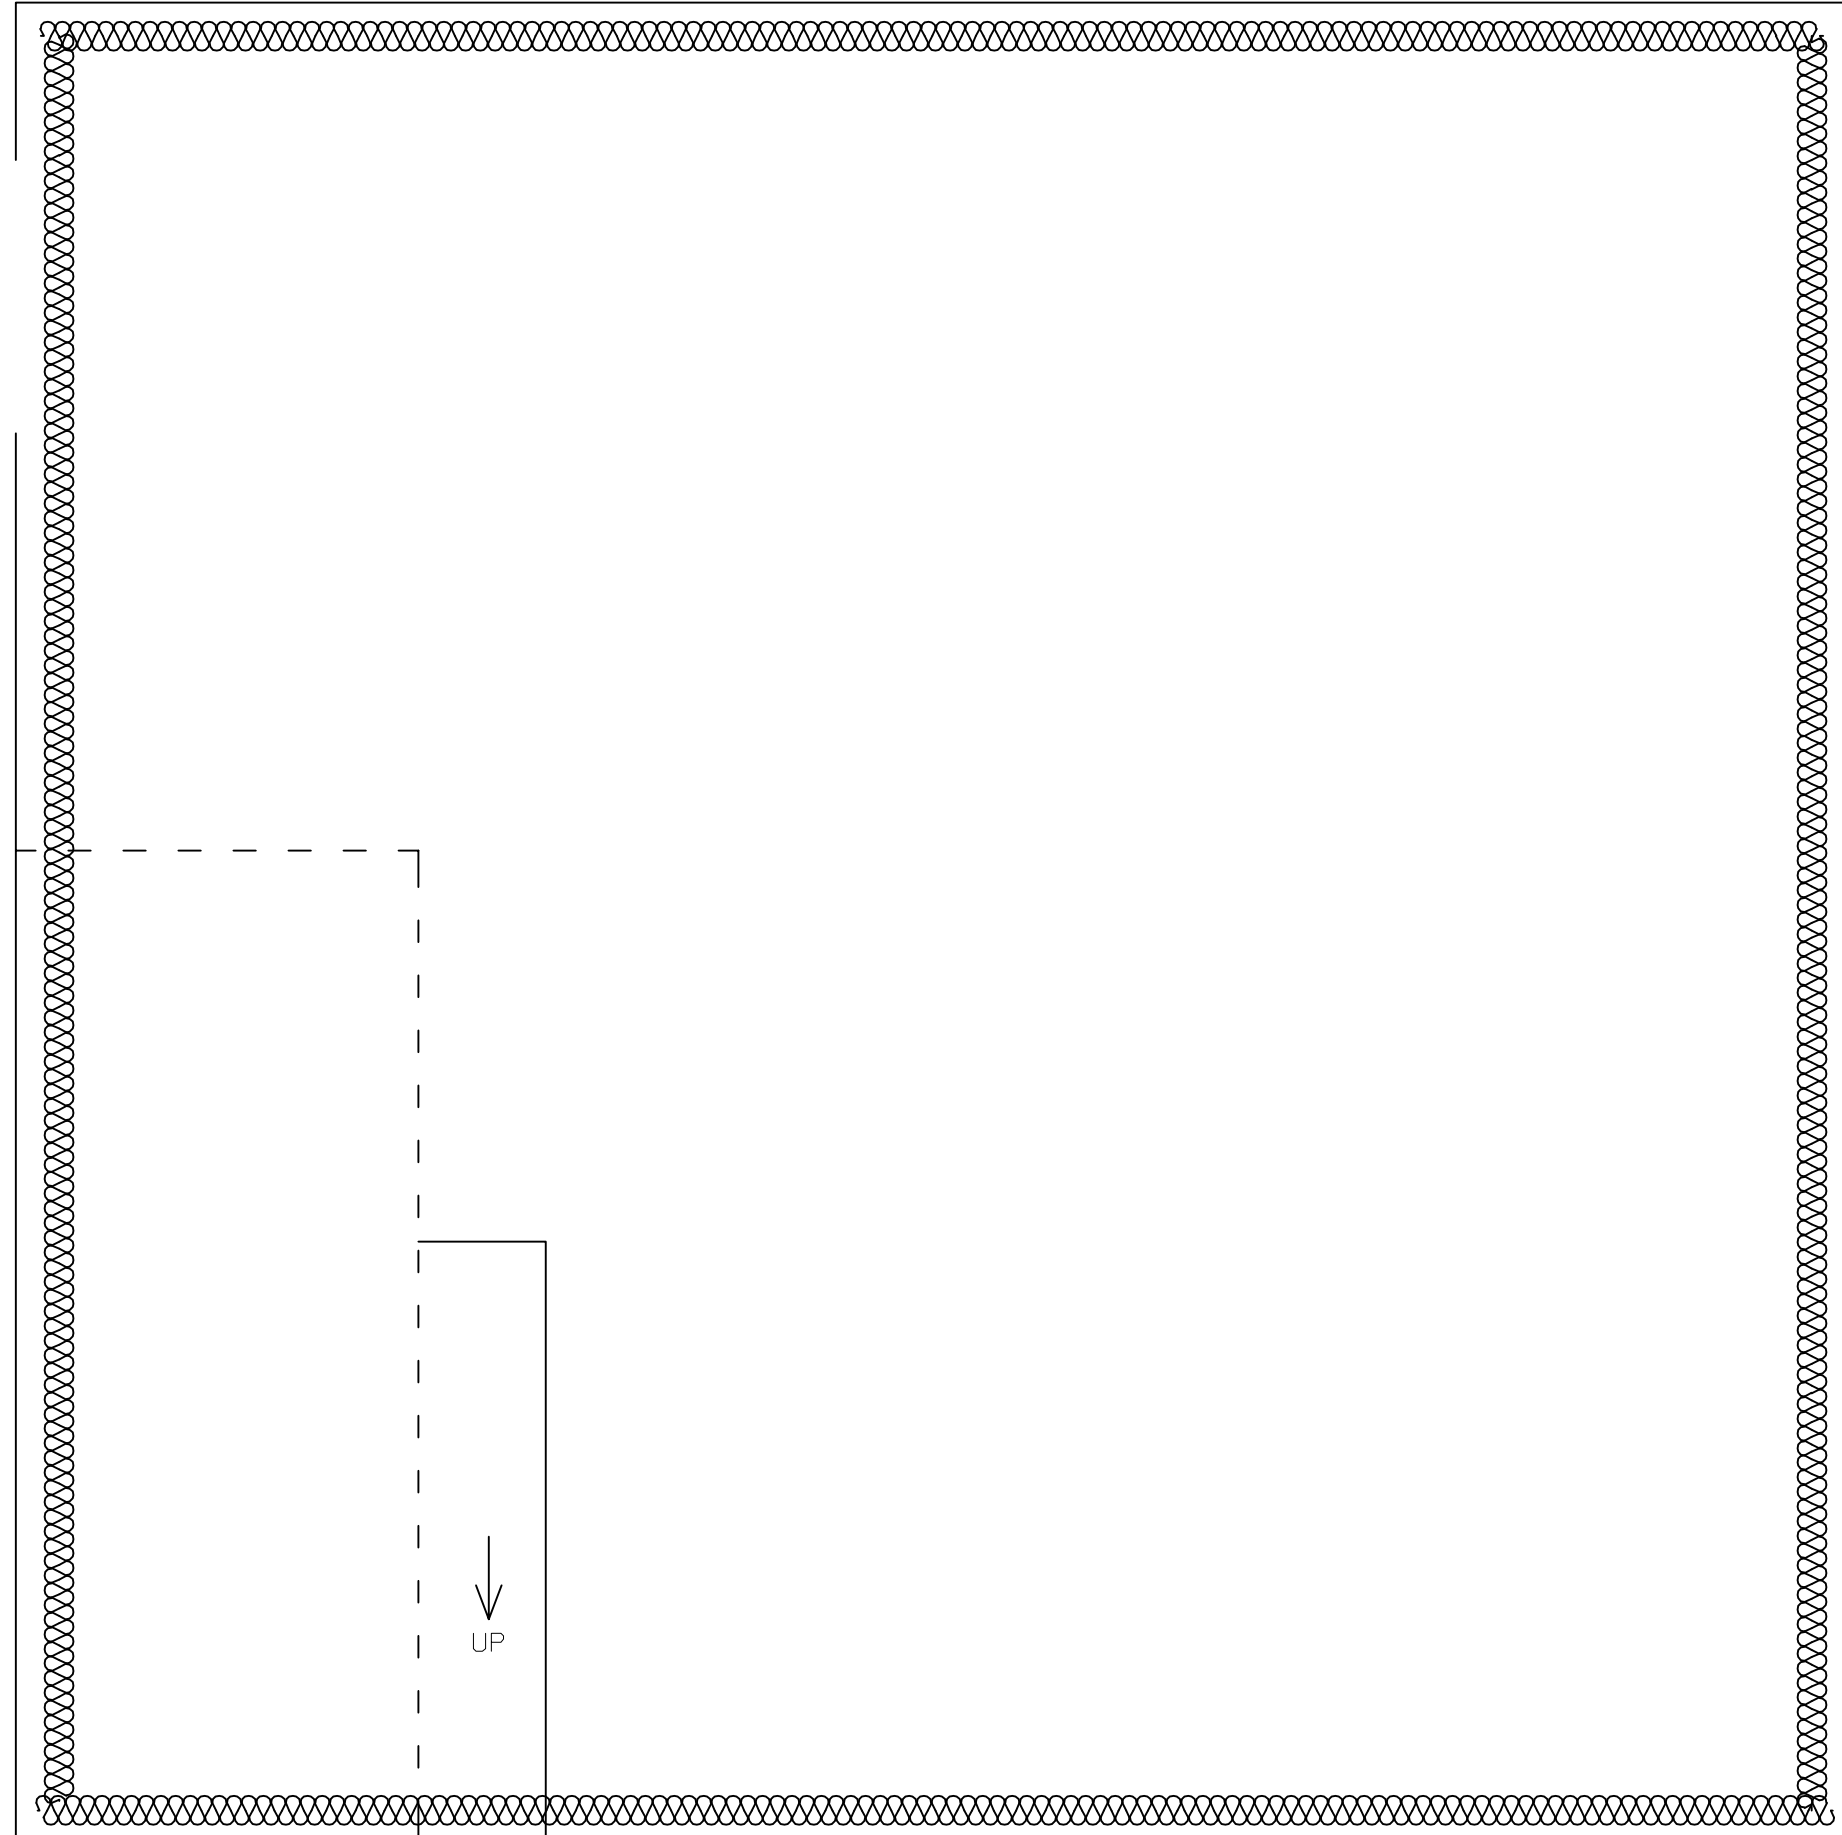
BUILDING 12

ASBESTOS-CONTAINING CMU COATING

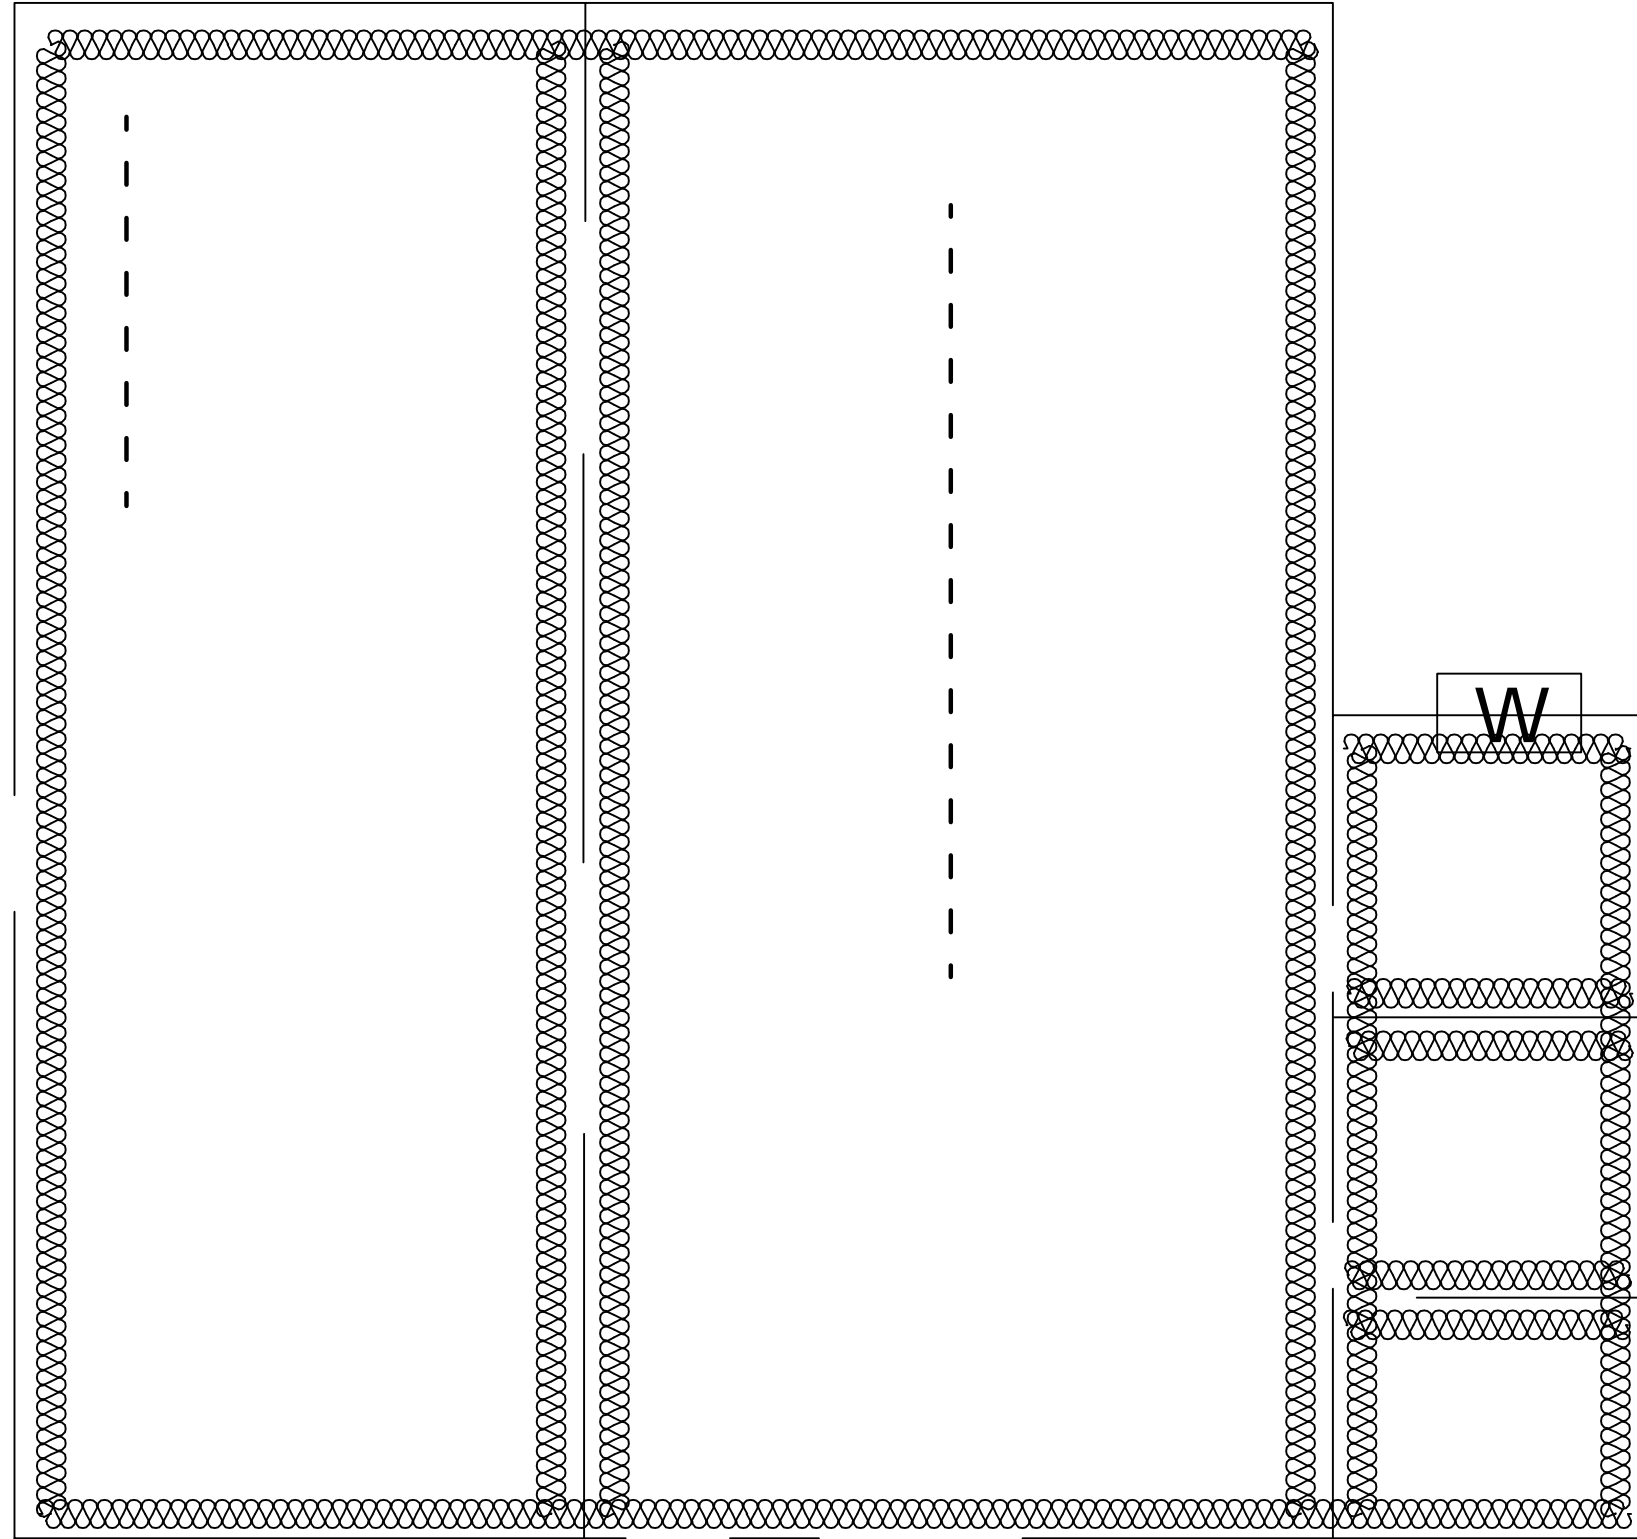
BUILDING 12

ASBESTOS-CONTAINING WINDOW CAULK AND GLAZING

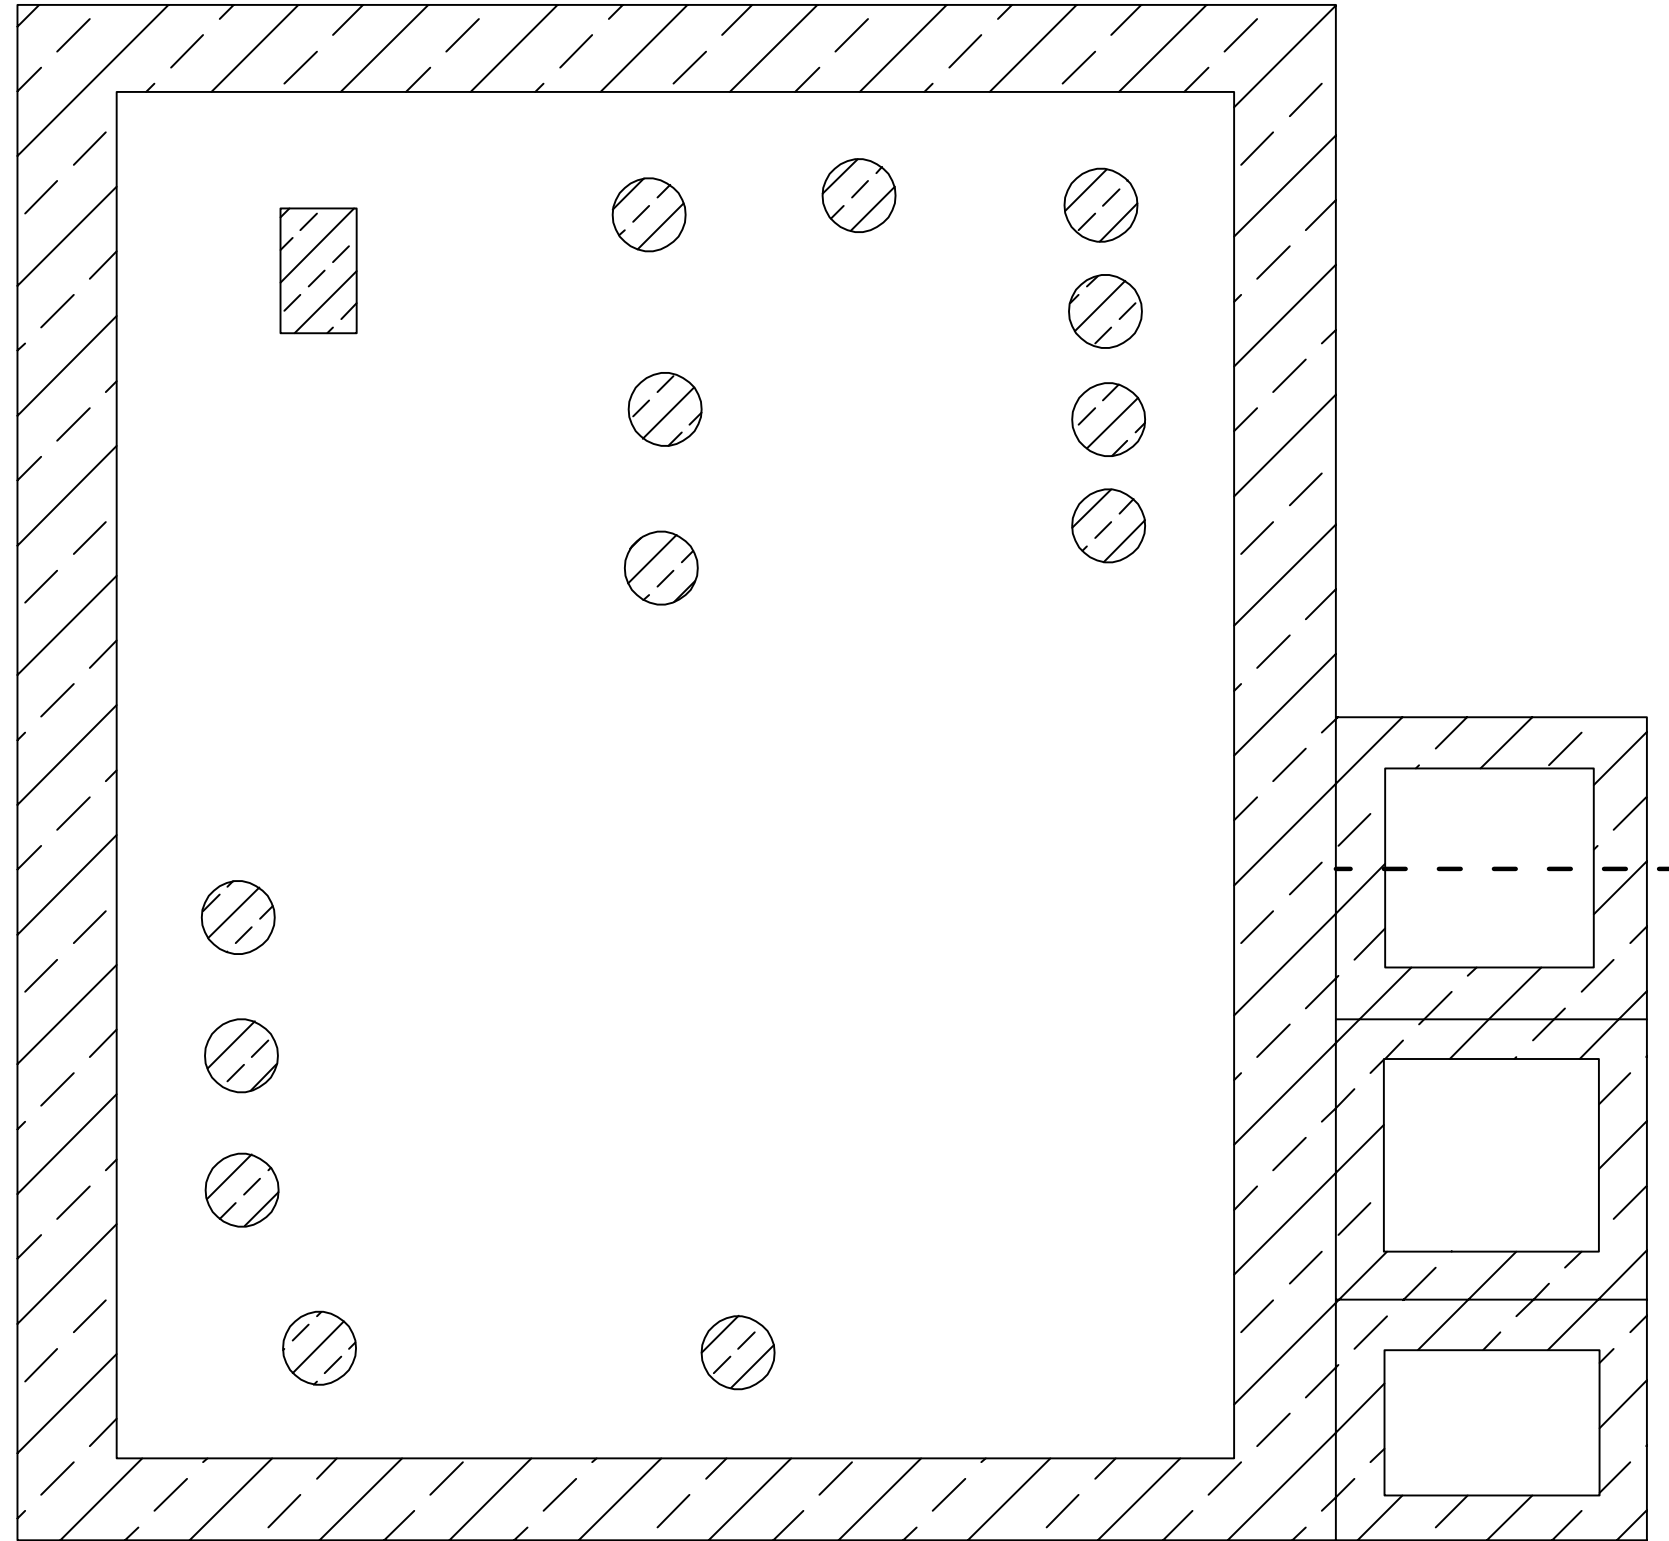
BUILDING 12

ASBESTOS-CONTAINING ROOF FLASHING AND BLACK ROOF TAR

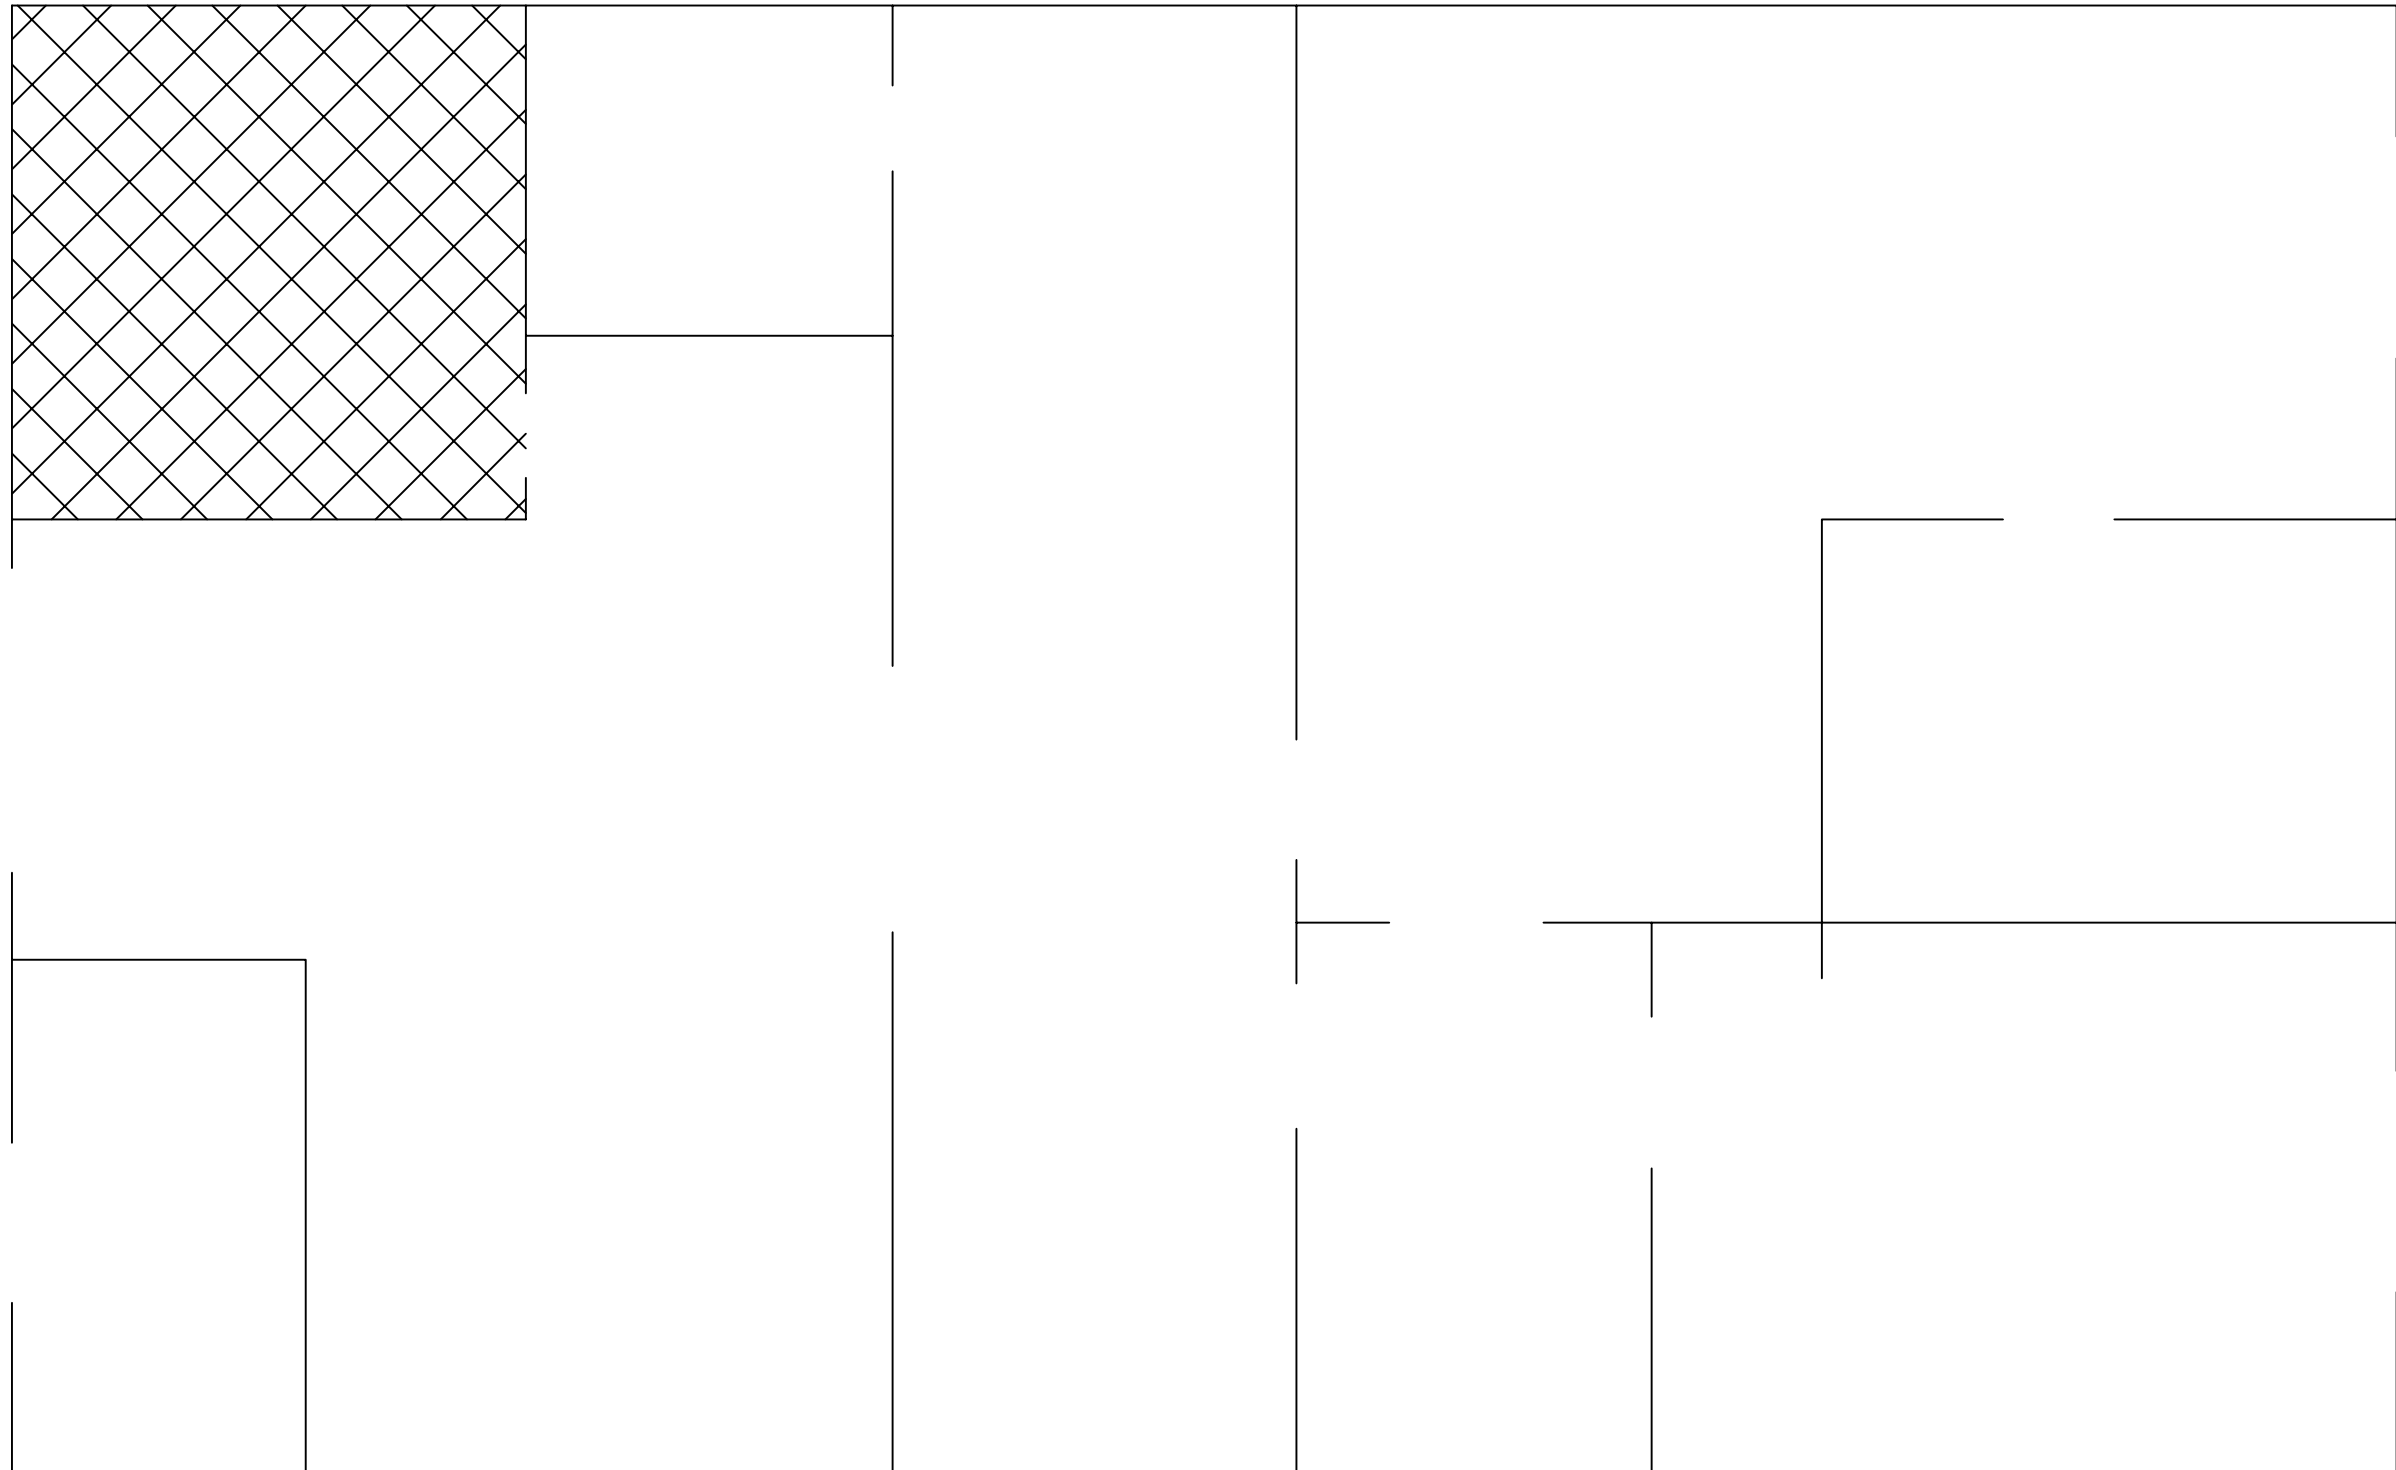
ASBESTOS-CONTAINING FLOOR MASTIC ASSOCIATED  
 WITH NON-ASBESTOS FLOOR TILE

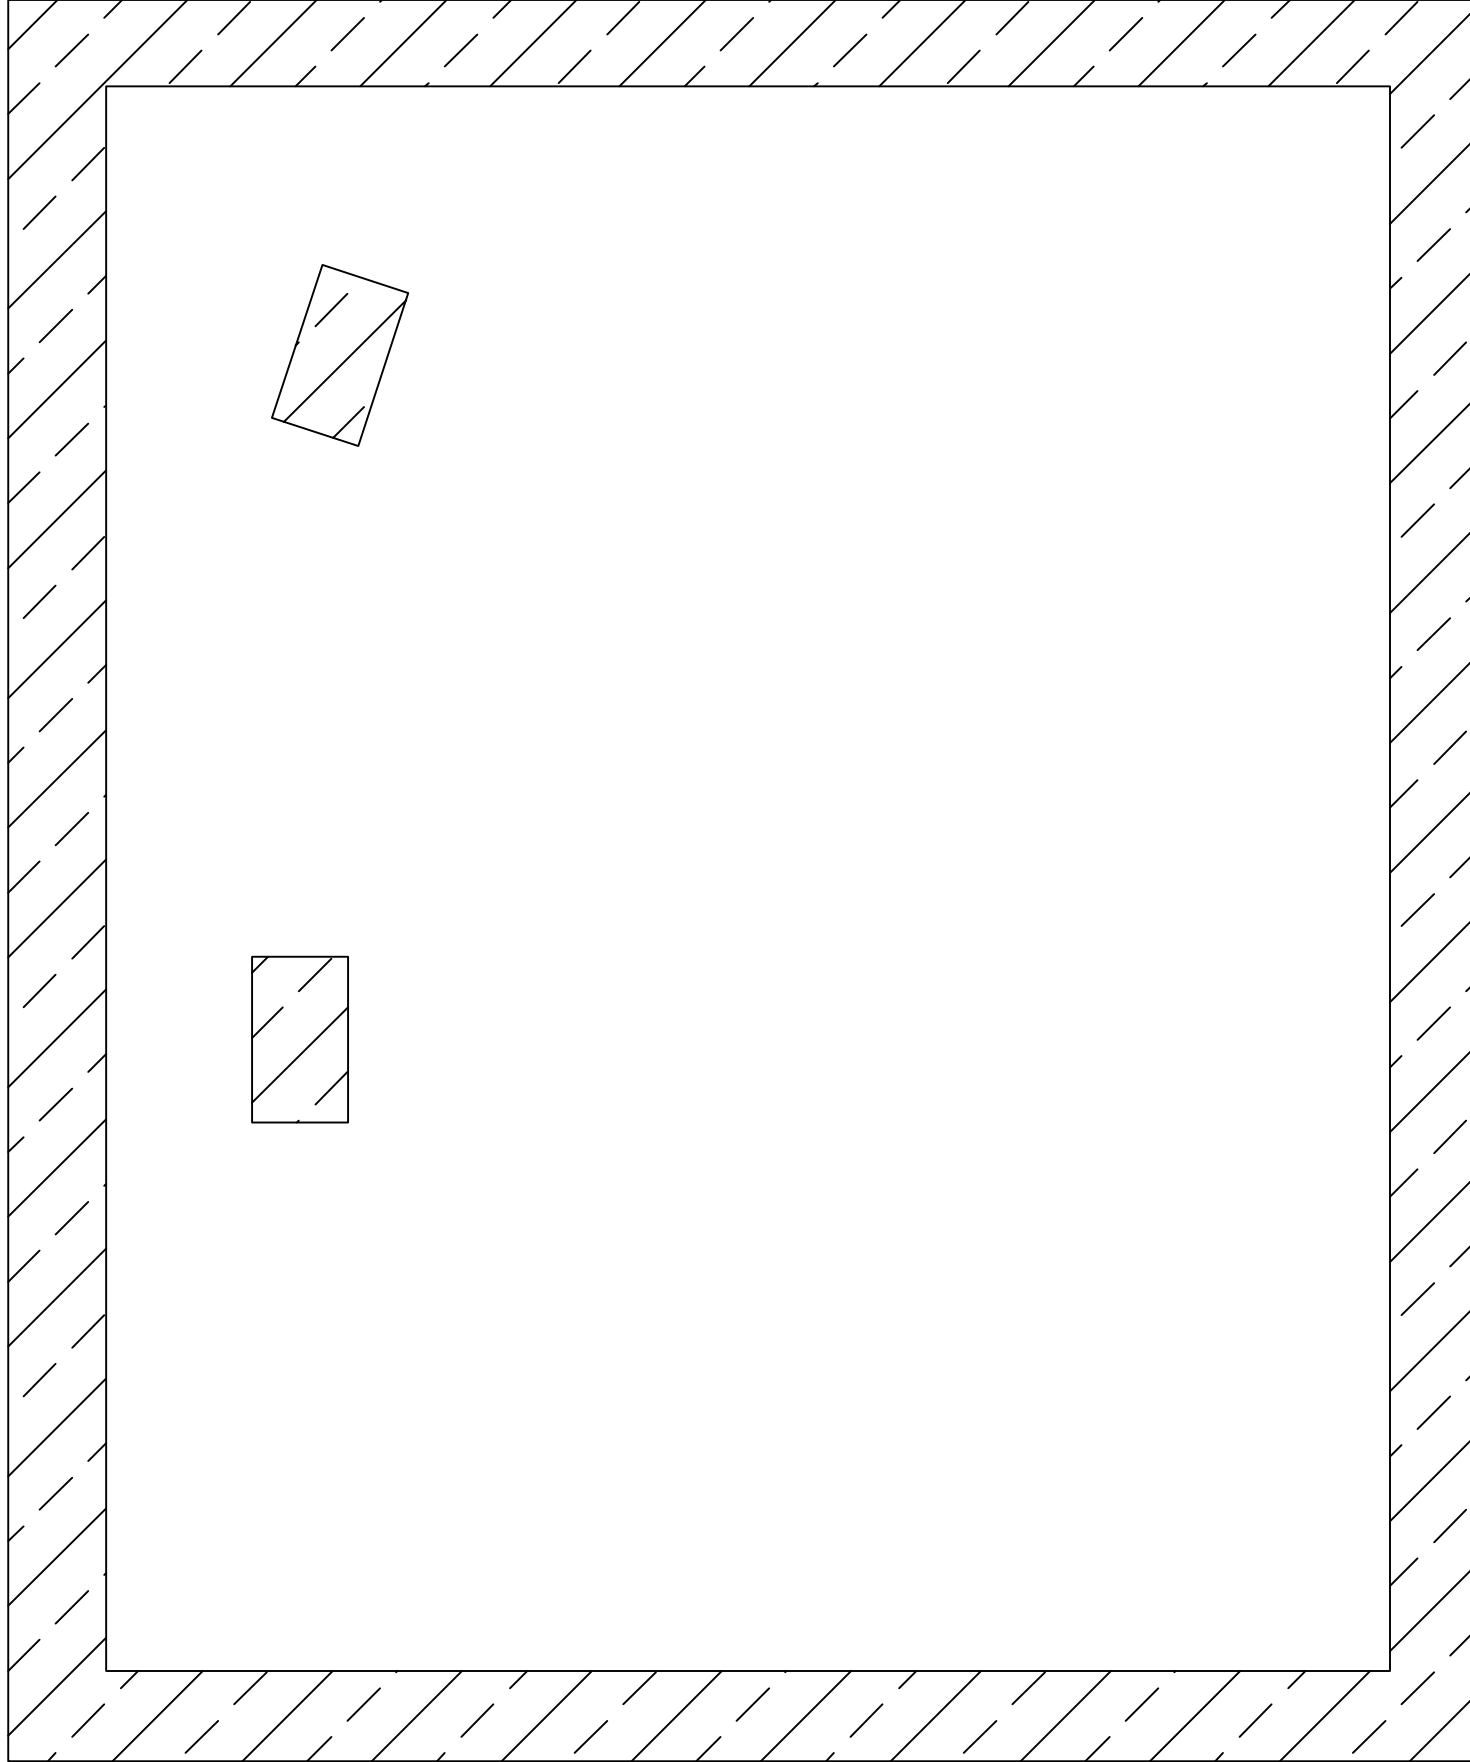
BUILDING 8

ASBESTOS-CONTAINING ROOF FLASHING  
AND BLACK ROOF TAR
