Job Name: Crompton and Knowles  
 Job Number: 71187168  
 Area: Building 7

FORMER CROMPTON AND KNOWLES SITE  
 1602 N. MAIN STREET  
 CHARLOTTE, NORTH CAROLINA

PROJECT NUMBER  
 71187168  
 SHEET  
 1-R

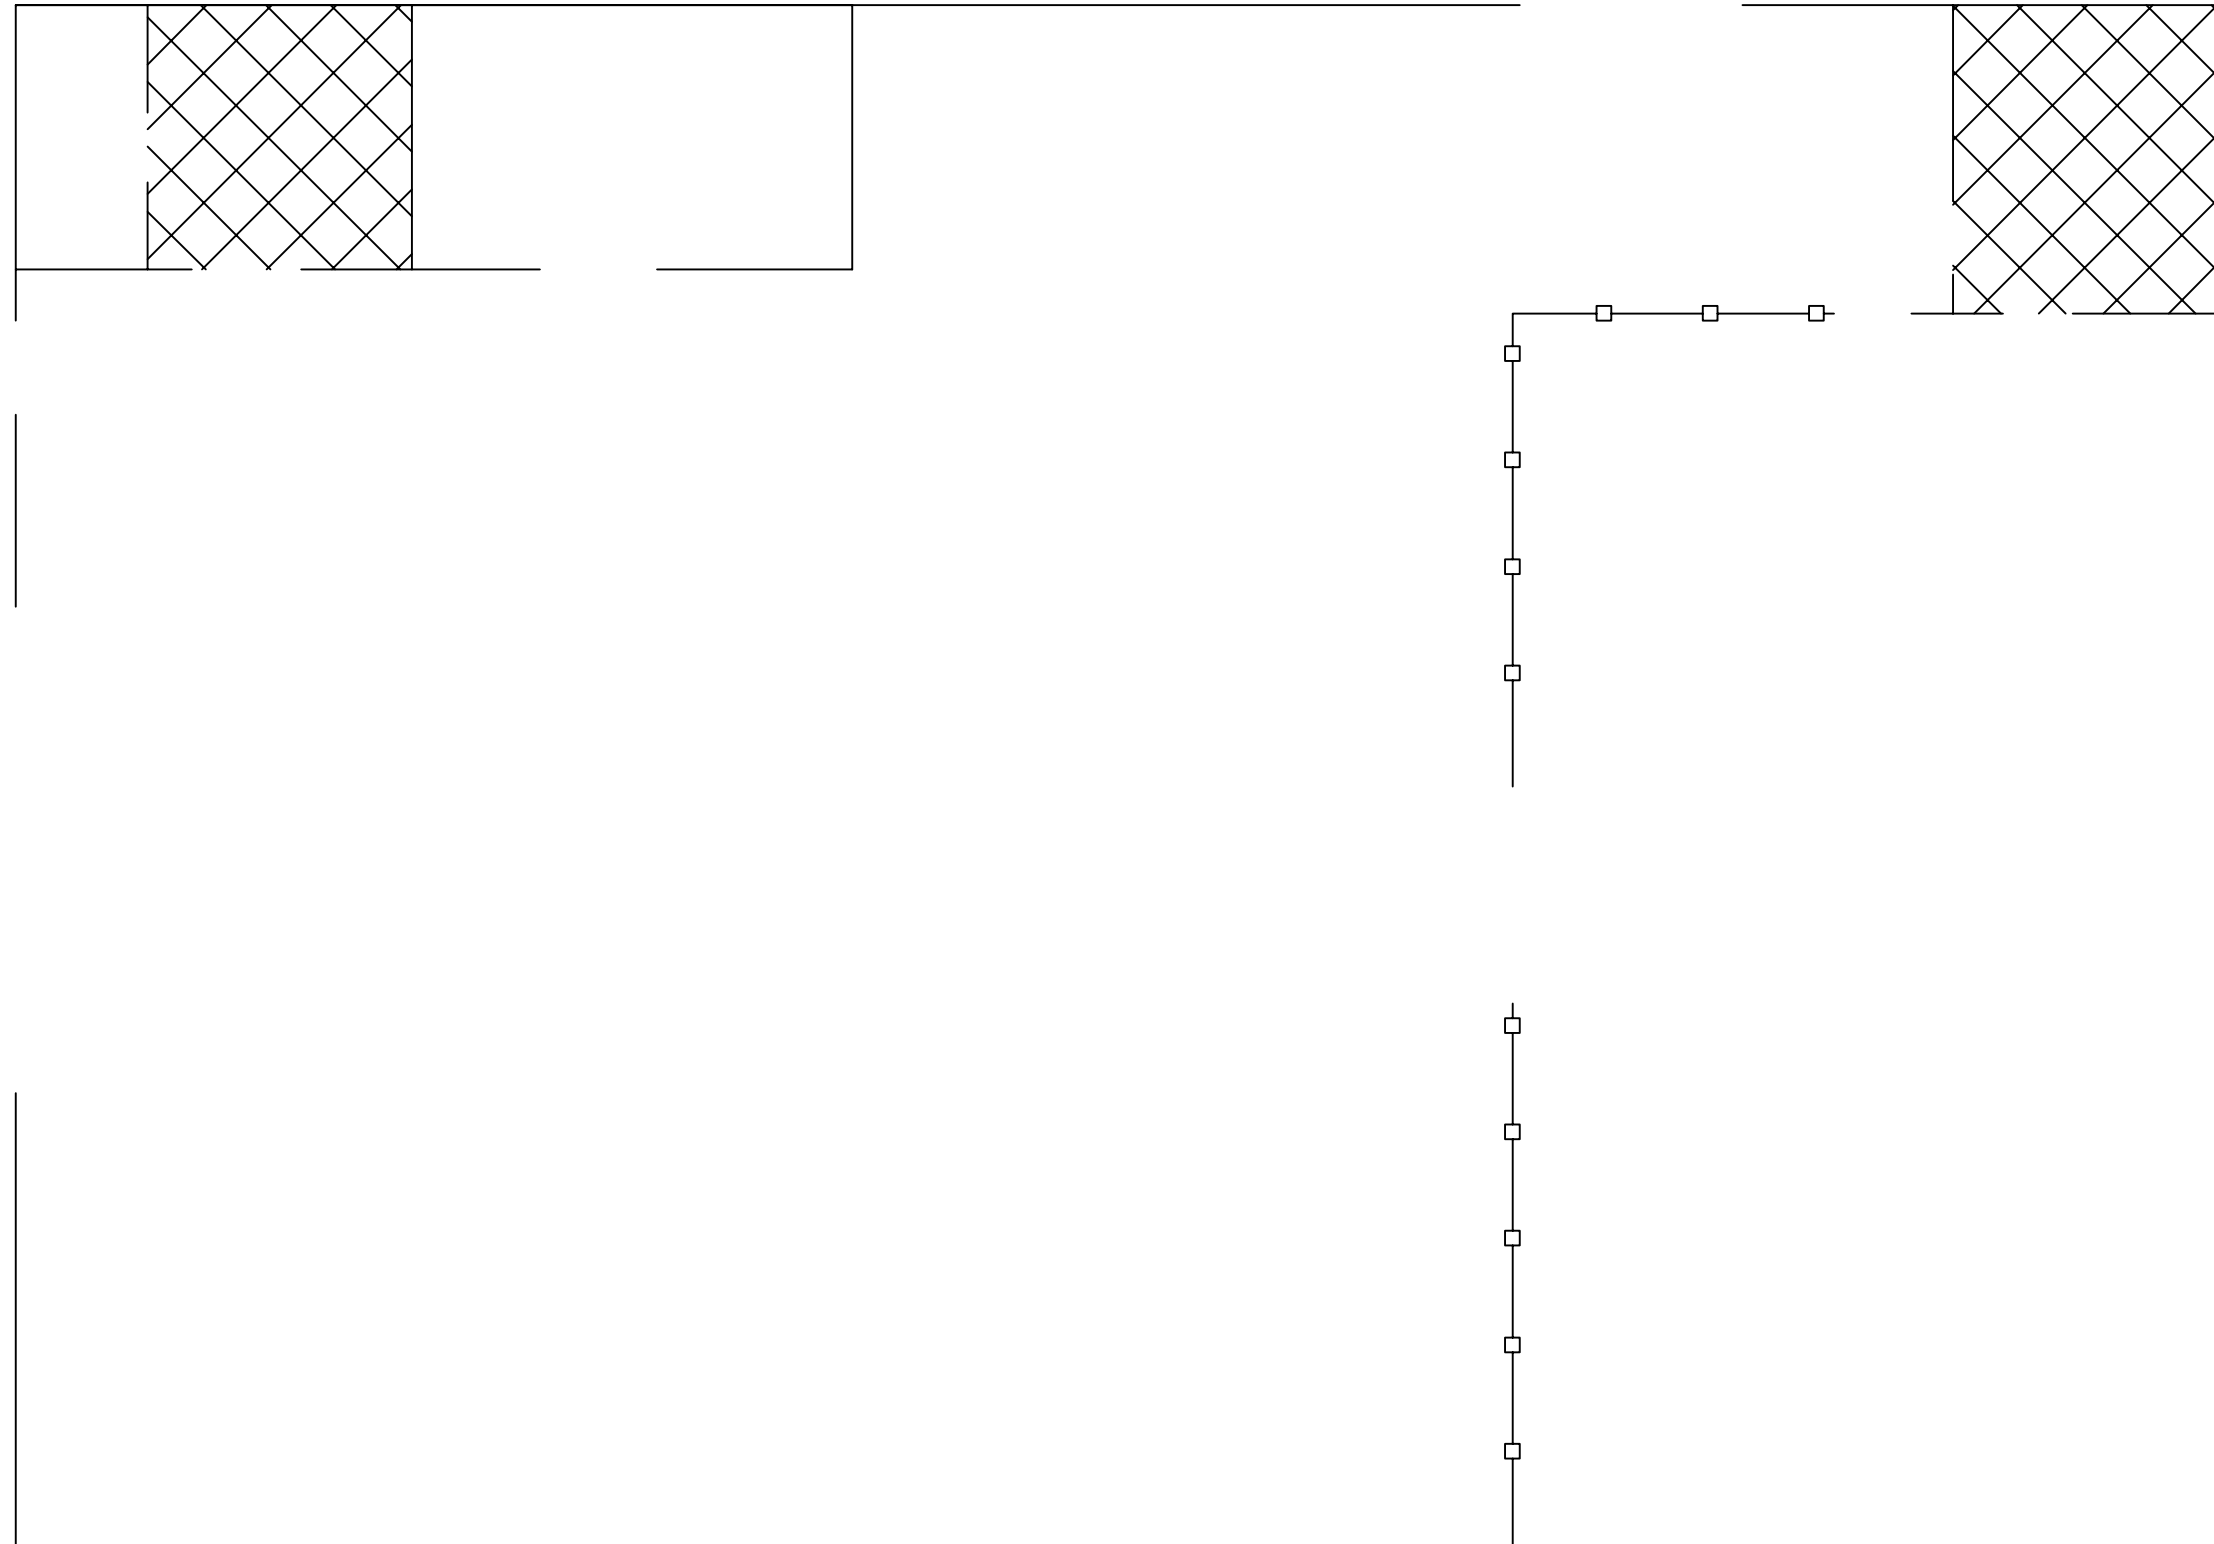
ASBESTOS-CONTAINING FLOOR TILE AND MASTIC

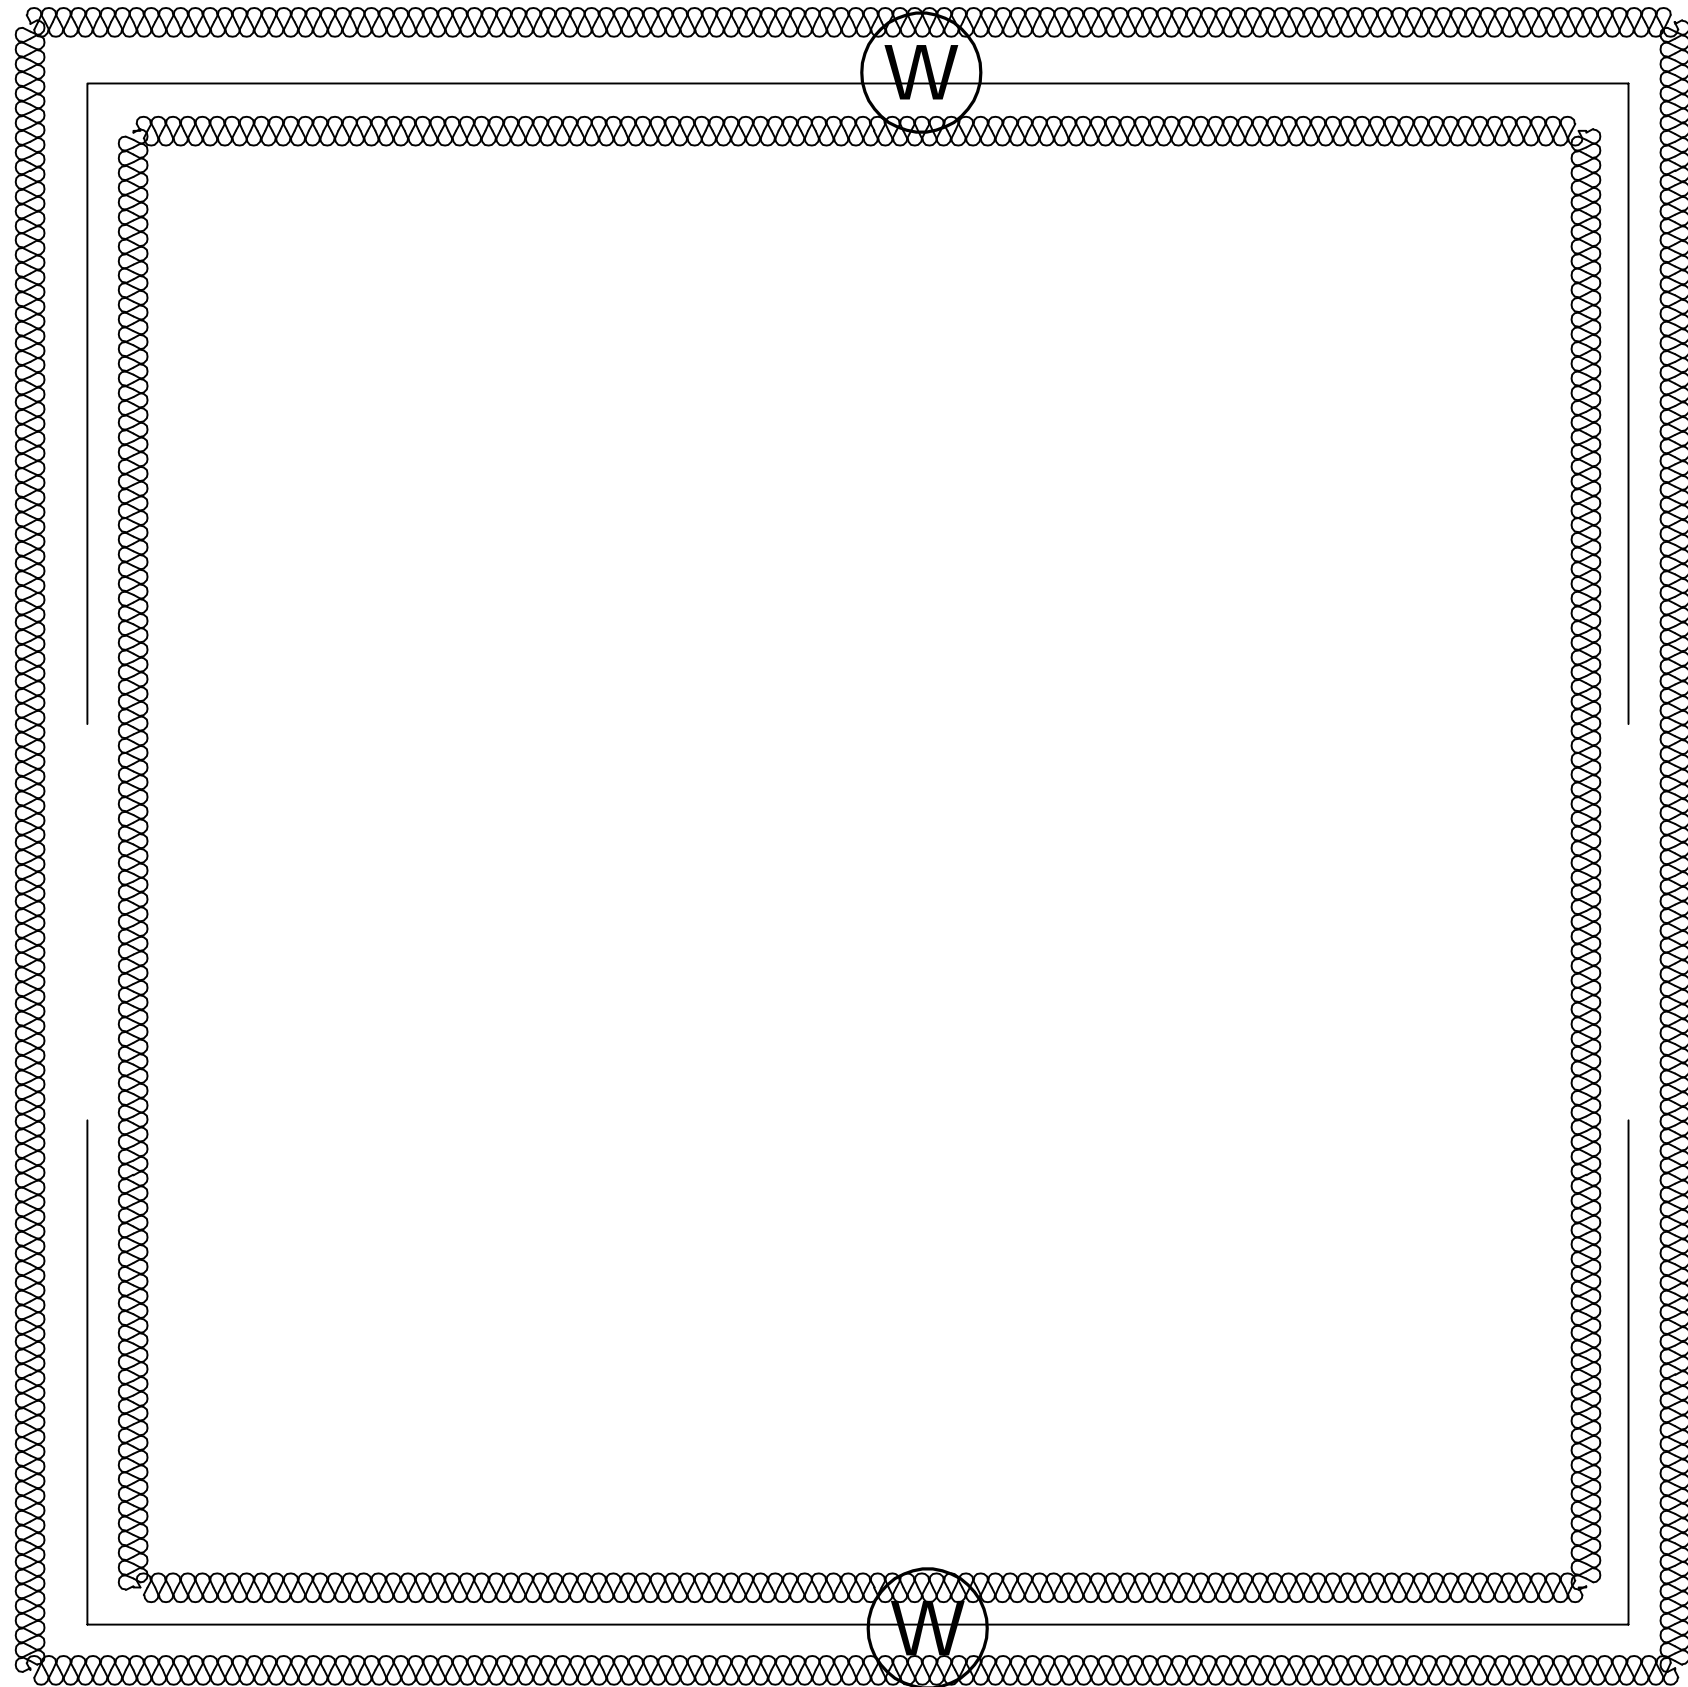
ASBESTOS-CONTAINING WINDOW GLAZING

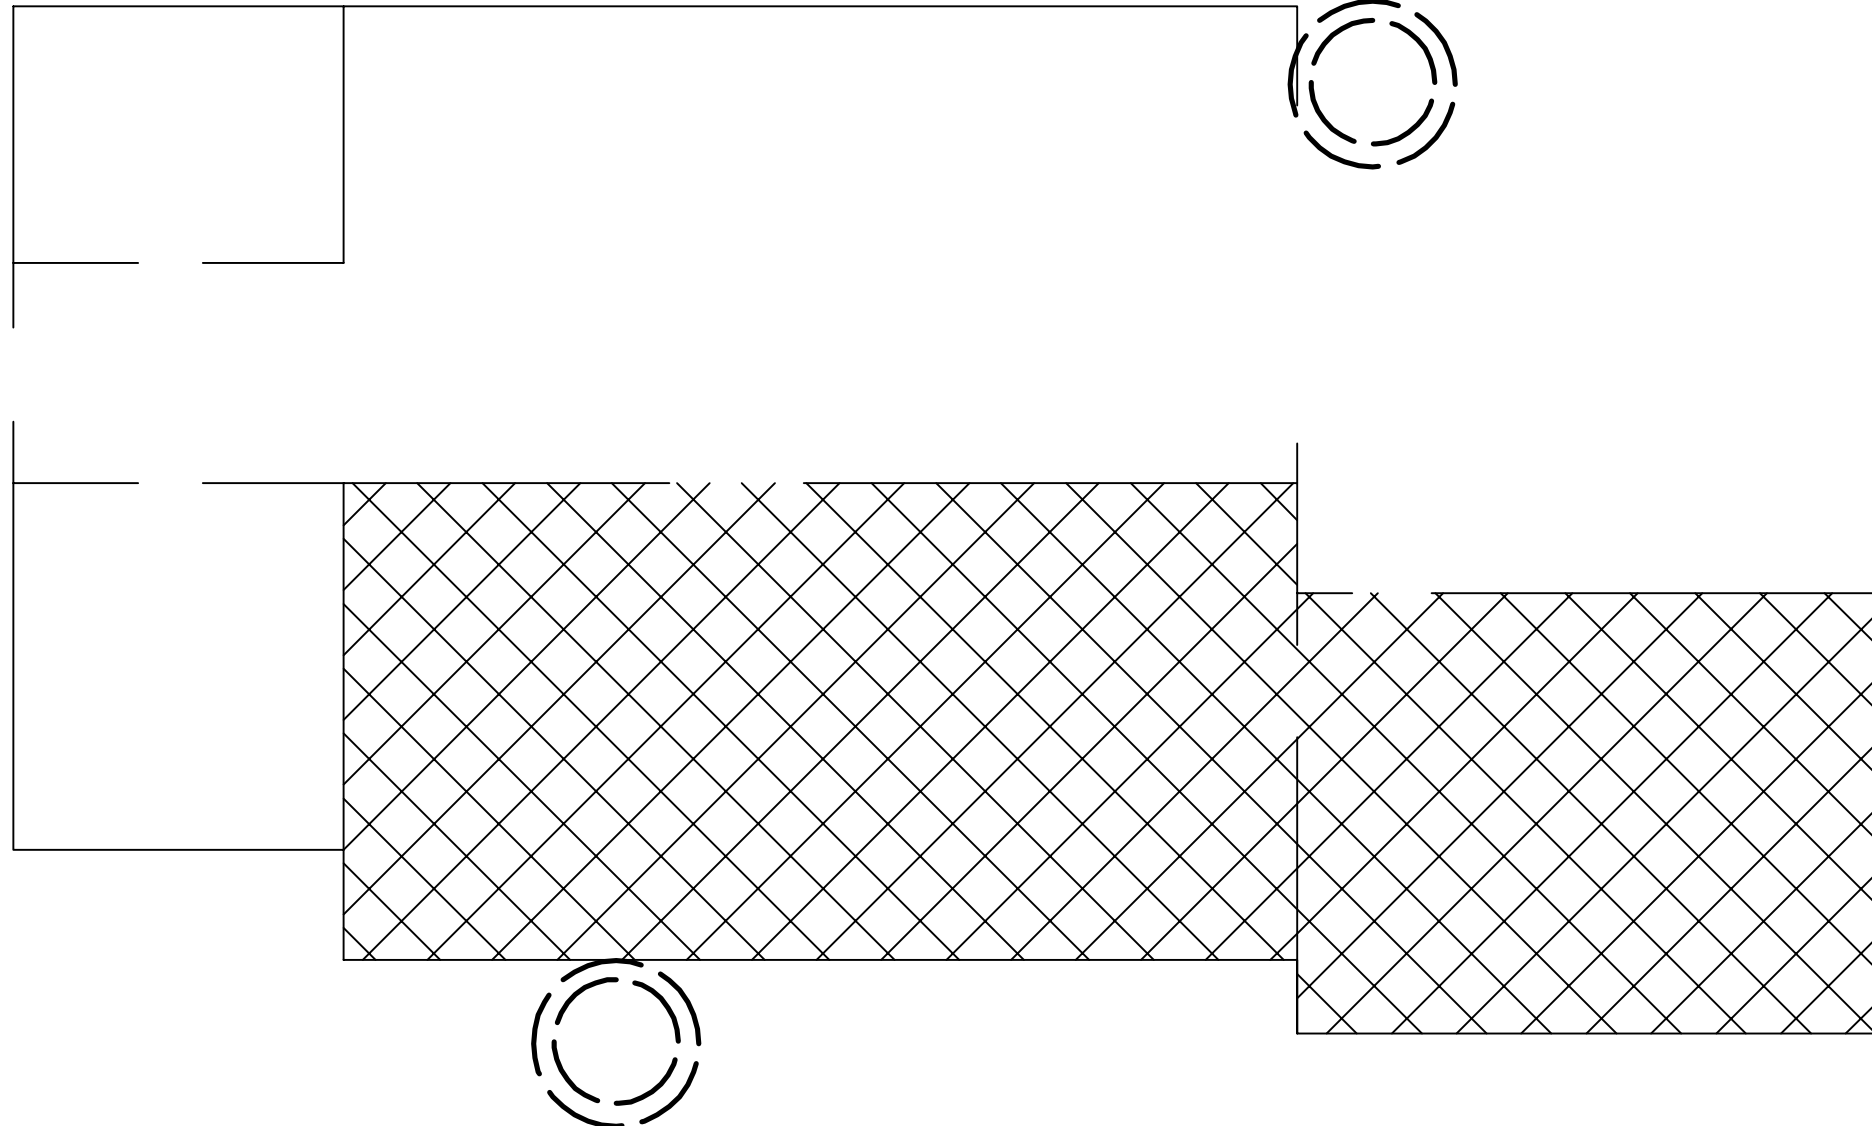
ASBESTOS-CONTAINING GASKETS

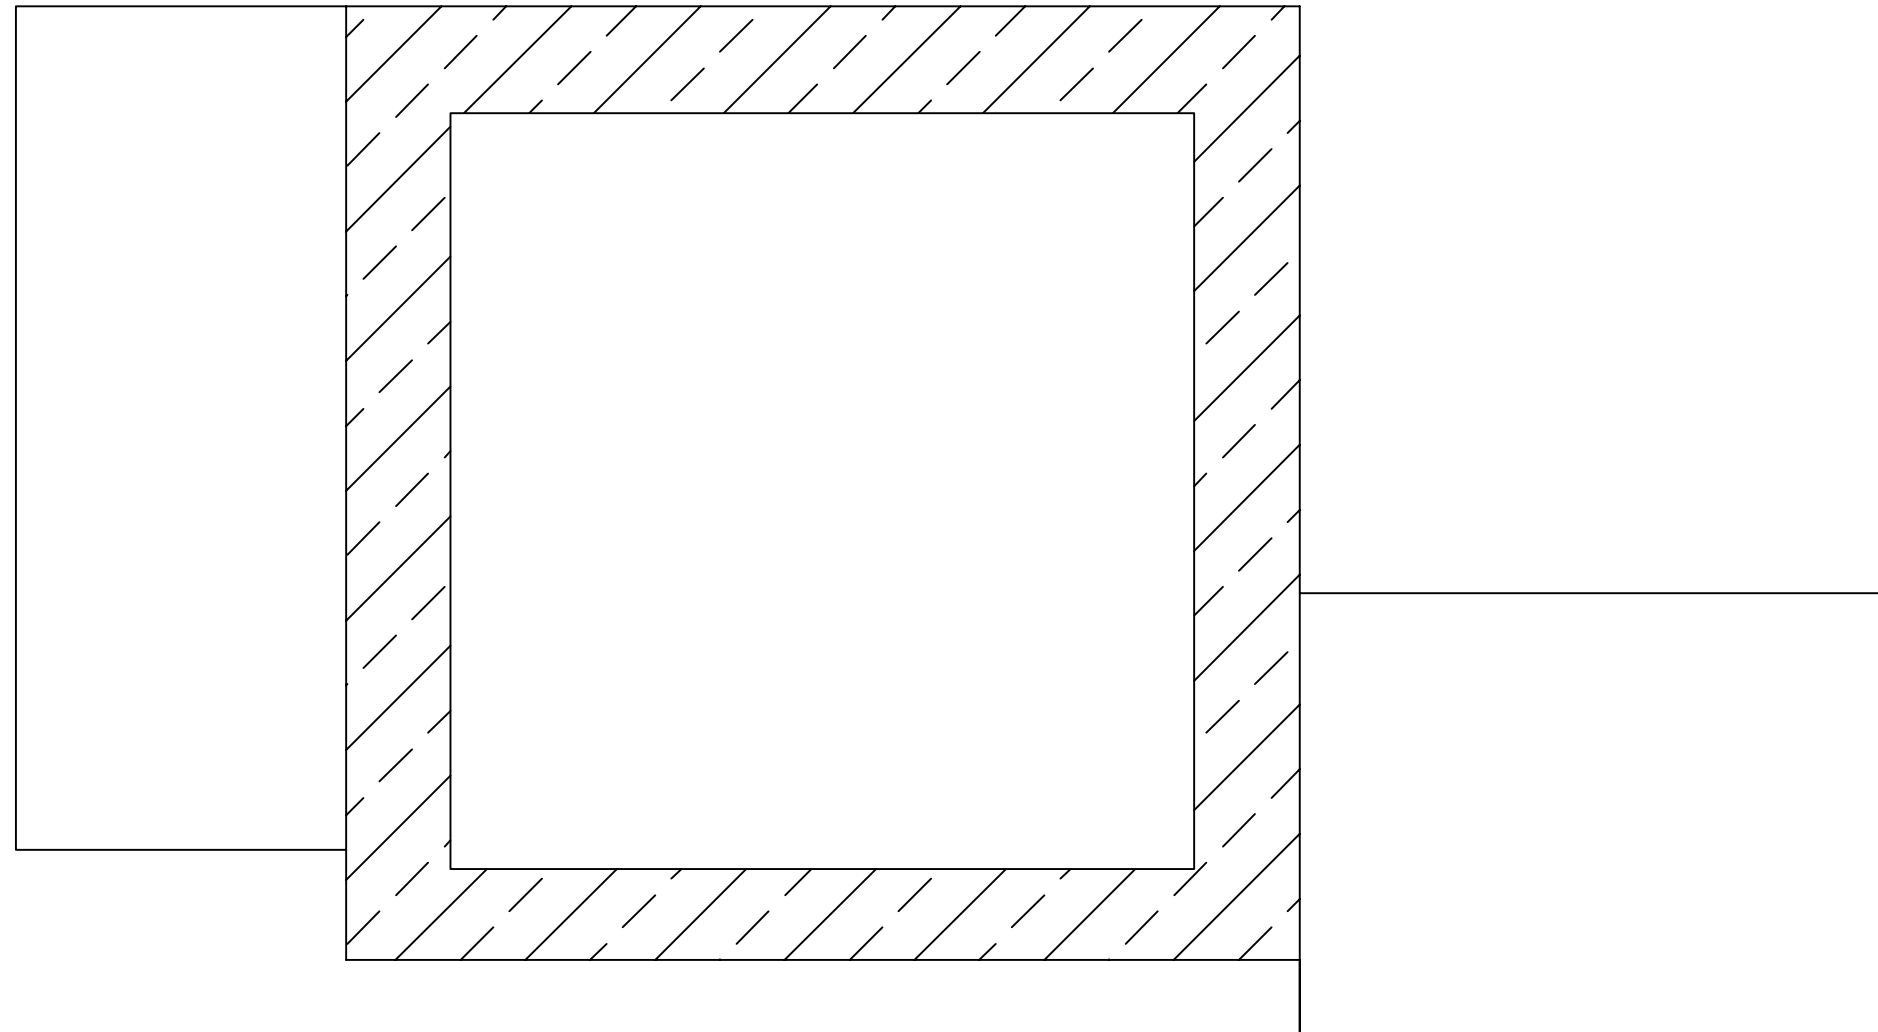
ASBESTOS-CONTAINING ROOF FLASHING

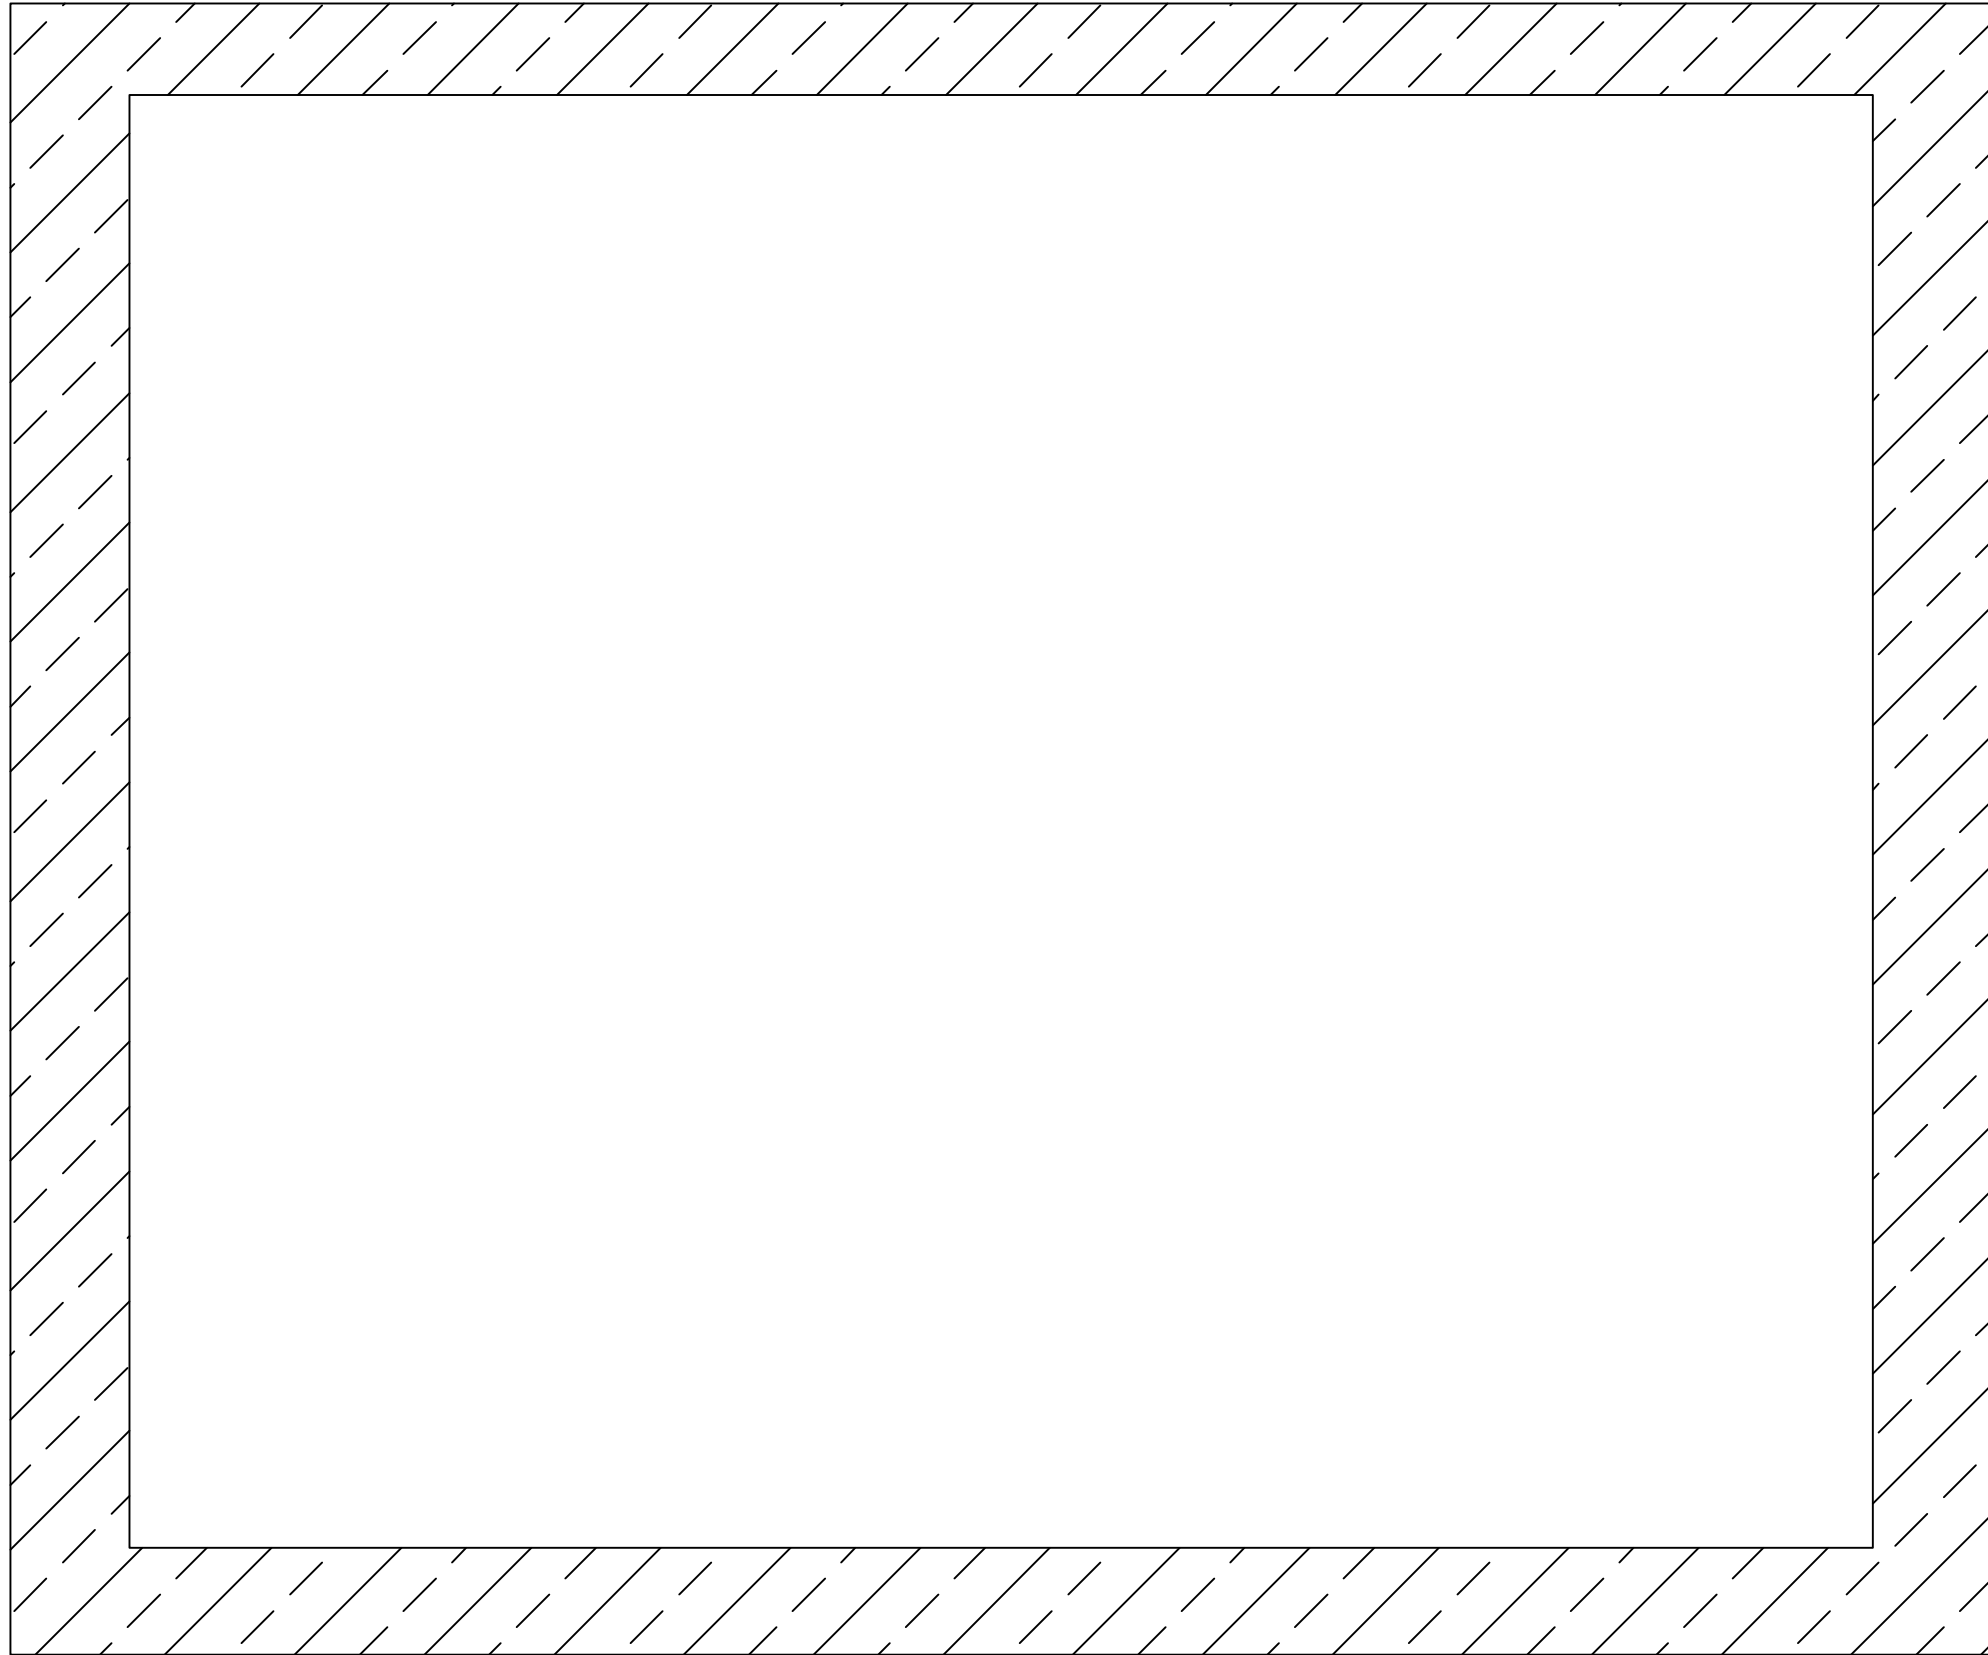
ASBESTOS-CONTAINING ROOF FLASHING
