**APPENDIX A**

**Building Summary Spreadsheet & Select  
Site Figures**

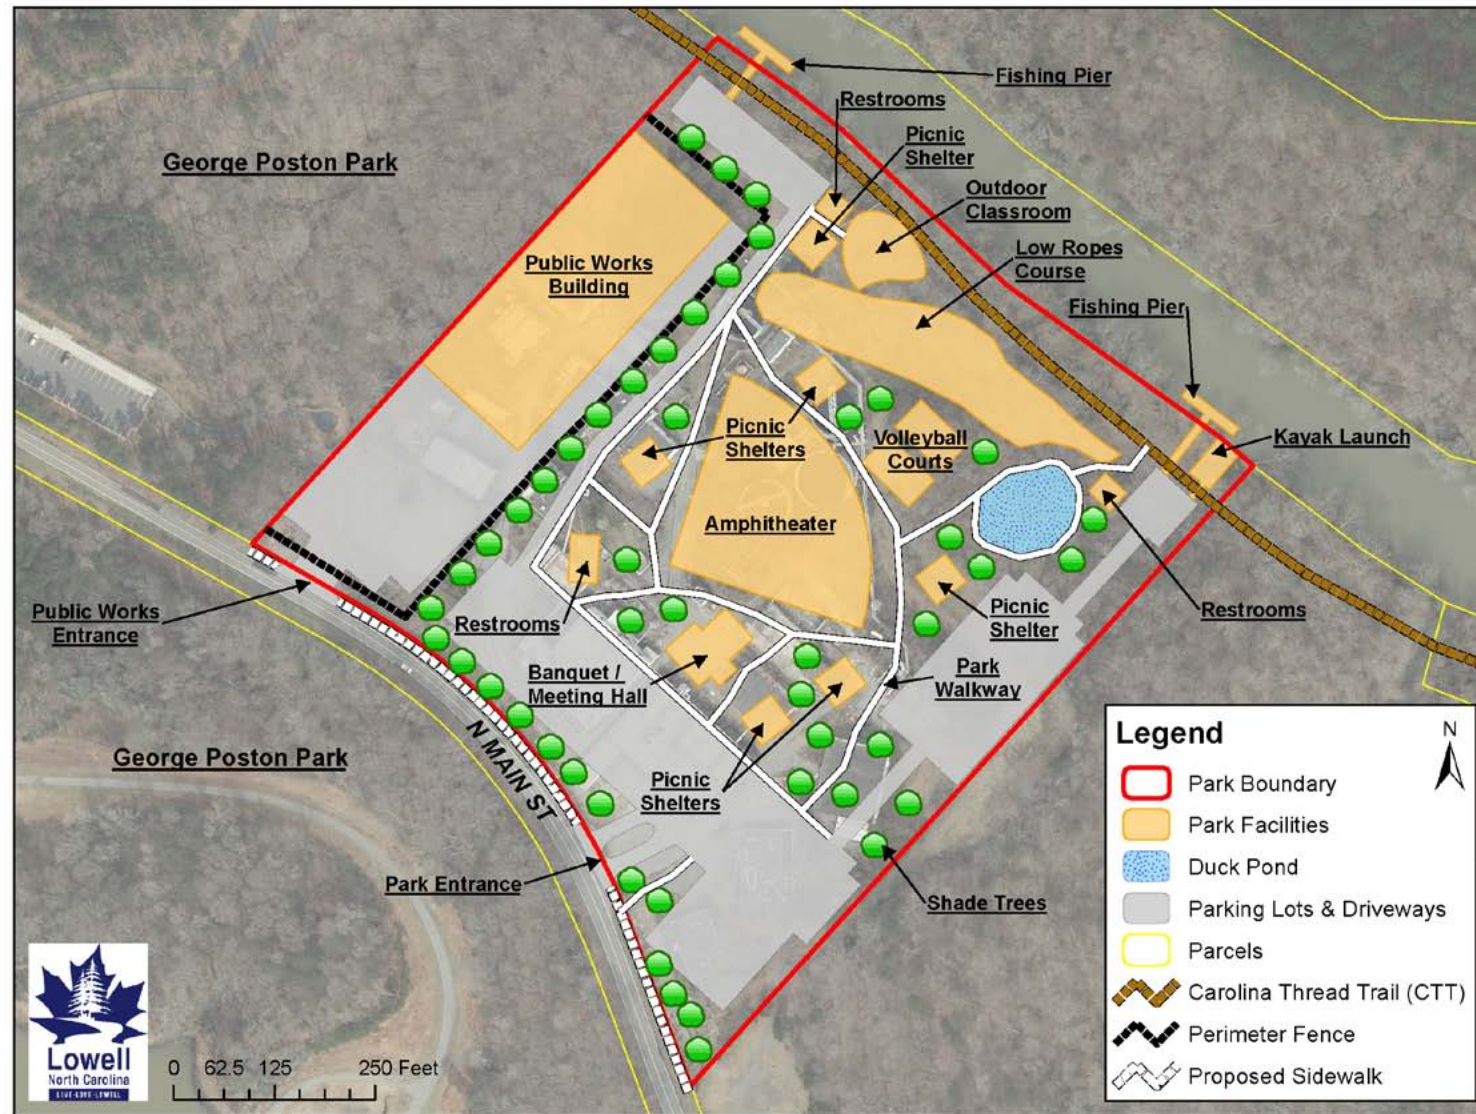
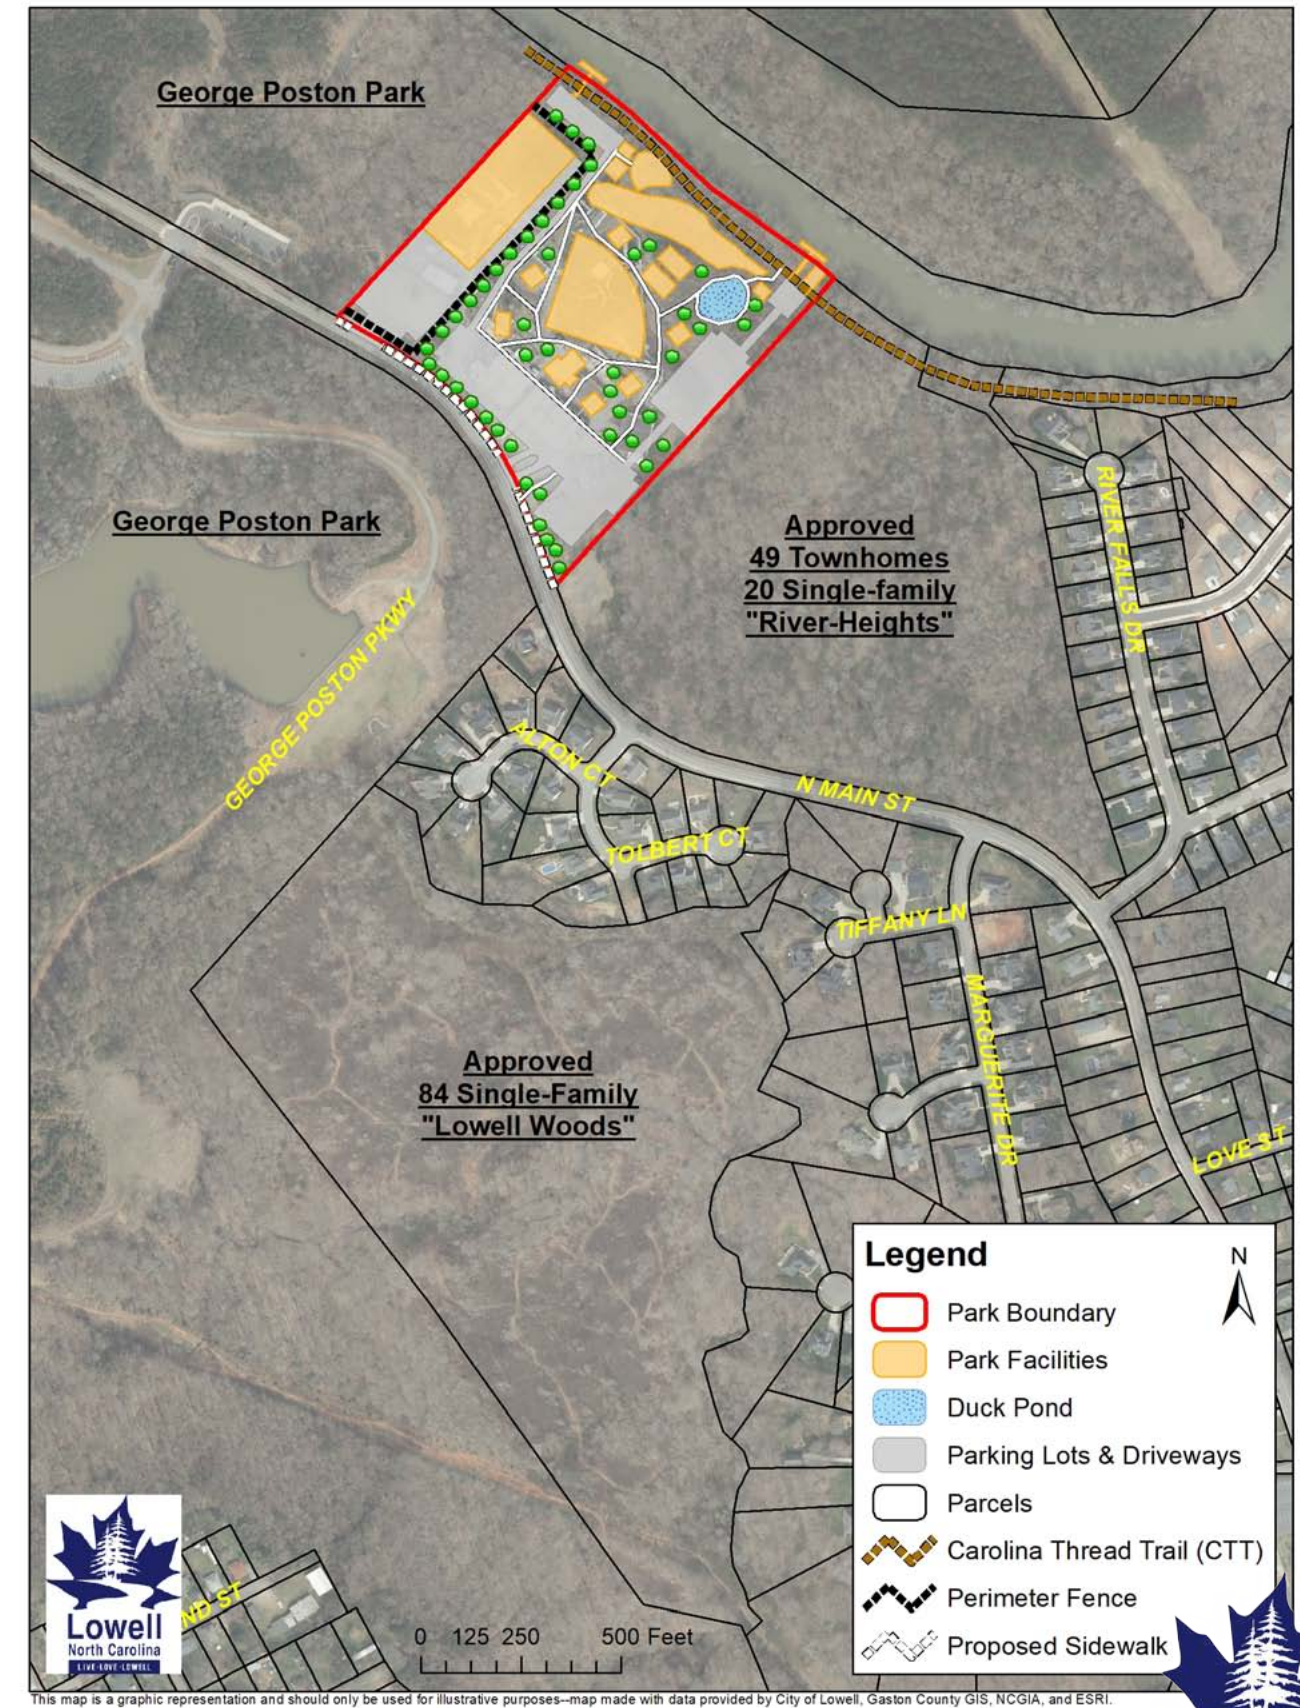
# EXISTING CONDITIONS

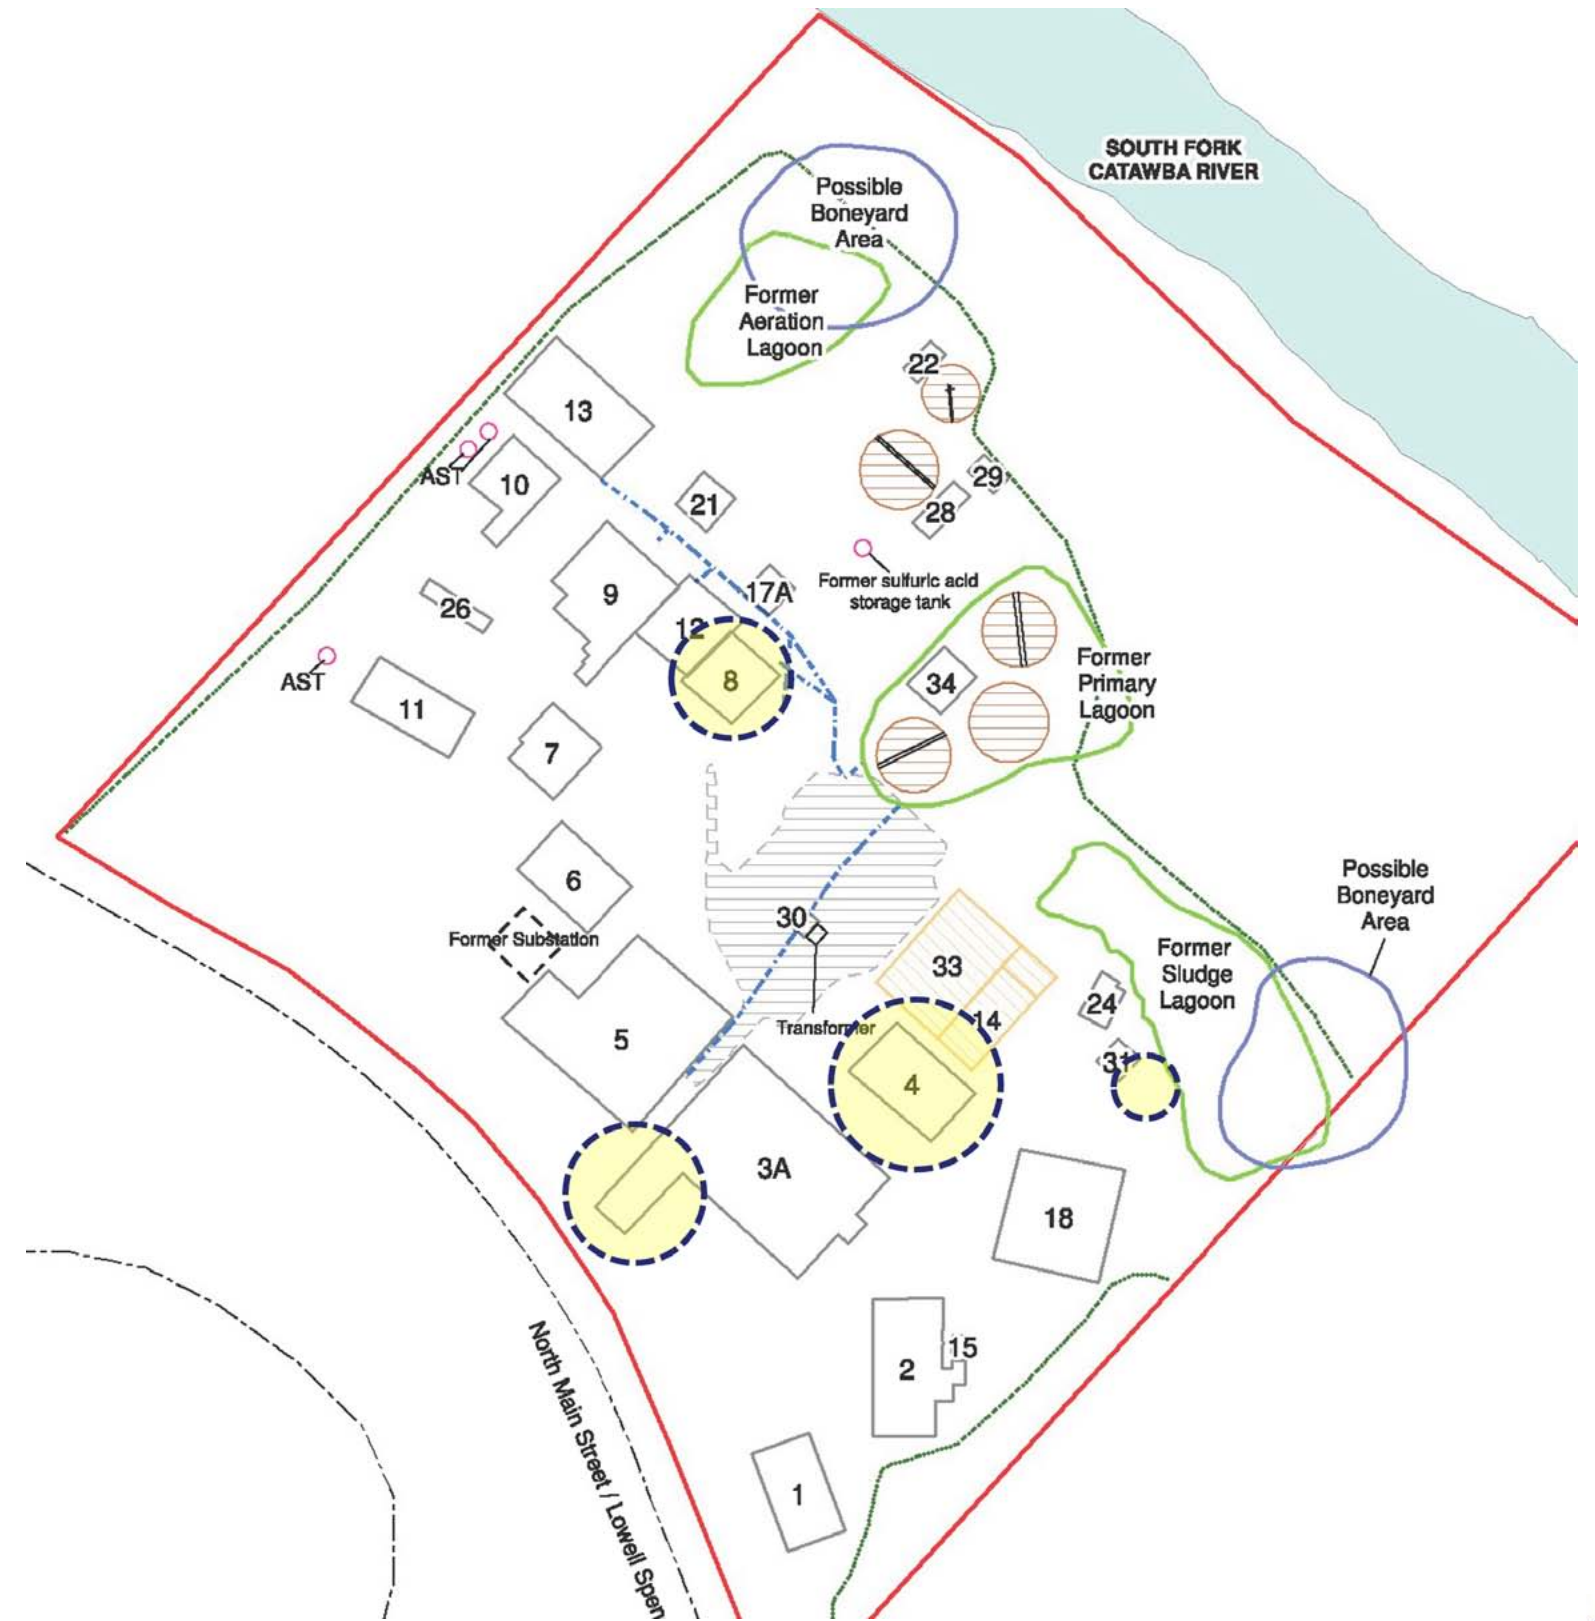
# E.C. - MILLING HOUSE

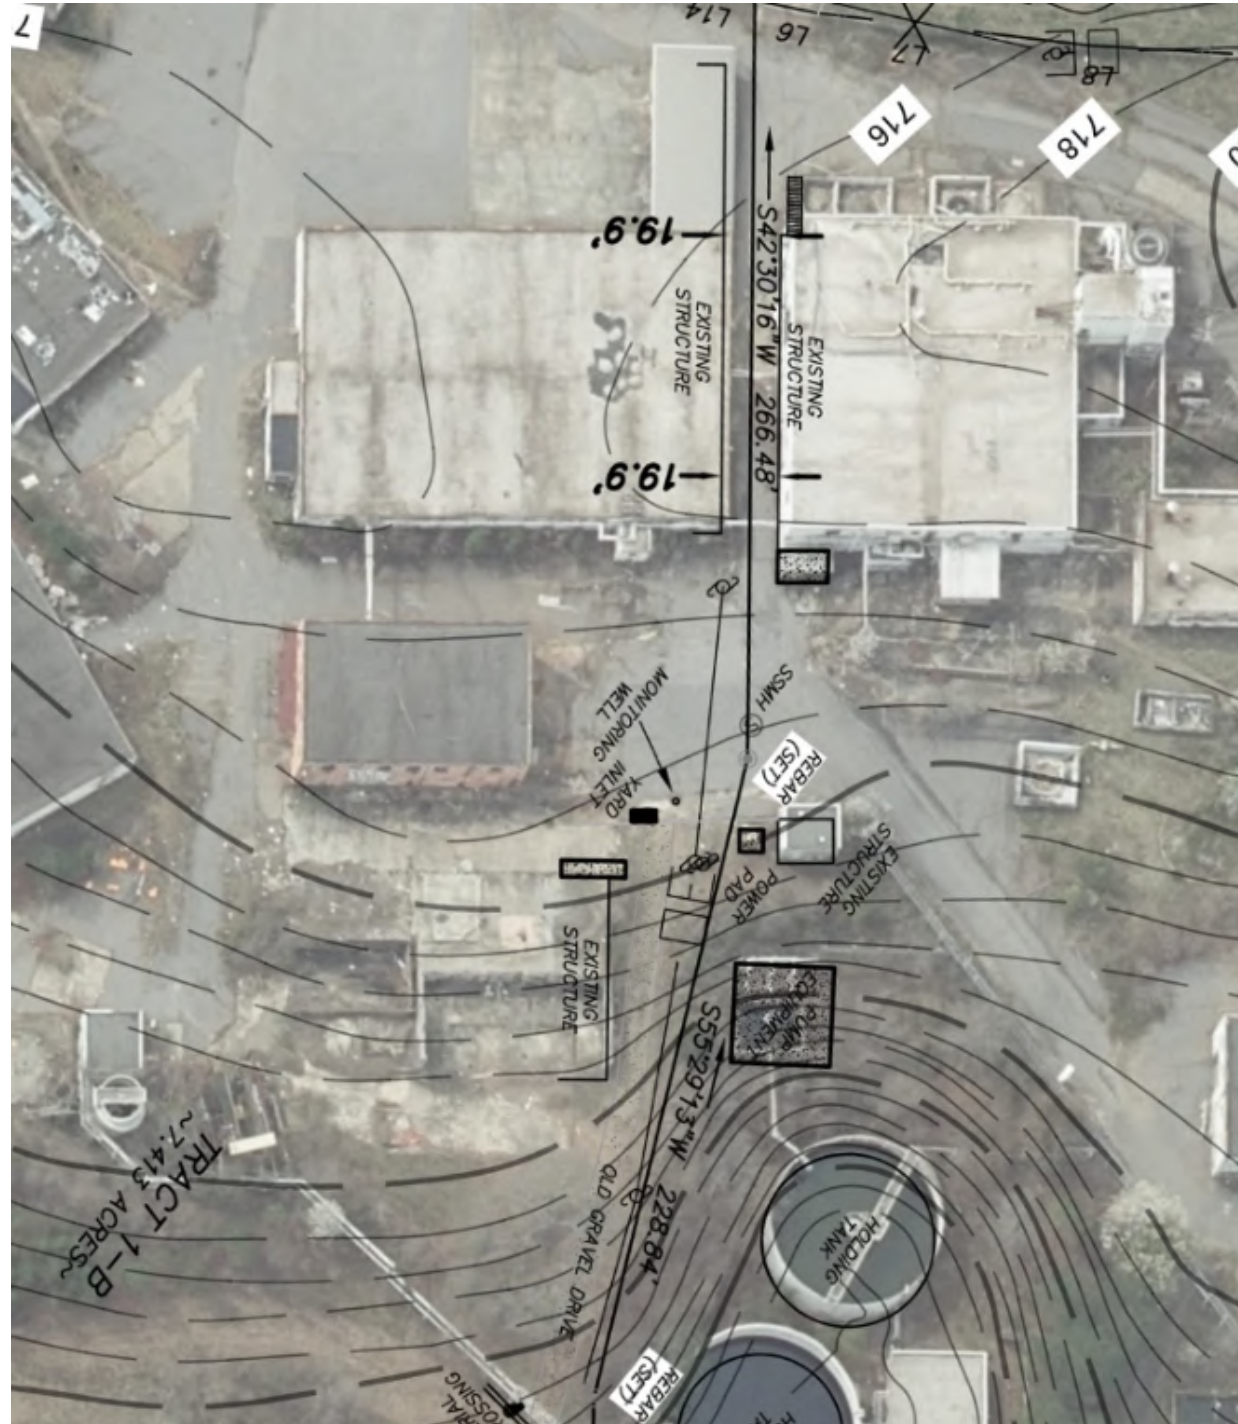
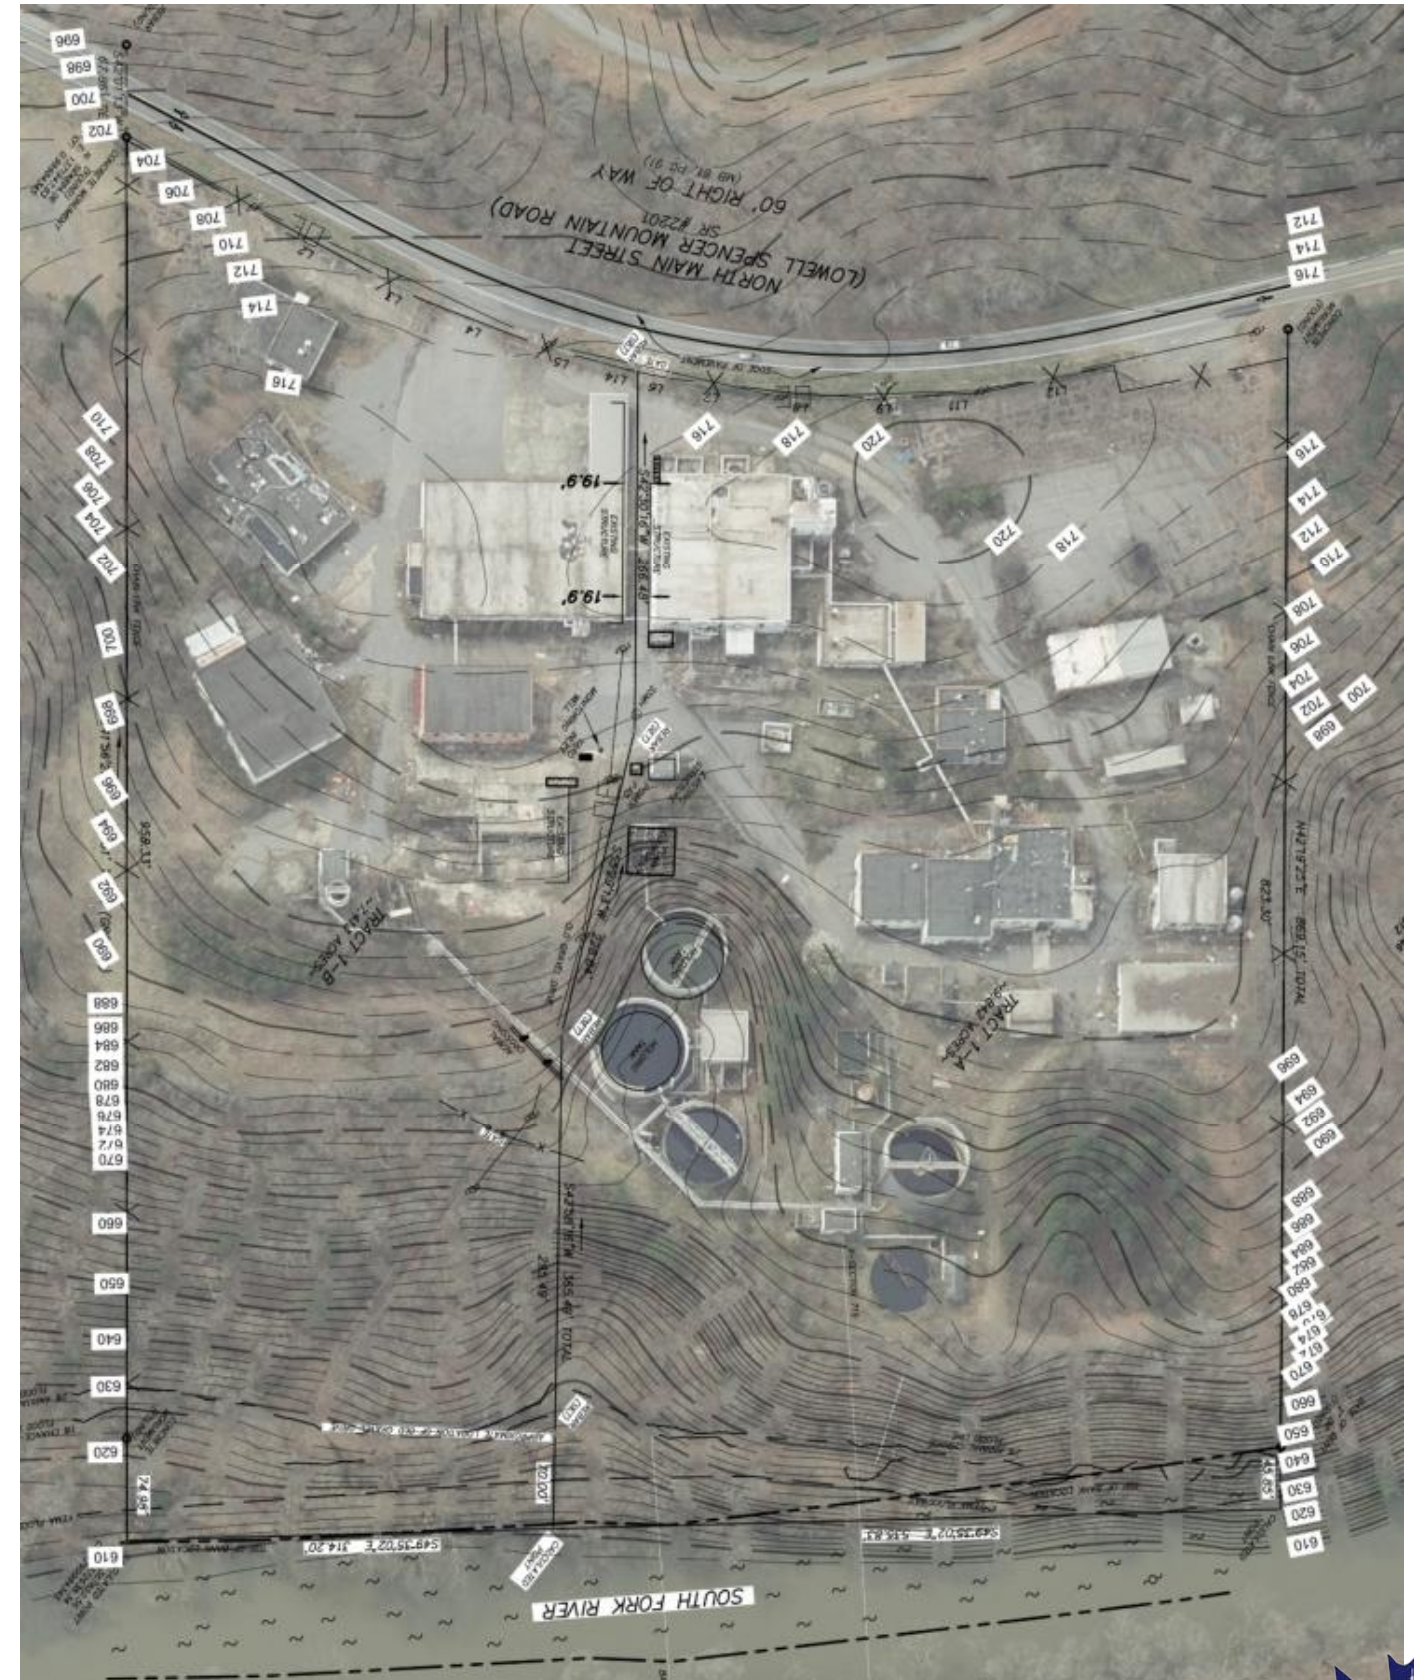
THE PARK MASTER PLAN IS A BOLD VISION FOR EXPANDED RECREATION FOR THE TOWN OF LOWELL. THE REDEVELOPMENT OF AN ABANDONED MILL FACILITY PROVIDES A UNIQUE OPPORTUNITY TO REPURPOSE AND PRESERVE A PART OF THE REGIONAL HERITAGE. KEY PARTS OF THE SPRAWLING MILL COMPLEX WILL BE RETAINED, AND THEIR FUNCTIONS REIMAGINED AS THE NEW PARK IS SHAPED WITHIN THEIR FRAMEWORK. THE PARK PROGRAM WAS DEVELOPED BY TOWN STAFF THROUGH INTERNAL VISIONING, STAKEHOLDER DISCUSSIONS, AND COMMUNITY INPUT. WHILE MOST OF THE PARK IS PASSIVE THE ENTERTAINMENT ASPECTS PROVIDE OPPORTUNITIES FOR HIGHLY PROGRAMMED EVENTS.

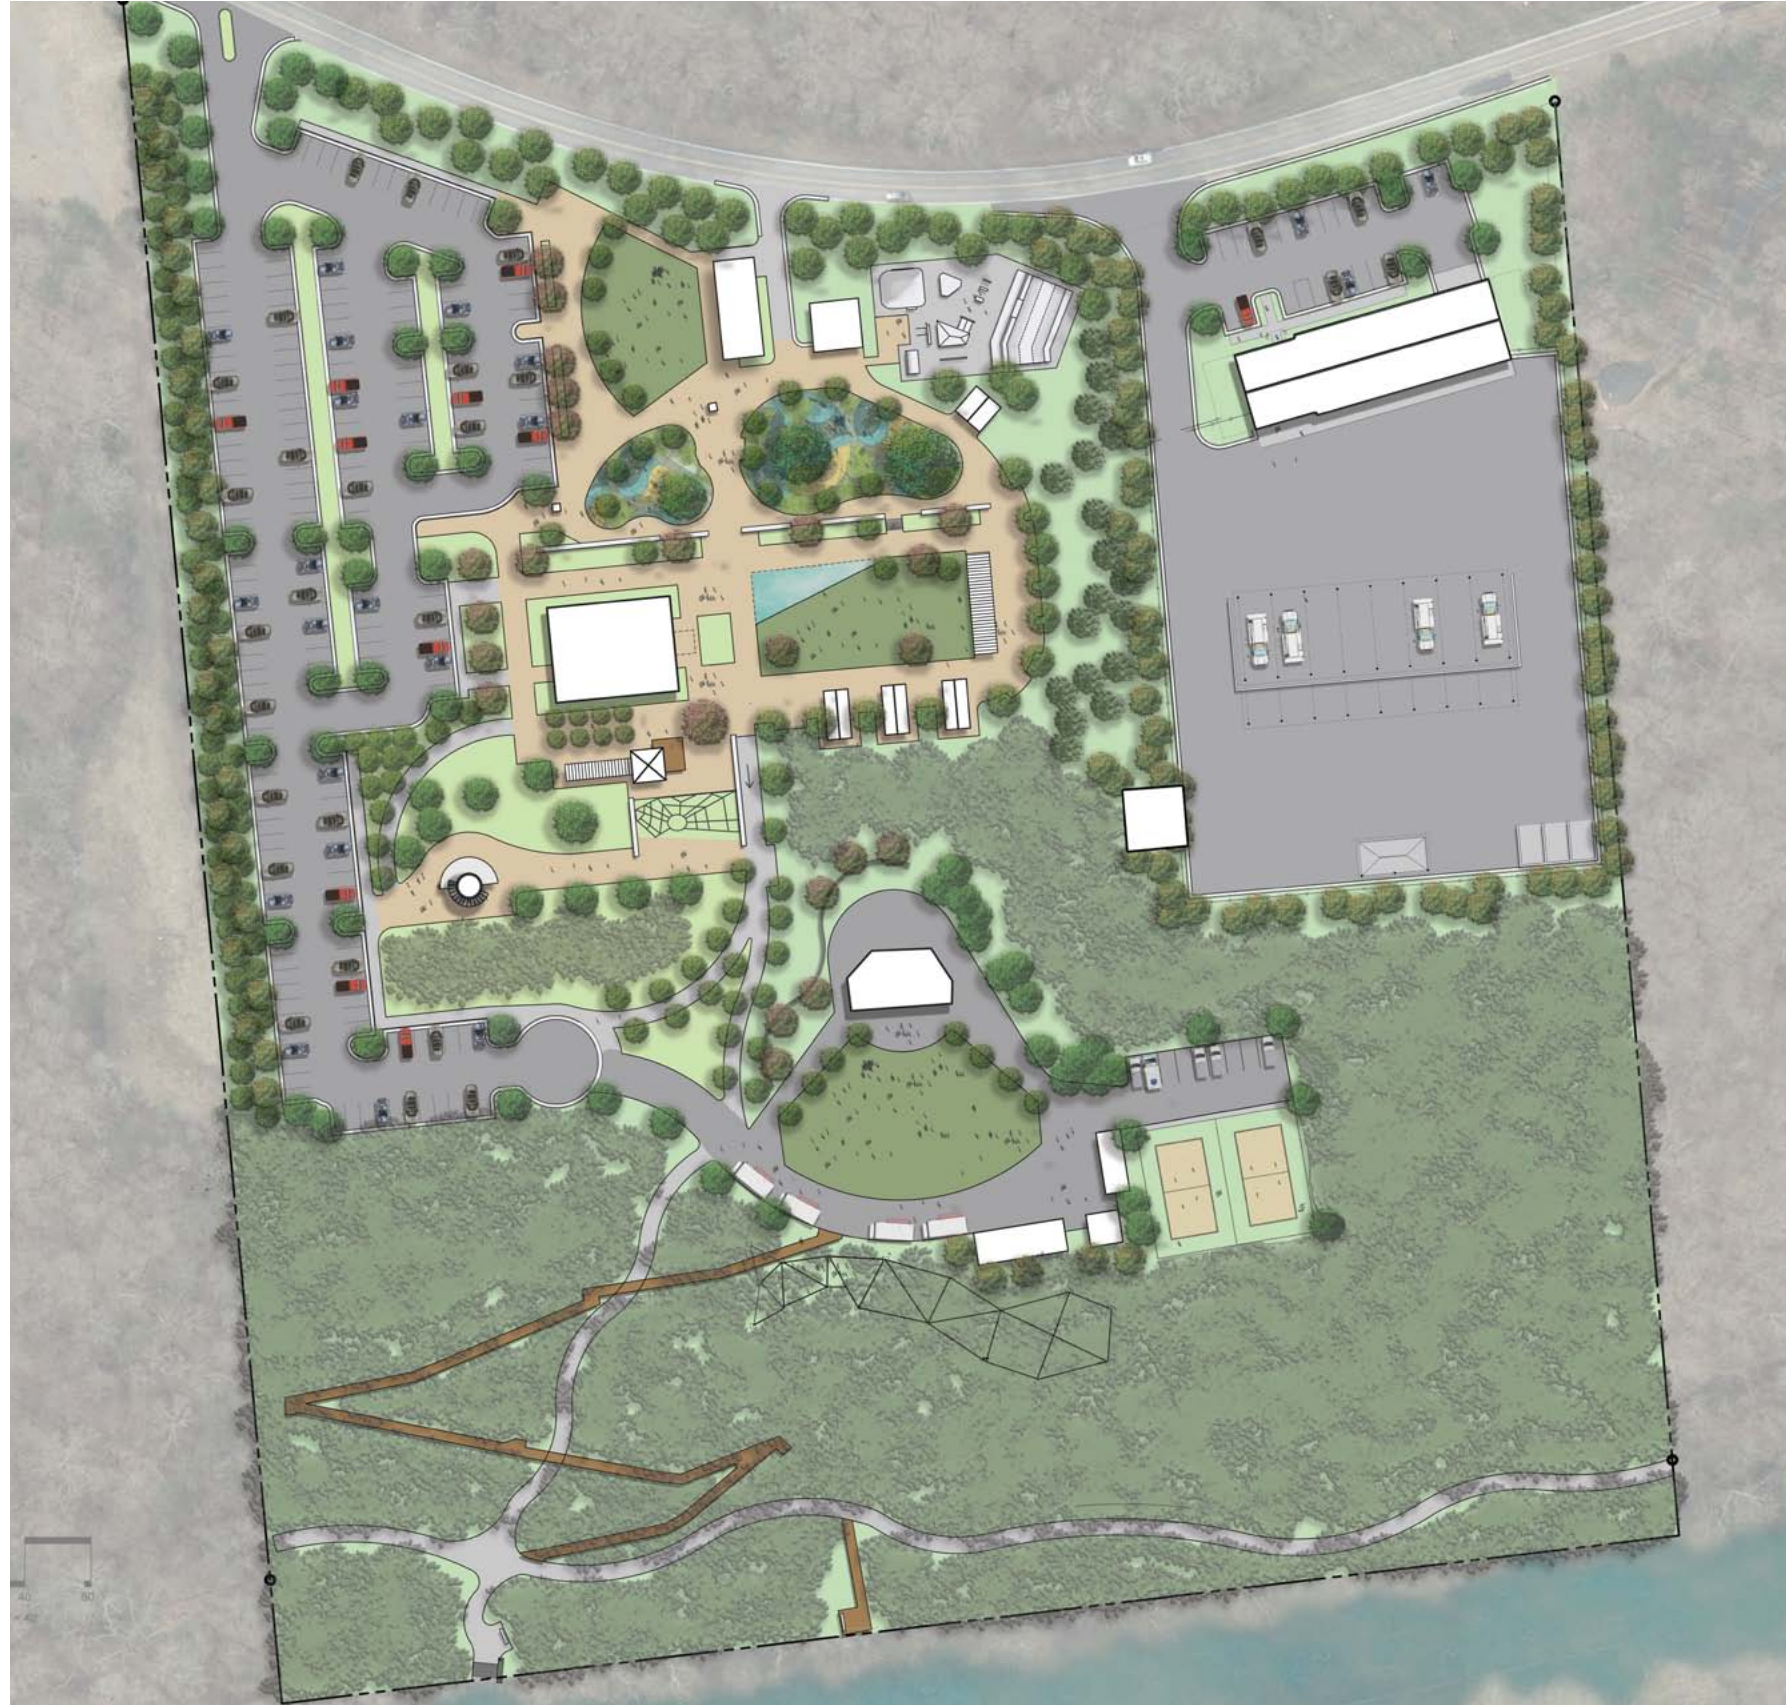
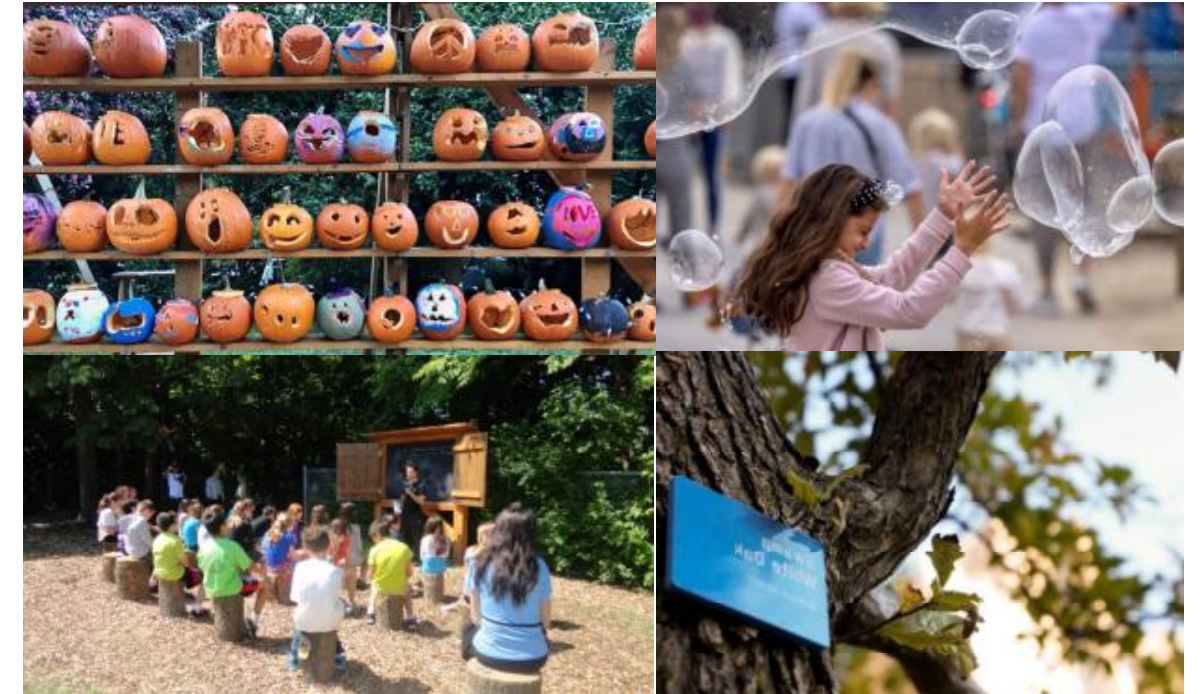
THERE ARE SEVERAL EXISTING CONDITIONS THAT INFLUENCE THE VISION OF THE PARK DEVELOPMENT THROUGH THEIR LOCATION, MATERIALITY, AND RELATIONSHIP TO GRADE. THE UPPER LEVEL OF THE SITE AT MAIN STREET AND THE LOWER LEVEL BEHIND THE LARGE WAREHOUSES CREATE 2 DISTINCT ZONES THAT MITIGATE THE SIZE OF THE LARGE PARCEL AND ADD AN ELEMENT OF HUMAN SCALE. THE KEY COMPONENT OF THE UPPER LEVEL IS THE STAGE CREATED BY AN ADAPTIVE REUSE OF THE EXISTING LOADING DOCK STRUCTURE. THIS ELEMENT CREATES A SMALL FLEXIBLE VENUE ADJACENT TO A VARIETY OF RECREATION AREAS. THE SECONDARY ELEMENT ON THE UPPER LEVEL IS THE PUBLIC WORKS FACILITY THAT IS PLACED ADJACENT TO POSTEN PARK AND EFFECTIVELY TUCKED AWAY IN THAT SITE QUADRANT. THIS FACILITY AND THE STORAGE AREA WILL BE SCREENED FROM VIEW WHILE IN THE PARK.

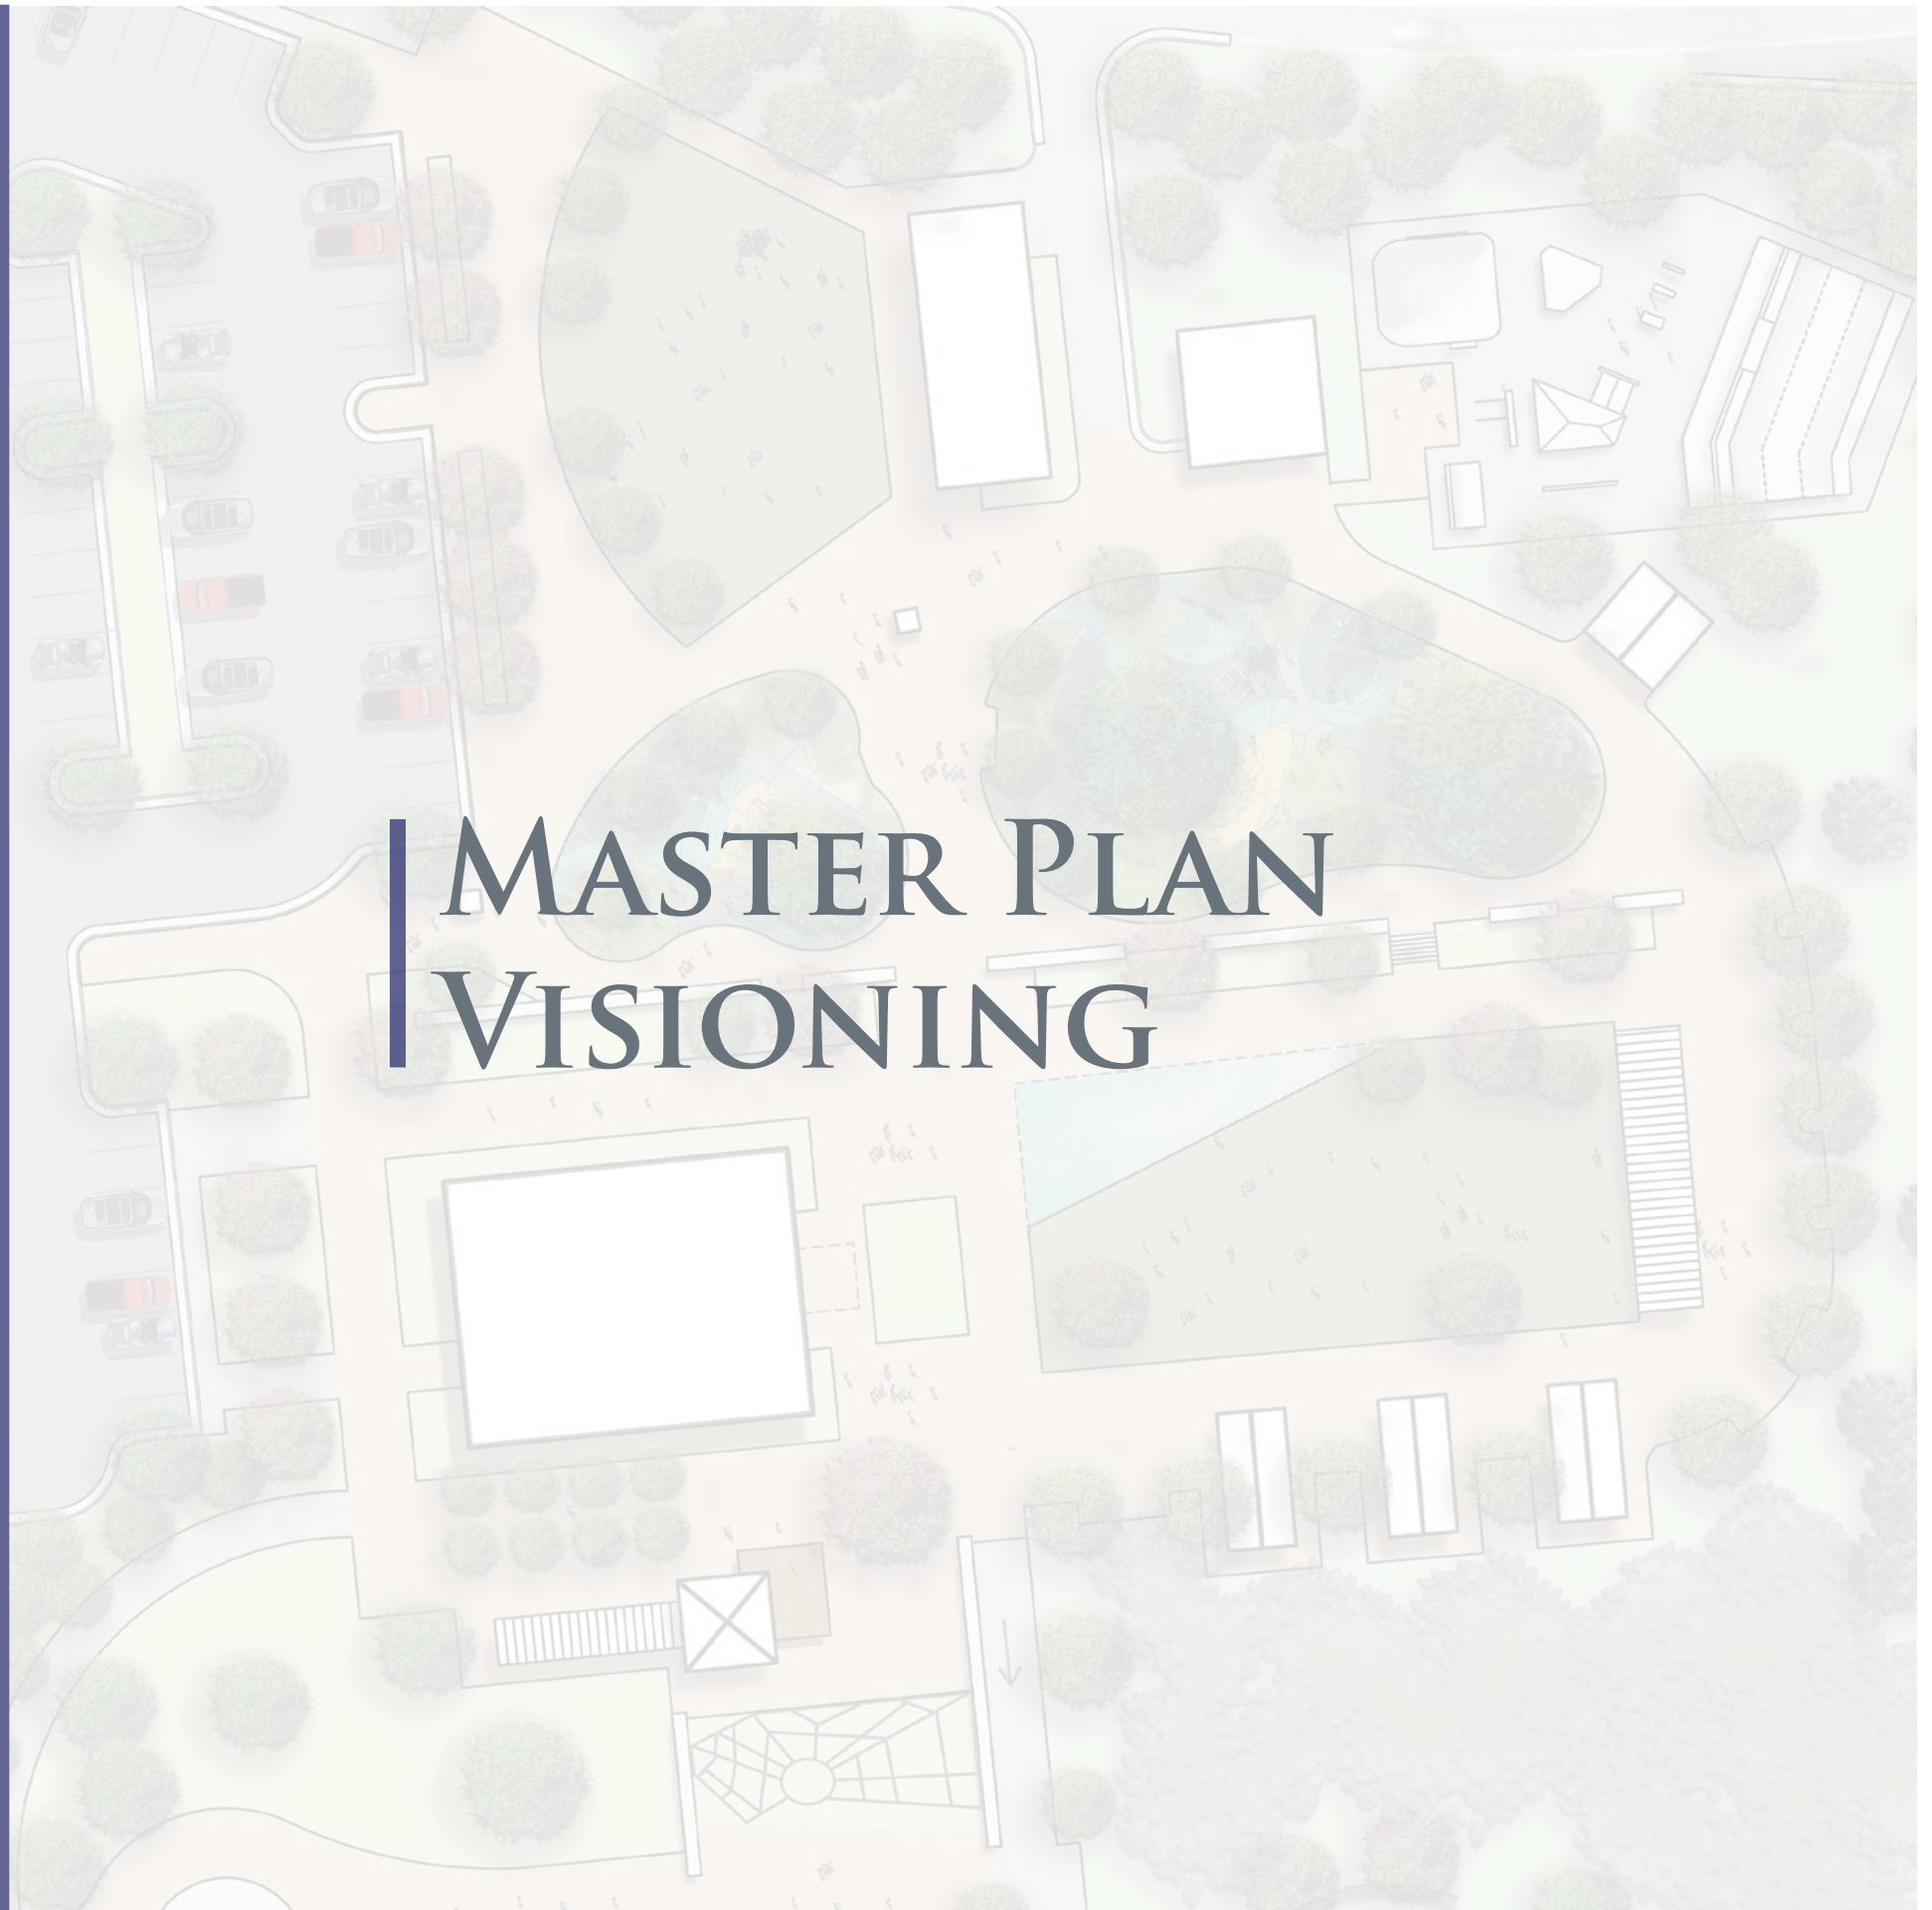
# MASTER PLAN VISIONING

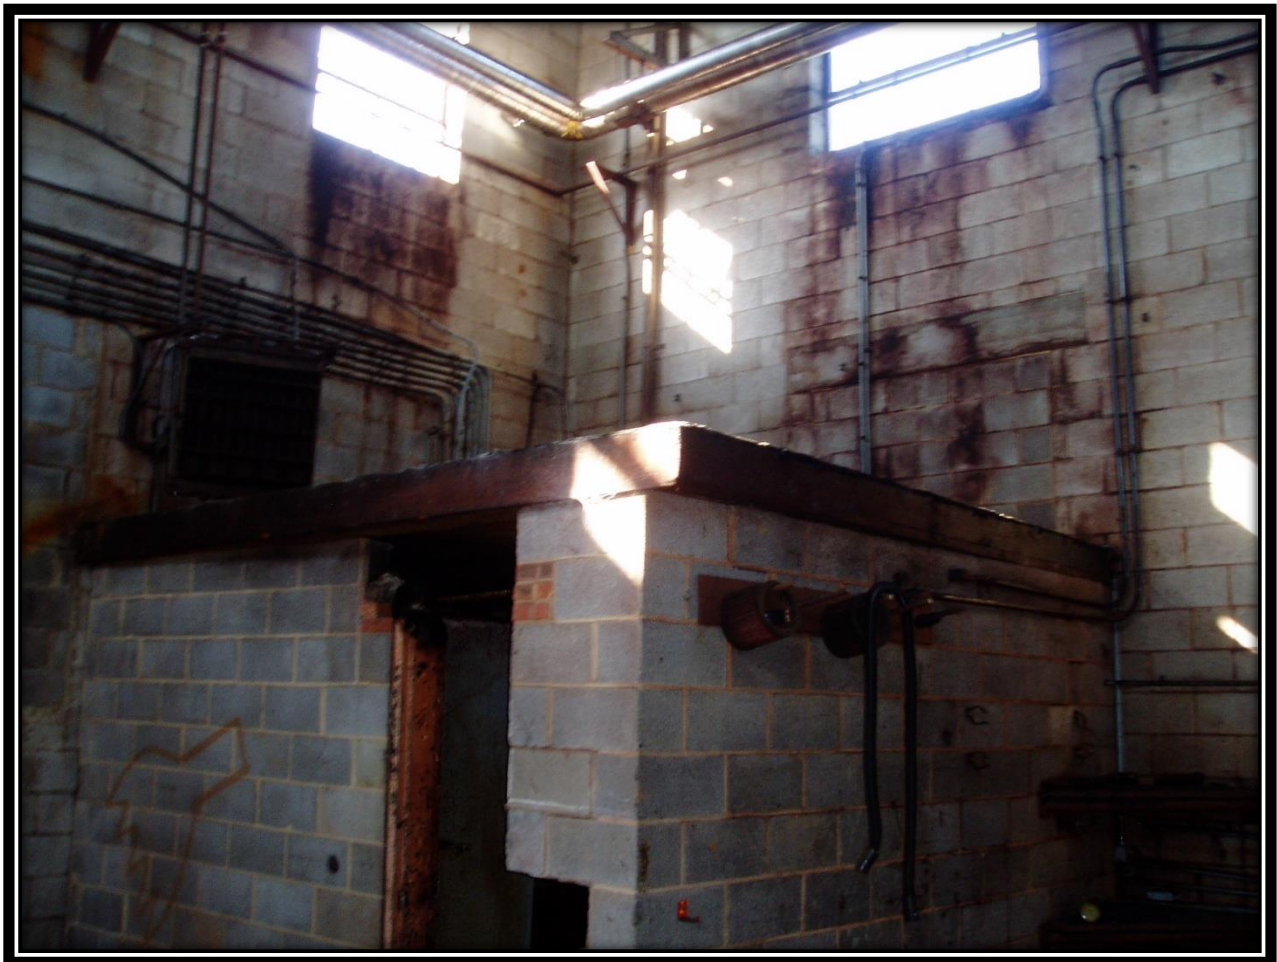
The information supplied above is based on the consultant's customary observation of the work and the consultant makes no representations that all deficient work has been reported on or that the observed conditions noted and reported on are meant to be a complete listing of all site conditions, issues, etc. No warranties are implied.

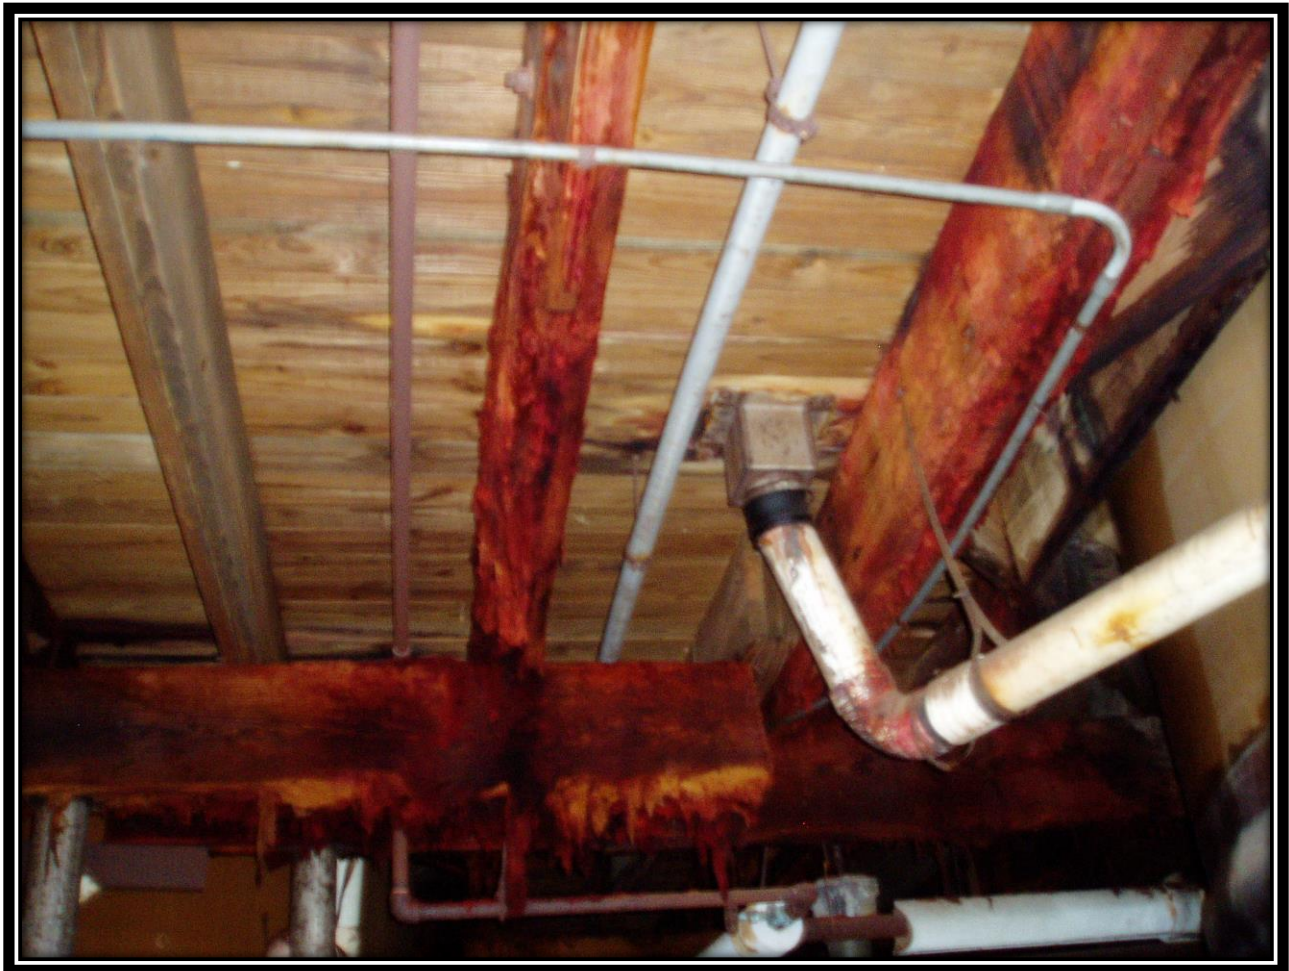
Bldg 5 – Visible chemical attack on wood framing. Do not walk on second level.

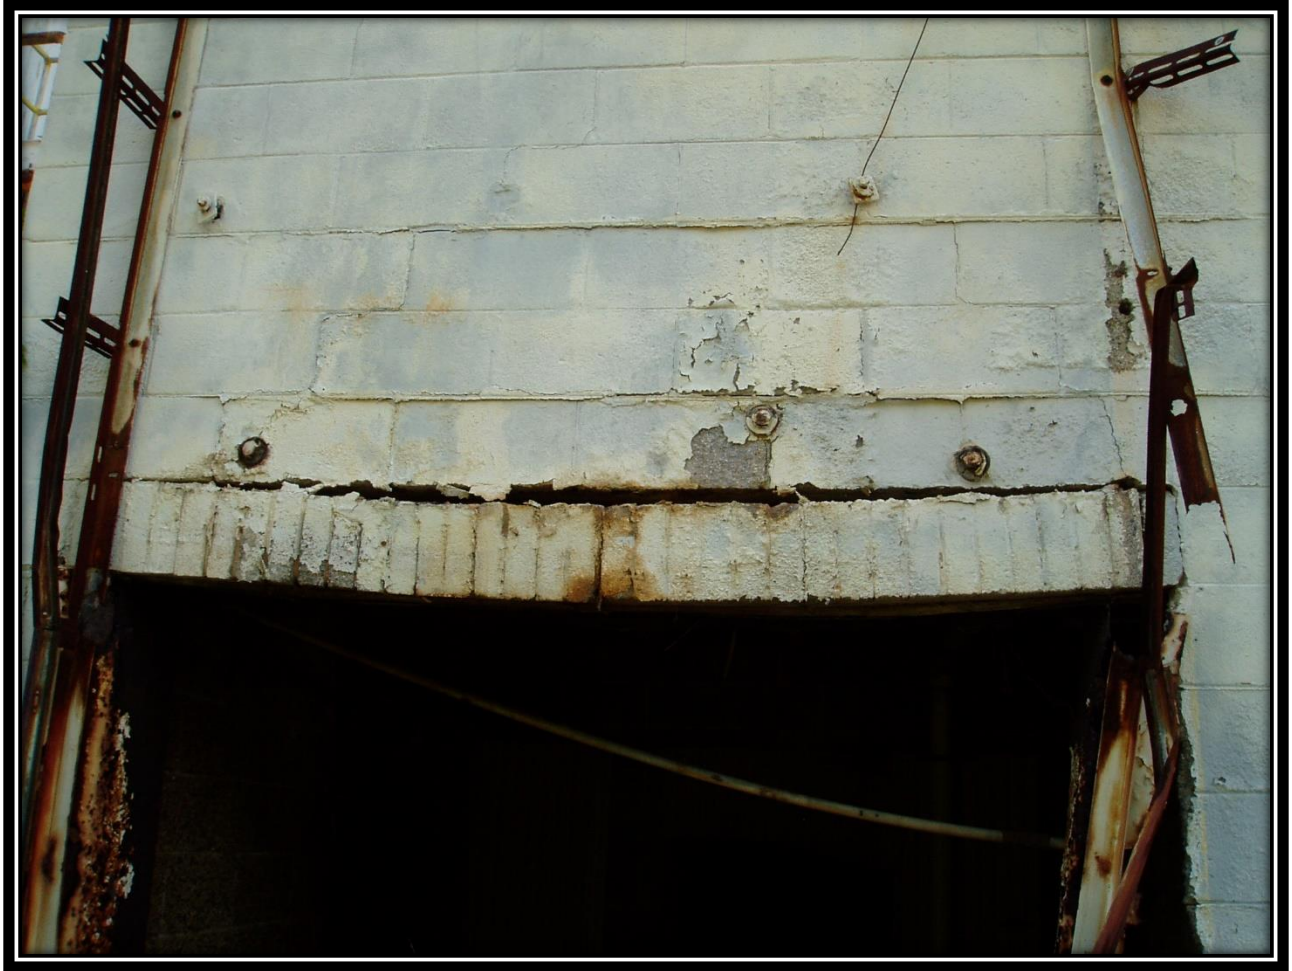
Bldg 5 – Lintel almost at failure. Avoid this back corner the building. Chemical attack on all building materials – steel, masonry and concrete.
