**APPENDIX A**

**Building Summary Spreadsheet & Select  
Site Figures**

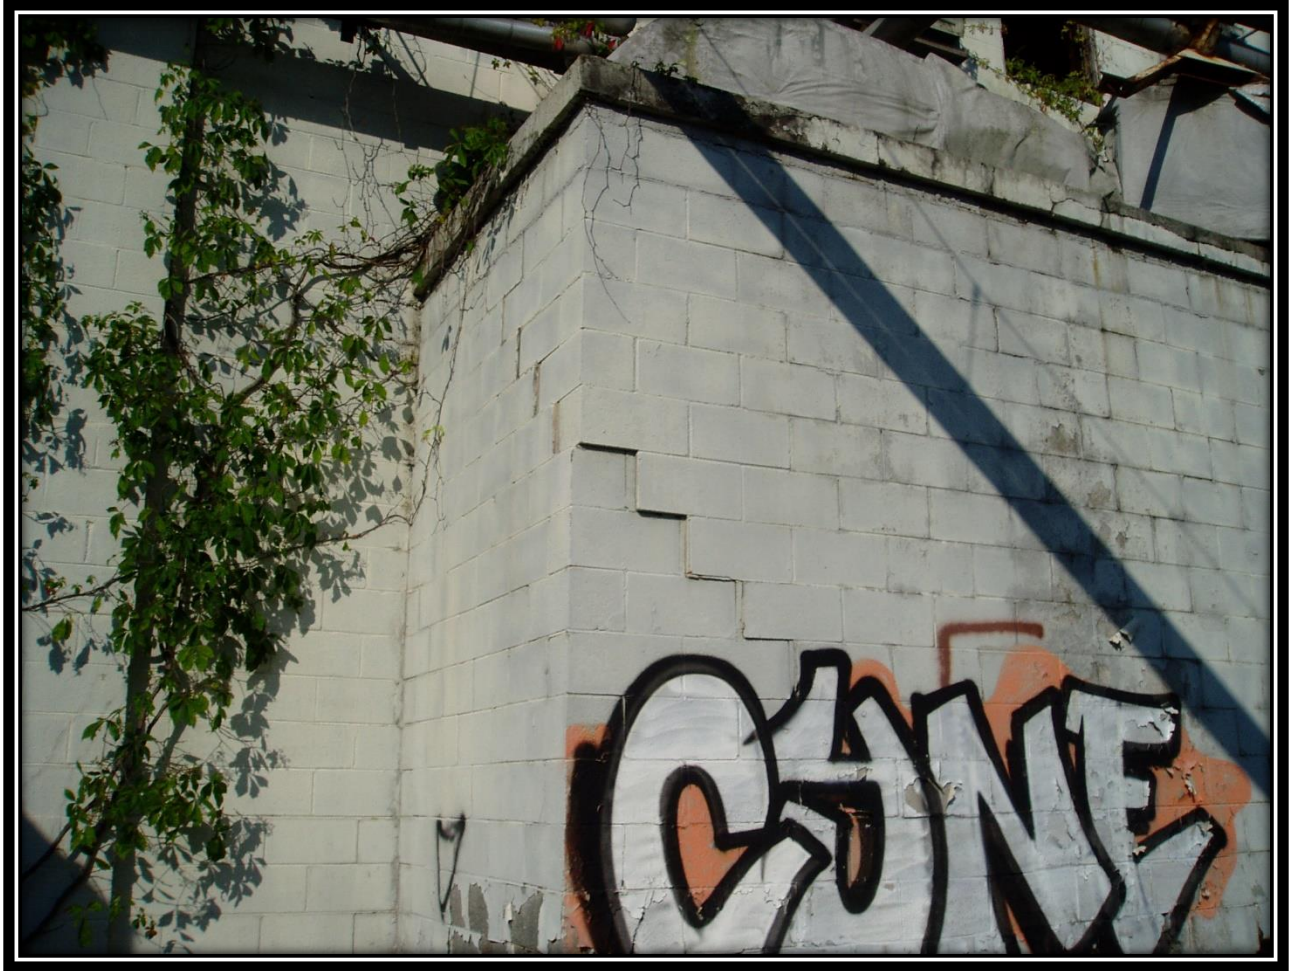
Bldg 5 – Appears as though forklift ran into corner of building. This would need to be repaired if the building is to be renovated. Do not climb on roof on this small addition.

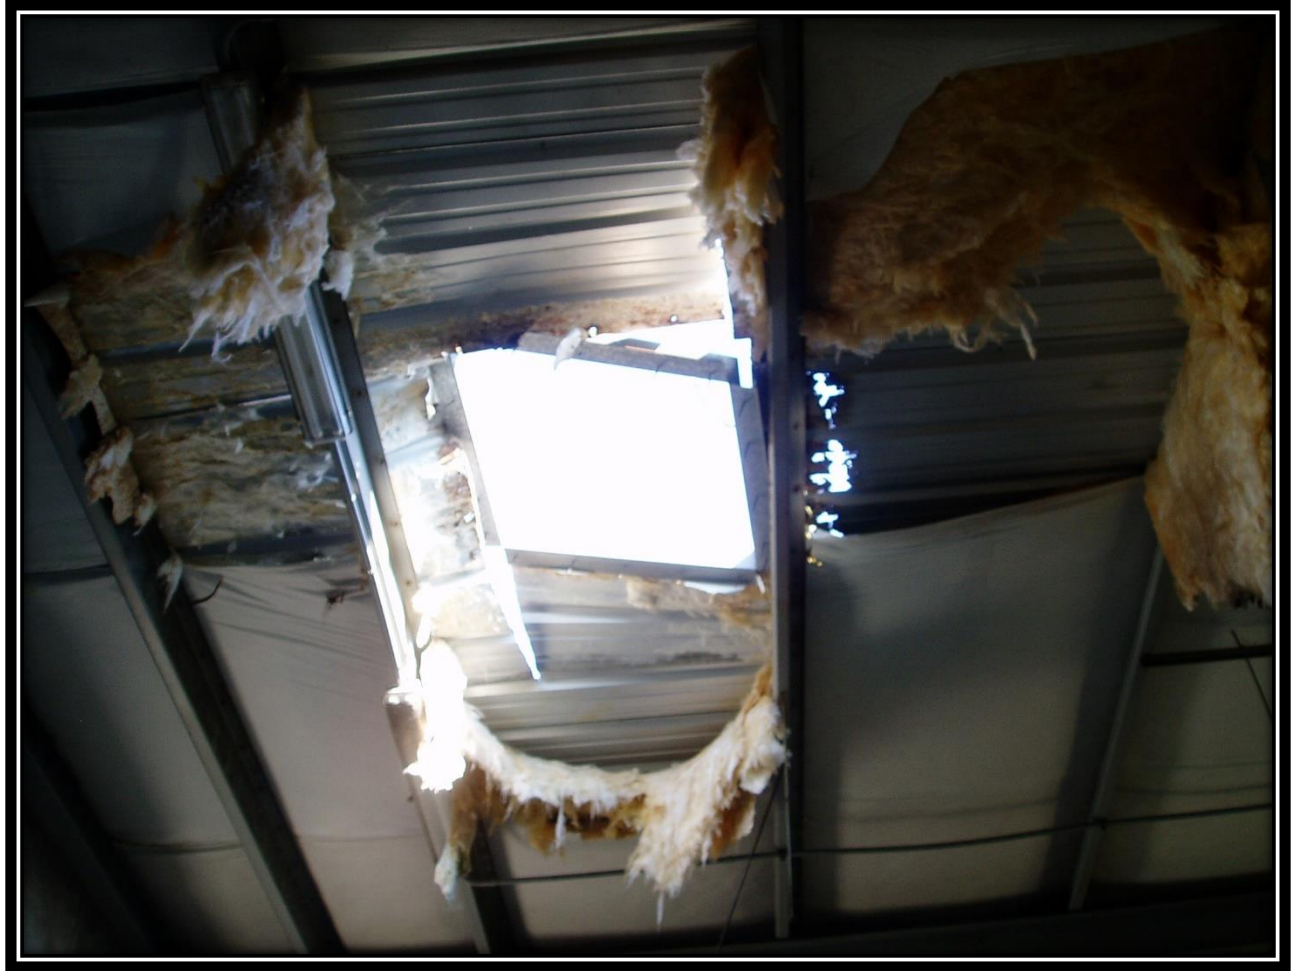
General – Proceed with caution anytime roof access is needed. There are open spots and weak deck spots that should be avoided.

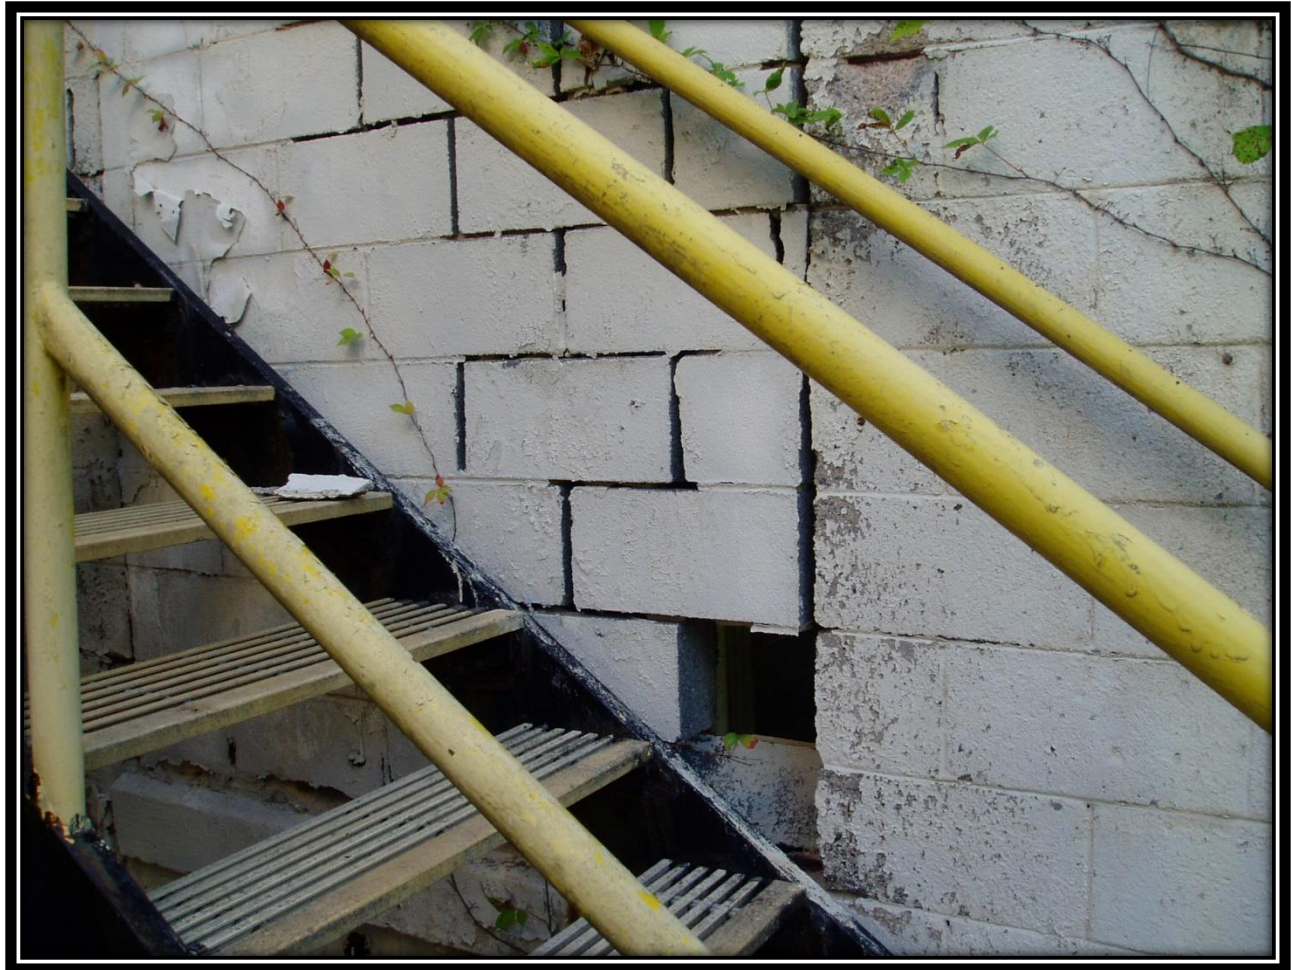
General – On any building that will be reoccupied load bearing CMU walls should be repaired.

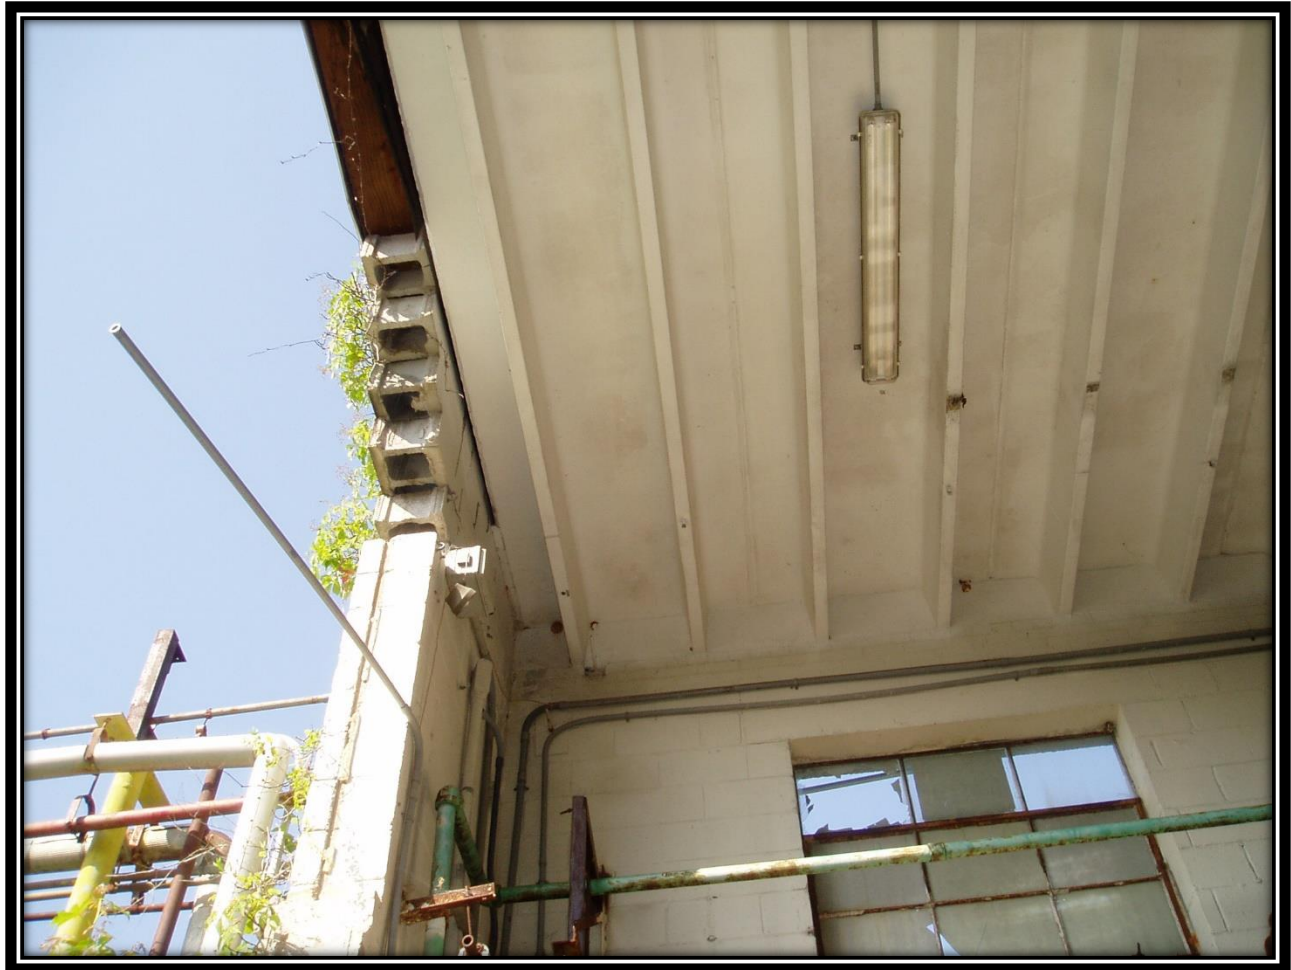
Bldg 10 – Hanging CMU pieces at entrance of building. Avoid this area in case they come loose and fall.  
This is a non-load bearing wall.

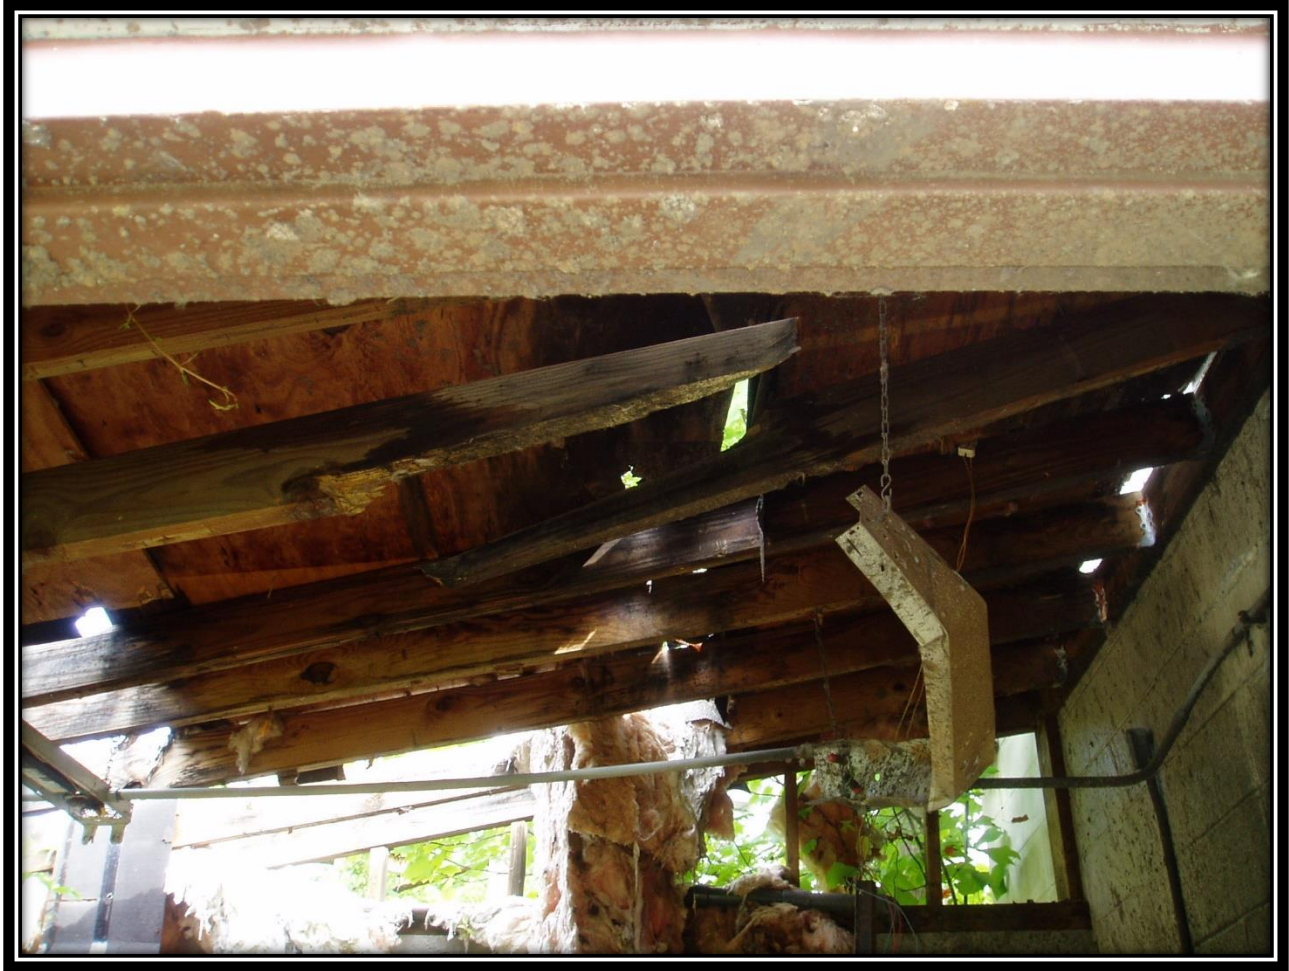
Bldg 21 – Wood framed lean-to on back of building should be avoided.
