BB2 Removal Project Impact Assessment and Mitigation, MCFCWCD, 2025

Building Bridge #2 Removal – Impact Assessment of Rise in Modeled Base Flood Elevation (BFE)

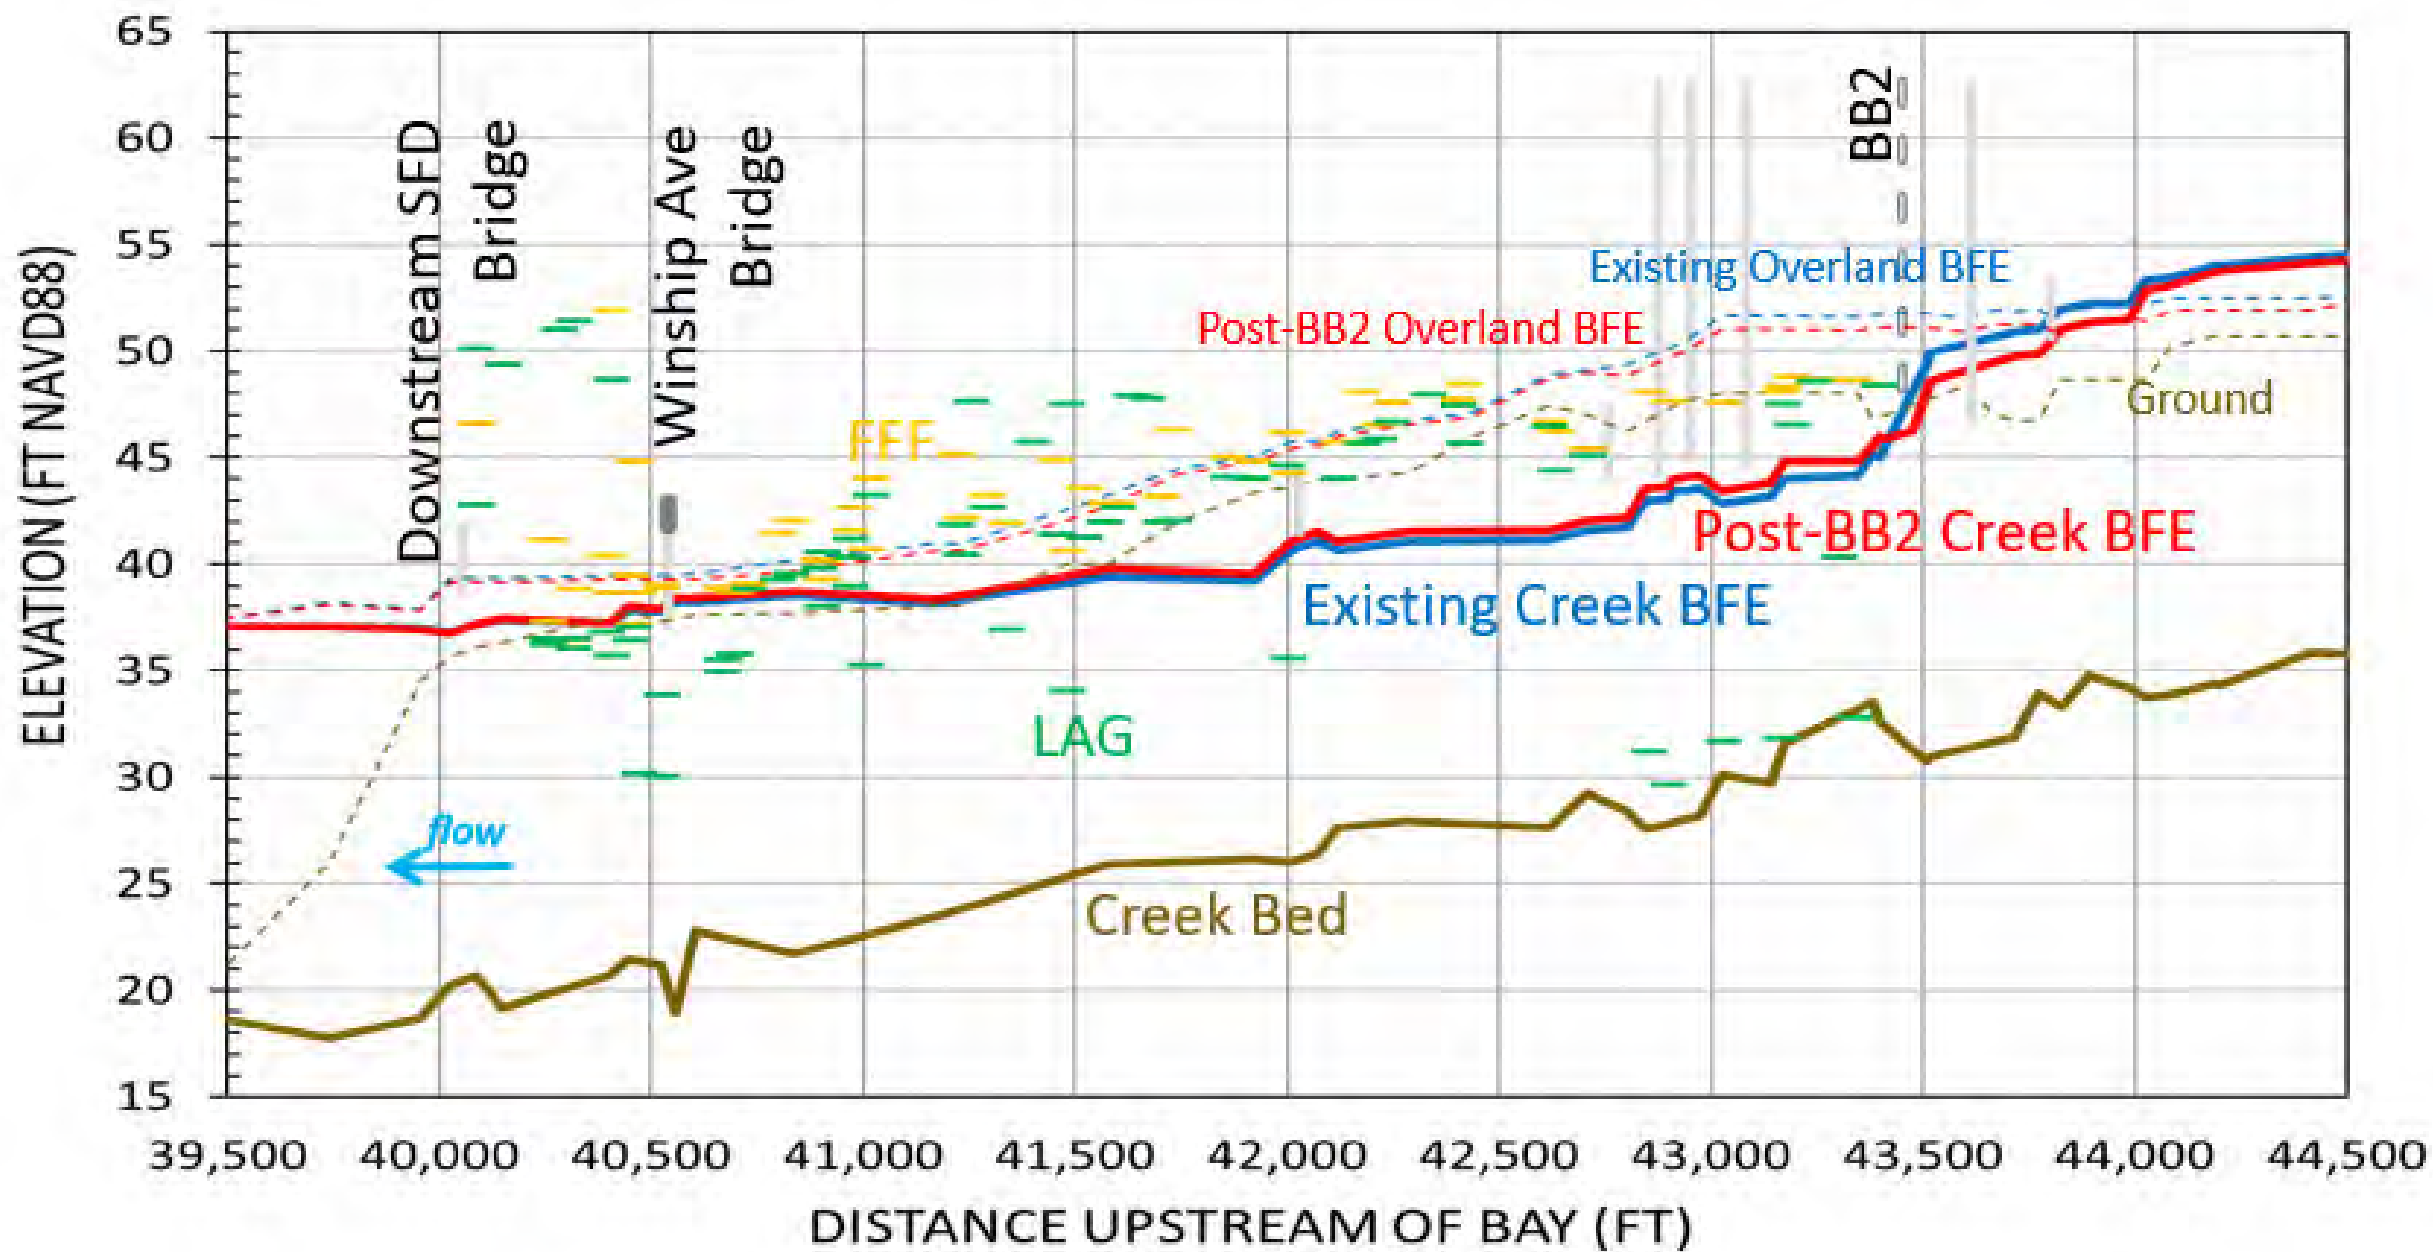
Figure 2. San Anselmo Creek Longitudinal Profile

- For the Base Flood (e.g., 100-year event) much of the flooding of structures along the creek would be caused by overflow from the street side (e.g., overland floodway), not from the creek (e.g., main channel floodway). The modeled water surface on the street side, which is higher than that on the creek side, drops in all modeled flood events with BB2 removed. This is shown on the longitudinal profile on **Figure 2**.

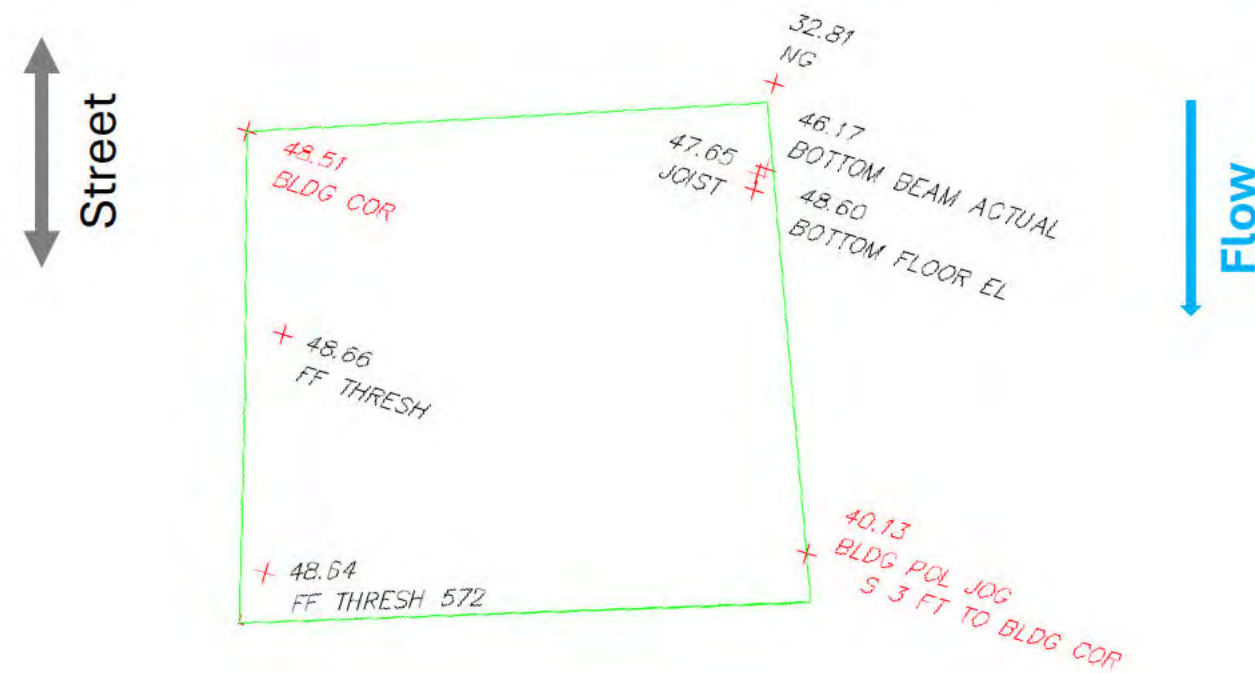
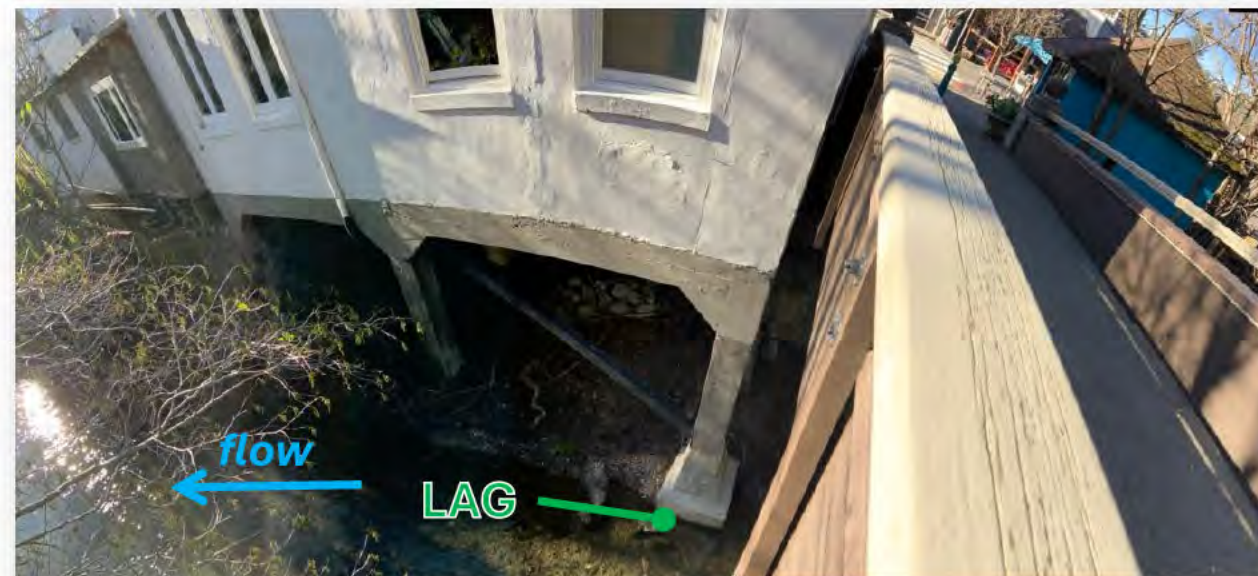
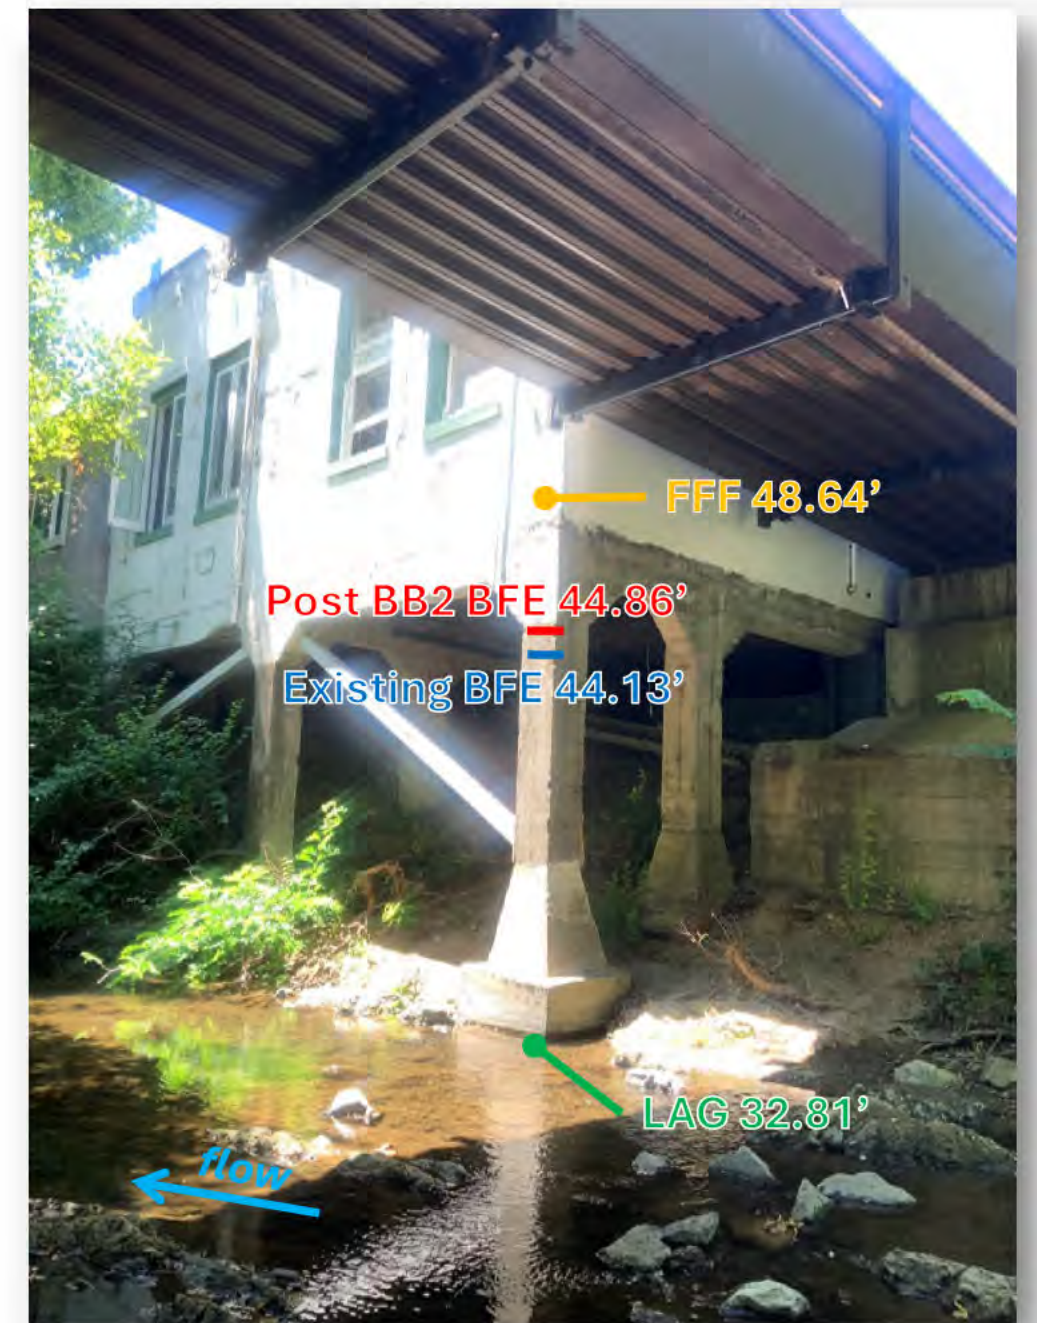
Exhibit No. 1: 574 – 572 San Anselmo Ave., San Anselmo

Rise affects concrete piers, which is a flood damage-resistant material.
Building piers' structural conditions are adequate to resist the additional flood-induced loads.
No mitigation needed.

Using the Flood Control District-supplied flood velocity of 6.62 feet per second, it was determined that the existing 16"x16" 'C1' column at 574 SA Avenue would not perform acceptably if constructed of plain (unreinforced) concrete. Flood loads imposed at this location on an unreinforced section fail to meet structural performance criteria.

However, when considering a reinforced column with a minimum of 1% vertical reinforcement and #3 ties spaced at 10 inches on center (consistent with the code requirements at the time of original construction), the structural performance improves. This configuration meets the acceptable performance threshold under the same loading conditions.

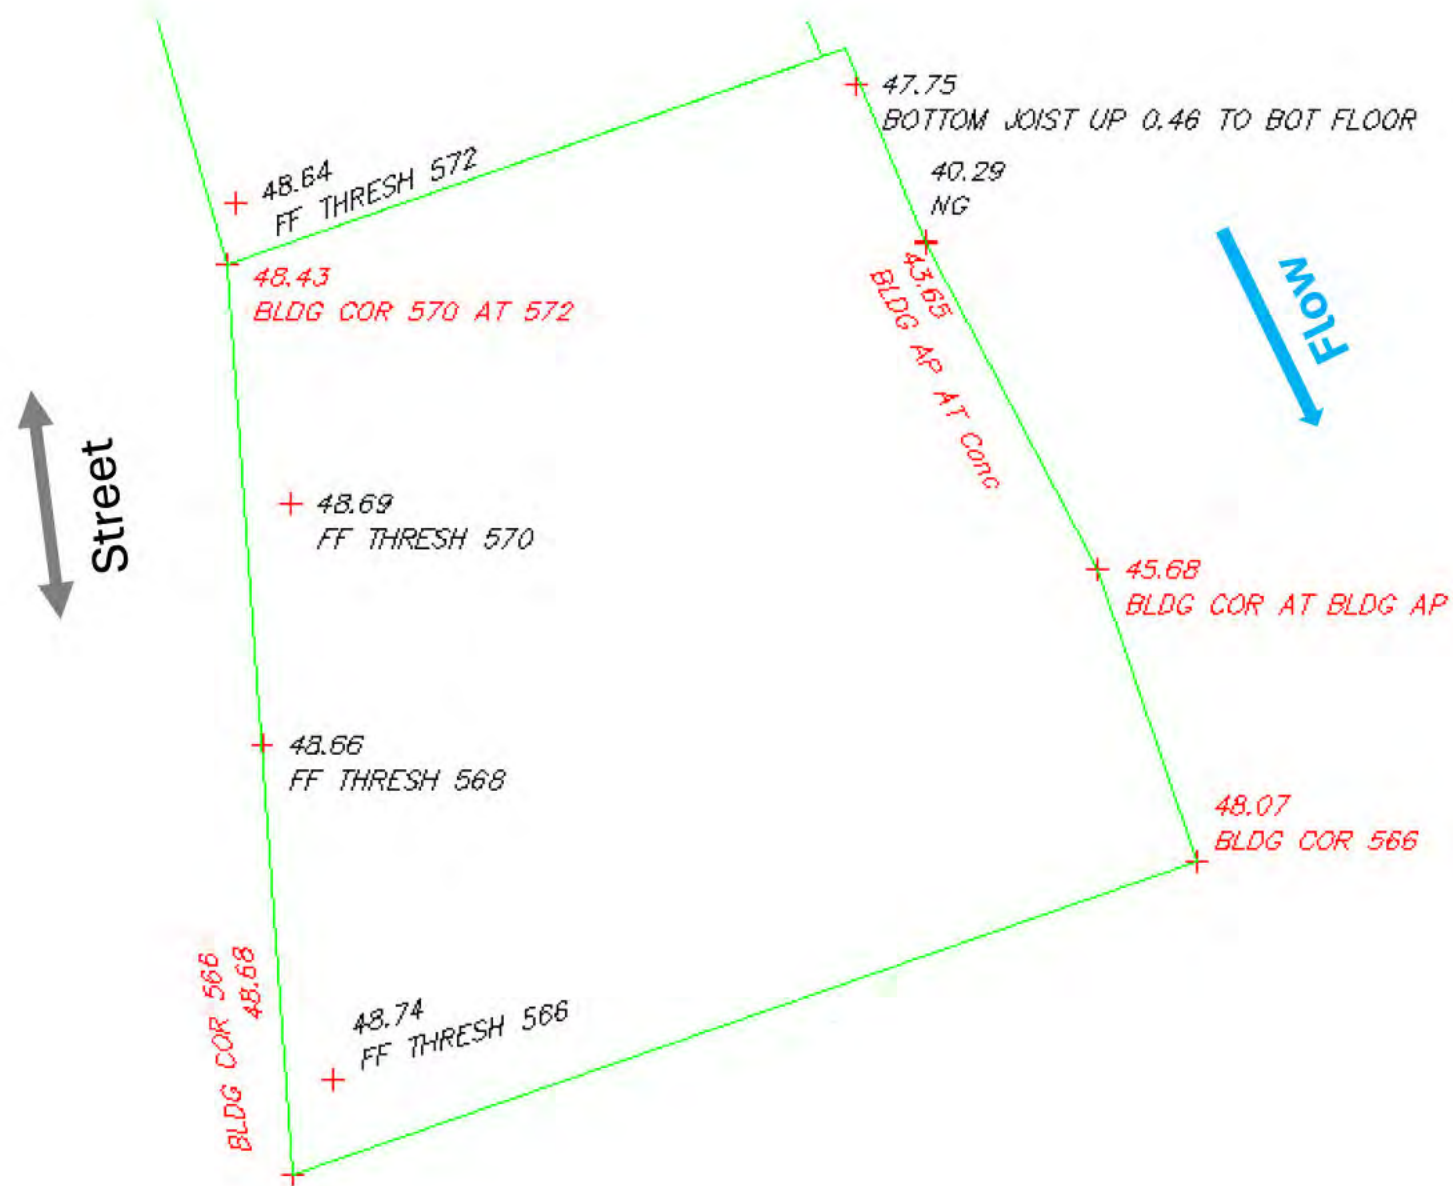
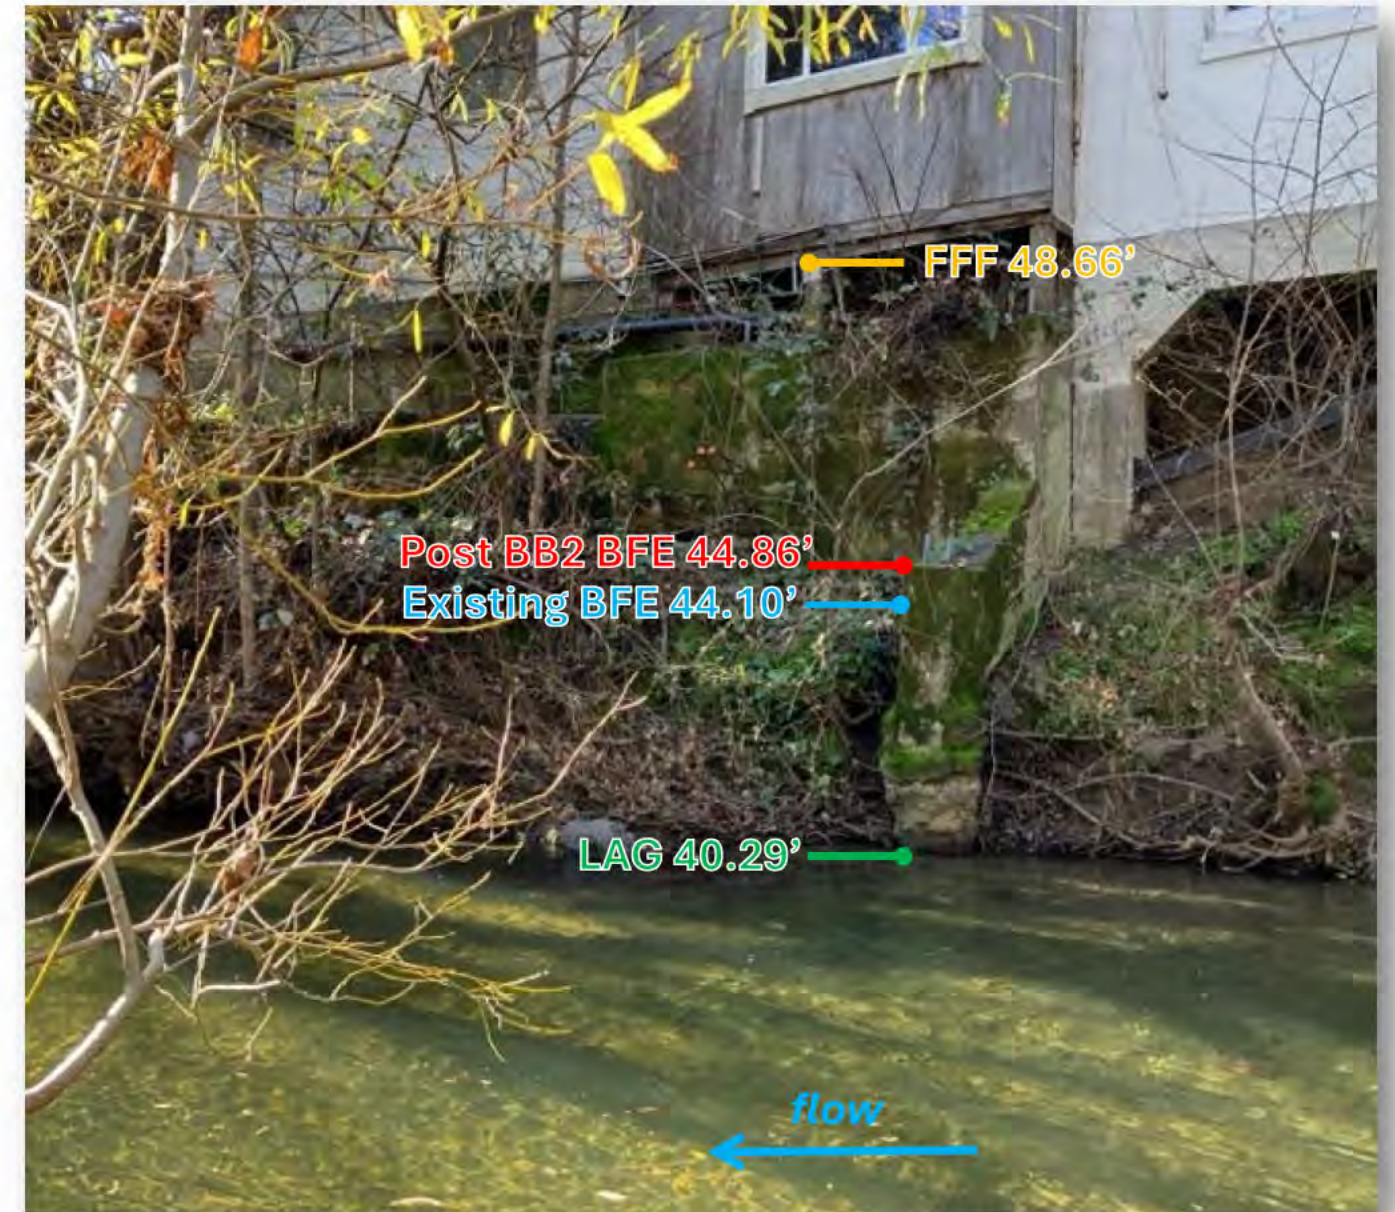
Exhibit No. 2: 570 - 566 San Anselmo Ave., San Anselmo

Rise affects concrete retaining wall, which is a flood damage-resistant material.
No mitigation needed.

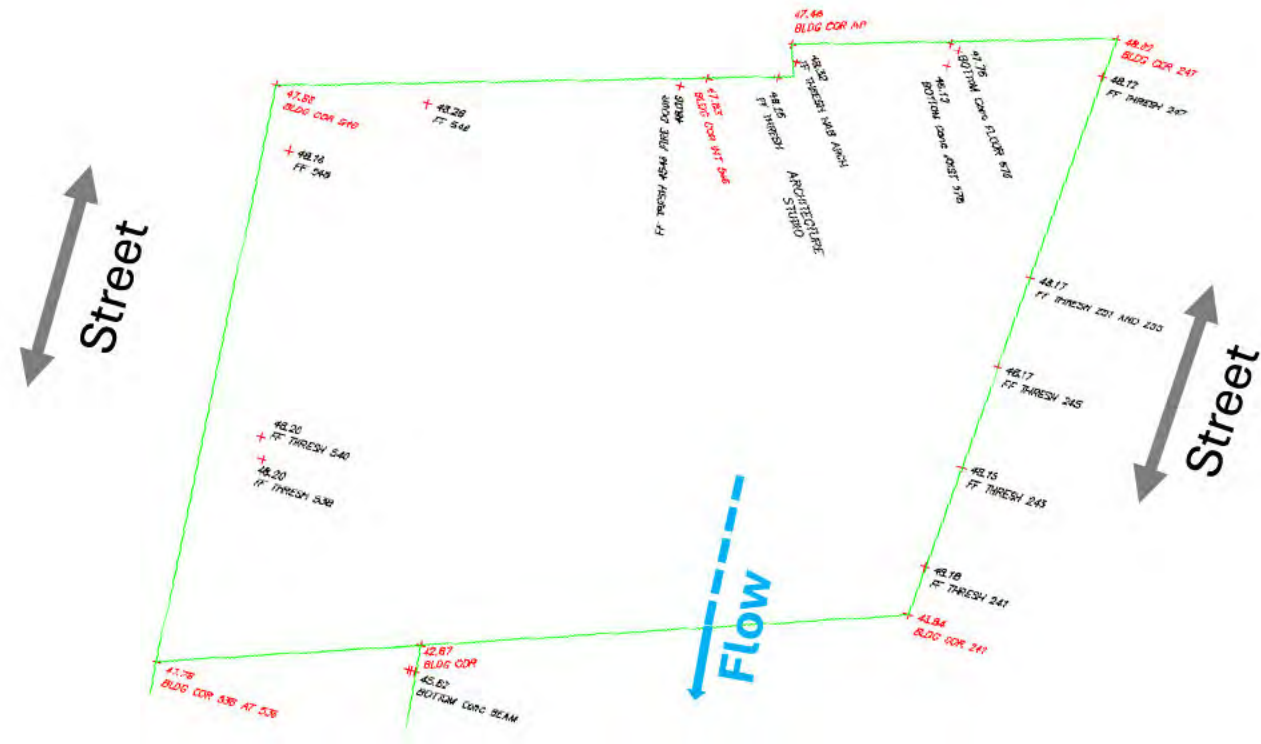
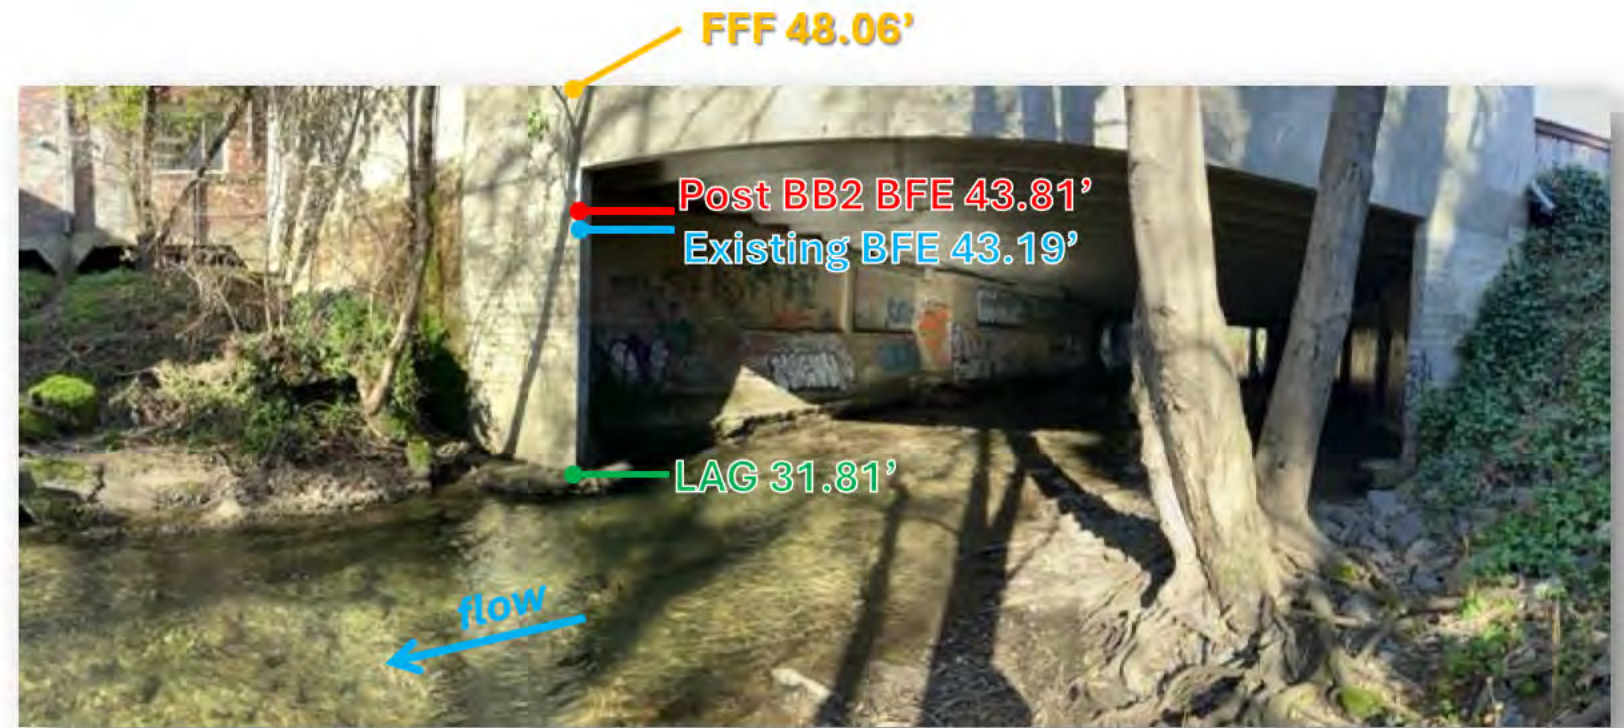
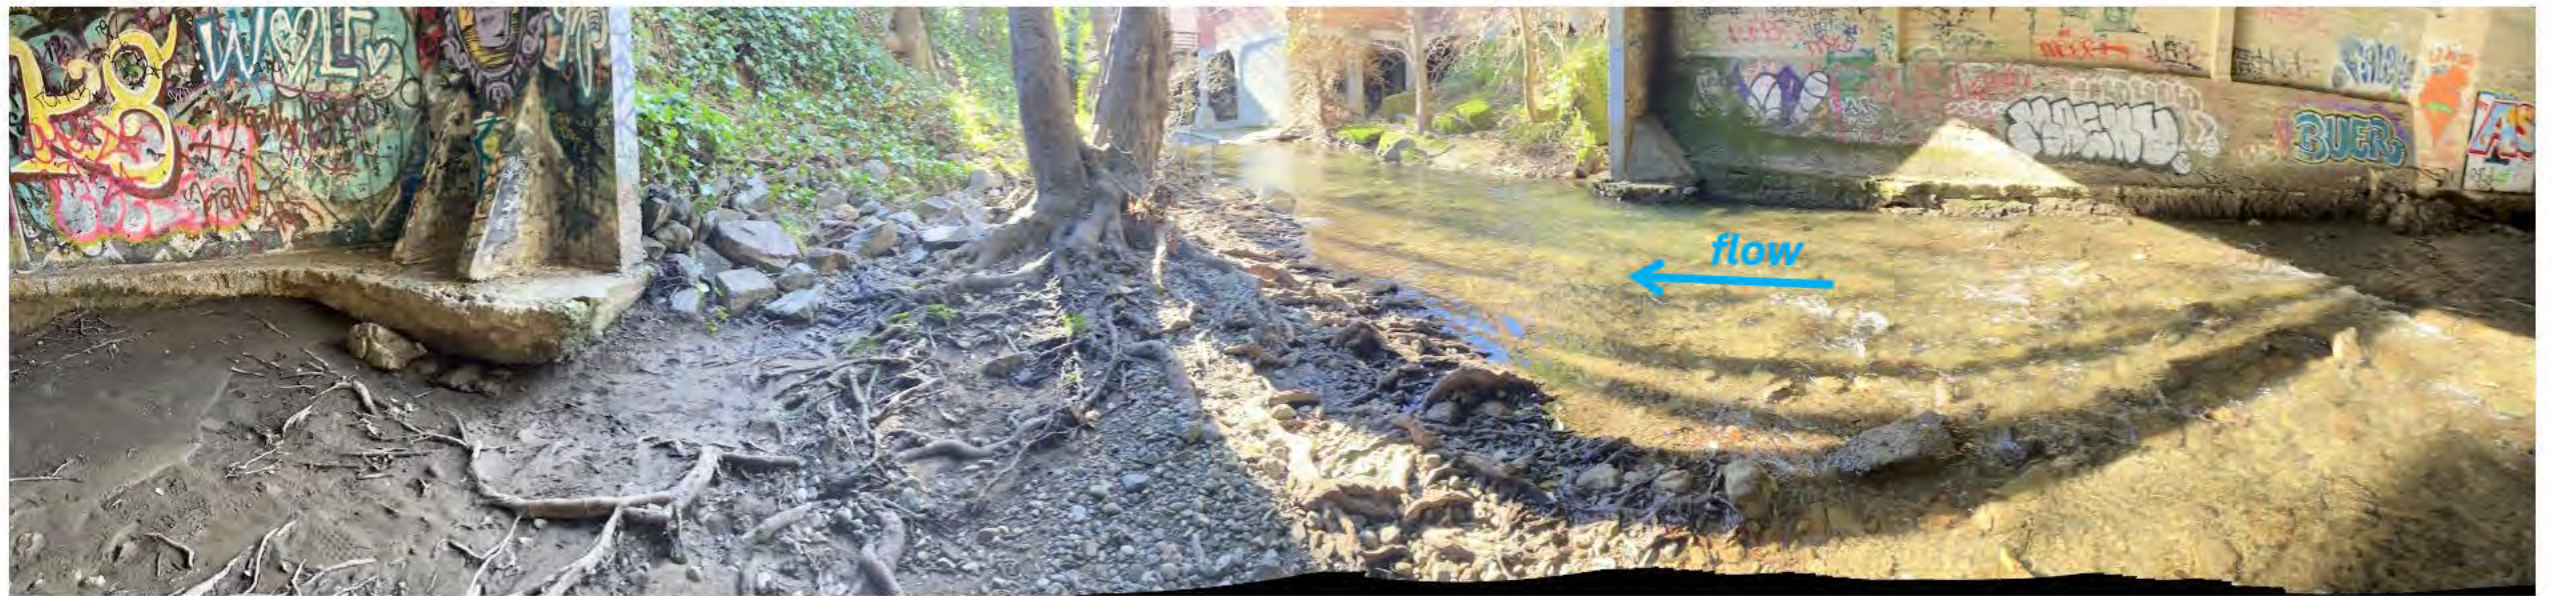
Exhibit No. 3: 546 - 538 San Anselmo Ave., San Anselmo

Rise affects concrete wing walls, which is a flood damage-resistant material. Mitigation includes reinforcing with Fiber-Reinforced Polymer (FRP) layering on wingwalls to increase strength and durability.

Using the Flood Control District-supplied flood velocity of 5.54 feet per second, it was determined that the existing 7' long, 10" wide 'W1' wing wall at 540 SA Avenue would not perform acceptably if constructed of plain (unreinforced) concrete. Flood loads imposed at this location on an unreinforced section fail to meet structural performance criteria.

When considering a reinforced wall with a minimum of 1% vertical reinforcement and #4 horizontal bars spaced at 12 inches on center (consistent with the code requirements at the time of original construction), the structural performance improves, but not enough for the given demands. This configuration still does not meet the acceptable structural performance threshold under the same loading conditions, so it is deemed *not acceptable*.

This evaluation confirms that even with the inclusion of minimum code-required reinforcement, the wall does not have adequate reinforcing to withstand the modeled 100-year flood loading. We recommend completing further exploration or analysis to address this inadequacy. This could include scanning the wall to determine the existing reinforcing layout or strengthening the wall via fiber reinforced polymer (FRP) as options to explore. Further recommendations and retrofit design are beyond the scope of this report.

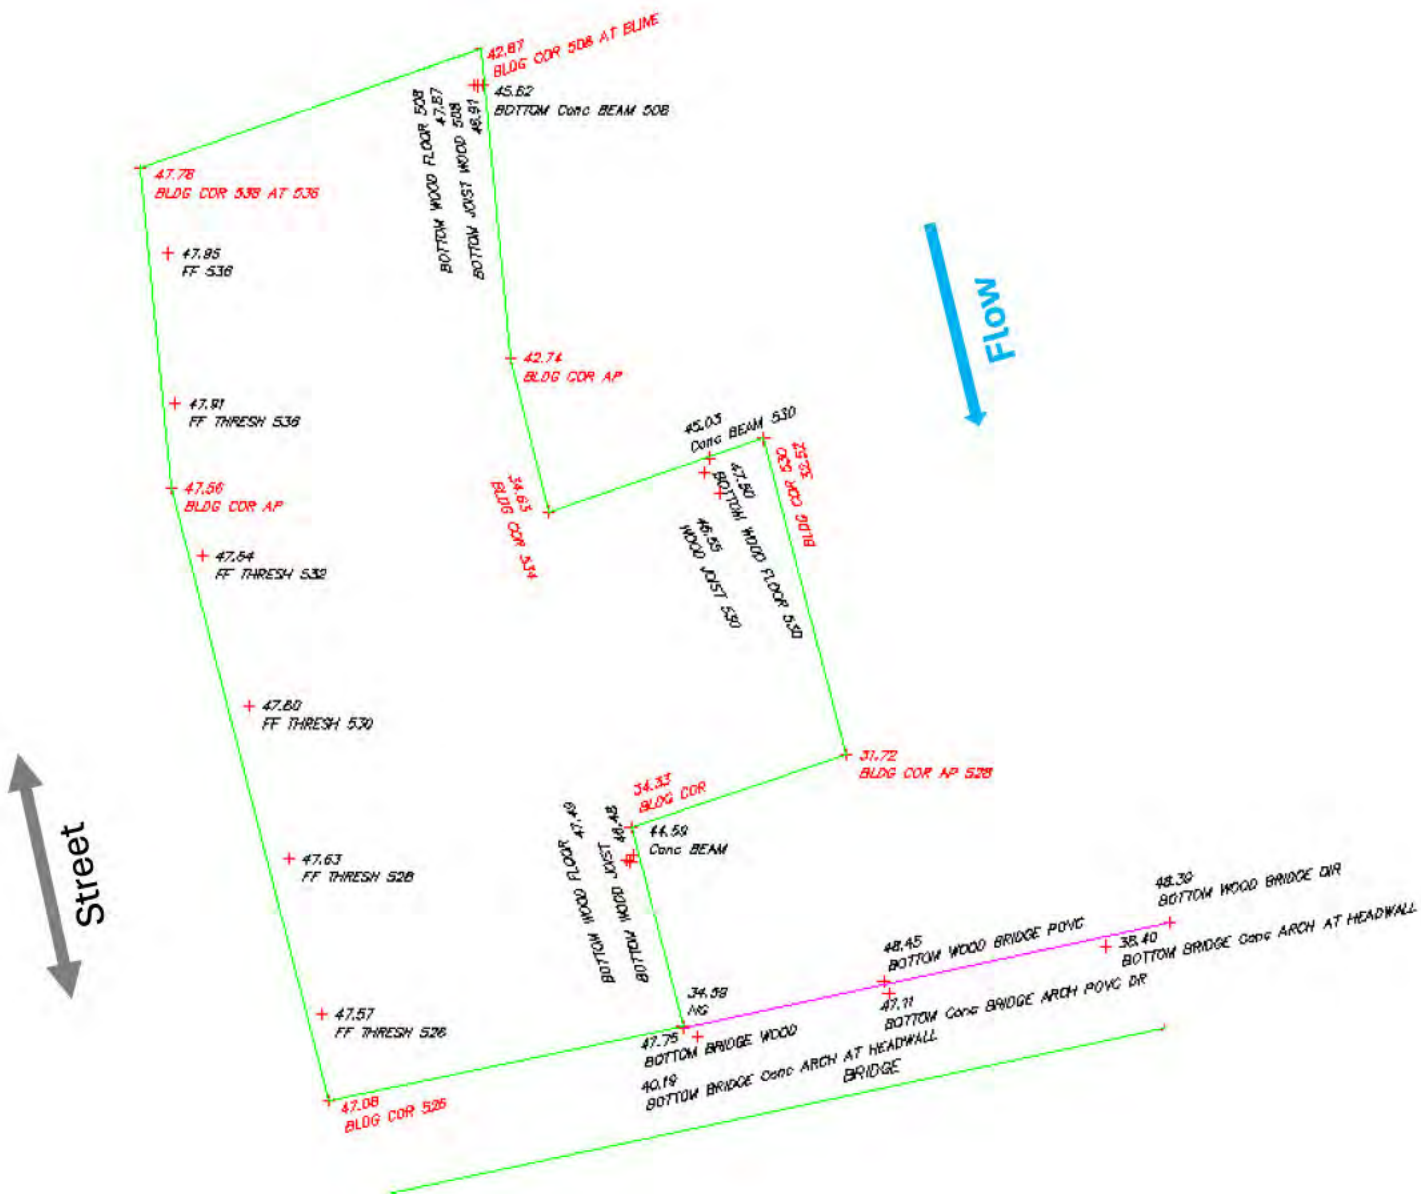
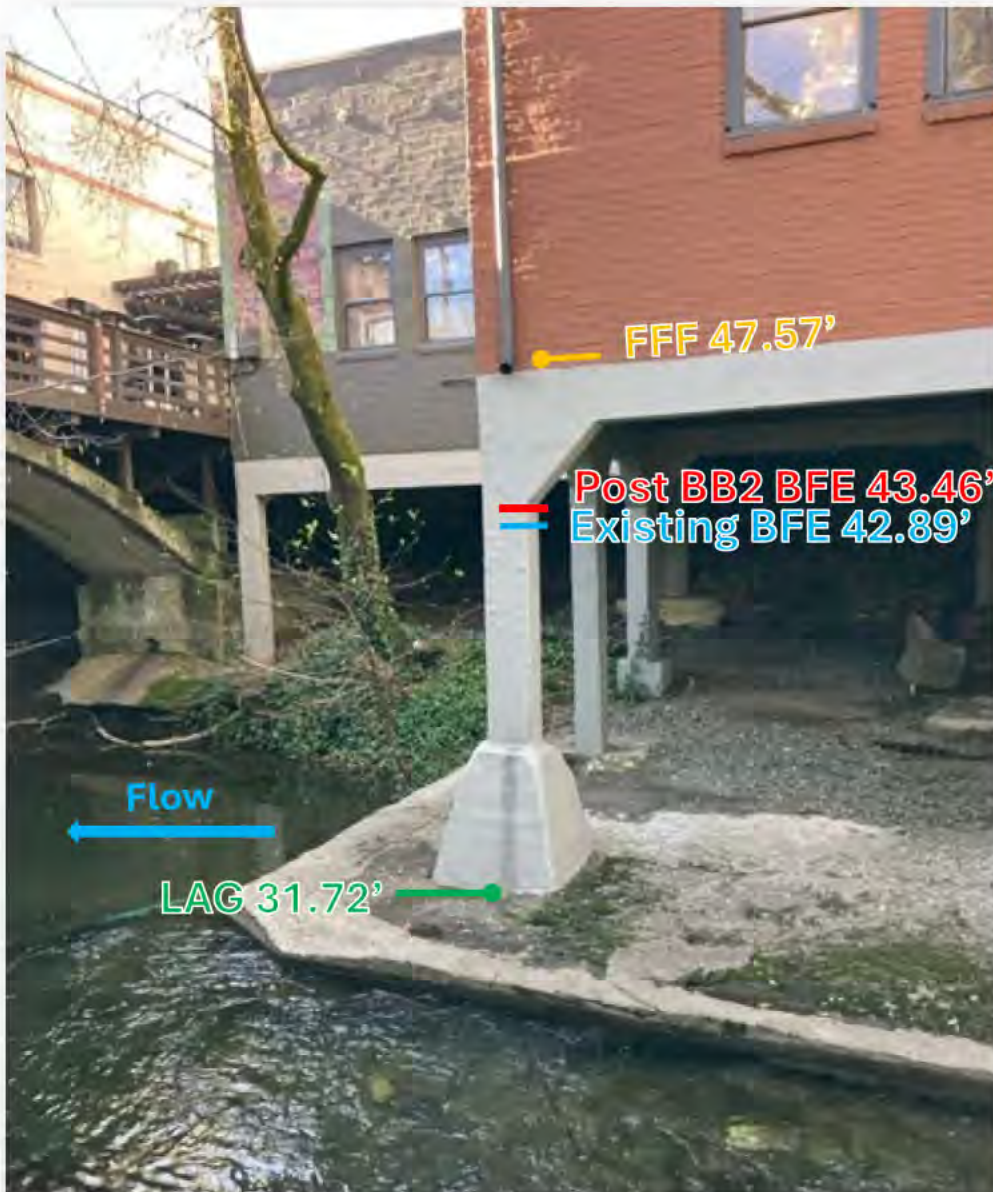
Exhibit No. 4: 536 - 528 San Anselmo Ave., San Anselmo

Rise affects concrete piers, which is a flood damage-resistant material.
Building piers' structural conditions are adequate to resist the additional flood-induced loads.
No mitigation needed.

Using the Flood Control District-supplied flood velocity of 4.47 feet per second, it was determined that the existing 12"x16" 'C2' column at 528 SA Avenue would not perform acceptably if constructed of plain (unreinforced) concrete. Flood loads imposed at this location on an unreinforced section fail to meet structural performance criteria.

However, when considering a reinforced column with a minimum of 1% vertical reinforcement and #3 ties spaced at 10 inches on center (consistent with the code requirements at the time of original construction), the structural performance improves. This configuration meets the acceptable performance threshold under the same loading conditions.

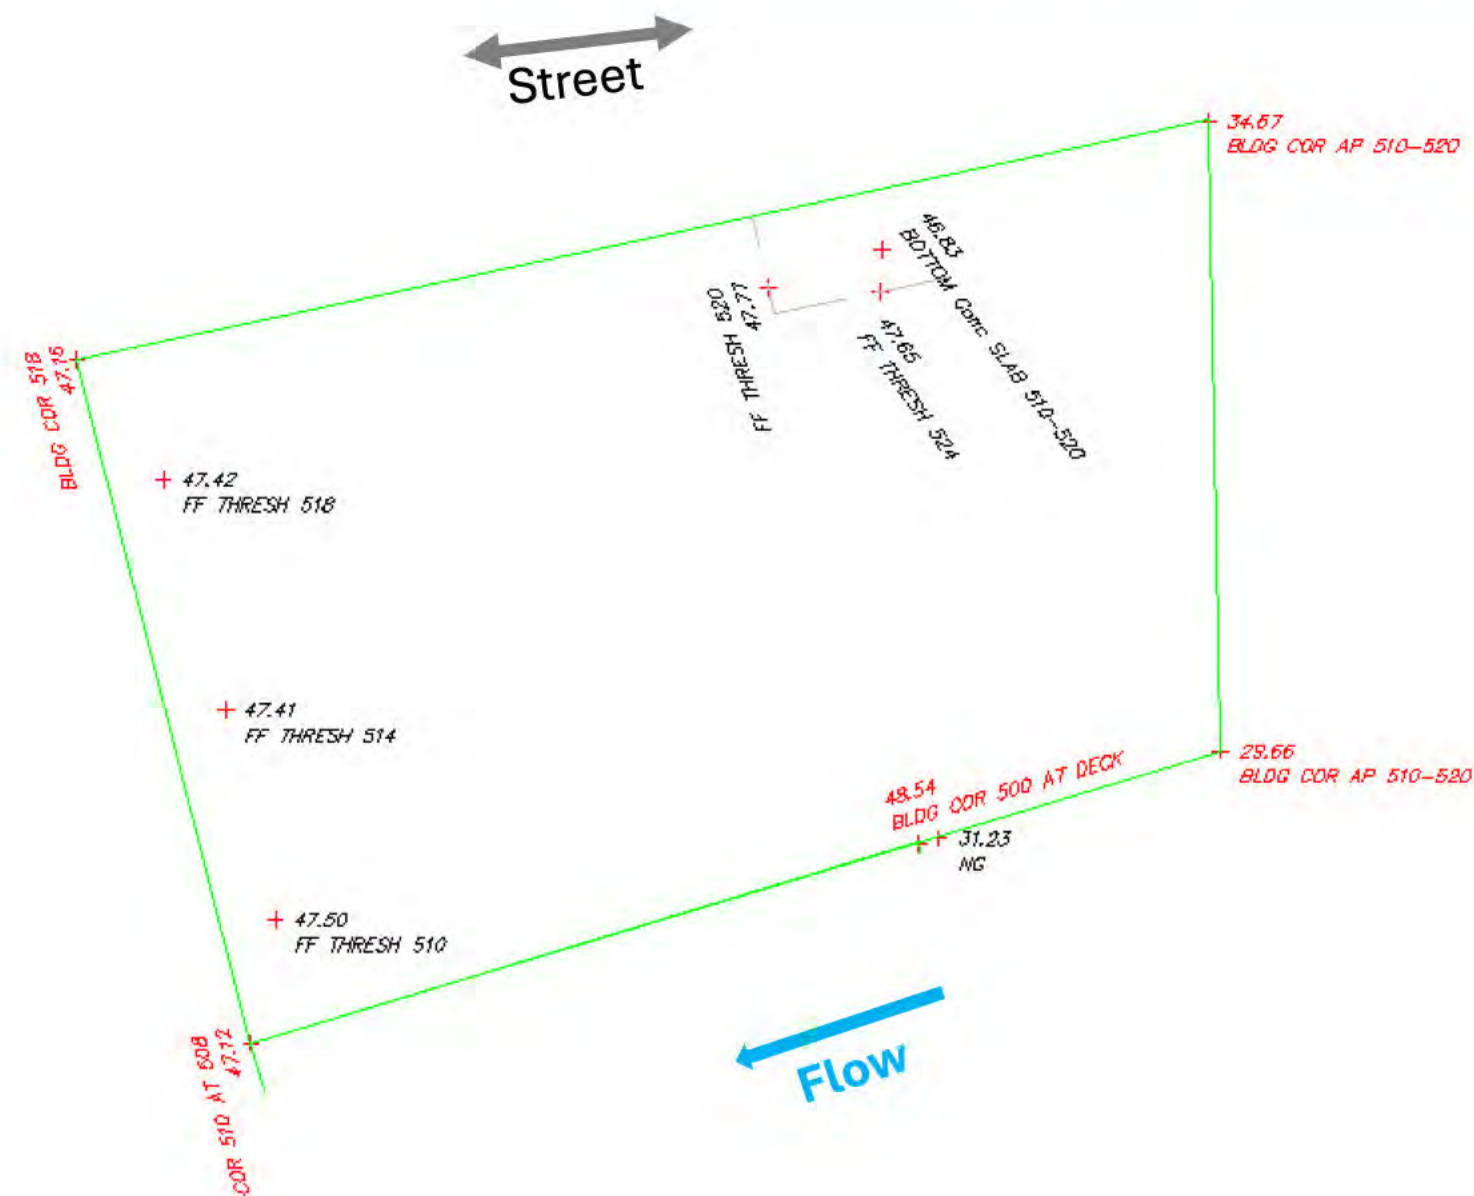
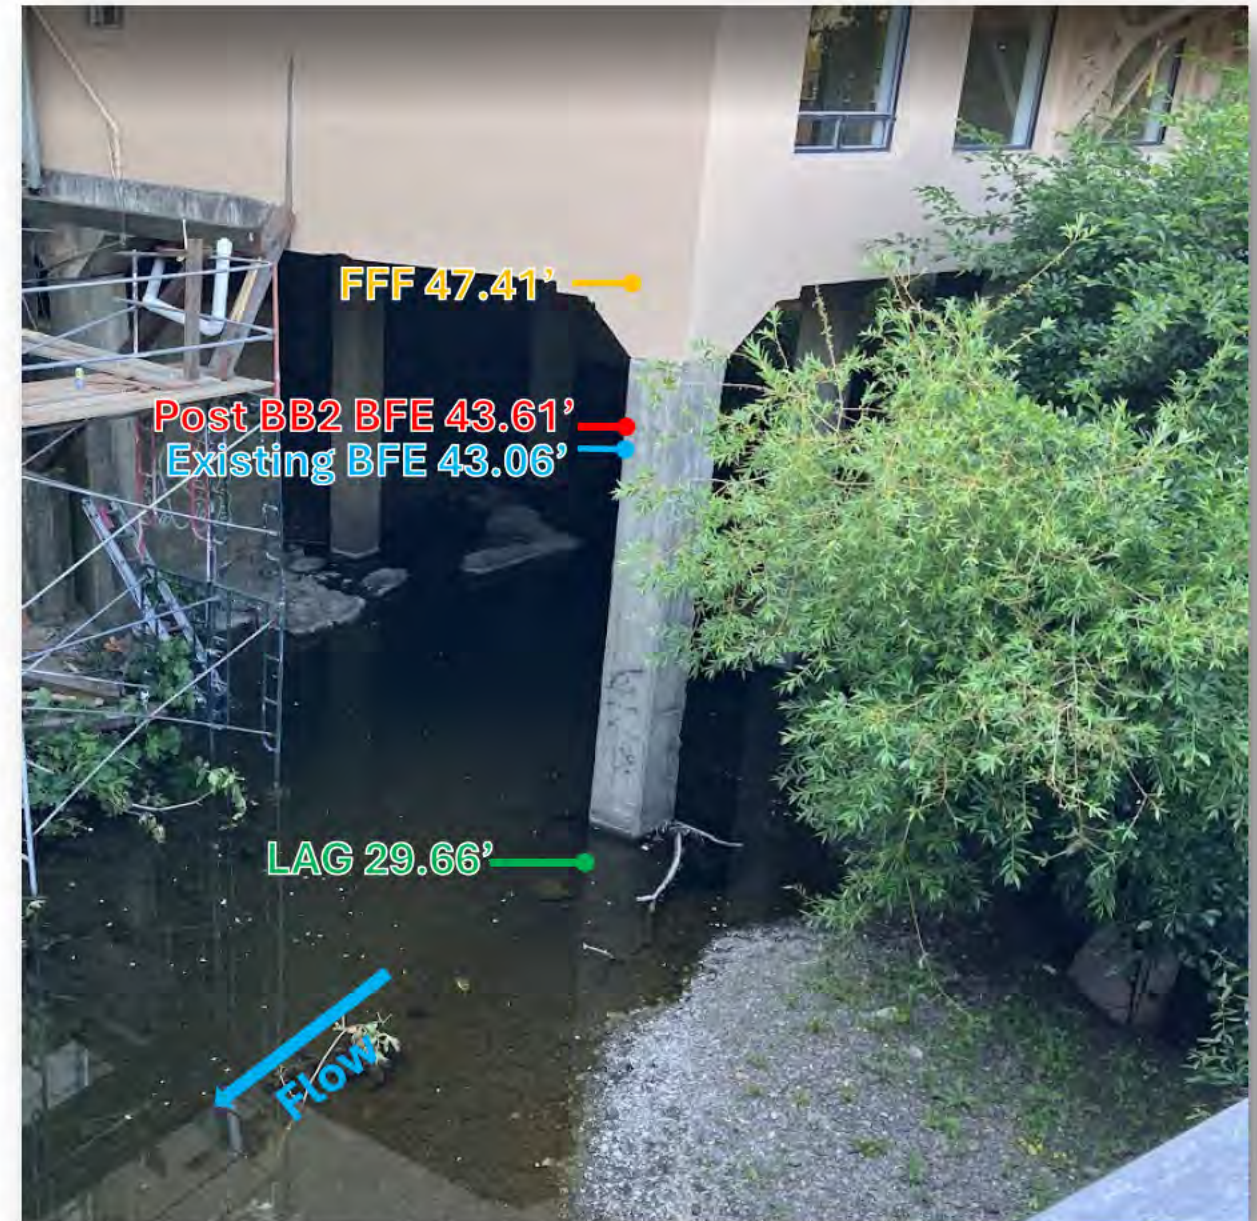
Exhibit No. 5: 520 – 510 San Anselmo Ave., San Anselmo

Rise affects concrete piers, which is a flood damage-resistant material.
Building piers' structural conditions are adequate to resist the additional flood-induced loads.
No mitigation needed.

Using the Flood Control District-supplied flood velocity of 4.53 feet per second, it was determined that the existing 20"x20" 'C3' column at 510 SA Avenue would not perform acceptably if constructed of plain (unreinforced) concrete. A 20"x20" column was assumed based on photos and adjacent structures, as we could not access this site directly. Flood loads imposed at this location on an unreinforced section fail to meet structural performance criteria.

However, when considering a reinforced column with a minimum of 1% vertical reinforcement and #3 ties spaced at 10 inches on center (consistent with the code requirements at the time of original construction), the structural performance improves. This configuration meets the acceptable performance threshold under the same loading conditions.
