BB2 Removal Project Impact Assessment and Mitigation, MCFCWCD, 2025

Building Bridge #2 Removal – Impact Assessment of Rise in Modeled Base Flood Elevation (BFE)

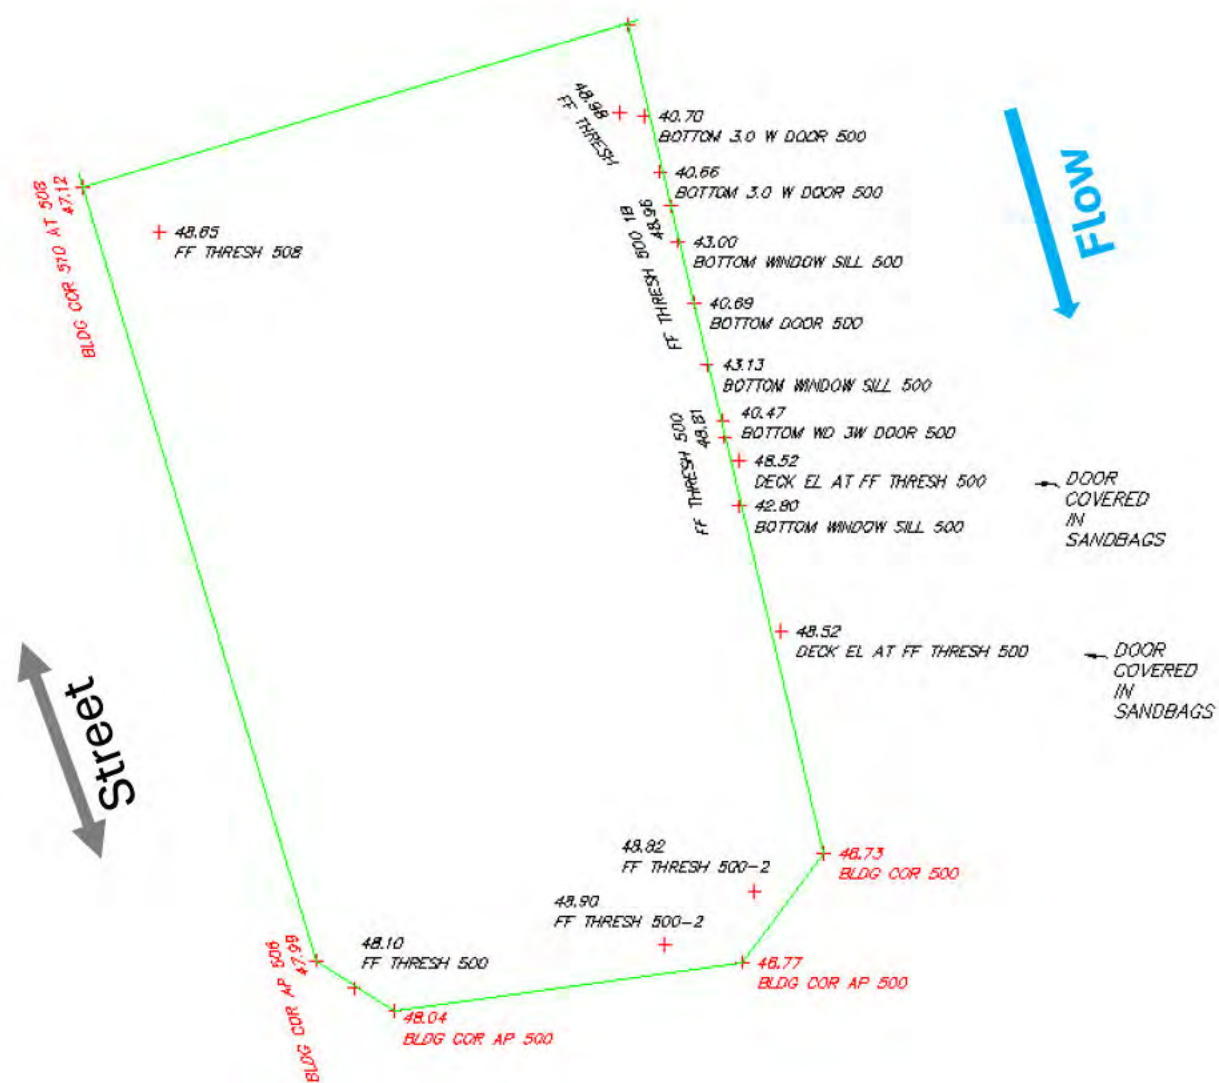
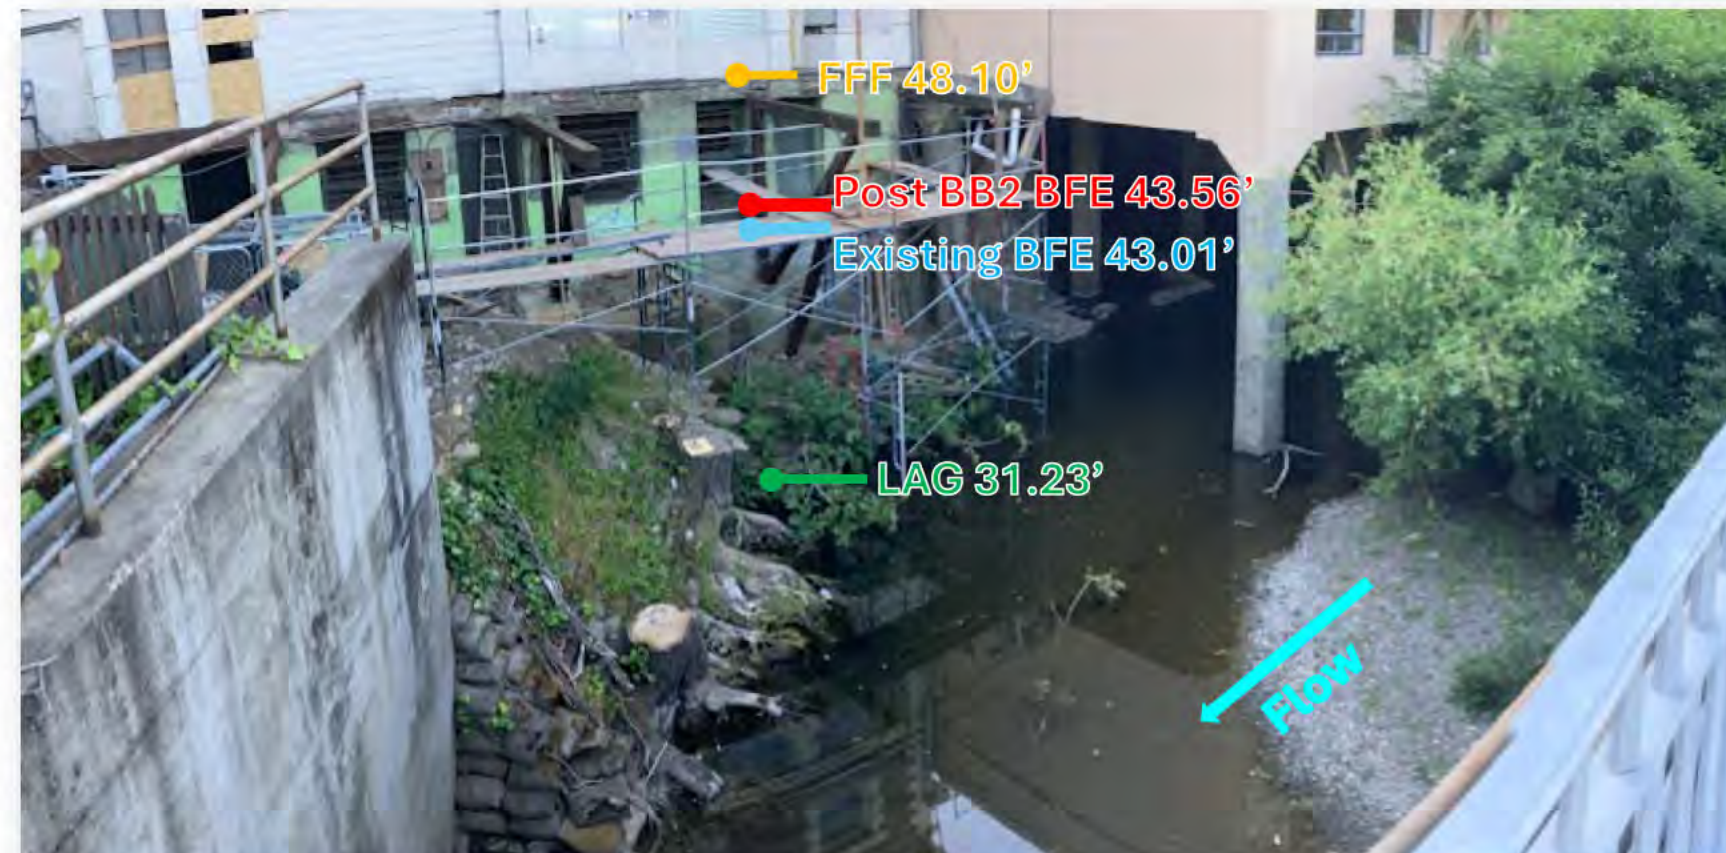
Exhibit No. 6: 508 – 500 San Anselmo Ave., San Anselmo

Rise affects concrete retaining wall, which is a flood damage-resistant material.
No mitigation needed.

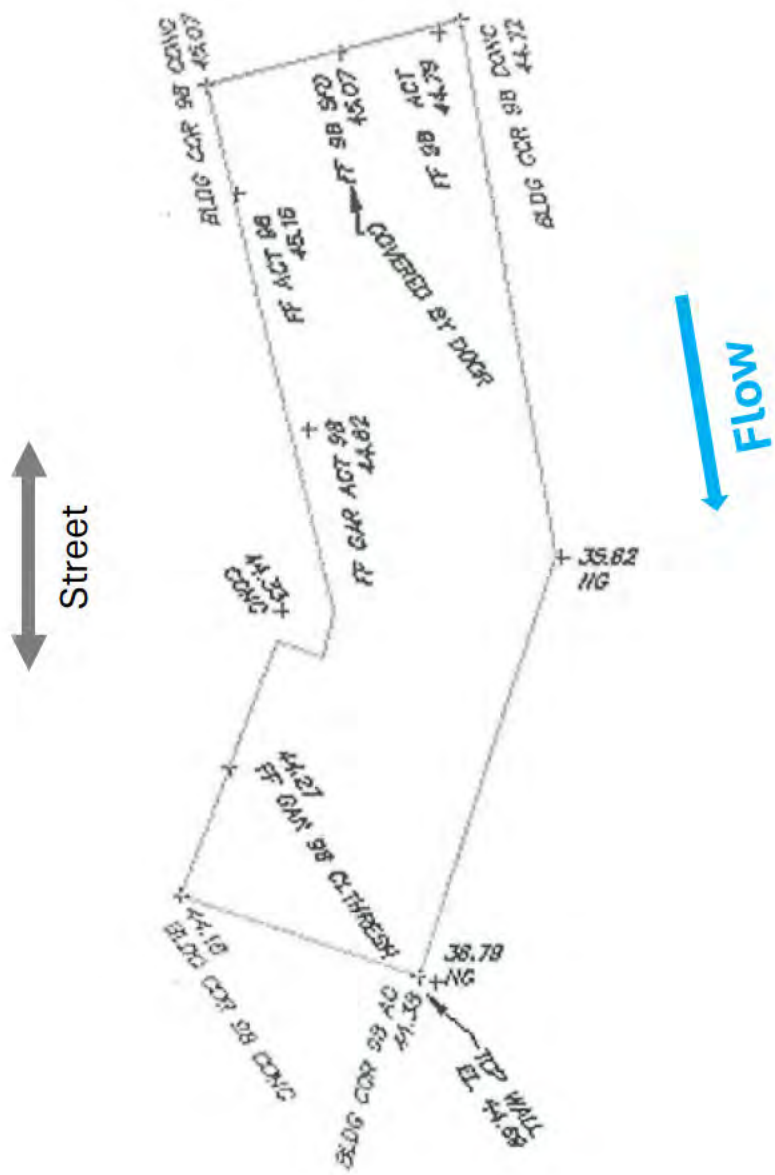
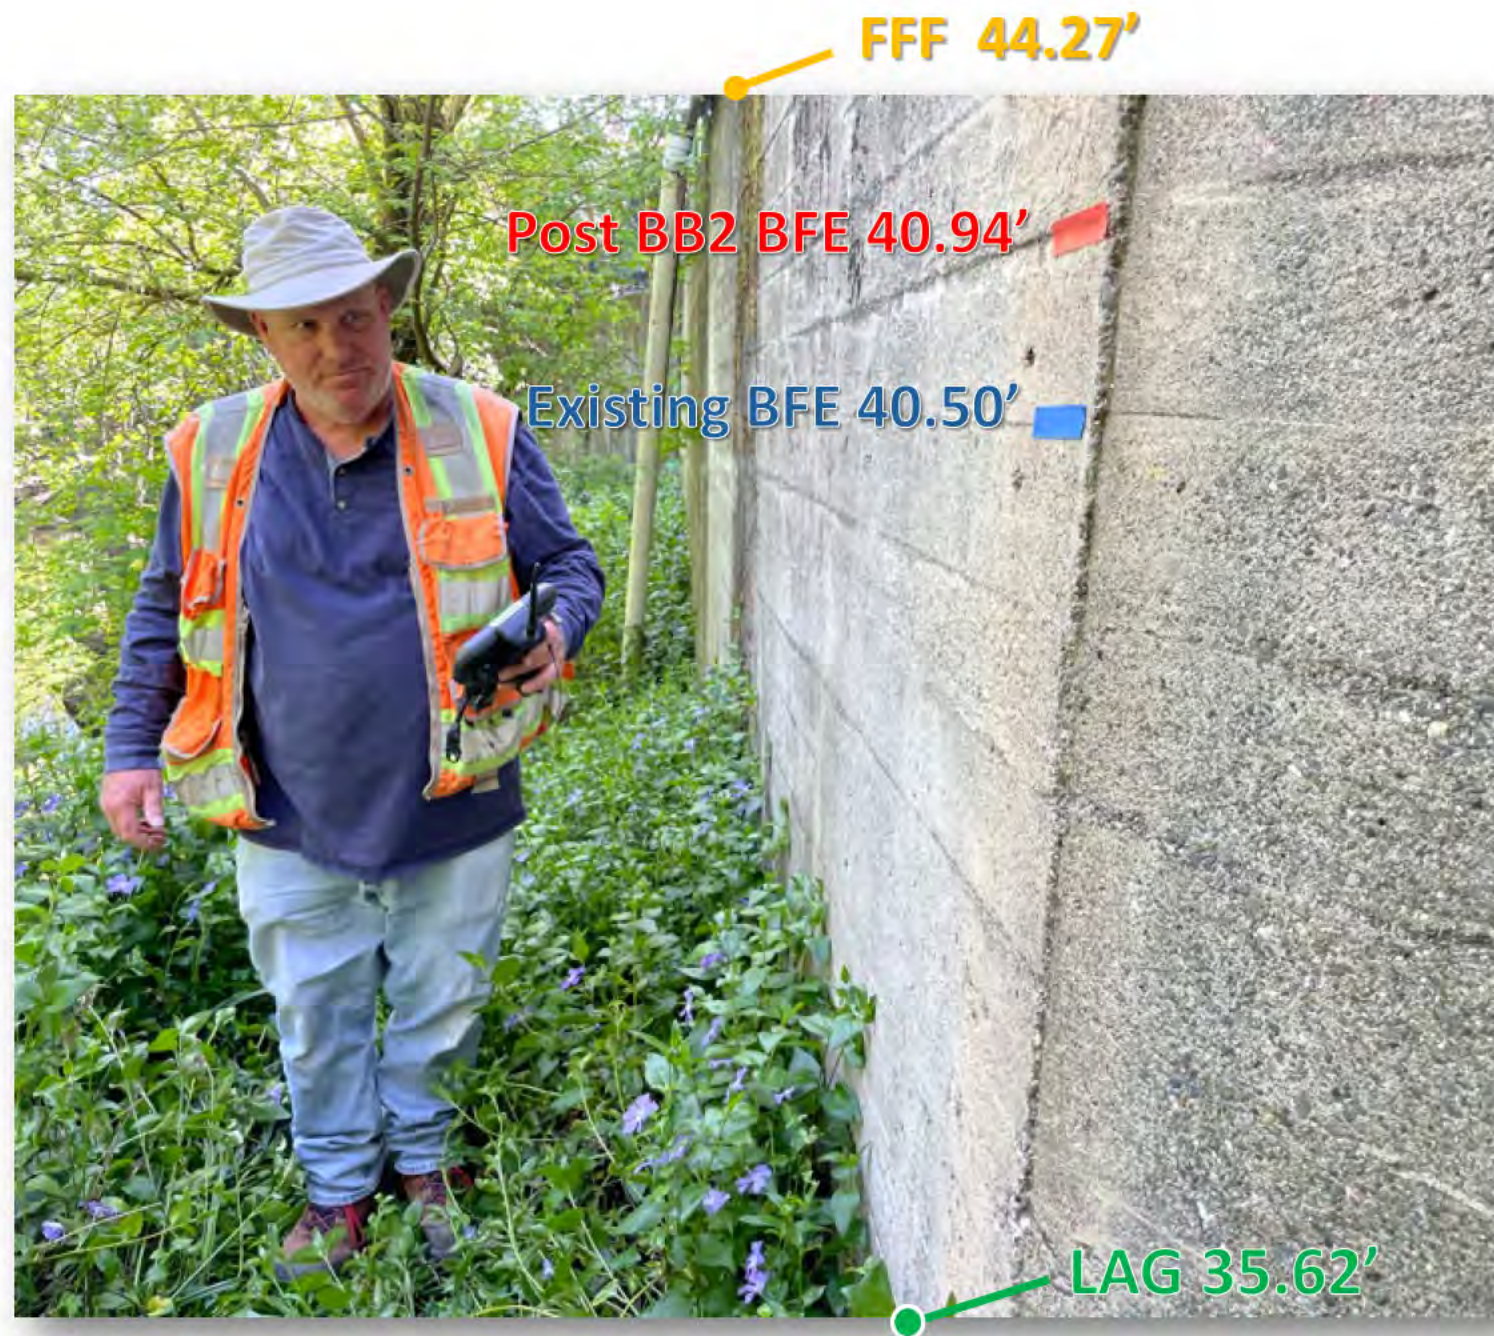
Exhibit No. 7: 98 Sir Francis Drake Blvd, San Anselmo

Rise affects concrete retaining wall, which is a flood damage-resistant material.
No mitigation needed.

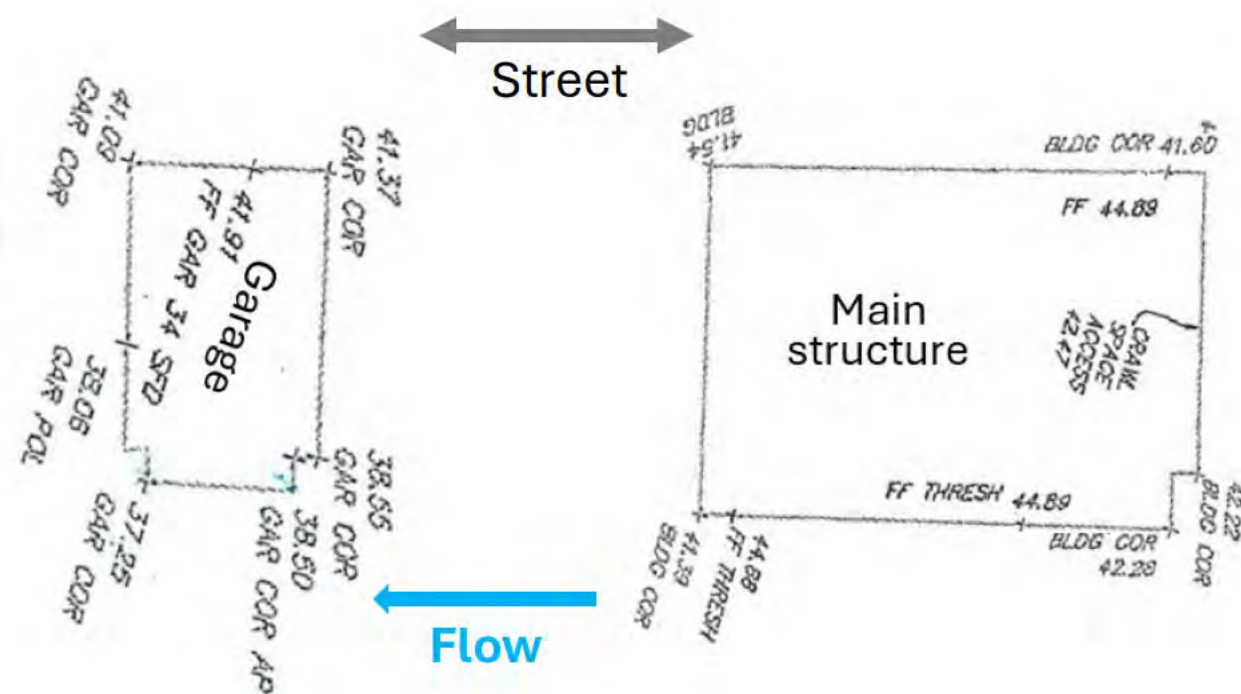
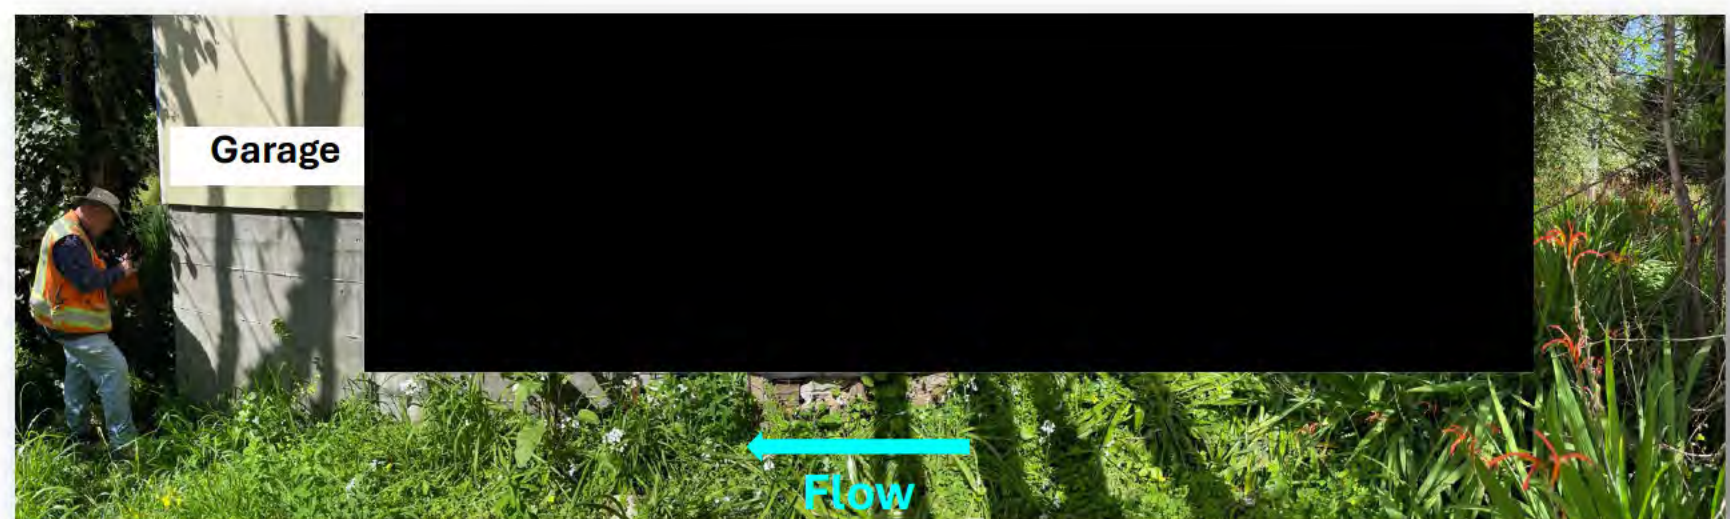
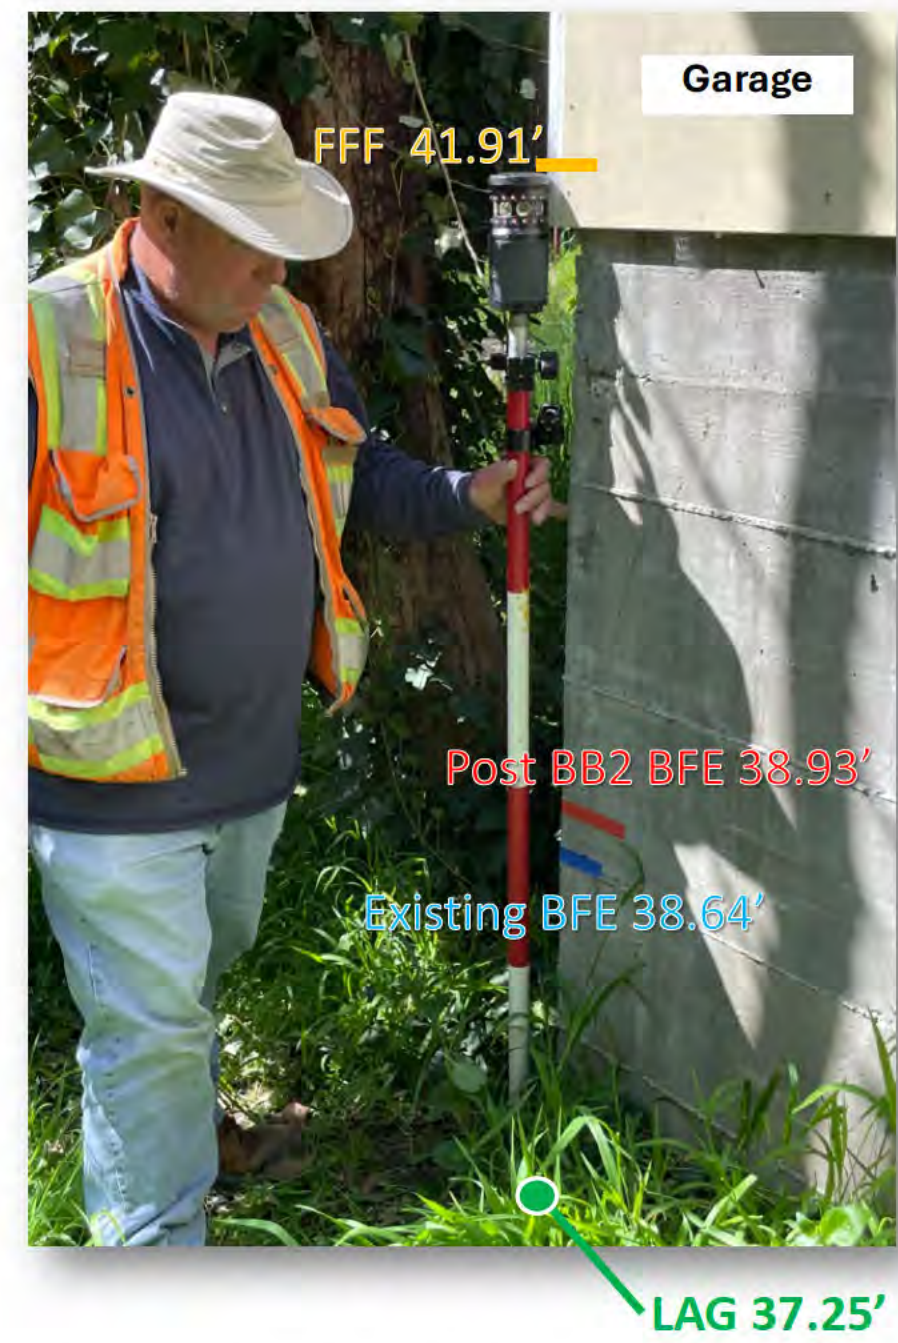
Exhibit No. 9: 34 Sir Francis Drake, San Anselmo - Garage

Rise affects concrete foundation, which is a flood damage-resistant material.
No mitigation needed.

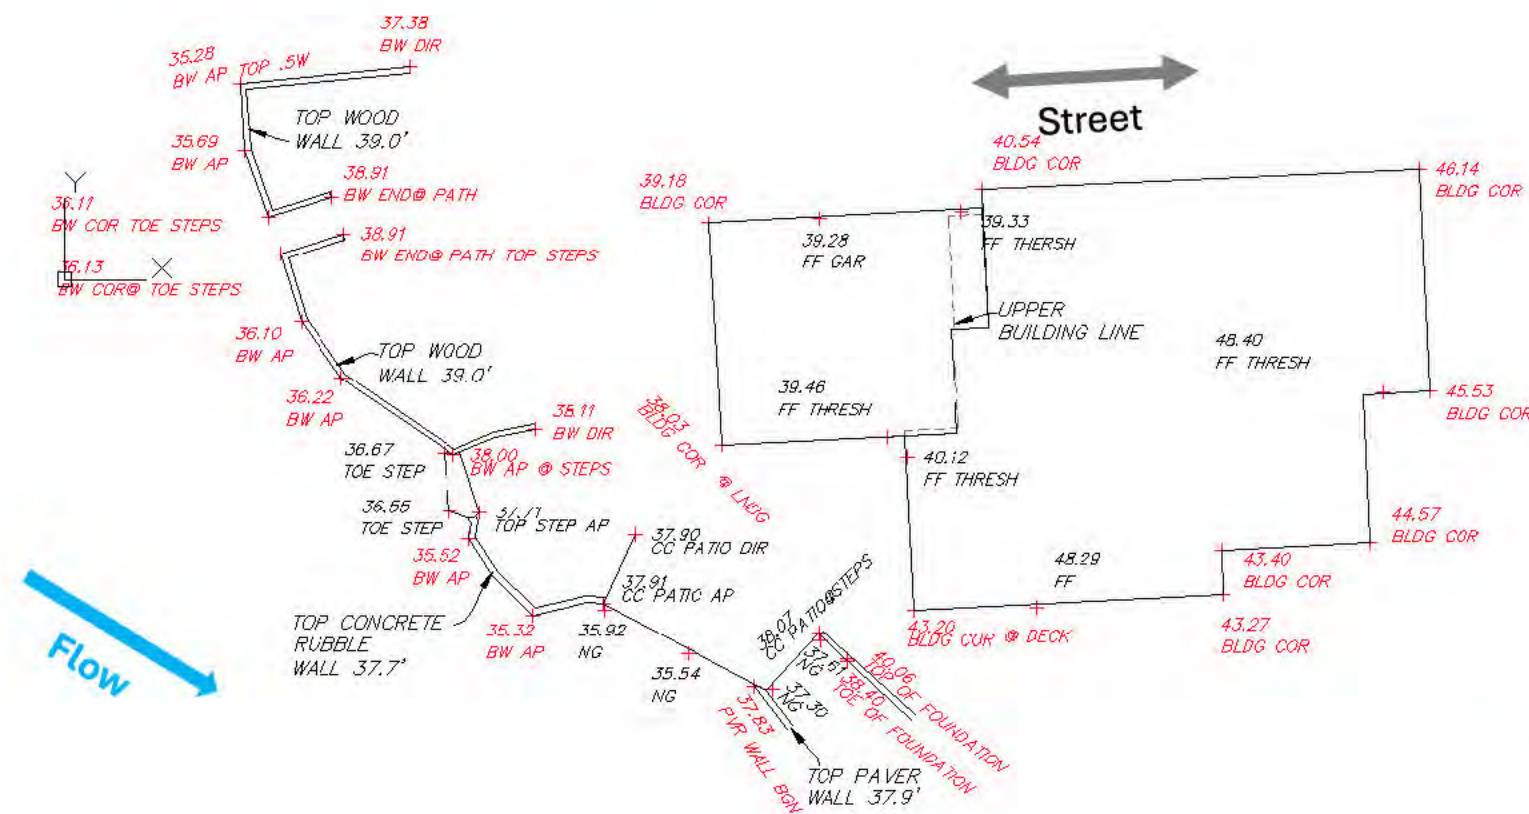
Exhibit No. 10: 10 Winship, Ross

Rise affects garage concrete foundation, which is a flood damage-resistant material.
BFE is below garage finished floor. No mitigation needed.

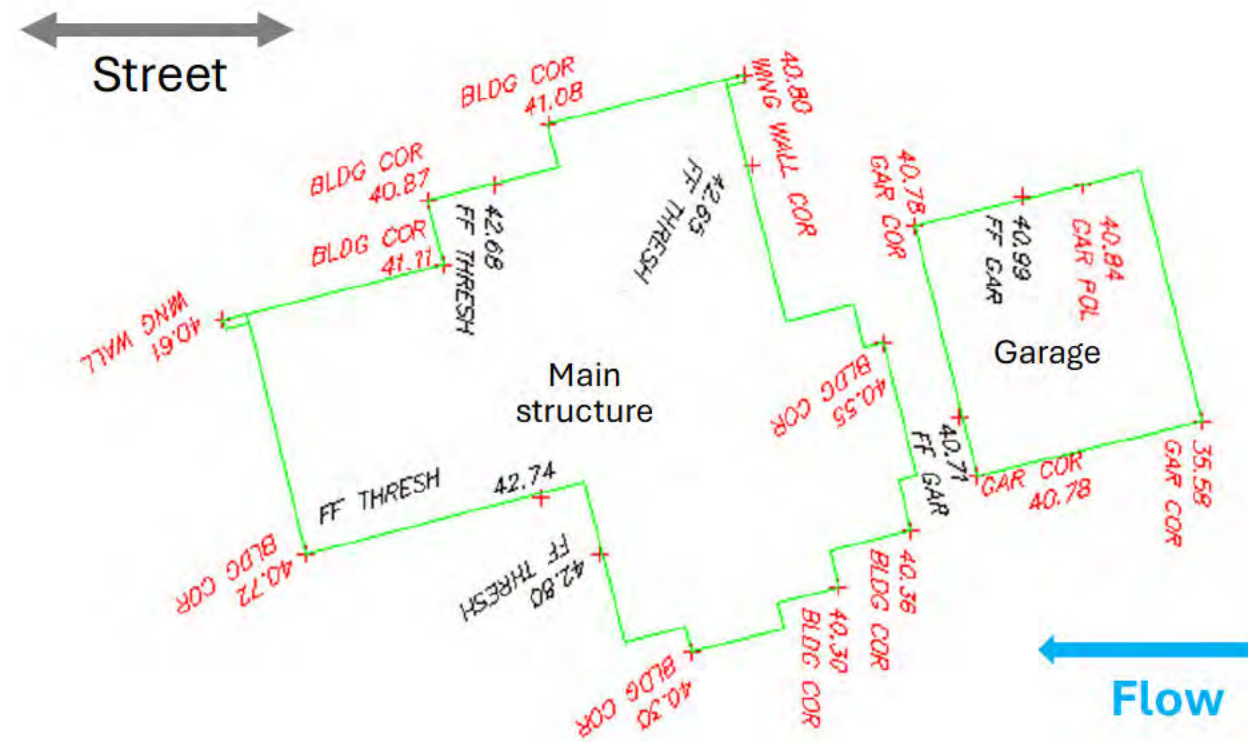
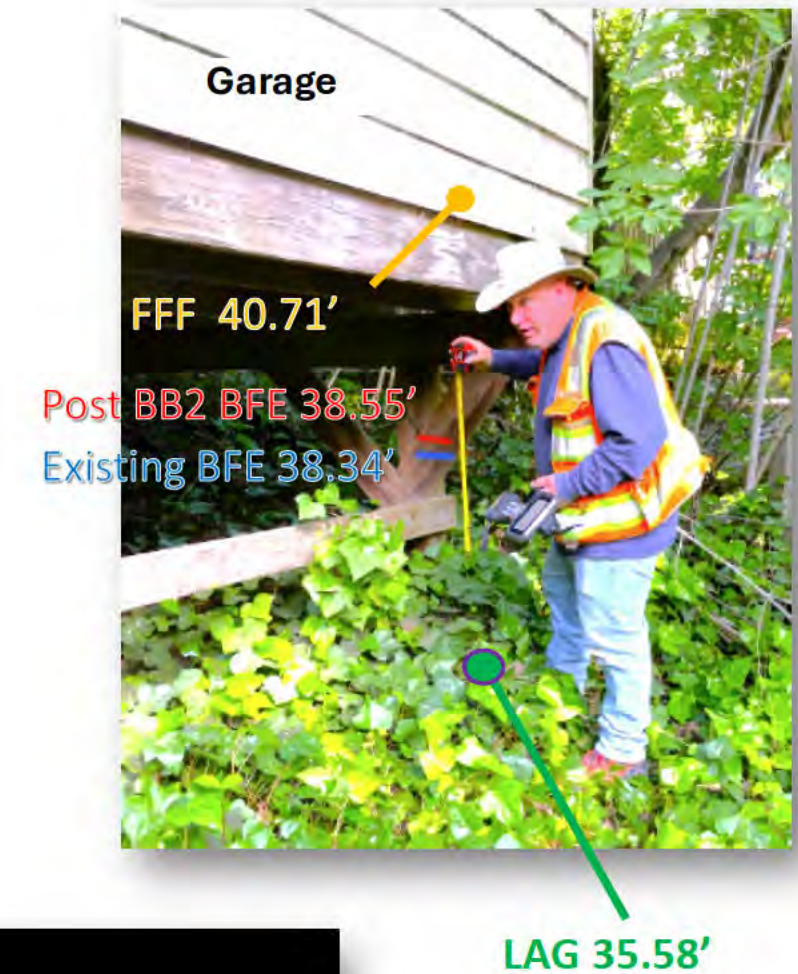
Exhibit No. 11: 100 Sir Francis Drake, Ross - Garage

Rise affects timber support, which is a flood damage-resistant material.
No mitigation needed.

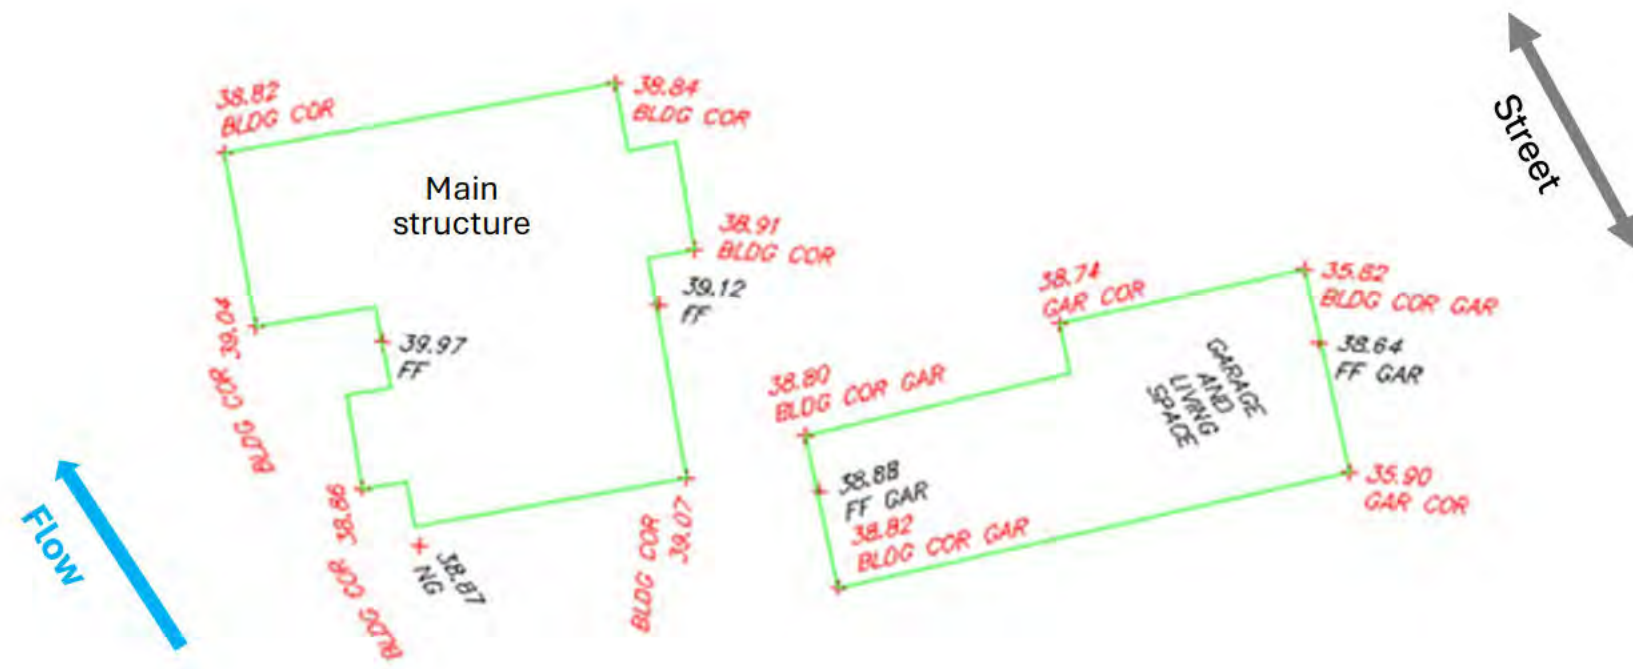
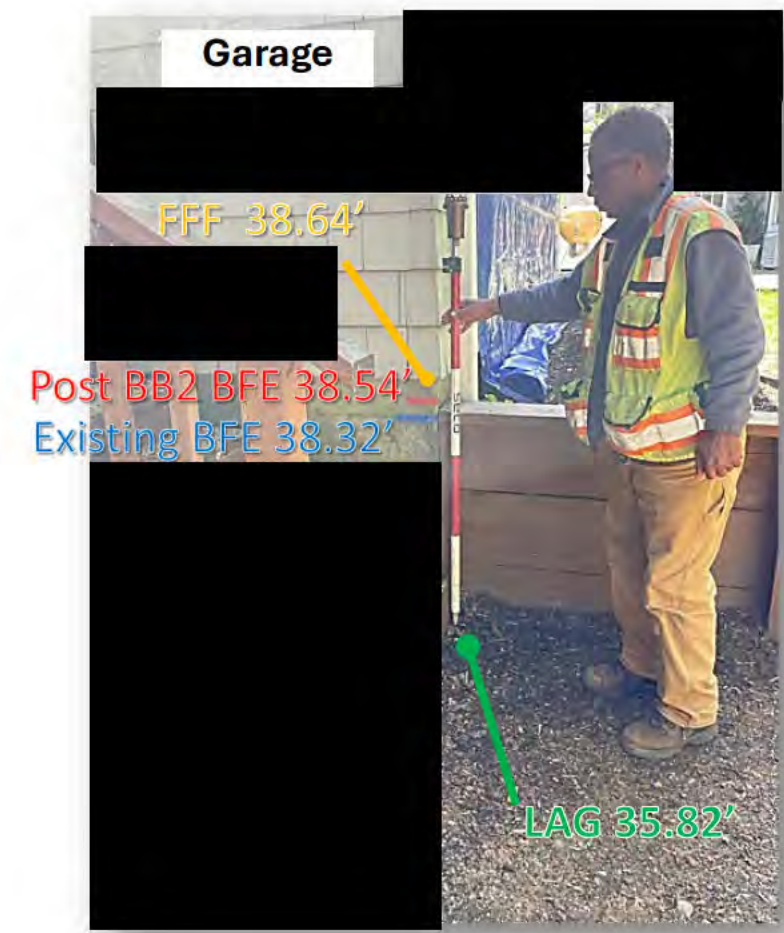
Exhibit No. 12: 92 Sir Francis Drake, Ross - Garage

Rise affects garage concrete foundation, which is a flood damage-resistant material. No mitigation needed.

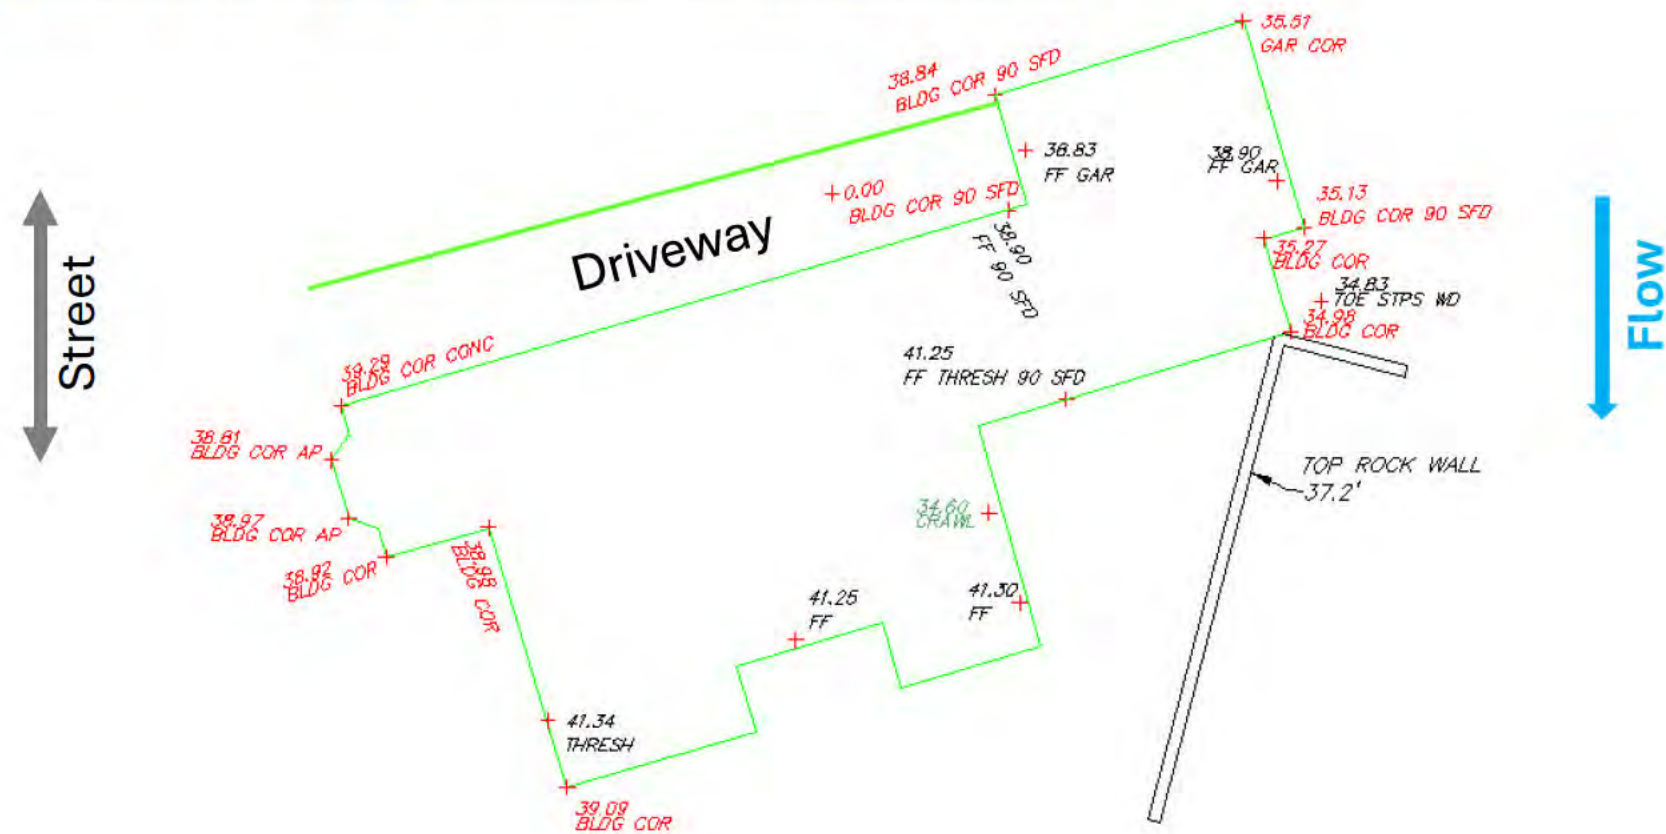
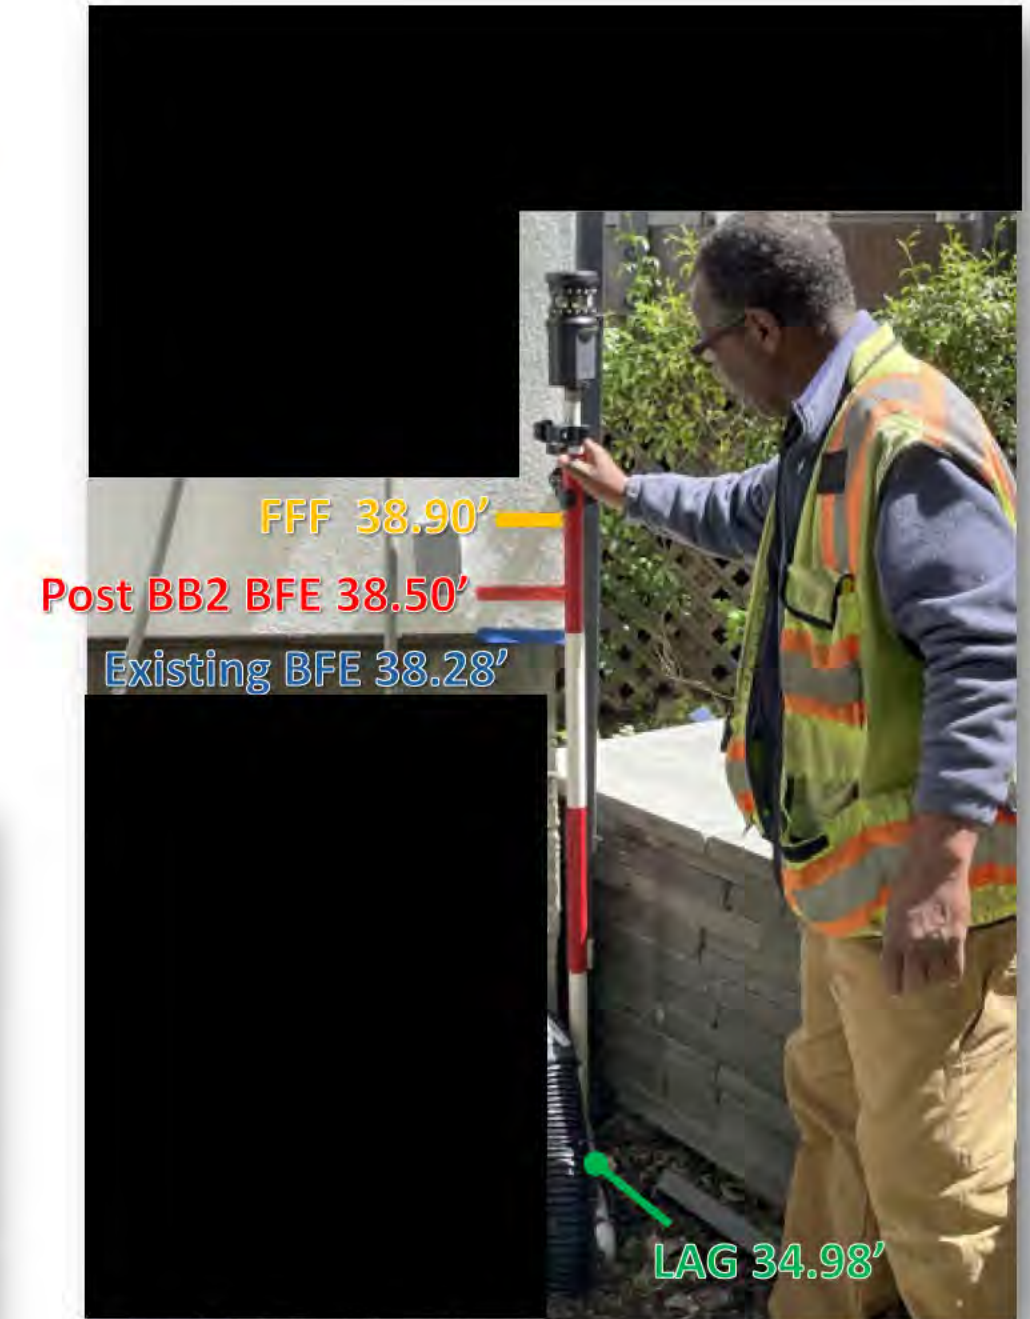
Exhibit No. 13: 90 Sir Francis Drake, Ross

- Electrical outlet
- HVAC equipment

Mitigation includes: elevating electrical boxes; elevating HVAC equipment; installing flood openings for crawl space; and anchoring support beams and floor joists to concrete foundation.

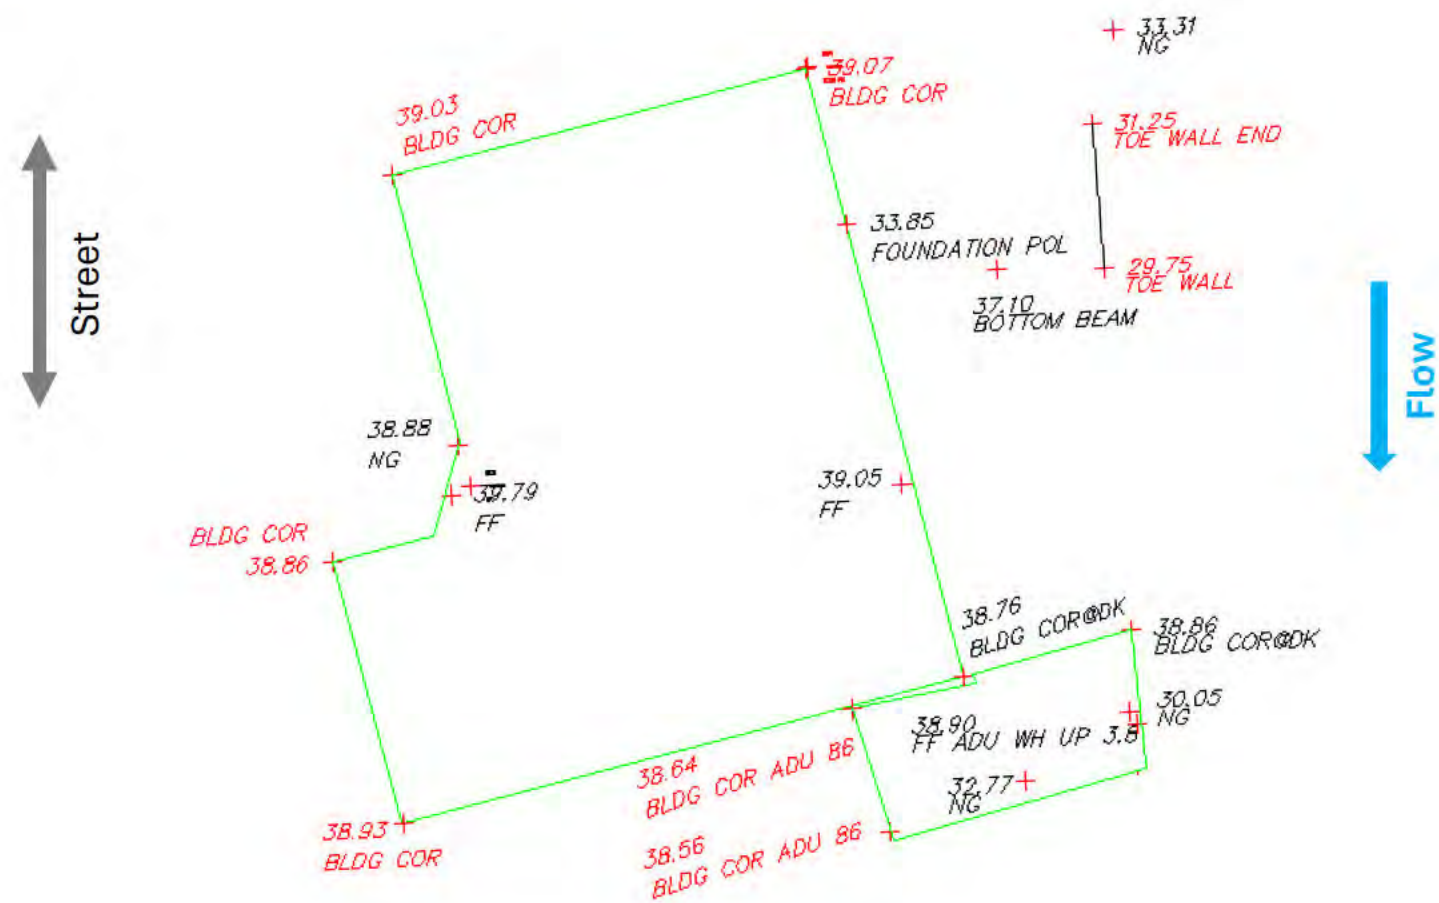
Exhibit No. 14: 86 Sir Francis Drake, Ross

FFF 39.05'

Post BB2 BFE 37.90'
Existing BFE 37.76'

LAG 33.85'

Utility piping

Mitigation includes: securing utility piping to floor joists; and anchoring wooden beams to posts and concrete foundation.

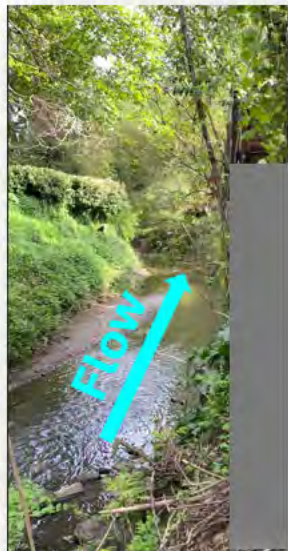
Exhibit No. 16: 84 Sir Francis Drake, Ross
ADU

Wooden beams

Mitigation includes anchoring wooden beams to posts and concrete foundation.

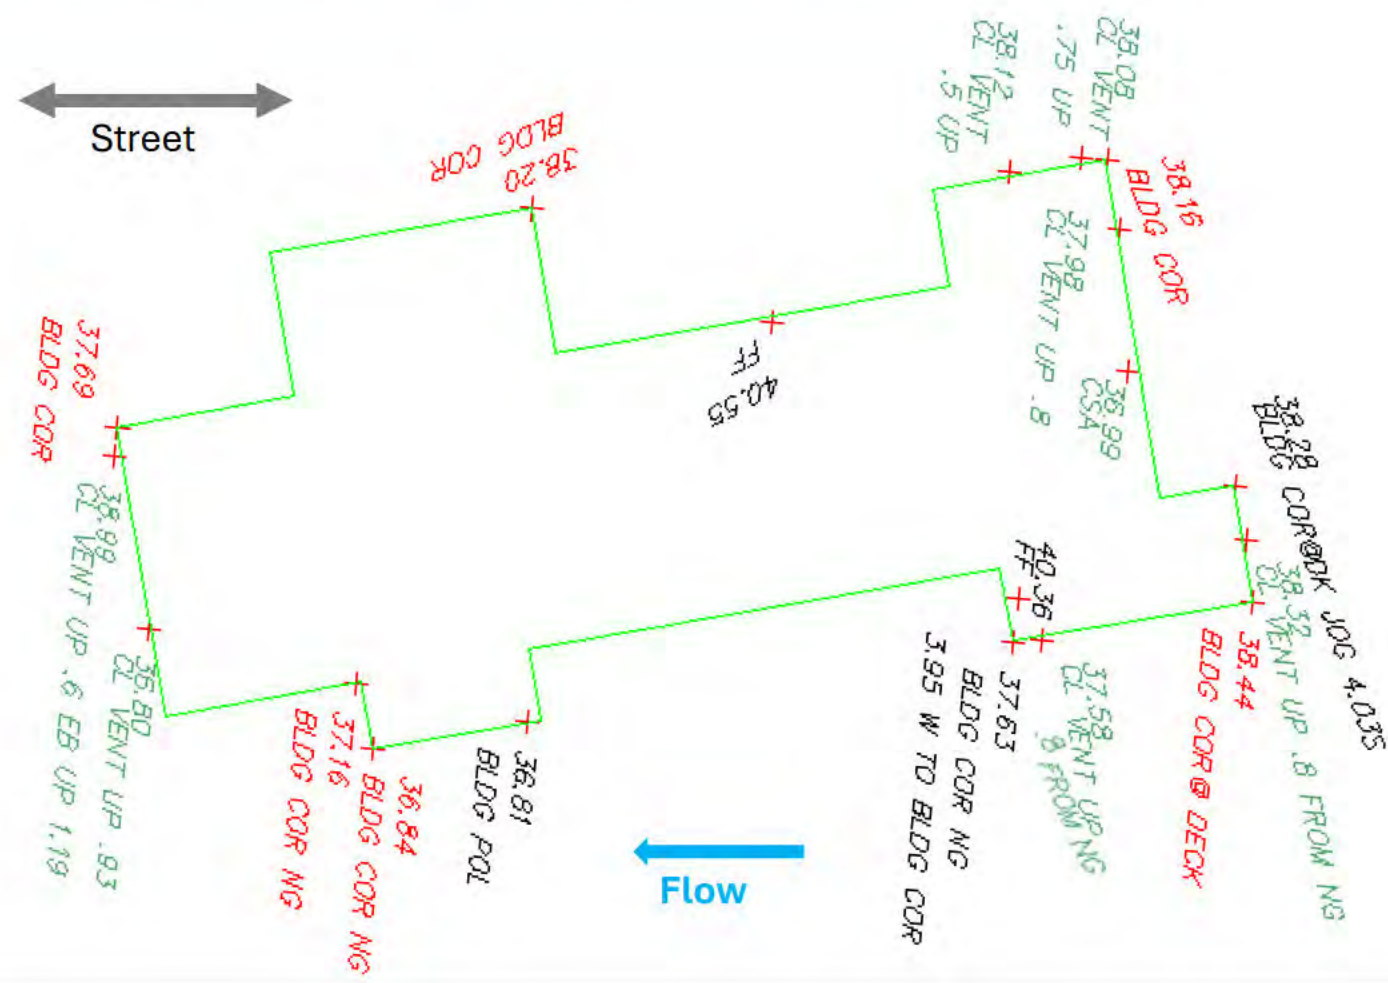
Exhibit No. 17: 82 Sir Francis Drake, Ross

FFF 40.36'

Post BB2 BFE 37.29'
Existing BFE 37.25'

Electrical boxes

Crawlspace

Mitigation includes: elevating electrical boxes; and installing flood openings in crawlspace.

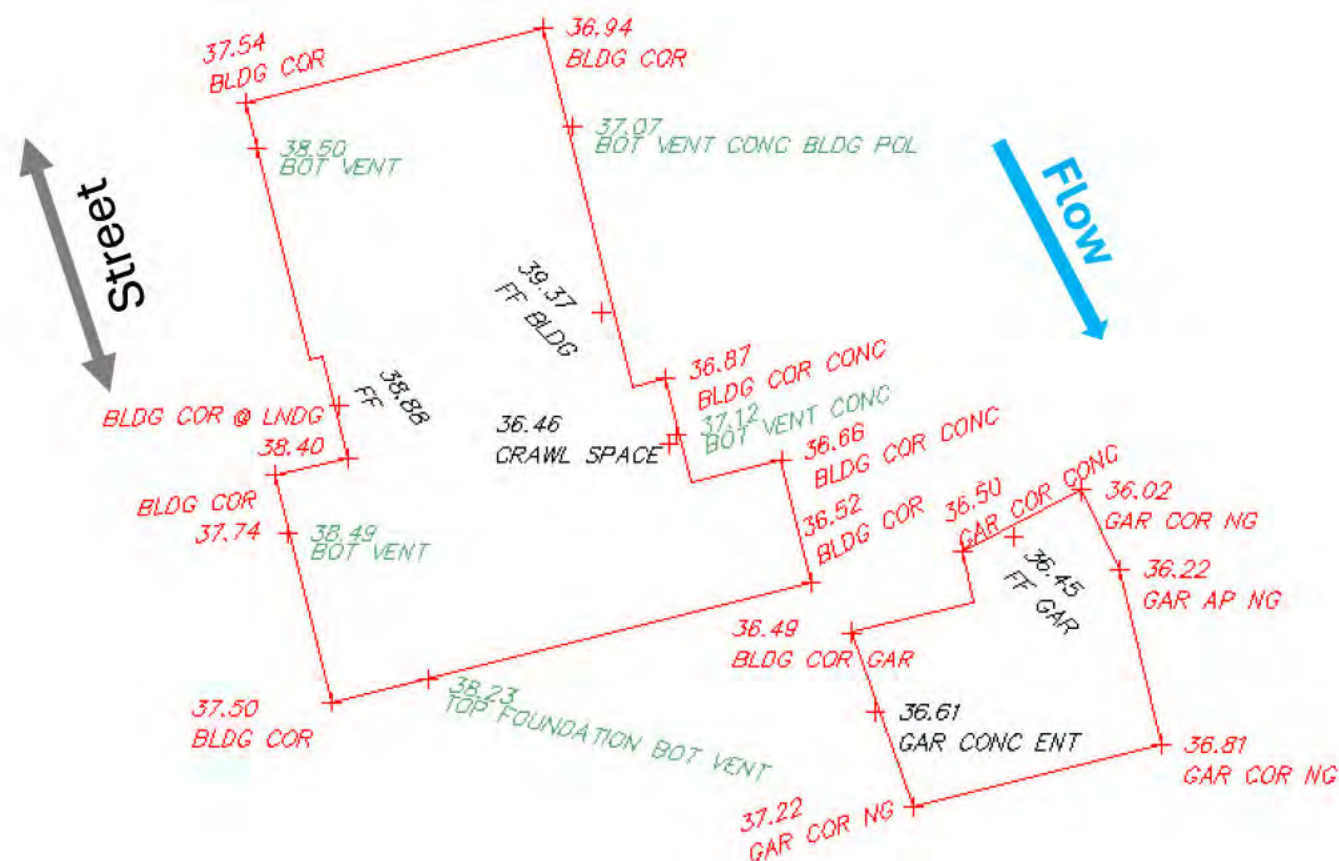
Exhibit No. 18: 78 Sir Francis Drake, Ross

FFF 38.88'

Post BB2 BFE 37.34'

Existing BFE 37.29'

LAG 36.52'

Crawlspace

Mitigation includes: installing flood openings for crawlspace; elevating and securing utility piping in crawlspace.

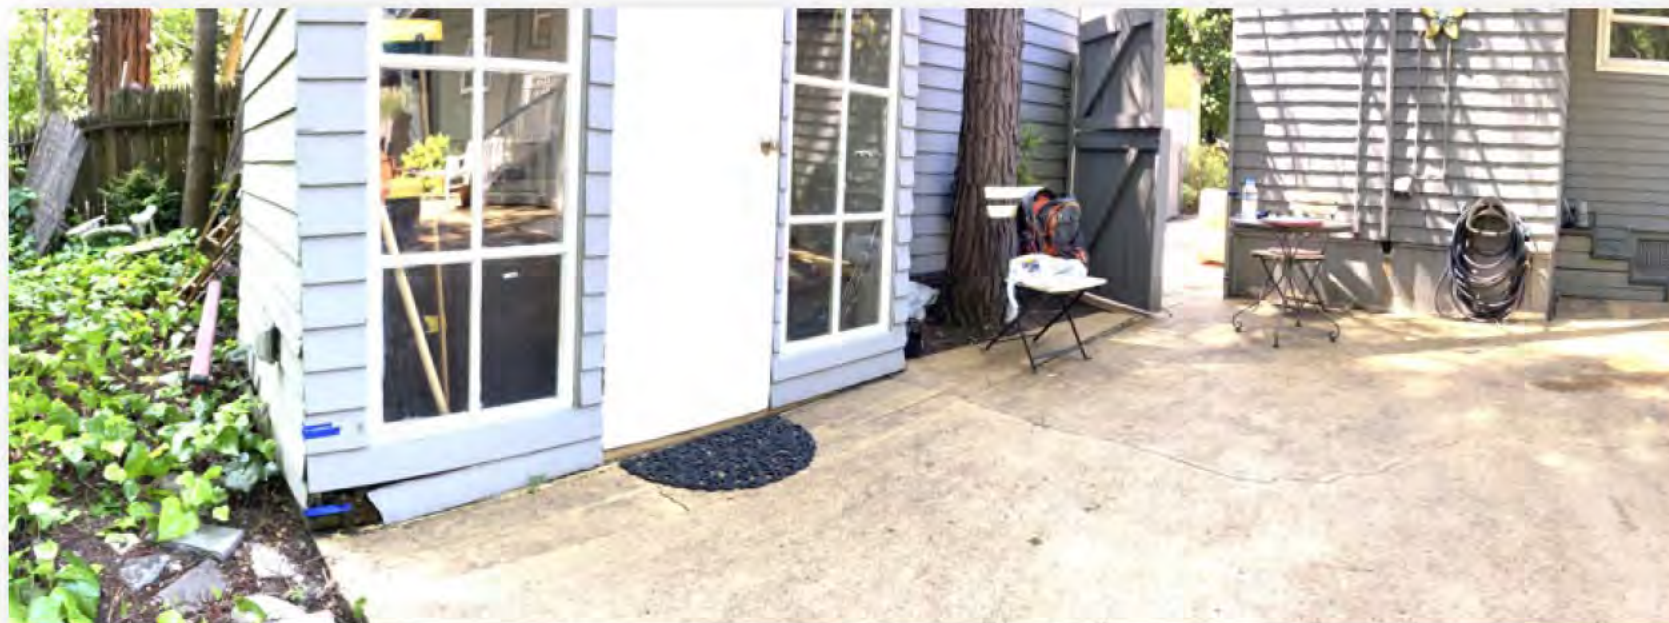
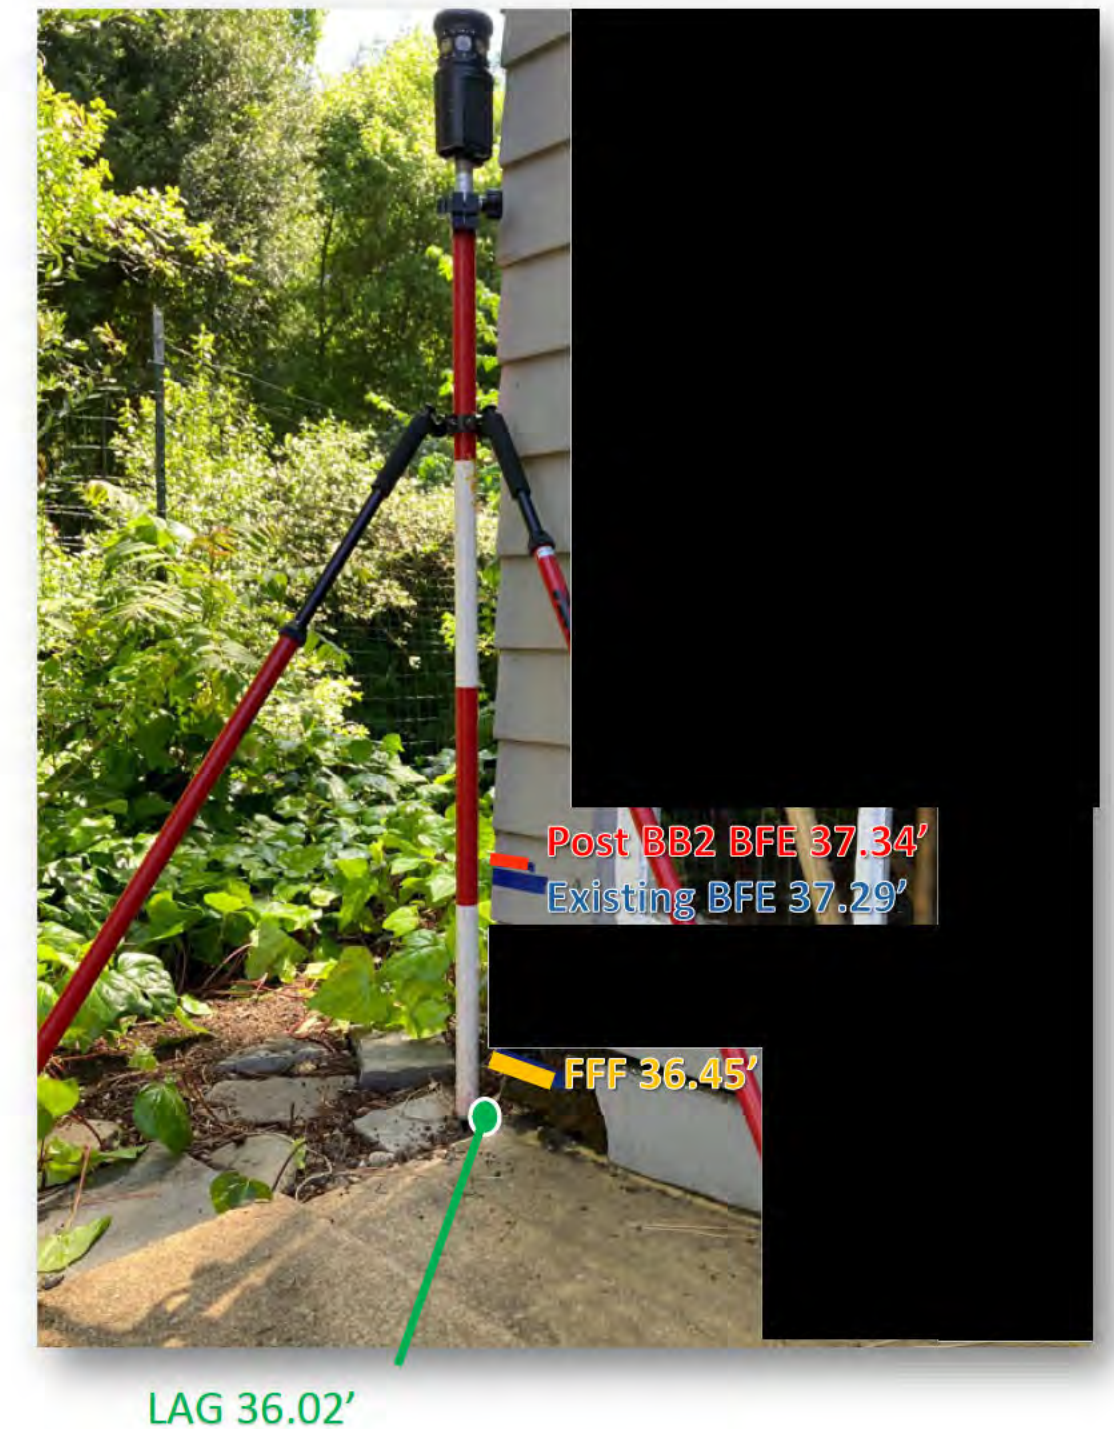
Exhibit No. 19: 78 Sir Francis Drake, Ross - Garage

Garage

Mitigation includes installing flood openings for garage.
