BB2 Removal Project Impact Assessment and Mitigation, MCFCWCD, 2025

Building Bridge #2 Removal – Impact Assessment of Rise in Modeled Base Flood Elevation (BFE)

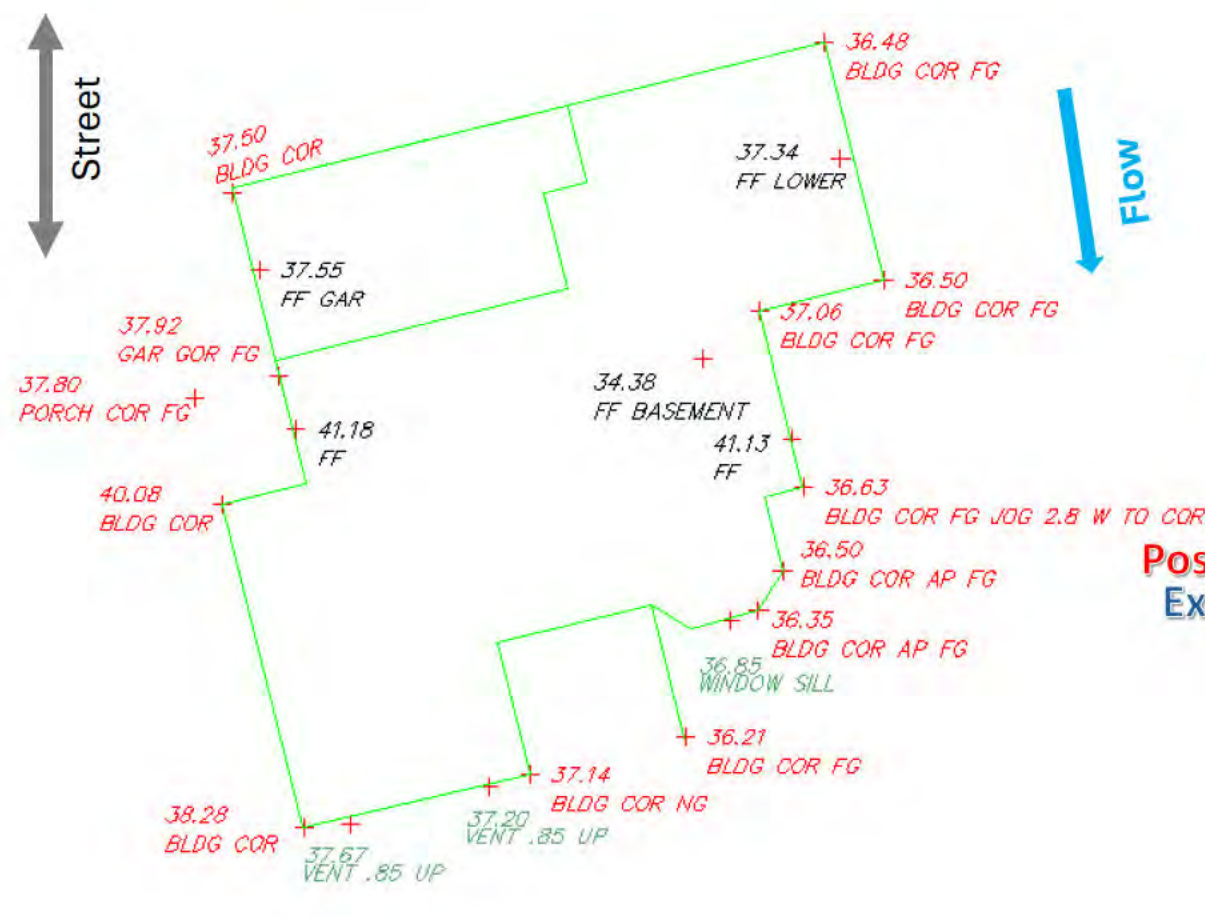
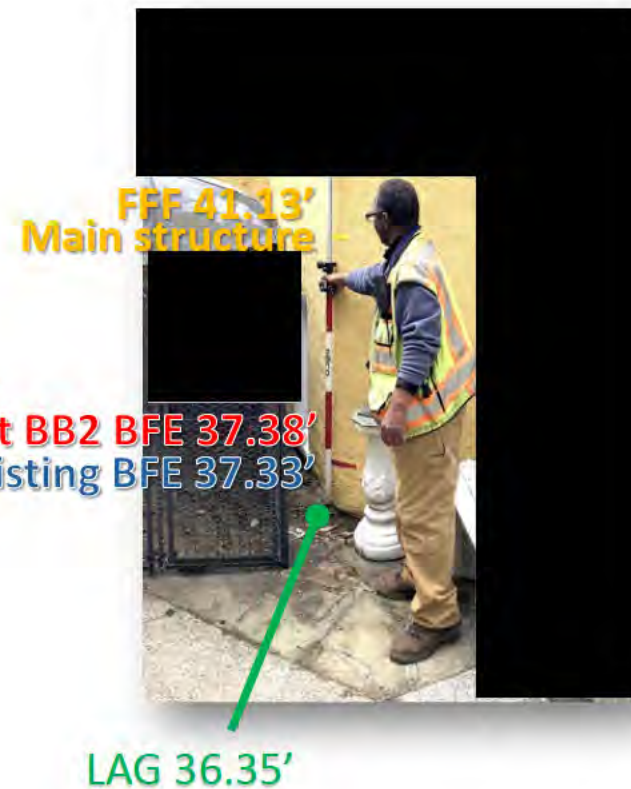
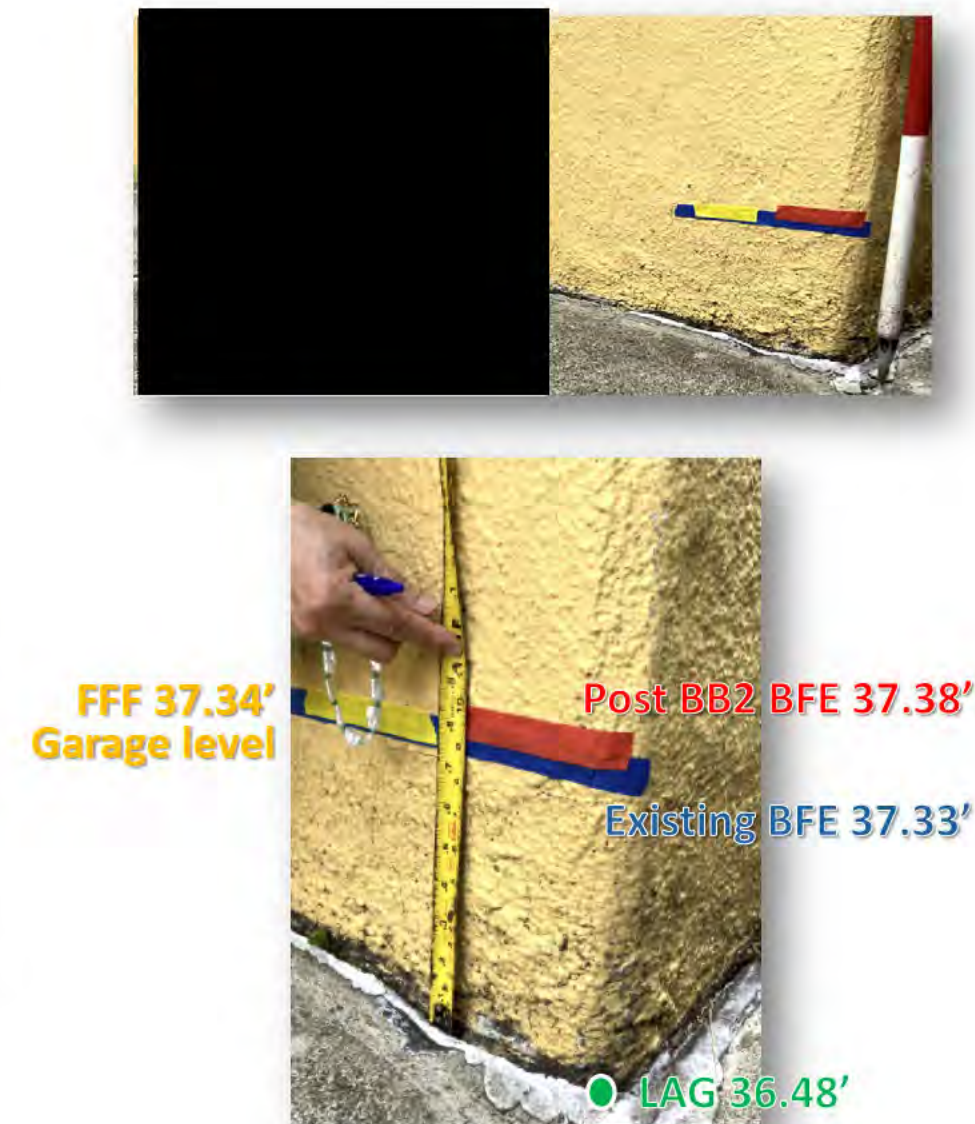
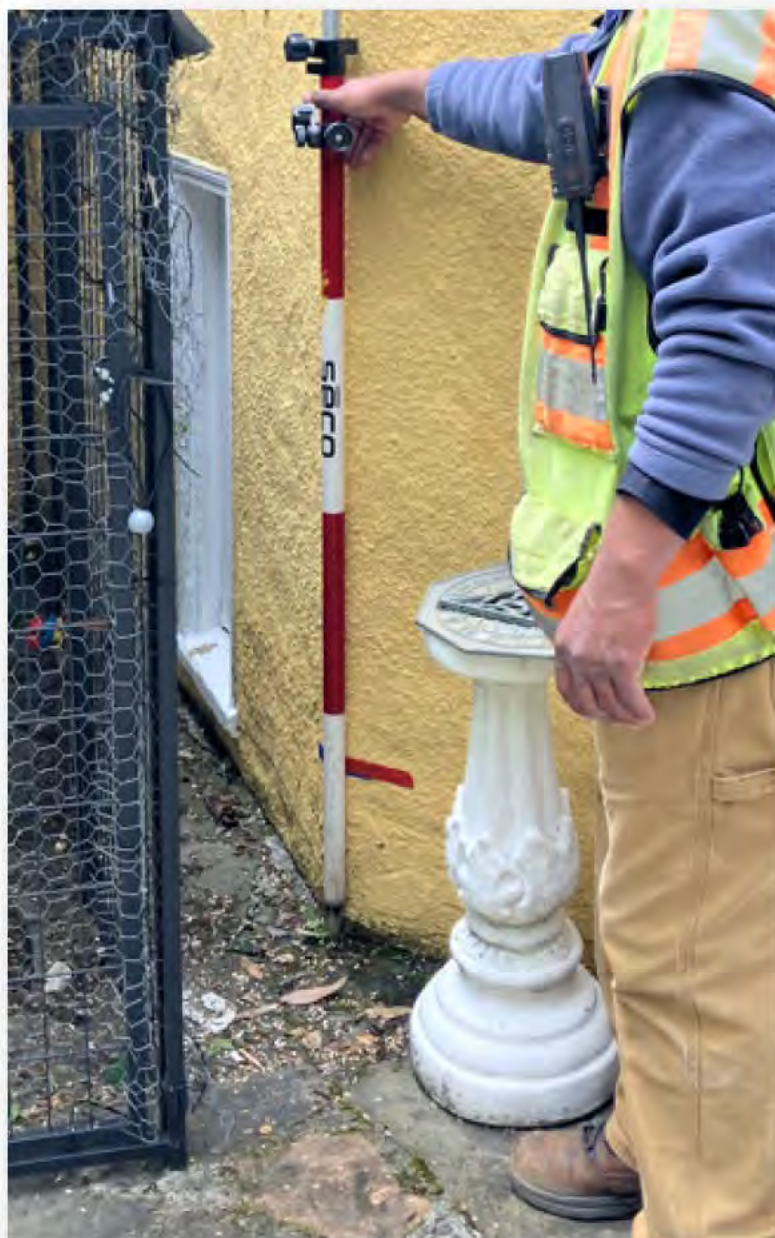
Exhibit No. 20: 74 Sir Francis Drake, Ross

Note: Mitigation is consistent with enclosure used solely for parking of vehicles, building access, or storage. Town of Ross does not have records to indicate whether the lower back room at garage level is a permitted living space and bathroom.

Basement window

Lower back room
at garage level

Electrical conduits and utility piping in crawlspace

HVAC equipment

Mitigation includes: relocating HVAC unit in crawlspace to higher elevation; securing electrical/utility piping in crawlspace to underside of floor joists; installing flood opening in crawlspace and back of garage level; and anchoring building to foundation.

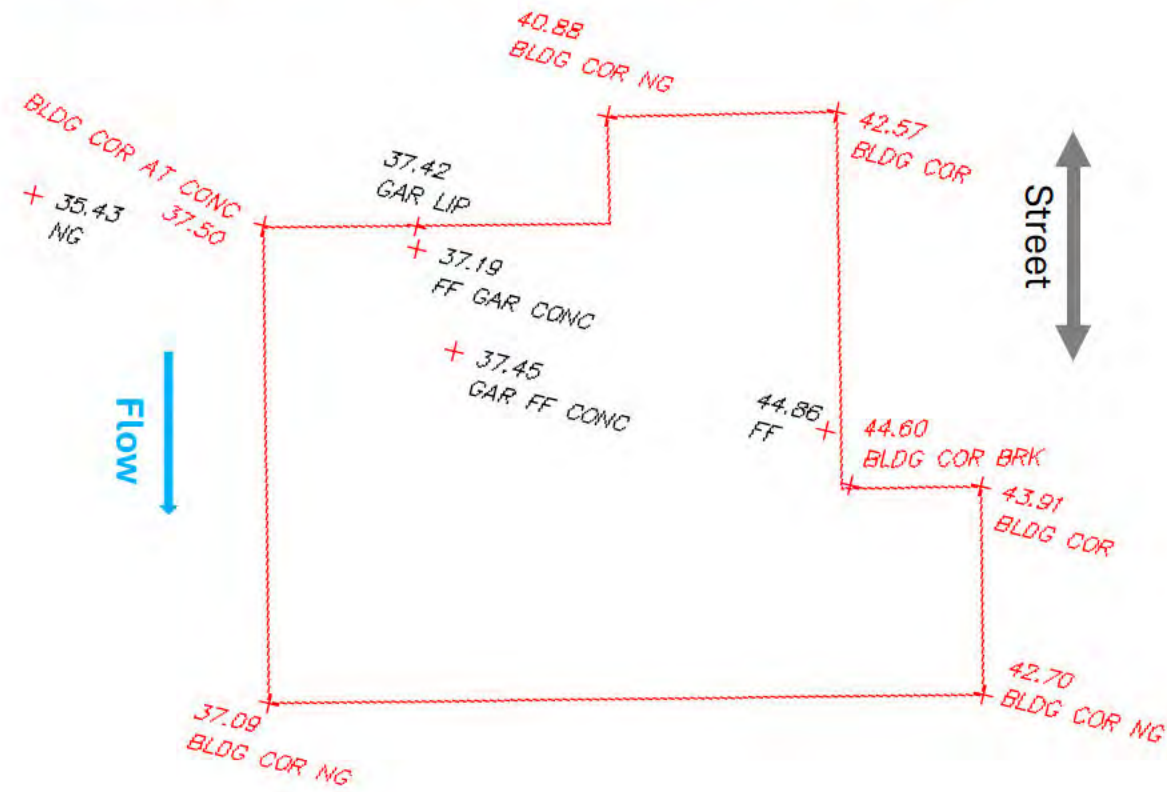
Exhibit No. 21 - 20 Winship, Ross

FFF 44.86'

Garage

Mitigation includes: elevating HVAC and water heater equipment; installing flood openings in garage door and/or garage exterior walls.

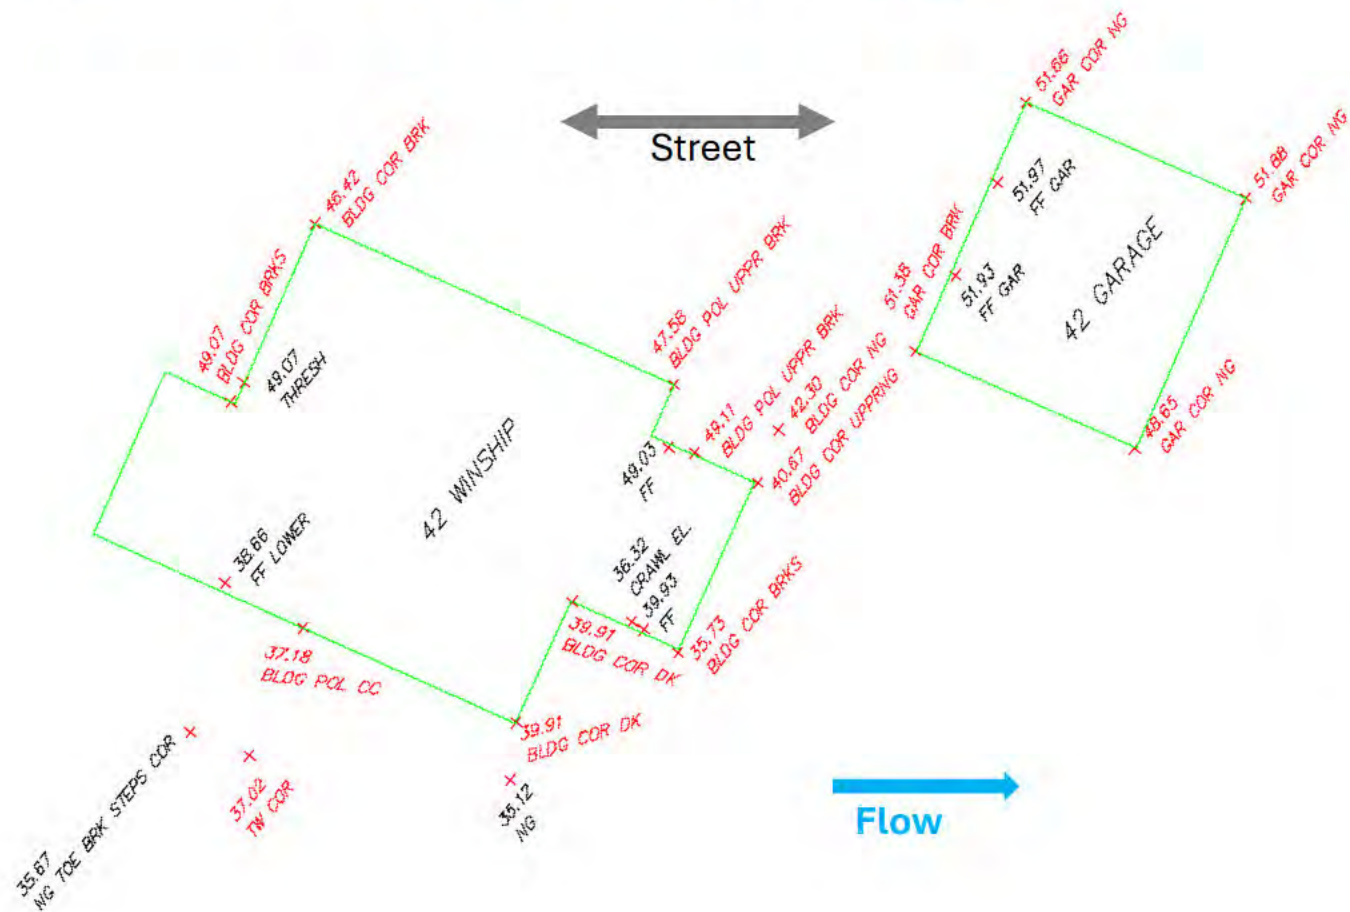
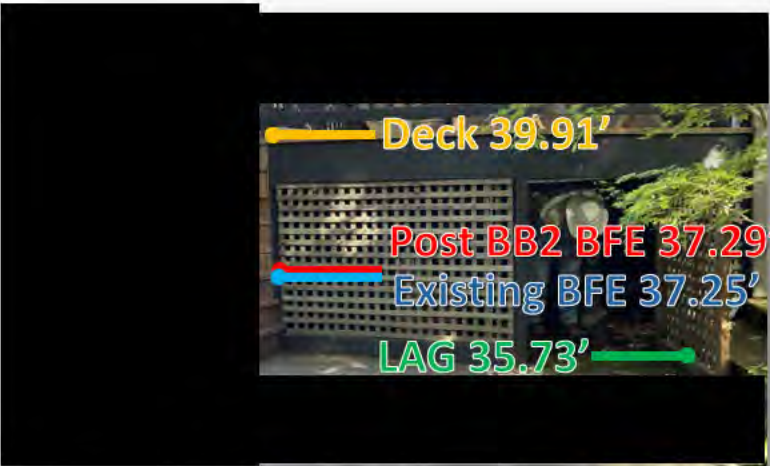
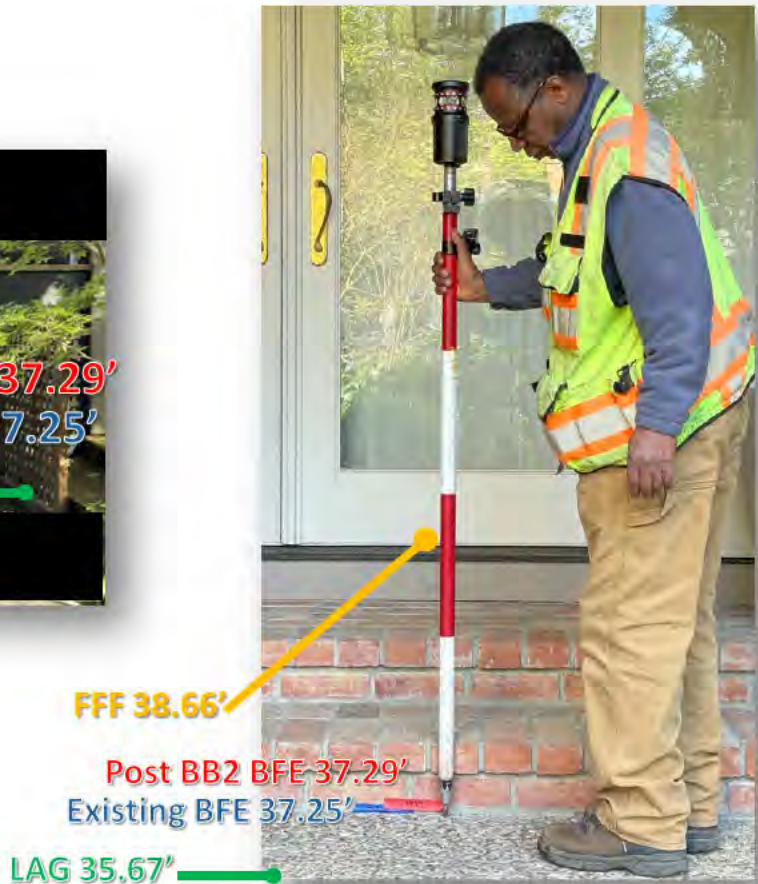
Exhibit No. 22: 42 Winship, Ross

Utility piping, electrical conduits, and tank

Fan
equipment

Crawlspace

Mitigation includes: relocating fan equipment to higher elevation; elevating and securing utility piping to floor joists; anchoring tank to foundation; and installing flood openings for crawlspace.

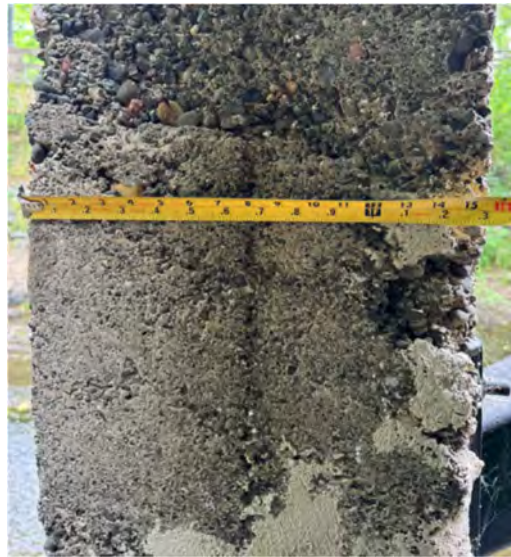
The existing material conditions and concrete quality at the column locations were not formally assessed as part of this study. However, visual observations identified signs of deterioration at several locations, including exposed aggregate and surface cracking. For the purposes of analysis, a cracked concrete section was conservatively assumed, but no additional material degradation factors were incorporated into the calculations.

Example of Concrete Spalling Not Evaluated in Report

To better characterize the structural performance of the creek structures, we recommend a more comprehensive evaluation of each column's condition. Expanding the assessment beyond the three representative cases studied in this
