**Client:** Marin County Flood Control & Water Conservation District  
**Project Location:** San Anselmo Creek Park, San Anselmo, CA  
**Inspection Date:** April 29, 2025  
**Arborist:** Ben Anderson

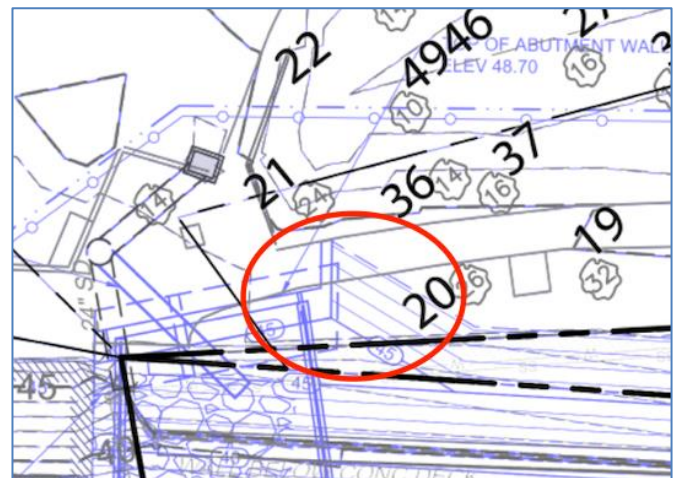
Adjacent to Trees 20 and 21, two large redwoods at the line's north end, the excavation turns into the park and crosses the existing sidewalk. This will involve much greater root disturbance and possibly the removal of one or both trees, depending on the number and size of roots encountered.

**Figure 1. Screenshot of area of concern near Trees 20 & 21. Blue lines are proposed improvements which will cross the existing sidewalk and require significant excavation in the structural root zones.**

1. The contractor shall meet with the arborist before work commences to discuss tree protection, site access, material storage, and excavation practices.
2. Install tree protection fencing according to the attached map prior to work on site. Additional fencing may be specified during the meeting described in Step 1.
3. Remove only as much of the curb by the redwoods as necessary (Figure 2), as it is likely in contact with large, structural roots that should be not disturbed.
4. Adjust the grading on the bank below the redwoods to follow the existing grade as much as possible to mitigate excavation below Trees 13 and 4716.
5. The arborist shall be present during concrete removal and grading within 10 feet of the trunk of any redwood.
6. The arborist shall be present during the excavation near trees 20 & 21 to determine whether these trees can be retained.

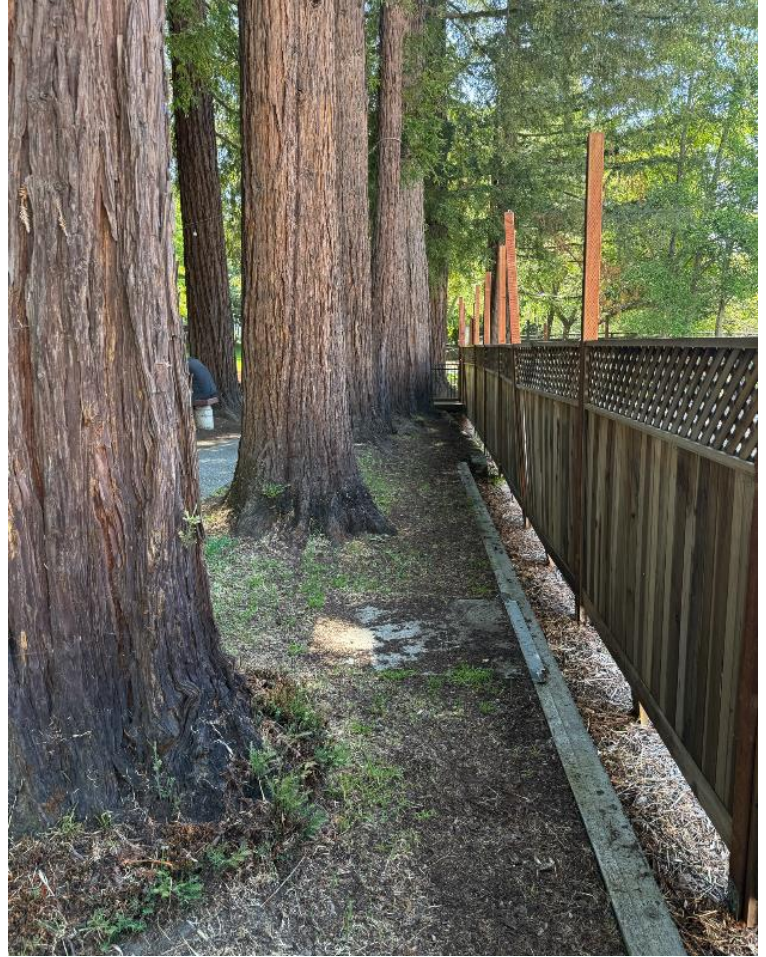
The most intrusive work will be along the line of redwoods on the creek's north side. There is an existing concrete curb with an unknown footing depth within 1-5 feet of the trunk bases. This is shown to be removed, and the area between the trees and the creek is to be regraded to make the ground gradually slope down from the trees to the creek channel. It is shown as a straight, uniformly sloping bank. The trees are generally healthy and do not appear to be significantly surface-rooted. A concrete sidewalk runs along their north side, which is only slightly lifted in a few spots. San Anselmo typically has good soils that allow for the deep rooting of redwoods.

**Figure 2. Line of redwoods adjacent to creek repair. The curb to the right of the trees will be removed, but only as deep as necessary to bury it.**
