Golden Gate National Recreation Area Preliminary Hydraulics Recommendations Report

CA FTNP FOPO 110(1) & GOGA 205(1)

Federal Highway Administration, Central Federal Lands Highway Division

June 2020

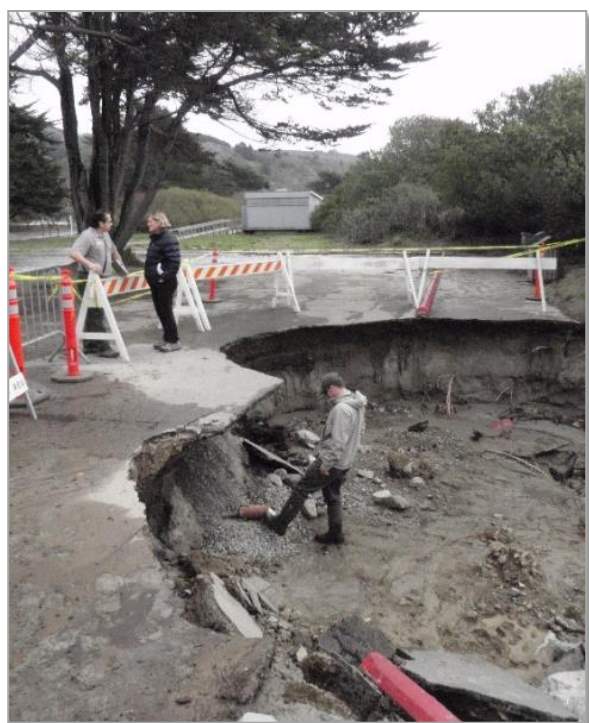
Figure 7.1: North Lot—Damage from Overtopping of Easkoot Creek

Flood damage to the community and park areas near Stinson Beach has been recorded since 1954. Damages to the bridges over Easkoot Creek, flooding in the residential streets, and damage to the building currently occupied by the Parkside café all have occurred. Based on District records, floods of note occurred in 1972, 1973, 1982, 1986, 1997, 2005, and 2018. Sediment removal within Easkoot Creek at the bend toward Bolinas Lagoon is part of the County’s annual budget under special permit with the NPS. Undermining failure to the north lot occurred during the 2018 storm (see Figure 7.1).

The existing drainage patterns for the Stinson Beach lots are shown in Appendix E, Exhibits E.5.1A, B, and C. The north lot drains from southeast to northwest and has been damaged by storm flows overtopping Easkoot Creek, which spill into the ocean at the north end (see Figure 7.1). The north half of the central lot drains generally from northeast to southwest and then northwest along the dunes. The south half of the central lot drains from north to southeast and ponds near the dunes at the southeast corner. A portion of the offsite commercial, residential, and park maintenance areas between Highway 1 and Marine Way drain into the north half of the central lot through a long scupper near Marine Way (see Figure 7.2). The south lot does not receive any offsite flow. The lot generally drains from north to south into three ponding areas along the dunes (see Figure 7.3). Flows overtopping ponding areas would migrate to the southeast and onto the beach near the southeast corner.

| Parking Lot | Recommendation |
|---|---|
| North Lot | Ensure pavement grading maintains historical flow patterns; incorporate channel grading through picnic area and through the dunes to the beach. |

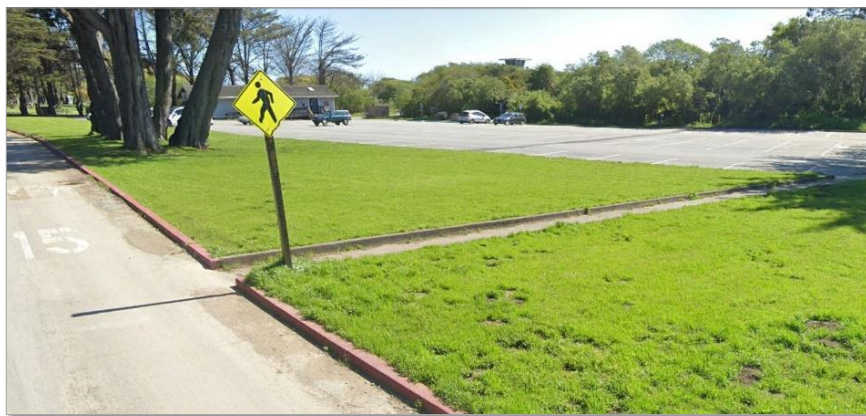
Figure 7.2: Central Lot—Long Scupper

The three parking lots of Stinson Beach do not contain significant drainage infrastructure. The existing 3-foot x 68-foot x 6-inch scupper passes offsite flows through the central lot. This scupper has a longitudinal slope of 1.6% and is lined with asphalt and adjacent concrete curbs. It carries approximately 9.0 cfs. The existing grassy ditch along the dunes in the south lot ponds any flows not ponding on the access road. All the parking lots generally slope southwest toward the dunes.

| Parking Lot | Recommendation |
|---|---|
| Central Lot | Grade offsite flows from SB_C_03 toward north side of dip-crossing; re-aligned park entry road; incorporate swale/channel grading; ensure pavement grading to historical flow patterns. |

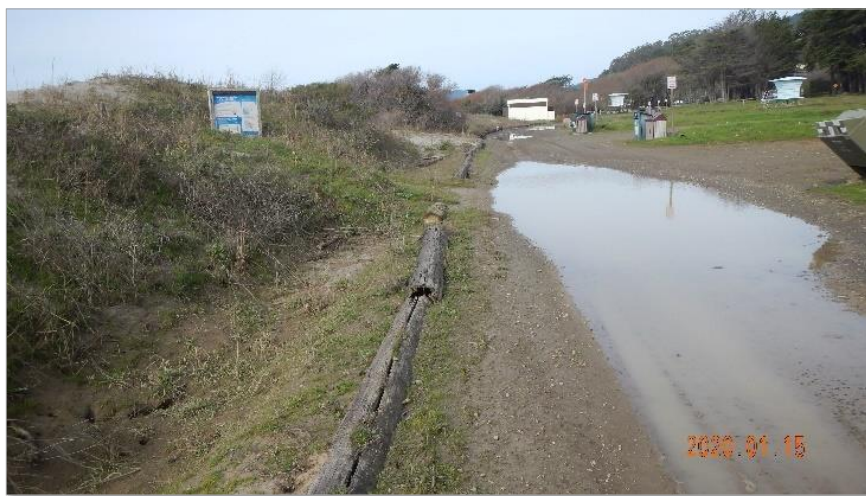
Figure 7.3: South Lot—Ponding Areas along the Dunes

The south lot is nearly 4 acres in size and is comprised of compacted earth with grass berms demarking 13 drive aisles with room for about 475 cars. The southwestern side is bordered by dunes and a small, flat, grassy ditch. Ponding occurs on the southwestern side of the parking area.

| Parking Lot | Recommendation |
|---|---|
| South Lot | Eliminate ponding on access road to convey flows to existing ditch/ponding areas near the dunes. |
