Willis Evans Canyon Creek at San Geronimo Valley Dr. (2005)

East Fork Woodacre Creek at the Woodacre Improvement Club (2005)

Woodacre Creek at Park St. (2006)

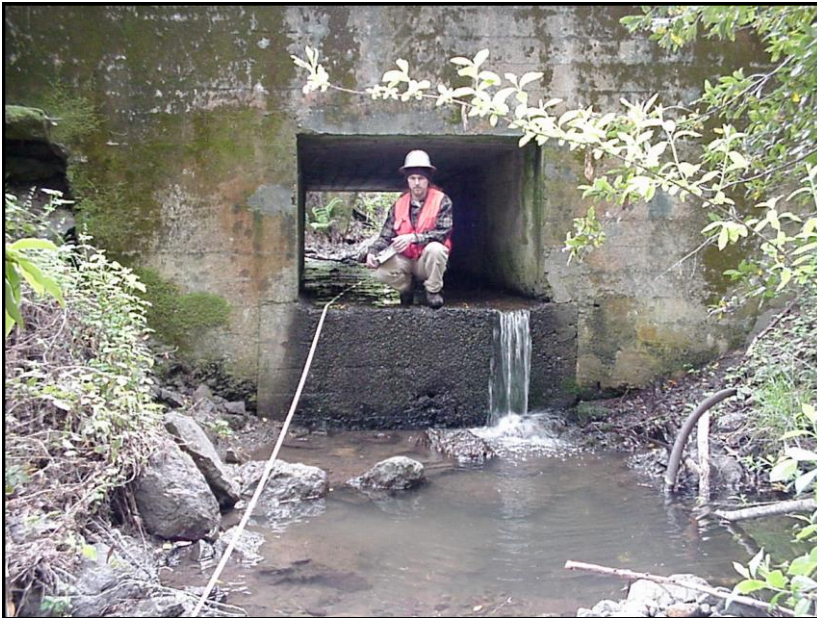
Before: Prior to construction, the old box culvert created a velocity barrier to coho salmon due to slick concrete inside and a jump barrier due to the scour hole at the outlet.

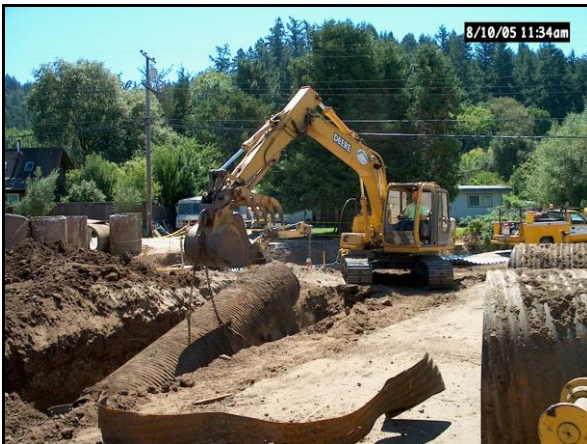
Before: Day-Lighting 200' of creek from beneath a tennis court

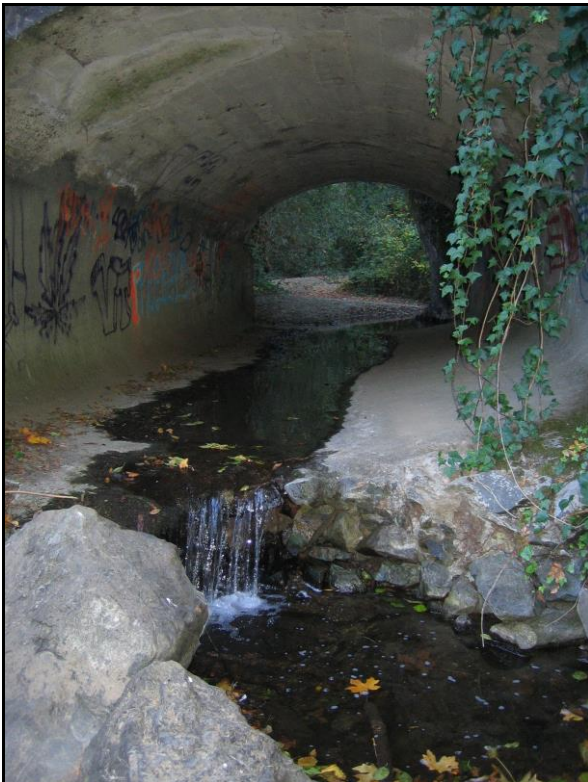
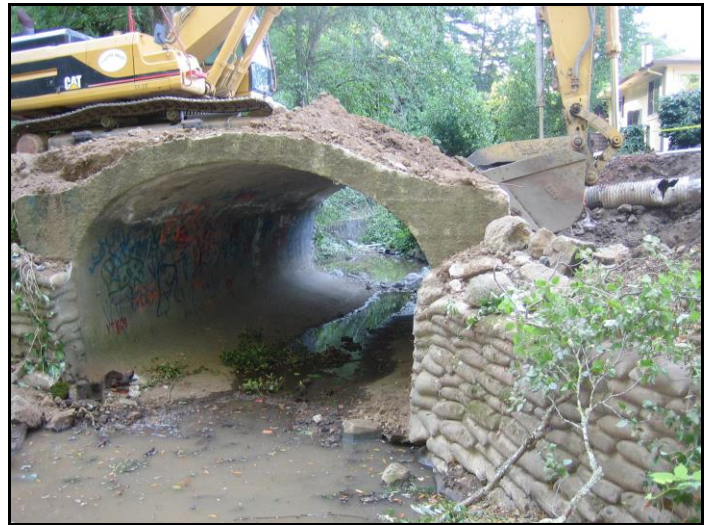
Before: High flow velocities through this slick, concrete culvert, combined with rocky rubble dumped at the outlet, created a jump and velocity barrier to salmon.

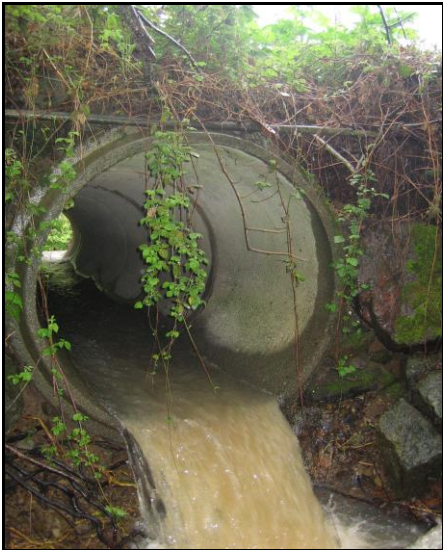
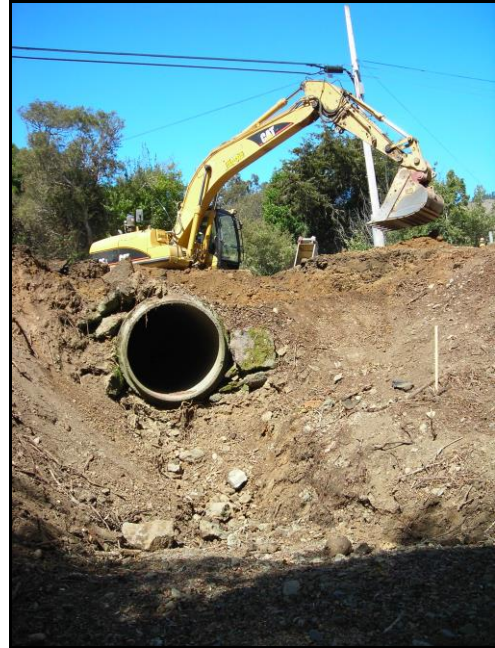
Before: This under-sized concrete pipe running under Muir Woods Rd. created a velocity and jump barrier for salmonids moving upstream from Redwood Creek to spawn in Kent Canyon. It was also a low flow barrier for juvenile fish moving downstream during summer low flows.

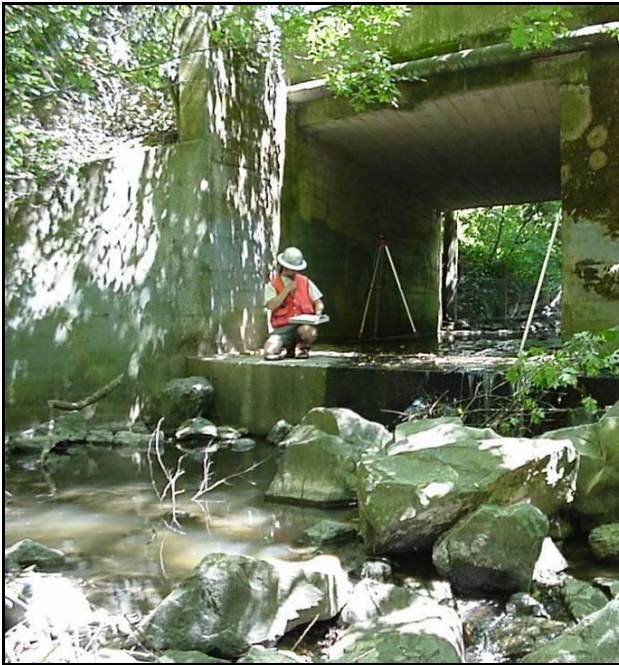
Before: The large box culvert under SG Valley Dr. created a velocity barrier due to the slick concrete bottom and wide flat surface which caused water to come roaring out of the box during spawning in the fall and winter.

Salmon also faced a jump barrier getting into the box due to downstream scour caused by the increased velocities and were impeded by low flows in the summer when water sheeted across the concrete creating a low flow barrier to migration.

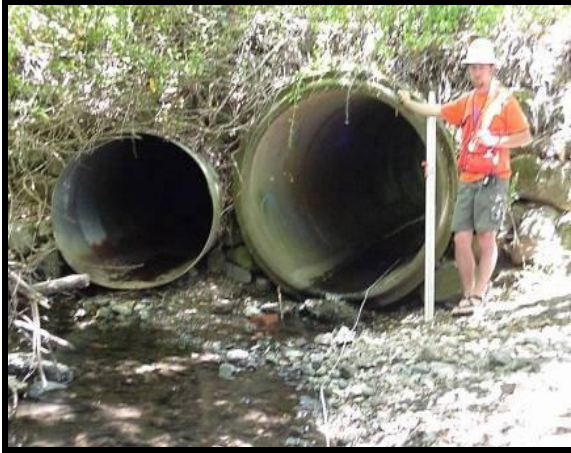
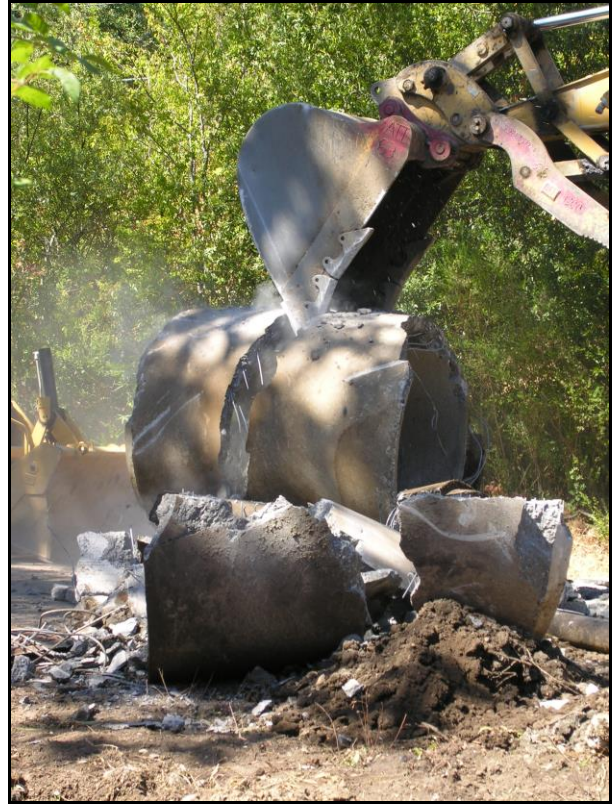
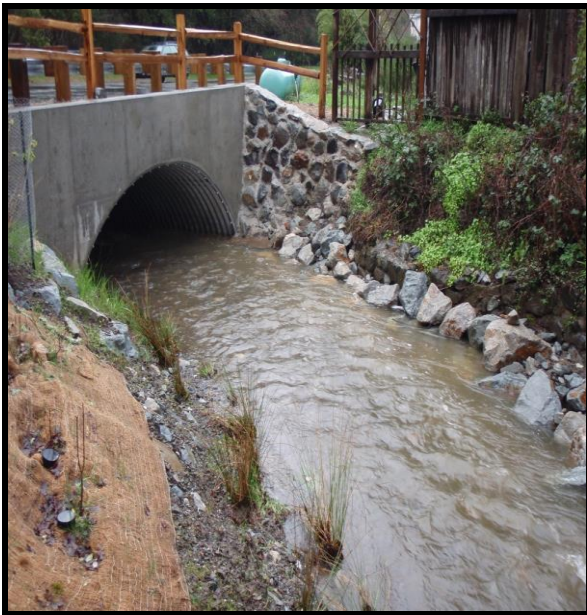
Before: Downstream view of the double barreled culvert prior to construction; the under-sized pipes created both velocity and low flow barriers to adult and juvenile coho salmon and steelhead.

After: Replacement of the old pipes with an open-bottomed arched culvert allows salmonids to move freely up and down through the crossing, regardless of time of year and level of stream flows. Completion of the construction of this project removed the last major barrier to coho salmon in the Woodacre Creek watershed.

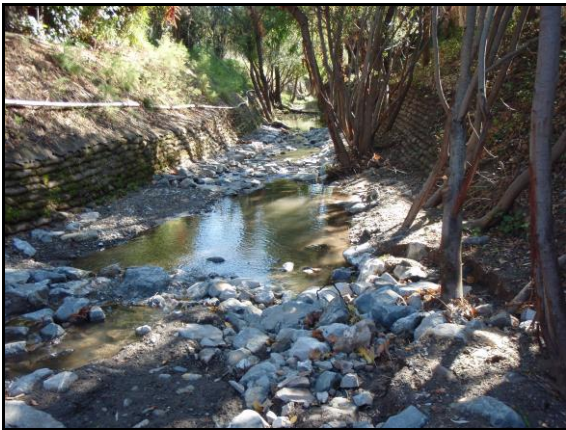
Before: This double box culvert on Vineyard Creek had a perched outlet with more than a five foot drop over riprap. It failed to meet fish passage criteria for all species of adult salmonids and all classes of juveniles.

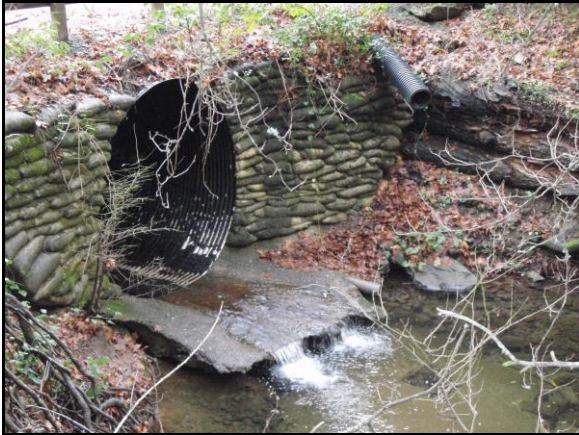
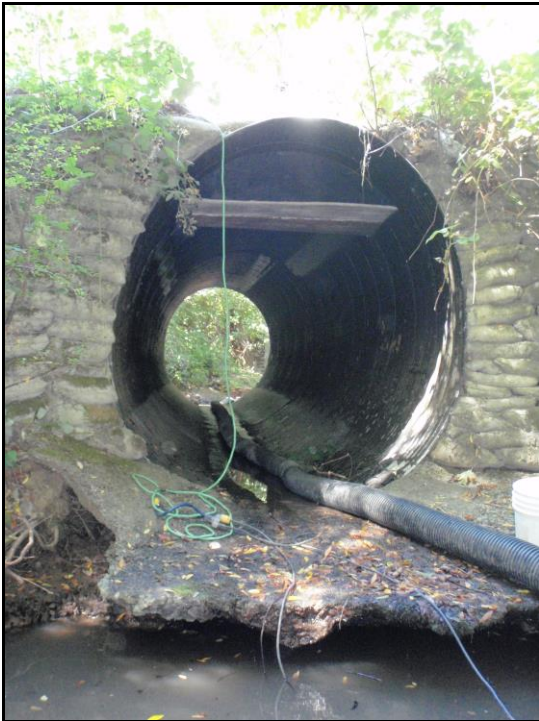
Before: The circular corrugated metal pipe presented both a velocity and jump barrier for coho salmon attempting to navigate into the structure in spite of the slick concrete apron and fast flows through the pipe.

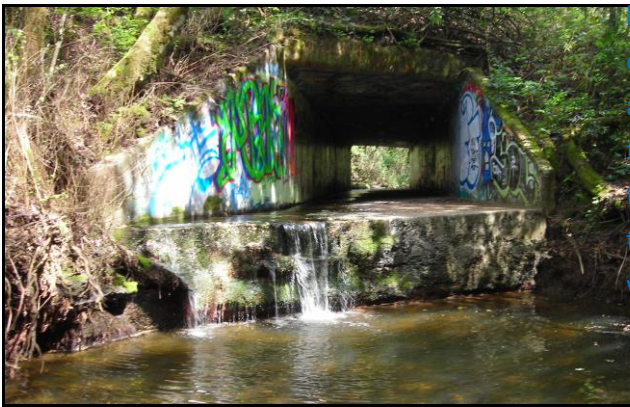
Before: A large box culvert on the mainstem of San Geronimo Creek, just upstream of the confluence with Woodacre Creek, was both a jump and velocity barrier for coho and steelhead. In 2011, a conceptual design was completed by Marin County Engineering, and after several years of construction grant applications was funded in 2015 by Department of Fish and Wildlife through the Drought resiliency program.

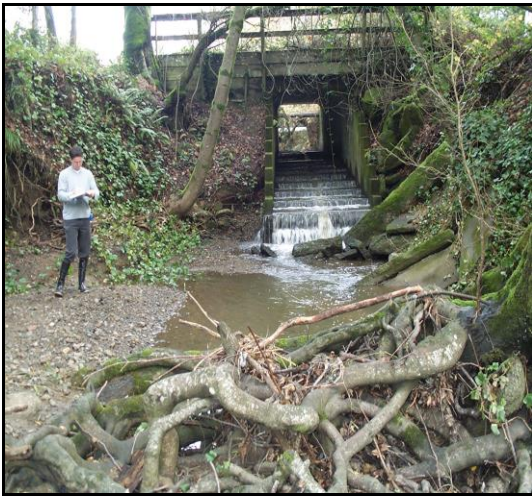
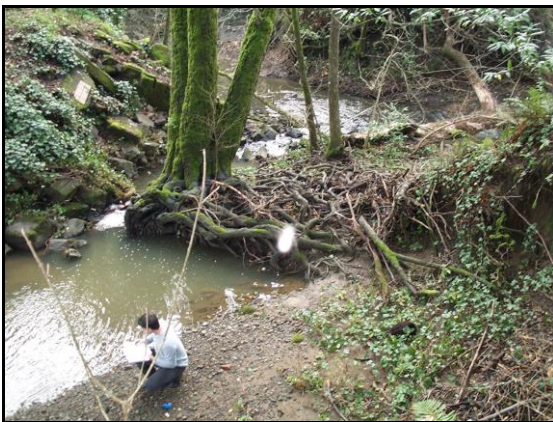
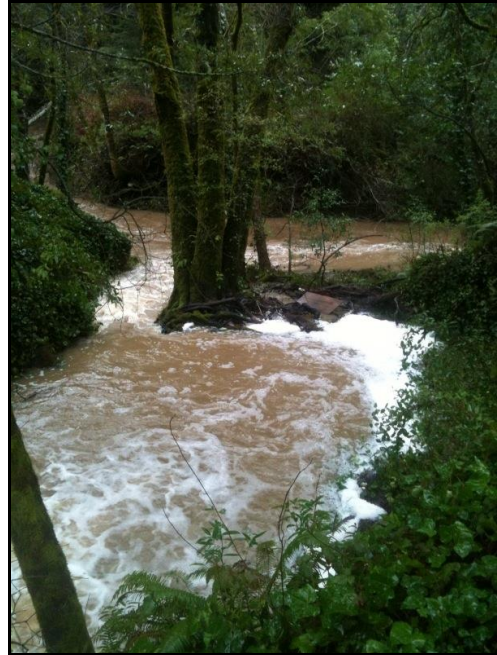
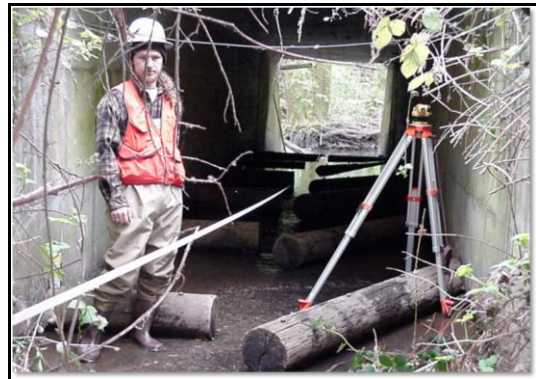
Existing Conditions: A series of baffles installed by Trout Unlimited in the 1980's attempted to address the jump and velocity barrier created by the slick, steep, perched box culvert running under Sir Francis Drake Blvd. Since then the baffles have degraded and leak, and have the potential to entrain and strand juvenile salmonids migrating downstream during low flows.

Barrier Removal Design- The new design installs a horseshoe shaped, partial flow fishway below the culvert and replaces the interior baffles to improve juvenile salmon migration during all times of year. The design also incorporates the naturally occurring peninsula in the downstream channel which provides high flow refugia in a watershed that is limited by lack of slow water for migrating and over-wintering juvenile coho.

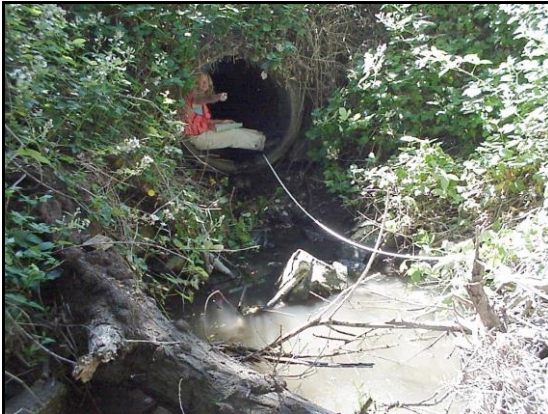
Existing Conditions: This circular concrete culvert near the confluence of Montezuma Creek with the mainstem of San Geronimo Creek was identified in the passage assessment report (Taylor 2003) as a partial barrier to coho and steelhead. Elimination of the barrier and restoration of the riparian zone in this reach of Montezuma Creek was later identified as a high priority in the San Geronimo Valley Landowner Assistance Program (SGVLAP); as part of the SGV LAP, a conceptual design was developed for the project. The full design for the project and implementation funds to construct it, are being sought through various grant programs for restoration.

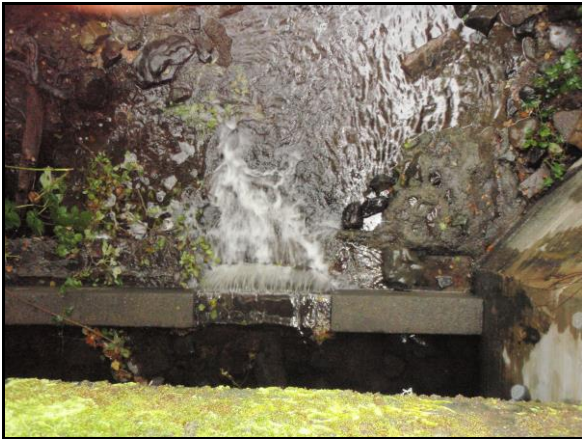
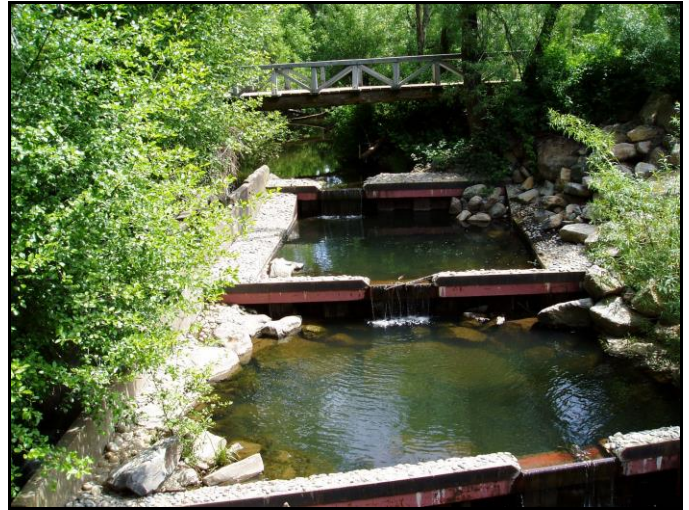
View from the top of road down to the County section of the project; a bridge sill which lies beneath the San Geronimo Valley Drive impedes passage during summer low flows.

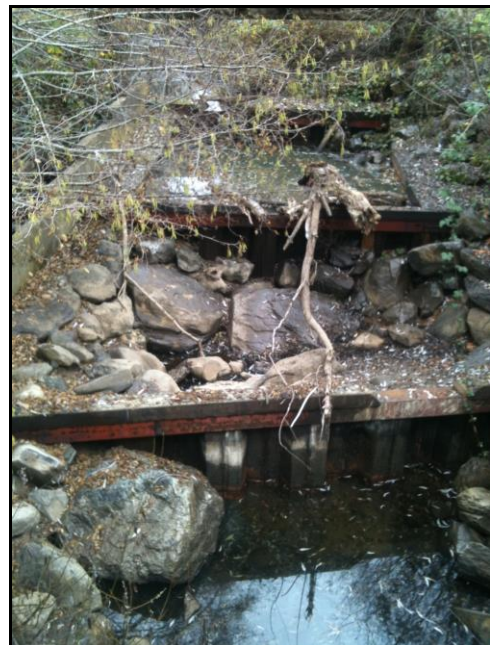
Barrier Removal Design: A fish ladder constructed in 1999 provides fish passage over a historic instream dam and includes a series of weirs large weir pools and a partial flow ladder for juvenile fish. Over time the Roy's Pools project has deteriorated and DFW has given the Golf Course a grant (2014) to redesign the structure including the County's bridge sill downstream.
