MEMORANDUM

To: Felix Meneau, Marin County
From: Dona Mann, A3GEO
Date: October 4, 2019
Project: Corte Madera Creek Levee Evaluation
Subject: Existing Conditions Technical Memorandum

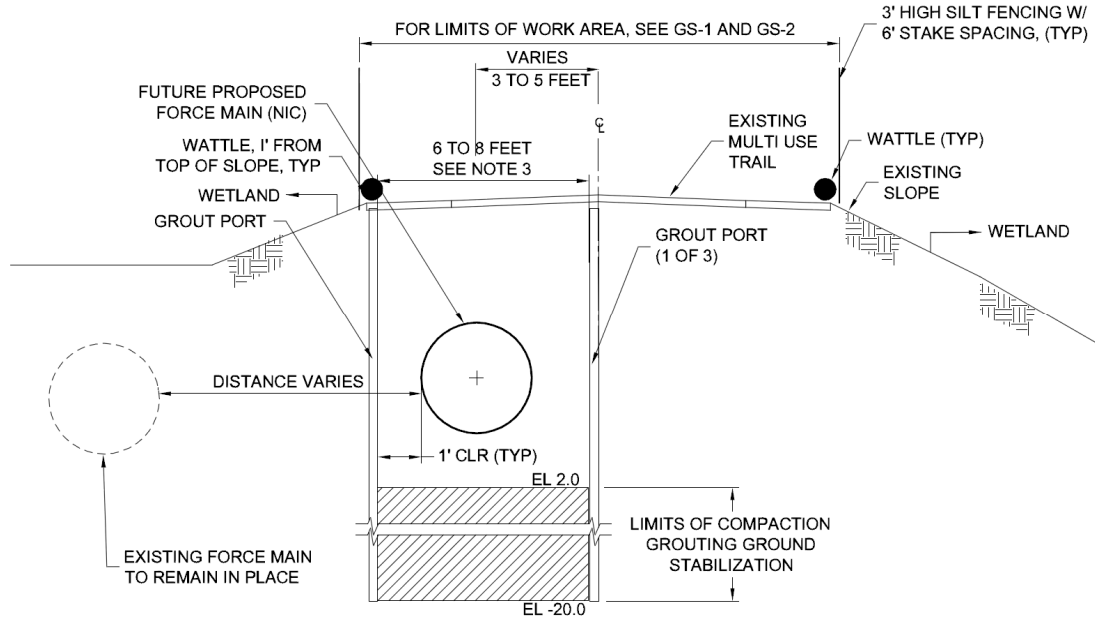
1. The Ross Valley Sanitary District replaced their force main **downstream** of Bon Air Bridge in 2012 and implemented an extensive ground improvement program beneath the existing left bank levee from Bon Air Bridge upstream to the stilling basin (~Sta. 283+50 to 319+00) to mitigate the effects of liquefaction and lateral spreading for a portion of the existing force main that is currently located beneath the left bank levee and for a planned force main which will be constructed under the left bank levee at some future time.
2. The ground improvement program consisted of creating an approximately 12-foot wide by 22-foot high grouted soil prism 8 to 30 feet below the ground surface from ~Sta. 283+50 to 319+00. Detail C on Sheet C-10 of the Brown and Caldwell 2012 Record Drawings is shown below.

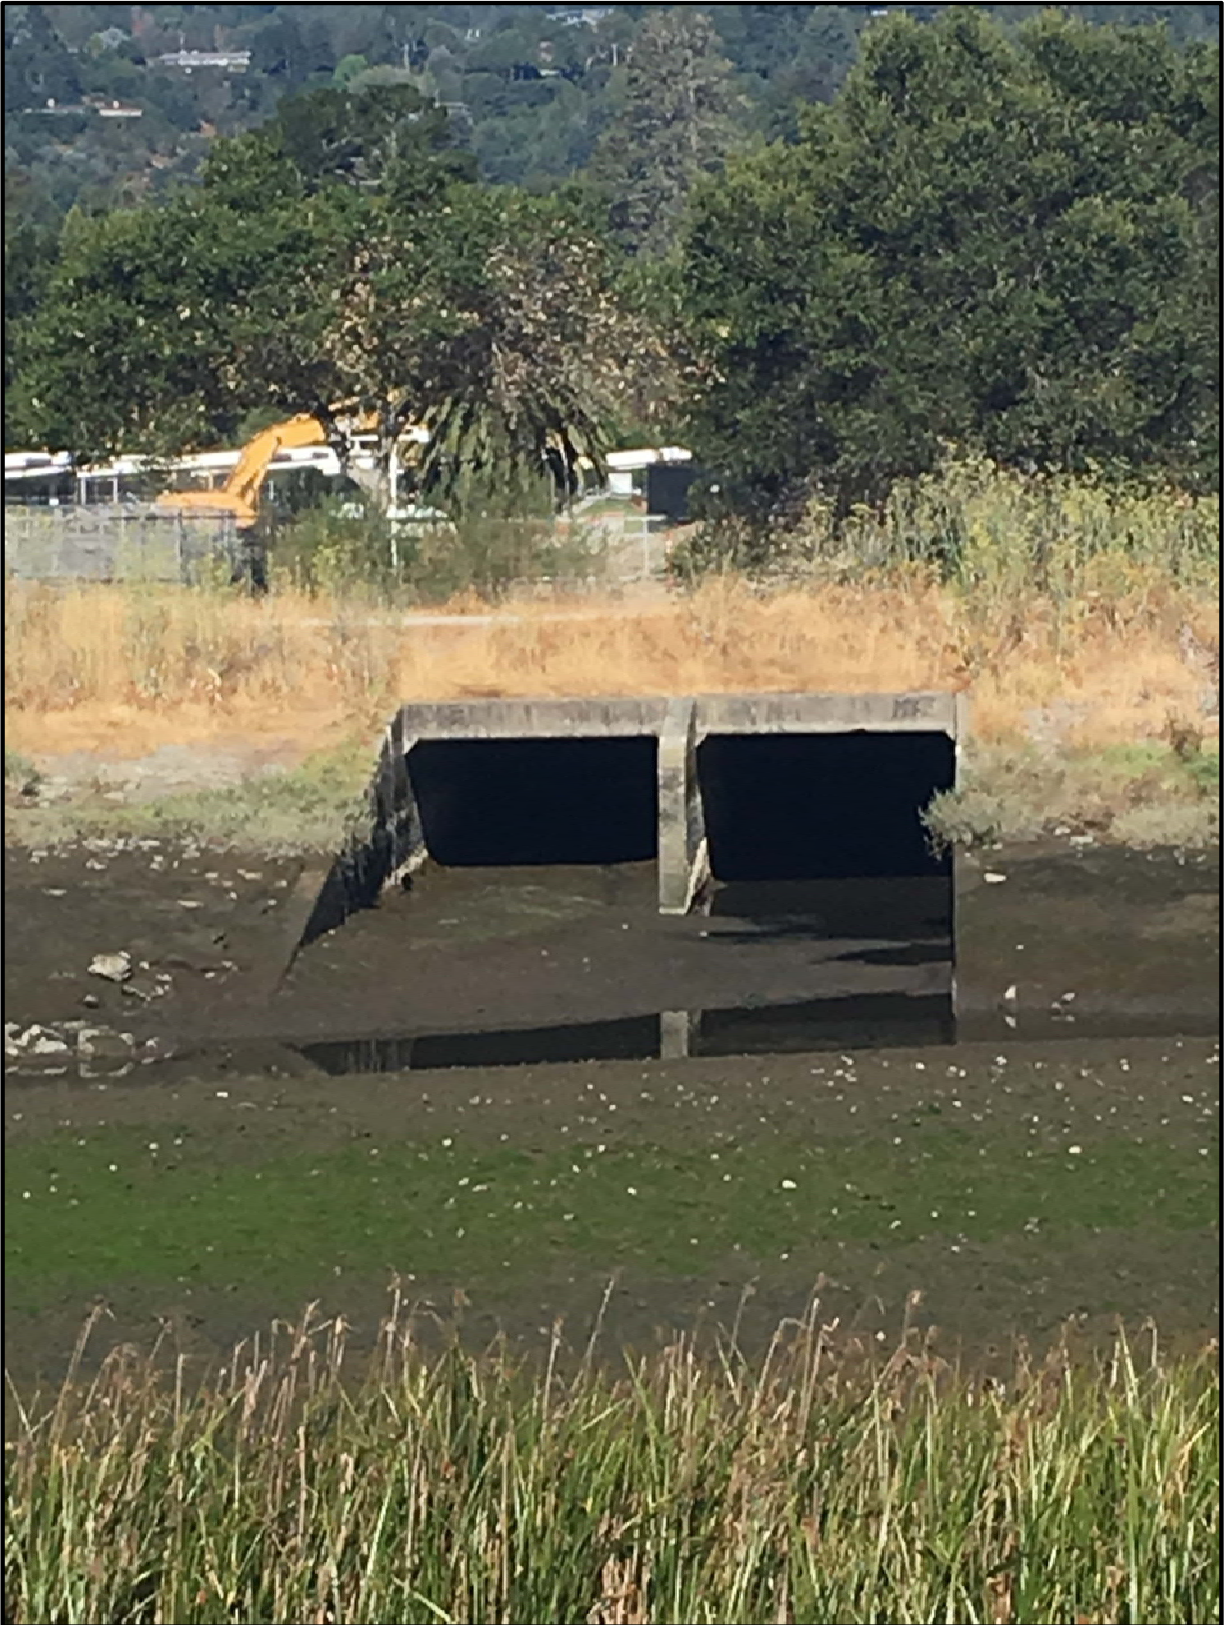
C	CREM_2017_a_007 (~Sta. 317+00)	Shoaling (Concrete Box Culverts- Right bank)	M	Approximately 30 to 50% sedimentation of the two 8x8ft concrete box culverts was observed. The condition is approximately the same as in previous inspection cycles. No negative performance has been reported, but the sediment should be cleared.	Plate No. 4	Approximately 30 to 50% sediment buildup inside two concrete box culverts was observed.	No significant change since 2017. Sediment has not been removed.

- Inspection details for culverts and culvert flap gates are included in Table 2.
- Four 60-inch CMP Culverts at ~Sta. 299+50 (left bank) are severely corroded with holes (Plate No. 6).
- Several culverts are up to 50% infilled with sediment (Plates No. 4, 5 and 9).

**Concrete Box Culverts (Right Bank - Appx CMC station 317+00)
A3GEO Inspection Point C**

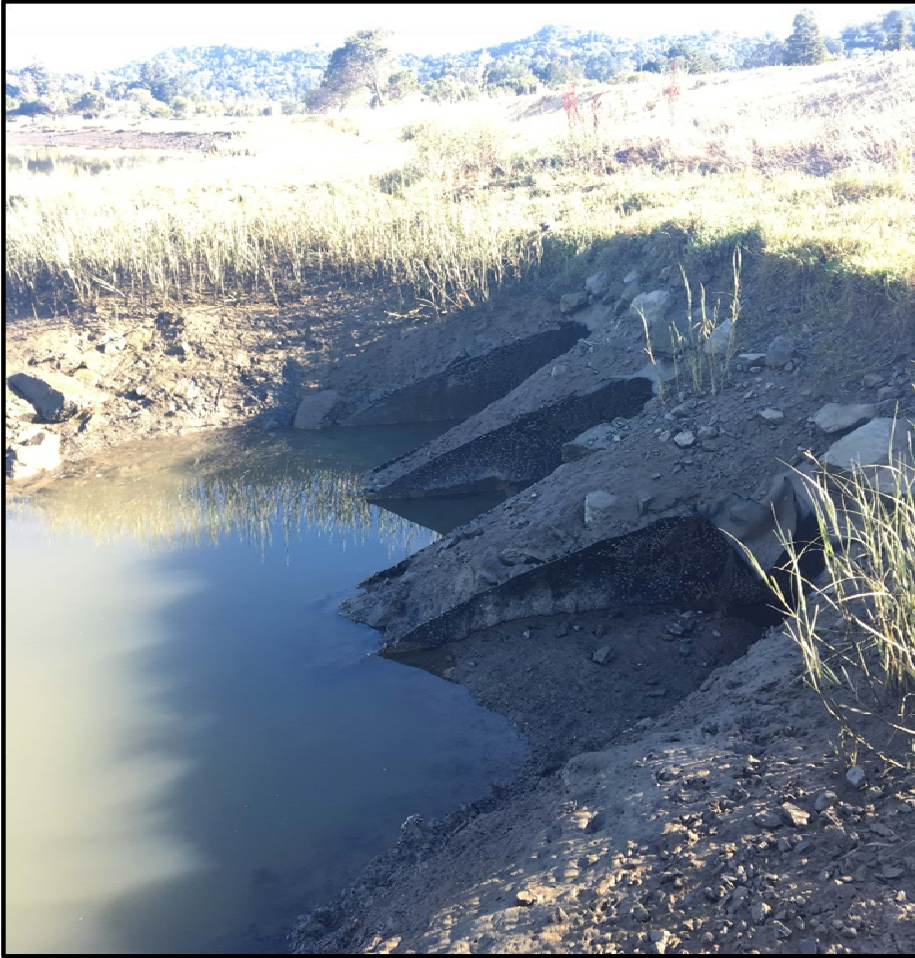
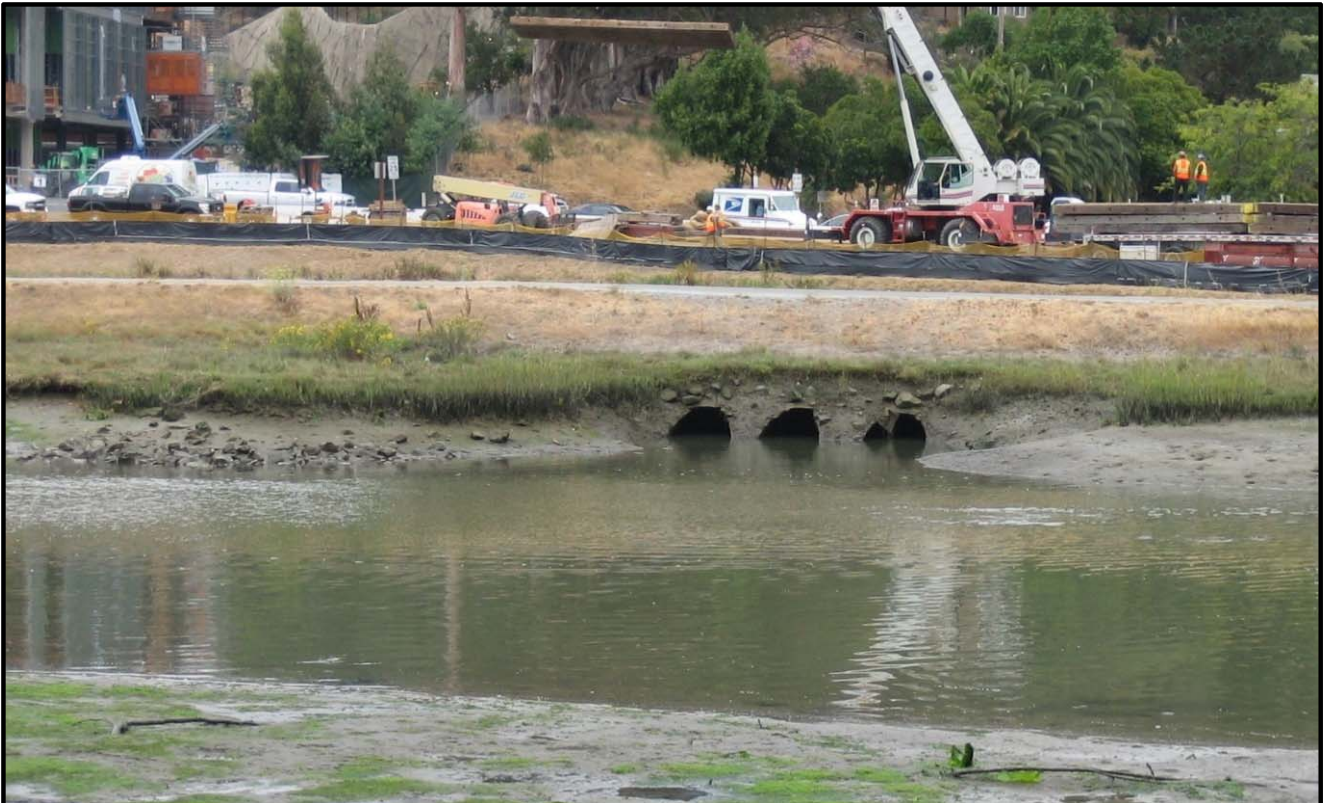
Plate No. 5

36-inch HDPE Culverts (Left Bank – Appx CMC Station 284+50)

A3GEO Inspection Point D

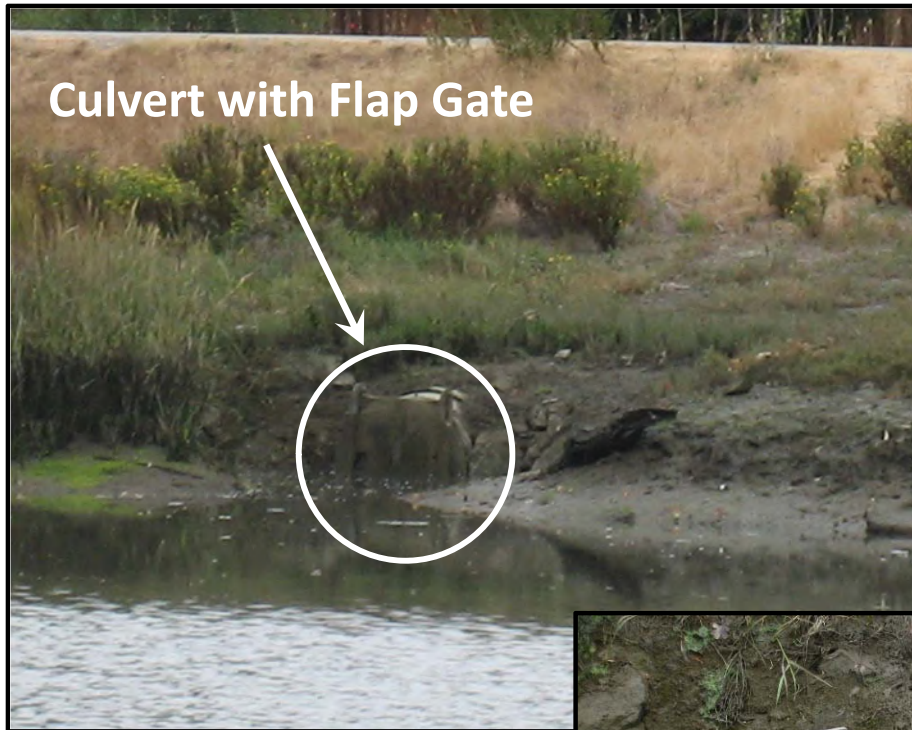
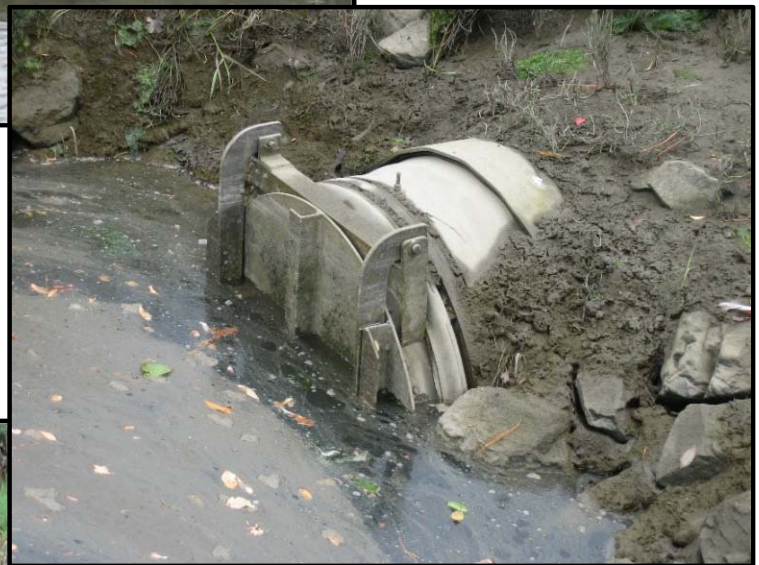
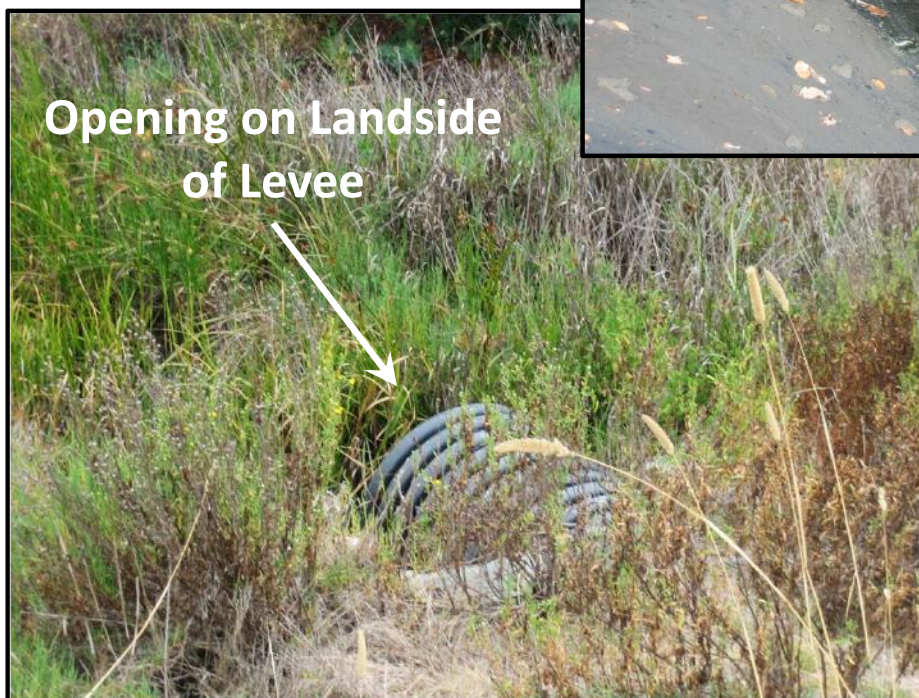
Plate No. 7

F	CREM_2017_a_0005_1 (~Sta. 308+00)	One 36-inch HDPE Culvert with Flap Gate (Left Bank)	A	No remarks were made regarding this culvert in 2017 routine inspection report.	Plate No.7	Culvert in good condition. Sediment is accumulating on sides of culvert entrance. The flap gate looks in good condition. Vegetation was observed in front of culvert opening on landside of the levee.	N/A (no remarks provided in 2017)
	G	CREM_2017_a_0005_2 (~Sta. 312+50)	Three 36-inch HDPE Culverts (Left Bank)	A	The culvert is in good condition and provide tidal exchange between the channel and the wetland. The outlet is clear of sediment/debris that would impact flow	Plate No.8	Culverts were observed to be in good condition and free of sediment/debris. Only one of the three culverts is currently active. Two exterior culverts are capped. Rip rap surrounds pipe entrance.	No significant change since 2017.
	H	CREM_2017_a_0004 (~Sta. 302+00)	Three 60-inch CMP Culverts (Right Bank)	M	Three 60-inch CMP culverts are 30 to 50% infilled; unchanged from 2013. The culverts are in good condition and provide tidal exchange between the channel and the wetland.	Plate No.9	Two exterior culverts significantly infilled (~50%). Middle culvert 10-25% infilled.	No significant change since 2017.

36-inch HDPE Culvert with Flap Gate – (Left Bank - Appx CMC Station 308+00)

A3GEO Inspection Point F

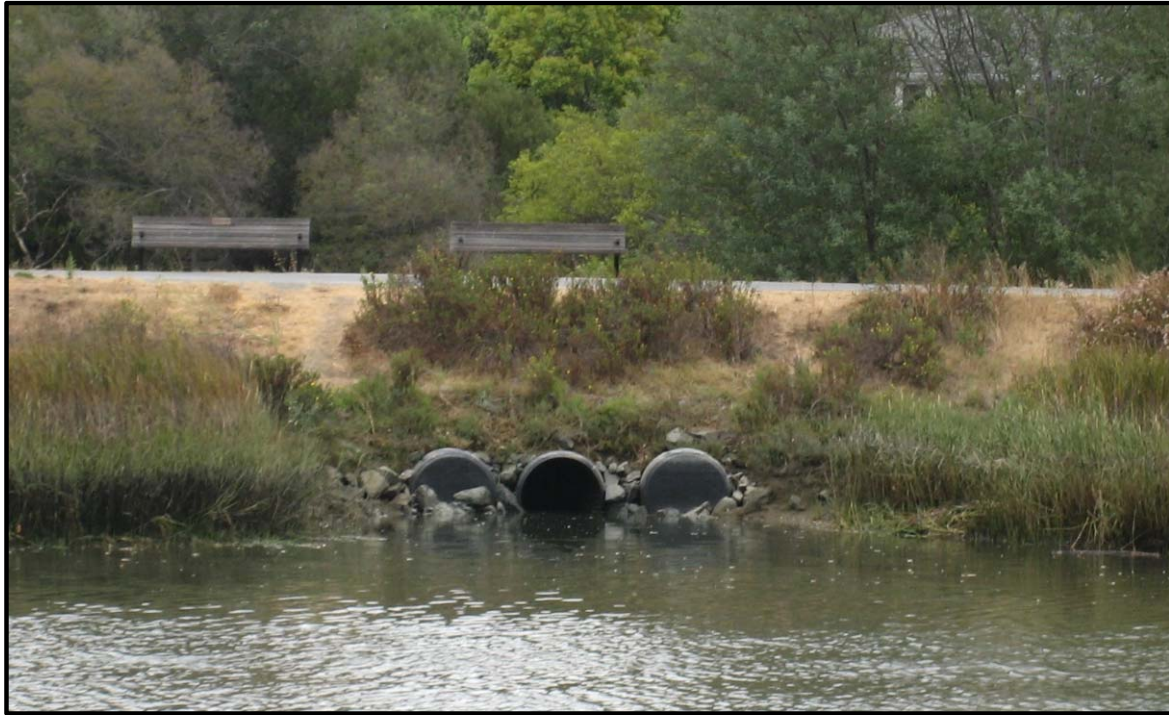
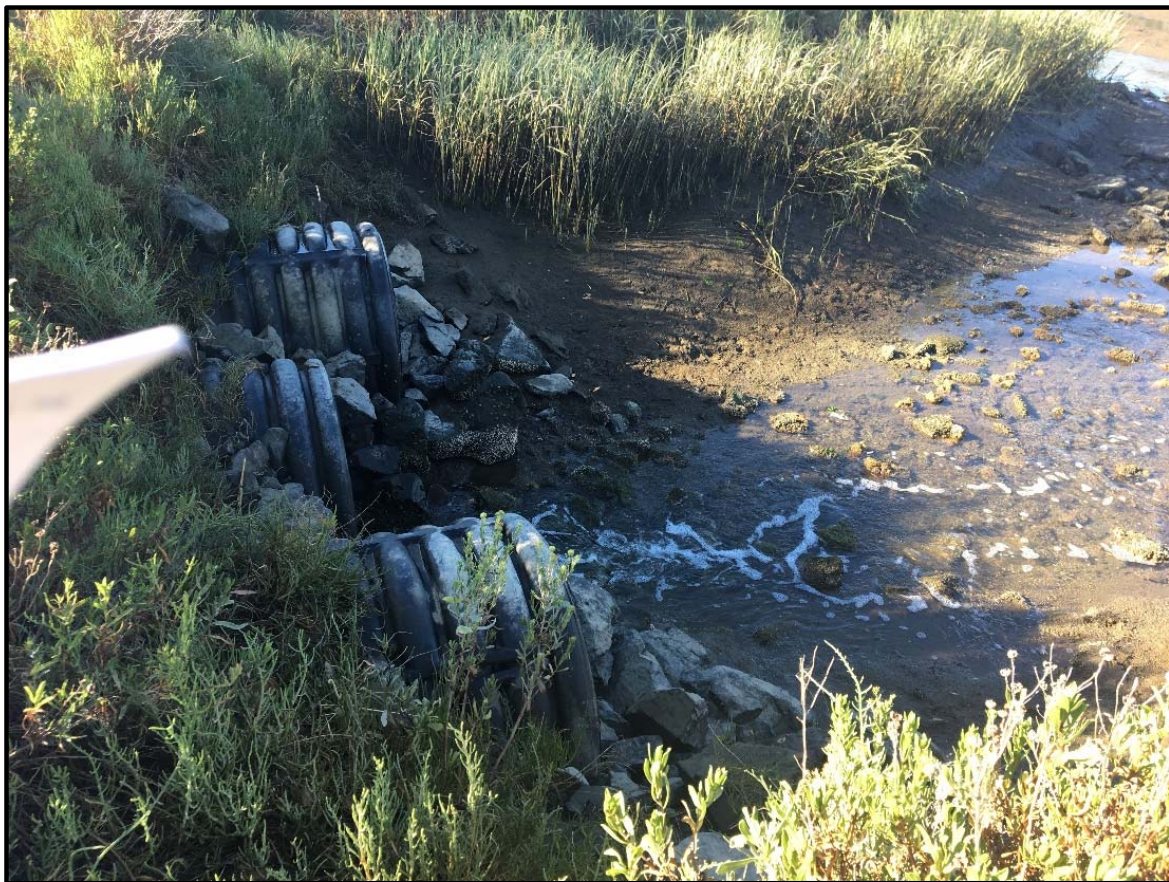
Plate No. 8

36-inch HDPE Culverts – (Left Bank - Appx CMC Station 312+50)
A3GEO Inspection Point G

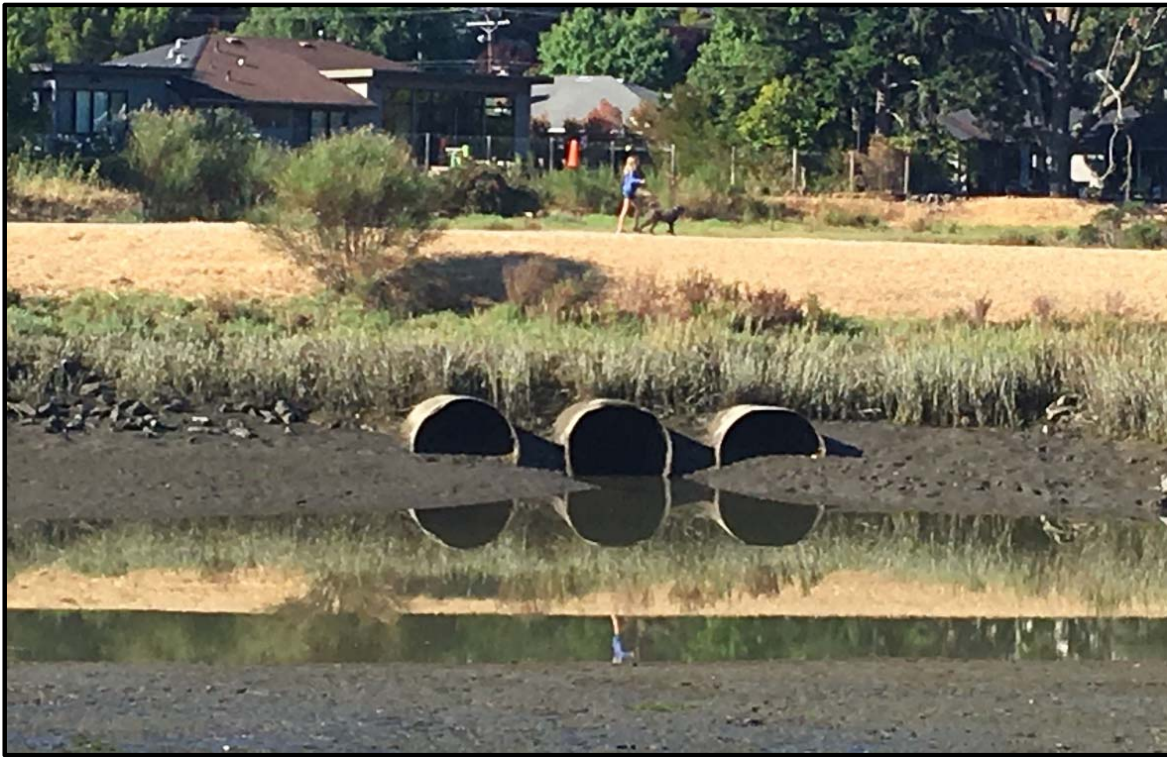
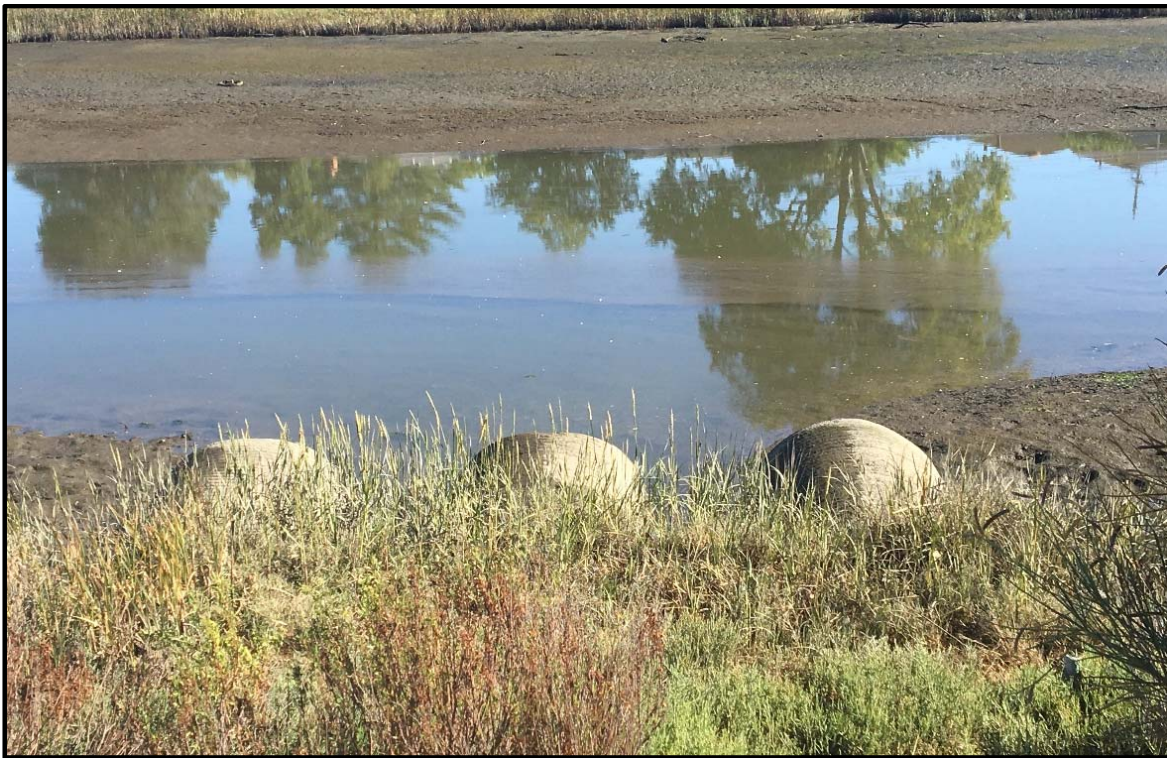
Plate No. 9

60-inch CMP Culverts (Right Bank - Appx CMC Station 302+00)

A3GEO Inspection Point H
