**GEOTECHNICAL DATA REPORT
LAS GALLINAS LEVEE SYSTEM
SAN RAFAEL, CALIFORNIA**

July 3, 2013

**SUBJECT: Geotechnical Data Report
Las Gallinas Levee System
San Rafael, California**

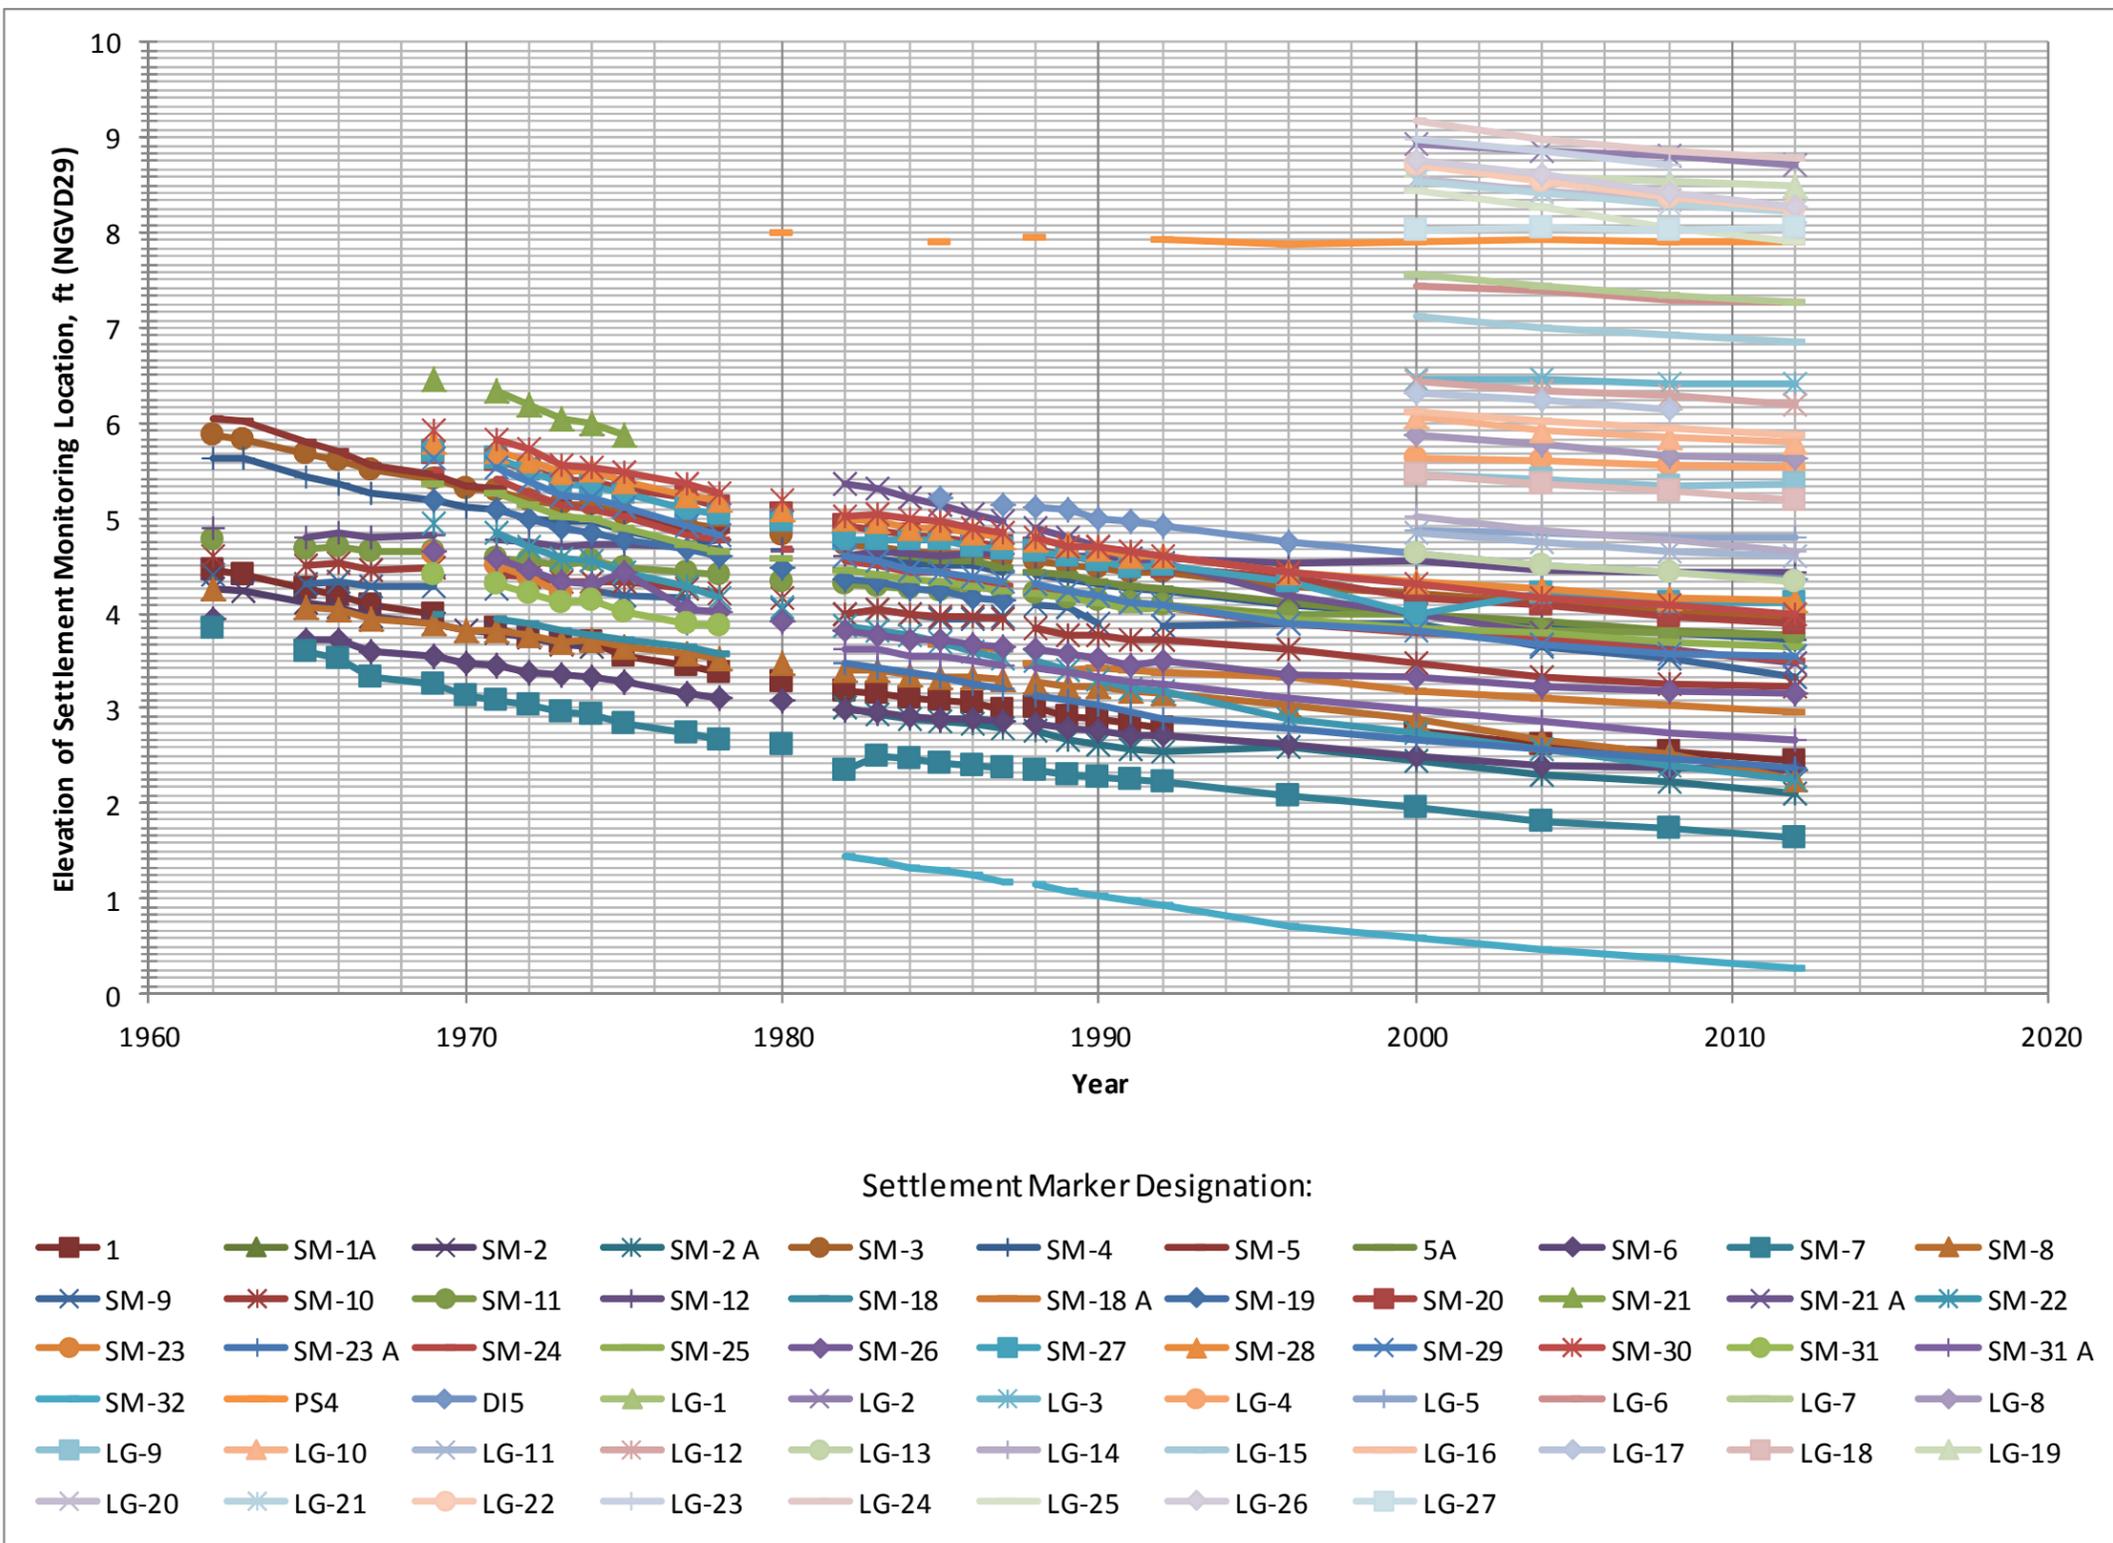
**SETTLEMENT MONITORING DATA
1962 TO 2012**

Based on the results of our subsurface investigation, which are detailed in Section 6, the levee lies on a foundation consisting of marsh deposits and a thick sequence (up to approximately 65 feet in depth) of soft, compressible bay sediments (locally referred to as Bay Mud), which has consolidated significantly since the levee's construction. The District, which maintains the levee, has monitored settlement points within the development periodically since 1962. Settlement data collected by the District is shown on Plate 3. The results of the monitoring indicate that cumulative settlement of approximately two feet has occurred in some areas. The average rate of settlement in the 1960's and 1970's was approximately six inches every ten years. A slight decrease is evident in the settlement rate over time; the average rate of settlement from the period 1990 to 2012 is approximately three to five inches every ten years.

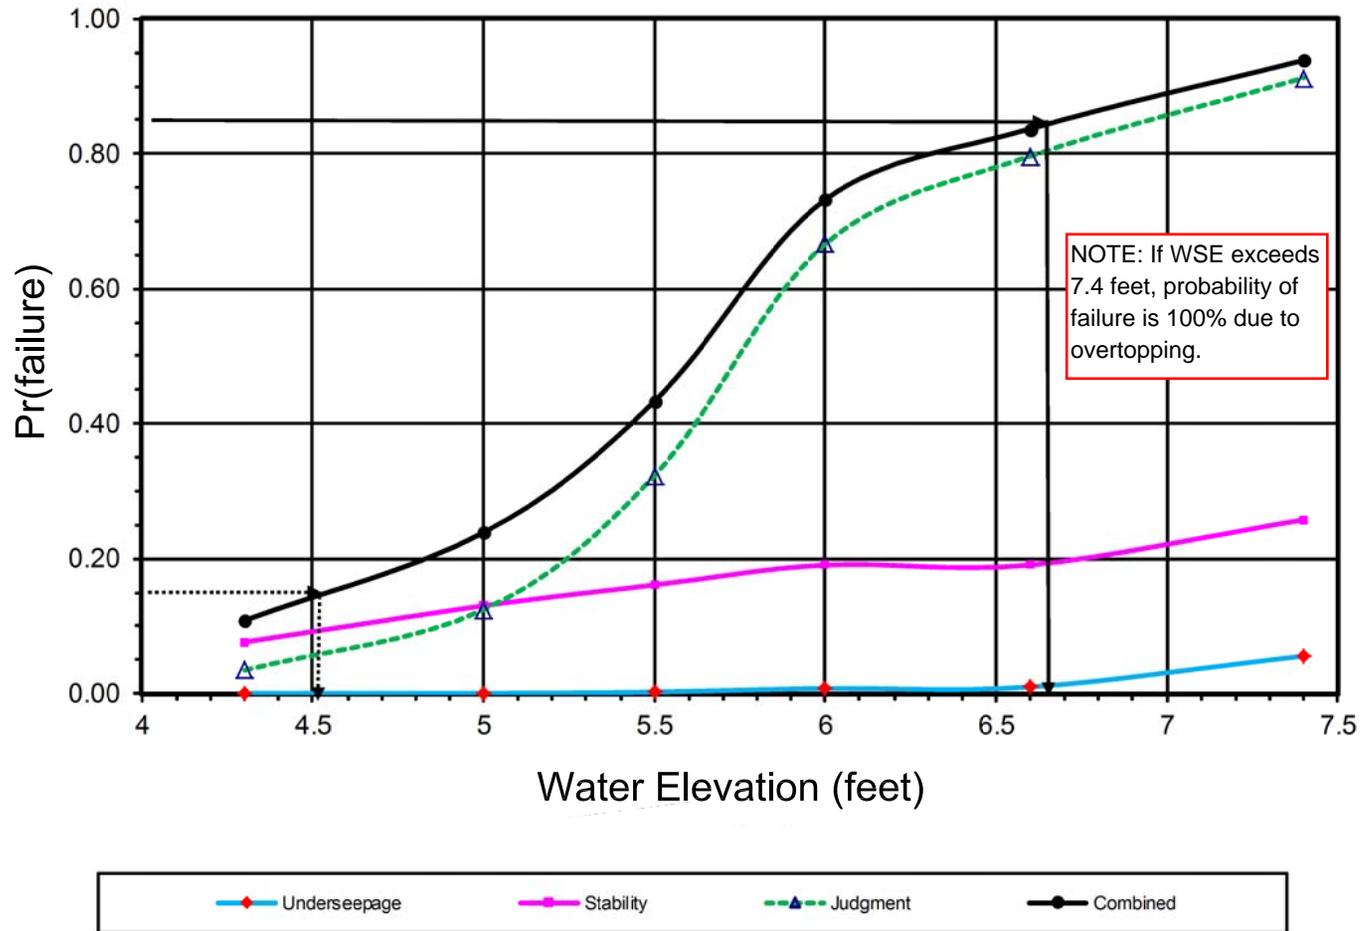
Combined Probability of Failure Existing Conditions

The total conditional probability of failure as a function of WSE has been developed by combining the probability of failure for three main failure modes; seepage, slope stability, and judgment. The reliability is the probability of no failure due to each mode considered in the calculations. The total probabilities of failure computed for the index point (i.e. cross section) are indicated in Plate 14.

The transition between the 15 percent probability of failure (PNP), marked with a dashed line on the graphs and the 85 percent probability of failure (PFP), marked with a solid black line, occurs over a change in water elevation of approximately two feet (from WSE 4.5 ft. to WSE 6.65 ft.). The primary drivers for the steepness of the combined fragility curve are the judgment factors. Appendix E provides a more detailed summary of the combined probabilities of the seepage, stability, and judgment conditional assessments for the various WSEs.

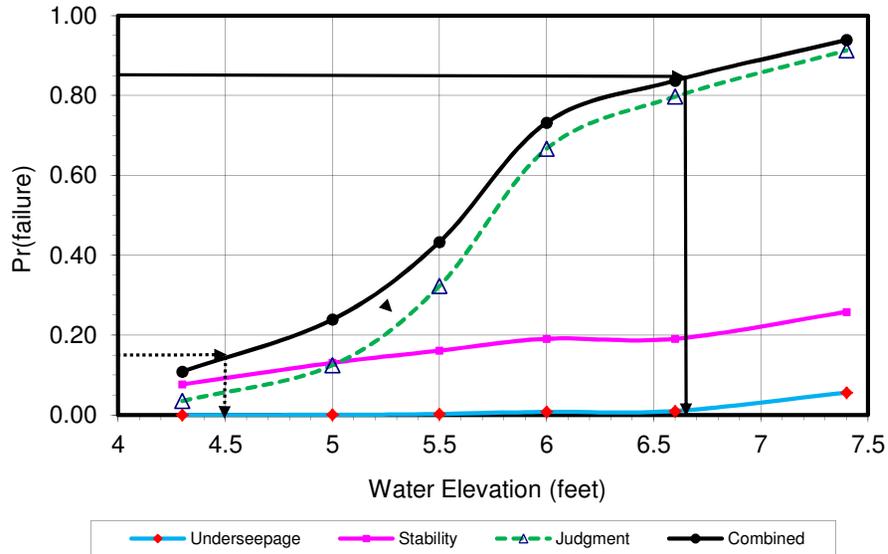
Combined Probability of Failure Existing Conditions

Levee Waterside Toe Elev. 4.3 feet
 Levee Crest Elev. 7.4 feet
 15% Probability of Failure 4.5 feet
 85% Probability of failure 6.65 feet

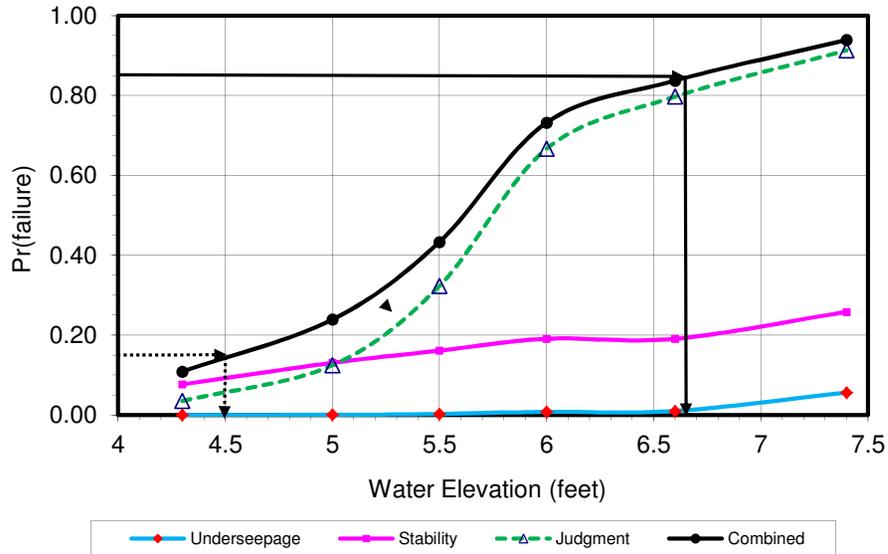
Combined Probability of Failure Existing Conditions

Levee Waterside Toe Elev. 4.3 feet
 Levee Crest Elev. 7.4 feet
 15% Probability of Failure 4.5 feet
 85% Probability of failure 6.65 feet
