**Geotechnical Evaluation of Phoenix Lake**

**PRELIMINARY GEOTECHNICAL EVALUATION  
DB5 – PHOENIX LAKE DAM & RESERVOIR  
WATERSHED FLOOD DAMAGE REDUCTION &  
CREEK MANAGEMENT STUDY  
MARIN COUNTY, CALIFORNIA**

May 6, 2010

Project 960.05

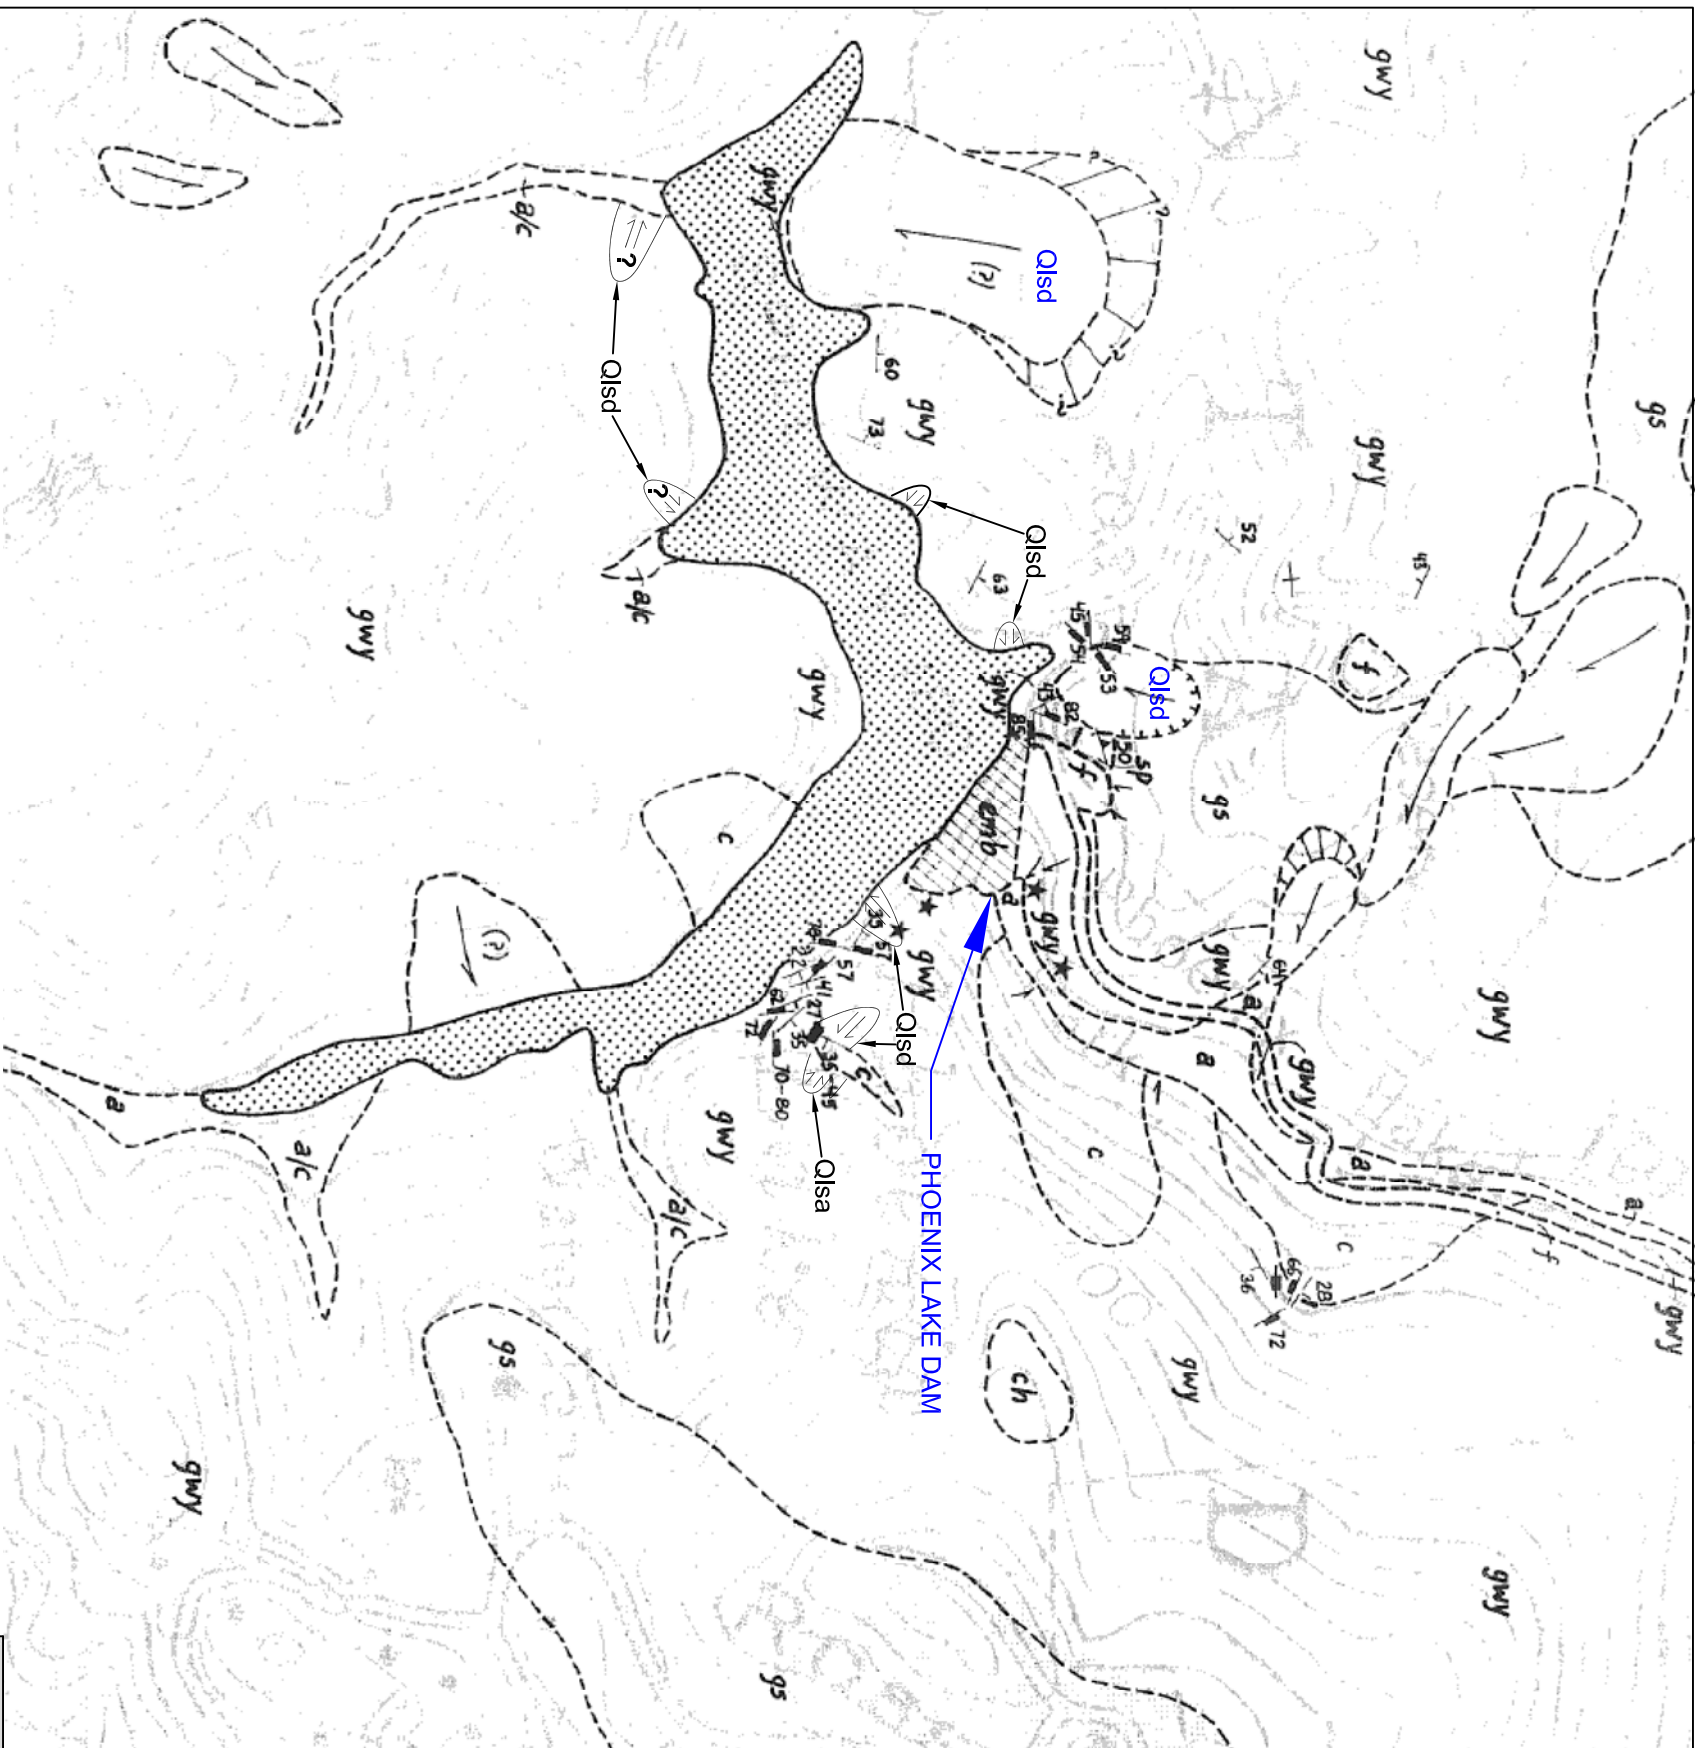
<b>Miller Pacific</b> ENGINEERING GROUP		504 Redwood Blvd. Suite 220 Novato, CA 94947 T 415 / 382,3444 F 415 / 382,3450 www.millerpac.com	
<b>Stetson - MC Flood Protection</b> Phoenix Lake Dam Marin County, California		Project No. 960.05 Date: 2/23/10	
Drawn: JTO Checked:		FIGURE 2

We performed a site inspection on February 17, 2010 to observe existing conditions and identify any significant visual threats that could preclude use of Phoenix Lake as a flood-control detention basin. Our geologic and geotechnical site reconnaissance is summarized below with our observations noted on the attached Figure 2, Geologic Map.

Two larger landslides were noted during our reconnaissance. Both are on the north shore of the lake, and have been mapped previously by Rice (1976). The main rim trail has been graded across both slides. One slide toes into the lake near its western end, while the other toes into a tributary which discharges at the north end of the dam. Both landslides deposited soil and rock debris into the reservoir which has likely reduced the storage capacity.

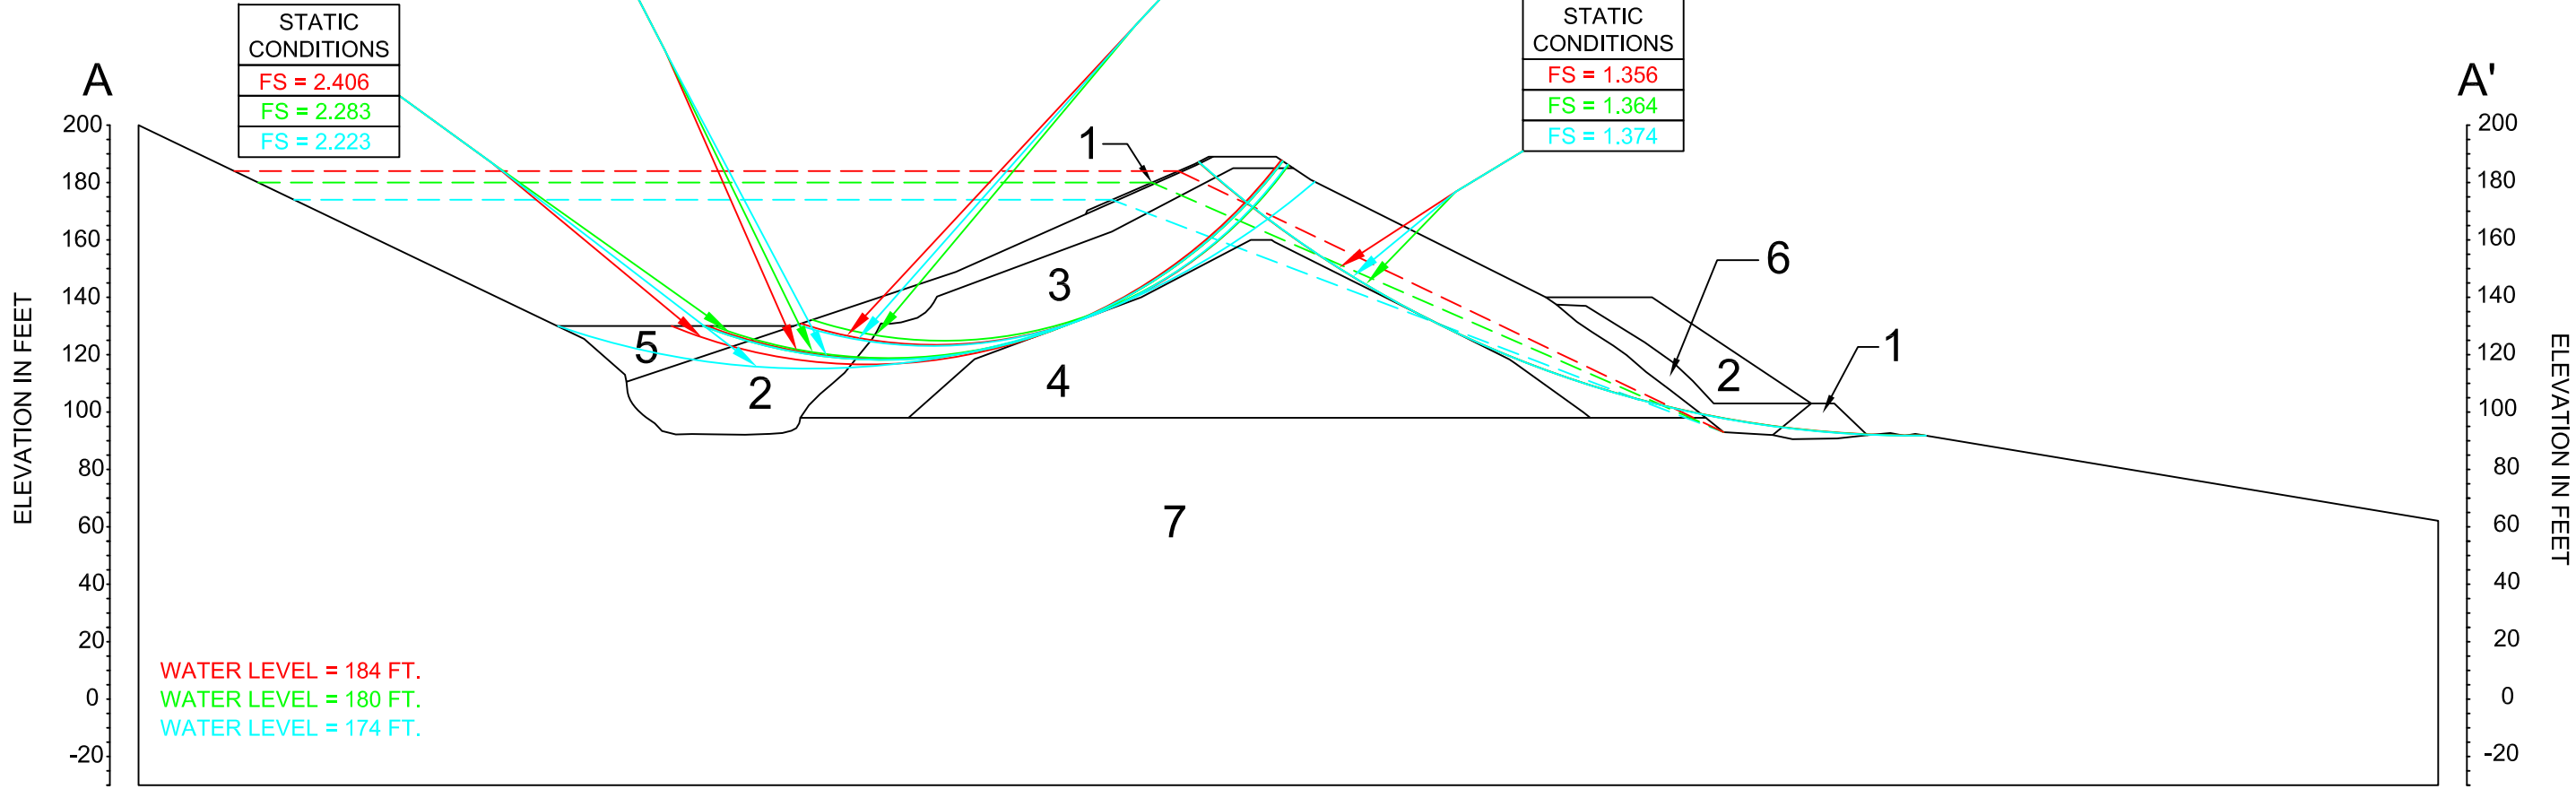
PHOENIX LAKE DAM  
STATIC CONDITIONS

We performed slope stability analyses for static, pseudo-static, and rapid draw down conditions using Spencer's Method with the computer program Slide version 5.043, produced by RocScience. We evaluated an idealized cross section that corresponded to the differing geometries of Phoenix Dam. Strength parameters for the materials were determined from a compilation of all available data, as shown on Figure 7.

RAPID DRAWDOWN TO EMPTY RESERVOIR		
INITIAL WATER LEVEL	FINAL WATER LEVEL	FACTOR OF SAFETY
184 FT.	130 FT.	1.376
180 FT.	130 FT.	1.384
174 FT.	130 FT.	1.398

RAPID DRAWDOWN TO HALF RESERVOIR		
INITIAL WATER LEVEL	FINAL WATER LEVEL	FACTOR OF SAFETY
184 FT.	157 FT.	1.592
180 FT.	155 FT.	1.576
174 FT.	152 FT.	1.551

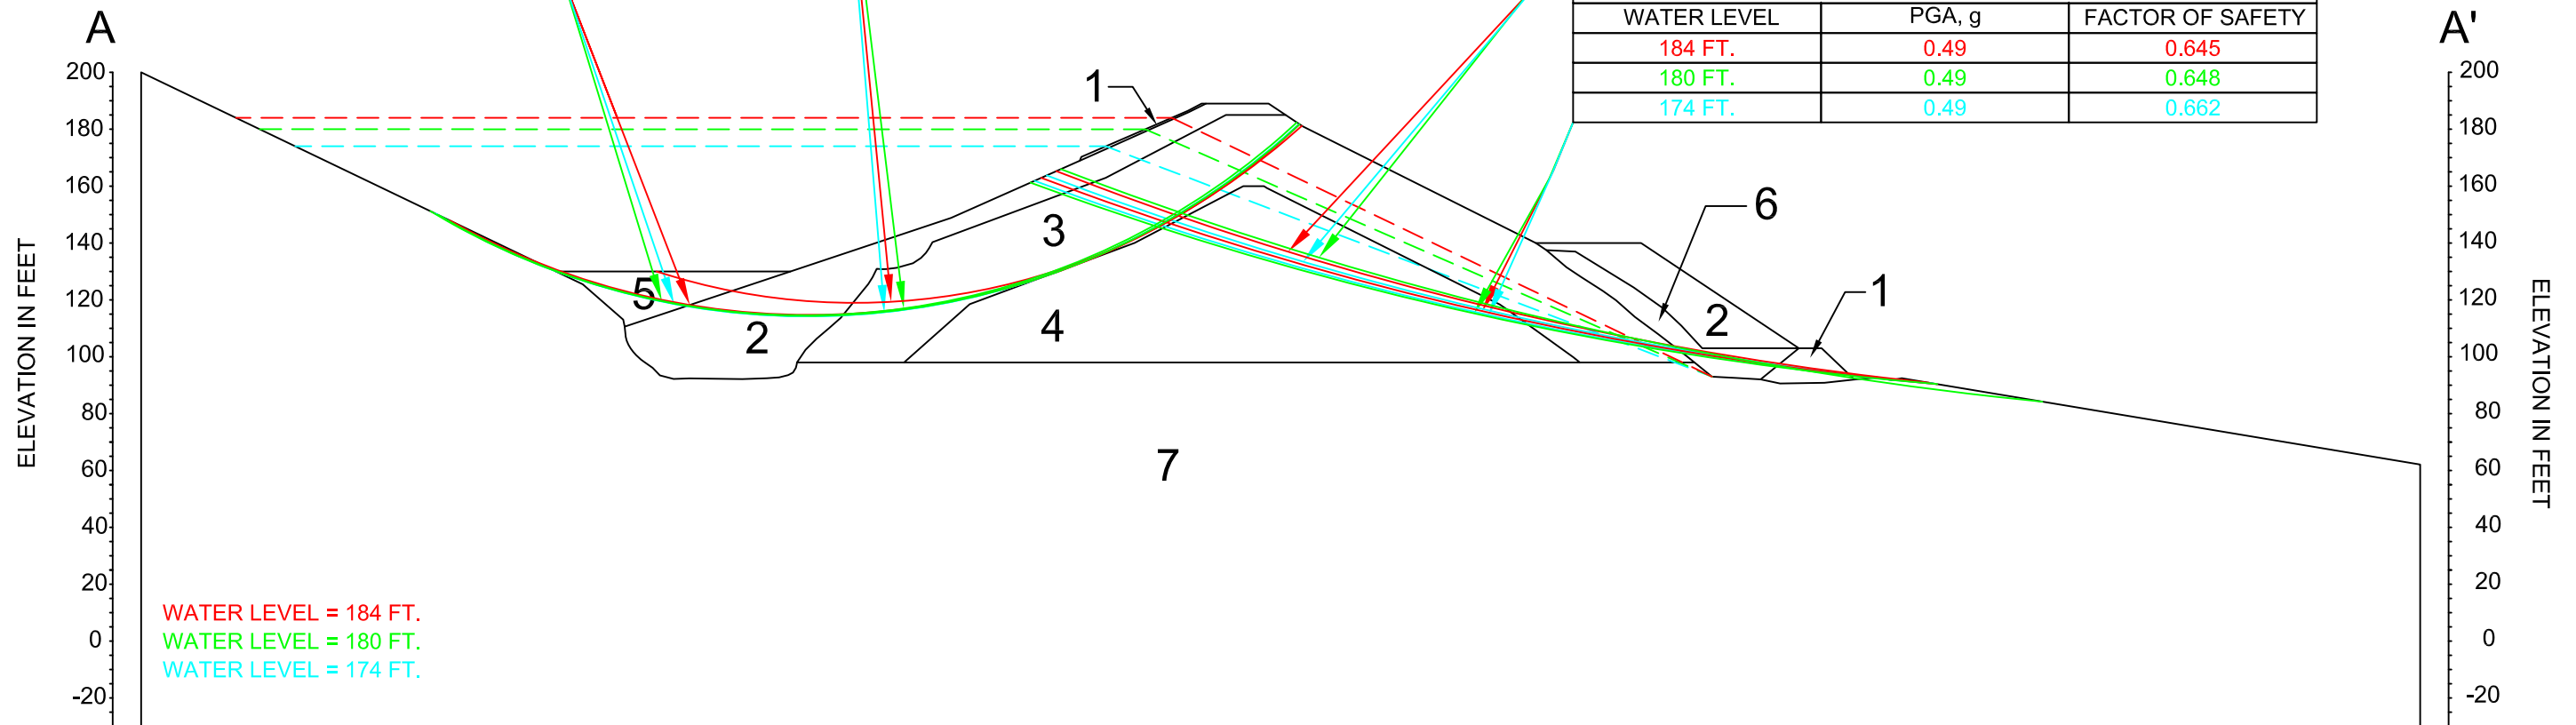
PHOENIX LAKE DAM  
SEISMIC CONDITIONS  
PROBABILISTIC ANALYSIS

Due to factors of safety below 1.0 under seismic conditions, the slopes of Phoenix Lake Dam will likely deform during the strong seismic shaking. The previous 1978 deformation analyses by Earth Science estimated 11 feet of elastic deformation along the slip plane which results in 5.3 feet of vertical settlement of the crest. We analyzed the potential slope displacement based on the procedures outlined by Bray & Travasarou (2007). The results of our analyses indicate that the anticipated range of displacements along the slip plane between 1 and 35 inches, depending on the seismic acceleration used in the analyses. The calculated potential dam displacements are shown on Table F.

2% PROBABILITY IN 50 YEARS		
WATER LEVEL	PGA, g	FACTOR OF SAFETY
184 FT.	0.78	0.464
180 FT.	0.78	0.468
174 FT.	0.78	0.477

10% PROBABILITY IN 50 YEARS		
WATER LEVEL	PGA, g	FACTOR OF SAFETY
184 FT.	0.49	0.645
180 FT.	0.49	0.648
174 FT.	0.49	0.662

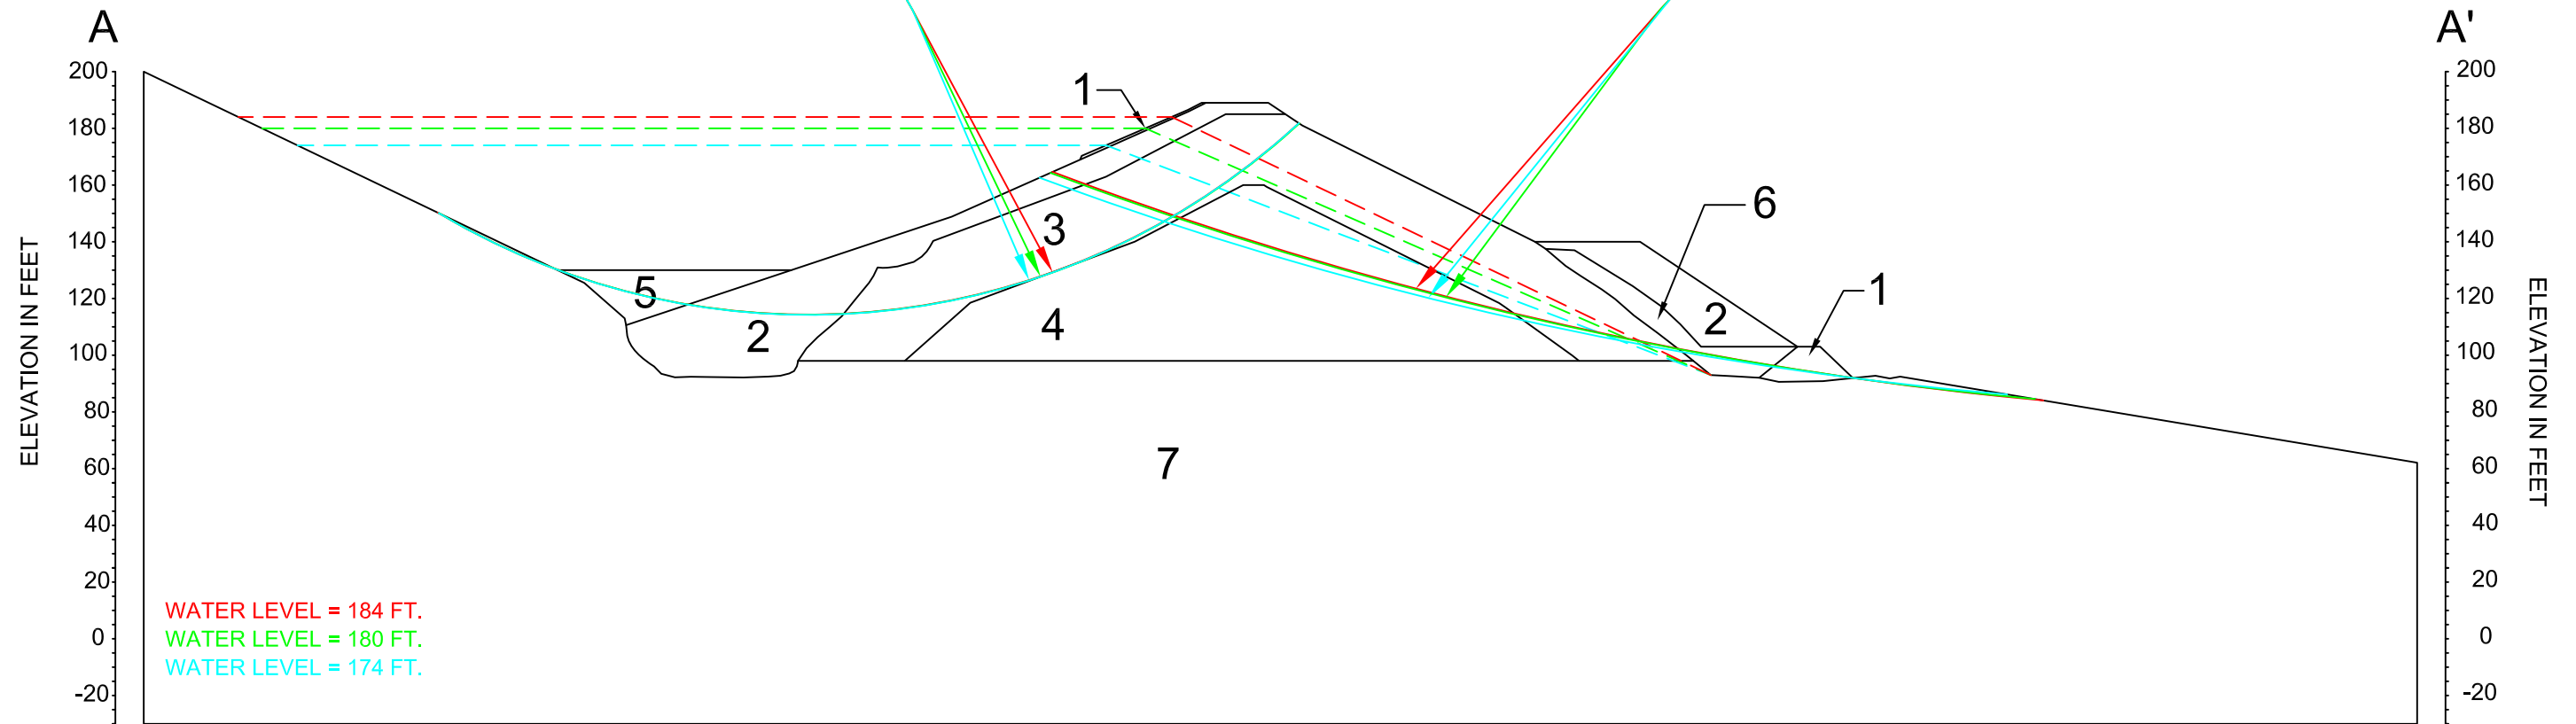
PHOENIX LAKE DAM  
SEISMIC CONDITIONS  
DETERMINISTIC ANALYSIS

DSHA 84th PERCENTILE		
WATER LEVEL	PGA, g	FACTOR OF SAFETY
184 FT.	0.53	0.623
180 FT.	0.53	0.620
174 FT.	0.53	0.621

DSHA 84th PERCENTILE		
WATER LEVEL	PGA, g	FACTOR OF SAFETY
184 FT.	0.53	0.605
180 FT.	0.53	0.611
174 FT.	0.53	0.626
