Appendix B

Site Reconnaissance Photographs

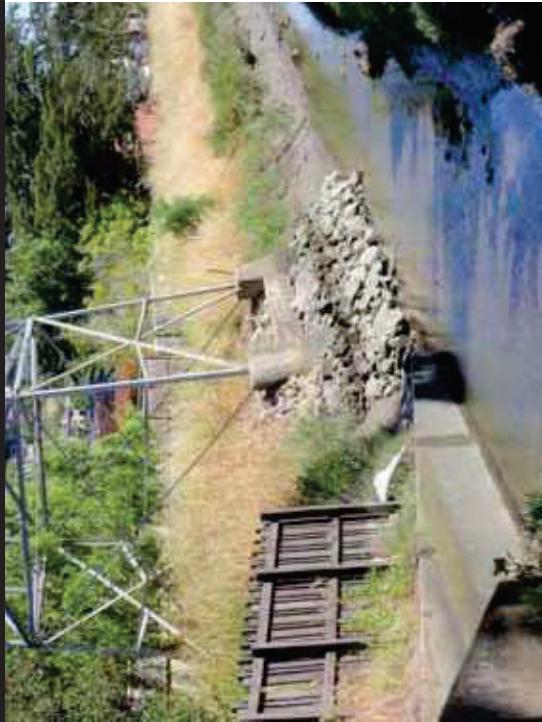
Photo 1

Nyhan Creek Left Bank: Rip Rap around PG&E Tower north of
Crest Marin Pump Station

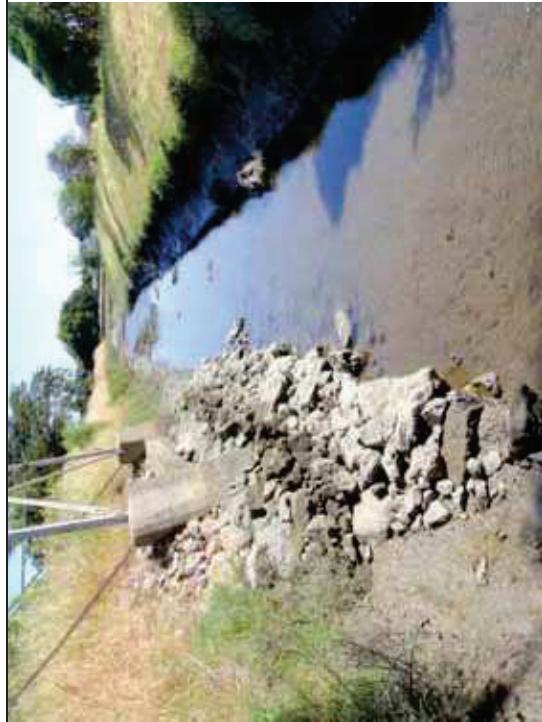
Photo 2

Nyhan Creek Left Bank: Waterside slope of rip rap around PG&E
Tower north of Crest Marin Pump Station

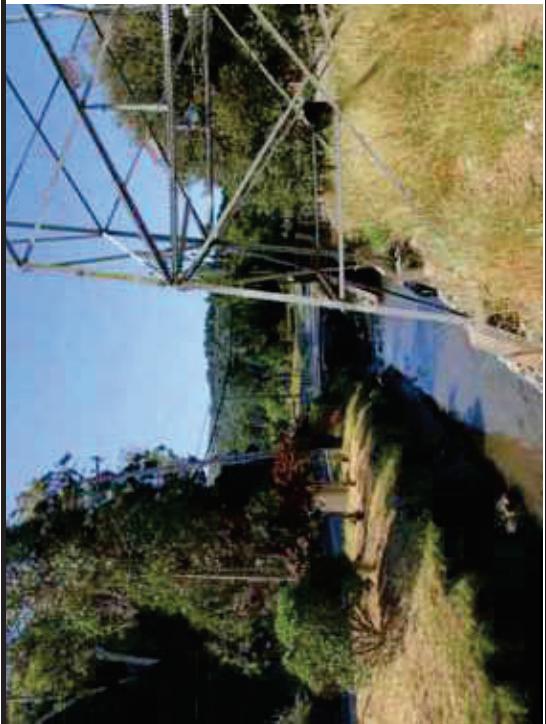
Photo 3

Nyhan Creek Left Bank: Vegetation around Crest Marin Pump
Station looking south

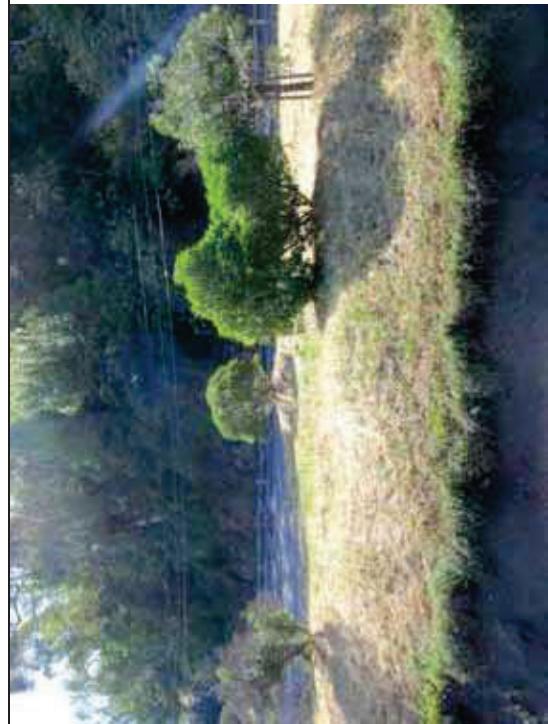
Photo 4

Nyhan Creek Right Bank: Vegetation along bank and high ground
(in background) near Tennessee Valley Rd.

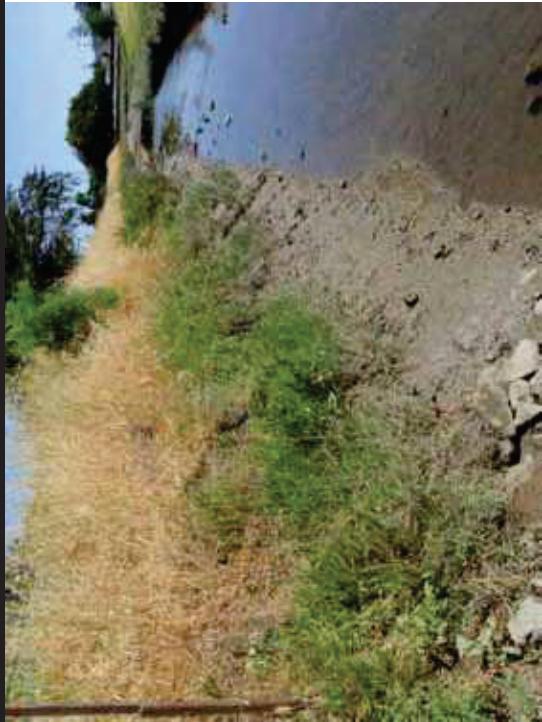
Photo 5

Nyhan Creek Left Bank: Waterside slope of GEI Cross-Section 1 looking downstream located ~100 feet north of Crest Marin Pump Station

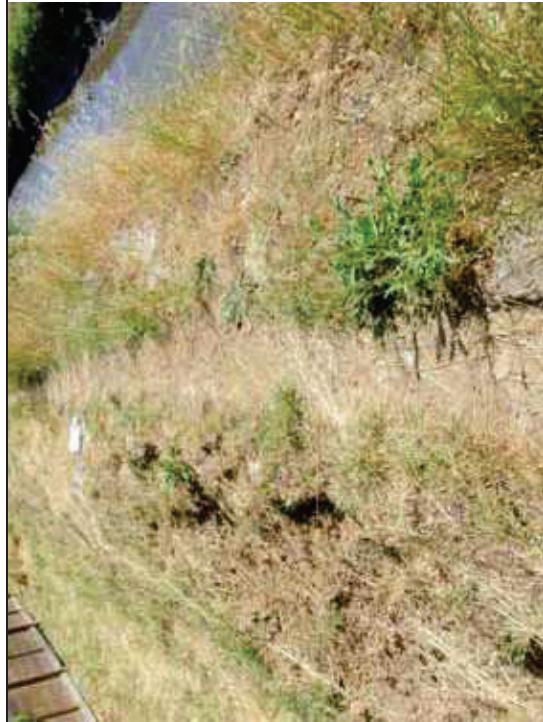
Photo 6

Nyhan Creek Left Bank: Crest of GEI Cross-Section 1 looking downstream located ~100 feet north of Crest Marin Pump Station

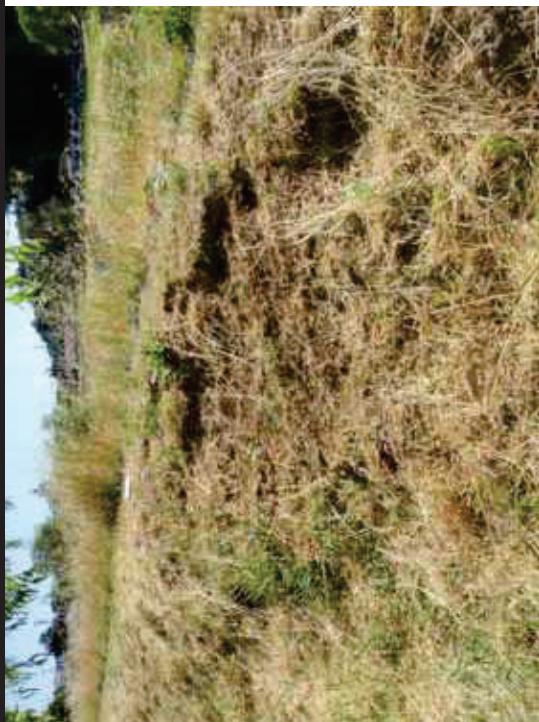
Photo 7

Nyhan Creek Left Bank: Landside slope of GEI Cross-Section 1 looking downstream located ~100 feet north of Crest Marin Pump Station

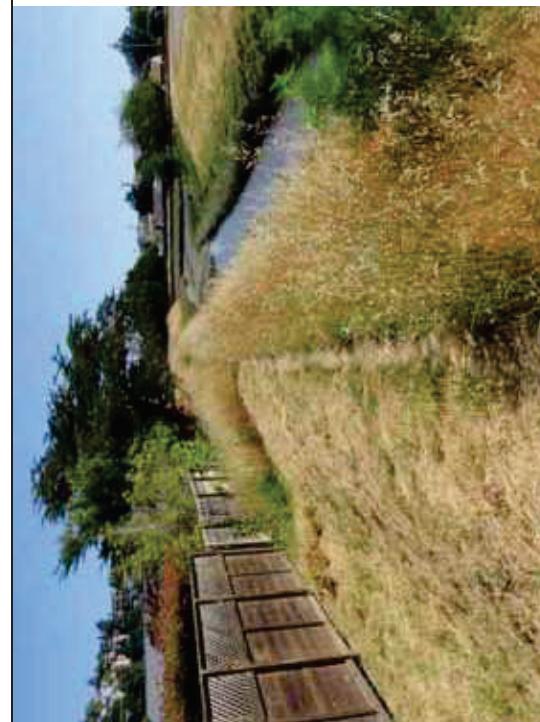
Photo 8

Nyhan Creek Left Bank: Vegetation on crest GEI Cross-Section 1 looking downstream located ~100 feet north of Crest Marin Pump Station

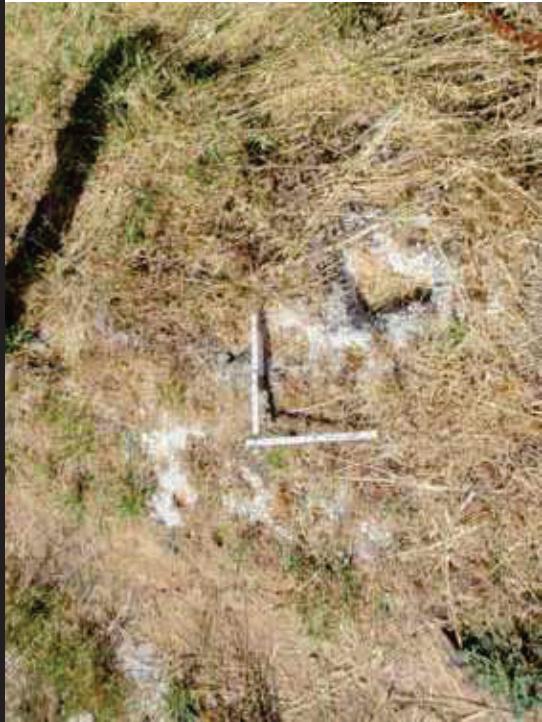
Photo 9

Nyhan Creek Left Bank: Typical rodent burrow abatement

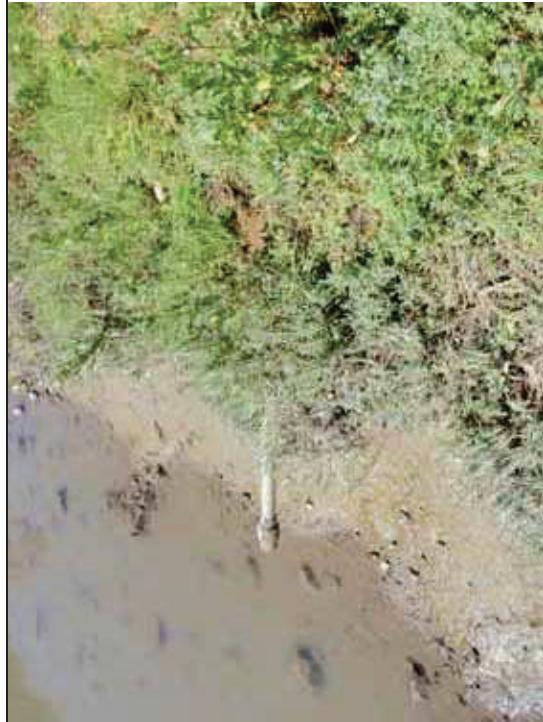
Photo 10

Nyhan Creek Left Bank: End of 2-inch PVC pipe on the waterside
~80 feet north of GEI Cross-Section 1

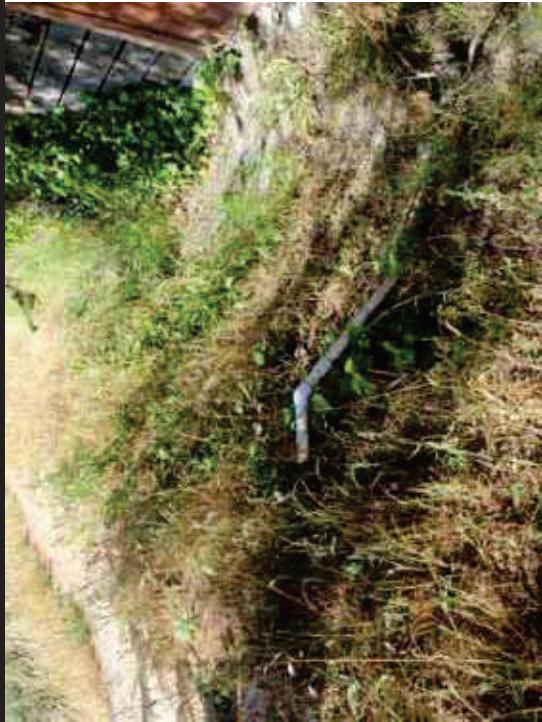
Photo 11

Nyhan Creek Left Bank: 2-inch PVC pipe on the landside ~80 feet north of GEI Cross-Section 1

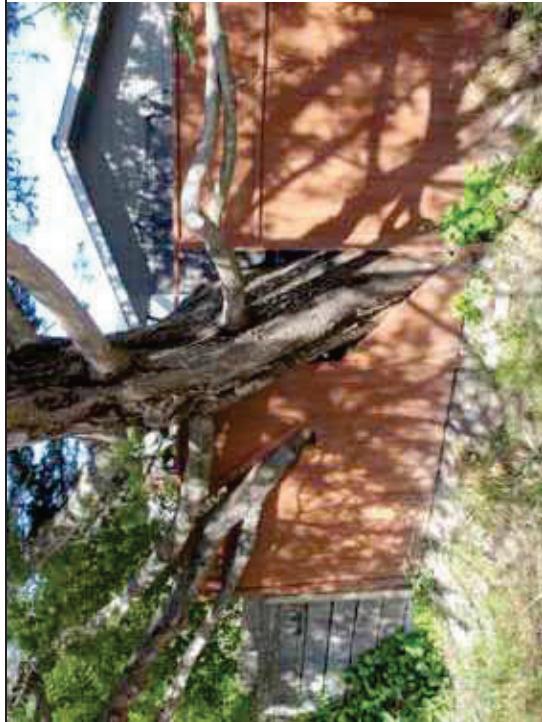
Photo 12

Nyhan Creek Left Bank: ~36-inch diameter tree within 15 feet of the levee toe landside ~80 feet north of GEI Cross-Section 1

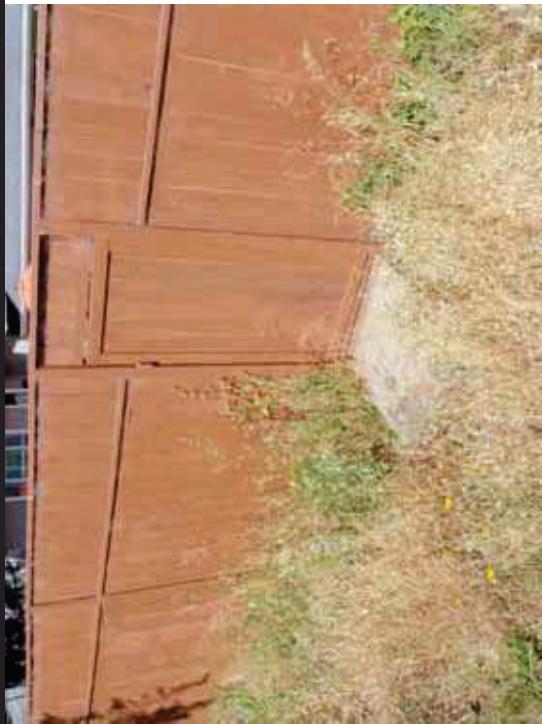
Photo 13

Nyhan Creek Left Bank: Small wooden walkway from fence to levee toe landside ~100 feet north of GEI Cross-Section 1

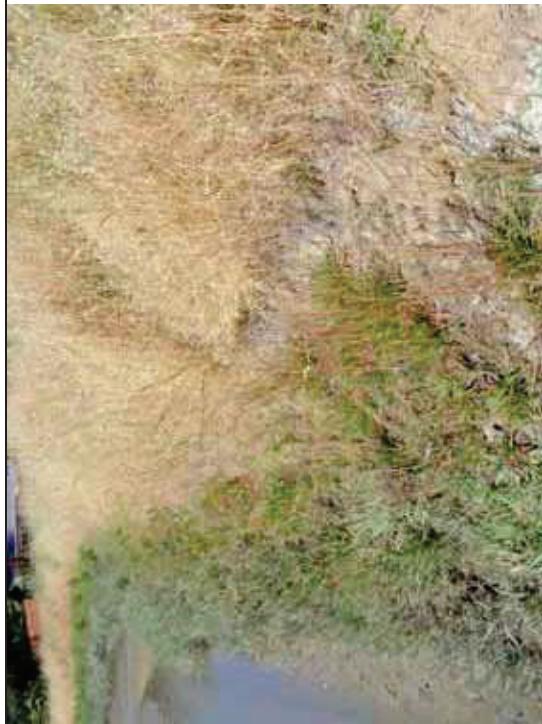
Photo 14

Nyhan Creek Left Bank: Waterside slope of GEI Cross-Section 2 looking upstream located ~300 feet north of Crest Marin Pump Station

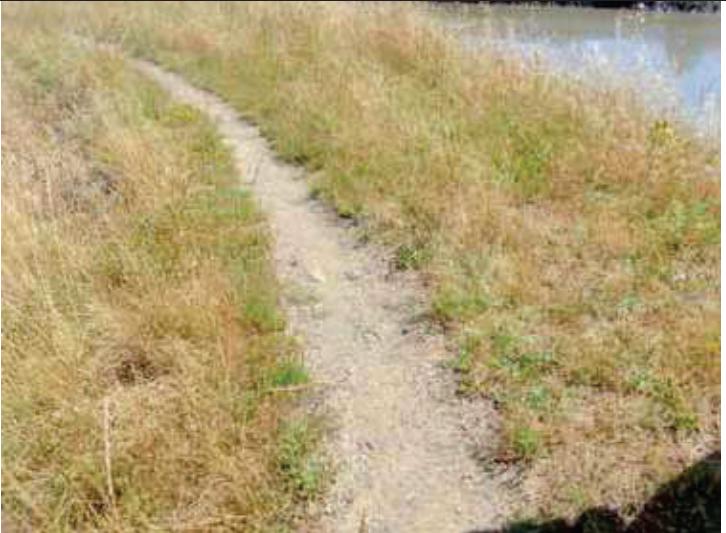
Photo 15

Nyhan Creek Left Bank: Crest of GEI Cross-Section 2 looking downstream located ~300 feet north of Crest Marin Pump Station

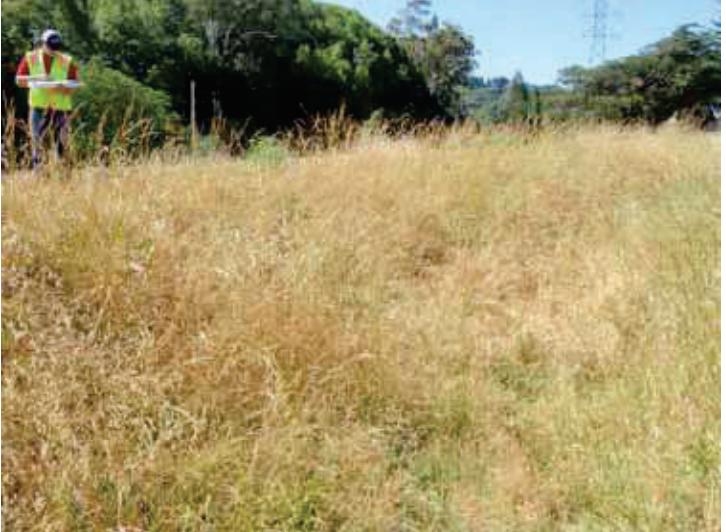
Photo 16

Nyhan Creek Left Bank: Landside slope of GEI Cross-Section 2 looking upstream located ~300 feet north of Crest Marin Pump Station

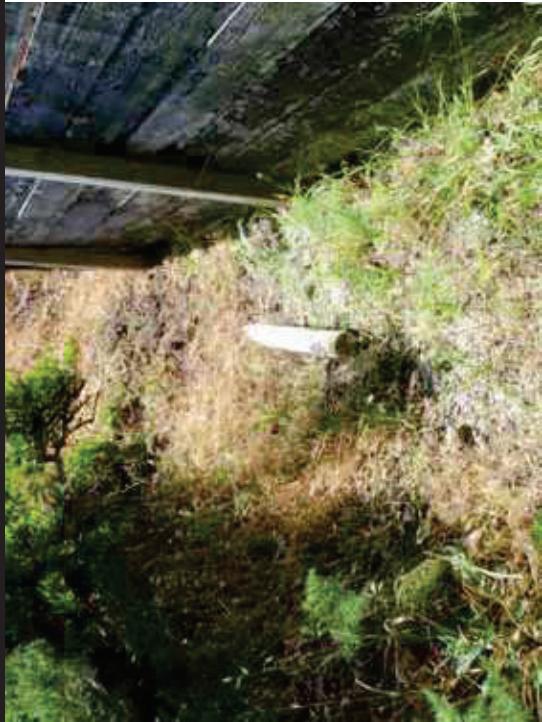
Photo 17

Coyote Creek Right Bank (~Sta 43+00): 4-inch PVC pipe at the landside levee toe

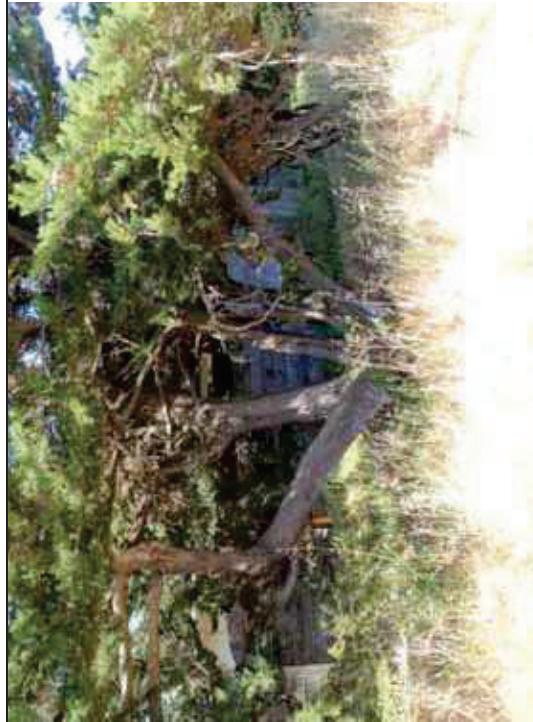
Photo 18

Coyote Creek Right Bank (~Sta 43+50): Tree at landside toe of levee

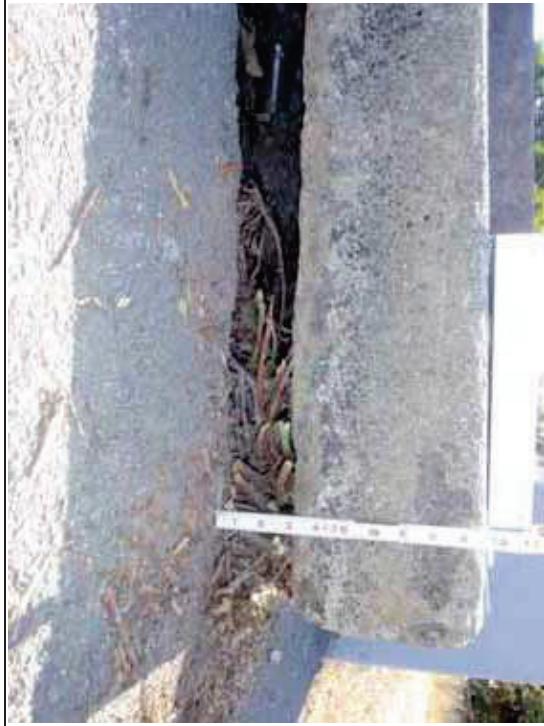
Photo 19

Coyote Creek Right Bank (~Sta 44+10): Settlement at the southeast corner of the Flamingo Road Bridge

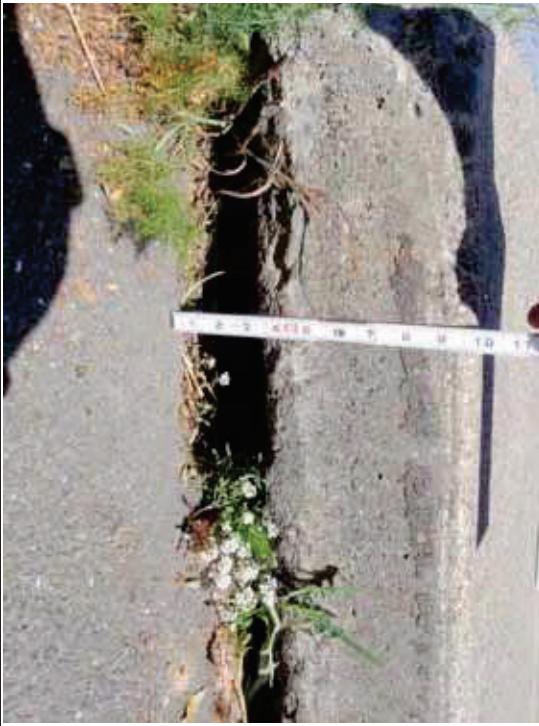
Photo 20

Coyote Creek Right Bank (~Sta 44+50): Settlement at the southwest corner of the Flamingo Road Bridge

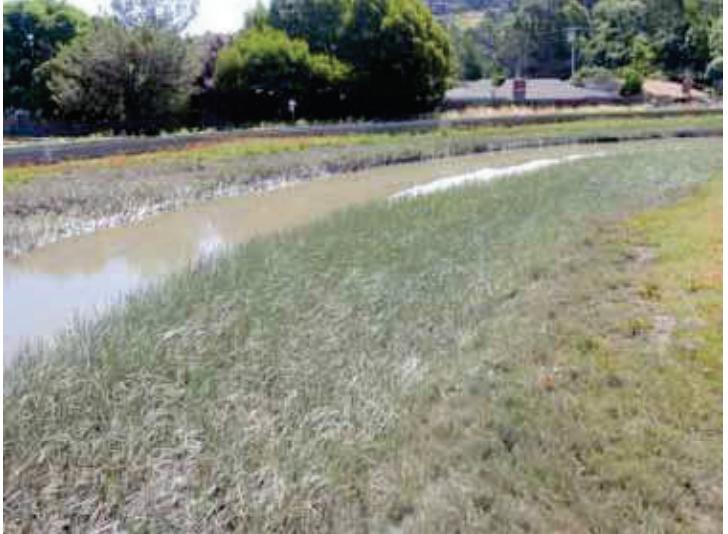
Photo 21

**Coyote Creek Right Bank (~Sta 44+10): Vegetation and shoaling
looking downstream from Flamingo Road Bridge**

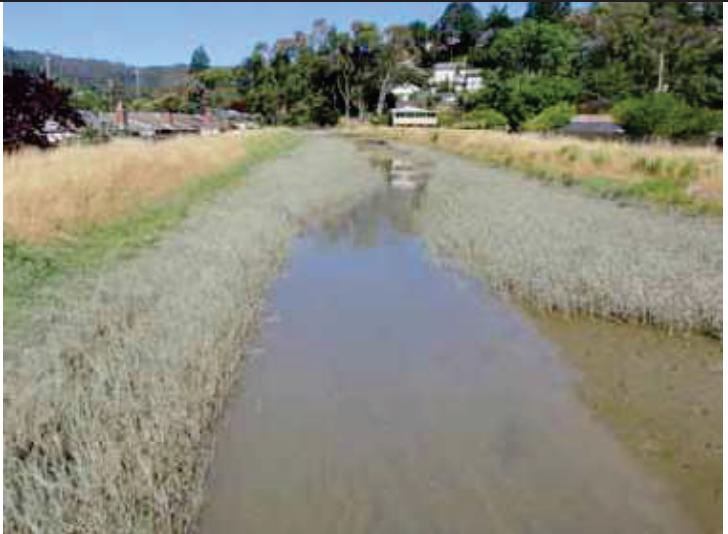
Photo 22

**Coyote Creek Right Bank (~Sta 44+50): Vegetation and shoaling
looking upstream from Flamingo Road Bridge**

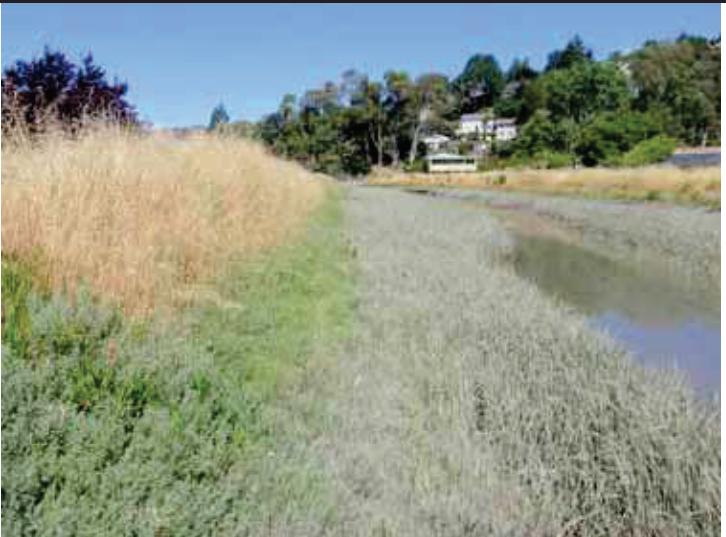
Photo 23

Coyote Creek Right Bank (~Sta 44+65): Waterside slope of levee looking upstream

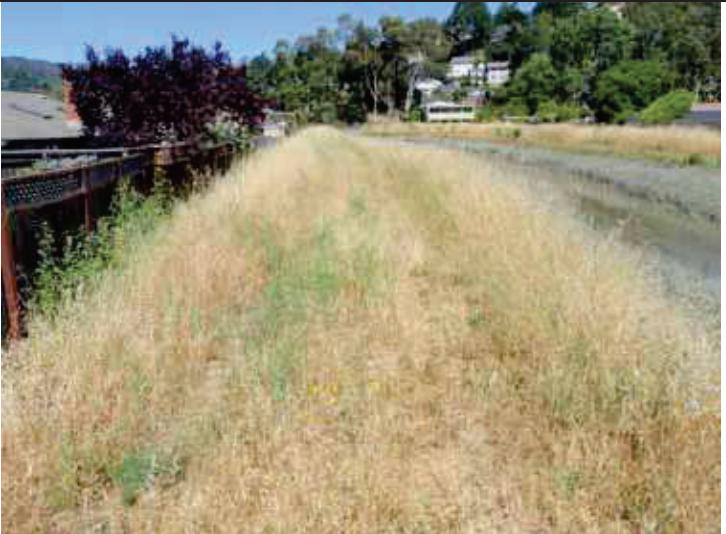
Photo 24

Coyote Creek Right Bank (~Sta 44+65): Crest of levee looking upstream

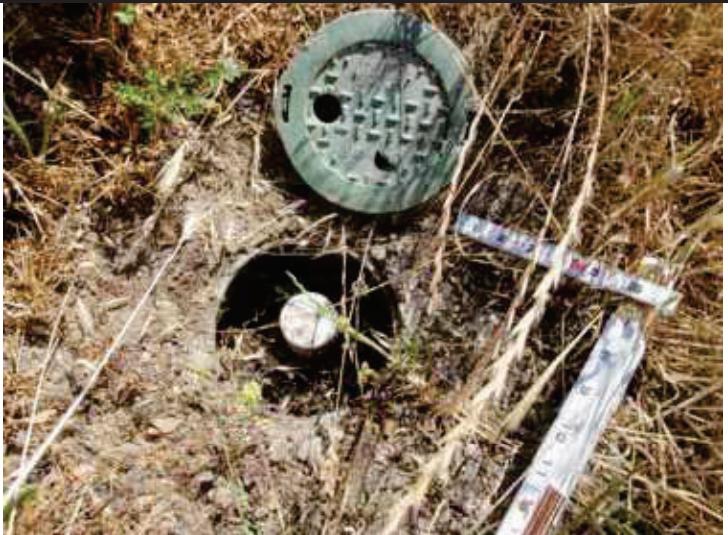
Photo 25

Coyote Creek Right Bank (~Sta 45+75): 1-inch irrigation control valve on the levee crest

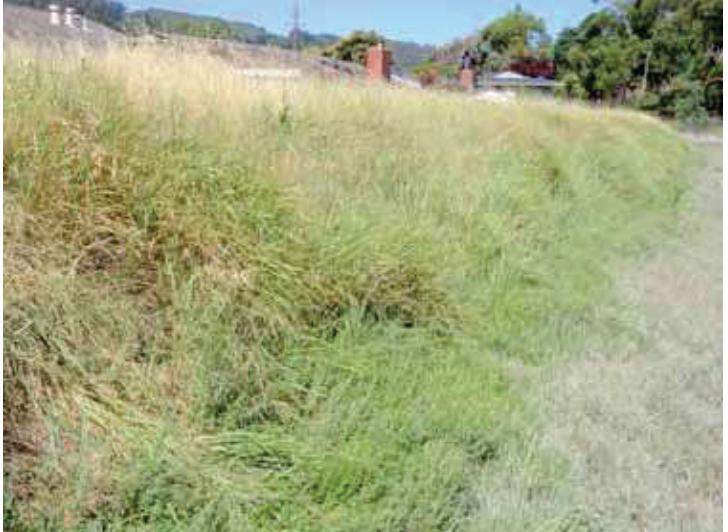
Photo 26

Coyote Creek Right Bank (~Sta 46+40): Waterside slope of GEI Cross-Section 3 looking upstream

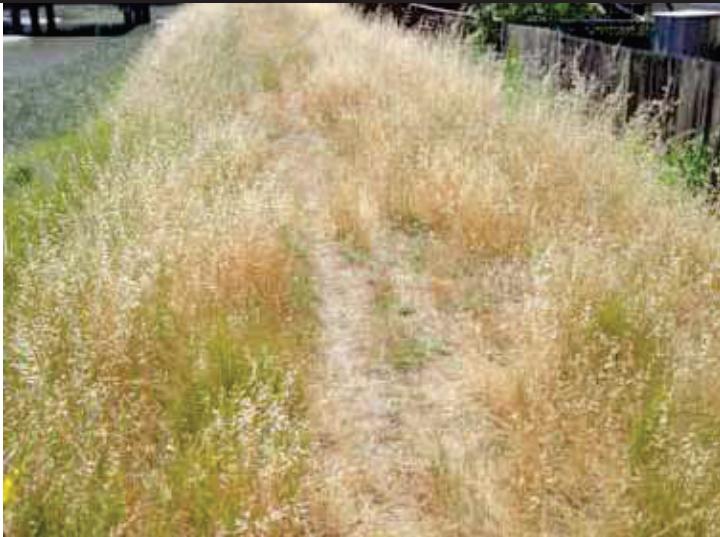
Photo 27

Coyote Creek Right Bank (~Sta 46+40): Crest of GEI Cross-Section 3 looking downstream located

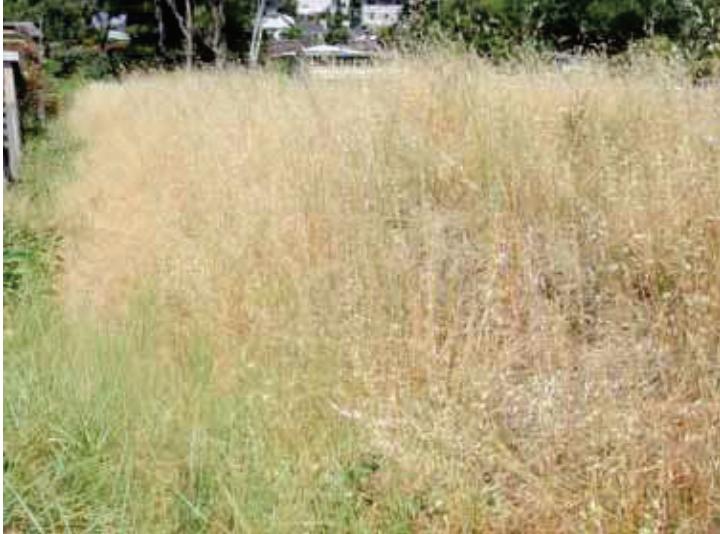
Photo 28

Coyote Creek Right Bank (~Sta 46+40): Landside slope of GEI Cross-Section 3 looking upstream

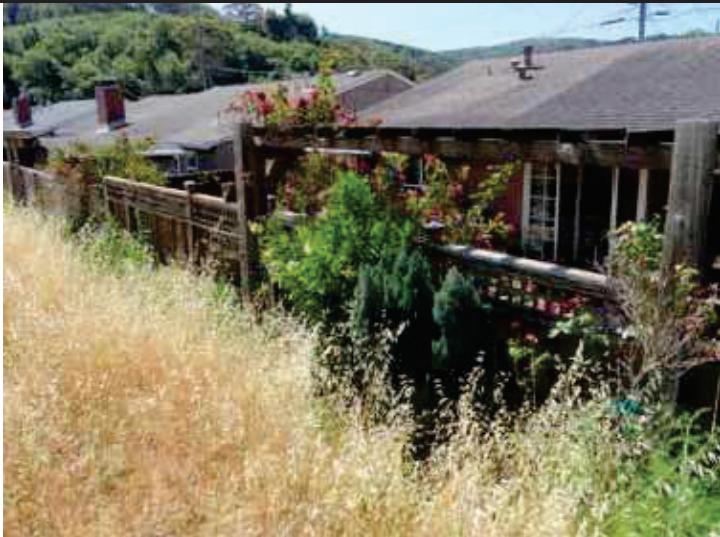
Photo 29

Coyote Creek Right Bank (~Sta 47+25): Plants and trellis at levee toe

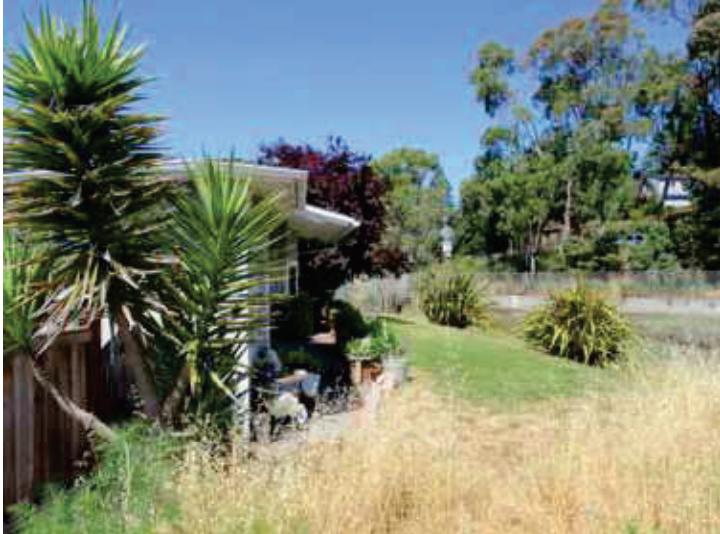
Photo 30

Coyote Creek Right Bank (~Sta 48+75): Plants, trees, and lawn on levee crest

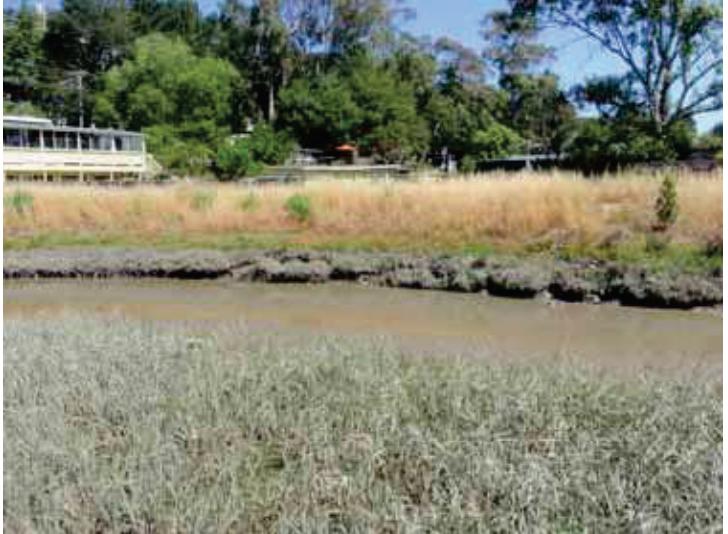
Photo 31

Coyote Creek Left Bank (~Sta 48+40): View of waterside toe erosion at GEI Cross-Section 4 from Coyote Creek Right Bank

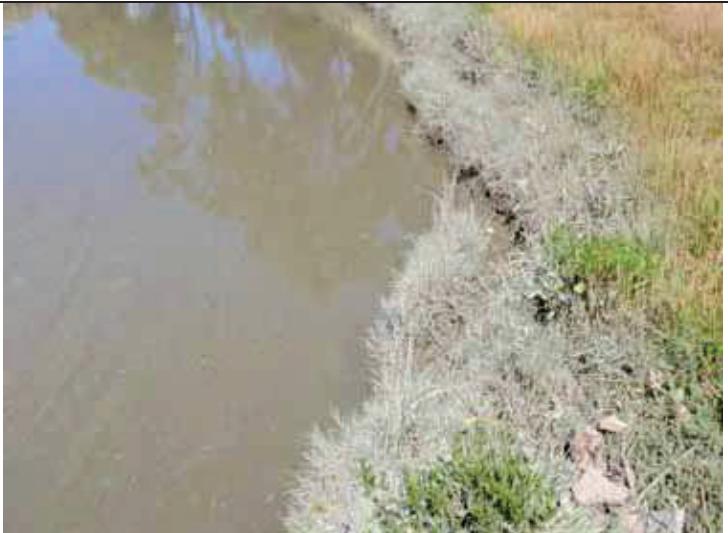
Photo 32

Coyote Creek Left Bank (~Sta 48+40): Waterside toe erosion at GEI Cross-Section 4

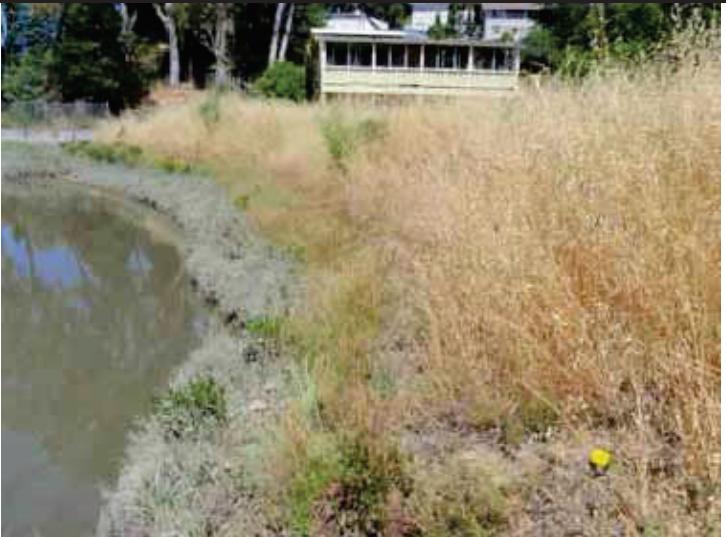
Photo 33

Coyote Creek Left Bank (~Sta 48+40): Waterside slope of GEI Cross-Section 4 looking upstream

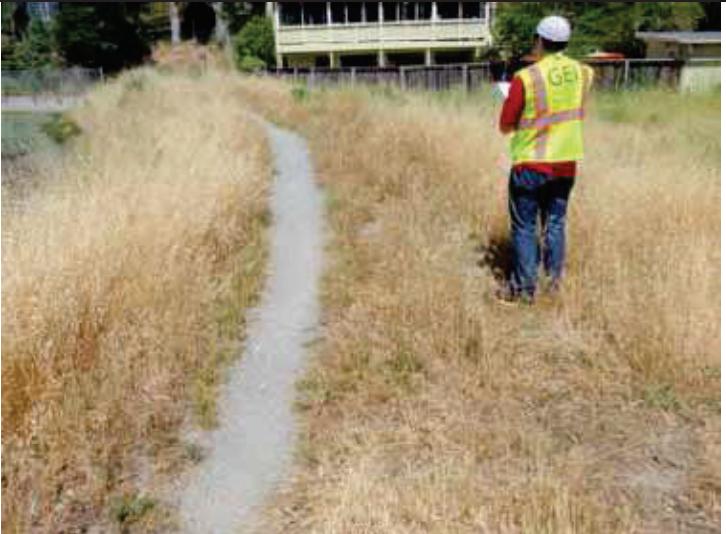
Photo 34

Coyote Creek Left Bank (~Sta 48+40): Crest of GEI Cross-Section 4 looking upstream

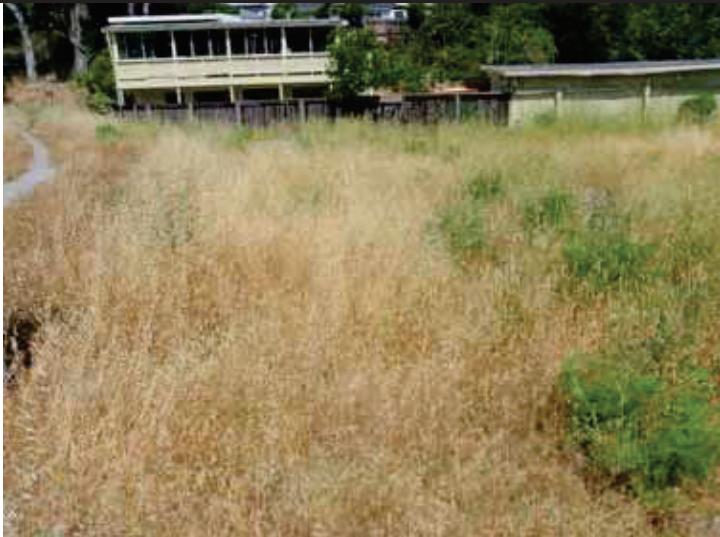
Photo 35

Coyote Creek Left Bank (~Sta 48+40): Landside slope of GEI Cross-Section 4 looking upstream

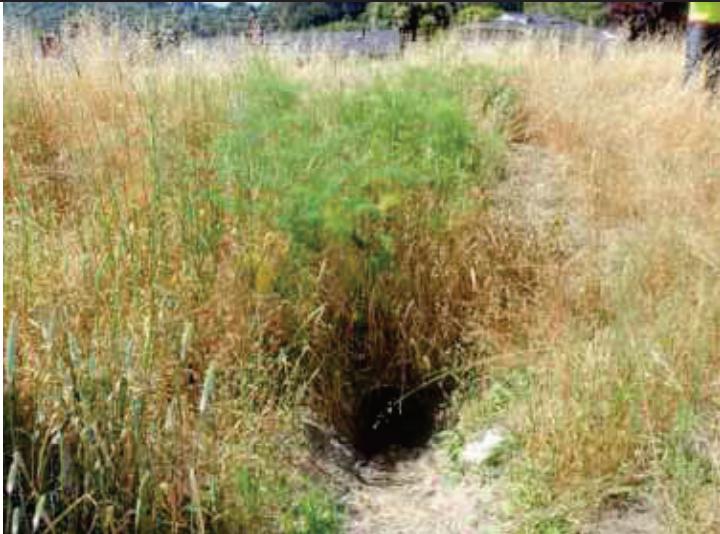
Photo 36

Coyote Creek Left Bank (~Sta 48+25): Storm drain inlet at landside toe, 18-inch corrugated metal pipe; ~2-inches of sediment

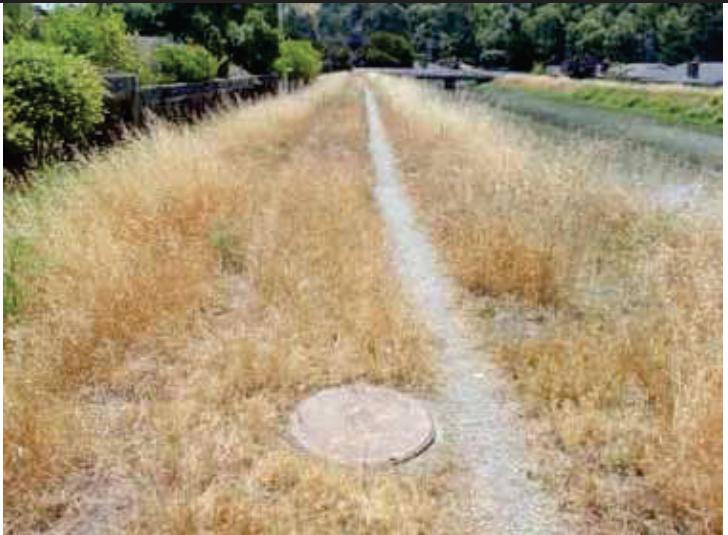
Photo 37

Coyote Creek Left Bank (~Sta 48+10): Storm drain manhole on levee crest looking downstream

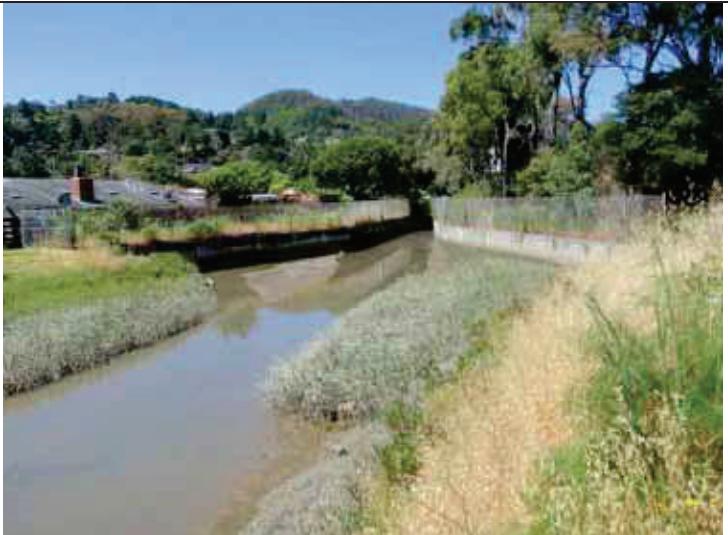
Photo 38

Coyote Creek Channel (~Sta 49+50): Looking upstream at concrete channel section

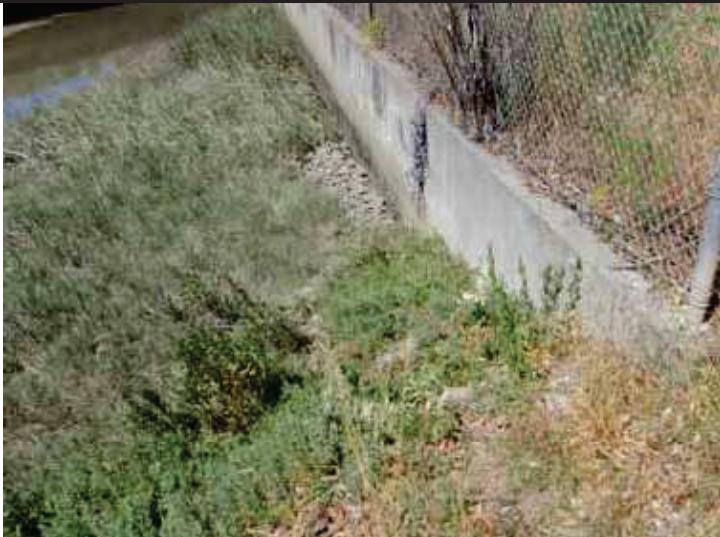
Photo 39

Coyote Creek Channel (~Sta 49+50): Shoaling and rip rap along left wing wall at the end of the concrete channel section

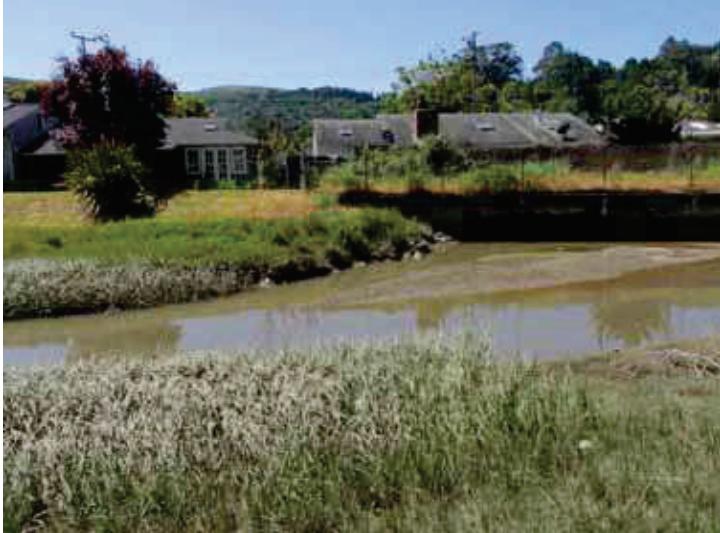
Photo 40

Coyote Creek Channel (~Sta 49+50): Shoaling at the end of the concrete channel section

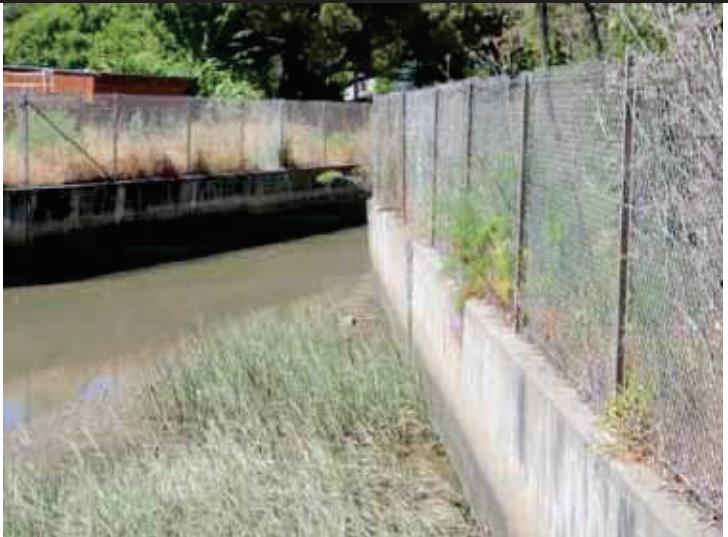
Photo 41

**Coyote Creek Channel (~Sta 49+50): Left wing wall displacement
at the end of the concrete channel section**

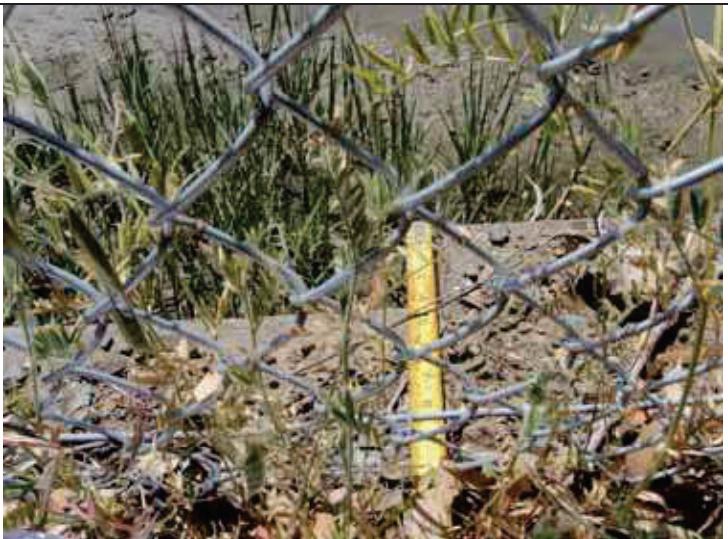
Photo 42

**Coyote Creek Left Bank (~Sta 49+50): Left wing wall displacement
at the end of the concrete channel section, 4-inches**

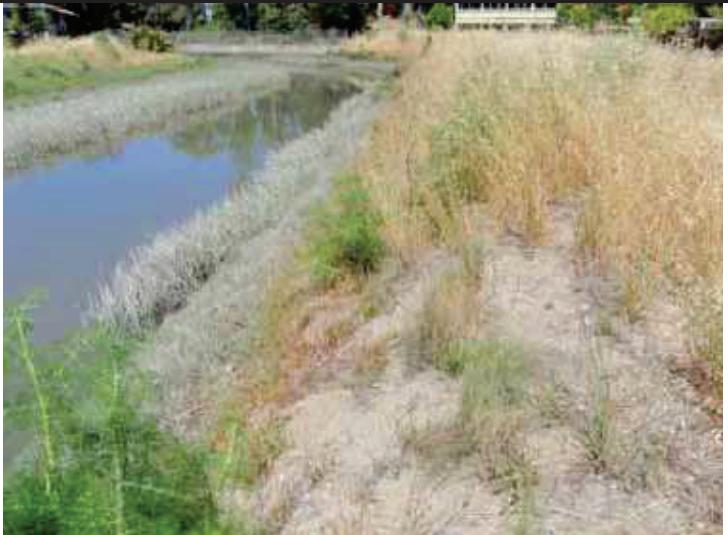
Photo 43

Coyote Creek Left Bank (~Sta 47+00): Waterside slope of GEI Cross-Section 5 looking upstream

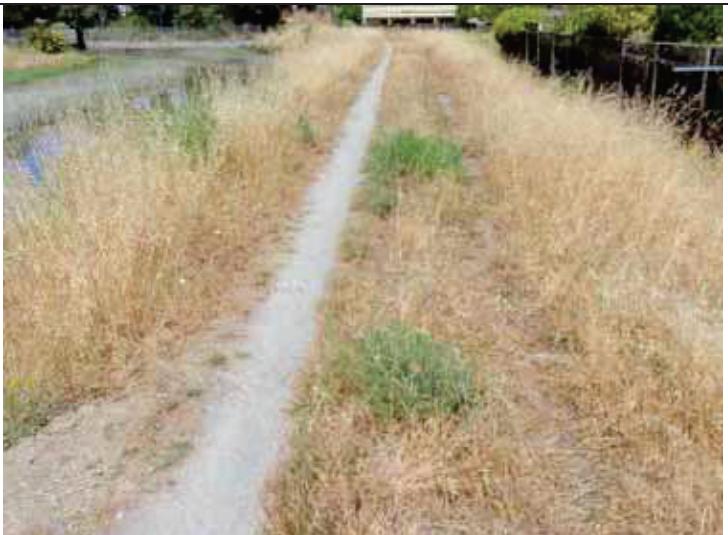
Photo 44

Coyote Creek Left Bank (~Sta 47+00): Crest of GEI Cross-Section 5 looking upstream
