Marin County Flood Control and Water Conservation District

**DRAFT MINUTES OF THE
FLOOD CONTROL ZONE 4 ADVISORY BOARD MEETING
HELD WEDNESDAY APRIL 25, 2023
HELD AT THE STRAWBERRY RECREATION DISTRICT**

Preliminary Flood Risk Reduction Alternatives

Tiburon, California

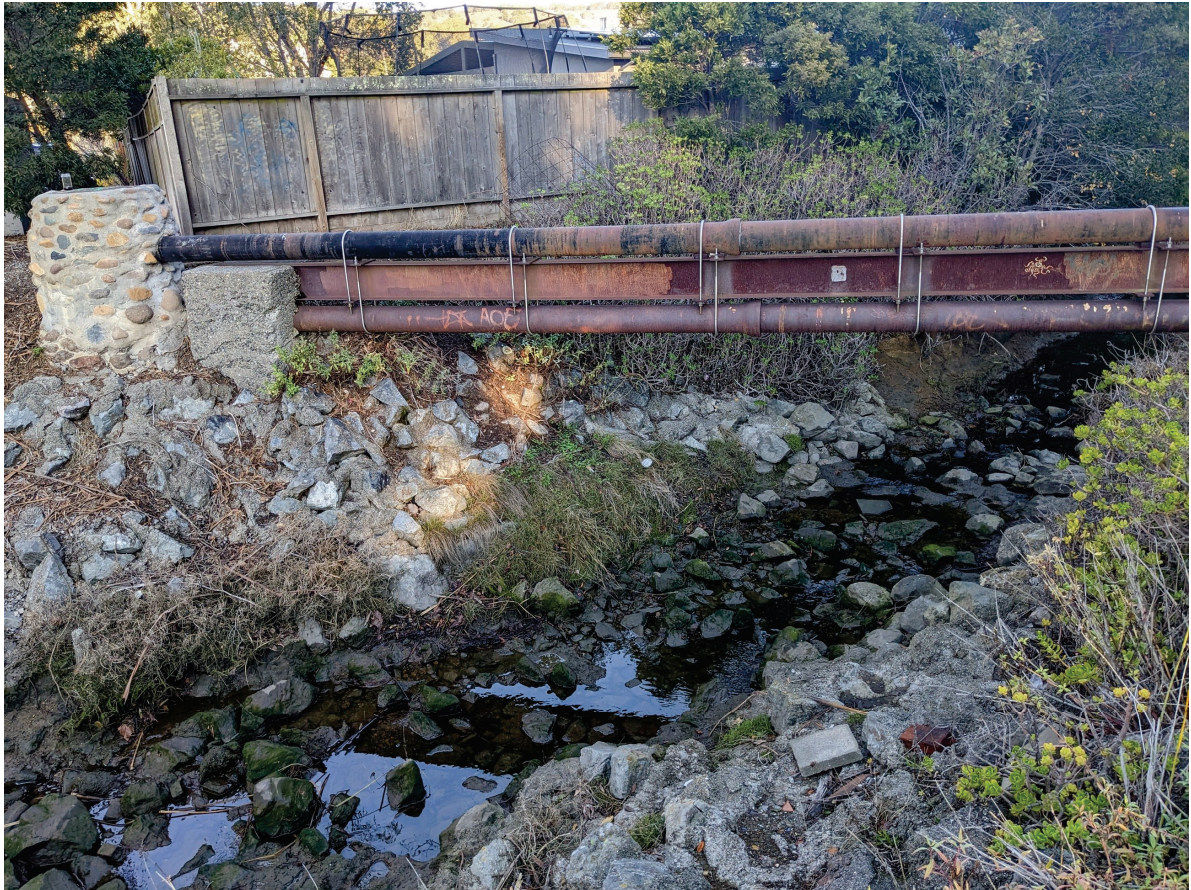
Looking upstream to East Creek from near STA 1+50' to RBSD sanitary sewer pipe crossing (December 16, 2022).

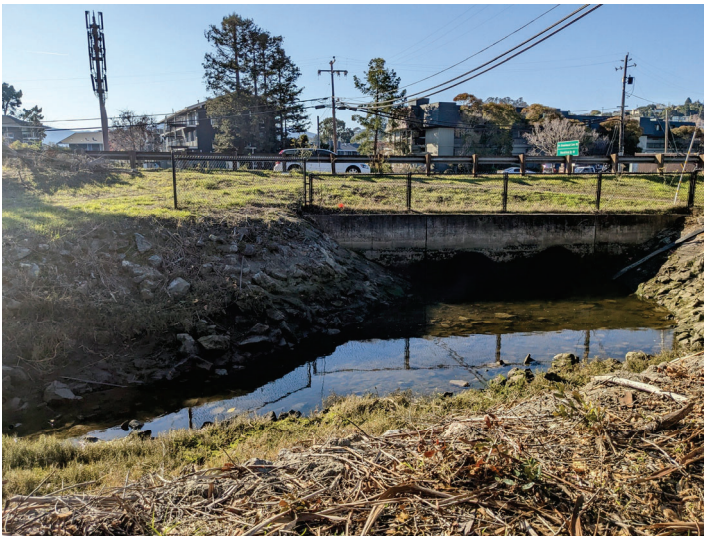
Photo 2. East Creek. Looking downstream from right bank of the grouted rock channel to the vertical concrete headwall inlet to the State Route 131 66" RCP "double-barrel" at Station 0+00' (December 16, 2022).

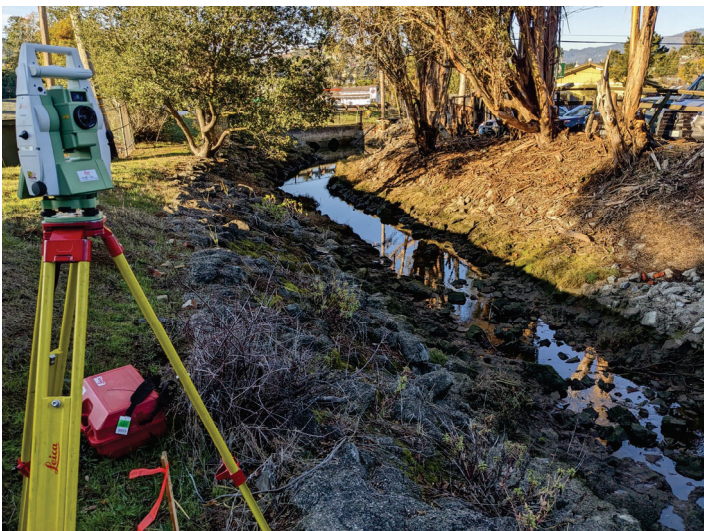
Photo 3. East Creek. Looking downstream from Control Point 1 near Station 1+55' to Lower East Creek. The grouted rock-lined channel extends from the sanitary sewer crossing near Station 1+80' to the State Route 131 "double-barrel" culverts headwall seen in background of view at Station 0+00' (December 16, 2022).

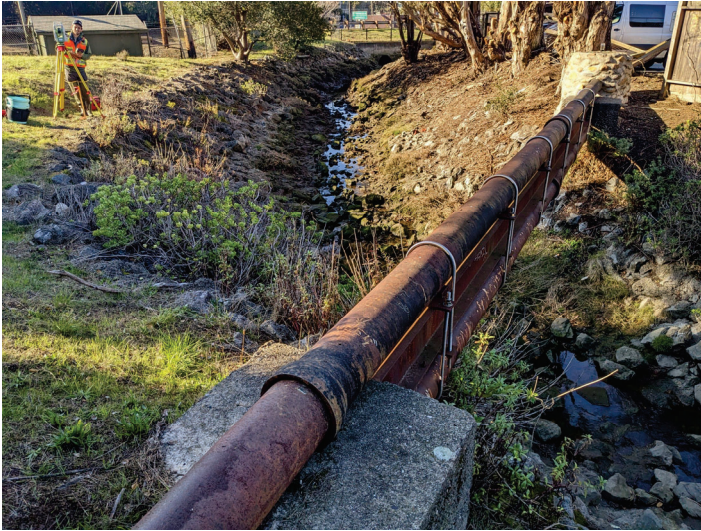
Photo 4. East Creek. Looking from left bank to right bank along the sanitary sewer crossing near Station 1+80' and narrow grouted rock channel with 4.7' invert on the pipeline section (December 16, 2022). See also cover photo.

- #2. Modify Richardson Bay Sanitary District's grouted rock-lined channel inlet at the Sanitary Sewer overhead crossing to widen and lower the channel bed, as would likely require new replacement steel-reinforced concrete abutments and foundations for the sewer pipe. Extend the "Lower East Creek Restoration Project" downstream to smoothly conform channel bed elevations with the lower channel inlet.

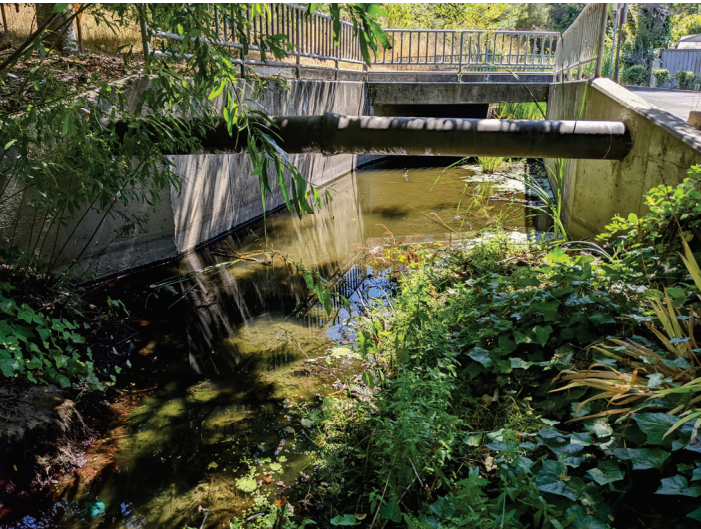
Photo 5. East Creek. Looking downstream from inlet to the 10-ft-wide open concrete box culvert and overhead sanitary sewer pipe crossing to 5'x10' Cecilia Way concrete box culvert downstream in background of view (August 3, 2022).

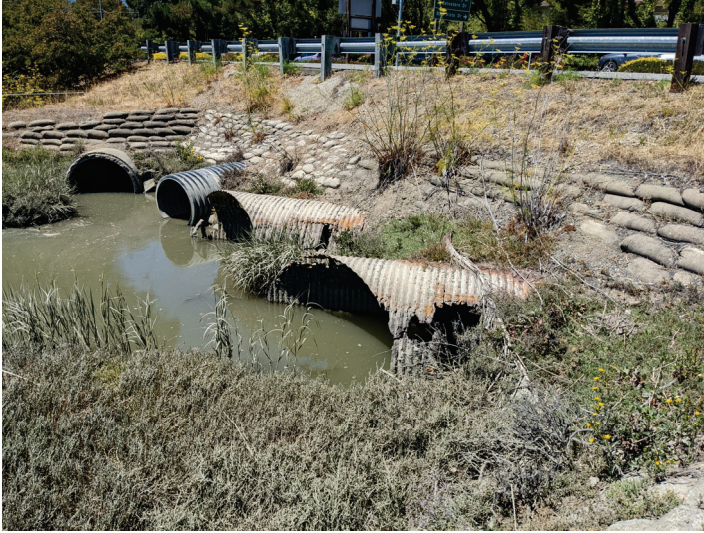
Photo 6. West Creek. Looking from left bank to outlet of two 60" CMP culverts (in foreground) outfalling to open natural channel downstream from Tiburon Boulevard (August 3, 2022).

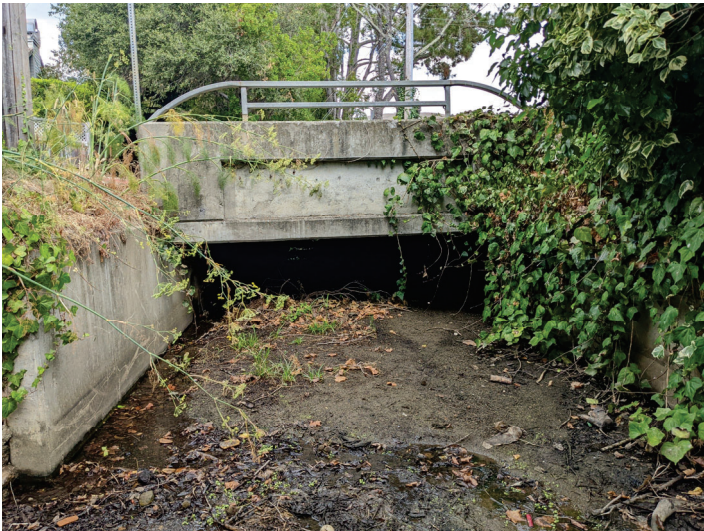
Photo 7. West Creek. Looking upstream to outlet of the Cecilia Way 5.3'x11.4' concrete box culvert (August 17, 2022). Note there is about 2-3 ft of fine sediment deposited within the downstream part of the culvert but much less sediment deposited in the upstream part of the culvert. This is the natural, unmaintained condition.

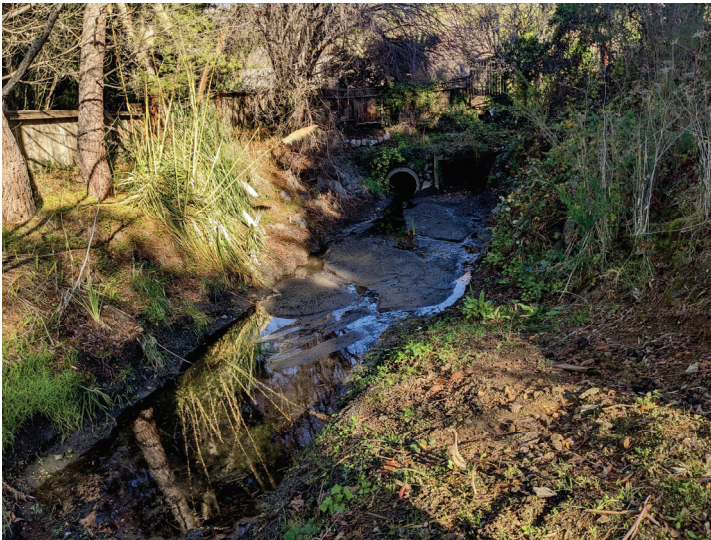
Photo 8. East Creek. Looking upstream to the outlet of culverts originating at or upstream from Karen Way (December 16, 2022). This is the maintained condition following channel maintenance dredging completed in October 2022. Note sedimentation near the culvert outfalls that occurred during November and December rainstorms.

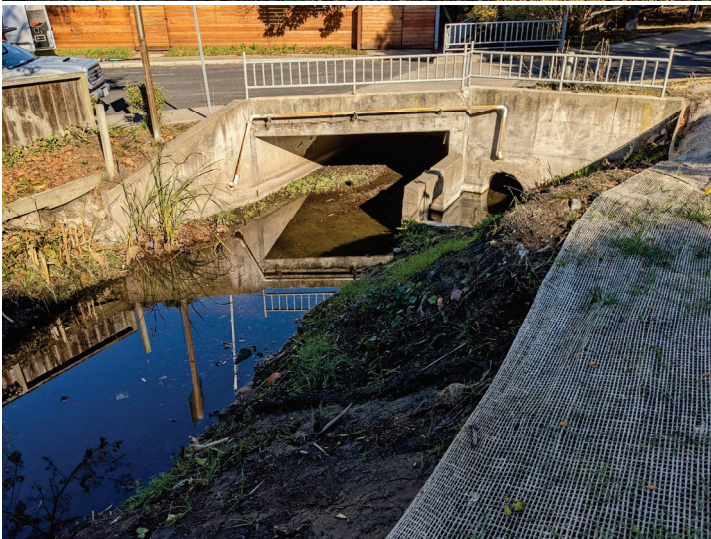
Photo 9. East Creek. Looking upstream to the outlet of Cecilia Way culvert (December 16, 2022). This is the maintained condition following channel maintenance dredging completed in October 2022. None or negligible sedimentation occurred downstream from Cecilia Way culvert during November and December rainstorms.

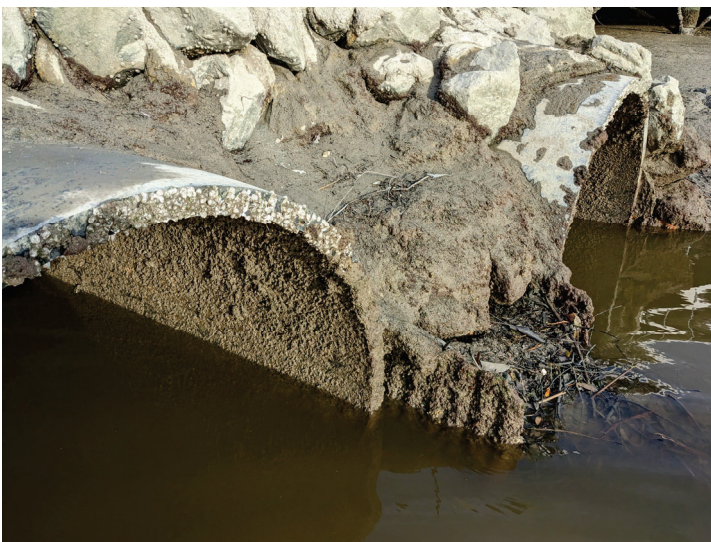
Photo 10. East Creek. View of the East Creek culvert outfalls in Richardson Bay near Station -3+95' (see also Photo 1). The original double-barrel 60" CMPs appear to have been slip-lined with 52" HDPE plastic pipe culverts (January 19, 2023).

These downstream culverts were also originally 60"-diameter CMPs. At the outfall they were measured to be 52" thick-smooth-walled HDPE plastic pipes (PPs) (Photo 10). It has not been confirmed if the 60" CMPs were slip-lined with the 52" PPs all the way upstream to the junction with the 66" RCPs, or if there are remainder segments of the original 60" CMPs downstream from the Cal-Trans Right-of-Way.

- #1. Replace the approximately 275-ft-long 52"-diameter culverts in the County Right-of-Way and easement between State Route 131 (Tiburon Boulevard) and the Richardson Bay outfall with 66"-diameter culverts (matching the diameter of the culverts under Tiburon Blvd).

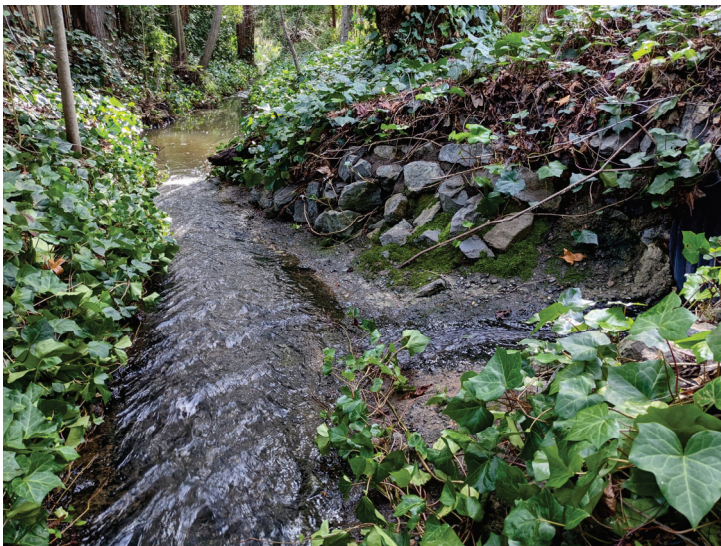
Photo 11. Looking downstream to the grade-controlling channel-spanning concrete stormwater outfall forming a headcut-step on Upper West Creek near Station 11+60' (January 19, 2023).

5.2.1 West Creek Medium Plan 1. Remove Concrete Stormwater Outfall (#5). Medium Plan 1 (Plan 48) simulates (adding to Minimum Plan 2) removal of the existing grade-controlled channel-spanning concrete stormwater outfall with an adequate width and depth rock-lined channel with a lower bed elevation.

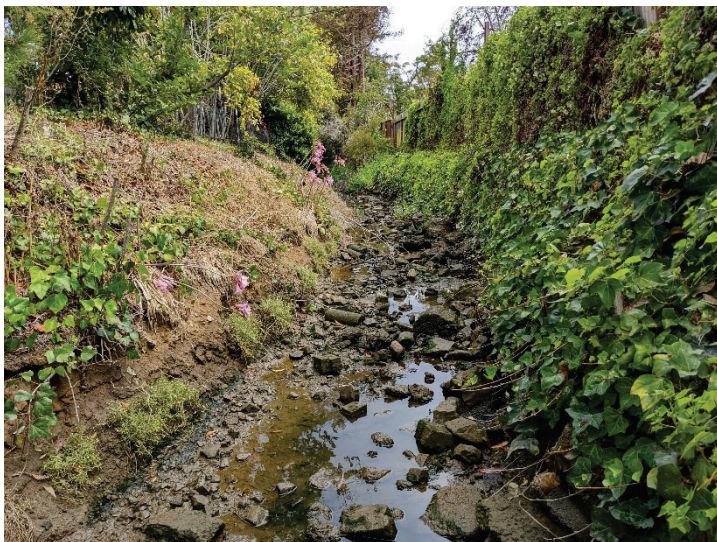
Photo 12. Lower West Creek. Looking upstream from Lower West Creek channel bed near Station 3+00' to the broken concrete rubble covered channel bed (August 17, 2022).

Minimum Plan 1 simulates removal of loose concrete rubble and foreign rock rip-rap pieces from Lower West Creek between sackrete transition structure (Station 1+04') to upstream end of rubble dominated reach (Station 3+96'), specifically hand-work to remove 8-10" thickness of material from the 6-ft average width channel bed over this 300-ft-long reach (50 CY). The

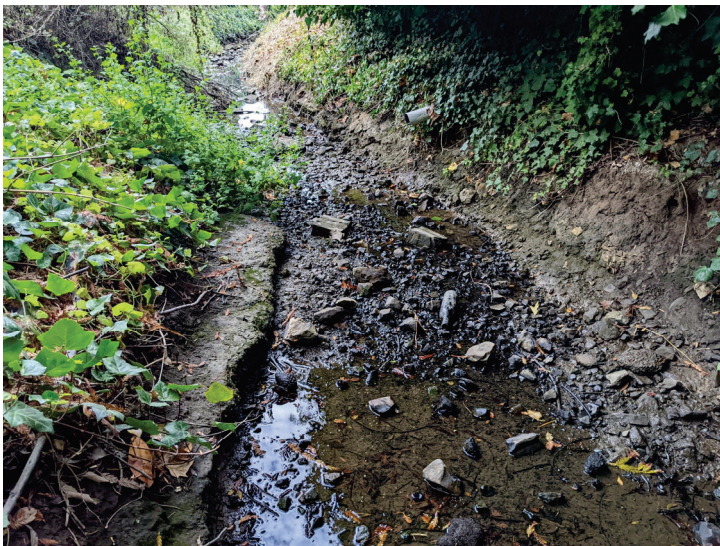
Photo 13. Lower West Creek. Looking downstream from the Lower West Creek channel bed near Station 4+10' to the lightweight foreign rubble deposited upstream from the rubble covered channel bed downstream, and evidence of recent natural tendency channel bed downcutting limited by coarse foreign material on the bed (August 17, 2022).

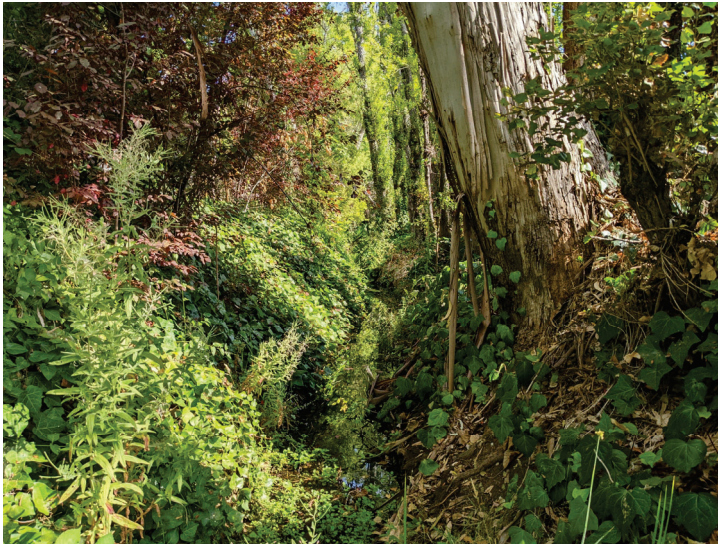
Photo 14. West Creek. Looking upstream from the channel bed near Station 7+60' to the left bank in-channel tree, Tree #4 (46"-diameter eucalyptus), surveyed on Cross-Section 58 at Station 7+77'. Tree #4 was topped approximately 10 years ago. Model simulations show that removal of Tree #4 reduces the computed 50-year flood water surface elevation by 0.4' upstream near Station 8+19' (August 17, 2022).

District would also remove the tree stumps from Trees #1,2,3,4 and repair the affected creek bank with combination vegetated rock slope protection to improve channel conveyance and bank stability.	Same as Medium Plan 3-2.
	<u>Plan Option:</u> Owners or District also install approximately 150 lineal feet minor top of bank flood barrier between Station 10+63' and 9+11'.	Same as Medium Plan 3-2.
		Also: (1) Caltrans upgrades the 60"-diam. Tiburon Blvd culverts to 66"-diam. culverts; and, (2) Town replaces the Cecilia Way box culvert with a wider or same-width natural with a natural, self-setting bed elevation.

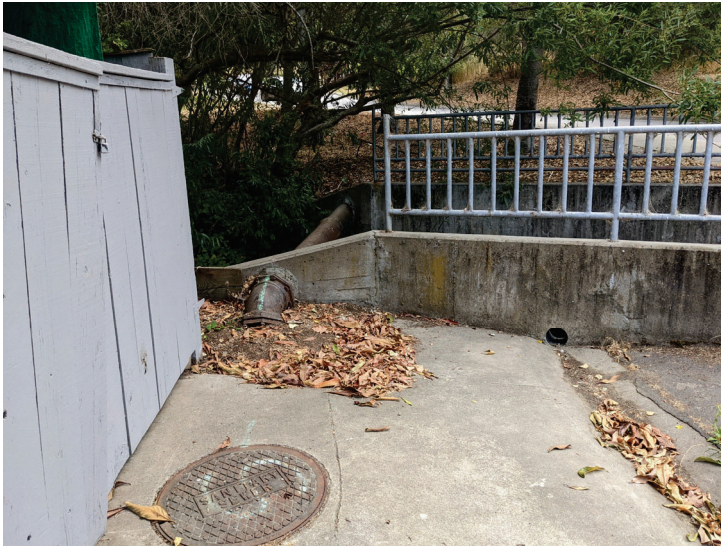
Photo 14. Upper East Creek. Looking from Cecilia Way to the upstream end of the right bank concrete transition channel wall about 30 feet upstream from the Cecilia Way culvert road crossing (August 17, 2022). The stormwater drain hole in the wall discharges creek flow onto the street during routine or average annual high creek flows. Blocking the drain hole combined with surface drainage improvements for directing the concrete swale flows to existing storm drain inlets near the Cecilia-Leland Way intersection should be considered.
