Client: City of Petaluma Department of Public Works
Project Location: Lucchesi Park, 320 N McDowell Blvd, Petaluma, CA
Inspection Date: July 17, 2024
Arborist: Ben Anderson

URBAN FORESTRY ASSOCIATES, INC.

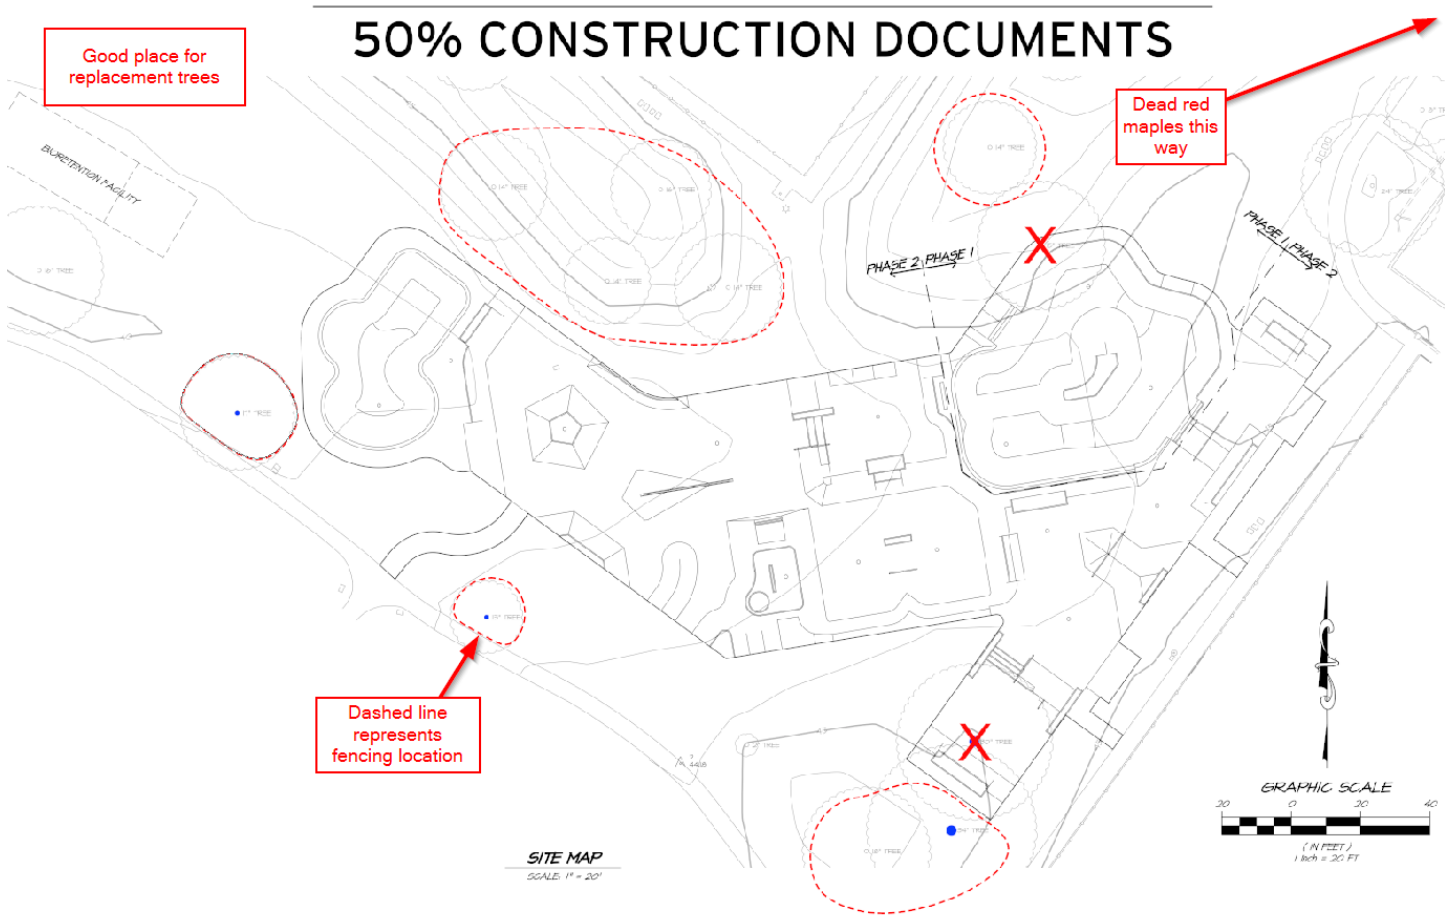
Figure 1. Map showing tree and fencing locations.

For the other trees close to the construction area, heavy equipment is likely to drive over their roots. These trees should have tree protection fencing installed 15 feet away from their trunks. This fencing should be a minimum of 4-foot-high metal deer fencing labeled with tree protection signage. Ensuring this protection will help maintain the trees' health and stability.

- Protect roots: Install tree protection fencing at least 15 feet away from the trunks of trees near the construction area (closer to the skatepark side of the ash above).

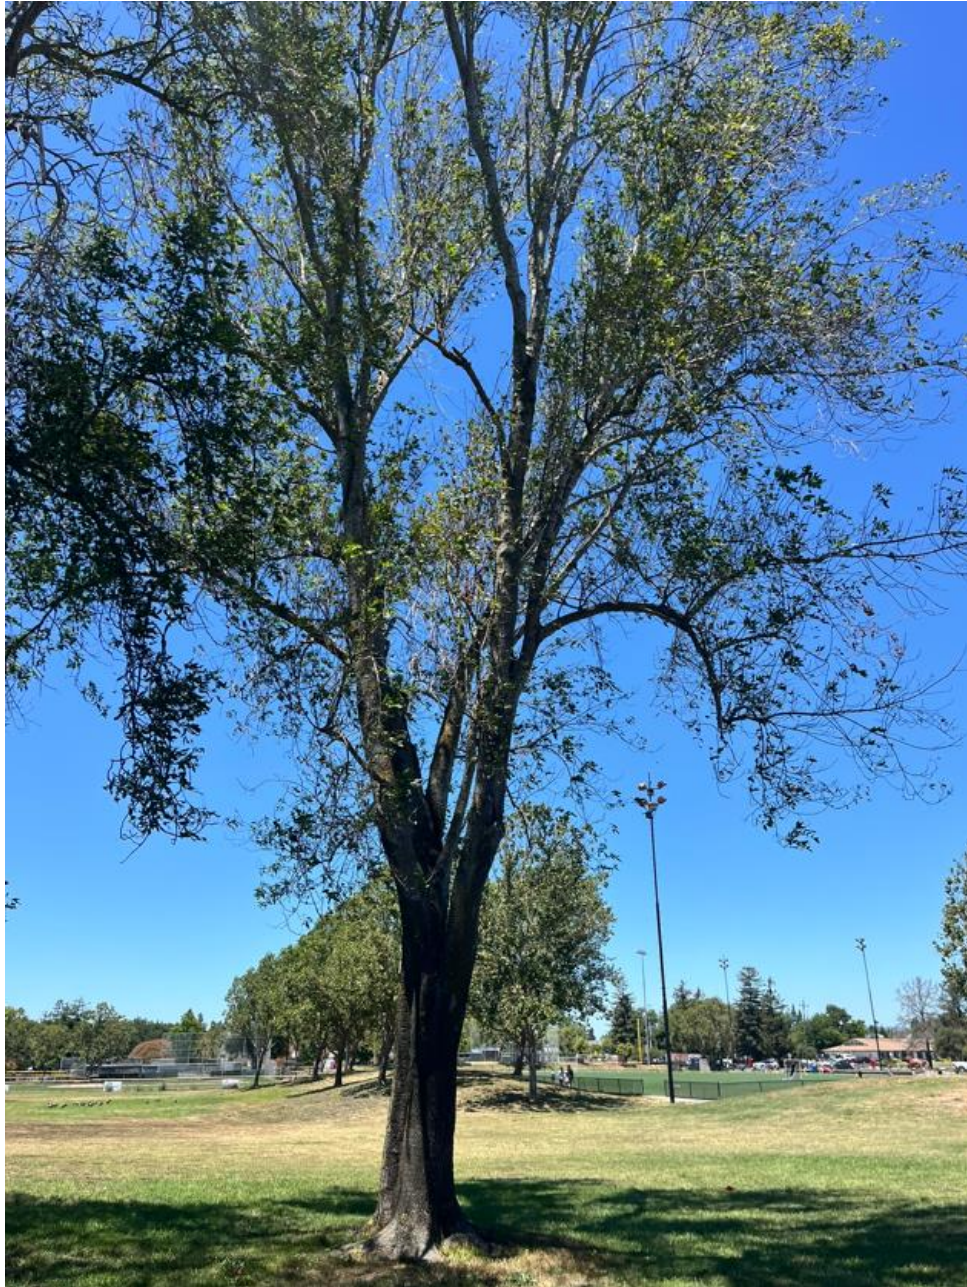
Based on the site survey, two trees are in the footprint of the proposed skatepark. The first tree is a Modesto ash (*Fraxinus velutina* 'Modesto') with a trunk diameter of 29 inches. This tree is in fair health, with a sparse upper canopy and twig dieback. This is markedly different than the condition of the tree in 2023 when it was photographed for the Parks Tree Inventory. The second tree is a London plane tree (*Platanus x acerifolia*) with a trunk diameter of 15.5 inches. This tree suffers from an anthracnose infection in the canopy, common for American sycamore (*Platanus occidentalis*) and London plane trees in Petaluma. Despite the infection, the tree is in fair health overall. The main trunk exhibits a strong lean to the east, likely resulting from the prevailing winds in the area, a condition also seen in the adjacent London plane trees.

Figure 3. Ash to be removed. The canopy is noticeably sparser than it was in 2023.

- Pre-Construction meeting: The project or city arborist should meet with the contractor before work commences to discuss tree protection.
- Tree Removal: Three trees will be removed: the large ash, the London plane, and the deodar cedar.

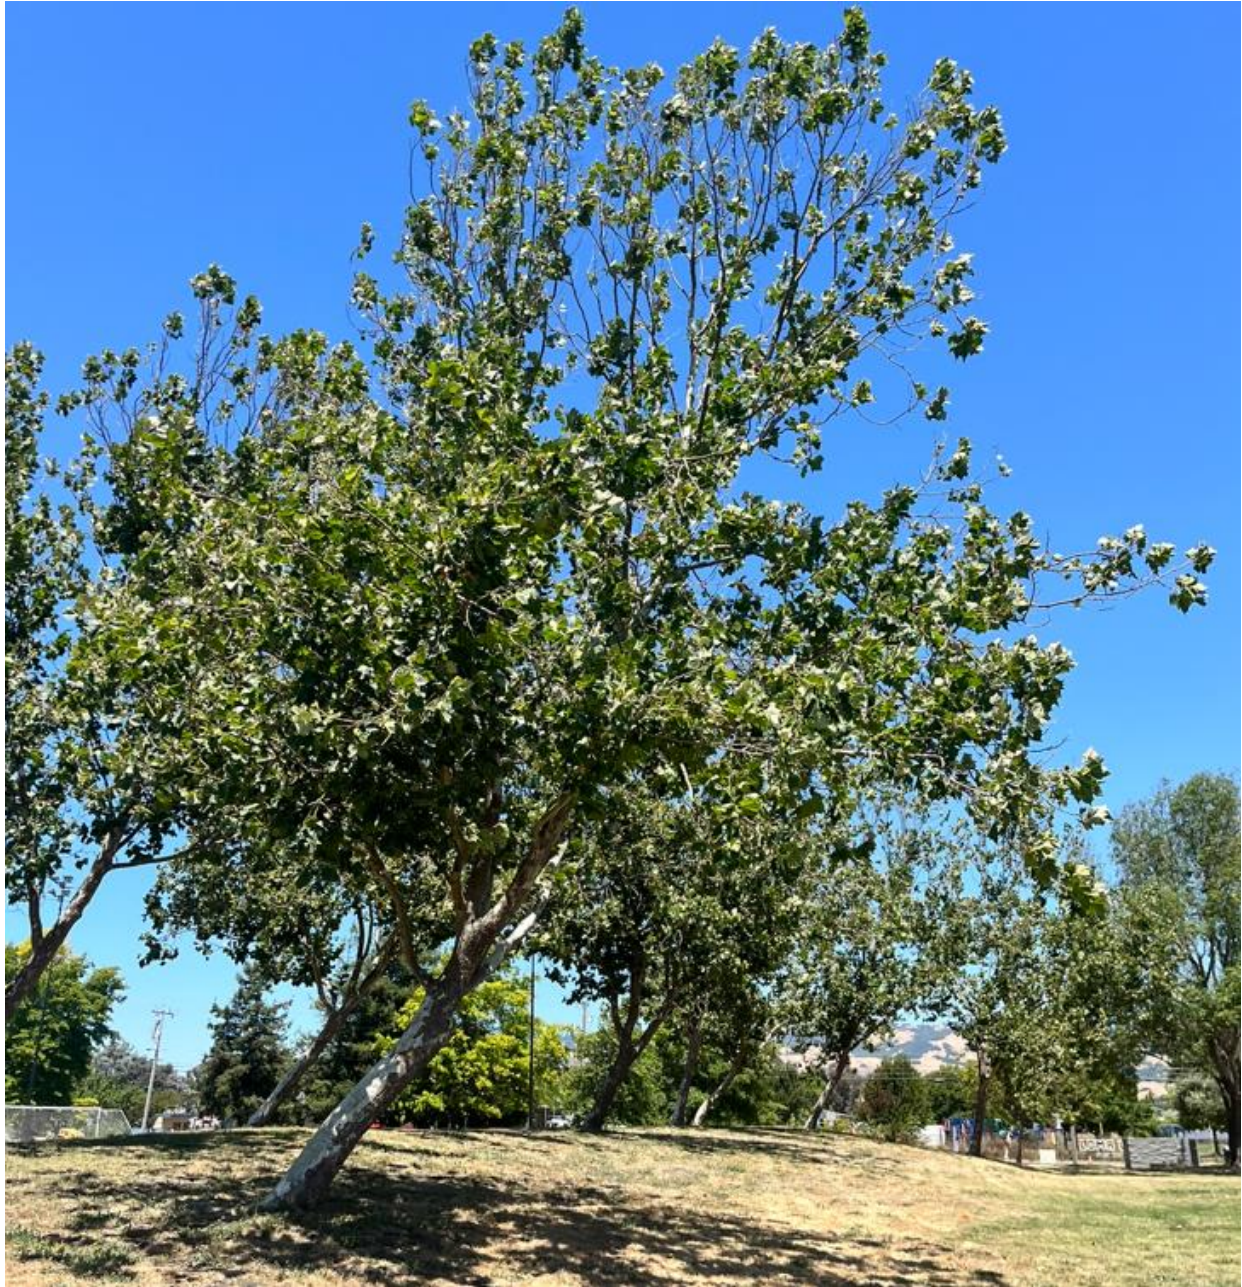
Figure 4. London plane to be removed.

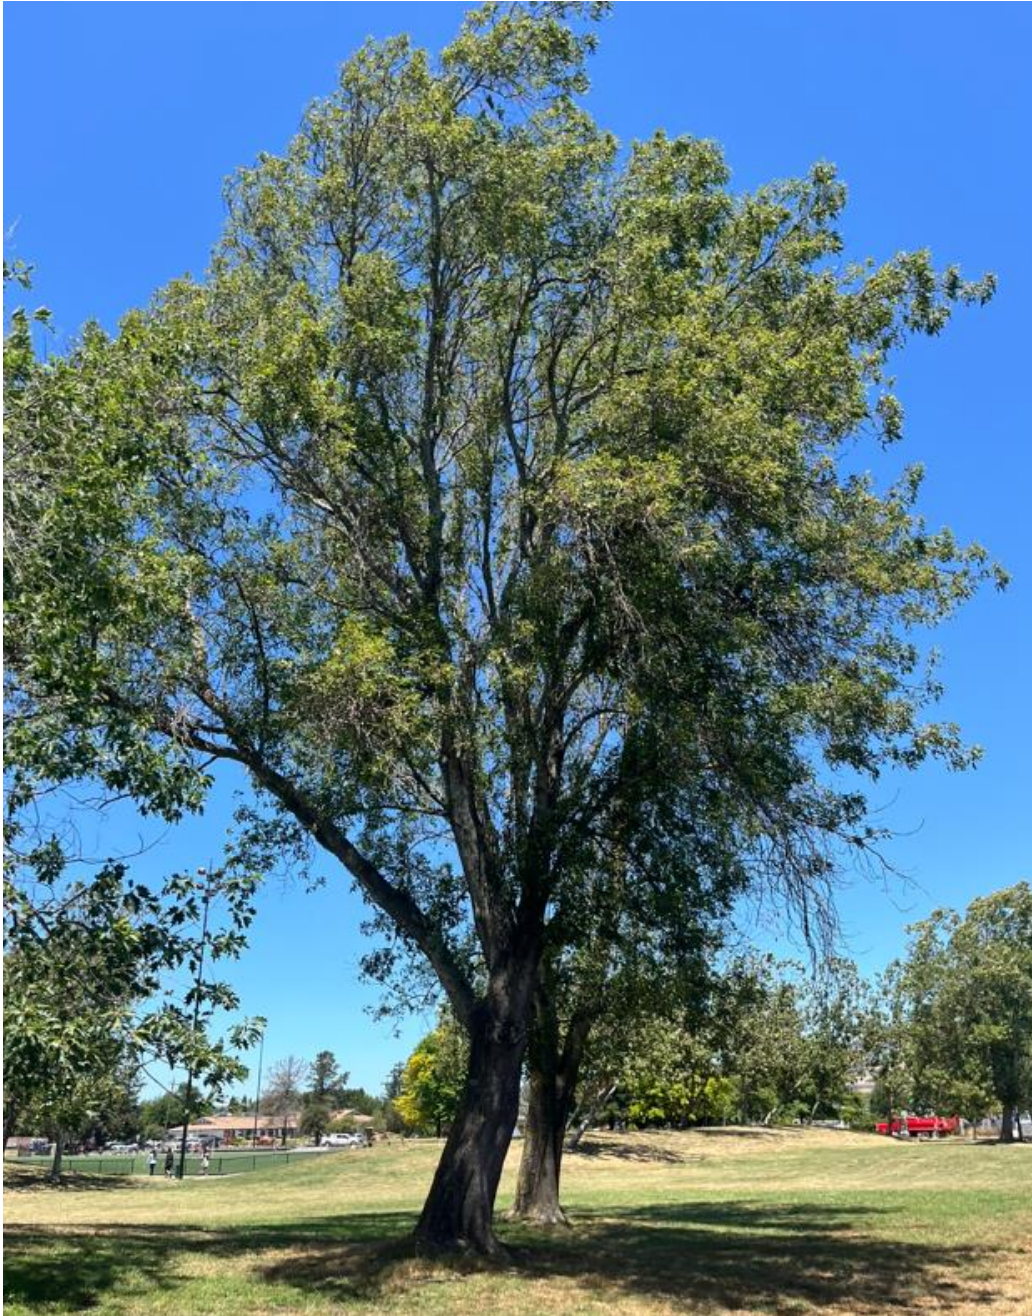
Another Modesto ash is slightly surface-rooted and in good health, with a trunk diameter of 30.5 inches. It is adjacent to the ash being removed. The edge of the proposed concrete is just over 7 feet from the tree's base. Beyond that is an east coast oak (c.f. *Quercus rubra*) in poor to fair condition. Additionally, a red ironbark eucalyptus (*Eucalyptus sideroxylon*) is in fair health, with a trunk diameter of 19 inches, about 18 feet from the edge of the proposed concrete. A second red ironbark has a trunk diameter of 13 inches and is about 30 feet from the excavation for the park but only about 17 from the path to the park.

Figure 5. Ash to hopefully stay, ideally increasing the clearance from excavation by several feet.

Along with the young cedar, the Modesto ash and London plane tree within the skate park footprint will be removed. Due to the two larger trees, the cedar removal will not be noticeable. For the Modesto ash on the south corner, all excavation should ideally stay at least 10 feet from the tree's base. While retaining the tree even without this modification is possible, the outcome will depend on the roots encountered during excavation. Keeping excavation outside this radius greatly increases the likelihood of retaining the tree in a healthy and stable condition.

- Retain Modesto ash: Keep all excavation at least 10 feet from the tree's base to maintain health and stability. If this is not possible, know that the tree may need to be removed, but the contractor could work with the project or city arborist to try to retain it.
