## ADDENDUM NO. 2

### D Street Bridge Electric and System Upgrades City Project No. C16101933

February 04, 2020

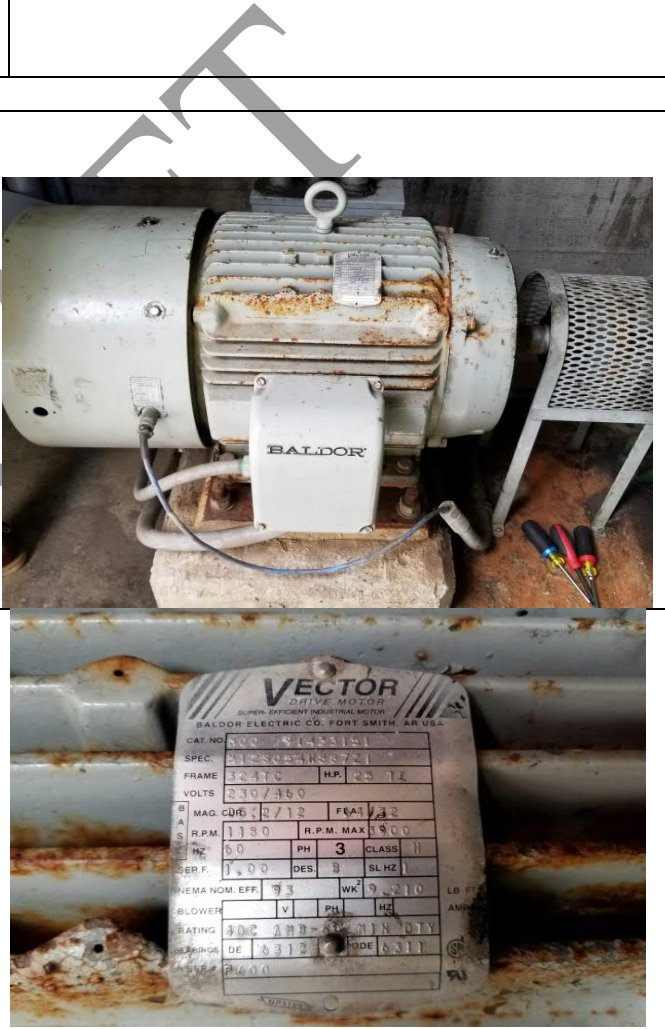
**NORTH WEST BRIDGE MOTOR DATA**

Each movable span is operated by one Baldor Electric Vector Drive motor model M00-91433151. Nameplate and torque settings are listed in the Appendix A. The motors were installed about 18-years ago. Motors were visually inspected and show signs of corrosion on the body and metal plate support. Refer to Photos E-7 and E-8.

ITEM	CONDITION
<b>FRAME EXTERIOR</b>	
CONDUIT BOXES	Fair
MOUNTING BOLTS	Poor
FRAME MOVEMENT	Fair
PAINT	Poor
OPERATION / NOISE LEVEL	Fair
VIBRATION LEVEL	Fair
BASE PLATE	Poor
MOTOR HOUSING	Fair

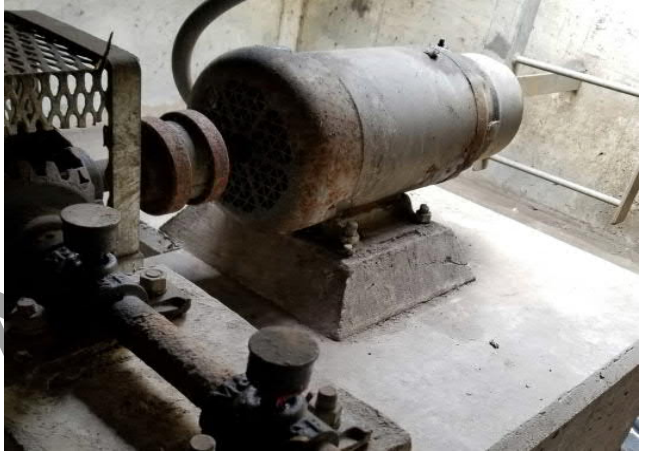
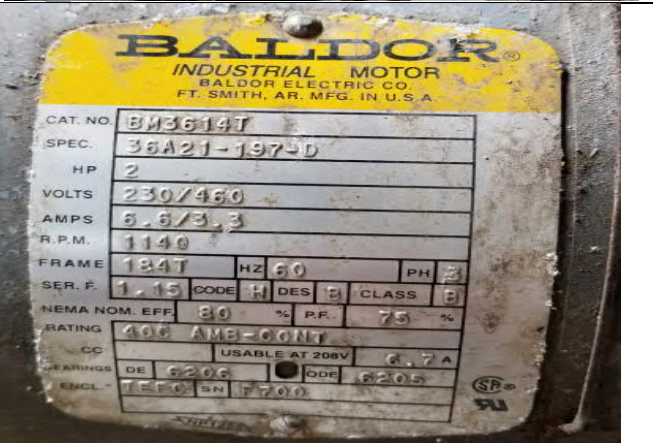
**SPAN LOCK MOTOR DATA**

There is one span lock located inside the End Lock machinery pit. The span lock is powered by a 2 HP Baldor industrial motor. Although the end lock machinery pit is underneath and covered, it is open to the environment through the lock-bridge window. The pit shows heavy collection of dust and the motor frame exhibits body corrosion (Refer to Photo E-9). Span locks are equipped

ITEM	CONDITION
<b>FRAME EXTERIOR</b>	
CONDUIT BOXES	Poor
MOUNTING BOLTS	Poor
FRAME MOVEMENT	Fair
PAINT	Poor
OPERATION / NOISE LEVEL	Fair
VIBRATION LEVEL	Fair
MOTOR HOUSING	Poor
BASE PLATE	Poor

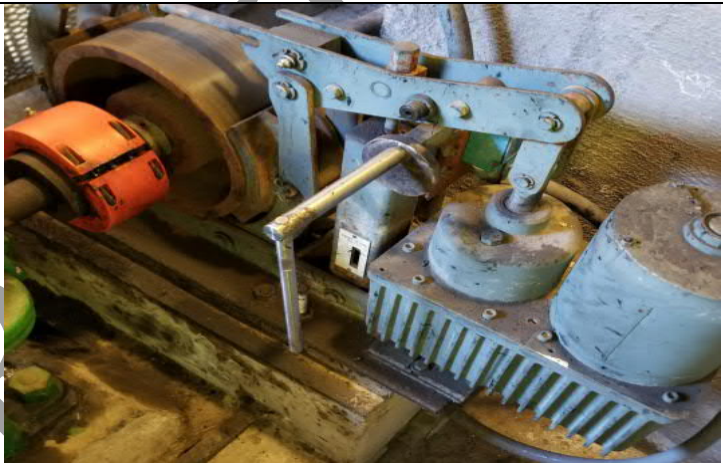
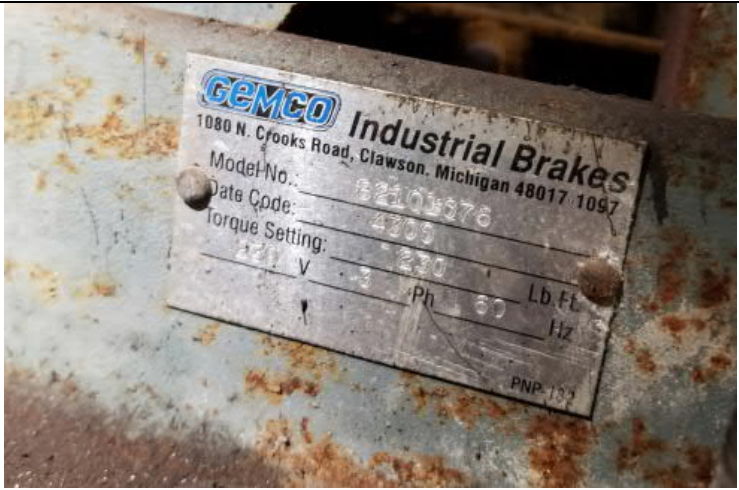
**NORTH WEST THRUSTER BRAKE DATA**

It was noted during the insulation resistance test that the insulation on the North-West Electro Thrust motor, which prevents interconnection between the motor windings to earth, was 0.1 Mega Ohms. This value is well below the 100 Mega Ohm which is the minimum accepted value per IEEE 43-2013. Low insulation resistance value of the insulation indicates the high possibility of insulation failure which can cause personnel injury due to dangerous voltages, fires, high-fault currents and explosions.

<b>EQUIPMENT IDENTIFICATION: Ne Motor Brake</b>		GEMCO Thruster Brake
<b>LOCATION: North West Machinery Pit</b>	MODEL No Available HP <u>2</u> VOLTAGE <u>230V</u> PH <u>3</u>	MODEL <u>82101076</u> DATE CODE <u>4300</u> TORQUE SETTING 230 Lb.Ft. 230V, 3-Phase, 60 Hz
<b>NUMERICAL RATING: 4</b>		
<b>NOTE: THE MOTOR FAILED THE INSULATION TEST</b>

ITEM	CONDITION
BRAKE FRAME	Fair
CONDUIT BOXES	Fair
MOUNTING BOLTS	Fair
FRAME MOVEMENT	Fair
LINKAGE, PINS, SPRING	Fair
OPERATION / NOISE LEVEL	Fair
BRAKE WHEEL	Fair
SHOE LINING	Fair
BRAKE RELEASED LIMIT SWITCH	Fair
BRAKE SET LIMIT SWITCH	Fair
HAND RELEASE LIMIT SWITCH – Honeywell Micro Switch GLAA01A1B	Fair
HAND RELEASE MECHANISM	None

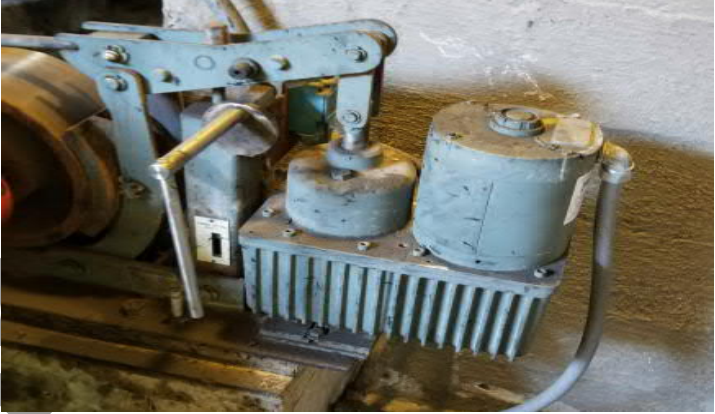
**NORTH EAST THRUSTOR BRAKE DATA**

<b>BRAKE IDENTIFICATION: NE MOTOR BRAKE</b>	PUMP	GEMCO Thruster Brake
<b>LOCATION: North East Machinery Pit</b>	MODEL No Available HP <u>2</u> VOLTAGE <u>230V</u> PH <u>3</u>	MODEL <u>82101076</u> DATE CODE <u>4300</u> TORQUE SETTING 230 Lb.Ft. 230V, 3-Phase, 60 Hz
<b>NUMERICAL RATING: 4</b>		
<b>Note: Motor Failed Insulation Test</b>

ITEM	CONDITION	
BRAKE FRAME	Fair

CONDUIT BOXES	Fair	
MOUNTING BOLTS	Fair	
FRAME MOVEMENT	Fair	
LINKAGE, PINS, SPRING	Fair	
OPERATION / NOISE LEVEL	Fair	
BRAKE WHEEL	Fair	
SHOE LINING	Fair	
BRAKE RELEASED LIMIT SWITCH	Fair	
BRAKE SET LIMIT SWITCH	Fair	
HAND RELEASE LIMIT SWITCH – Honeywell Micro Switch GLAA01A1B	Fair	
HAND RELEASE MECHANISM	None

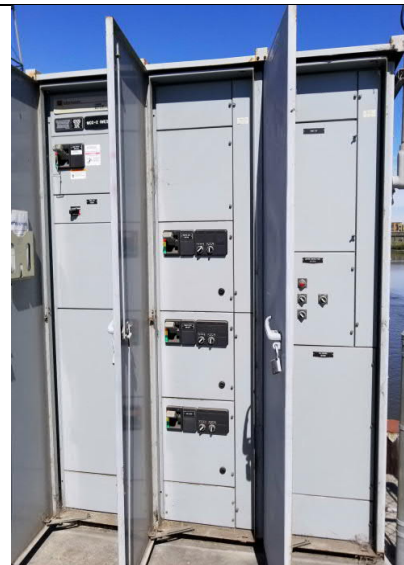
The existing MCC-2 is a 400A service entrance rated MCC located on the South West side of the bridge which was installed about 18-years ago. It shows minor signs of metal skin deterioration below the ceiling of the enclosure. The interior of the enclosure includes heat strips that remove moisture and water condensation and are powered from the interior lighting panel LP2. It was noticeable that the wireless antenna mounting hardware attached on the side of MCC-2 was very corroded and in need of replacement. The enclosure was not identified with an Arc Flash Label. Refer to photos E-5, and E-6.

<b>POWER DISTRIBUTION SYSTEM</b>	
IDENTIFICATION: MCC-2	
LOCATION: Control House Electrical Room NUMERICAL RATING: 2	Main Disconnect Switch: 600V, 100A Meter: 3 Phase, 4W, Wye

ITEM	CONDITION
HOUSING	Poor
WIRING	Good
BREAKER	Good
DISCONNECT SWITCHES	Good
CONDUITS	Good

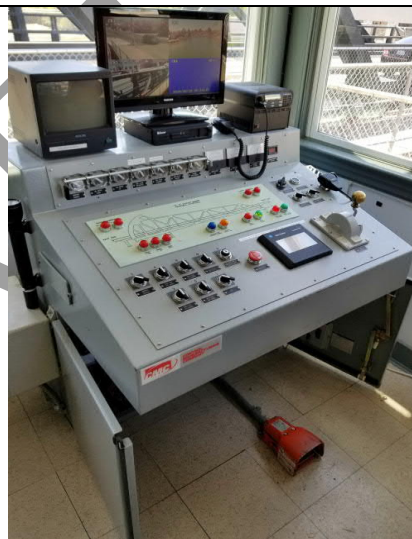
**CONTROL CONSOLE**

Although the PLC components and the local interface terminal are outdated, they have reached the end of the manufacturer lifecycle and with limited or no support or spare parts, the components on the main control console are in satisfactory operating condition and provided correct bridge status during operations. Overall the control console was in fair condition. Refer to Photos E-14, E-15 and E-16.

IDENTIFICATION: Control Desk	Base Line Road
LOCATION: Control Room	
NUMERICAL RATING: 4	
<p><b><u>NOTE: A NUMERICAL RATING OF 4 IS GIVEN DUE TO LACK OF REDUNDANCY ON THE CONTROL SYSTEM. THE FAILURE OF ANY PLC IN THE SYSTEM WILL PUT THE BRIDGE OUT OF SERVICE FOR A PERIOD EQUAL TO THE TIME NEEDED TO REPLACE OR REPAIR OF THE FAILED PLC PLUS THE TIME TO RECONFIGURE/REPROGRAM THE NEW UNIT.</u></b></p>

ITEM	CONDITION
HOUSING	Fair
WIRING	Fair
INDICATOR LIGHTS	Fair
PUSH BUTTONS	Fair
EMERGENCY STOP	Fair
HMI SCREEN	Fair
TERMINAL BLOCKS	Fair

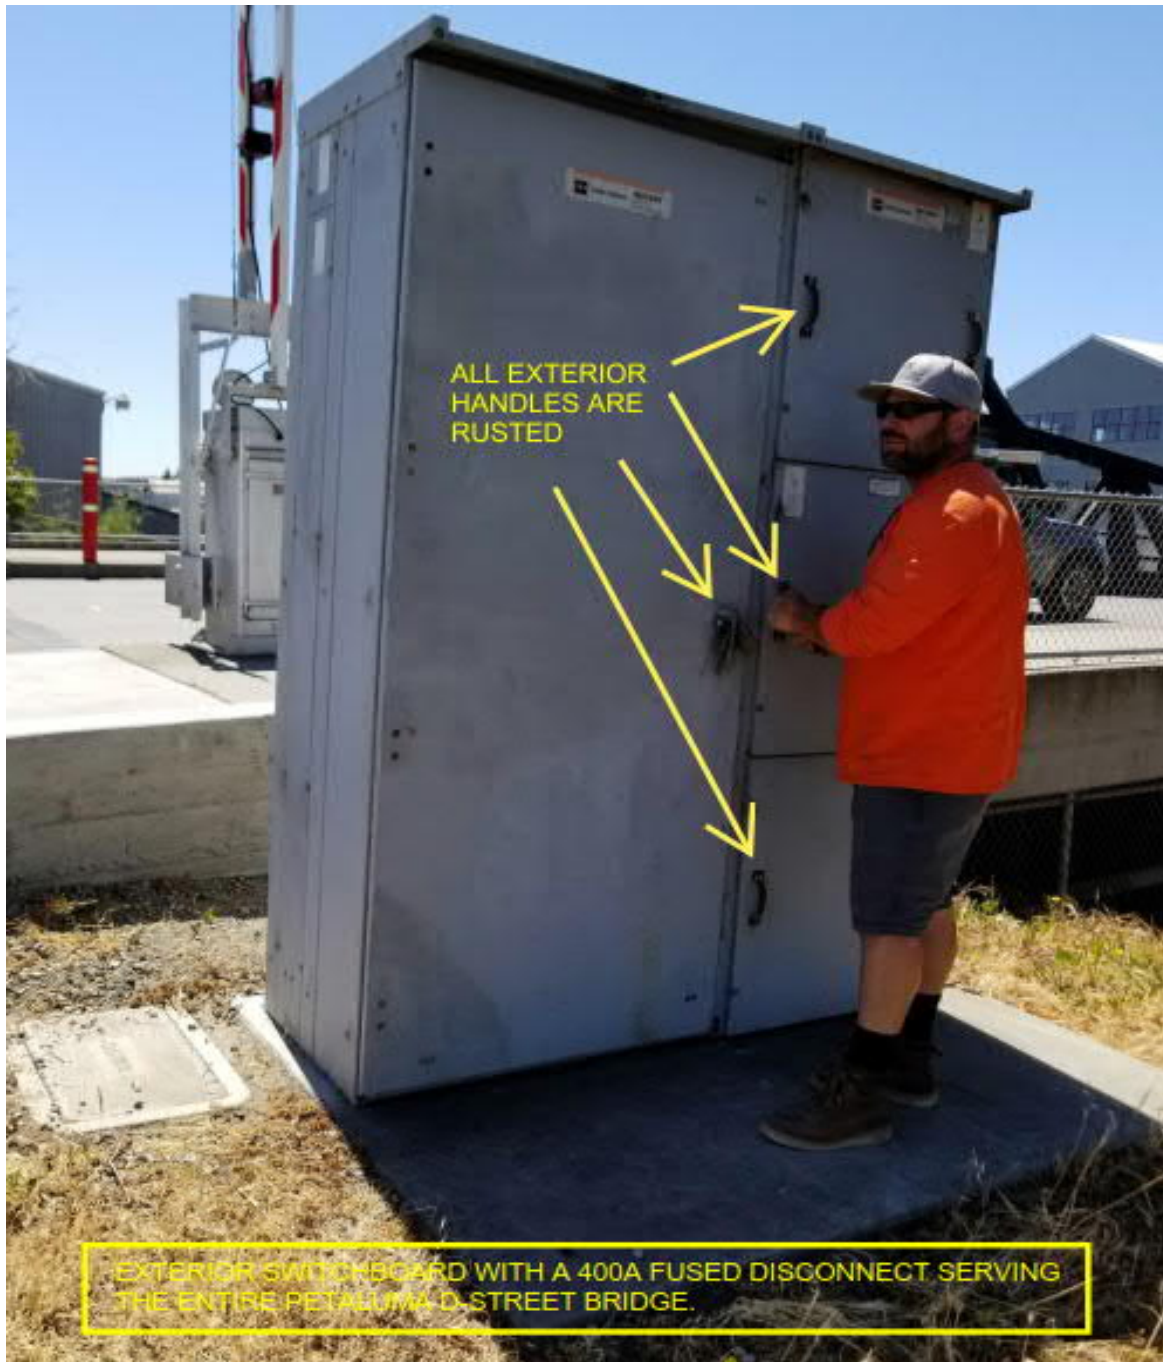
Photo E- 1  
Exterior Service Entrance Switchboard

The existing 600A switchboard houses a 400A (200A fused) disconnect which was installed about 18 years ago. It shows signs of metal skin deterioration due to corrosion on portions of the exterior, interior, below the ceiling, and handles of the enclosure. Rust corrosion on the metal skin of the enclosure may indicate internal electrical parts with possible moisture and condensation of water. Circuit breakers and other tripping devices damaged by water condensation may not trip when an electrical overload occurs creating an unsafe condition for personnel. The enclosure was not identified with an Arc Flash Label which is required by NFPA-

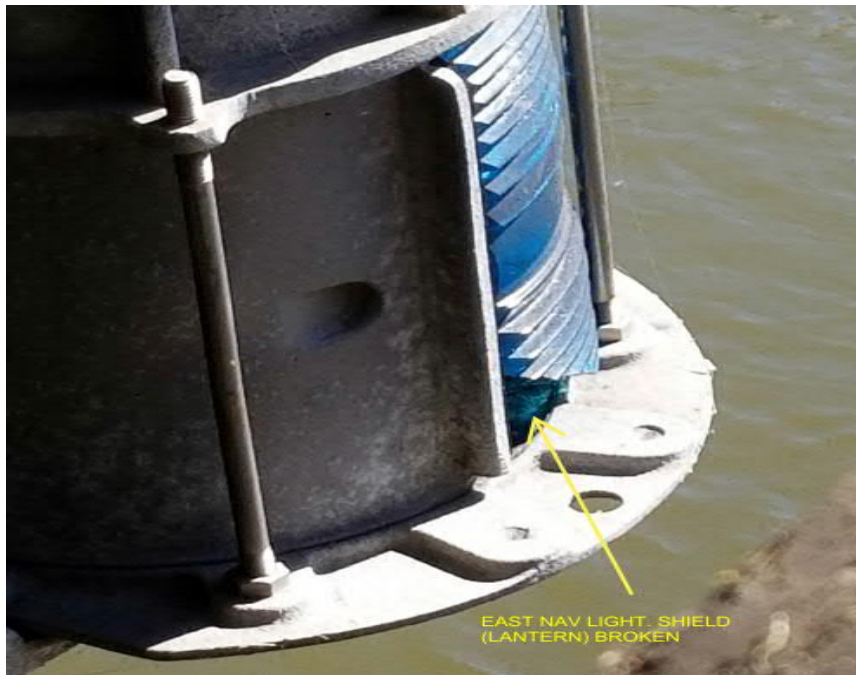
Photo E- 20

One navigational light on the north east of the bridge appeared to be broken at the green lantern body. The navigation light on the south section below the bridge appeared to have damaged light bulbs. At the time of the inspection, with the exception noted, all navigation lights appear to be operating as intended.

EAST NAV LIGHT SHIELD (LANTERN) BROKEN

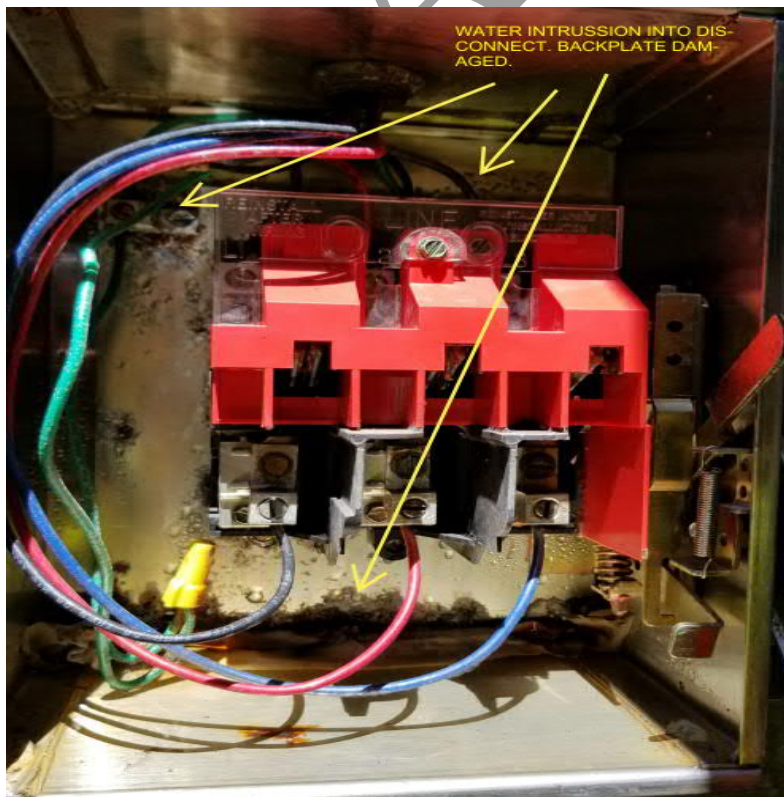
Photo E- 21

- The North West thruster brakes disconnect was found with water intrusion in the interior of the enclosure with extreme metal corrosion in the back plate of the enclosure. This needs to be remediated immediately, as water accumulation inside the disconnect enclosure may create a low resistance fault that tripping devices such as circuit breakers can't react to putting personnel at risk of an electric shock.

WATER INTRUSION INTO DISCONNECT. BACKPLATE DAMAGED.

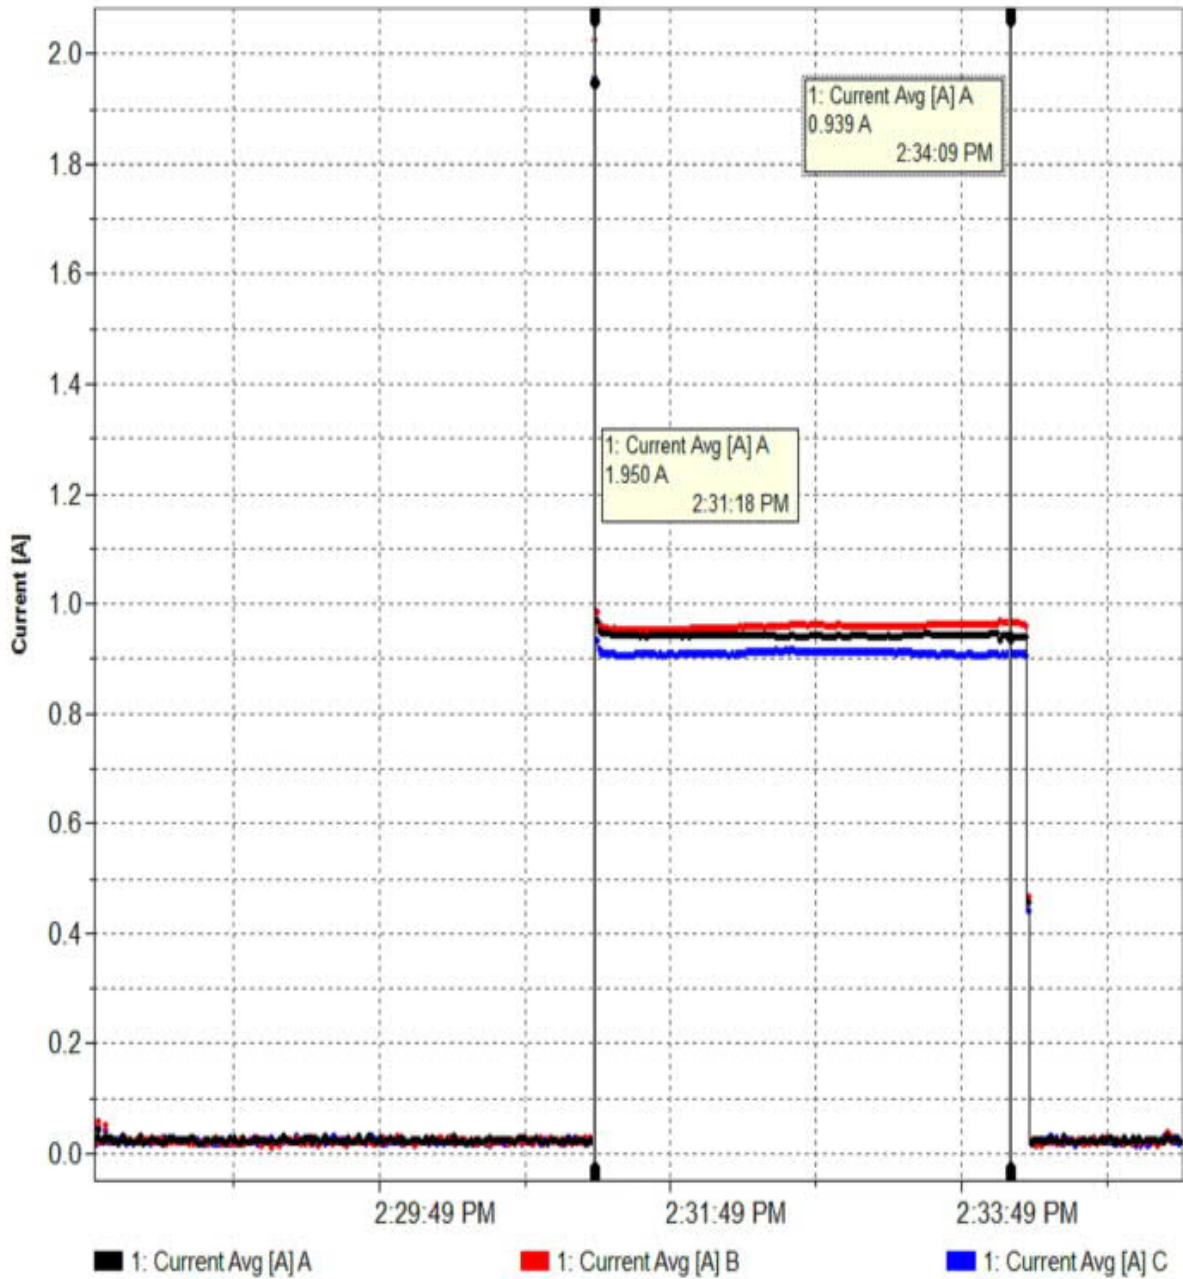
### North East Brake Thruster Motor

At span operation, output of the North-East brake thruster Motor ramped up to 2.096 Amps holding a steady value of 0.941 Amps throughout the bridge operation. This amperage value is within the manufacturer's operating conditions.

Note: Current transformers connected at motor disconnect.

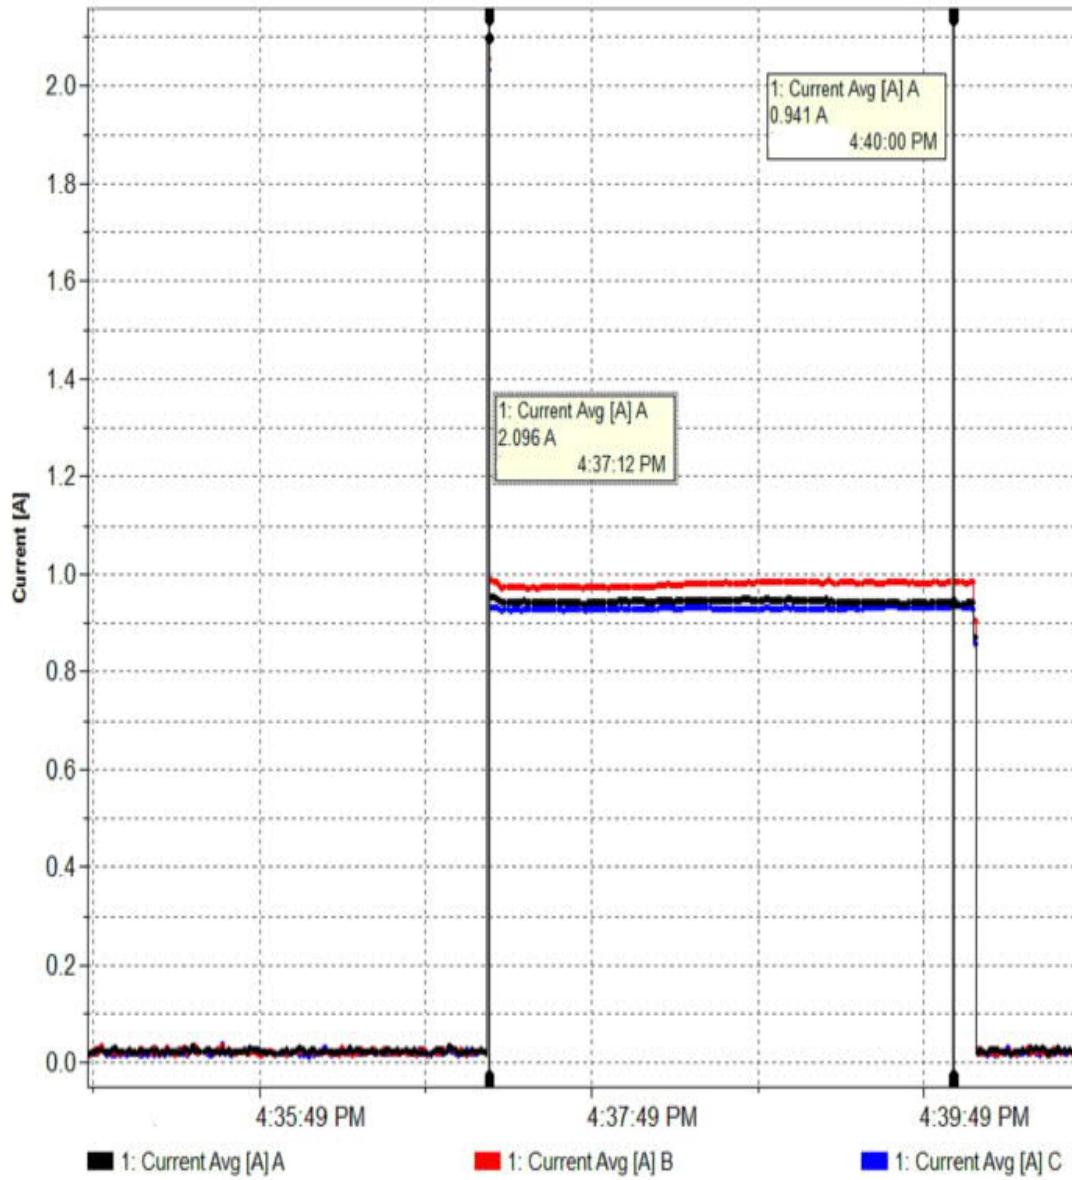
### North West Brake Thruster Motor

At the span operation, output of the North-West brake Thruster Motor ramped up to 1.95 Amps holding a steady value of 0.9 Amps throughout the bridge operation. This amperage value is within the manufacturer's operating conditions.

Note: Current transformers connected at motor disconnect.
