## **APPENDIX 4.4**

### **Cultural and Tribal Cultural Resources**

Re: Petaluma  
Evaluation of Main Barn, Garage and Small Storage Structures  
GECG Job No. 61608-N/A

Per your request, we visited the property at 1680 D Street, Petaluma, CA, to evaluate stability of the existing structures.

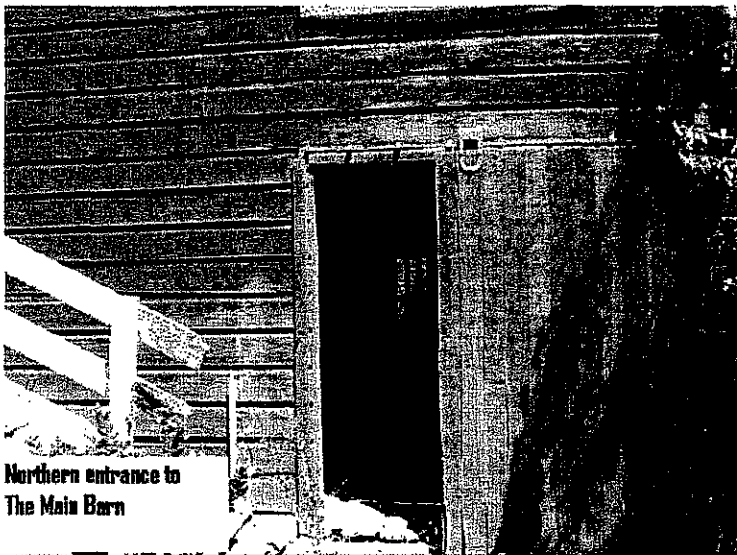
Northern entrance to  
The Main Barn

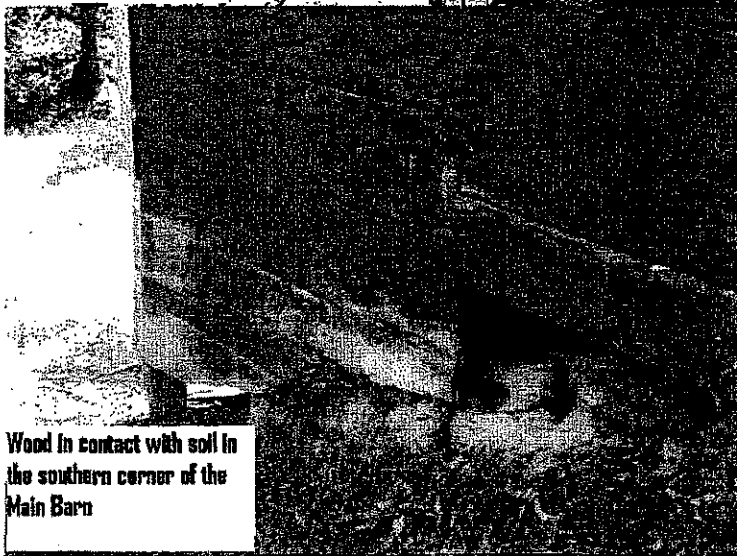
Foundations. The structure is not supported on a continuous foundation system. At the north side, the floor framing is placed directly on the ground (on cut onto the hill site ledge). The finished exterior grade is higher than the first floor and the floor framing is in contact with earth. The framing is not made up of preserved wood. At the south side, the floor is supported on approximately 2'-6" high cripple walls supported on 12"x12" pre-manufactured post base blocks that are without any confinement into the ground. Some of these blocks are tilted, losing bearing support and out of plumb. The blocks appear to have been added in recent past to provide additional support and preventing the structure from collapse. Interior girder's supports are sitting directly into the ground; so are some supports for the southeast corner of the building. Many supports have sustained dry rot and termite damage - most evident at southeast corner.

Wood in contact with soil in  
the southern corner of the  
Main Barn

storage structures, additional framing at exterior walls will be required to provide minimum bearing of 1.5" for the floor joists and full height floor blocking at interior support is required. All framing of the Main Barn below the floor needs to be removed and replaced. This is due to the fact that a large portion of the first floor framing is damaged due to being in contact with earth. Window and door openings should be re-framed.

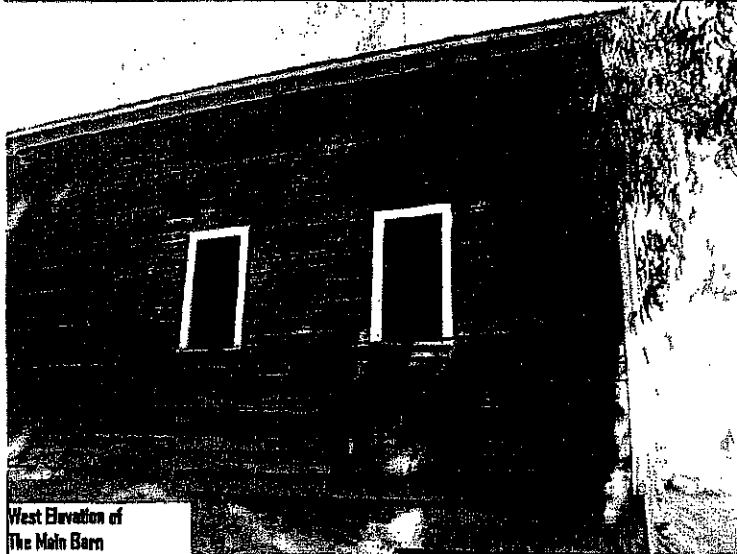
West Elevation of  
The Main Barn

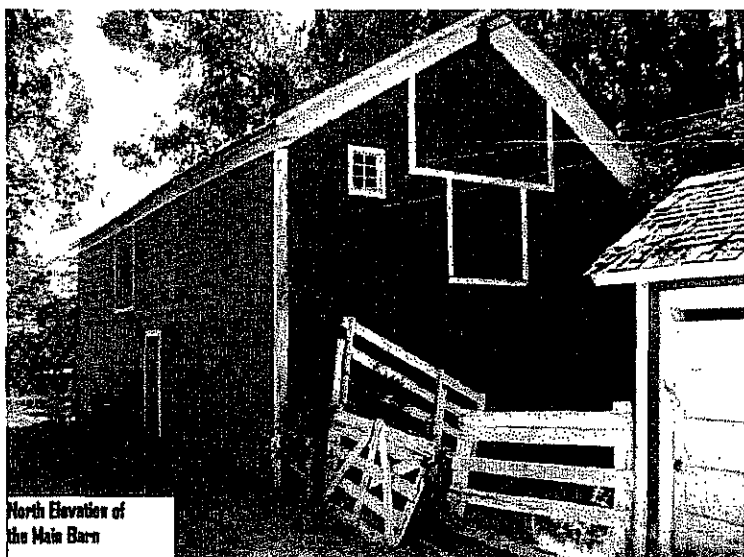
North Elevation of  
the Main Barn

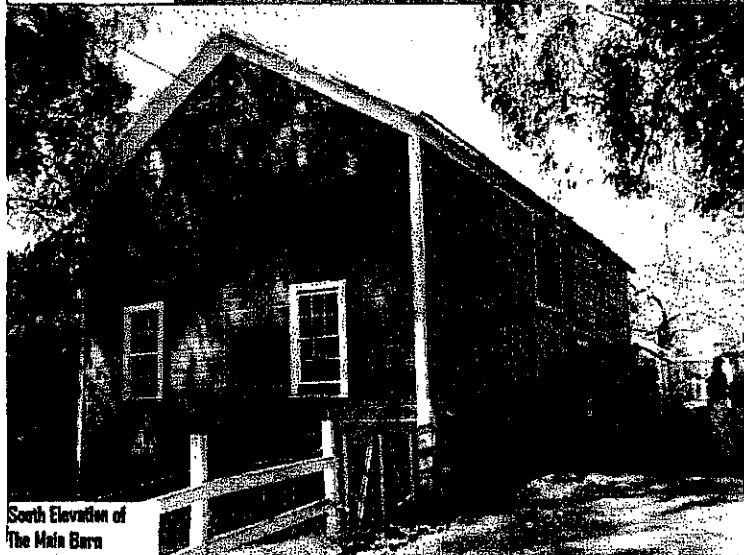
South Elevation of  
The Main Barn

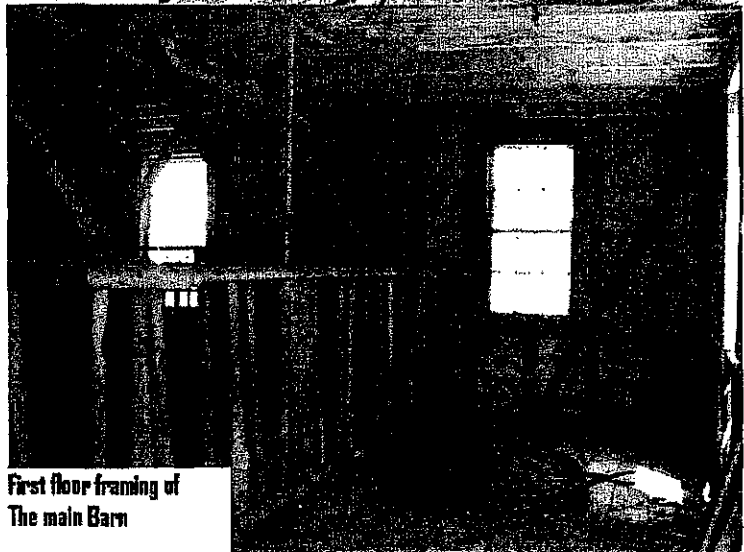
First floor framing of  
The main Barn

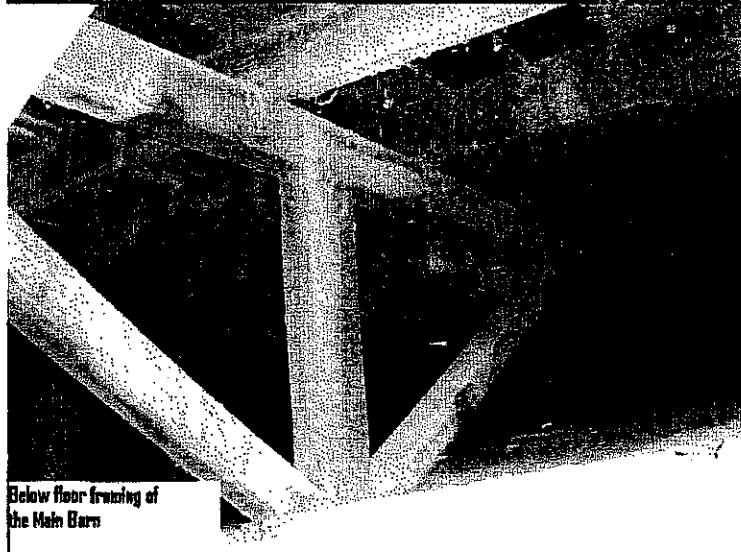
Below floor framing of  
the Main Barn

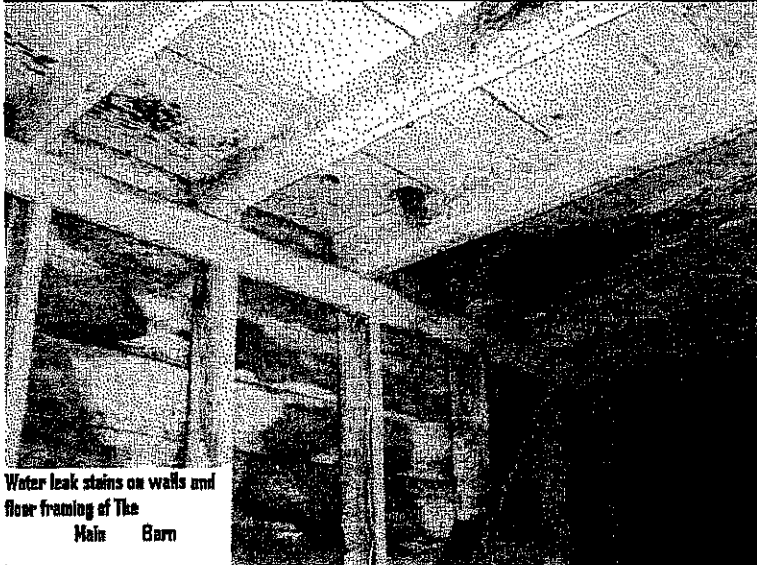
Water leak stains on walls and  
floor framing of The  
Main Barn

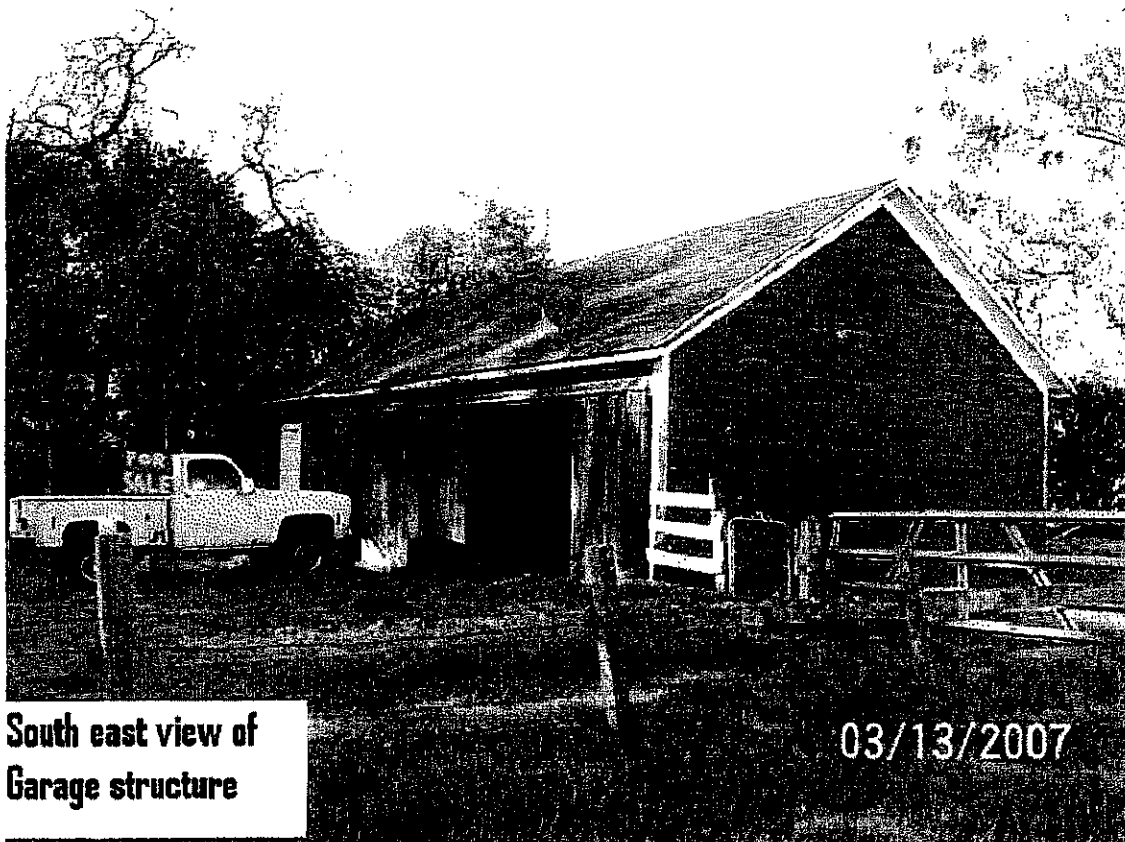
South east view of  
Garage structure

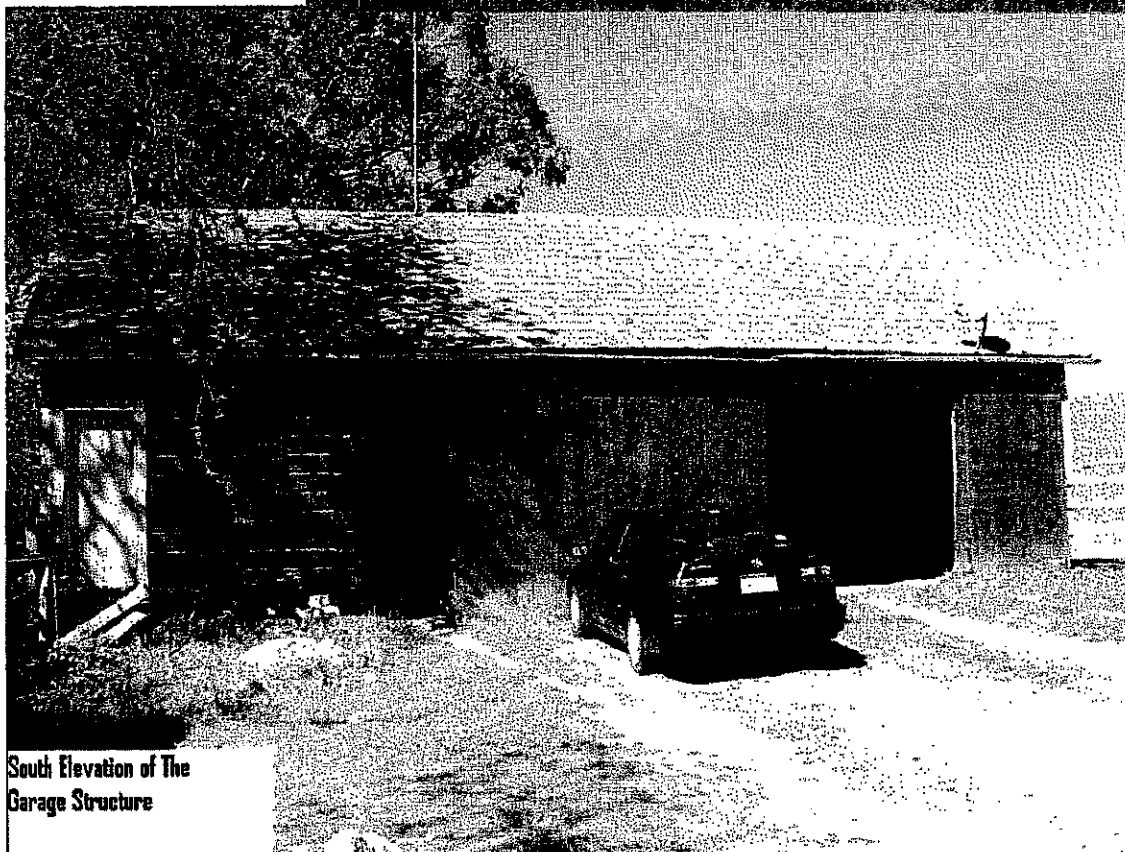
South Elevation of The  
Garage Structure

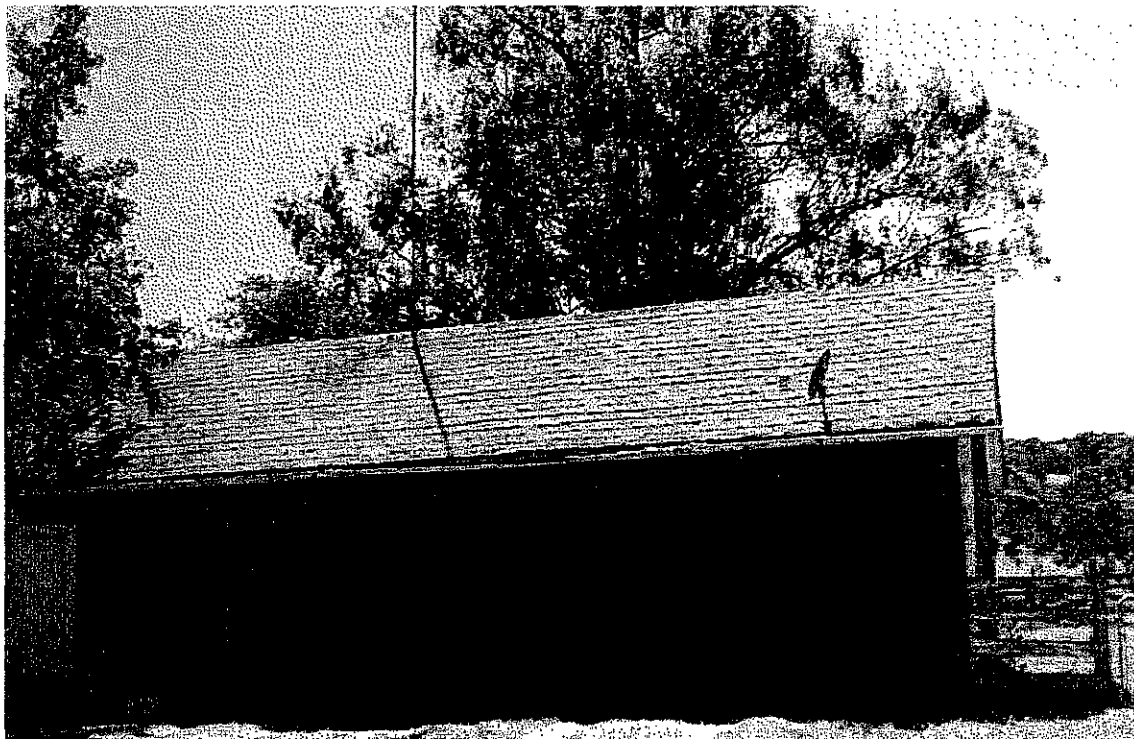
**South Elevation of  
Garage structure**

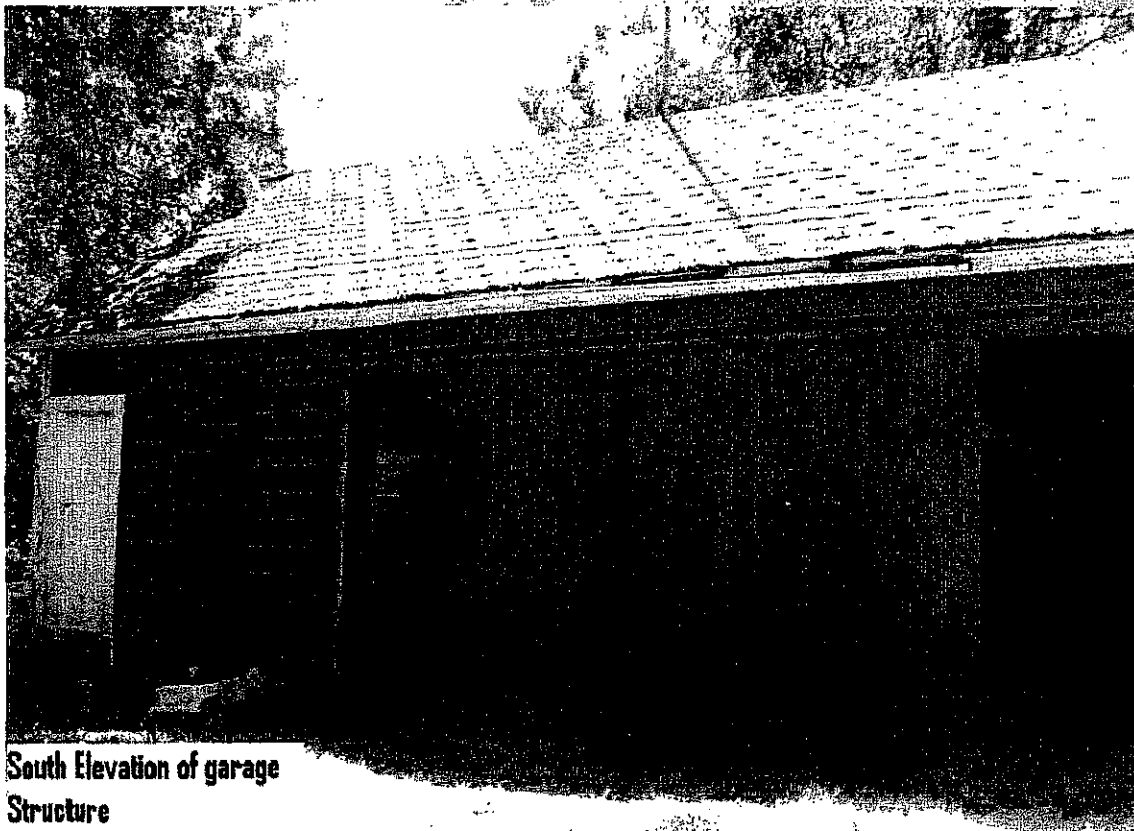
**South Elevation of garage  
Structure**

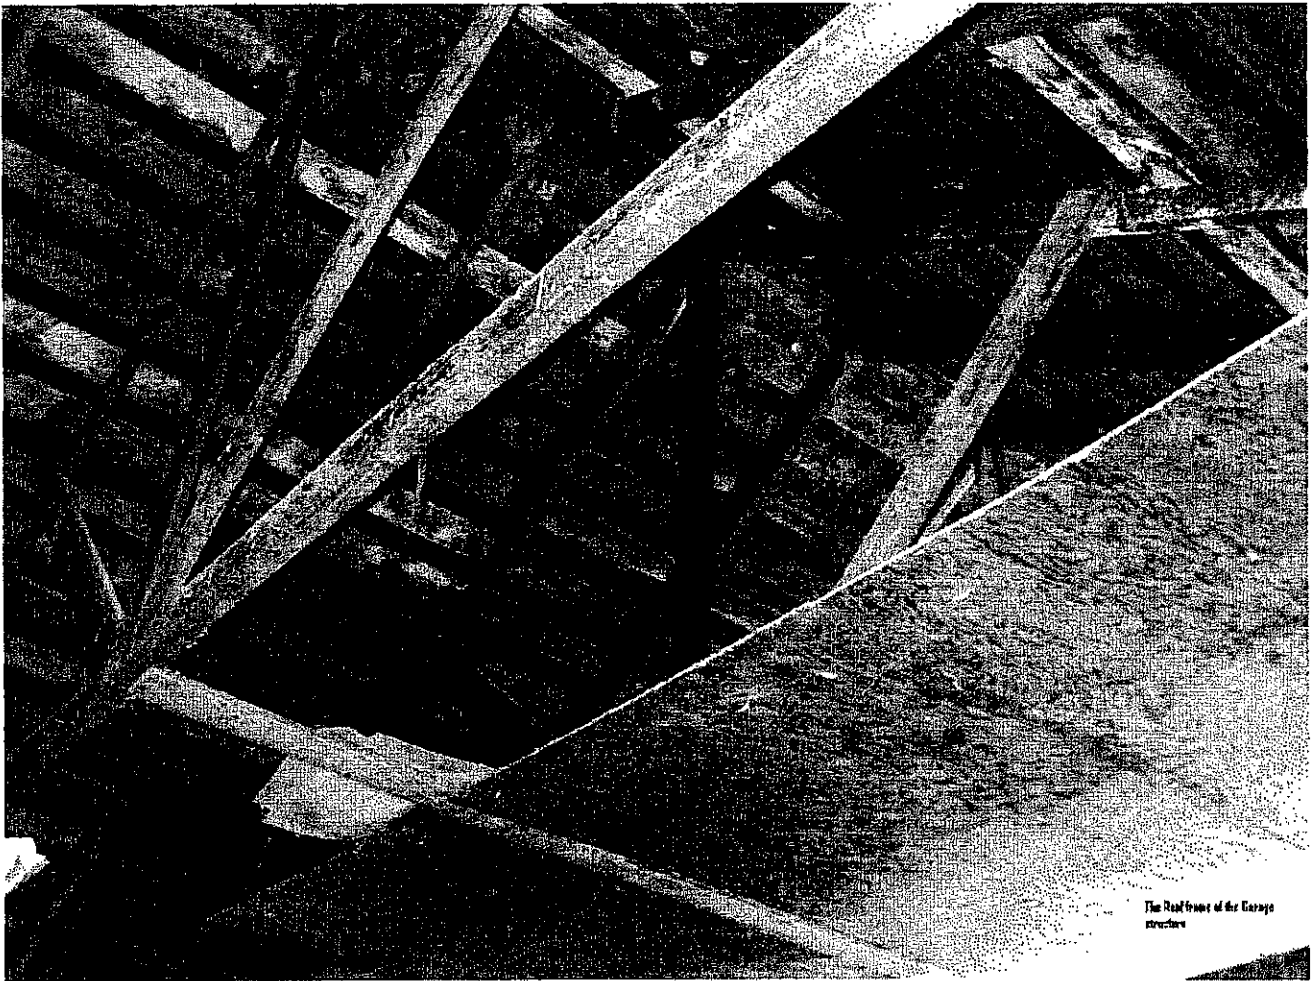
The Roof frame of the Garage  
structure

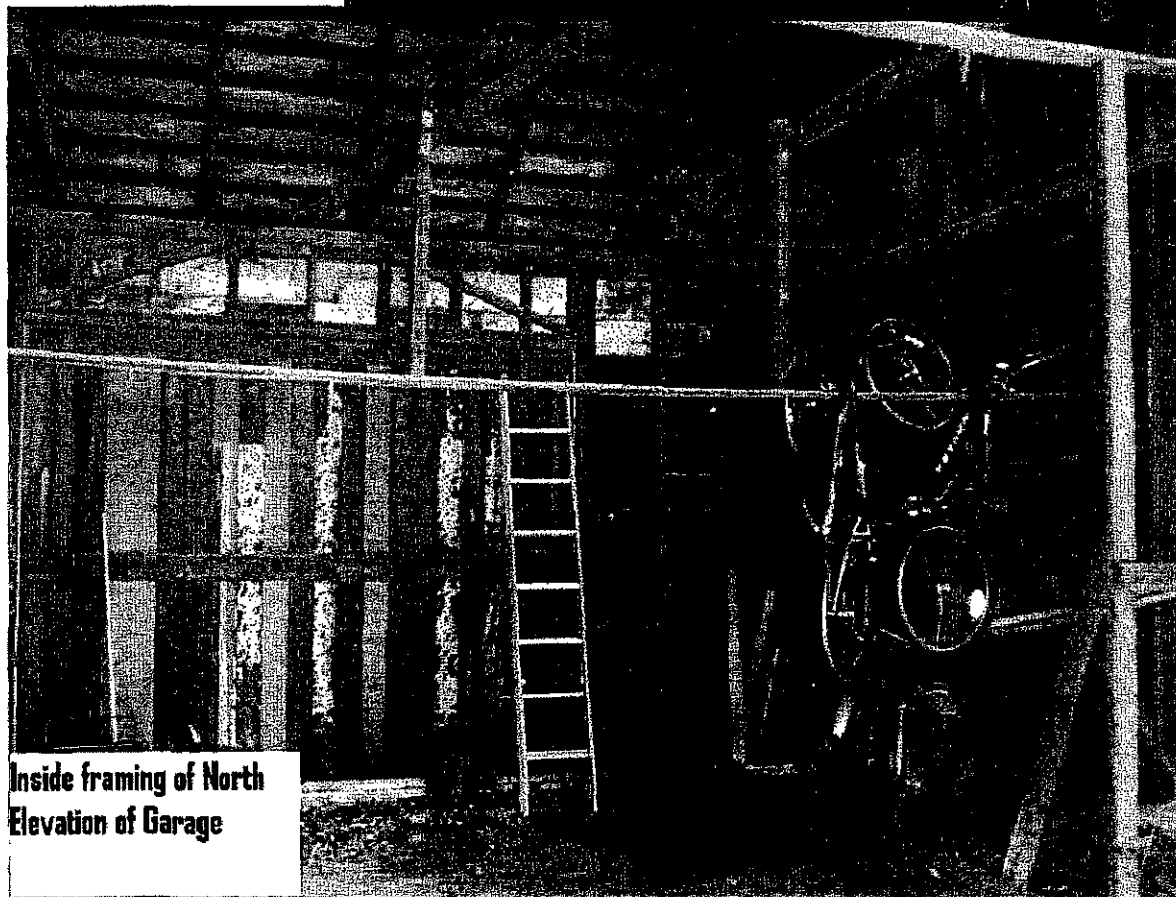
**Inside framing of North  
Elevation of Garage**

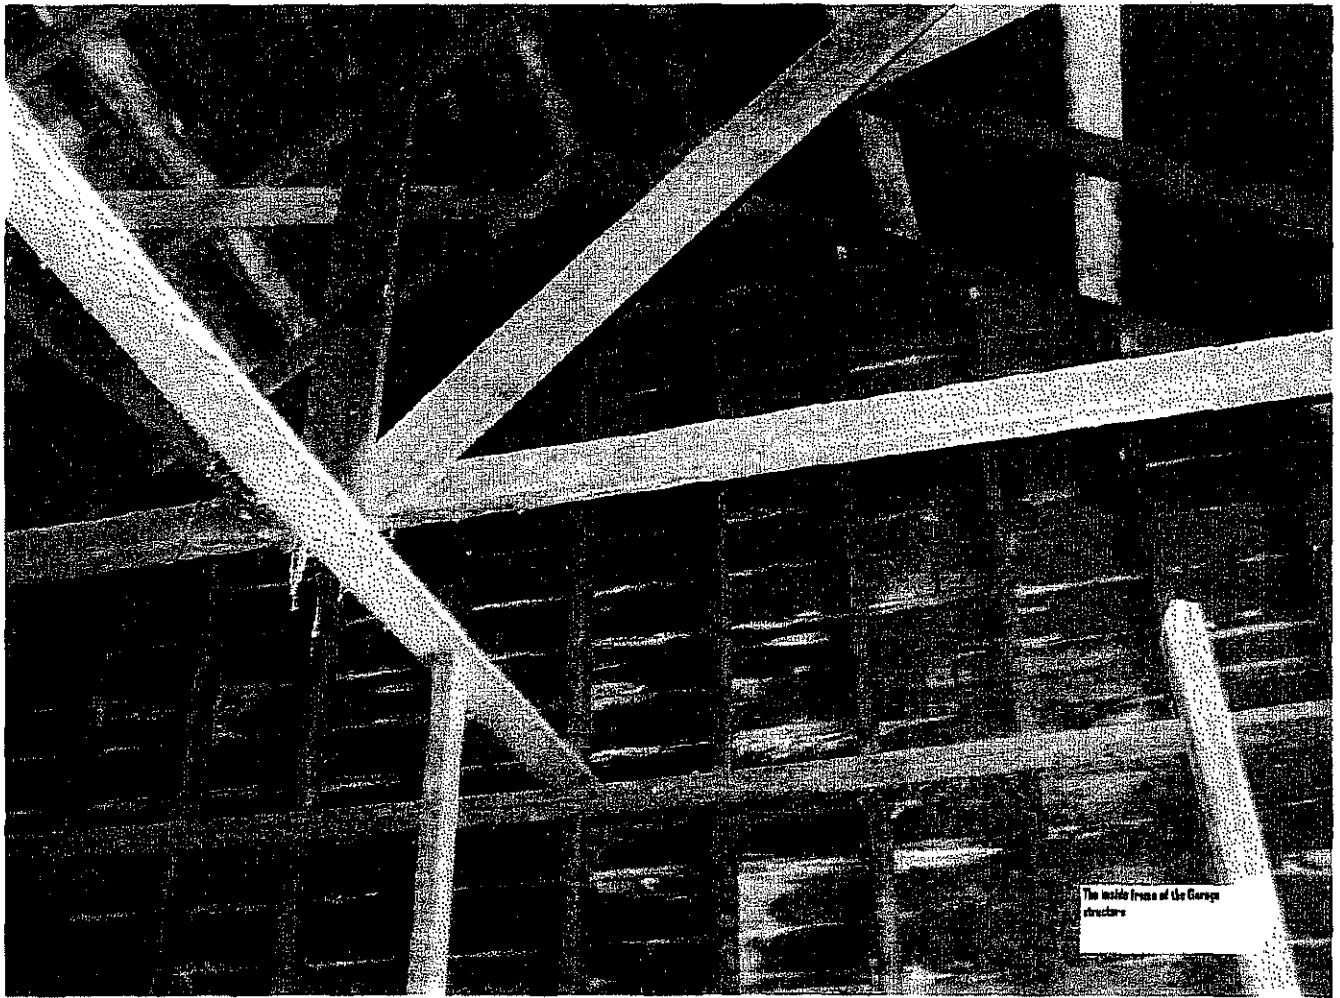
The inside frame of the Garage structure

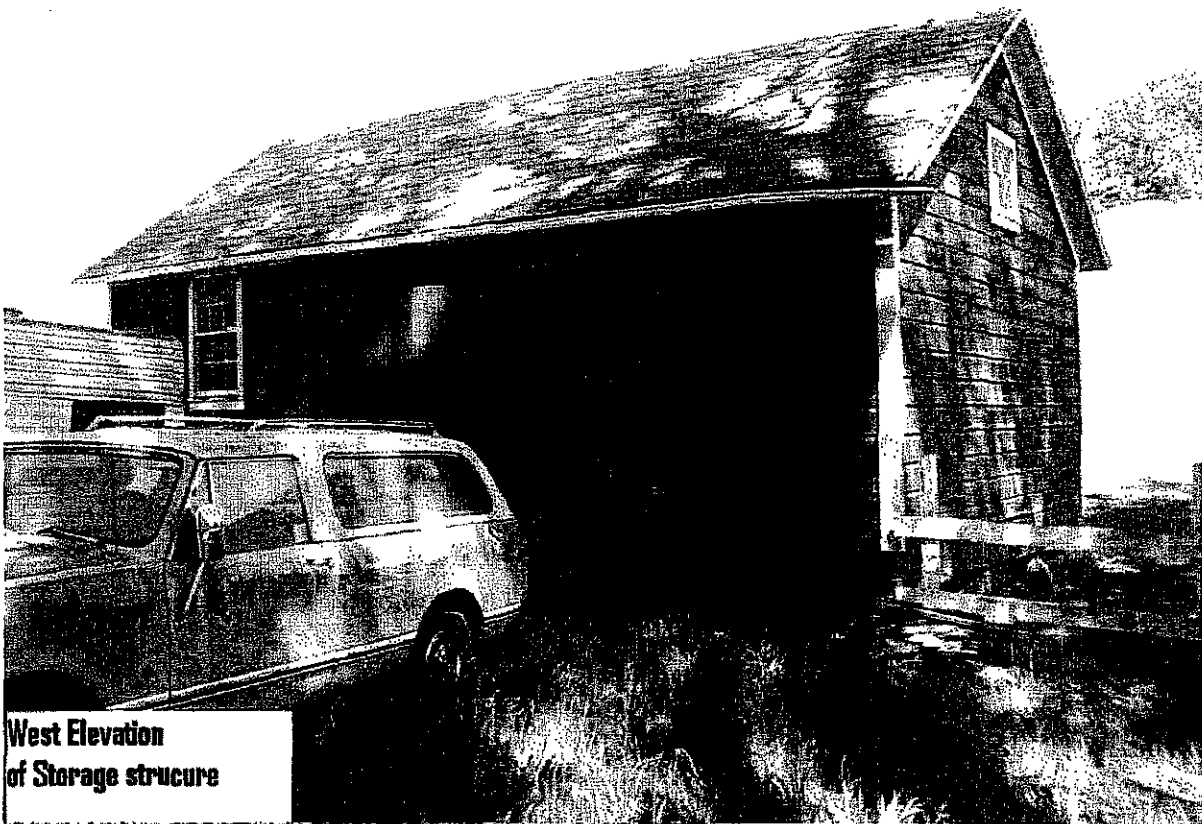
**West Elevation  
of Storage structure**

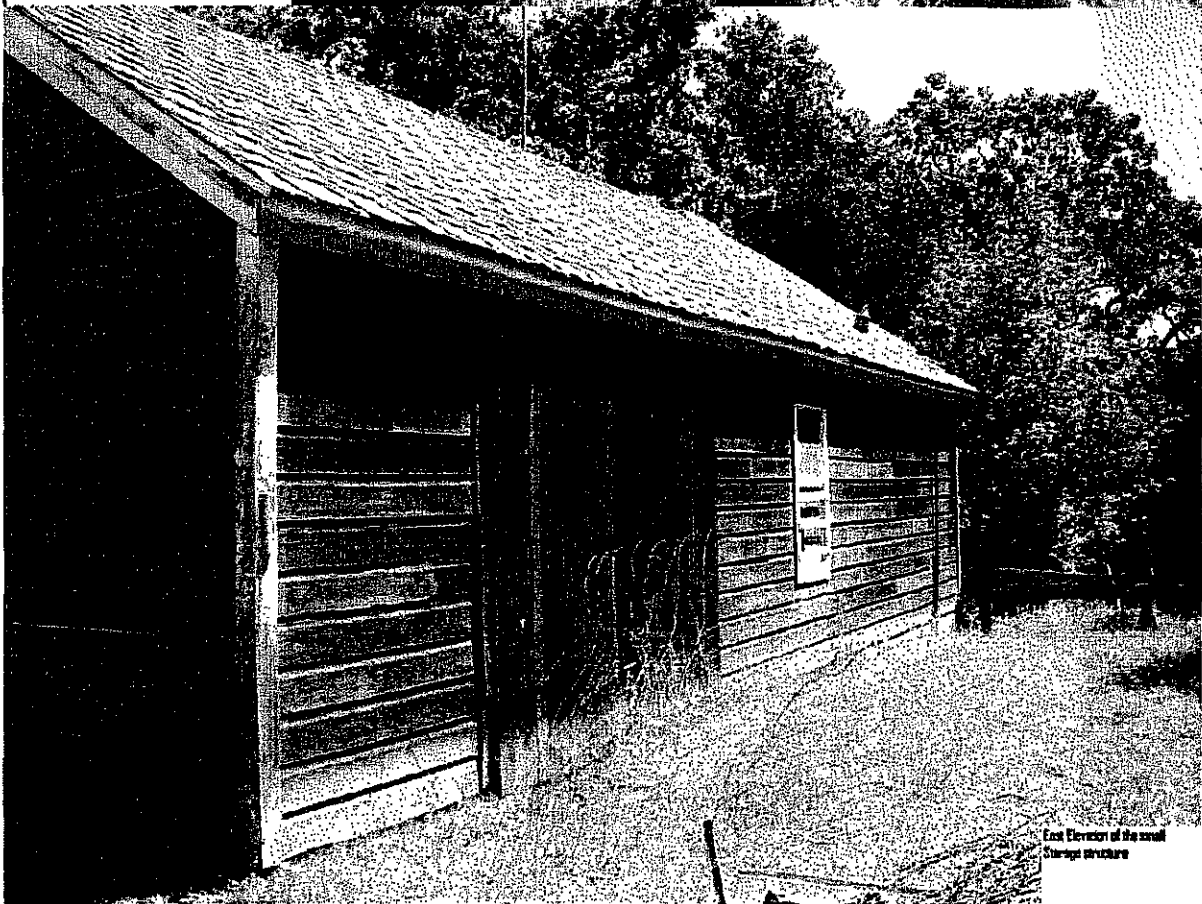
**East Elevation of the small  
Storage structure**

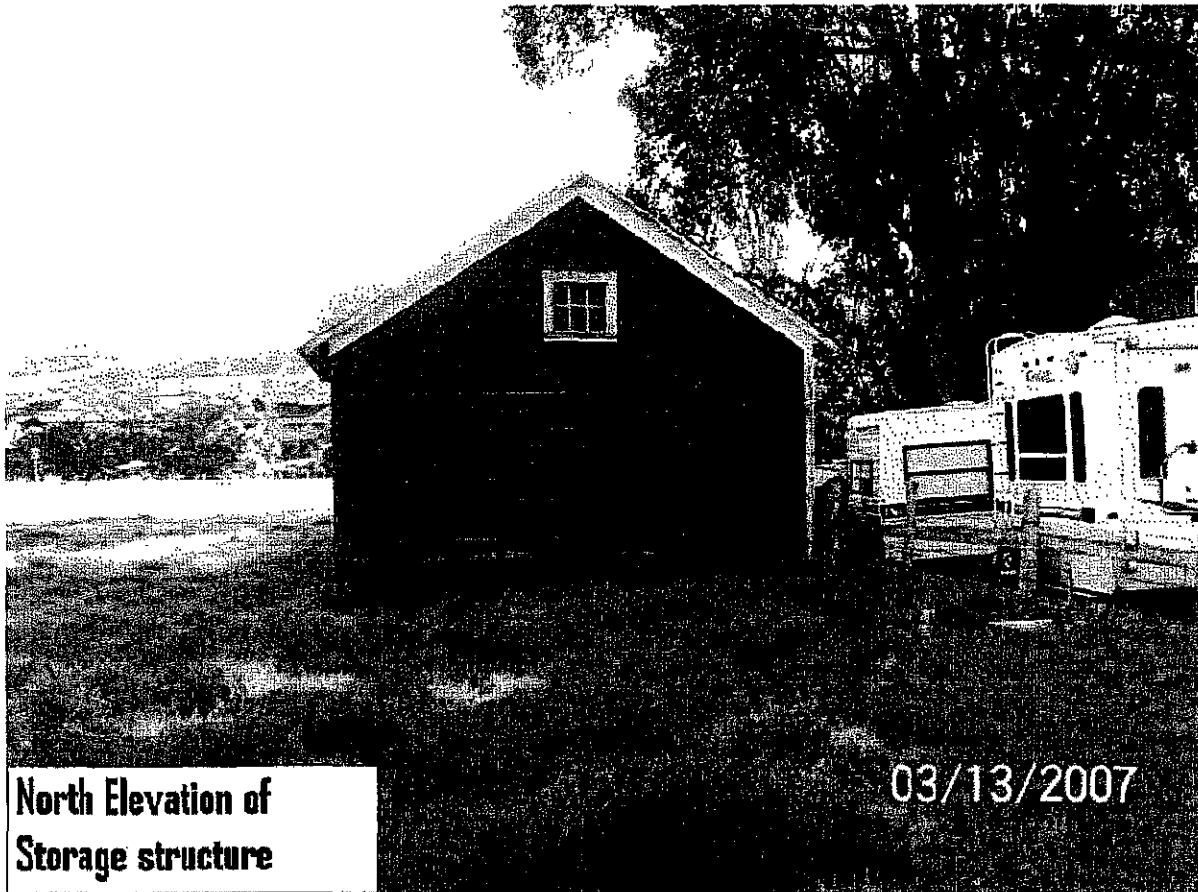
**North Elevation of  
Storage structure**

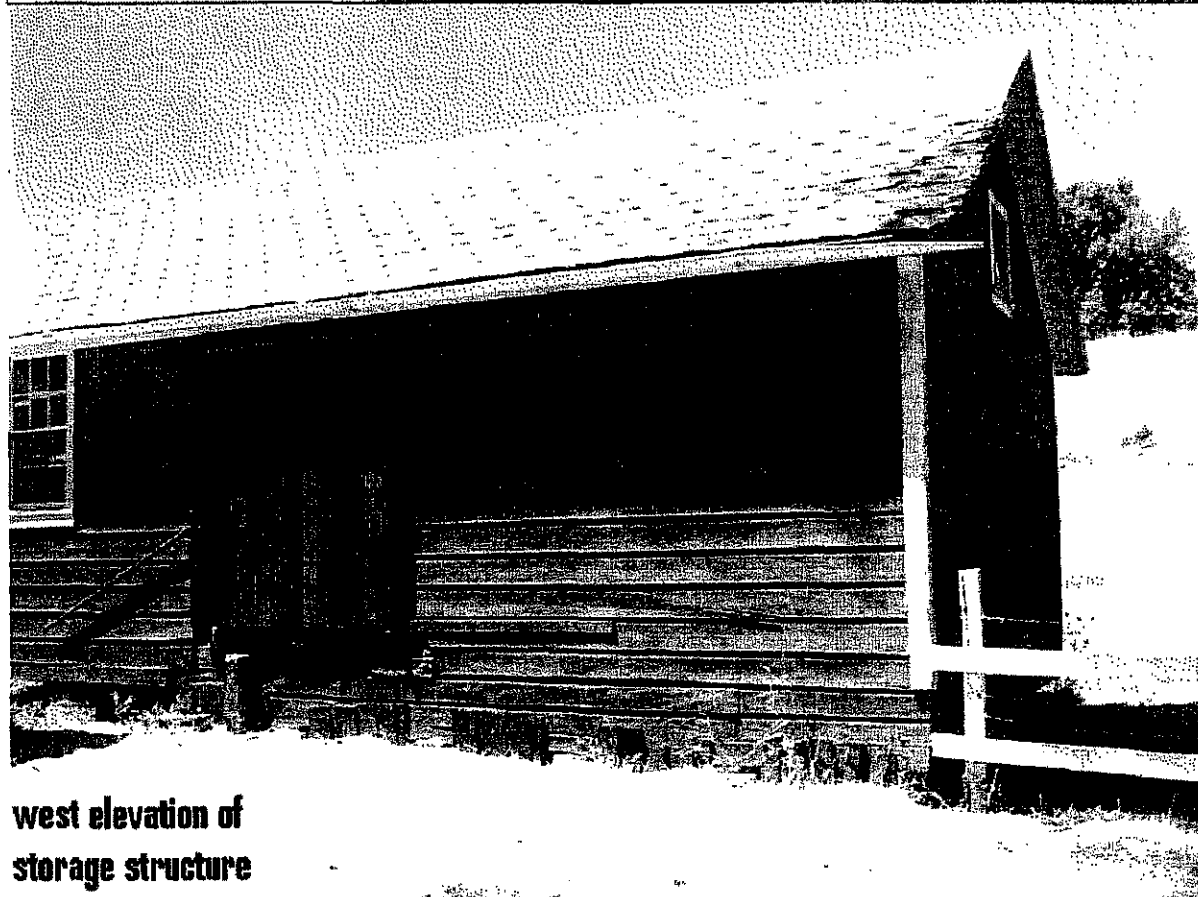
**west elevation of  
storage structure**

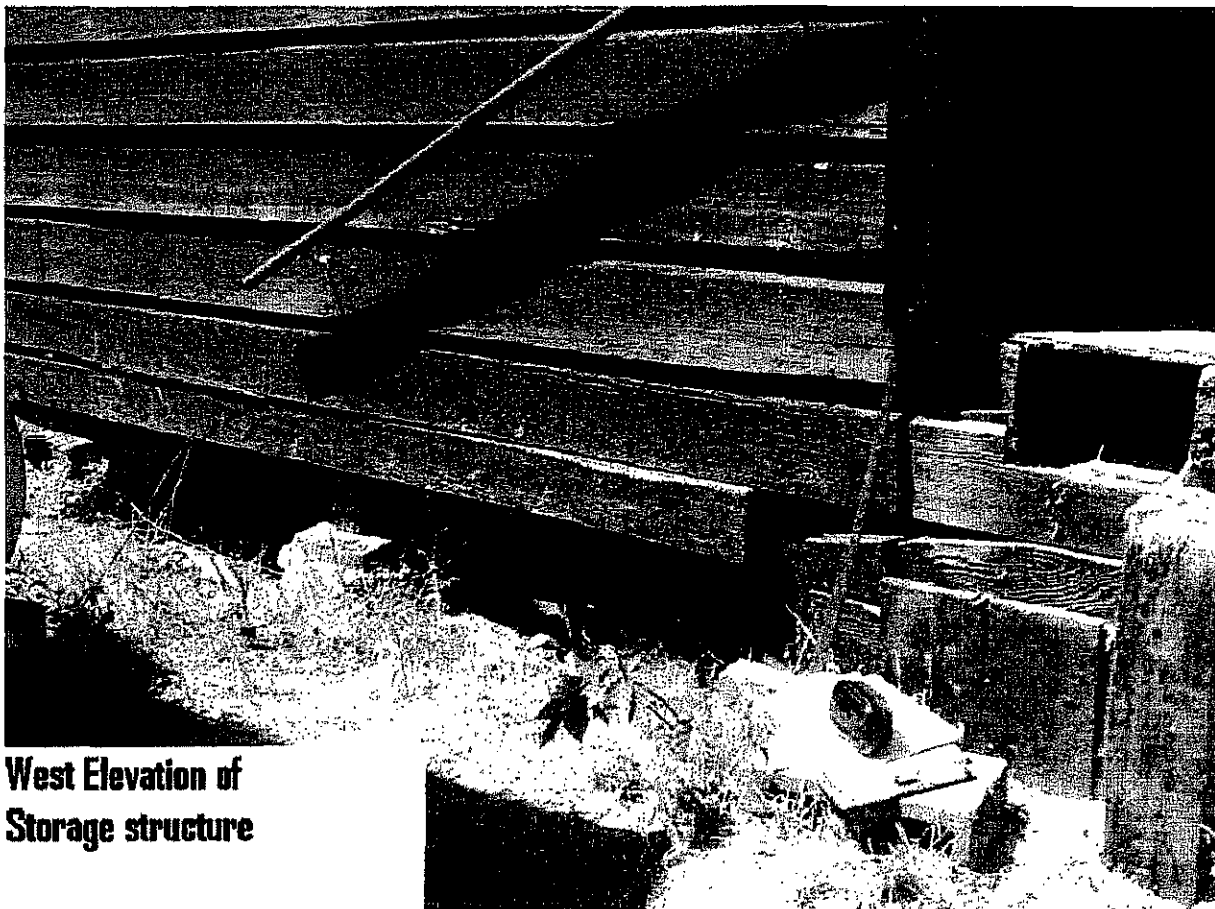
**West Elevation of  
Storage structure**
