RBMC- Petaluma Subdivision Tree Inventory and Assessment Report

July 1, 2019

RBMC-Petaluma Subdivision- Tree Inventory and Assessment Report

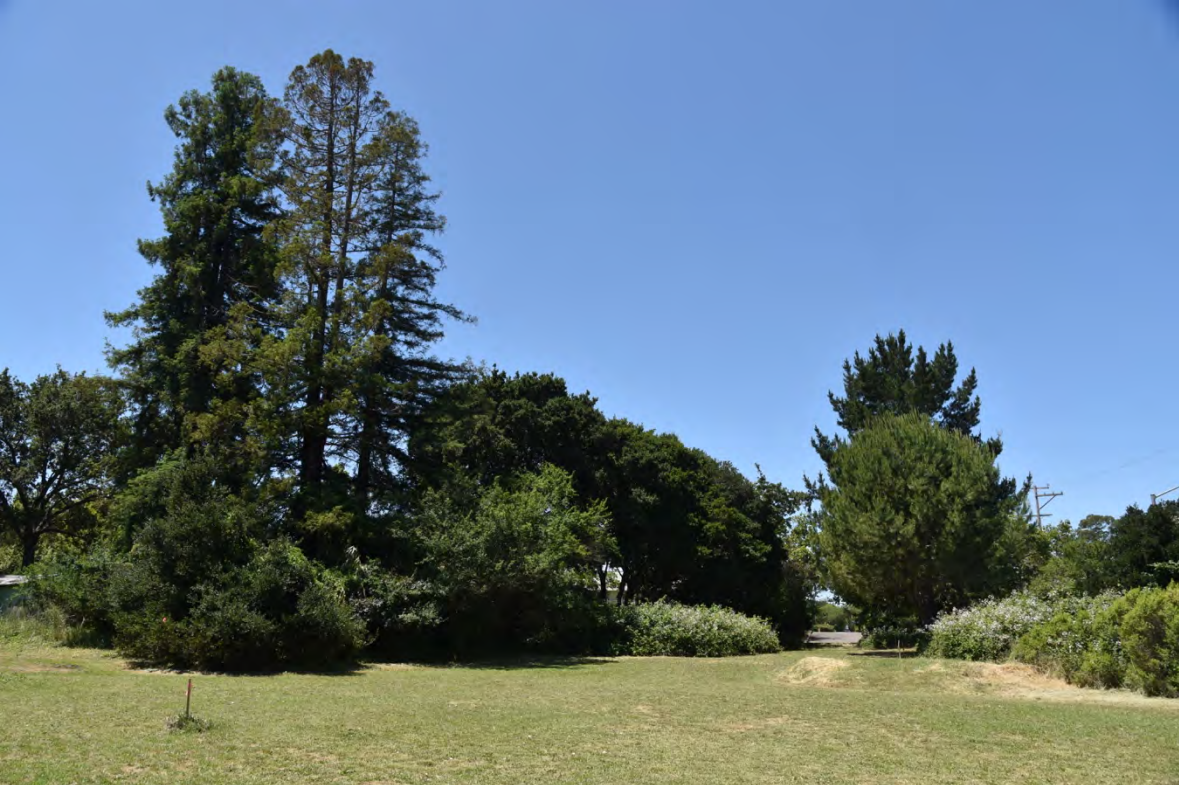
View of tree vegetation to the west from center of property showing coast redwoods, oaks, and pines.

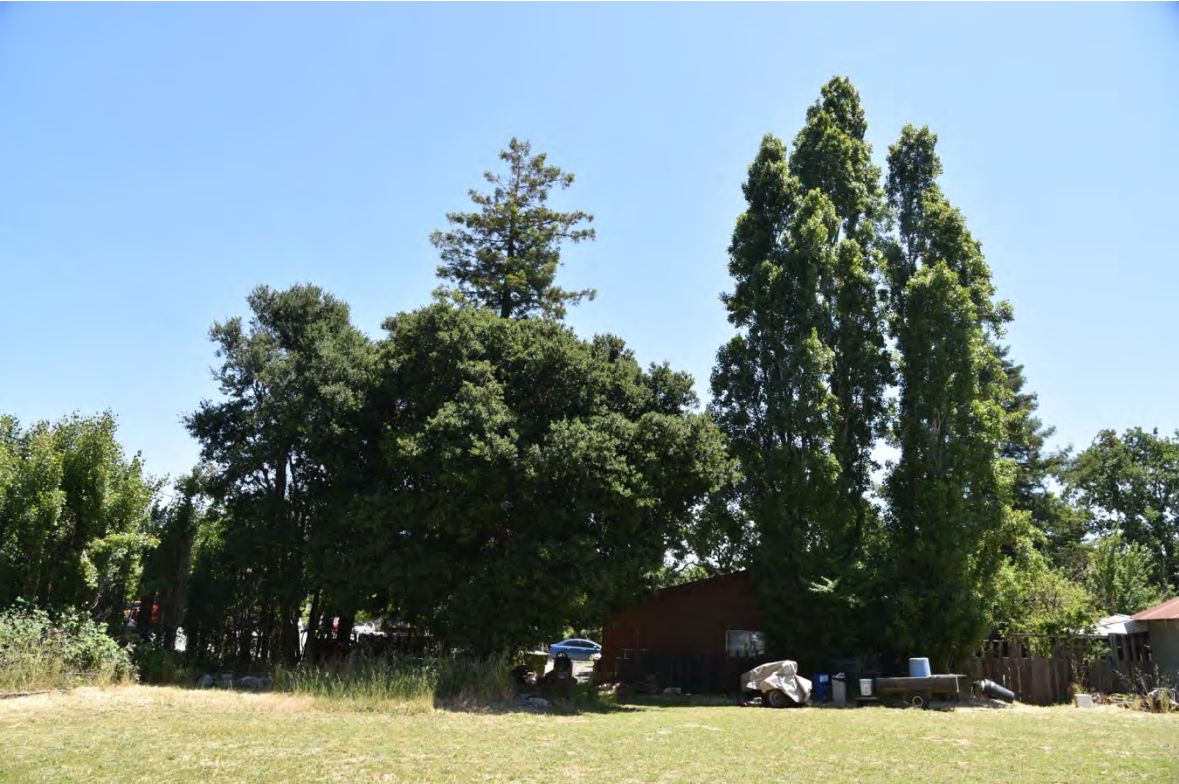
View of west side of residence on S. Petaluma Blvd. showing Lombardy poplars, oaks, and redwood.

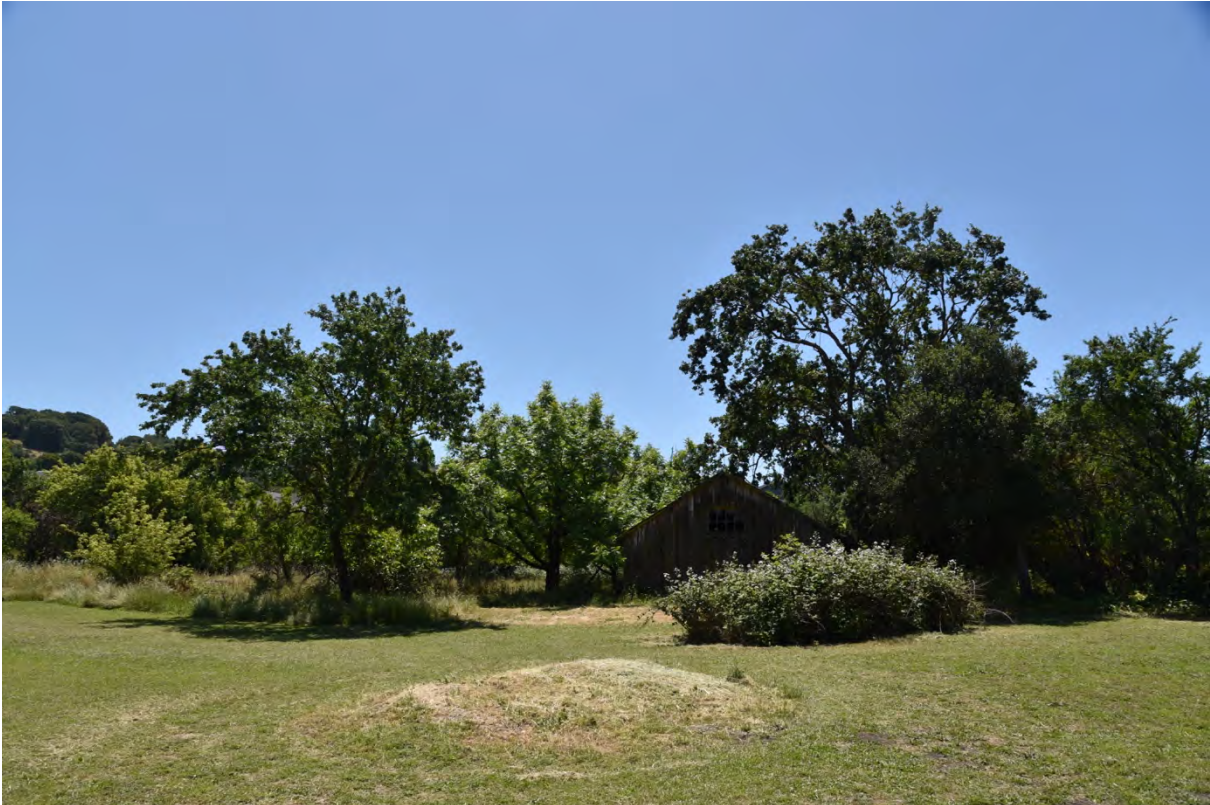
View of oaks and black walnuts around barn in center of property.

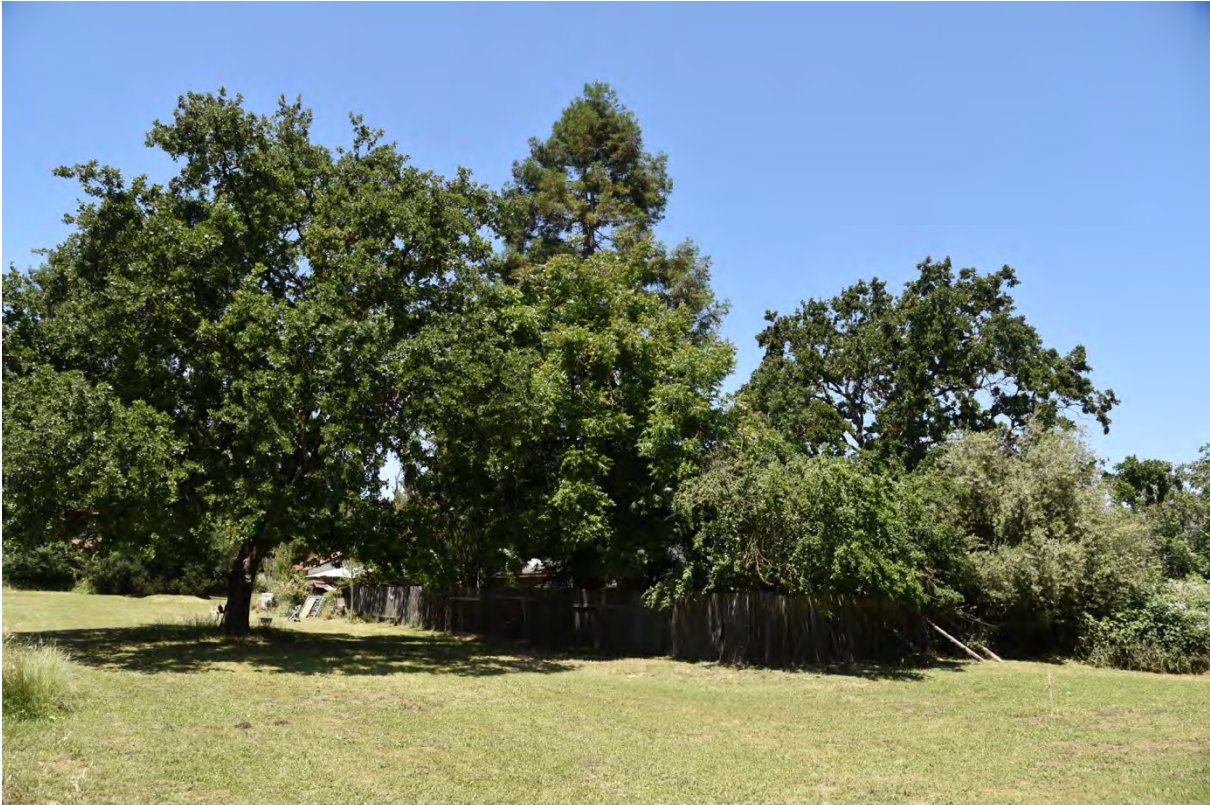
Mature valley oak and trees in rear portion of S. Petaluma residence.

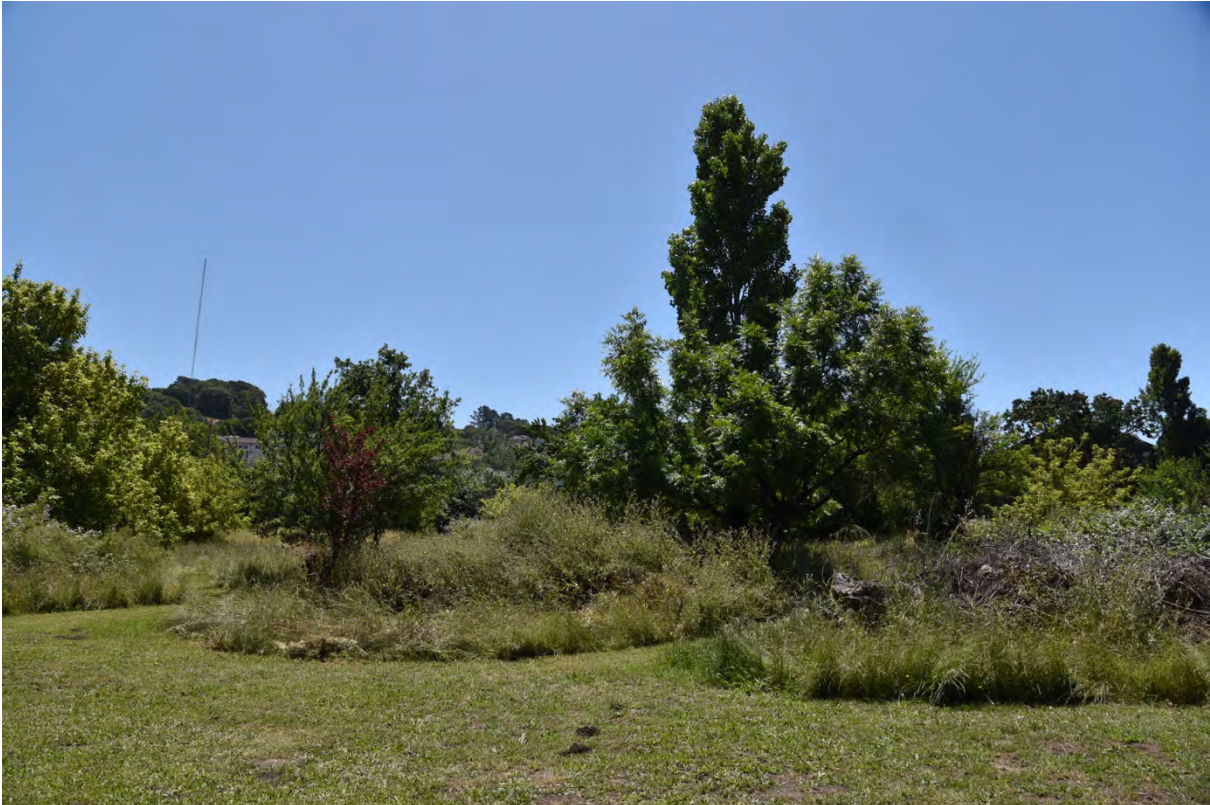
View of center portion of property to east with smaller oaks, black walnuts, and box elders. Lombardy poplar is in background.

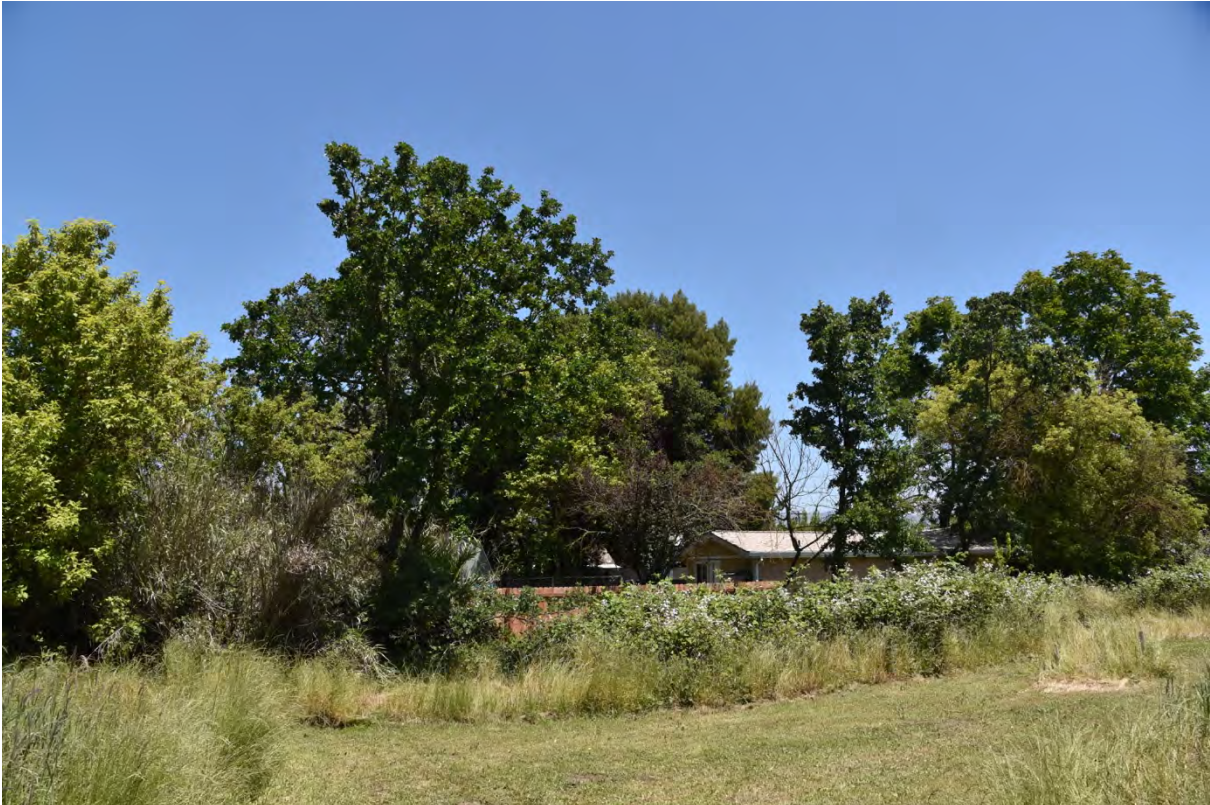
View of vegetation in rear area behind residence at northeast corner of the property/

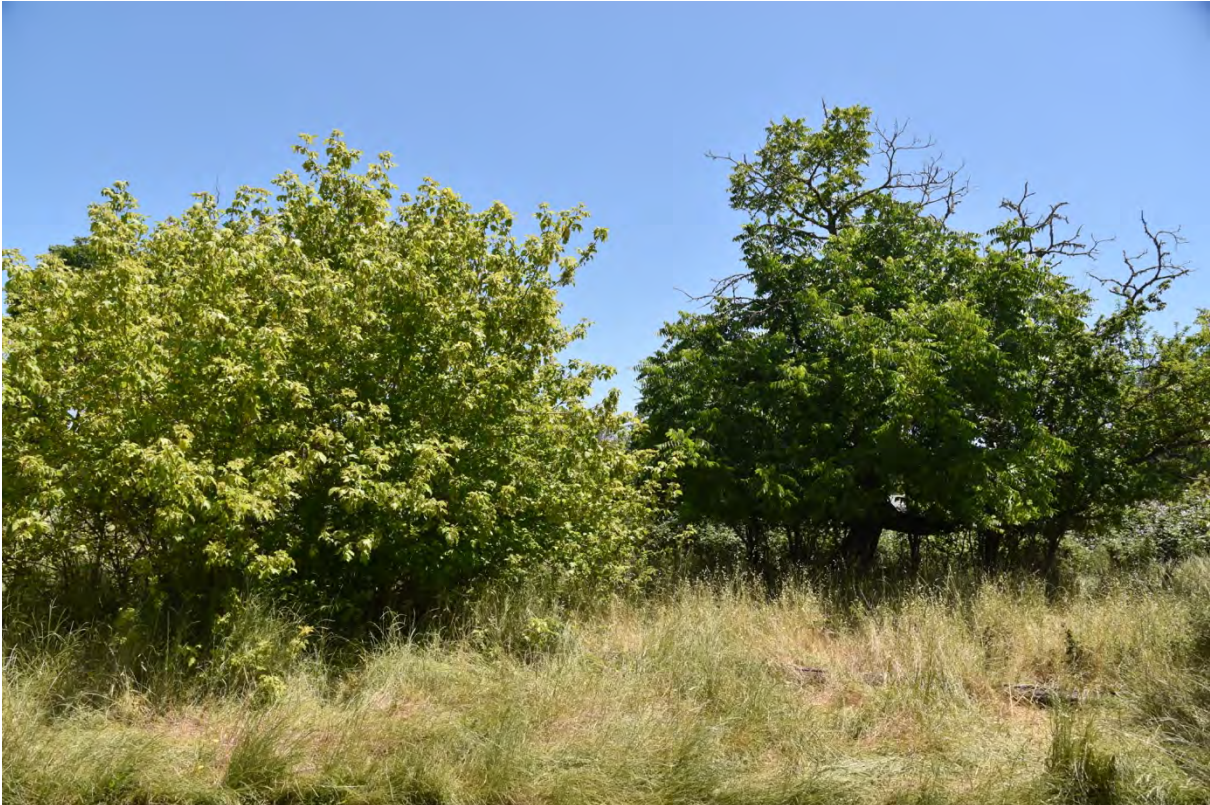
Box elder and black walnut in center of property.

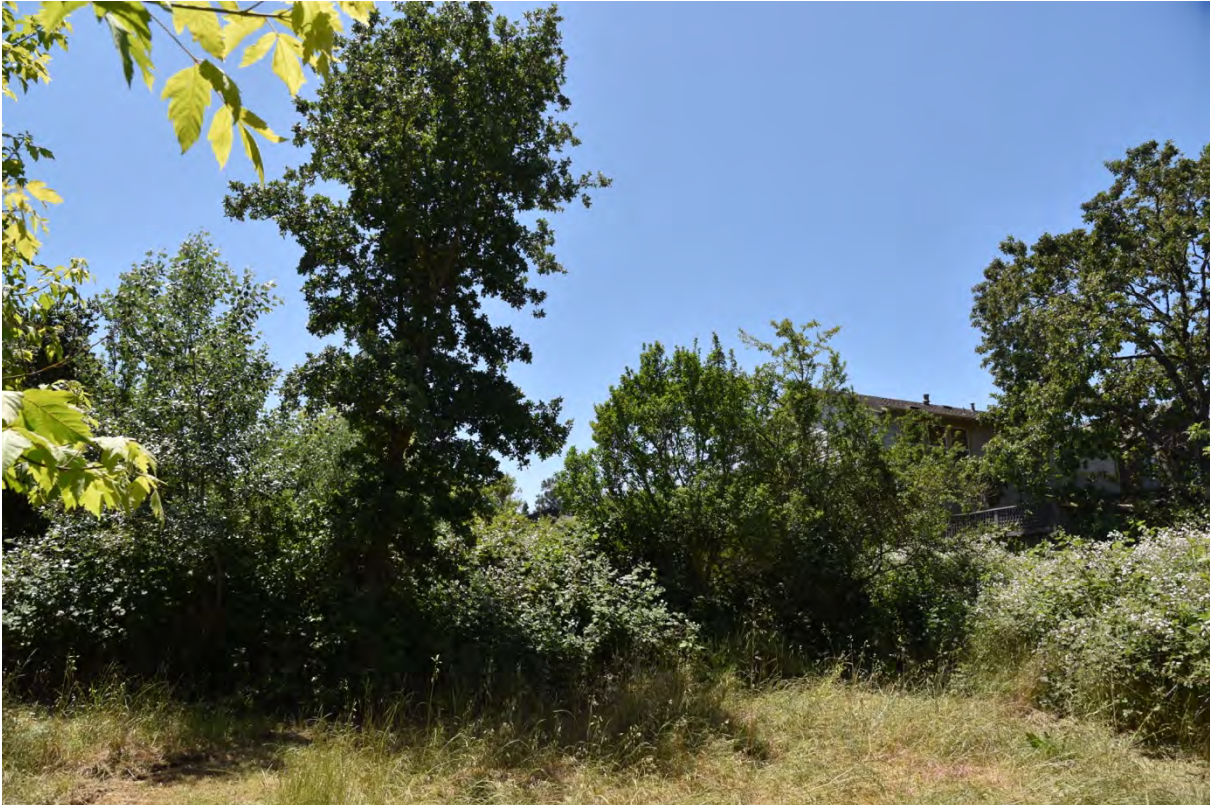
Area with dense blackberries and oaks near south edge of property.

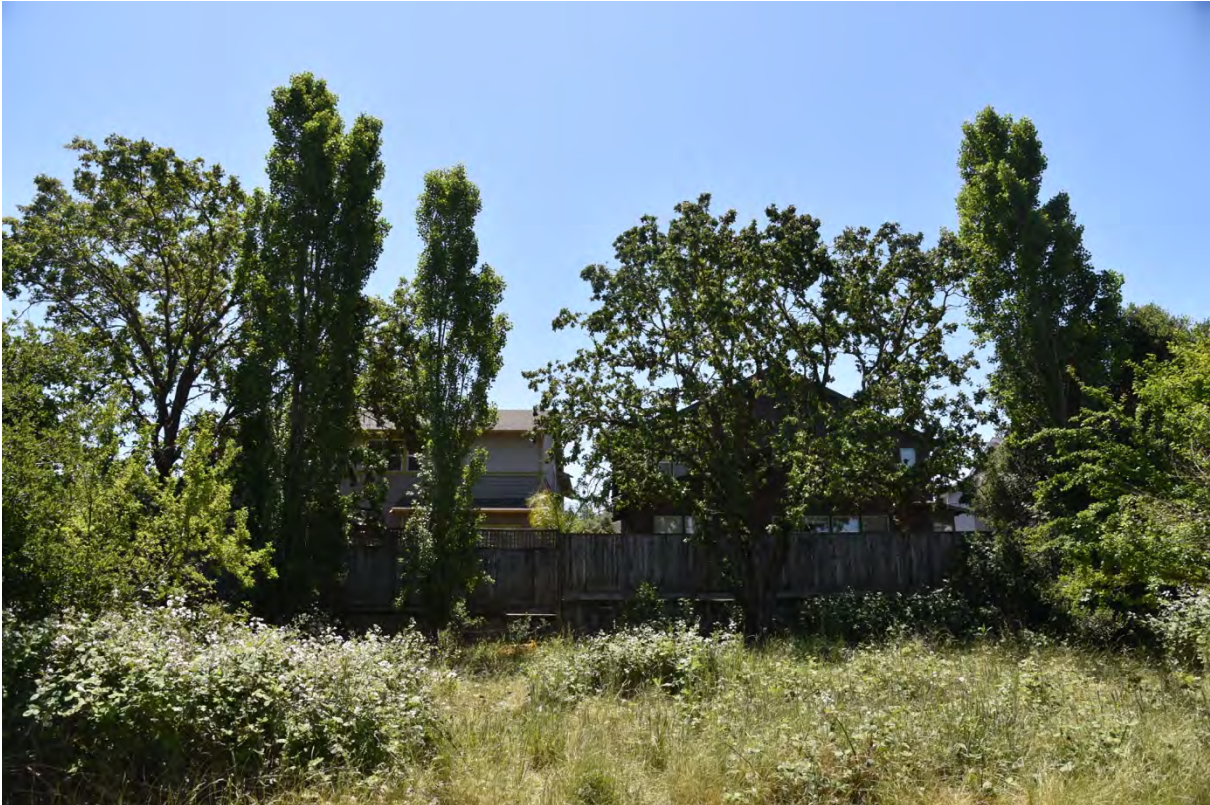
View of oaks and Lombardy poplars along south property line.

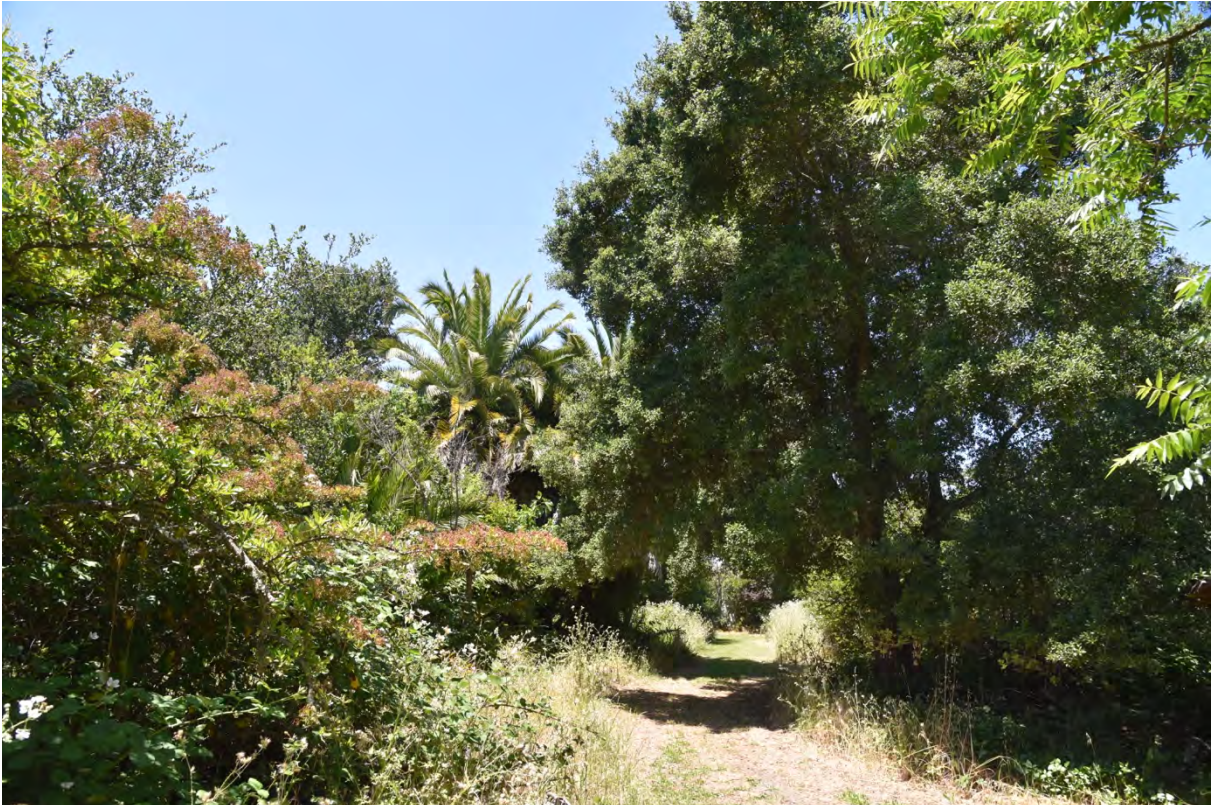
Dense vegetation in southwest portion of property.

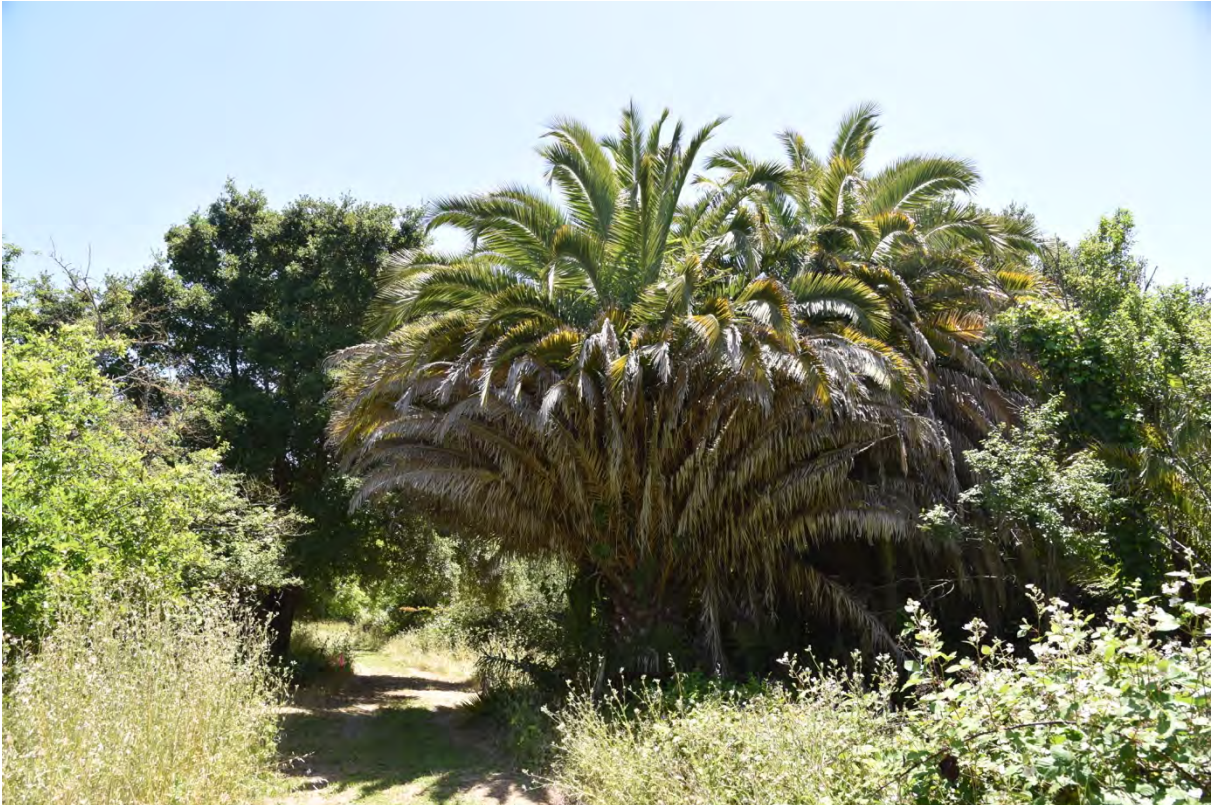
Canary Island date palms are prominent in southwest portion of property.

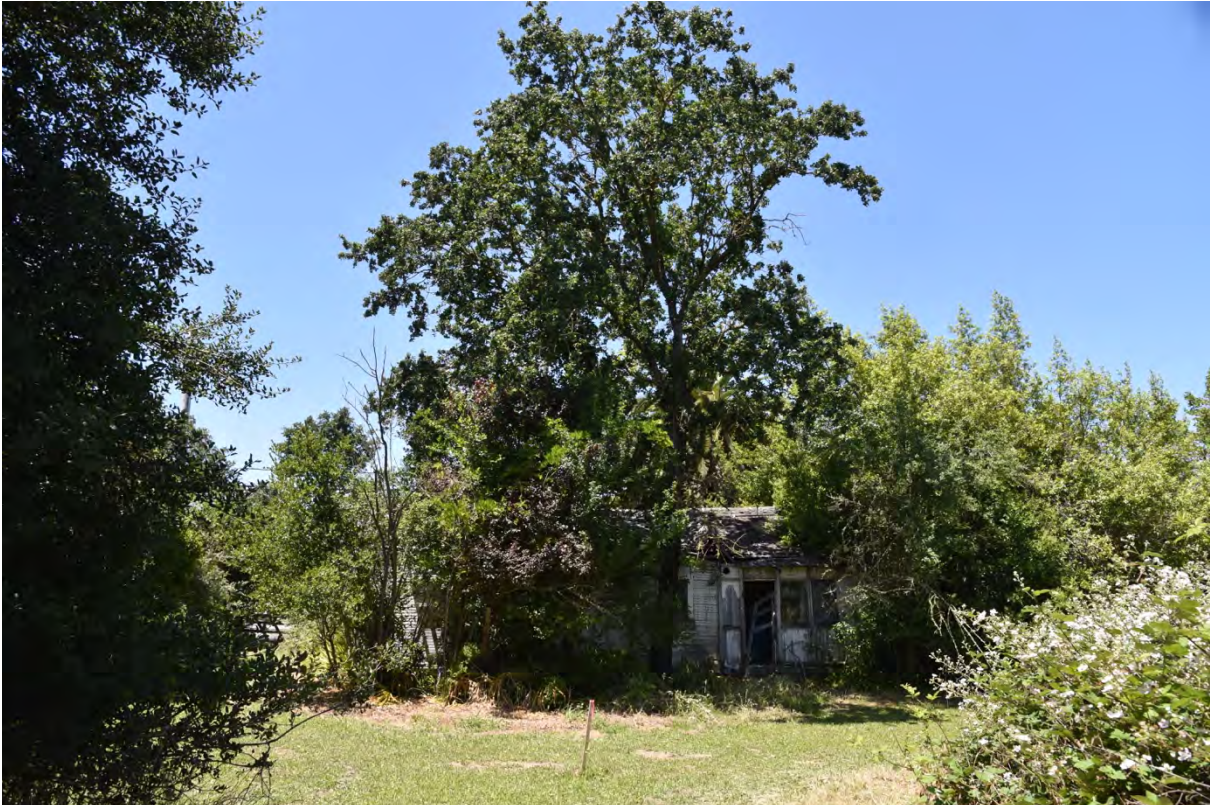
Valley oak growing adjacent to original residence on Mc Near Avenue.

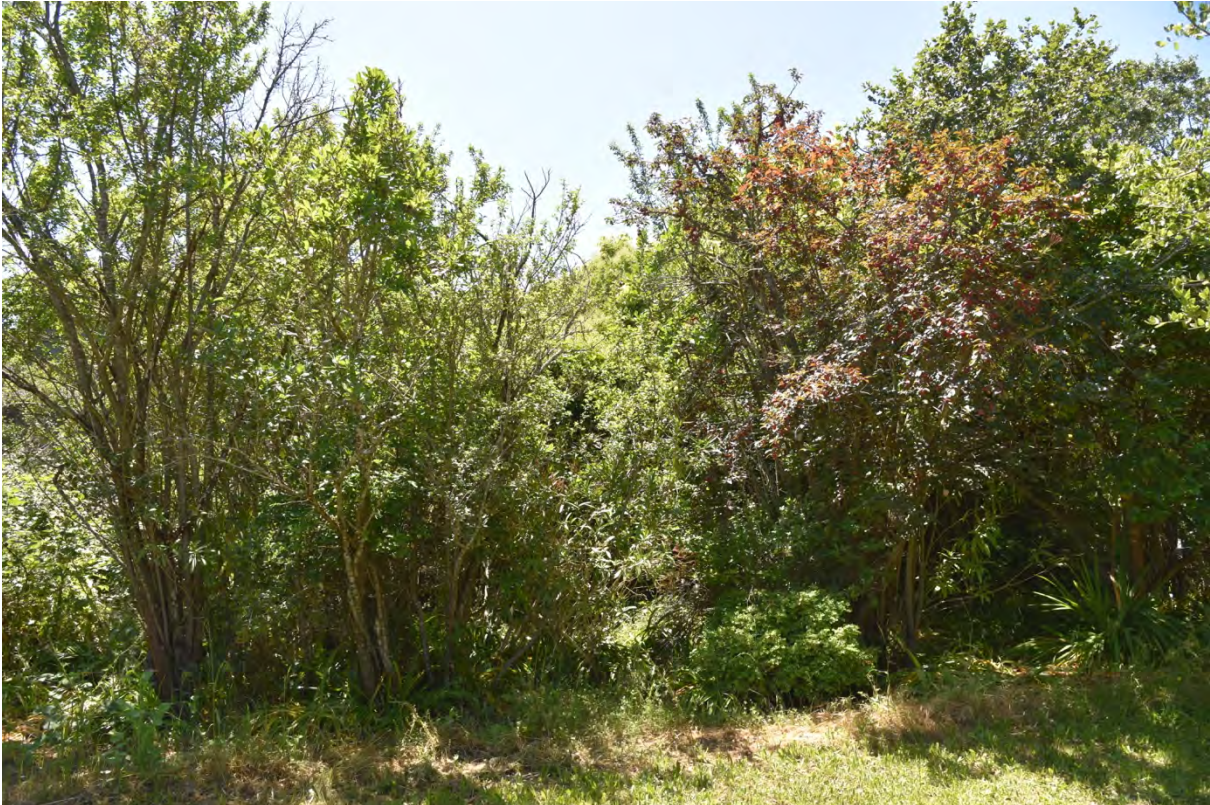
It should be noted that this inventory did not capture all of the volunteer seeding plums and glossy privet (*Ligustrum lucidum*) growing on the site. These two species have naturalized and are not considered significant tree species. The general location of these trees is noted on the Tree Numbering and Location Plan.

Dense areas of volunteer plums and glossy privet.

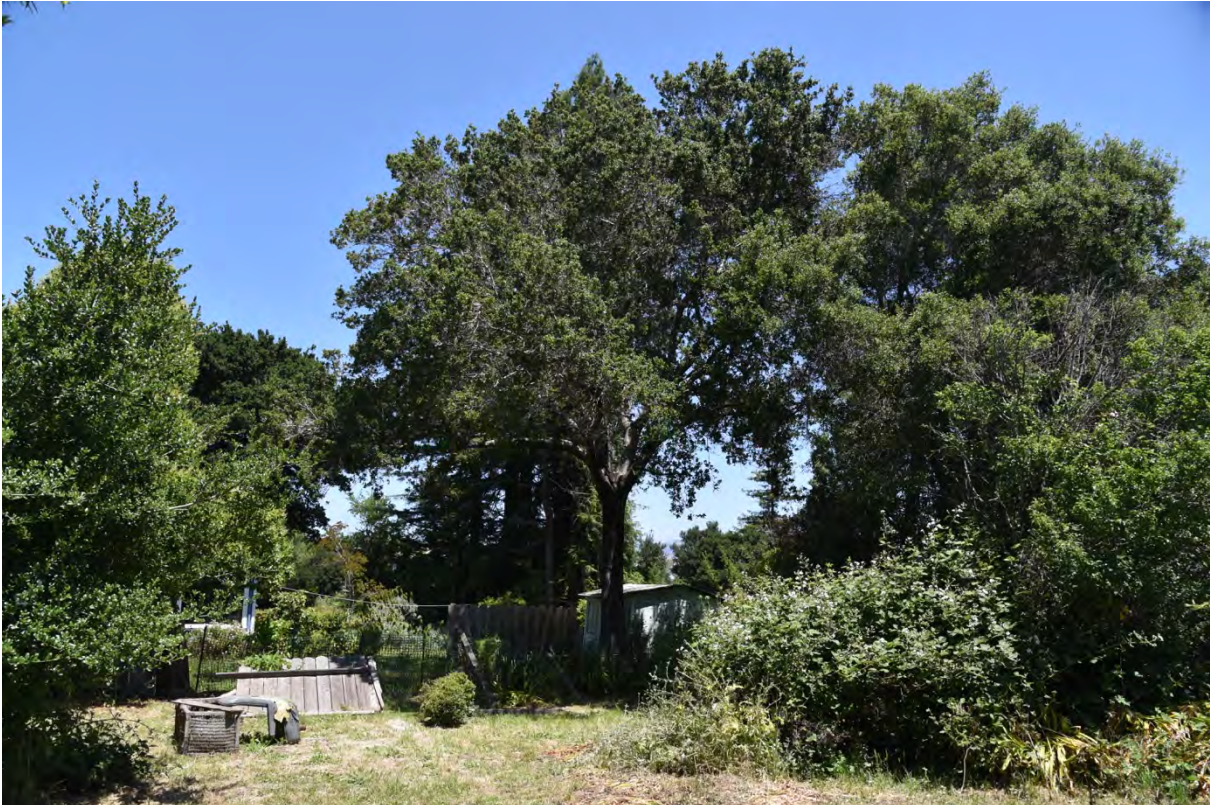
Mature coast live oaks at rear of residence on McNear Avenue.

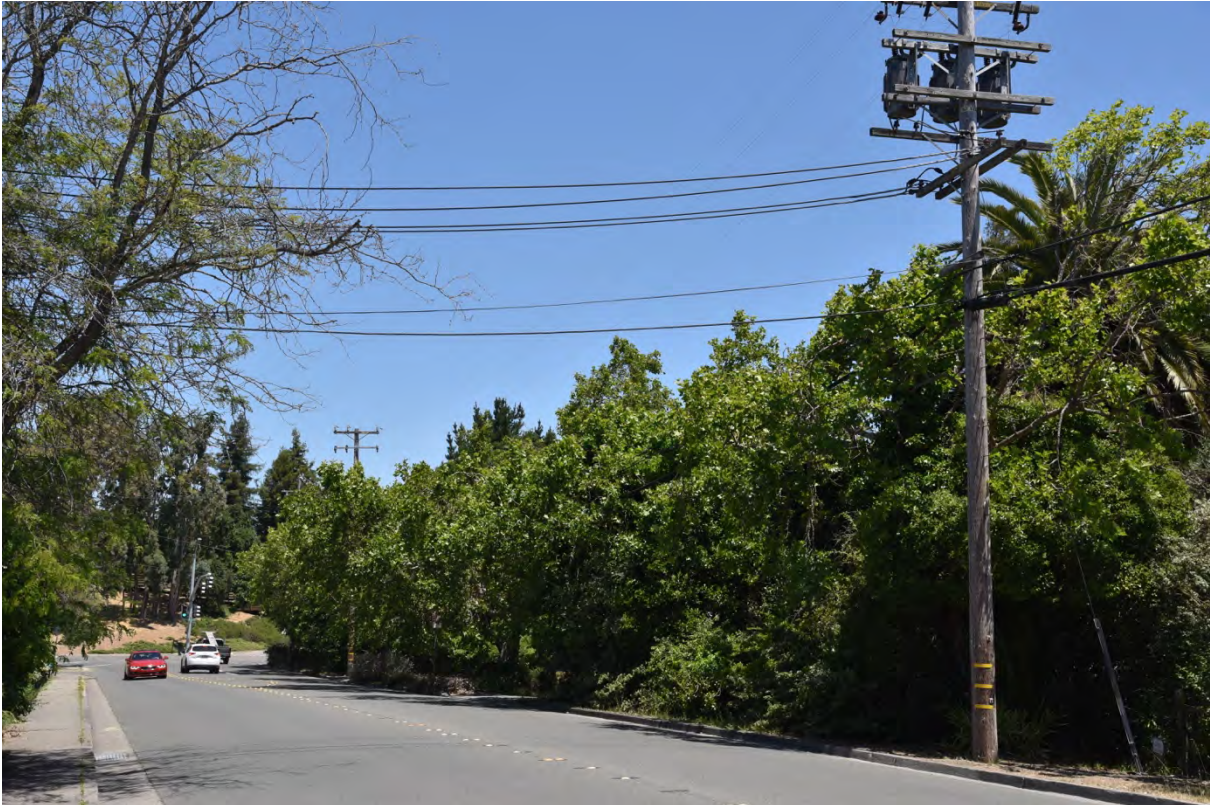
London plane trees are planted along Mc Near Avenue as street trees. All are subject to electrical line clearance pruning.

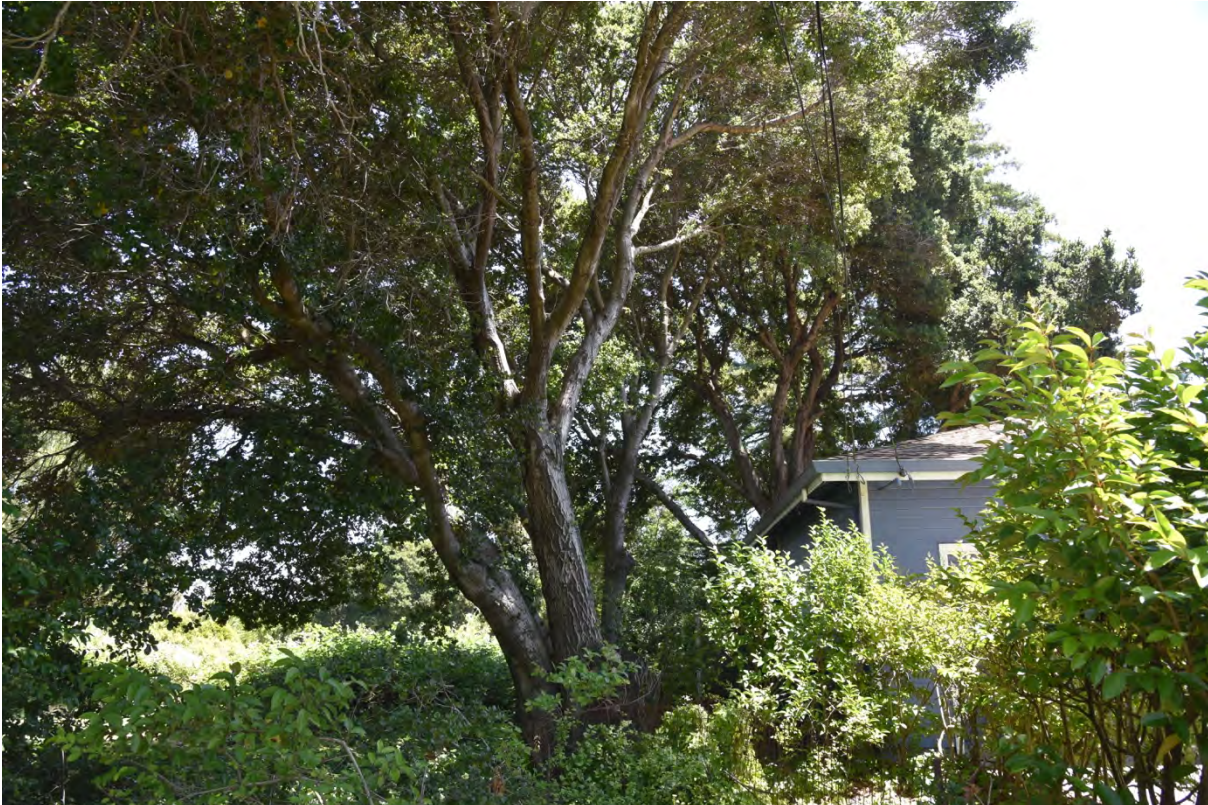
Coast live oak at rear north corner of Mc Near Avenue residence.

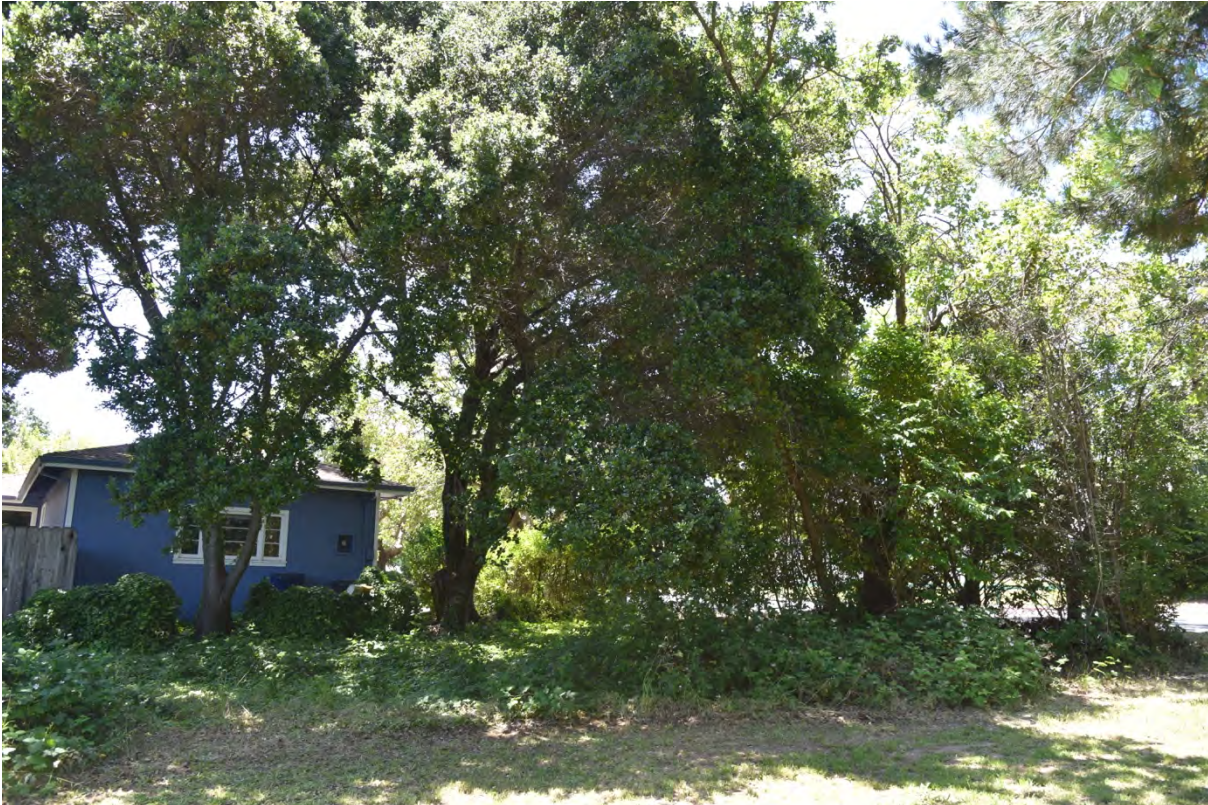
Other mature coast live oaks and smaller oaks near McNear Avenue.

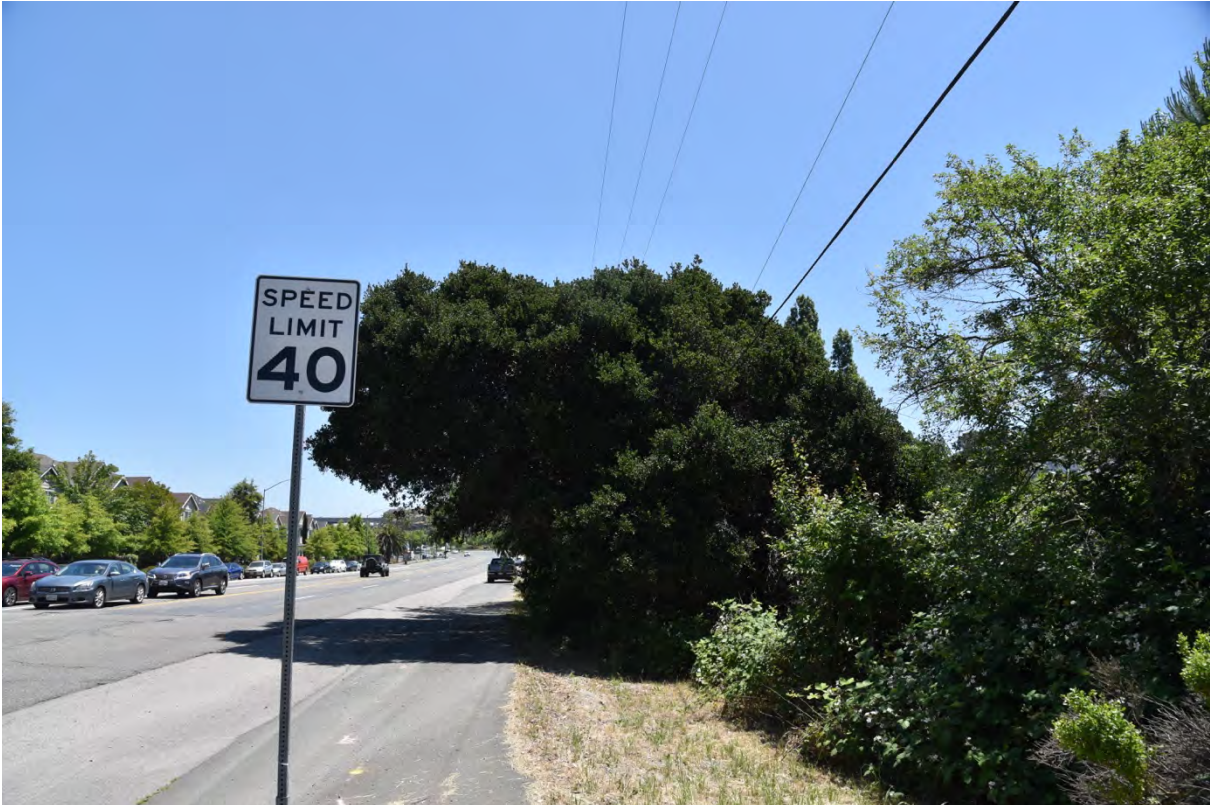
Coast live oak pruned for electrical line clearance along South Petaluma Blvd.

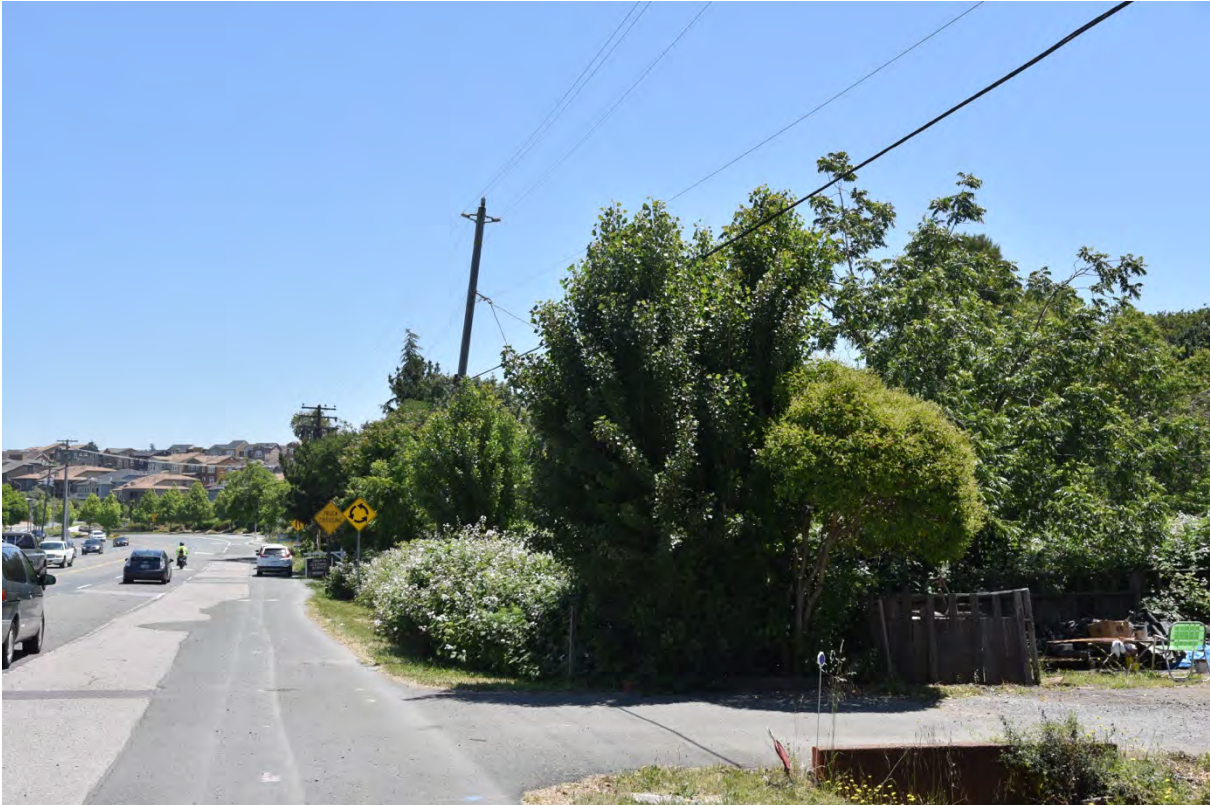
Numerous volunteer Lombardy poplars along South Petaluma Blvd. are being top pruned for electrical line clearance.
