## ADDENDUM NO. 2

### Corporation Yard Tank Demolition: Phase 2 City Project No. E66502027

**SUBJECT: PRE-DEMOLITION/RENOVATION HAZMAT INSPECTION  
FOUR STRUCTURES AT THE CORPORATE YARD  
PETALUMA, CALIFORNIA**

Pre-Demolition/Renovation HazMat Inspection  
Four Structures/Buildings  
City of Petaluma Corporate Yard

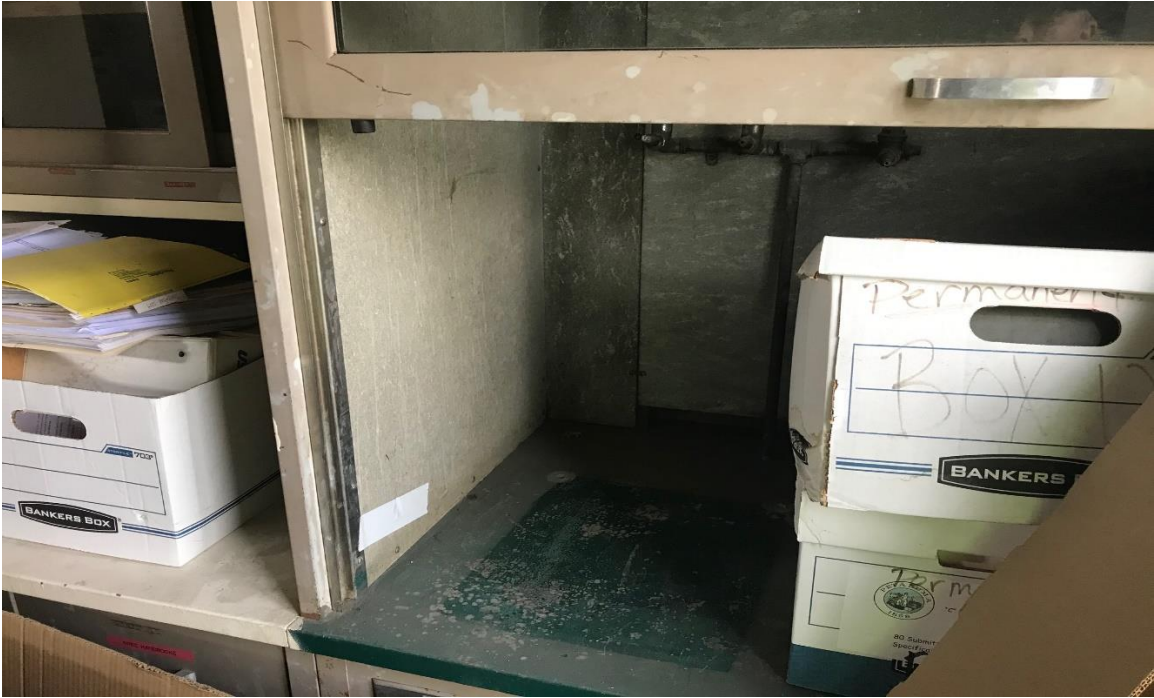
Asbestos cementitious “transite” hood panels in the lab of the Operations Building

**Analytical results indicated that the black roofing sealant on the raised portion of the roof of the Secondary Digester and vinyl floor tile/mastic and cementitious hood panels in the Operations Building contain asbestos. NorBay Consulting recommends that a licensed asbestos abatement contractor be utilized to remove these materials prior to demolition or renovation activities taking place that would disturb them. The contractor chosen must be familiar with and abide by the strict rules and regulations regarding the removal, packaging and disposal of asbestos containing materials and/or materials containing detectable levels of asbestos.**

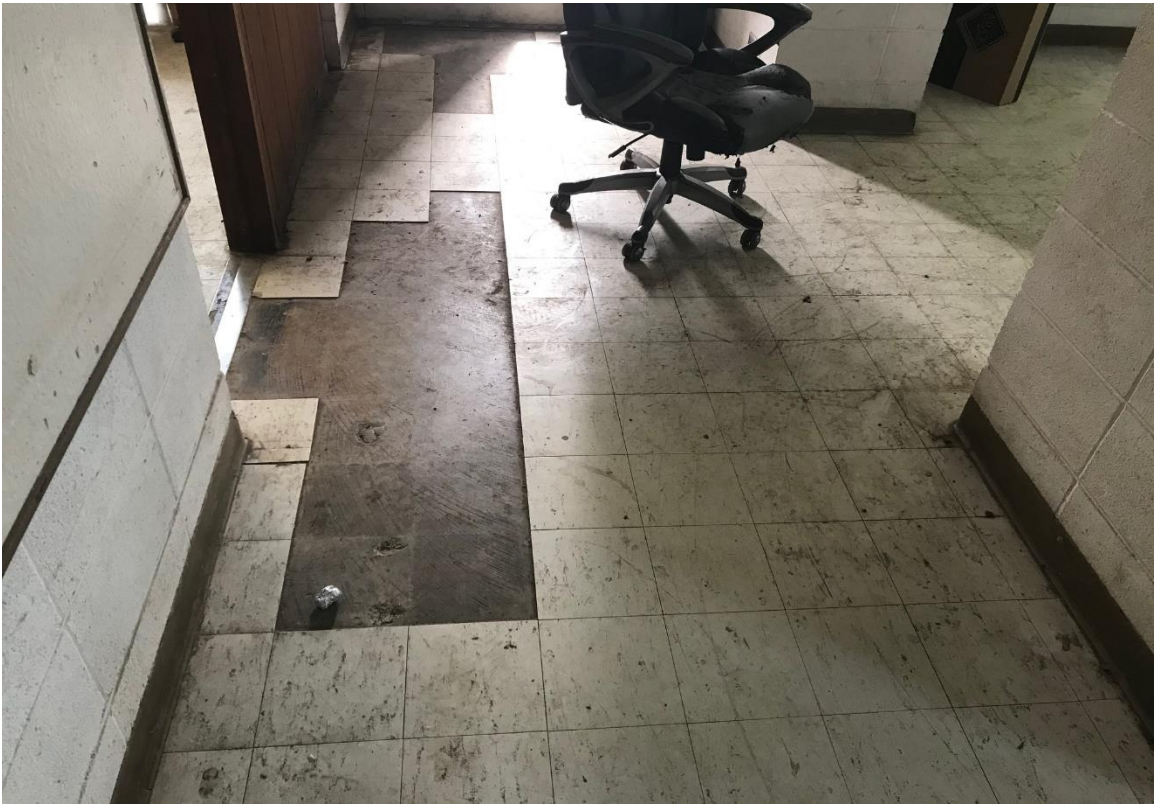
Asbestos containing 9” vinyl floor tile w/black mastic in the Operations Building

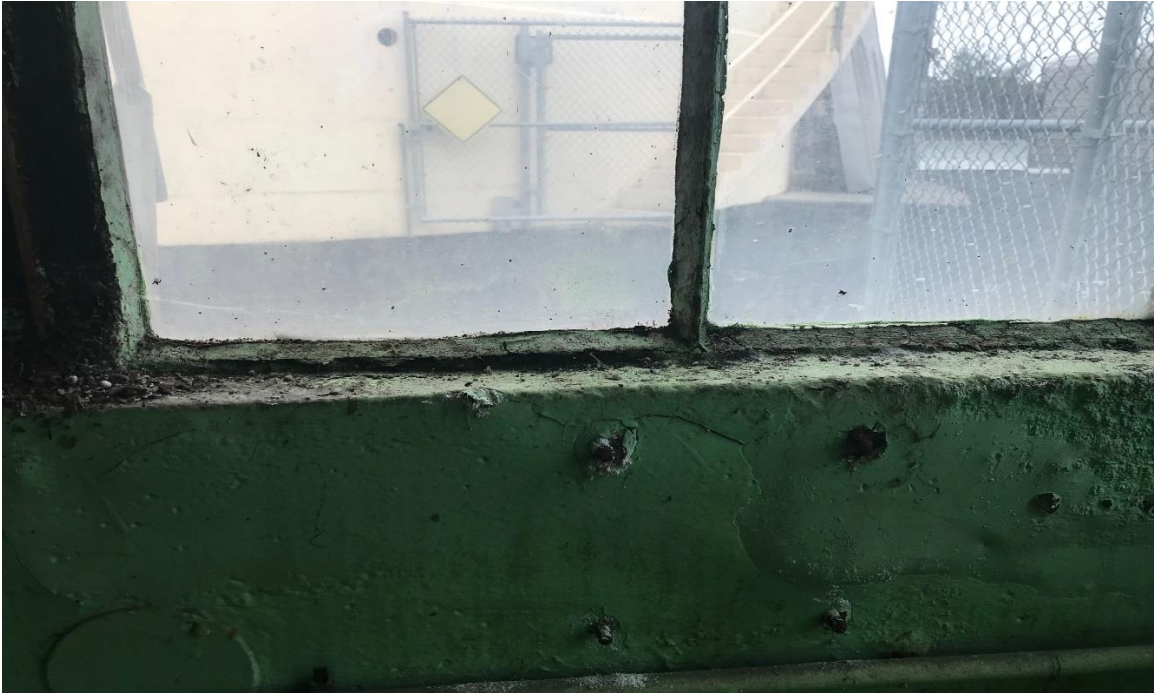
- ◆ Interior green metal window of the Secondary Digester;
- ◆ Exterior yellow metal windows of the Secondary Digester.

Lead based interior green metal windows of the Secondary Digester

Any proposed renovation/demolition, which may involve the removal of building materials with lead-based paint and/or lead containing painted surfaces, should include provisions to minimize the potential for airborne release of lead contaminated dust. It is recommended, as a minimum, that demolition of building materials which have lead-based and/or lead-containing paints be conducted with the materials kept in a wetted state and removed in sections, as feasible, to reduce the potential for airborne lead emissions.

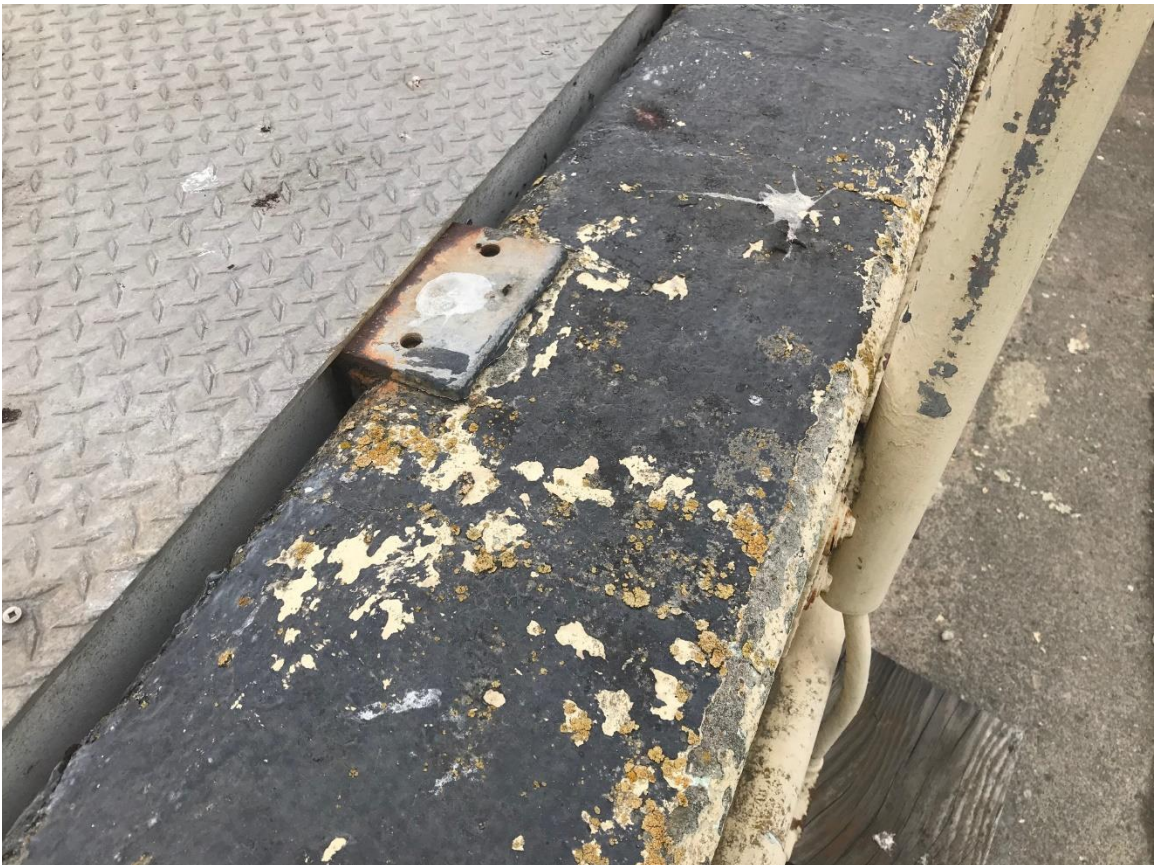
Asbestos containing black mastic on the raised portion on the roof of the Secondary Digester

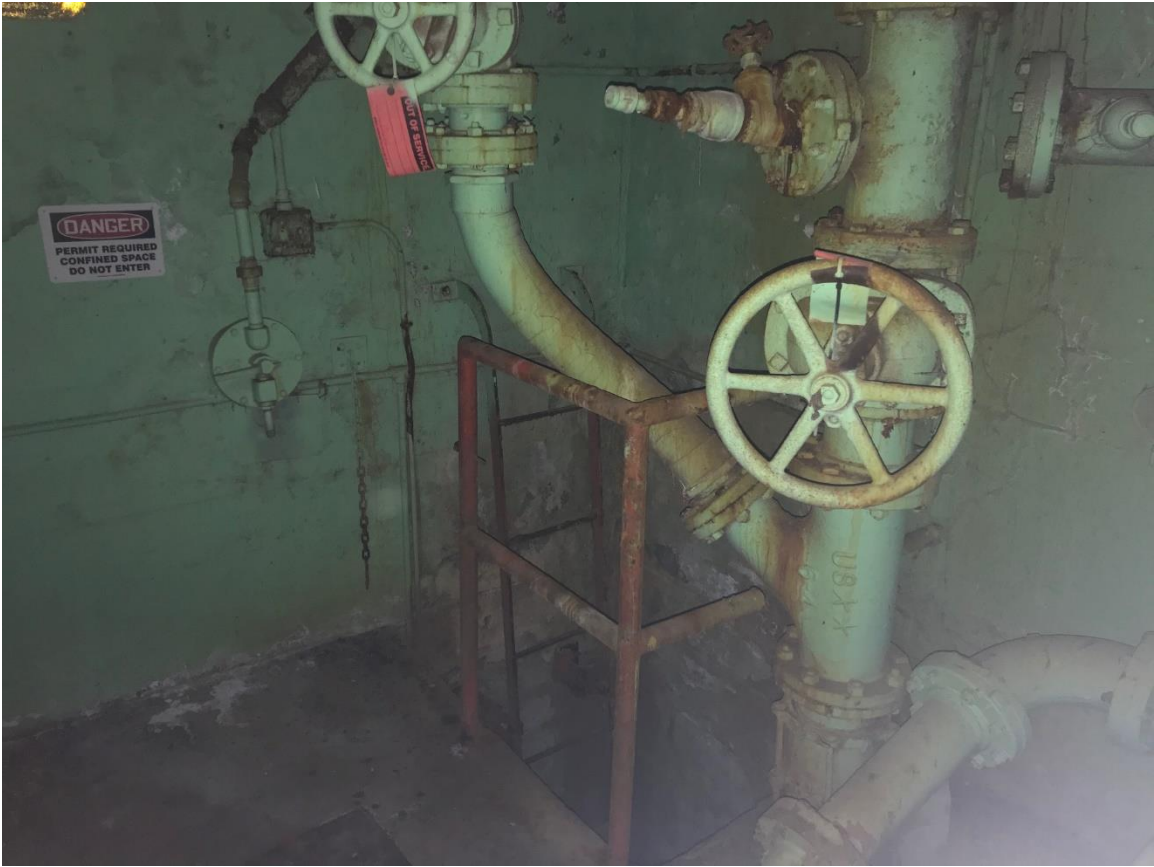
Lead based interior green concrete wall, green metal ladder to pit, and red metal railing on the lower level of the Secondary Digester
