Client: Perry Patel
Project Location: 450 Jefferson St, Petaluma, Ca
Inspection Date: October 21, 2021
Arborist: Ben Anderson

Perry Patel asked me to inspect and document the Canary Island palm (*Phoenix canariensis*) in the footprint of a planned expansion to the hotel at 450 Jefferson Street. This report is intended for the Planning Department as part of the development application. No one met me on site.

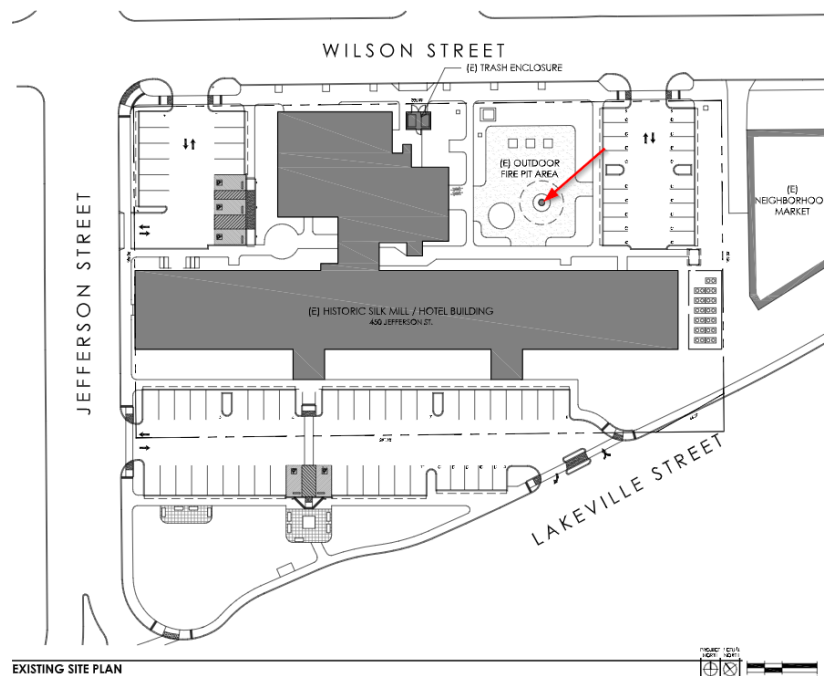
Figure 1. Section of Silk Mill Expansion plans showing tree location (red arrow)

I reviewed a plan set titled "Silk Mill Expansion" dated 8/13/2021. It appears as if this is the only tree on the site that will be impacted by the proposed development. It sits in the middle of the footprint of the proposed addition to the hotel.

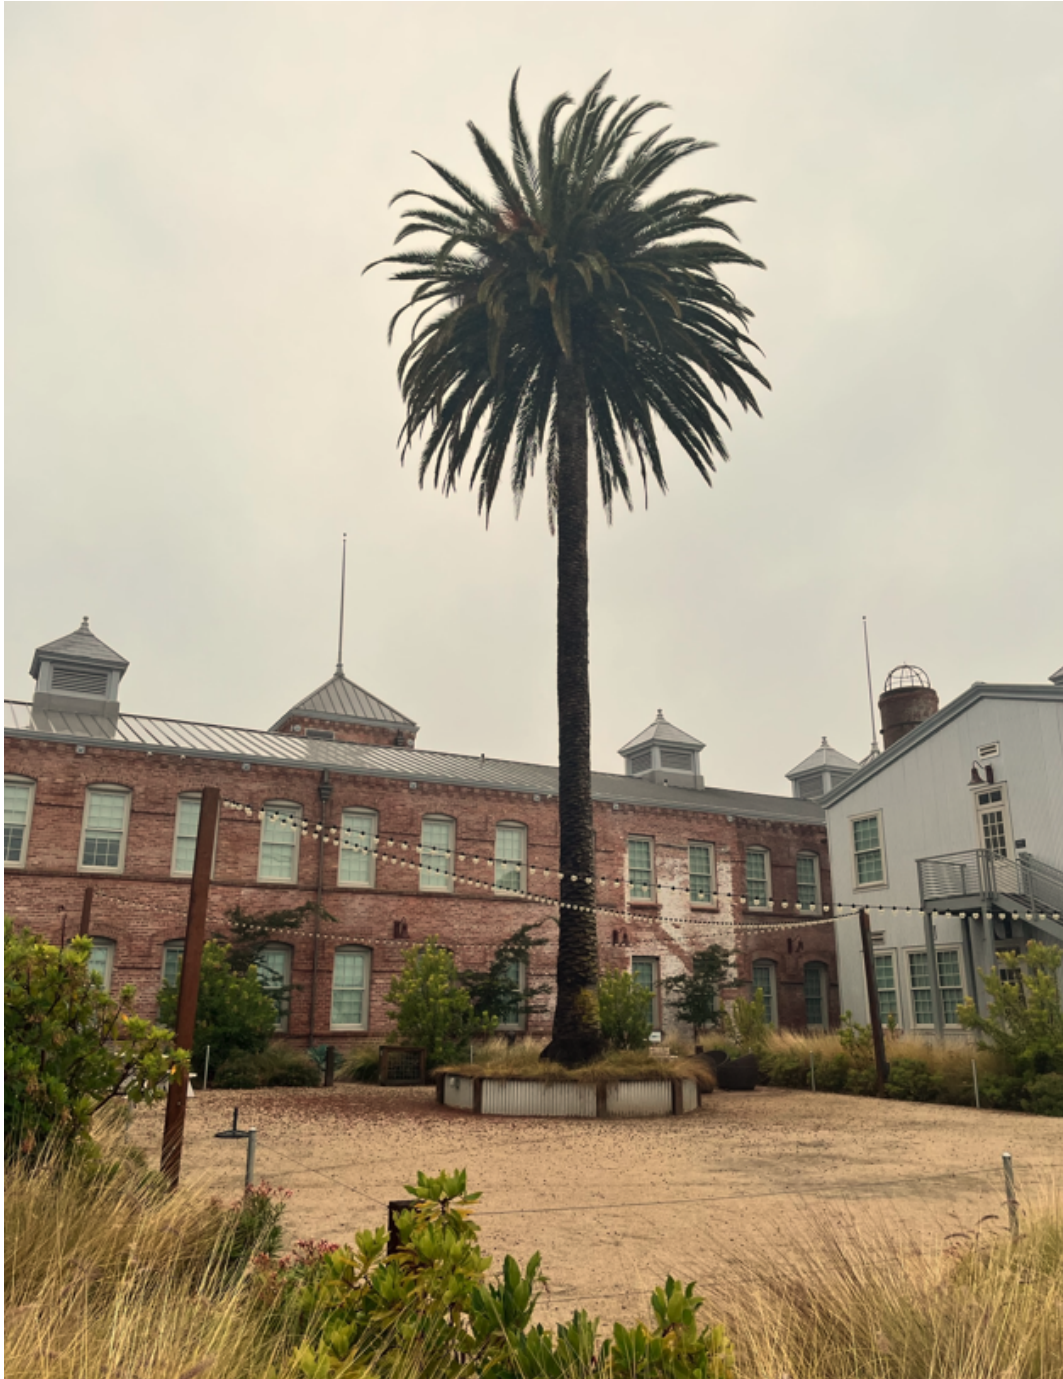
The subject parcel is a flat, mixed use (MU2) lot with a recently renovated, historic building used as a hotel. The subject tree is a Canary Island date palm with a trunk diameter of 30.5 inches and a height of approximately 65 feet¹. It is growing behind the building (Figure 1) in a raised planter in a retaining wall approximately two feet tall (Figure 2). I reviewed the Google Street photography and the grade in the planter appears to be the historic grade around the tree, which was lowered as part of the building rehabilitation. The newer fronds of the palm are slightly stunted when compared to the older, lower fronds, likely due to the stress of the initial grading in the tree's root system. The new fronds display good color and adequate size. The trunk is vertical and uniform in diameter. The tree was cleaned of dead material in the canopy and on the trunk at the time of the recent development. There are many younger palms on this and adjacent parcels that are likely volunteers from seeds of this plant.

Figure 2. Photo of subject palm taken from adjacent sidewalk.
