**ADDENDUM NO. 4
TO THE
CONTRACT DOCUMENTS
FOR**

**City of Port Orchard, Washington
MCCORMICK WOODS WELL 11 SITE IMPROVEMENT PROJECT**

DIVER INSPECTION REPORT

McCormick #1

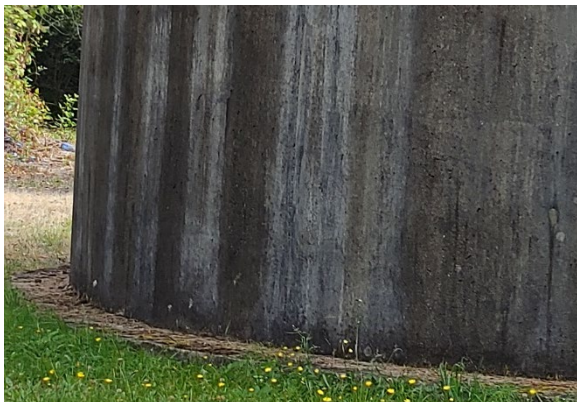
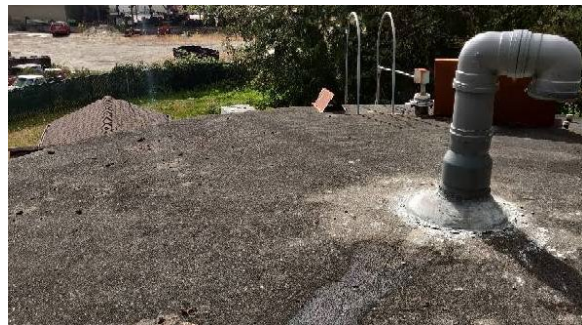
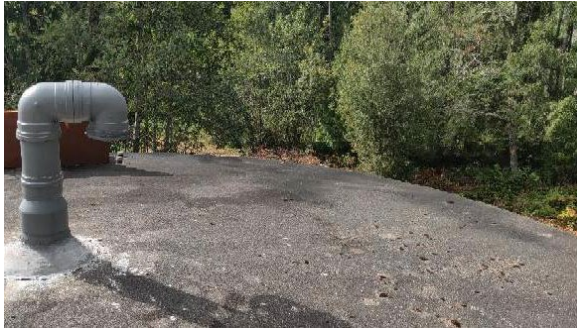
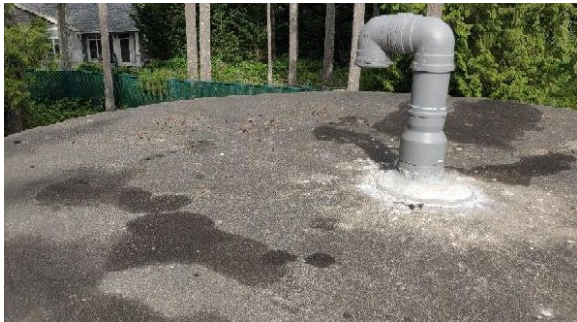
The exterior walls and roof are in fair condition with calcium deposits and residue covering the reservoir. **Recommend pressure washing reservoir exterior to remove residue.** (see pictures #3-8).

1. Pressure wash exterior to remove residue on reservoir.
2. Install coarse screen on roof vent to prevent damage to the fine mesh screen.
3. Install gasket on the roof access hatch to provide weather tight roof as per WAC 246-290-235 (1) (a).
4. Install OSHA confined space placard on roof access hatch.

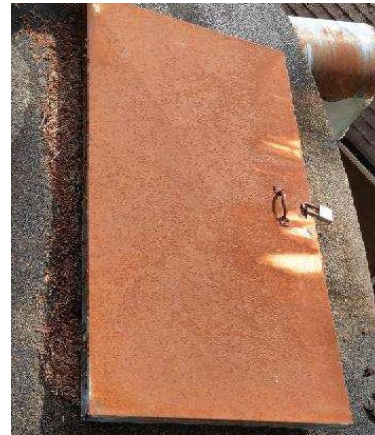
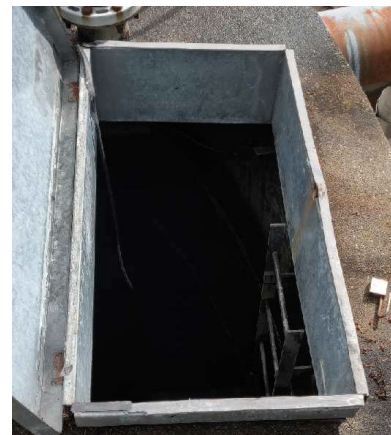
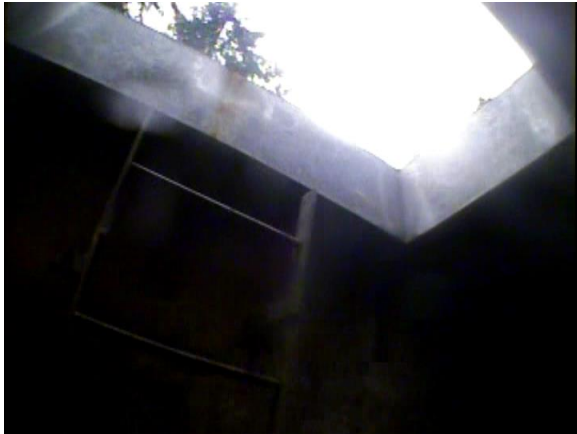
Corrosion observed on hatch interior. A lock is in place (see pictures #6,11-13). **Recommend installing gasket on the roof access hatch to prevent entry of insects and or runoff and meet Washington Administrative Code 246-290-235 (1) (a).**

(#11) Roof Access Hatch

(#12) Roof Access Hatch Gasket

(#13) Hatch Interior

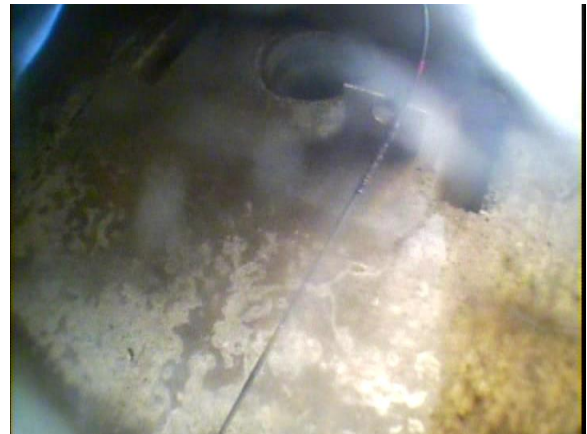
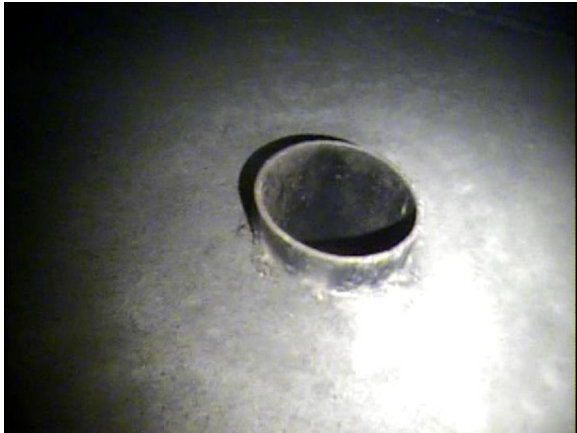
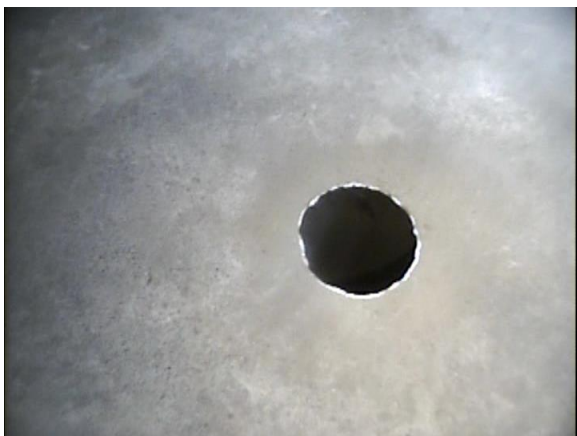
The inlet and outlet pipes are in good condition with only mild staining and corrosion. The interior of the overflow pipe has corrosion and nodules (see pictures #17,25,27).

(#17) Overflow

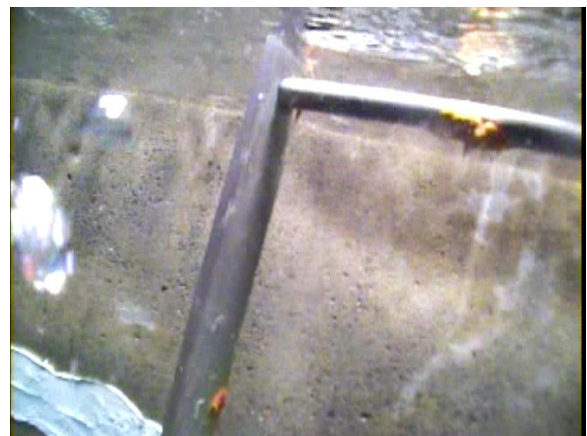
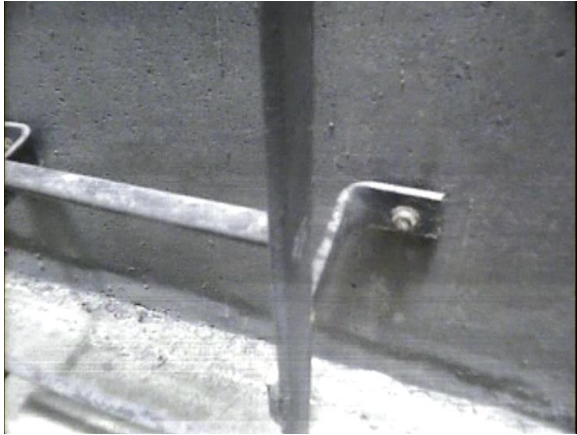
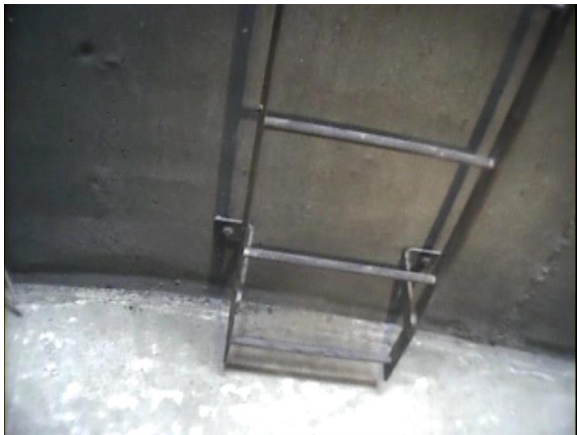
The interior ladder is in good condition with few nodules present on ladder. Brackets and bolts are in good condition with only minor corrosion (see pictures #13,18-20).

(#18) Interior Ladder Rust Nodules

(#19) Interior Ladder Bracket

(#20) Interior Ladder Base

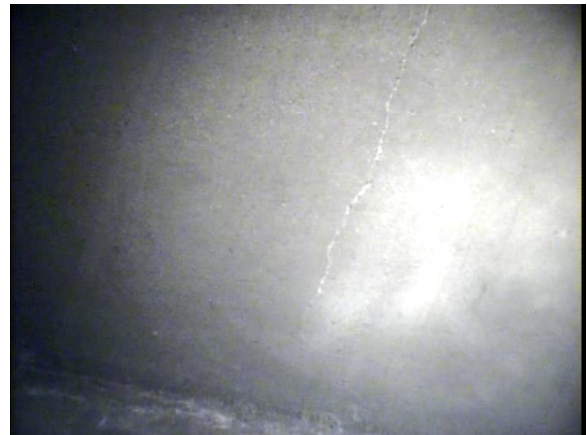
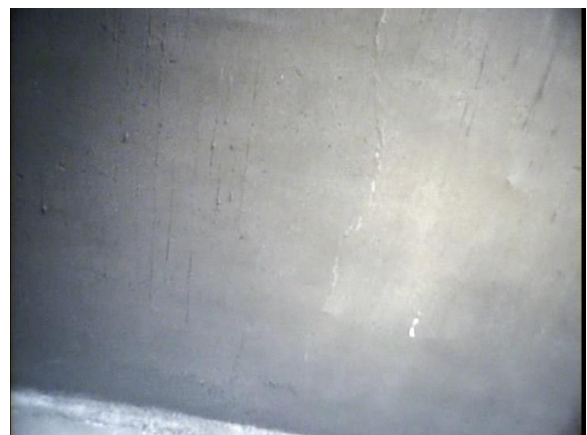
The interior walls and epoxy repairs are in good condition. There are cracks on the lower courses of quadrant 3 and 4 but no leakage was observed (see pictures #21-24).

(#22) Wall Crack Quadrant 3

(#23) Wall Crack Quadrant 4

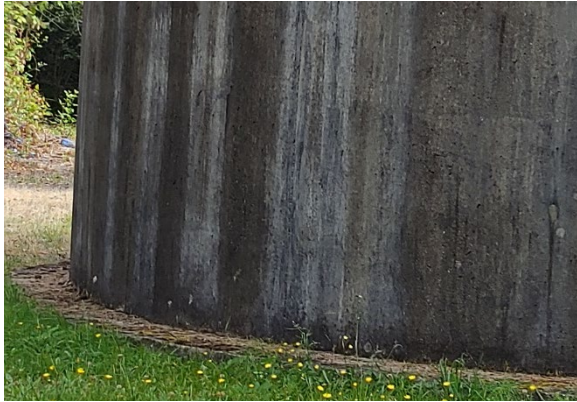
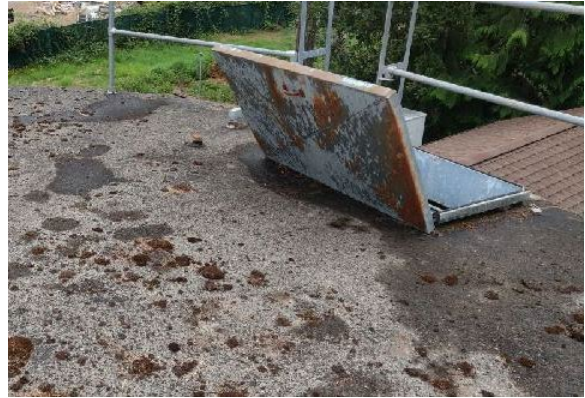
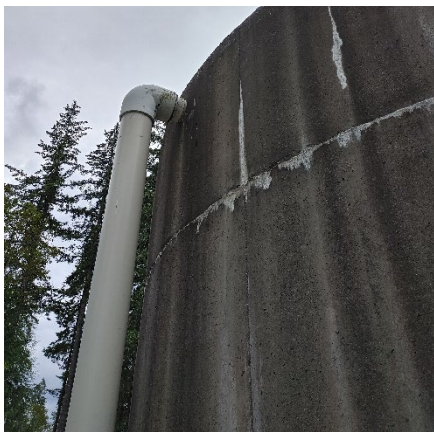
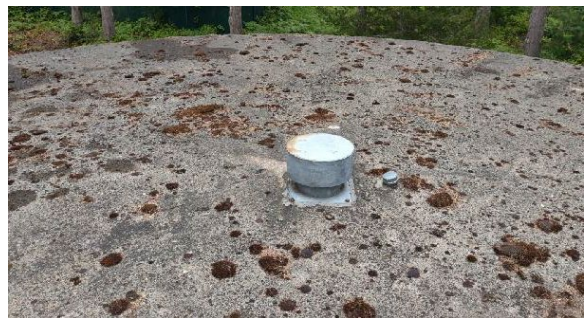
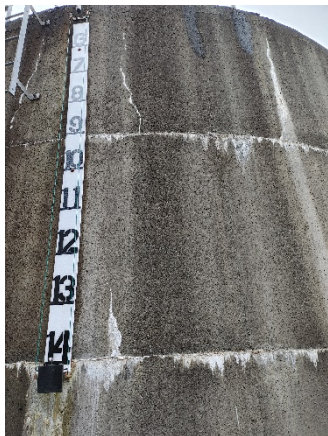
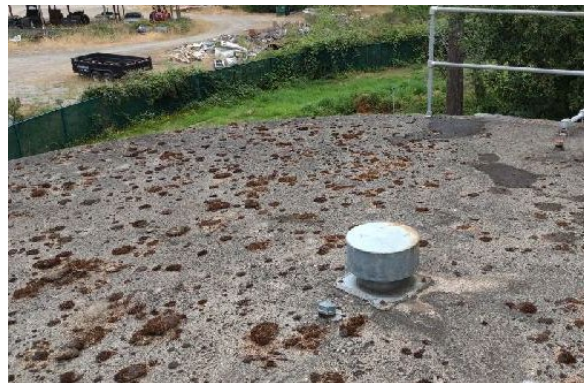
The exterior walls and roof are in fair condition with calcium deposits on shell and extensive moss growth on roof (see pictures #1-6). **Recommend pressure washing reservoir exterior to remove residue and moss bio-growth from roof.**

1. Pressure wash exterior to remove residue and bio-growth on reservoir.
2. Install safety climb on exterior ladder see page 16.
3. Replace gasket on the roof access hatch per WAC 246-290-235 (1) (a).
4. Reattach float assembly.
5. Install OSHA confined space placard on roof access hatch.

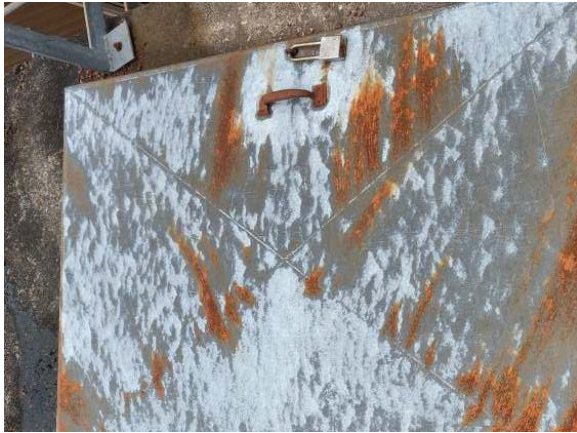
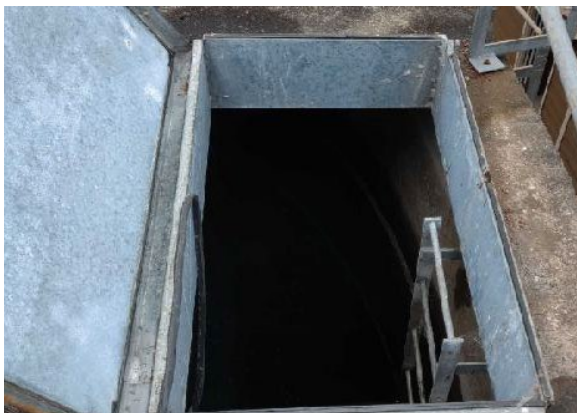
Corrosion observed on hatch exterior. A lock is in place and there is a gasket (see pictures #4,8,9). **Recommend replacing gasket on access hatch to meet WAC 246-290-235 (1) (a) for a watertight roof.**

(#8) Roof Access Hatch

(#9) Roof Access Hatch Gasket

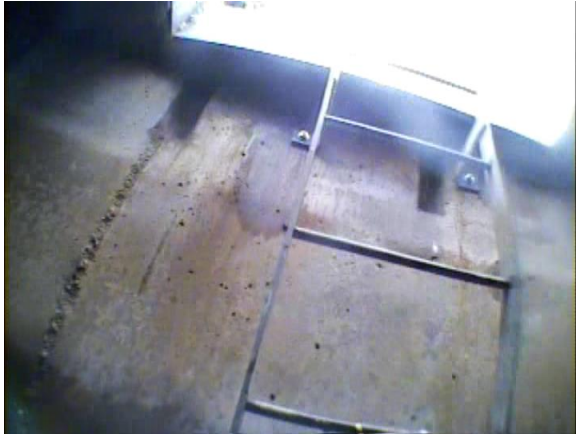
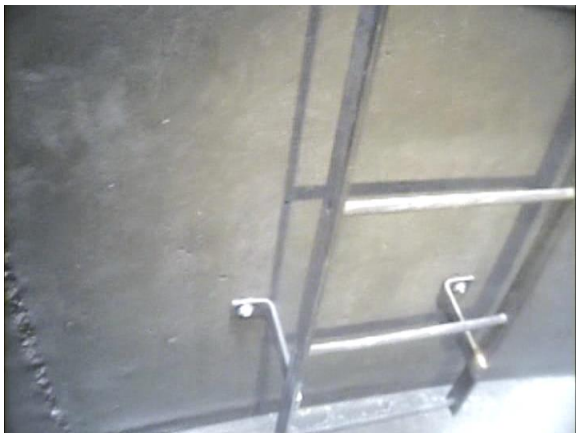
The interior ladder is in good condition with only mild corrosion. (see pictures #13-15).

(#13) Interior Ladder Upper

(#15) Interior Ladder Base

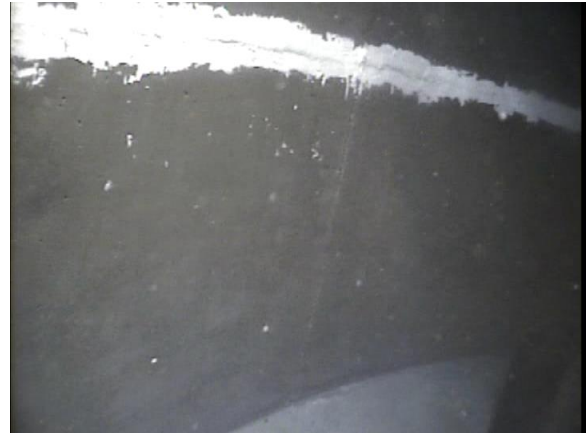
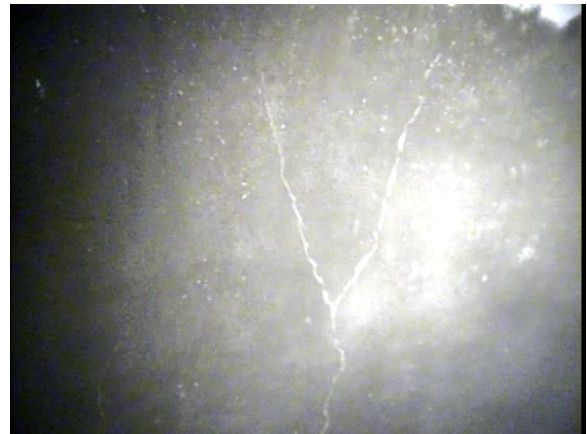
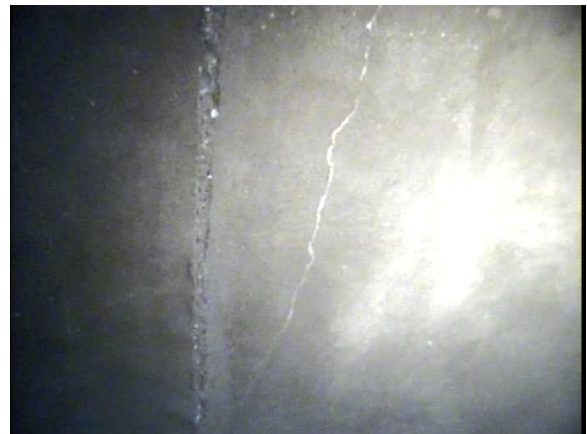
The interior walls and epoxy repairs are in good condition. There are cracks on the lower courses of quadrant 3 and 4 but no leakage was observed (see pictures #10-13,15-18).

(#16) Wall Quadrant 1

(#17) Wall Quadrant 3

(#18) Wall Quadrant 4

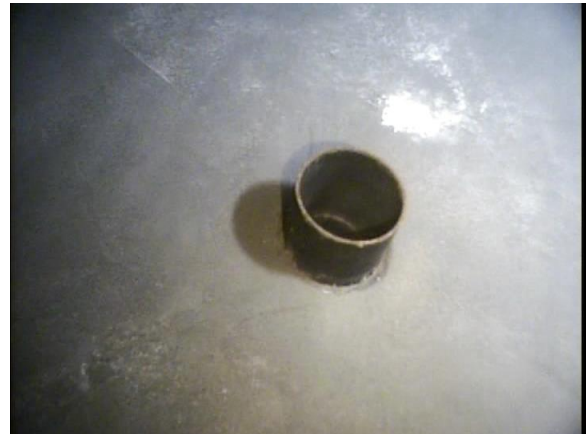
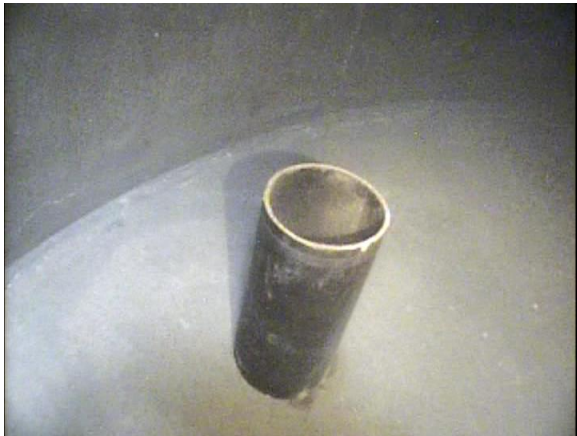
The inlet, outlet, and overflow pipes are in good condition. A silt ring is present on the outlet (see pictures #10,20,22).

(#22) Outlet

(#20) Inlet
