ORACLE OAK, LLC

ARBORIST REPORT

Date: 3/25/24

Re: Dominican Project (APN 015-
163-03)

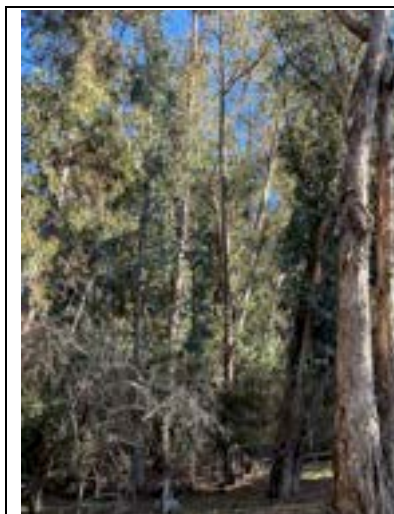
Fig. 3. Eucalypts are by far the dominant species in the parcel, constituting approximately 90% of the tree canopy cover.

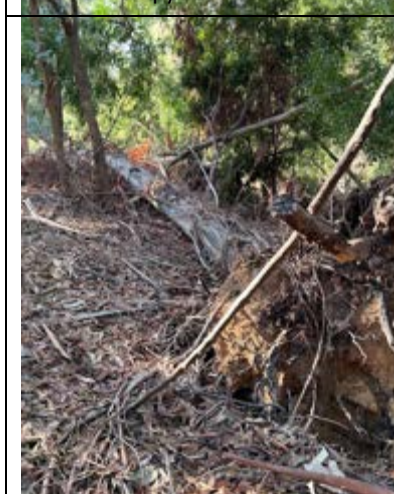
Fig. 4. Many structural failures have occurred in the Eucalyptus stands. Here a Eucalypt uprooted during the storms of 2022-23.

occurred (Fig. 4). Collectively, the stand is assessed as being unstable and future structural failures are probable. In addition to health and structural issues, the Eucalypts are viewed as being a fire hazard due to their size, stand density, combustibility, and proximity to power lines and homes. Due to their fire hazard potential, the San Rafael Fire Department classifies *E. globulus* as “combustible vegetation” that should be removed within 100 feet of structures (<https://www.cityofsanrafael.org/protecting-your-home-from-wildfire/>).

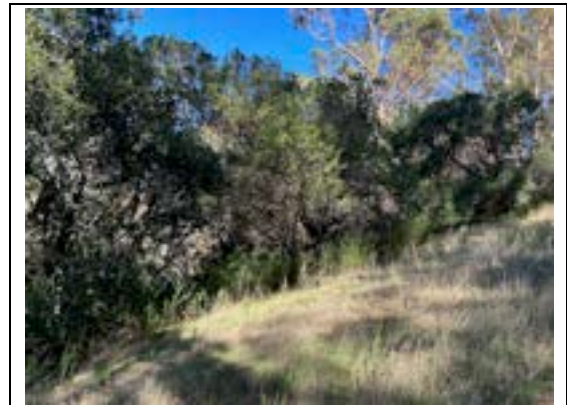
Fig. 5. Coast live oak represents less than 4% of the canopy cover at the site. The stand here occurs at the edge of a Eucalyptus stand and near a grassy opening.

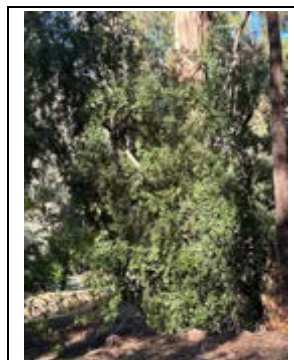
Prior to the introduction of Eucalypts, CA bay likely occurred in substantial numbers in the subject area. Now, very few CA bay are found – and most are very small (Fig. 7). Similar to coast live oak, many of the CA bay likely were suppressed by Eucalypts.

Fig. 7. Few CA bay were found in the Project Area 1, while none were evident in Areas 2 and 3.

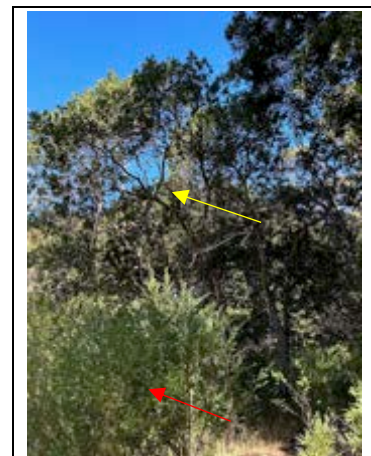
Fig. 6. Coast live oaks were found only in Project Area 1 (yellow arrow). Most were suppressed by adjacent Eucalypts, with additional competition for water resources from Scotch broom (red arrow), an invasive species.

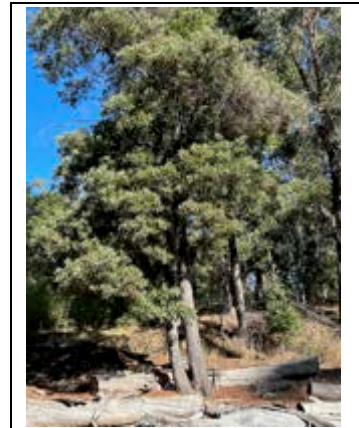
Occurring in similar numbers as coast live oak, blackwood acacia was found scattered through Project Area 1, with fewer in area 2, and very few in Area 3 (Fig. 8). Being an invasive species, blackwood acacia may either have been planted (along with Eucalypts) or they grew as volunteers from seeds that were introduced into the area. In general, the blackwood acacias are in moderately good health, while their structure is assessed as being poor, with multiple stem architecture, weak branch attachments, and top-heavy crowns.

Fig. 8. Blackwood acacia were largely located in Project Areas 1 and 2, while very few were in Area 3. Being an invasive tree, blackwood acacia may have become established by seed.

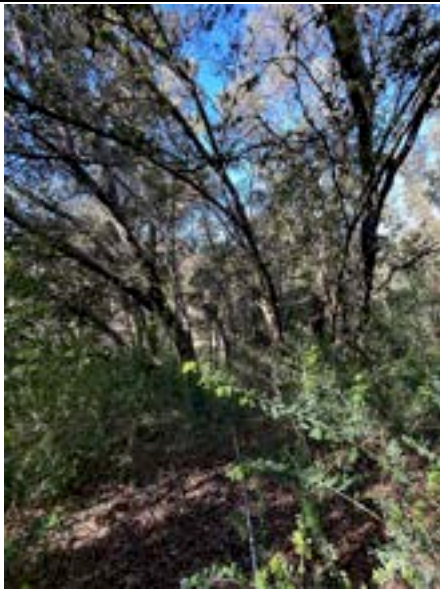
A cluster of coast live oaks (#1-8) were found on a slope in the southwest section of project area #1 (Fig. 10), while trees #9-11 were found in project area #3 approximately 21 feet downslope from Margarita Dr. (Fig. 11).

Fig. 10. Coast live oaks (8) that qualify as significant trees were located in the southwest section of project area #1.

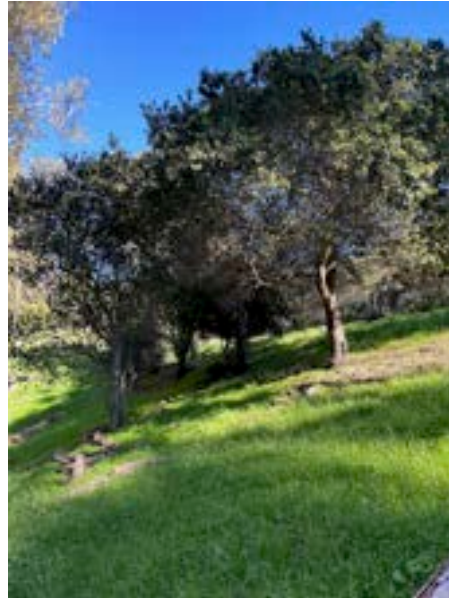
Fig. 11. Coast live oaks (3) that qualify as significant trees were located downslope from Margarita Dr in project area #3.

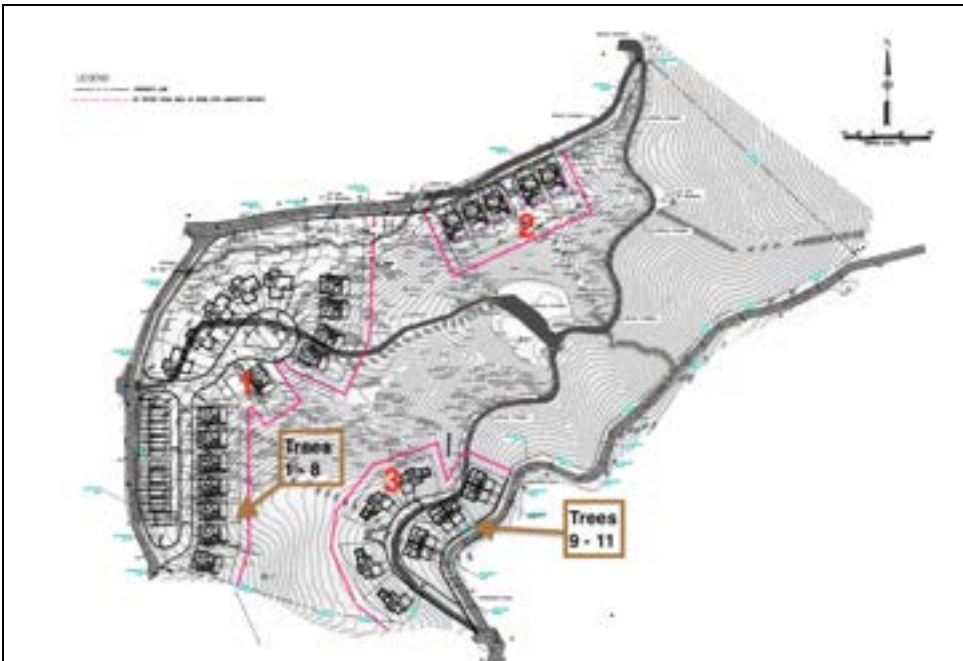
Coast live oaks that qualify as significant trees were located in project areas 1 and 3 (Figs. 12, 13,).

Fig. 12. Locations of significant trees in project areas 1 and 3. No significant trees were found in project area 2. A numbered aluminum tag was attached to each significant tree.

It is recommended that the following oak species be considered as replacement species in project areas: coast live oak (*Q. agrifolia*), island oak (*Q. tomentella*), and Oregon white oak (*Q. garryana*).
