## ARBORIST REPORT

Date: 3/25/24

Submitted to: Comari, Inc.

Re: Dominican Project (APN 015-163-03)

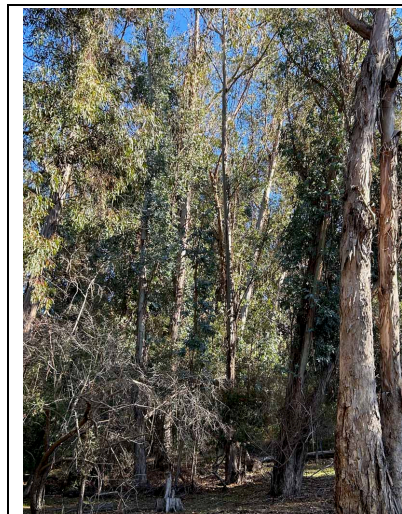
Fig. 3. Eucalypts are by far the dominant species in the parcel, constituting approximately 90% of the tree canopy cover.

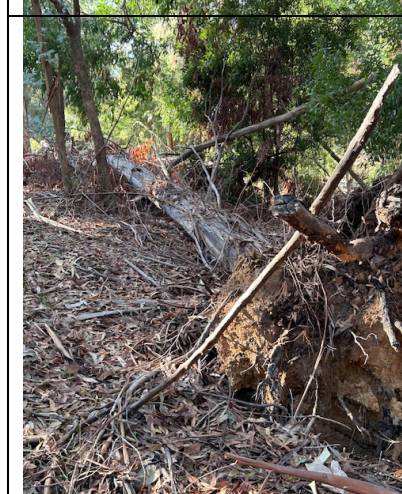
Fig. 4. Many structural failures have occurred in the Eucalyptus stands. Here a Eucalypt uprooted during the storms of 2022-23.

occurred (Fig. 4). Collectively, the stand is assessed as being unstable and future structural failures are probable. In addition to health and structural issues, the Eucalypts are viewed as being a fire hazard due to their size, stand density, combustibility, and proximity to power lines and homes. Due to their fire hazard potential, the San Rafael Fire Department classifies *E. globulus* as “combustible vegetation” that should be removed within 100 feet of structures (<https://www.cityofsanrafael.org/protecting-your-home-from-wildfire/>).

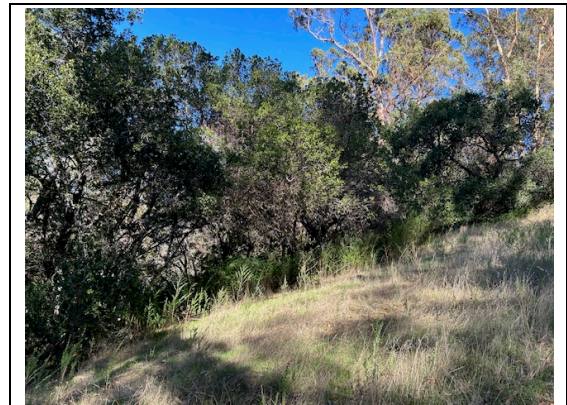
A relatively small percentage of the parcel canopy cover (~4%) is made up of coast live oaks (Fig. 5). Historically, the hills and valleys in this area were largely oak woodland, composed of coast live oak, CA bay, Pacific madrone, and Douglas fir, with associated understory plants (e.g., toyon). After the Eucalypts were planted, it is most likely that the coast live oaks were shaded out by the larger-crowned Eucalyptus species. The remaining coast live oaks are located largely on the edges of Eucalyptus stands, where they have reasonably good light exposure (Figs. 3&5). The health of these oaks is assessed as being moderate to good, while their structure is assessed as moderate (largely due to their multi-stem architecture). A small number of coast live oaks (~ 8) are located in project area 1 (Fig. 6), while none were located in Project Areas 2 and 3. It is expected that removing Eucalypts adjacent to coast live oaks (in the project area and elsewhere in the parcel) will result in a strong and positive growth response (i.e., of the oaks).

Fig. 5. Coast live oak represents less than 4% of the canopy cover at the site. The stand here occurs at the edge of a Eucalyptus stand and near a grassy opening.

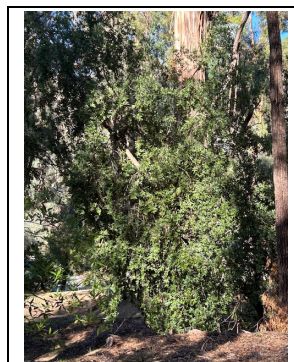
Prior to the introduction of Eucalypts, CA bay likely occurred in substantial numbers in the subject area. Now, very few CA bay are found – and most are very small (Fig. 7). Similar to coast live oak, many of the CA bay likely were suppressed by Eucalypts.

Fig. 7. Few CA bay were found in the Project Area 1, while none were evident in Areas 2 and 3.

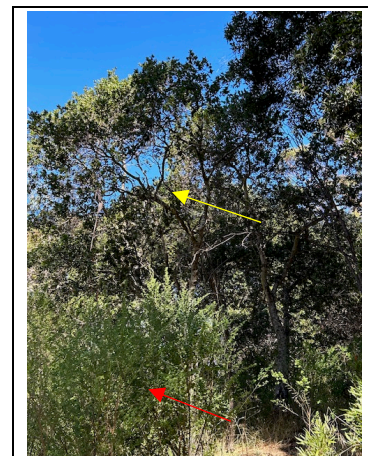
Fig. 6. Coast live oaks were found only in Project Area 1 (yellow arrow). Most were suppressed by adjacent Eucalypts, with additional competition for water resources from Scotch broom (red arrow), an invasive species.

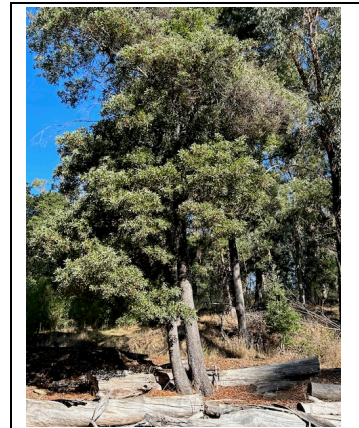
Occurring in similar numbers as coast live oak, blackwood acacia was found scattered through Project Area 1, with fewer in area 2, and very few in Area 3 (Fig. 8). Being an invasive species, blackwood acacia may either have been planted (along with Eucalypts) or they grew as volunteers from seeds that were introduced into the area. In general, the blackwood acacias are in moderately good health, while their structure is assessed as being poor, with multiple stem architecture, weak branch attachments, and top-heavy crowns.

Fig. 8. Blackwood acacia were largely located in Project Areas 1 and 2, while very few were in Area 3. Being an invasive tree, blackwood acacia may have become established by seed.

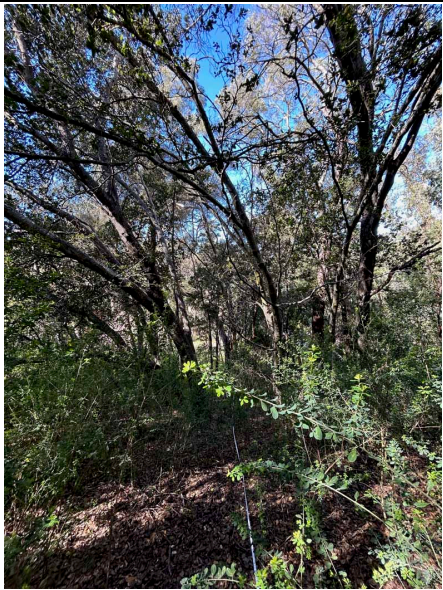
A cluster of coast live oaks (#1-8) were found on a slope in the southwest section of project area #1 (Fig. 10), while trees #9-11 were found in project area #3 approximately 21 feet downslope from Margarita Dr. (Fig. 11).

Fig. 10. Coast live oaks (8) that qualify as significant trees were located in the southwest section of project area #1.

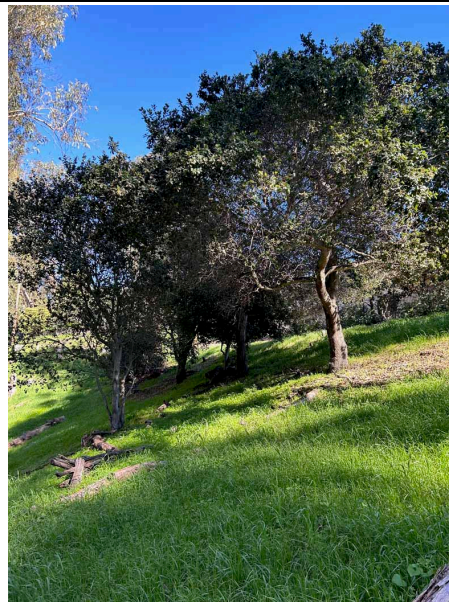
Fig. 11. Coast live oaks (3) that qualify as significant trees were located downslope from Margarita Dr in project area #3.
