**SAN RAFAEL
PUBLIC LIBRARY
FACILITIES PLANNING
PROJECT**

**EXISTING FACILITIES
REPORT**

**City of San Rafael
California**

July 2019

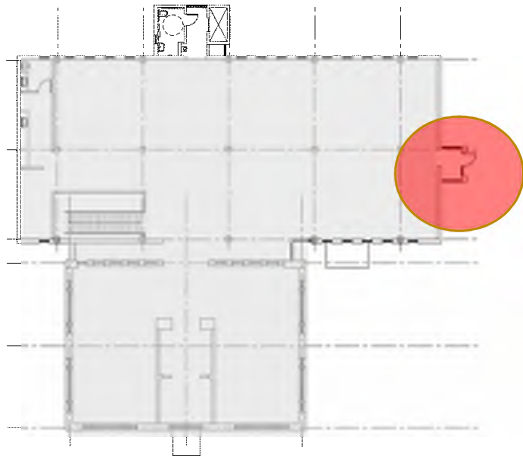
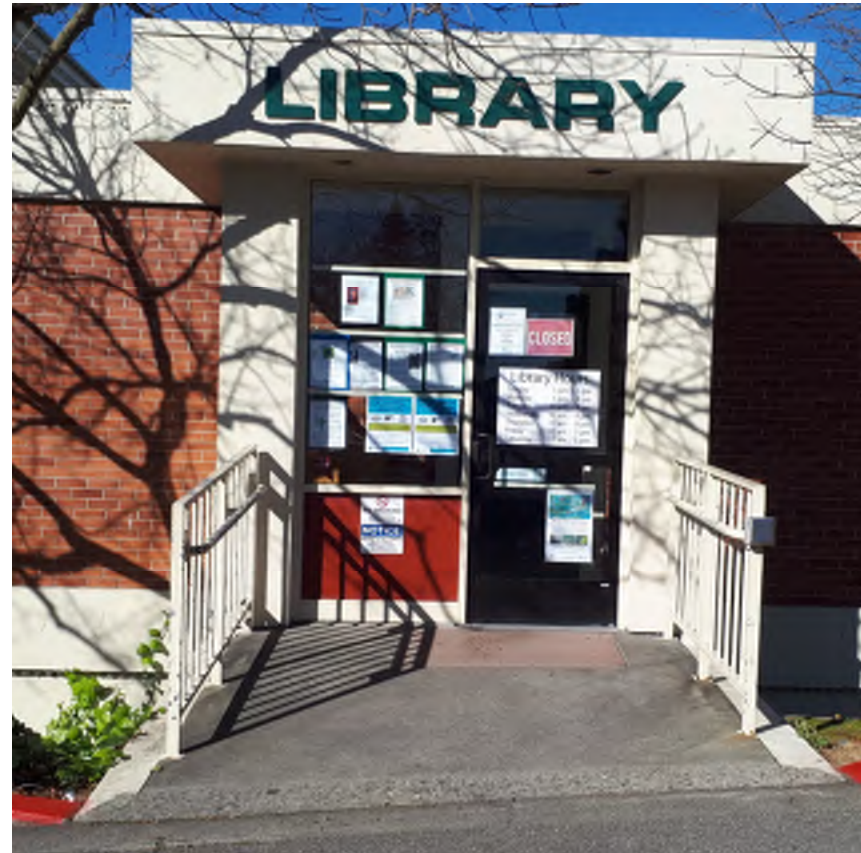
Existing landing on east Entry

- West entrance on Level one and East entrance on Level Two was reviewed for code compliance per ADA Standards.
- Per 2016 C.B.C. West entrance was not found to have code violations per 2016 C.B.C.
- Per 2016 C.B.C. 1010.1.5 East entrance does not have an exterior level landing at the doorway as required.

- Existing landing on East entry shall be measured to determine if it slopes 1/4 : 12 units (2% slope).
- If landing slopes greater than 2% it is not code compliant and it should be amended to be code compliant.

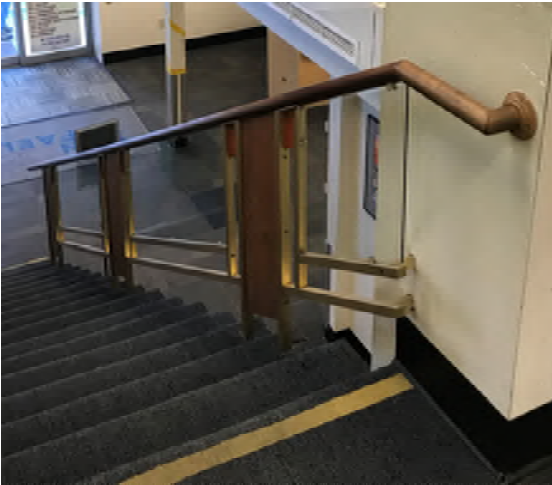
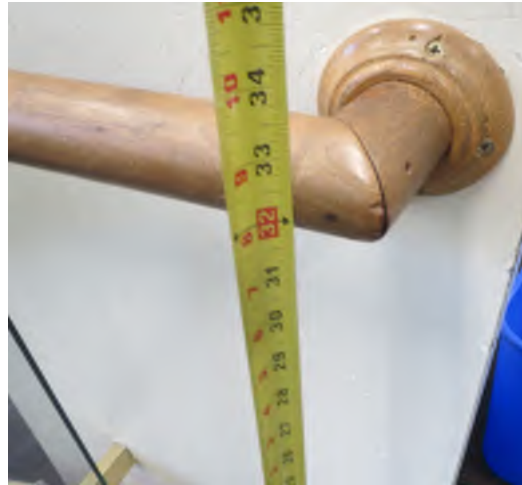
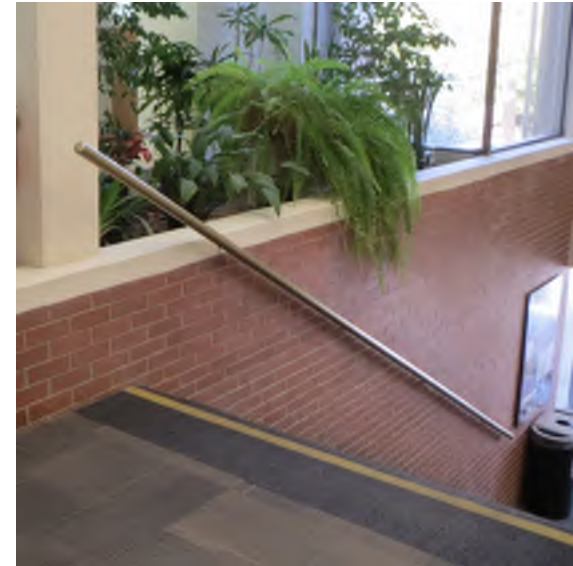
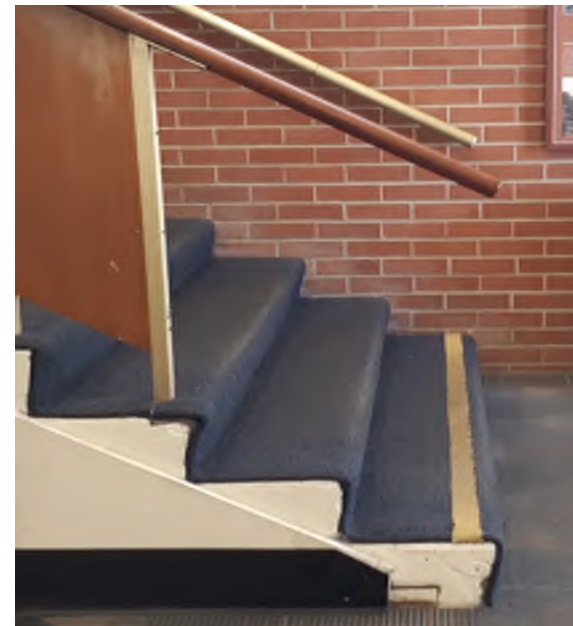
- Internal public staircase does NOT have a code compliant handrail as required per C.B.C 11B-505. 4.
- The handrail is 32.5" above the finished floor and not 34" -38" above the finished floor.
- Public internal staircase does NOT have a code compliant handrail as required per C.B.C 11B-505. 10.3.
- The handrail extensions do not extend 23" minimum beyond last tread.
- The ends of the handrails do not return to the wall.

Determination: Remove guardrail and handrail from open side of stairwell and the handrail from the wall side. Replace with code compliant guardrail and handrails.

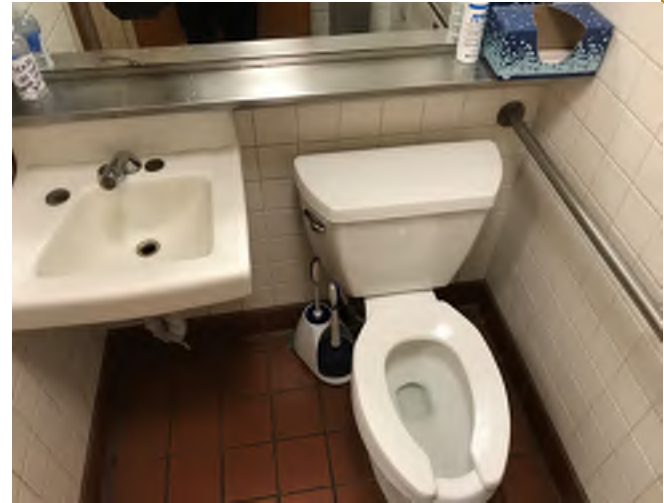
STAFF RESTROOM - FEMALE

- Staff restroom (F) is not ADA compliant – size of room is too small.
- Staff restroom (M) no longer functions as a restroom – some fixtures have been removed. Room currently stores cleaning supplies.
There is inadequate clearance distances around location of potential fixtures.
- Janitors closet has an older mop sink, most likely leaks.

Female restroom on Level One does not have adequate space to be code compliant per ADA Standards.

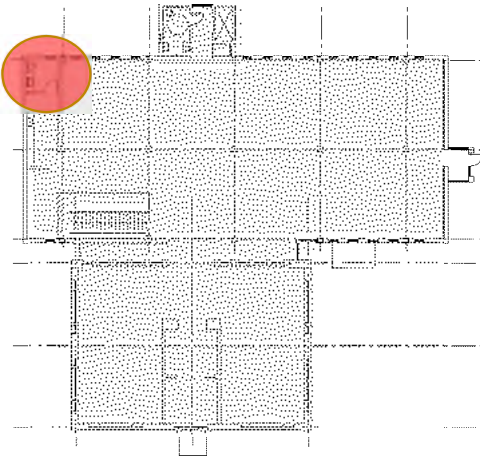
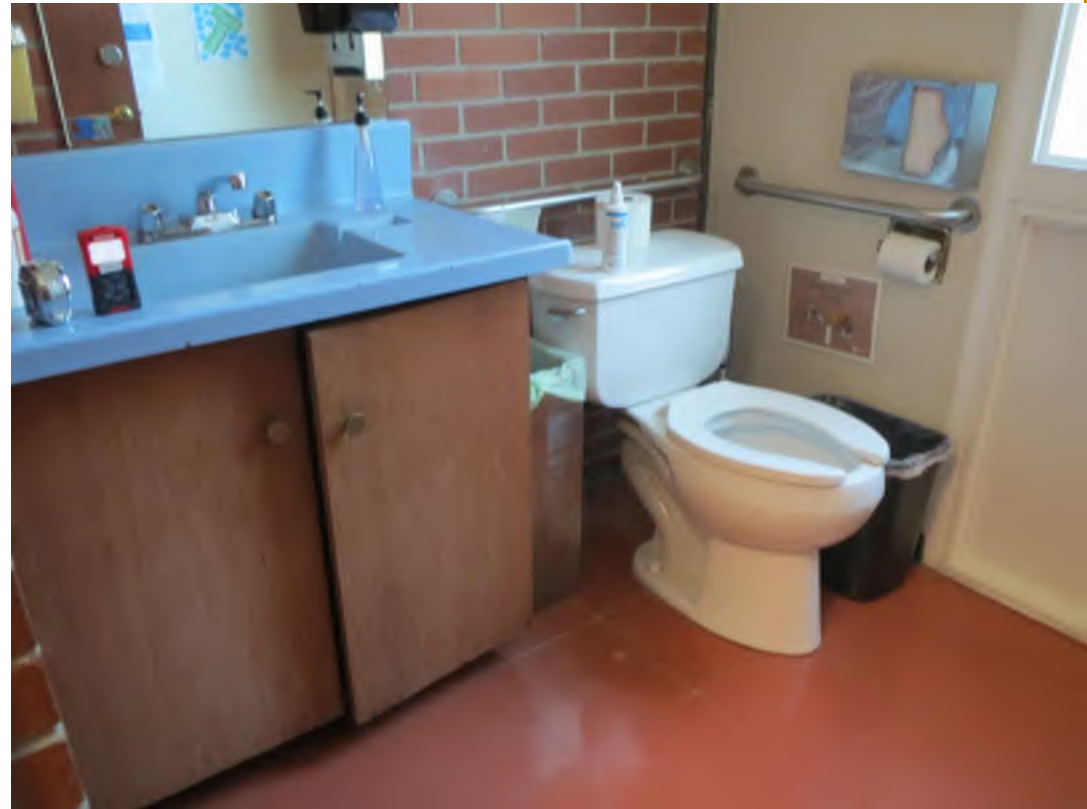
- Grab bars are not code compliant.
- No accessible space under lavatory for wheelchair
- Toilet paper dispenser is too high

Staff restroom on Level Two should be remodeled to be code compliant.

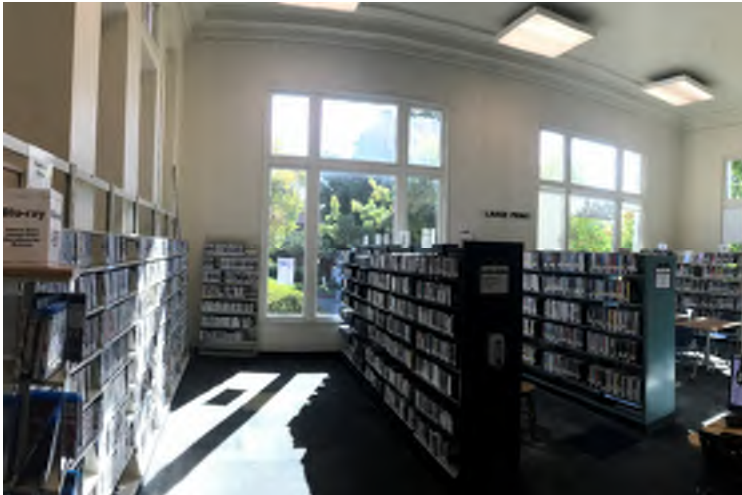
- Several Library Stacks in reading area on second floor were not structurally braced to the main structure or to each other. Based on their loading these stacks appear to require bracing. These stacks are 73” and 77” high.
- Per 2016 C.B.C 1010.1.1 The height of door openings cannot be less than 80”. *Interpretation:* one can pass under an 80” high “opening” for a temporary period of time. If these 73” high stacks are braced to each other at the top of the stacks they will not be in code compliance for access.

Determination: Replace existing stacks with 4'-0” high lower stacks that do not require to be braced. Alternatively brace the stacks from above or below.

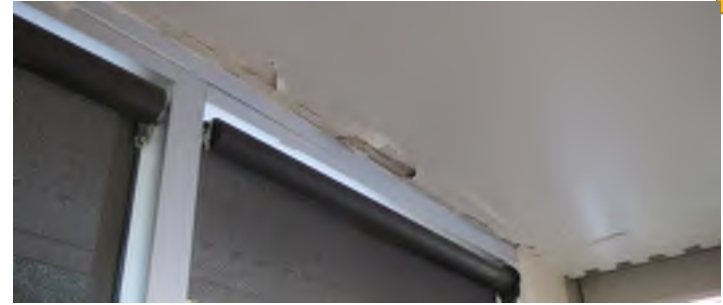
LEVEL ONE ENTRY LOBBY

- Level One Entry lobby has evidence of leaks in the ceiling in two locations.
- Level One has a leak in ceiling within office space
- Level Two circulation desk: leaks occurring above circulation desk – captured in plastic bag.

Determination: Determine cause of leaks and repair all affected ceilings.

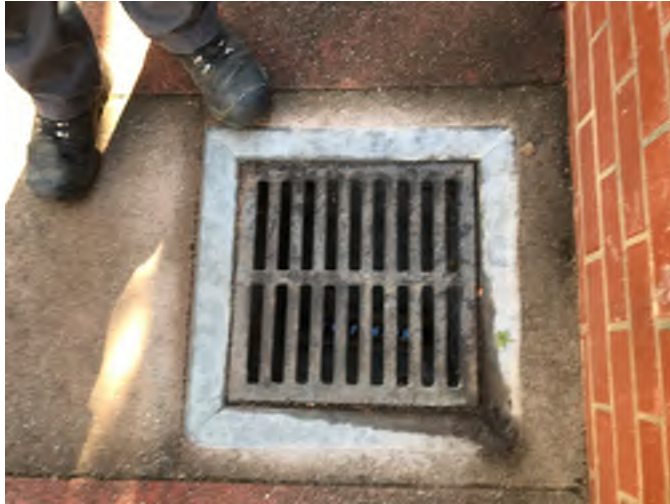
As noted from Facility Repair Supervisor, main cleanout is right outside entrance door towards Fifth Street. Cleanout consists of a concrete box with open grate on the top. All sewer running thru pipe gets exposed to rain. Sewer pipe flows towards the South to City sewer at Fifth Avenue, 2 sewer cleanouts can be seen at the side walk, See Pictures 1.1 and 1.2.

1.1 Sewer Main cleanout

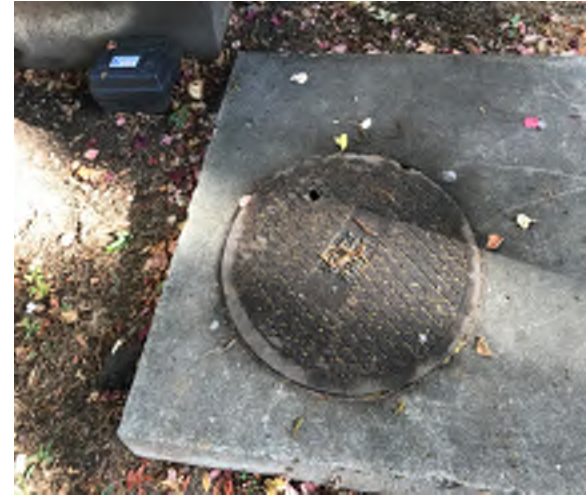
A sump pump basin can be found on the Southeast corner of the building that per Facility Supervisor is for the perimeter subsoil storm drain. The water is discharged to a nearby curb where runoff is to flow towards Fifth Ave.

1.3 Perimeter Drain Sump Pump Location

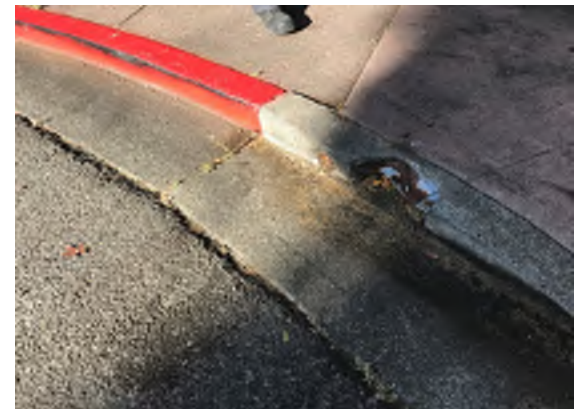
1.4 Perimeter Drain Sump Pump discharge at curb

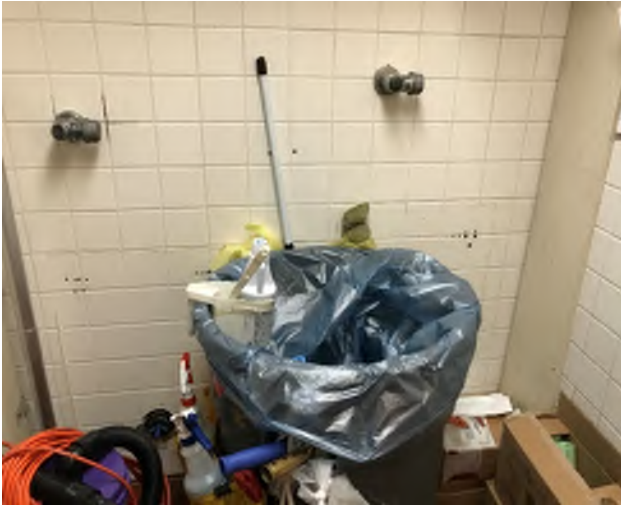
2.2 Level 1 Staff men's restroom

The Men's Restroom which has 1 floor mounted tank type water closet, 2 urinals stubs and 1 lavatory. The water closet fixture is not connected to the sewer pipe on the floor. The urinal fixtures were missing and not found inside the toilet room. The lavatory is still seen mounted on the wall. The restroom had been temporarily closed from occupants and has been converted to a temporary storage space.

According to the Facility Repair Supervisor, there had been sewer odor detected from the adjacent Admin area that is coming from the toilet. To temporarily mitigate the problem, the toilet had been disconnected from the sewer pipe, and the whole toilet room temporary closed for further repair. See Pictures 2.1, 2.2 & 2.3. According to the Facility Repair Supervisor, the odor is more apparent during after rain. There may be a crack in the sewer pipe under the Men's water closet that lets rain water enter the sewer system that worsens the odor and there might also be a crack in the vent lines that lets sewer gases out.

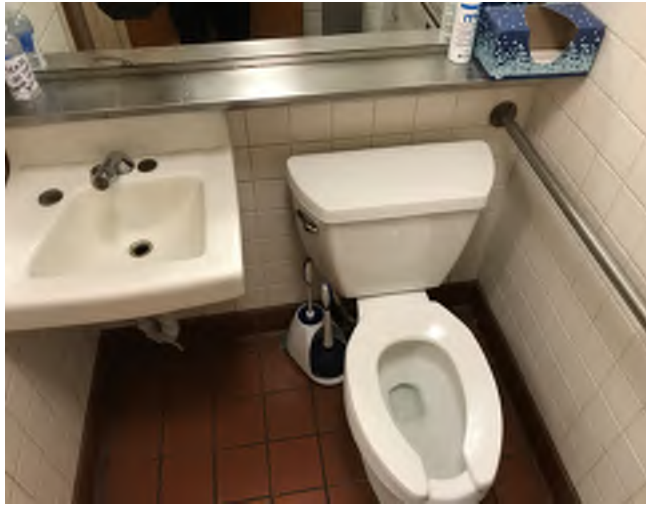
2.4 Level 1 Staff women's restroom

The Women's Restroom has 1 floor mounted tank type toilet and a lavatory. Both fixtures seem to be in working conditions but may not be compliant with current ADA regulations. Restroom currently used as an all-gender restroom. See Picture 2.4.

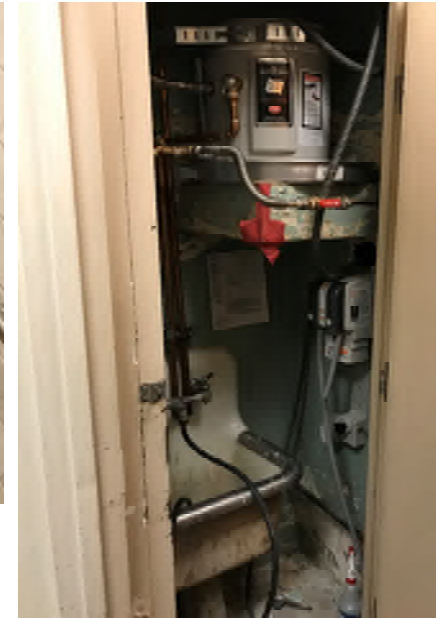
2.5. Level 1 Janitors Closet

The Janitor's Closet has 1 Wall mounted mop sink with a water heater at the top. Water heater is an Electrical Water heater which seems to have been recently installed. See Picture 2.5.

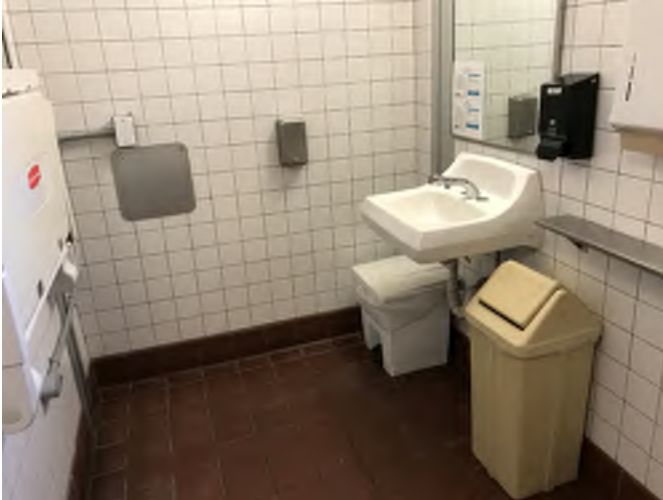
3.1 Level 1 Public All-Gender restroom

Two restrooms found at the North end of the New wing. Restrooms are for public use. Both restrooms seem to be in good working condition. Both restrooms seem to have identical layouts sharing same stacked piping systems. See picture 3.1 & 3.2.

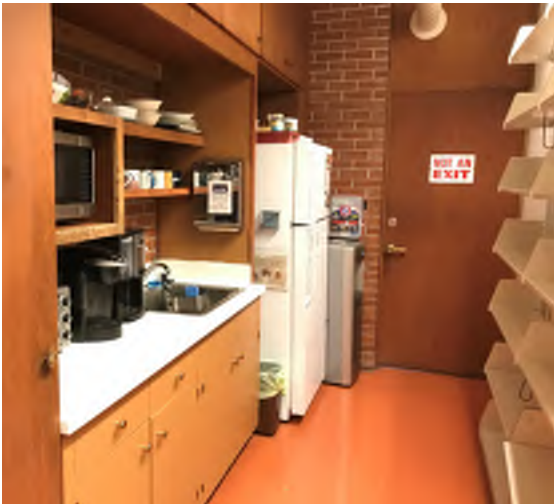
4.1 Level 2 Staff kitchen

Kitchen sink seems to be in good working condition. It has been found that the kitchen sink vent terminates just below the countertop and is not routed to the outdoors. See picture 4.1

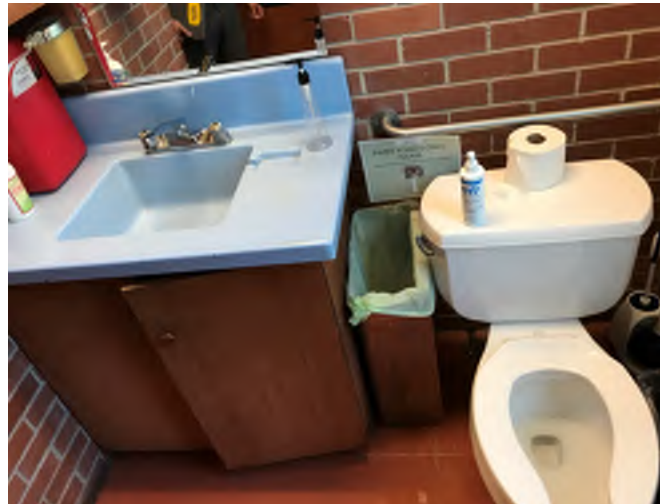
4.2 Level 2 Staff bathroom

The fixtures inside Staff Restroom appears to be in good working condition. See picture 4.2

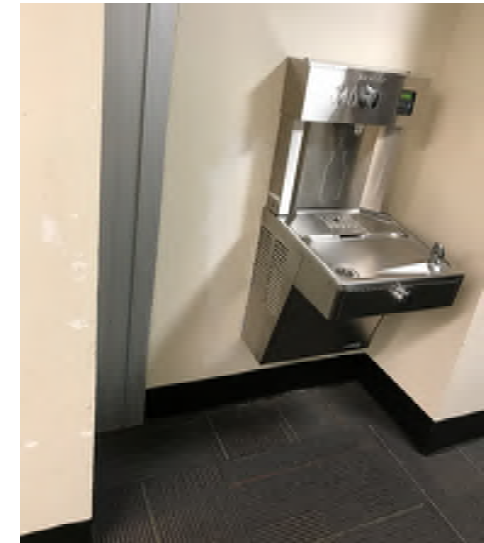
3.4 Level 1 Drinking Fountain

Adjacent Drinking Fountains seems new and they are in good working condition. See picture 3.3 & 3.4.

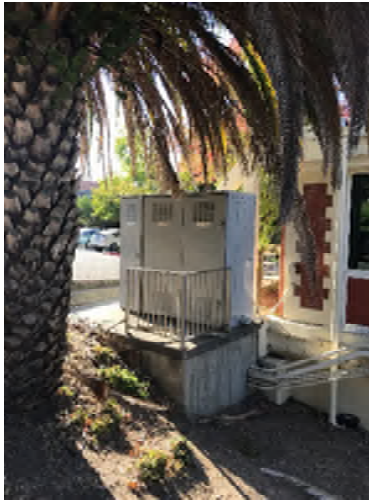
Main Electrical Service Panel

The electric service gear is in good condition and includes resettable circuit breakers. It has additional physical space in the distribution section for additional sub-feeders. It is not the original building service and was upgraded to the current switchboard some time in 2007. It back-feeds the older original switchboard, as described below under the power distribution system.

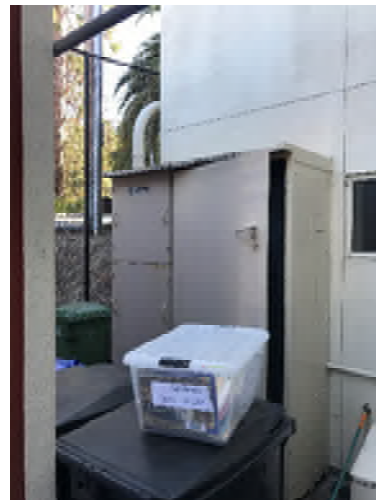
Original Switchboard

The original building switchboard is located at the North/West exterior by the rear door of the Circulation Desk / Office area and is sub-fed via an exterior conduit routed along the exterior. It includes existing original sub-feeders to original branch panels inside the original library. These original panels (including the original switchboard) are rather old and near the end of their useful life. They should be replaced with any modernization or upgrade of the existing building.

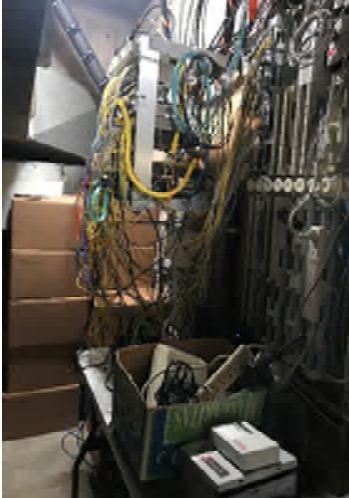
Storage C0-located with MDF

The MDF is currently located in a shared Storage / Mechanical Room and has numerous stored boxes and misc. equipment stored in the same room. The MDF should be provided with a dedicated space in the same location. The basic telecom distribution system is in good condition, but it includes older style Category 5 and 5e cabling that limits the bandwidth capability of the system. The system can be expanded with new components and wiring, such as higher category rated cabling to bring the system into current-day telecom standards.
