March 27, 2020

Coby Friedman, CF Contracting, Inc., 96 Forrest Ave, Fairfax, CA 94930

Re: Arborist Report for vacant lots 59 and 60 (APN #012-141-59 and APN# 012-141-60), and Ross Street Terrace, San Rafael, Marin County, CA

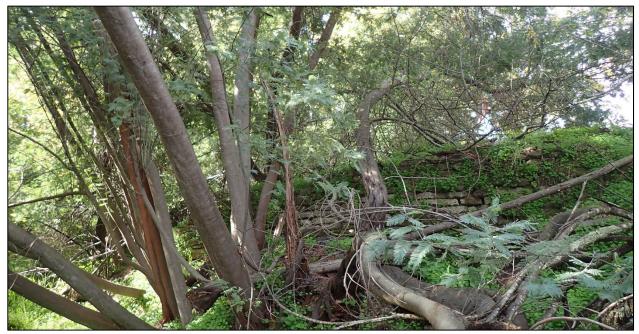
Photograph 1. Photograph depicting non-native, invasive silver wattle (*Acacia dealbata*), significant trees #778 and #779 to be removed within the parcels. These trees exhibit poor structure, with several leaning codominant trunks.

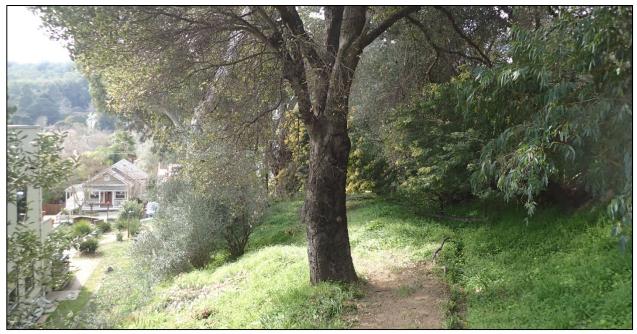
Photograph 2. Photograph depicting a native coast live oak (*Quercus agrifolia*), tree #748, a 26.9-inch City tree within the Ross Street Terrace right-of-way, which is proposed for removal.

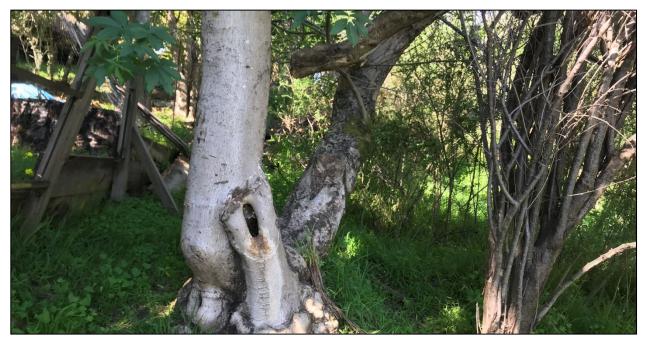
Photograph 3. Photograph depicting tree #763, a 24.2-inch aggregate DBH multi-trunked California buckeye (*Aesculus californica*), a significant tree located in the parcels. This tree ranked poor in condition, health, and structure with major internal decay and dieback, and is proposed for removal.

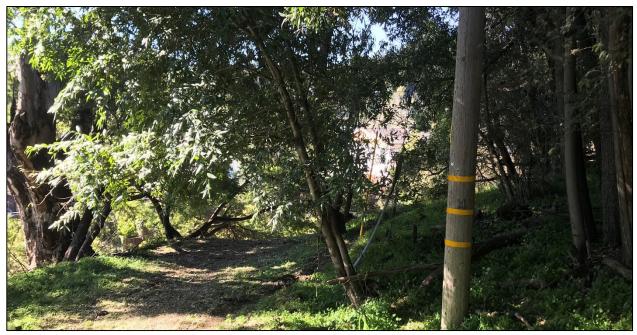
Photograph 4. Photograph depicting tree #739, an 8.1-inch aggregate DBH California bay (*Umbellularia californica*) City tree in the Ross Street right-of-way, to be removed. A large, 54.9-inch red gum (*Eucalyptus camaldulensis*) City tree proposed for removal can be seen at left.
