November 10th, 2020

RE: Underground Culvert Structural Analysis
Undeveloped property
Brookdale Ave
San Rafael, CA

JN: TNC2001

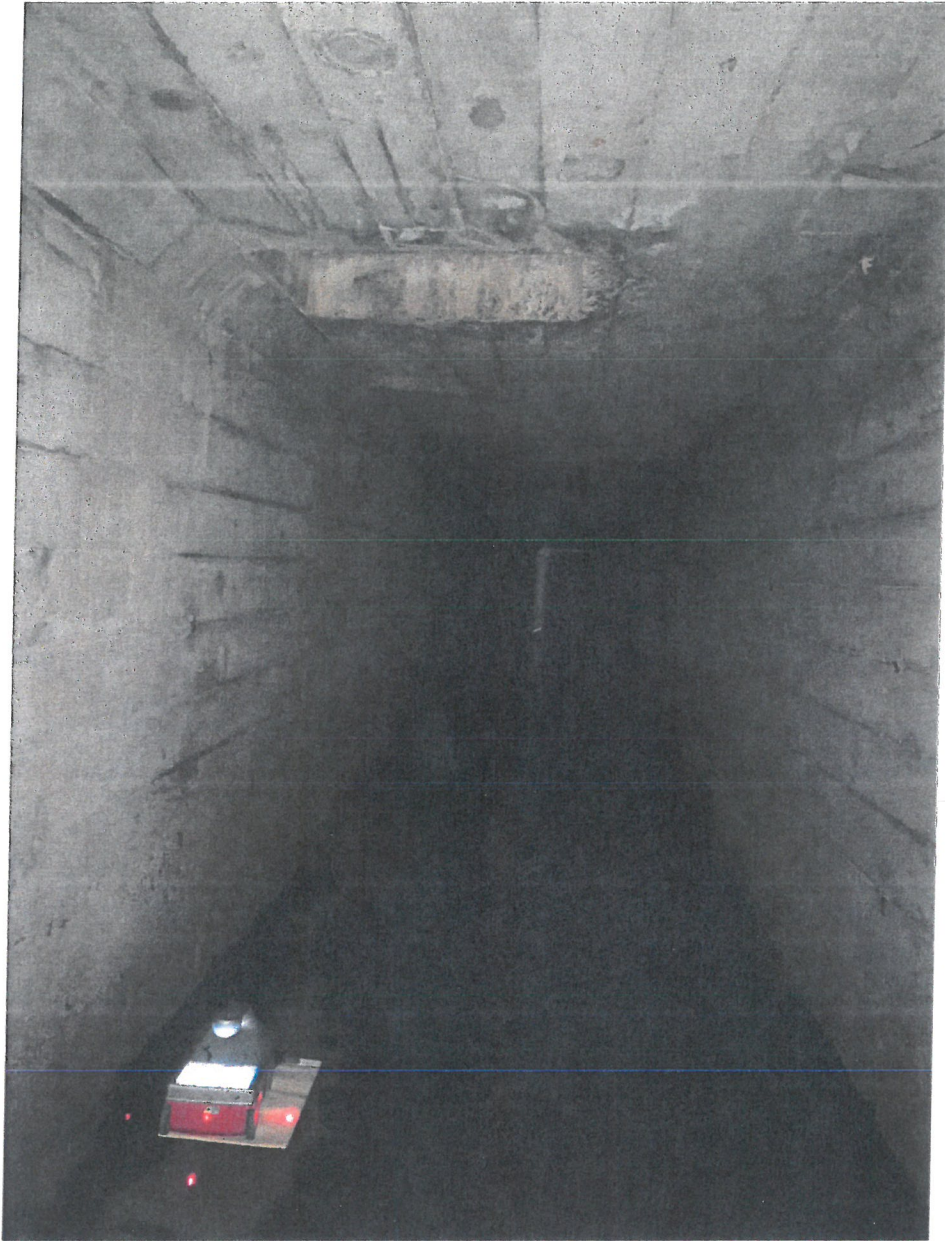
Picture from inside the culvert. Blocked access hole shown in roof

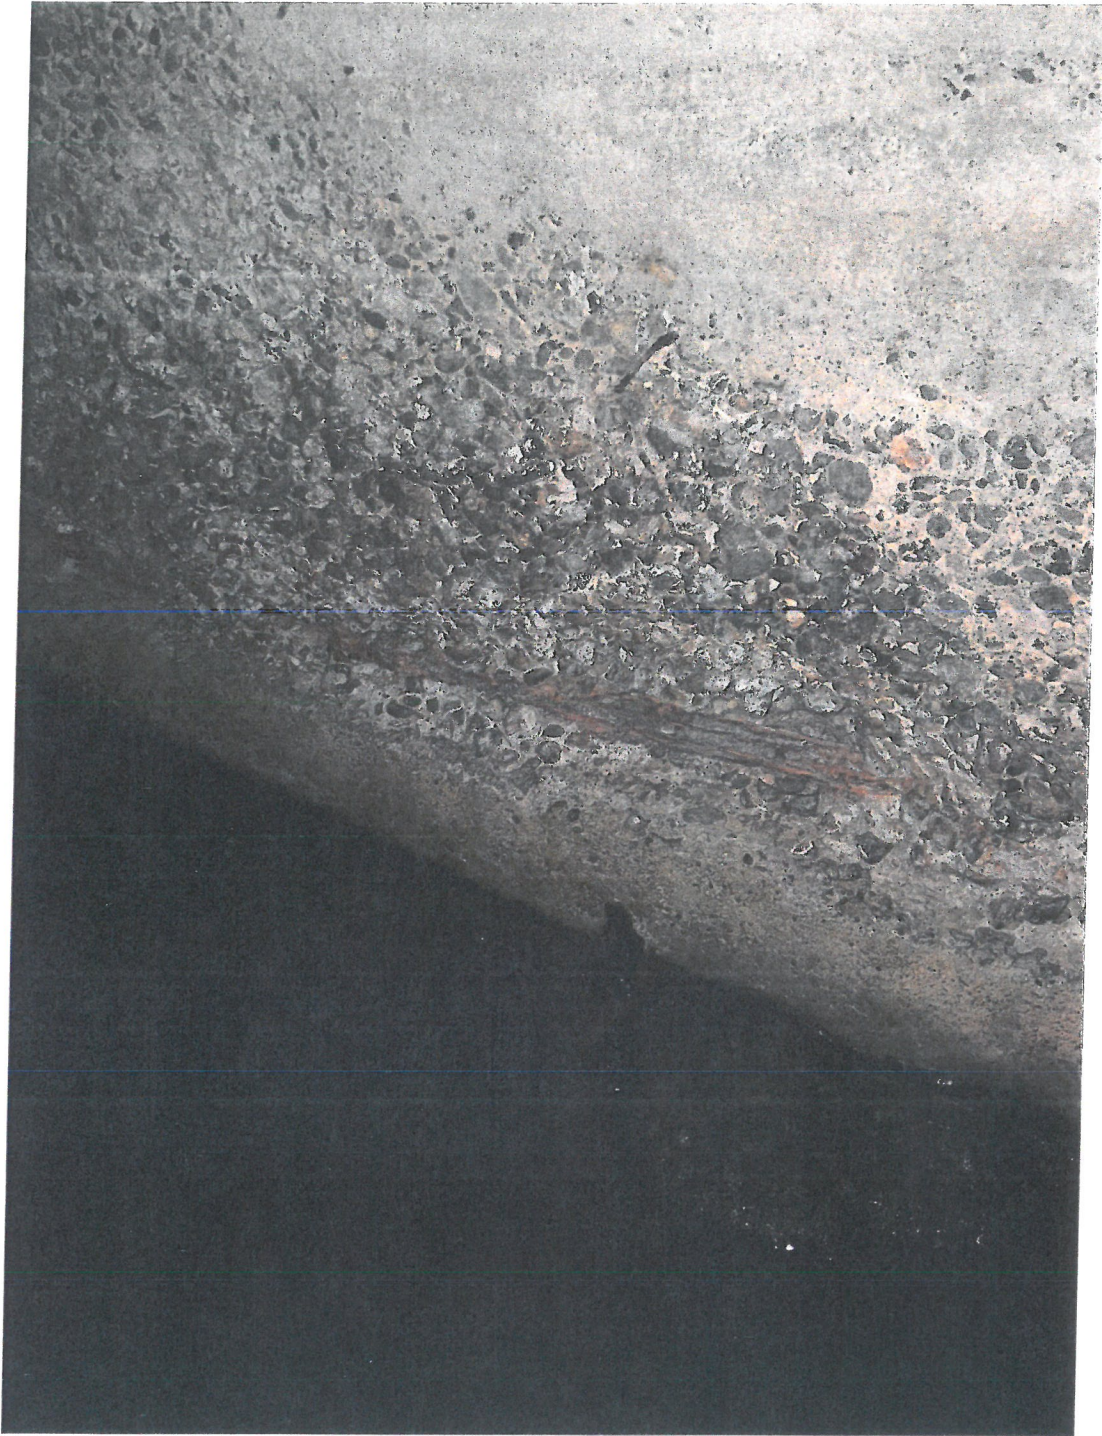
From my visual inspection of the culvert, the structure shows no signs of failure due to loading or seismic movement. There are areas where the reinforcement is exposed and corroded, however, these areas would appear to be from flaws in the initial construction and not structural failure of the culvert. This conclusion is based on the lack of cracking at the areas of failure which would indicate failure from loading or deformation. Throughout the entire area of culvert inspected, I witnessed only minor cracking likely caused by temperature shrinkage or other common, non-detrimental causes.

Case of spalled concrete and corroded reinforcement. This was the worse spot identified, however, there was no evidence of cracking around the area which would indicate wall failure. Spots like this need to be repaired by a licensed contractor.

1. Hire a licensed contractor to repair the portions of the culvert where the wall has been compromised. At a minimum the repair should include the removal of corrosive scale around the steel reinforcement and patching of the wall using grout or a similar bonding agent that will help protect the reinforcement from further corrosion.
2. Place 1" thick steel plates over top of the culvert during construction. Steel plates should be centered on the culverts and be a minimum of eight feet wide, measured perpendicular to the culverts flow direction.
3. Perform periodic inspections of the culvert during construction when machinery is on-site and operating over top of the culvert (on the 1" steel plates). Periodic inspections should also be performed after major rain events and seismic events.

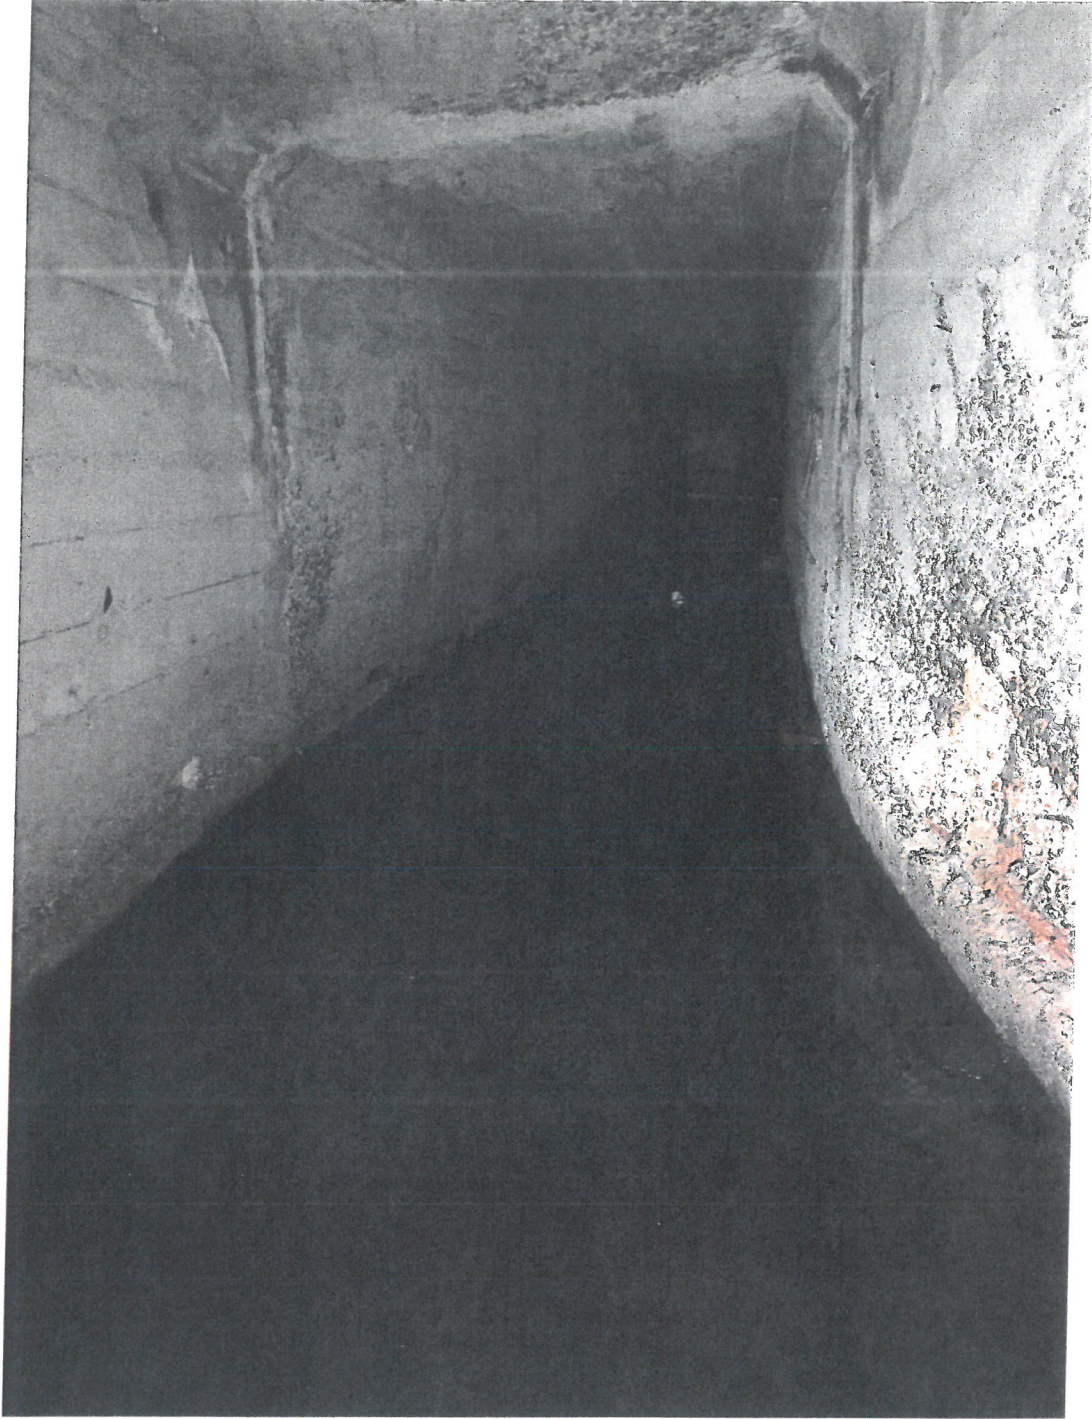
Another picture of the culvert. On the right is another location of concrete spalling and reinforcement corrosion. This area of spalling shows the vertical reinforcement as well as the horizontal. Once again, the problem area shows no indication of cracking but does need to be repaired.

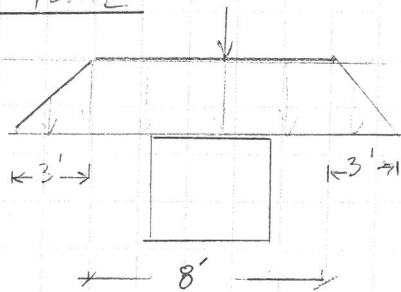
TRY w/ 8' PLATE

$$W_{track} = 16,000 \frac{\text{#}}{14' \cdot 6"} = 190 \text{ PSF}$$

$$M_u = \frac{wL^2}{12} = \frac{(1.2 \cdot 360 + 1.6 \cdot 190) \cdot (4.5)^2}{12} = 1.2 \text{ k-ft}$$

$$\phi M_n = 1.7 > 1.2 \quad \phi M_n \geq M_u \quad \text{OK w/ 8' PLATE}$$

From the analysis, the soil plus construction load created a higher ultimate demand than the expected capacity of the culvert. To lower the demand on the culvert, 1 inch thick, 8-foot-wide steel plates need to be laid over the culvert, on top of the soil, wherever any machinery is expected to cross over it. The 1 inch thick, 8-foot steel plates plus the 3 feet of soil will disperse the load and lower the demand on the culvert to less than the capacity. The 8,000-pound load plus the soil did not exceed the required demand to capacity ratio of the culvert. With the expected addition of Asphalt Concrete or regular concrete anywhere that trucks will be driving or heavy point loads may occur, I do not anticipate any issues with the culvert from the proposed development. This includes the possibility of two car loading scenarios with car lifts.
