REPORT DATE: February 25, 2022

REPORT TYPE: ARBORIST REDWOOD TREE ASSESSMENT

SITE LOCATION: 52-54 Fremont Road, San Rafael, California 94901 **A.P.N.:** xx

ARBORIST(S): James Lascot

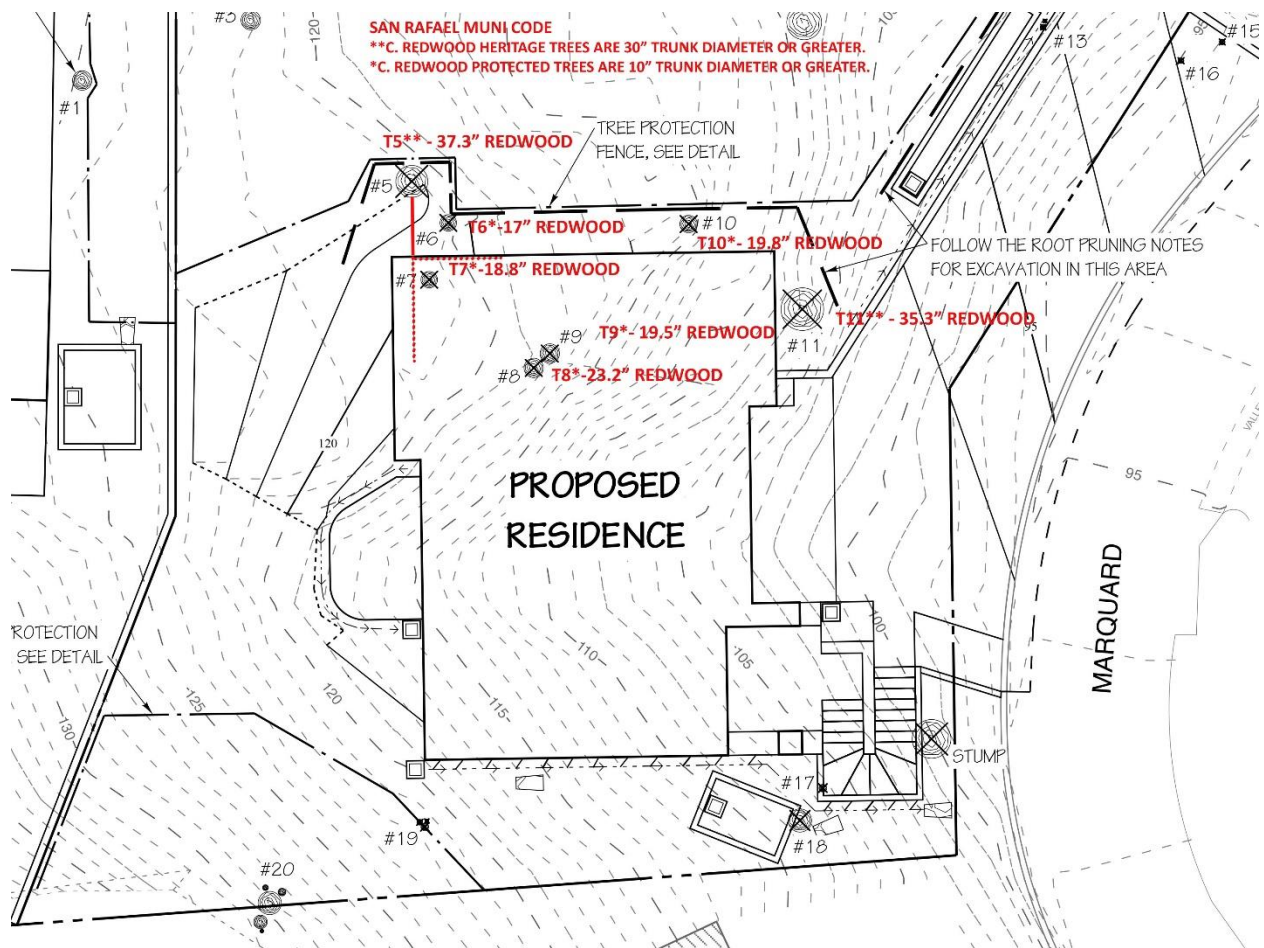
TREE LOCATION: See Tree Map shown as a portion of the approved Tree Plan 1/11/21.

- 1) Within the proposed plan, redwood T5 root losses are approximated at 25%.
- 2) Minimizing overcut of foundation will also minimize root losses to Redwood T5.
- 3) Redwood trees T8 and T9 should be considered the same tree with two co-dominant trunks with imbedded bark and a chronic structural defect.
- 4) redwood t11 has two co-dominant trunks with embedded bark and a chronic structural defect. Its location on a steep slope contributes to determining it a hazardous tree.

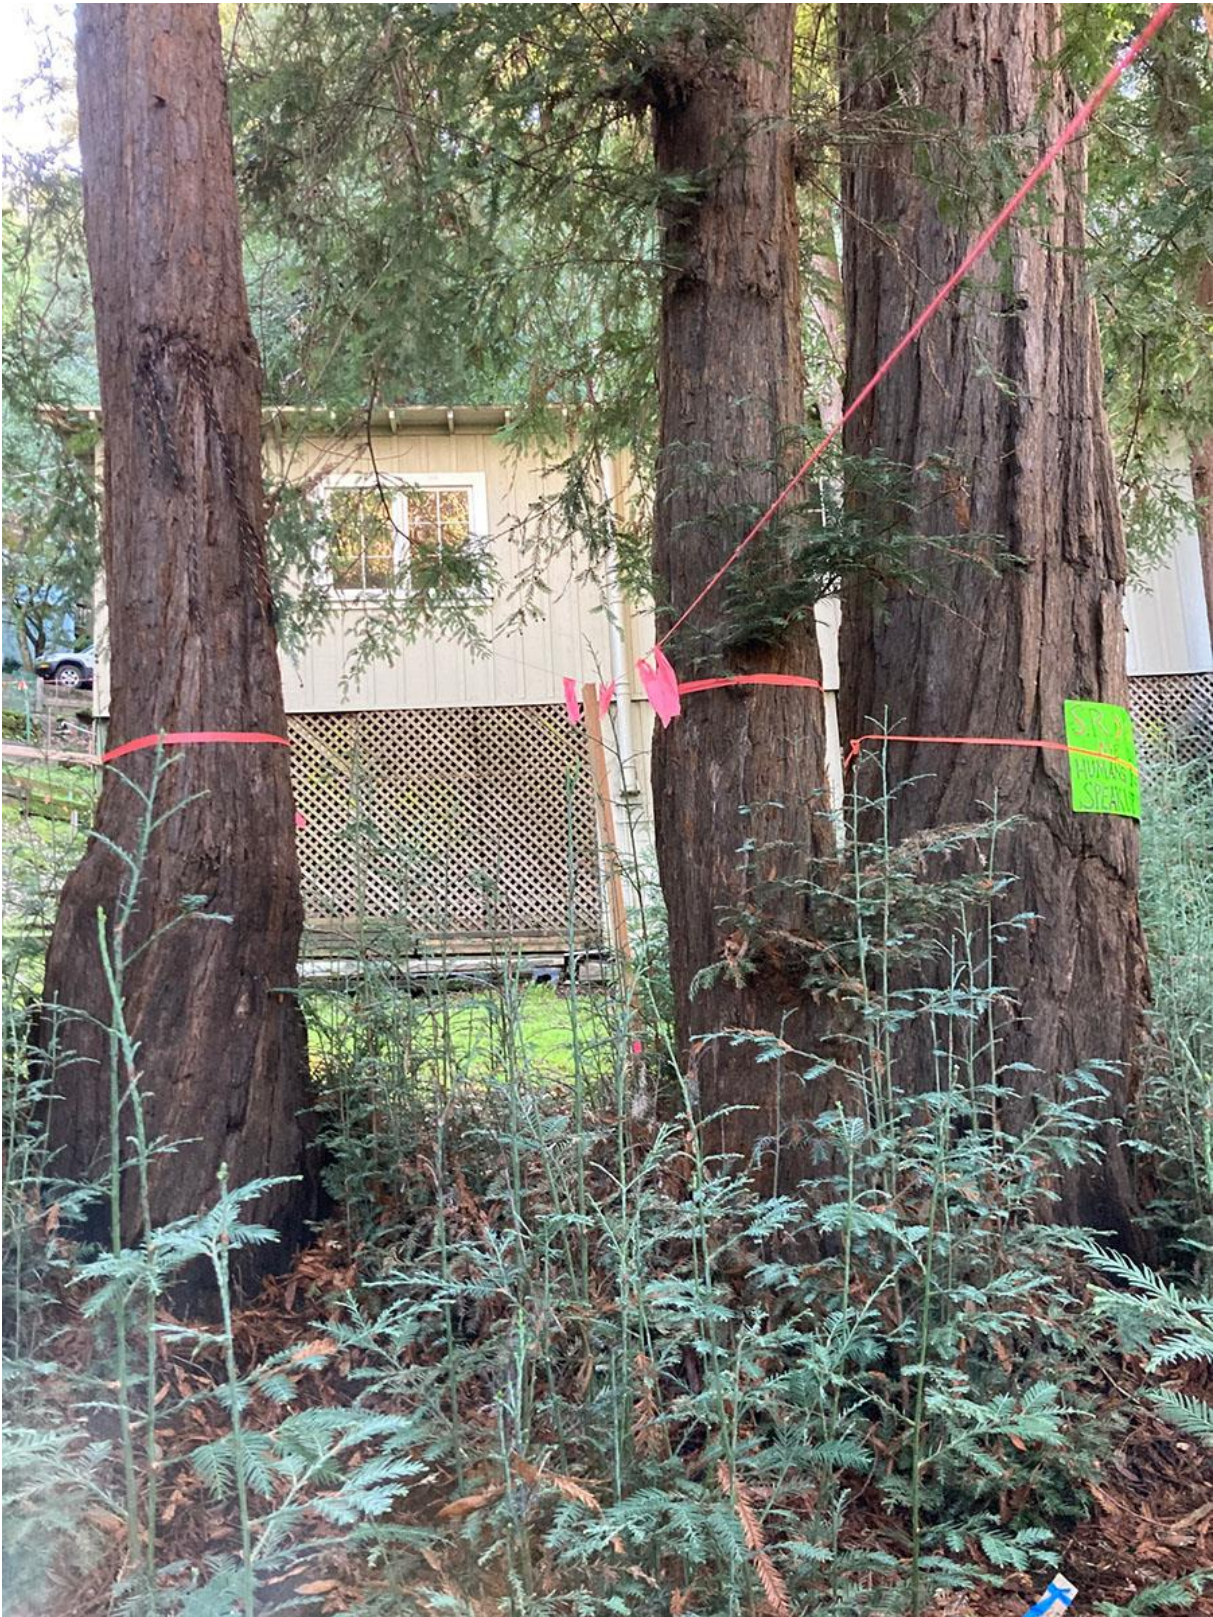
PHOTOGRAPH 1 - Subject tree No. T5 (right), T6 (center), and T7 (left).

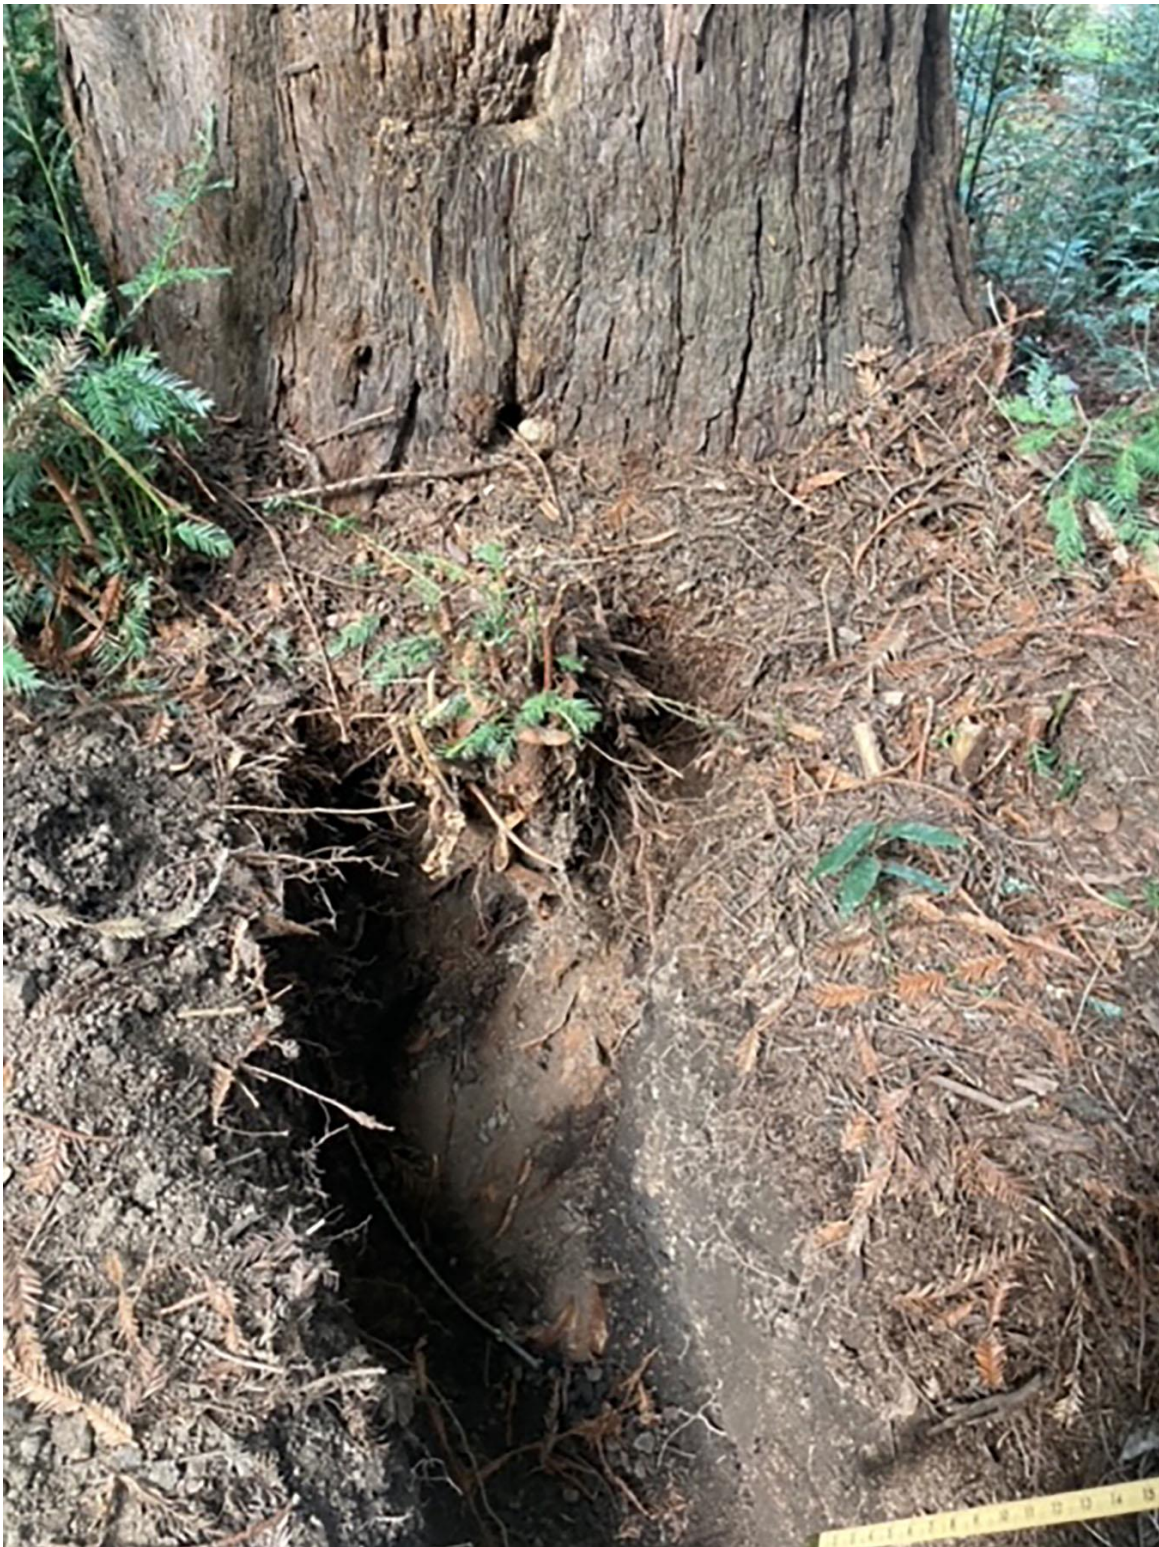
DISCUSSION: The subject is a mature native tree located approximately five feet of the proposed rear corner of the proposed residence. Exploratory excavation to a depth of 24"-36" was performed on 1/7/22 and 1/21/22 and further examinations on 2/24/22. There was one 3" diameter root that was found in the trench, but it was likely coming from tree T6 and not from tree T5. There were no other significant roots (over ½ inch diameter) within the proposed soil cut of the retaining wall from this tree. One six-inch (6") was discovered at the base of the trunk but did not appear to be in the direction of the proposed soil cut. The trunk cavity at the base is significant but most structural roots appeared intact.

PHOTOGRAPH 2 - Subject redwood tree No. T5 following root excavation. Note: There is a six-inch root directly below the trunk but does not appear to be headed toward proposed soil cut.

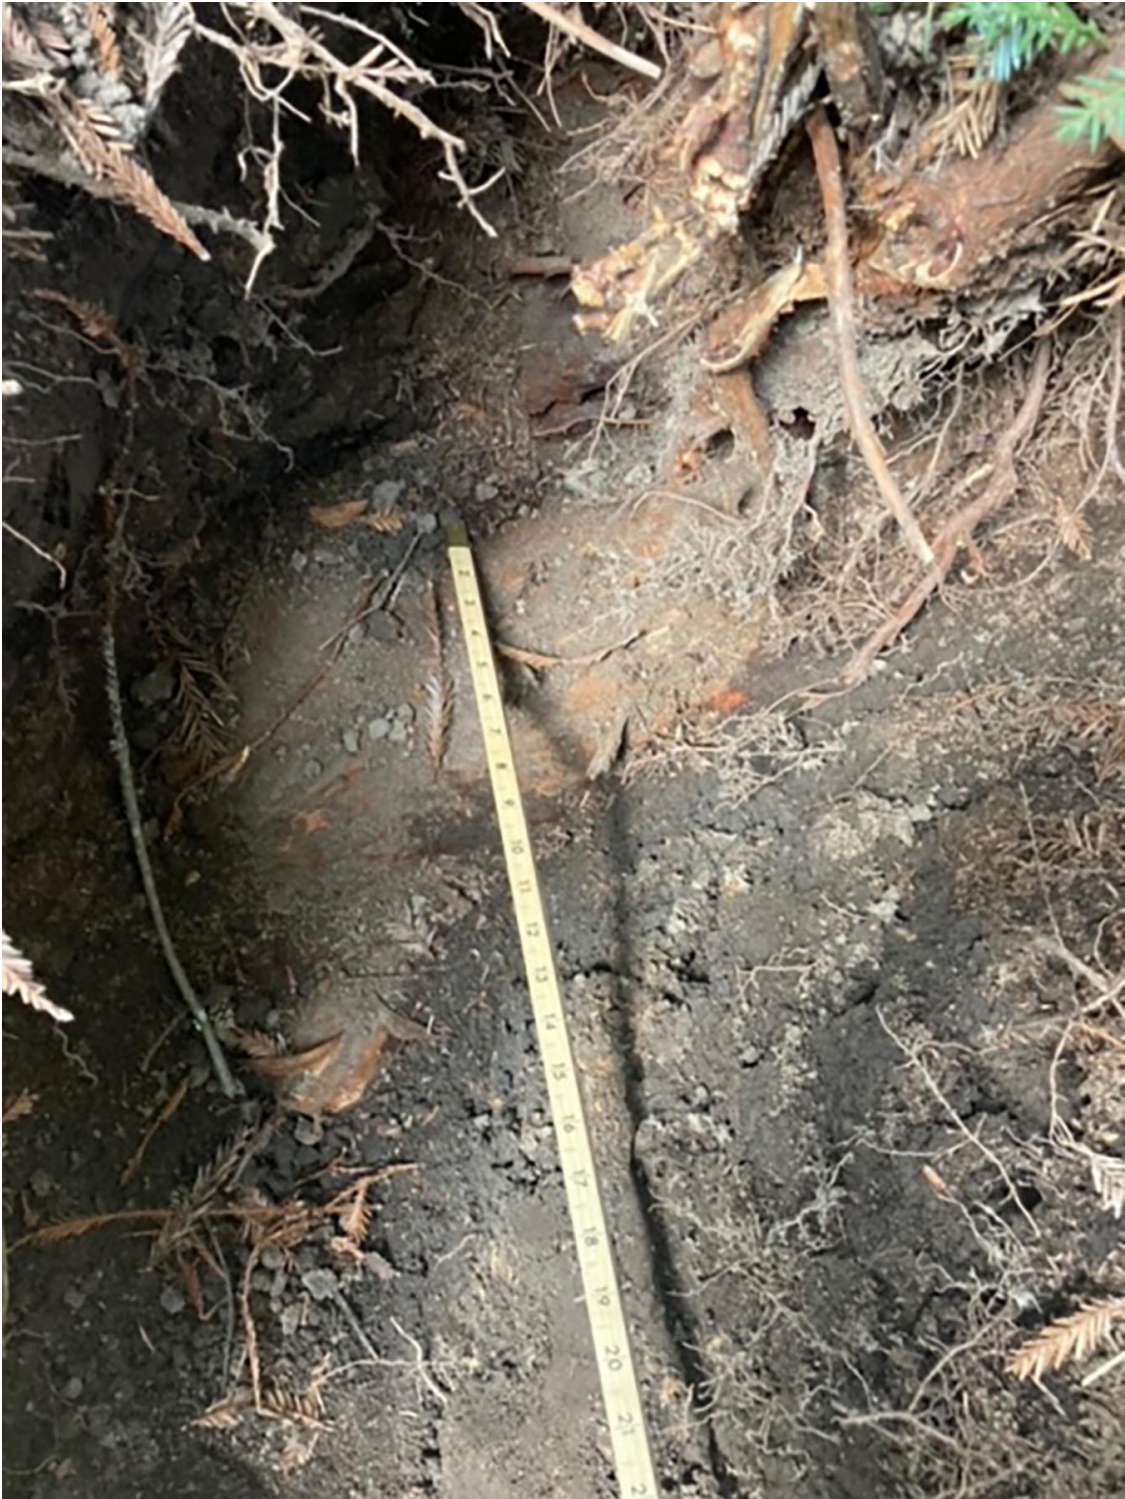
PHOTOGRAPH 3 - Subject redwood tree No. T5 showing a closer view of the six-inch root directly below the trunk but does not appear to be headed toward proposed soil cut.

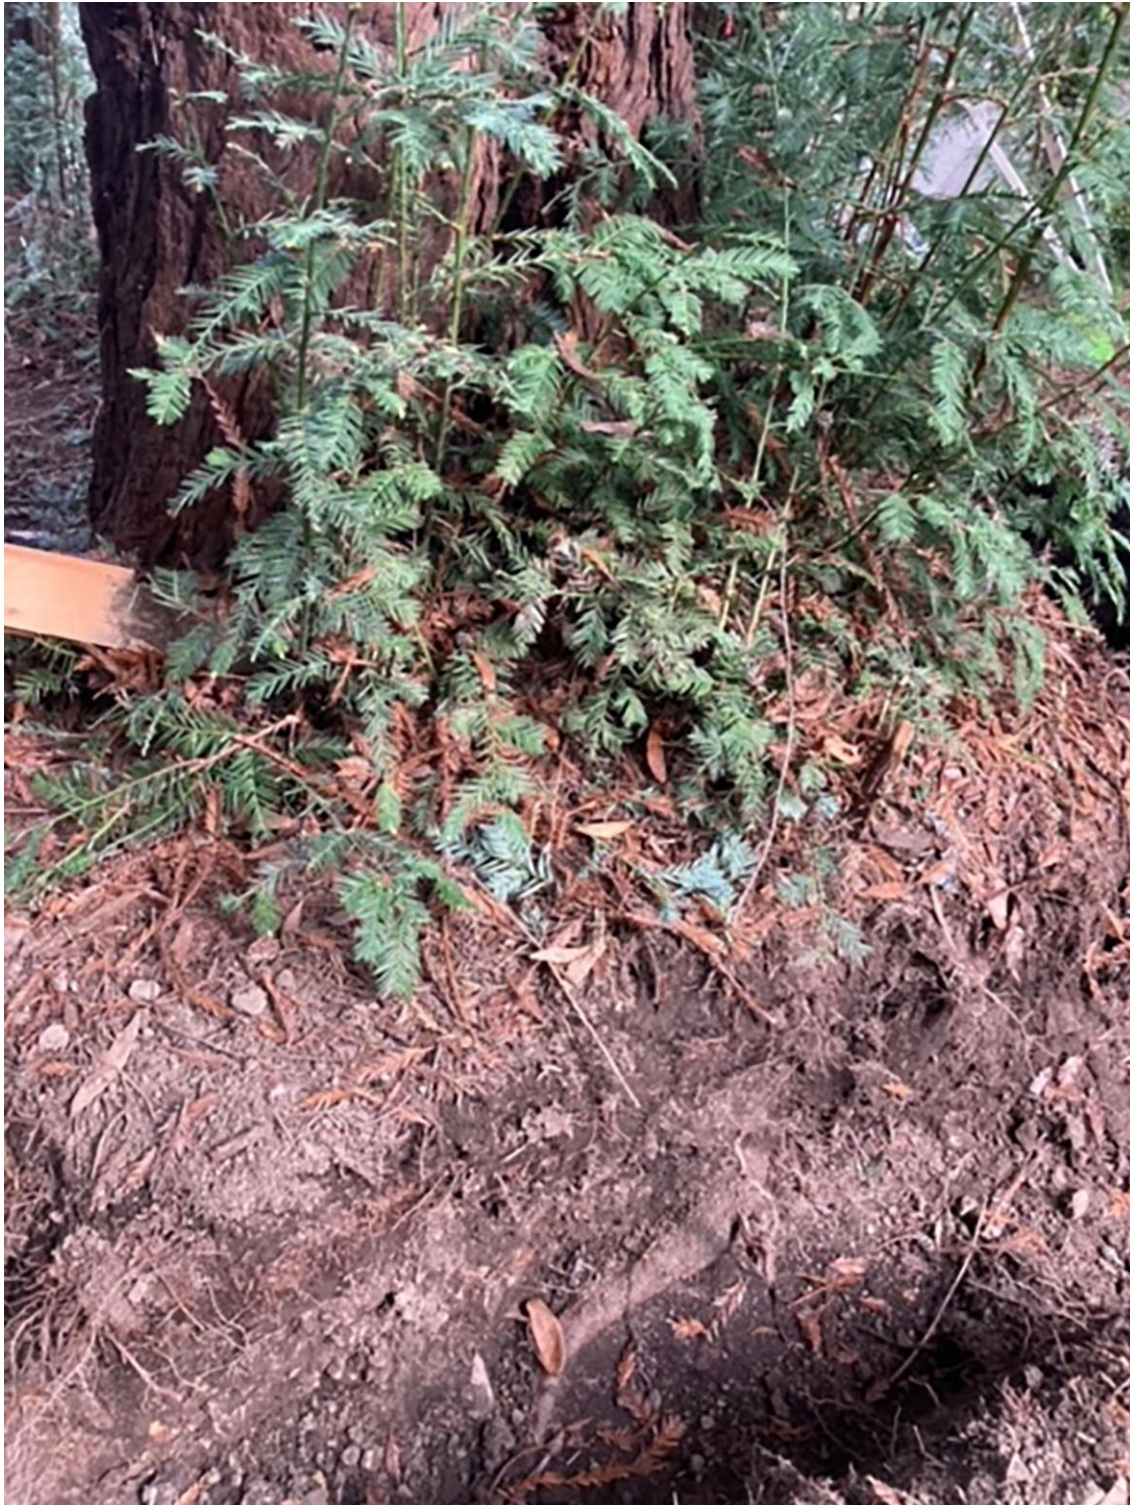
PHOTOGRAPH 4 - Subject redwood tree No. T6 showing the presence of a three-inch (3") root. Note: This root does not appear to be from redwood T5.

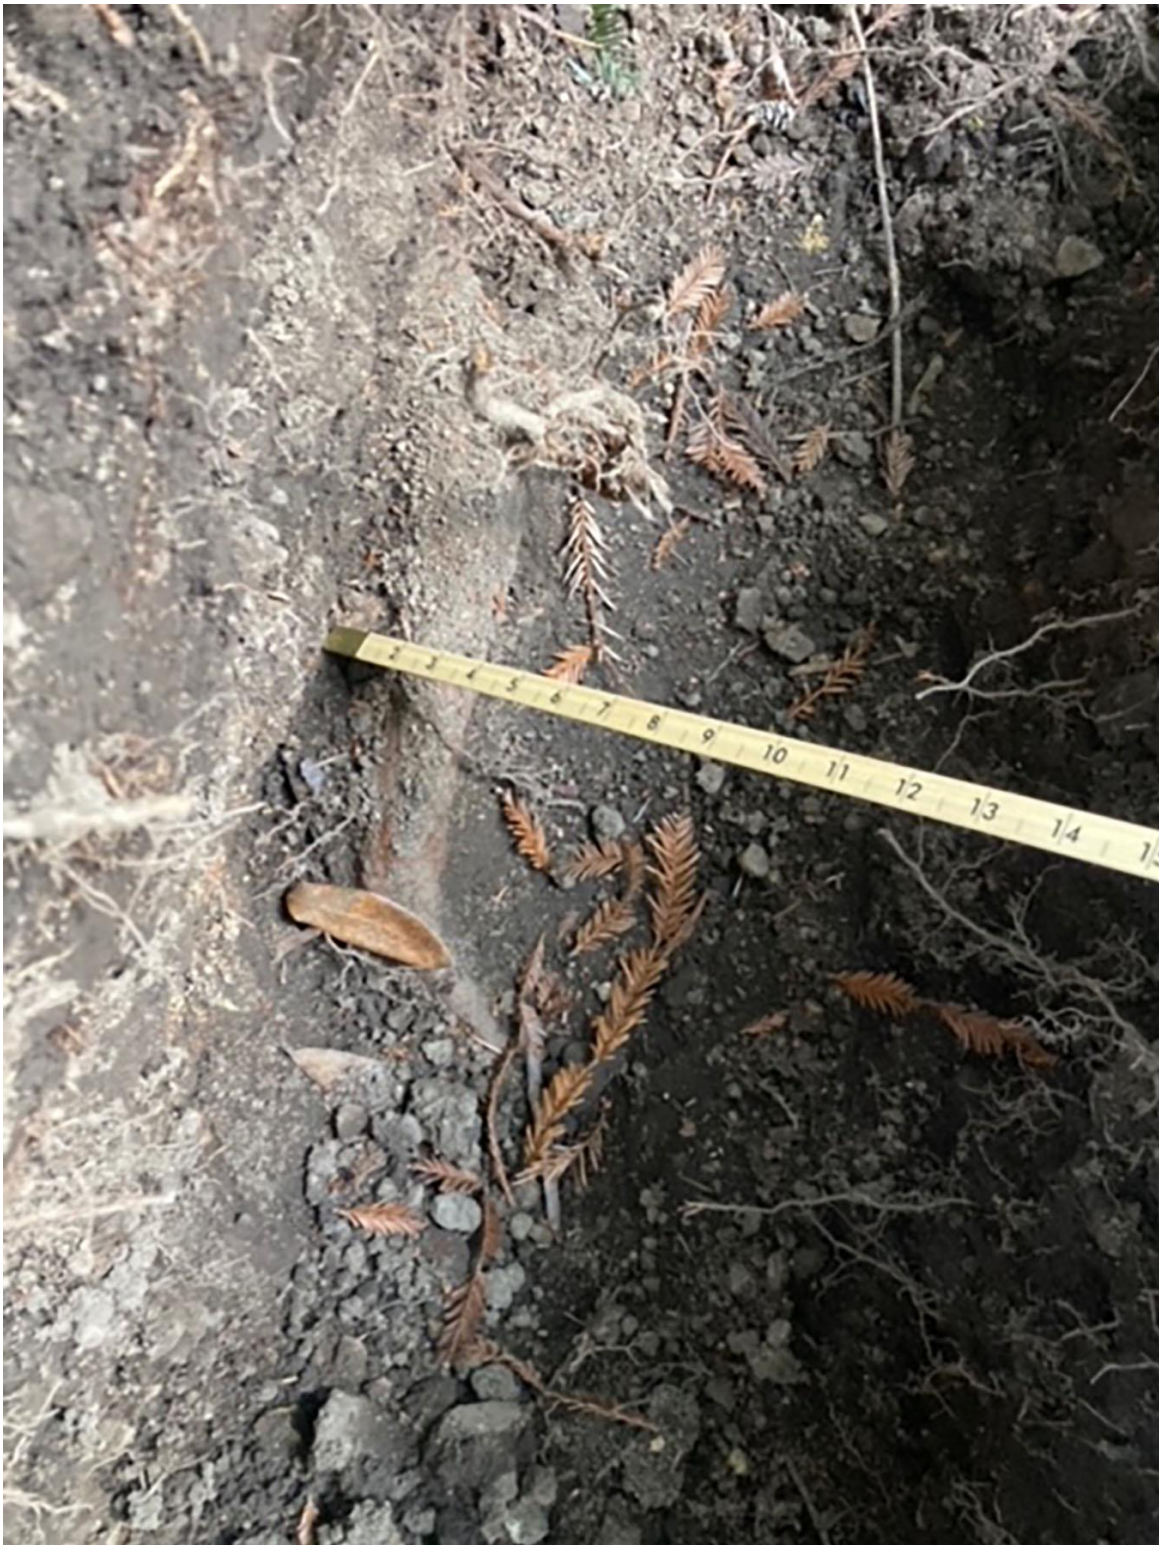
PHOTOGRAPH 5 - Subject redwood tree No. T6 showing a closer view of a three-inch (3") root. Note: This root does not appear to be from redwood T5.

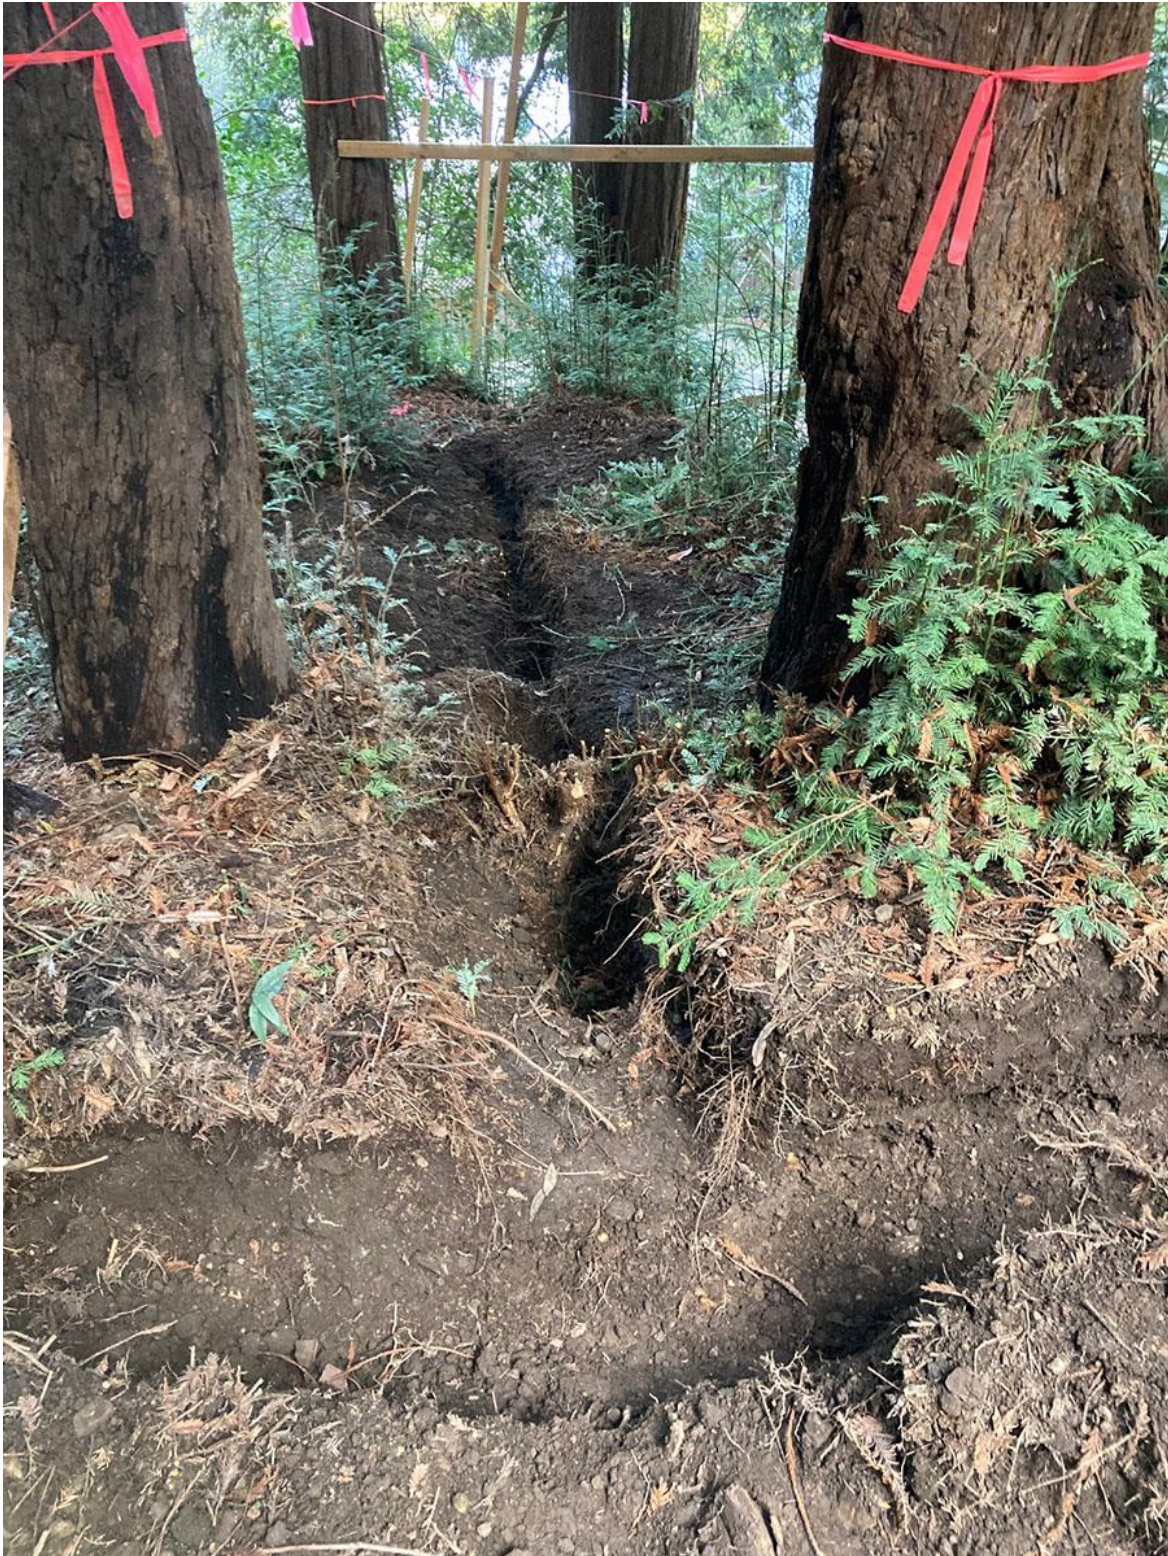
PHOTOGRAPH 6 - Subject redwood tree T6 (near left) and tree T7 (far right). Down slope is tree T10 (left) and tree T11 (right). Note: No roots over ½ inch were found in any of trenches.

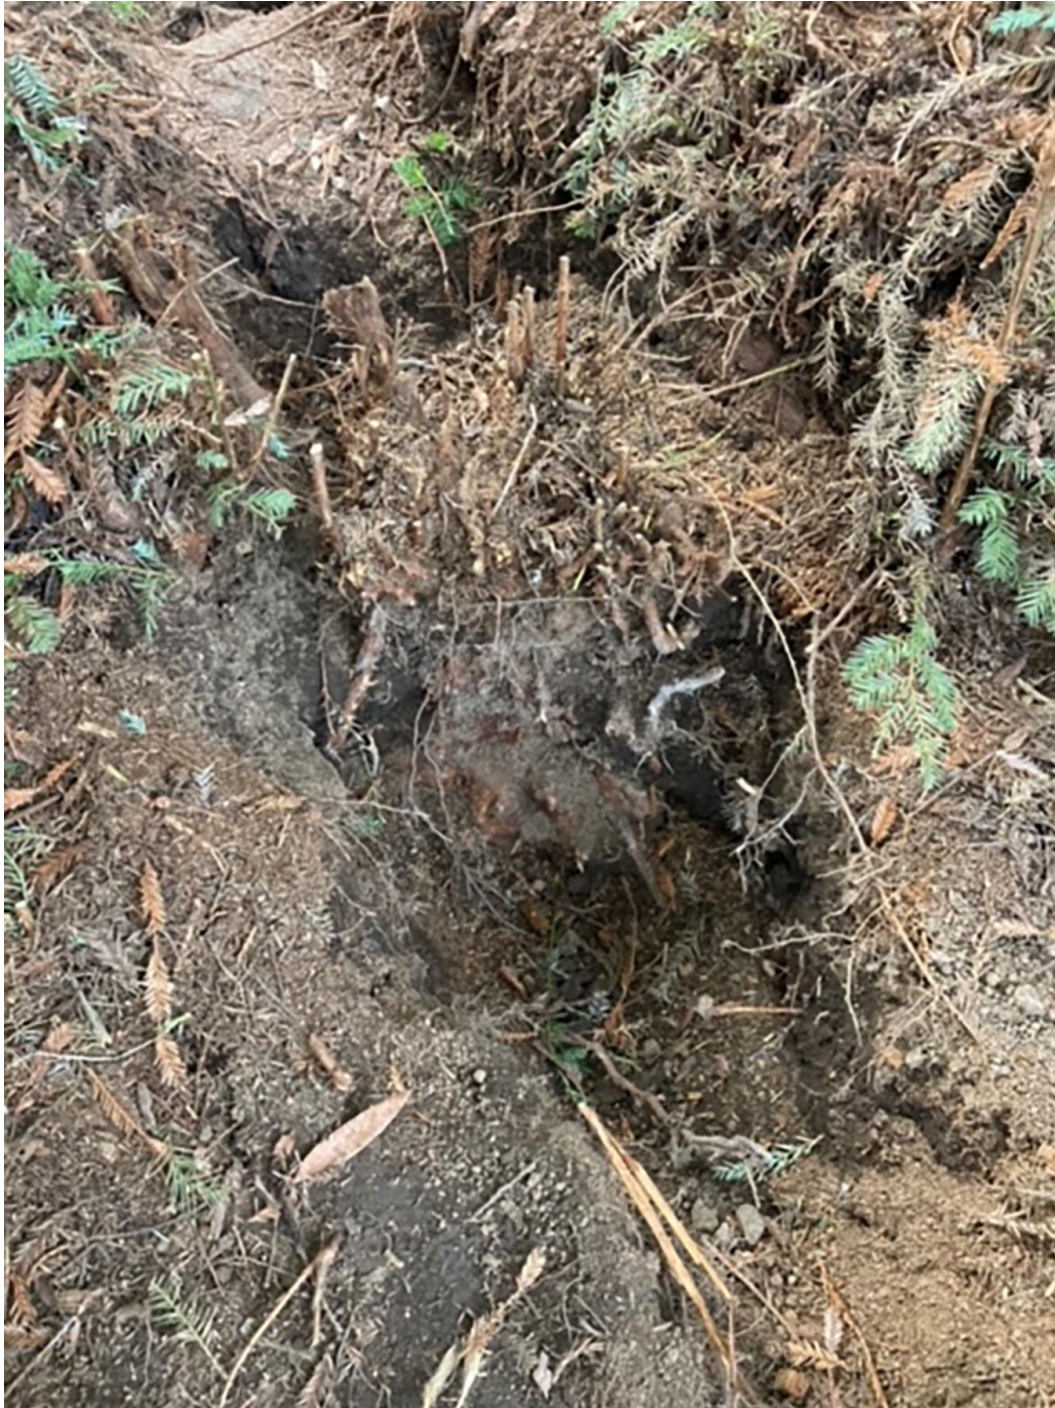
PHOTOGRAPH 7 – Following the exploratory excavation a root sprout was found between redwood tree No. T6 (right) and T7 (left). Note: root sprouts are not considered significant roots for the health of parent trees.

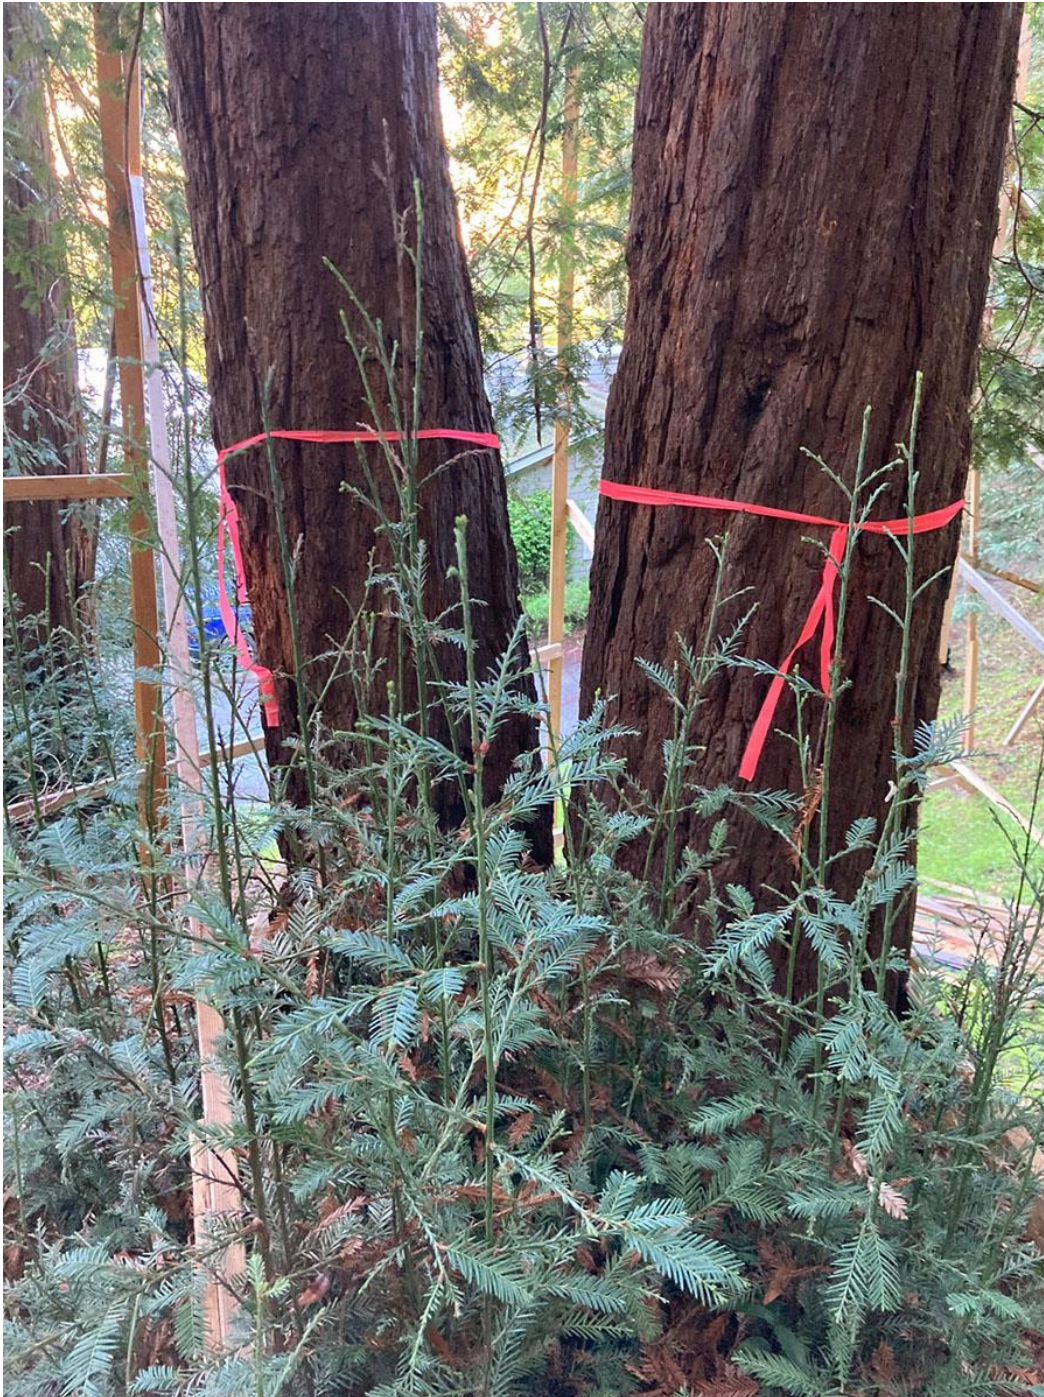
I found that one subject Heritage size redwood (T11) and two Protected size trees (T7 and T8) had codominant trunks that are considered significant chronic structural defects within the arboricultural industry and were considered poorly suited specimens for preservation despite the proposed development. There appeared to be no mitigation measures that could preserve these trees from the proposed development. I agreed that these trees should be removed.

In conclusion, I have determined that the Heritage tree T11 with Protected trees T8 and T9 are so close to have a significant and chronic structural defect (co-dominant trunks) that make them poor specimens for preservation. I also find that there are no mitigation measures that could reasonably spare them from the currently proposed development. It should also be noted that these trees may also have internal trunk damage if they were exposed to the same fire incident as tree T5, but the examination of the trunks has not been performed at this time. I would recommend removal of these tree due to poor structural integrity and the for the proposed development.

PHOTOGRAPH 8 - Subject redwood trees No. T8 (left) and T9 (right) can be considered one tree with co-dominant trunks with embedded bark which is a chronic structural defect.

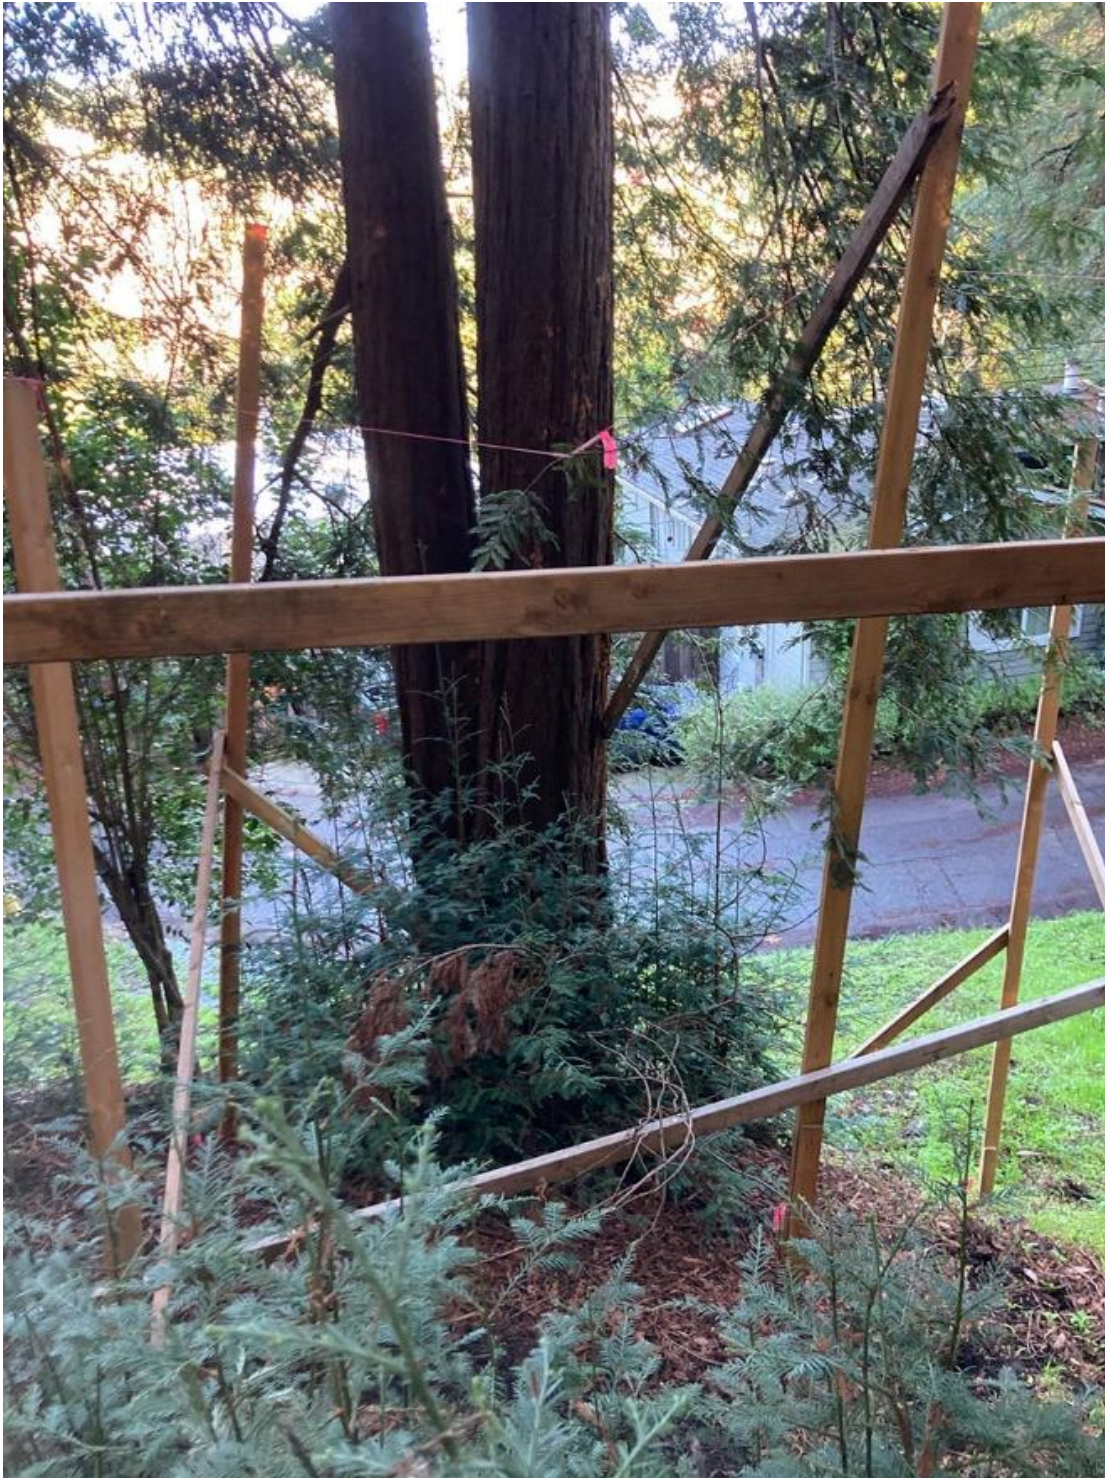
PHOTOGRAPH 9 - Subject redwood tree No. T11 with co-dominant trunks with embedded bark which is considered a chronic structural defect.

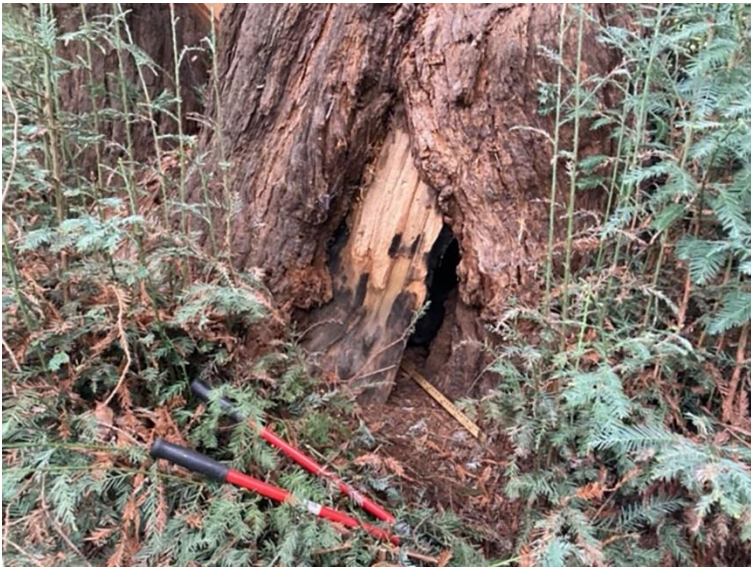
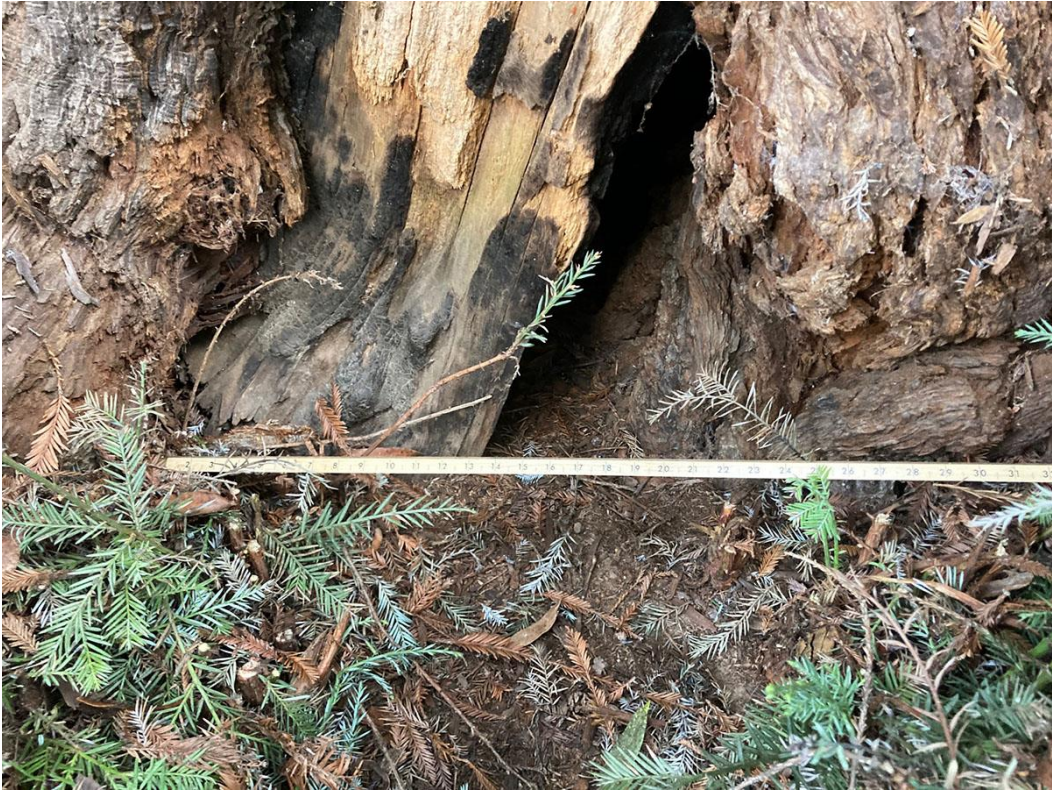
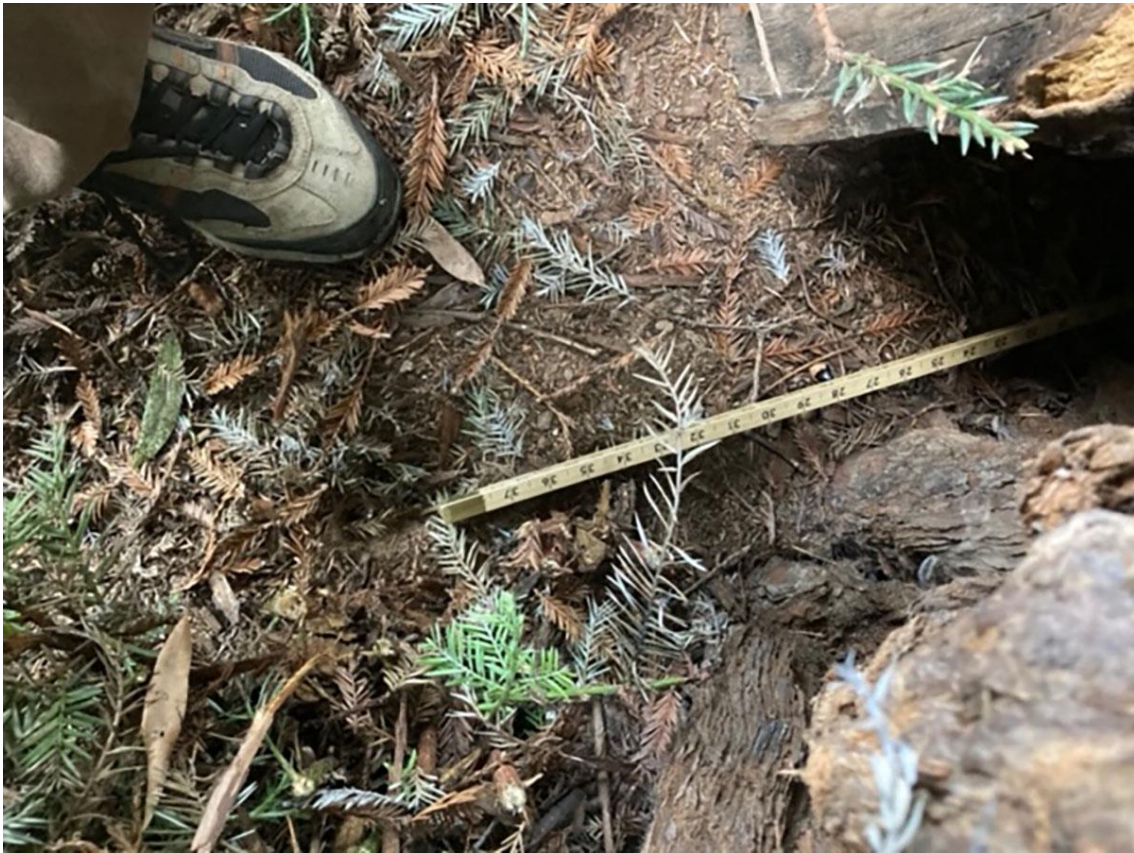
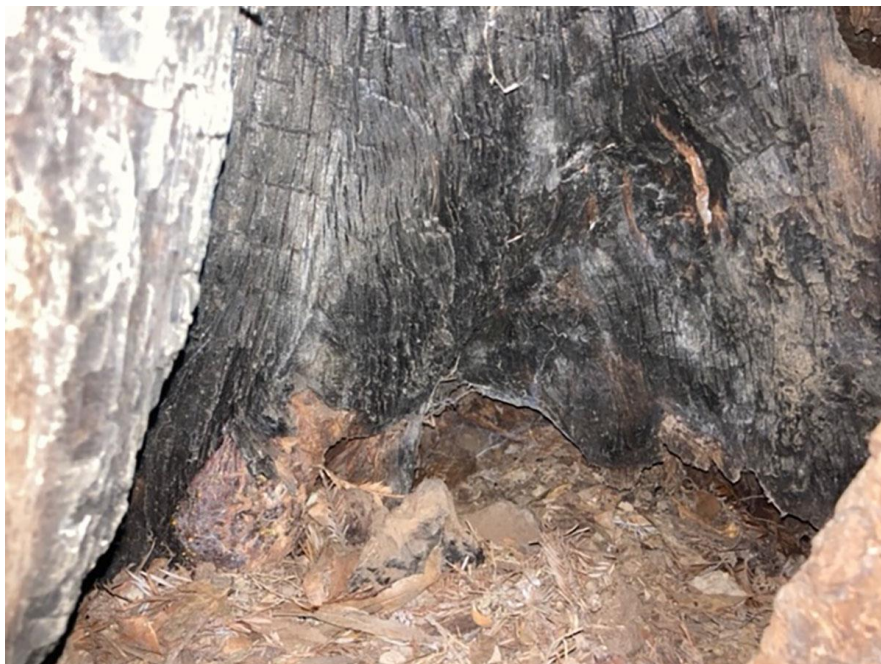
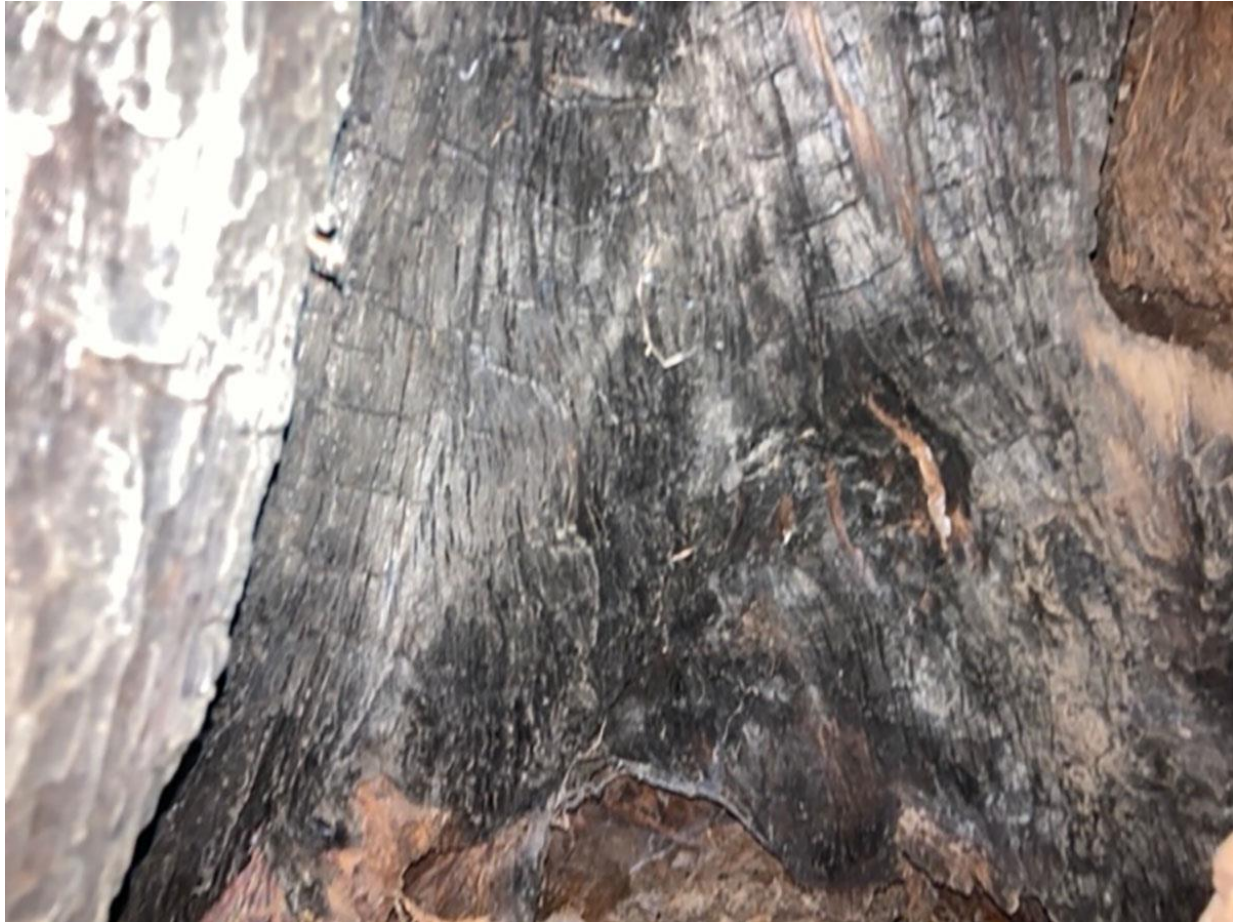
During the process of exploratory excavation, we discovered that this tree (T5) had a major trunk cavity on the backside (northwest) of this tree. Further investigation found that this tree had a significant gap in the and that the trunk of this tree was hollow at its base. The trunk decay was significant, but the tree had already compartmentalized the wound. The cause of the hollow trunk appeared to be from a prior fire incident.

Tree T5 also has a significant structural defect (trunk is hollow at its base) and would normally be recommended for removal of this tree due to poor structure and for the proposed development.

CONDITION: Poor; this tree is hollow at its base with an approximately thirty-six inch (36") cavity. The cavity has burn marks throughout. The opening at the base of the trunk is approximately 23 inches wide. The height of the cavity within the trunk was not determined but may be estimated as approximately 4-6 feet above soil grade. Most of the structural roots appear intact.

PHOTOGRAPH 10 - Subject redwood tree No. T5 showing trunk cavity.

PHOTOGRAPH 11 - Subject redwood tree No. T5 showing trunk cavity.

PHOTOGRAPH 12 - Subject redwood tree No. T5 showing trunk cavity.

PHOTOGRAPH 13 - Subject redwood tree No. T5 showing trunk cavity.

PHOTOGRAPH 14 - Subject redwood tree No. T5 showing trunk cavity.

Option 1: Removal of this tree for the reasonable economic enjoyment of the property. The stump should be ground or removed as it will re-sprout from its stump.

Option 2: Approve its removal but every effort will be taken to preserve this tree.
