**CITY OF SAN RAFAEL
ESSENTIAL FACILITIES**

FACILITY EVALUATION REPORT

APPENDIX TO STRATEGIC ANALYSIS REPORT

AUGUST 2003

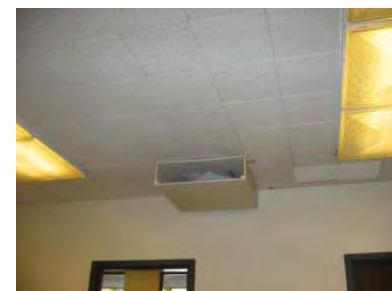
Yellowing, aged fluorescent fixtures and a modified diffuser at City Hall.

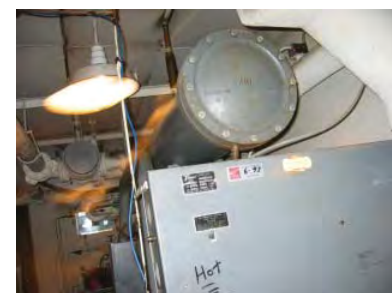
The boiler at City Hall is over 35 years old and past its useful life.

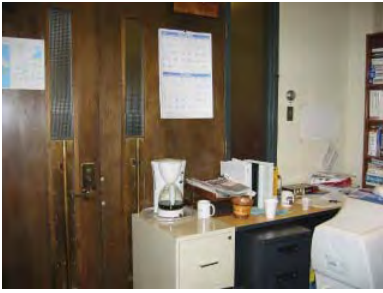
Offices in City Hall are crowded.

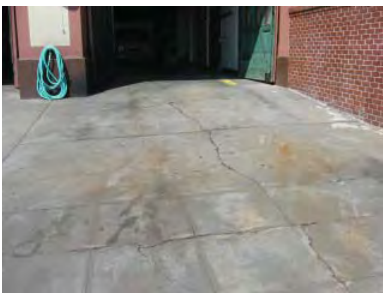
The driveway at Fire Station No. 1 is aged and cracking.

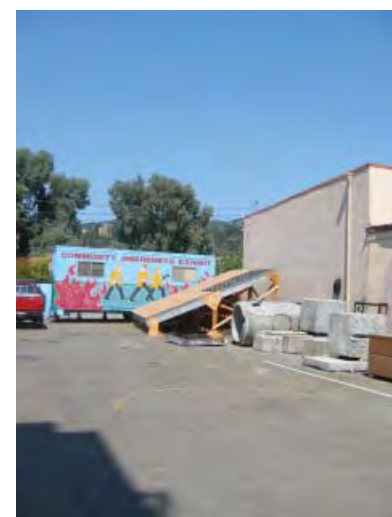
Training equipment at Fire Station No. 2 makes the site even more crowded.

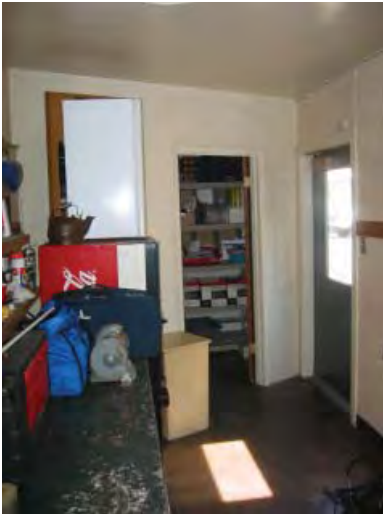
Lack of storage space at Fire Station No. 2 limits the station's efficiency.

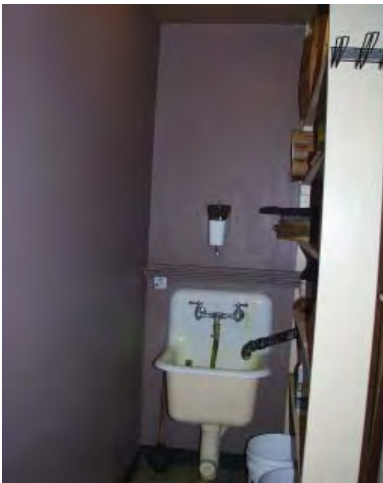
Fire Station No. 4 lacks appropriate space for decontamination

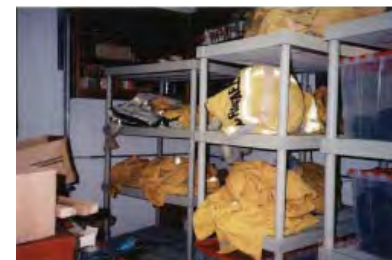
Inappropriate gear storage at Fire Station No. 5.

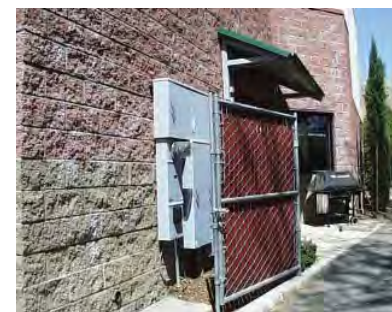
Electrical panels are close to the driveway on Fire Station No. 6's restrictive site.

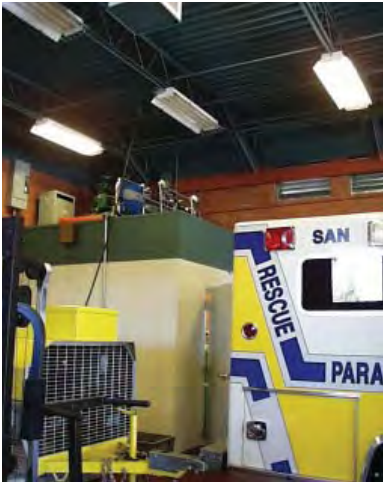
Although it is less than 10 years old, Fire Station No. 6 already lacks storage space.

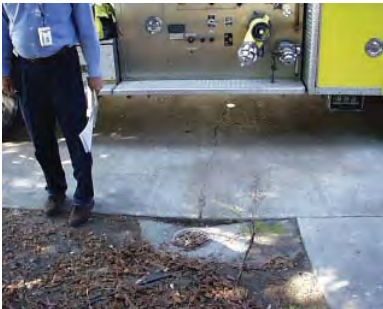
Fire Station No. 7 suffers from drainage problems.

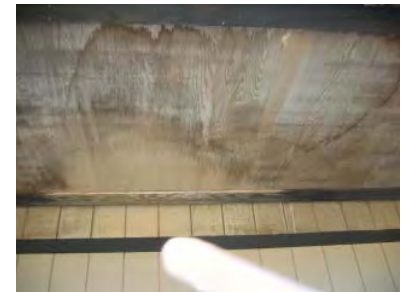
Exterior soffits at San Rafael Community Center show signs of water damage.

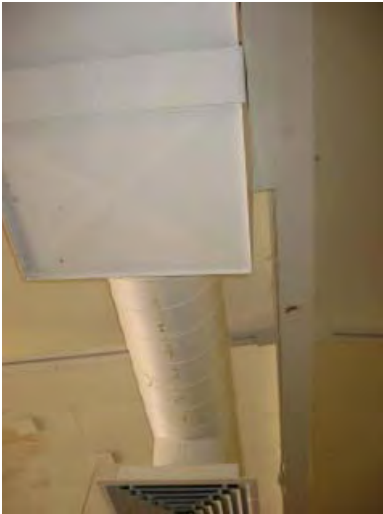
Worn finishes and signs of water leakage in the multipurpose room of Terra Linda Community Center.

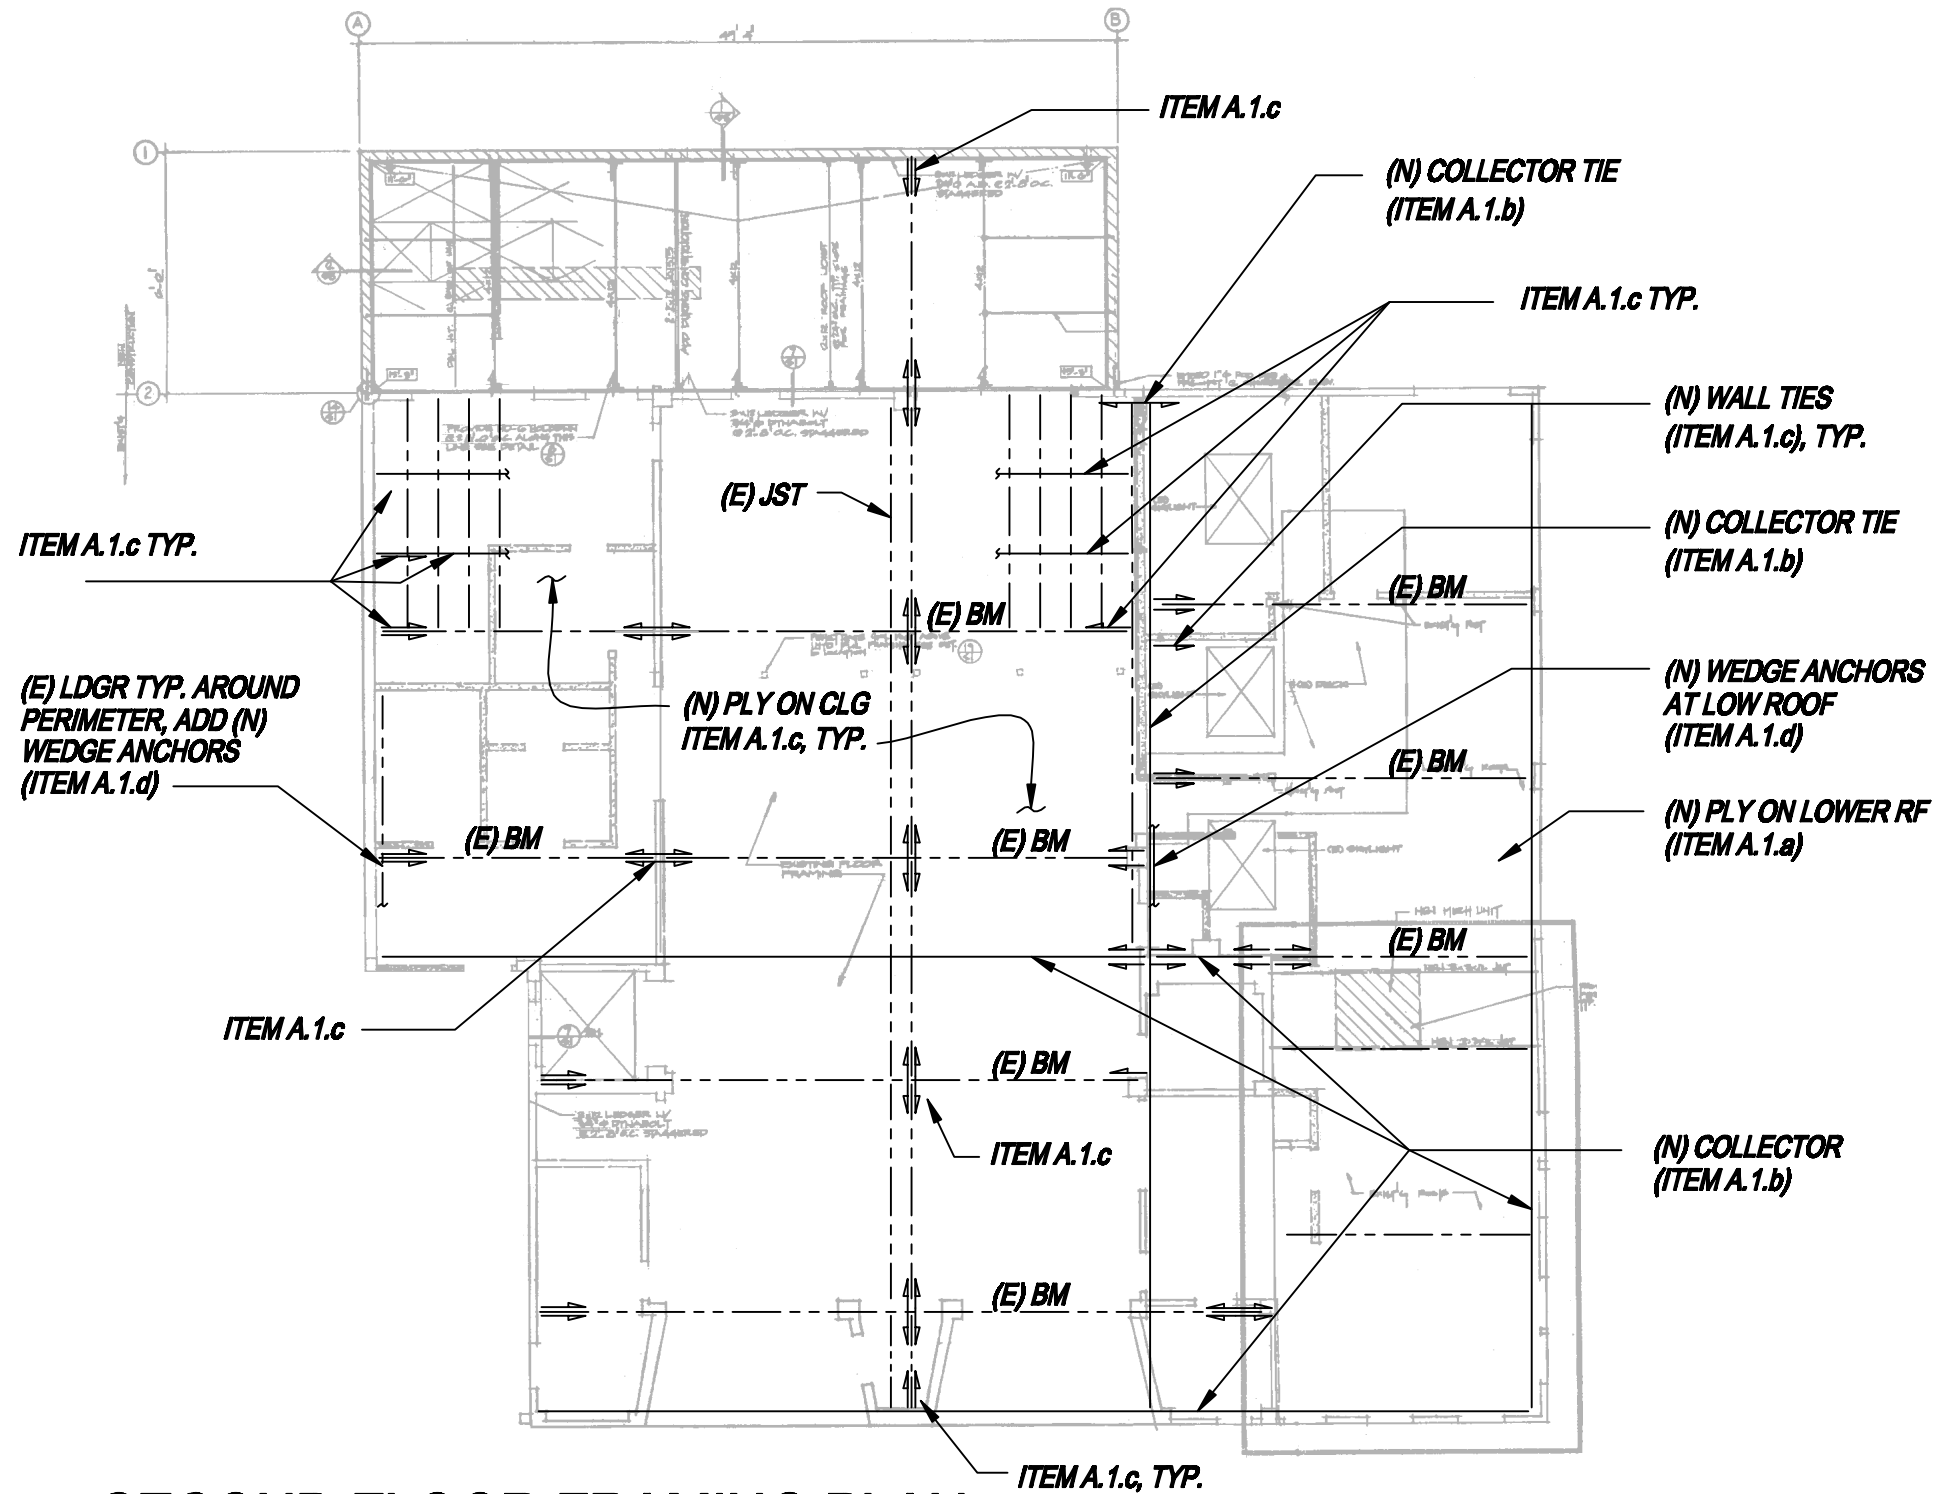
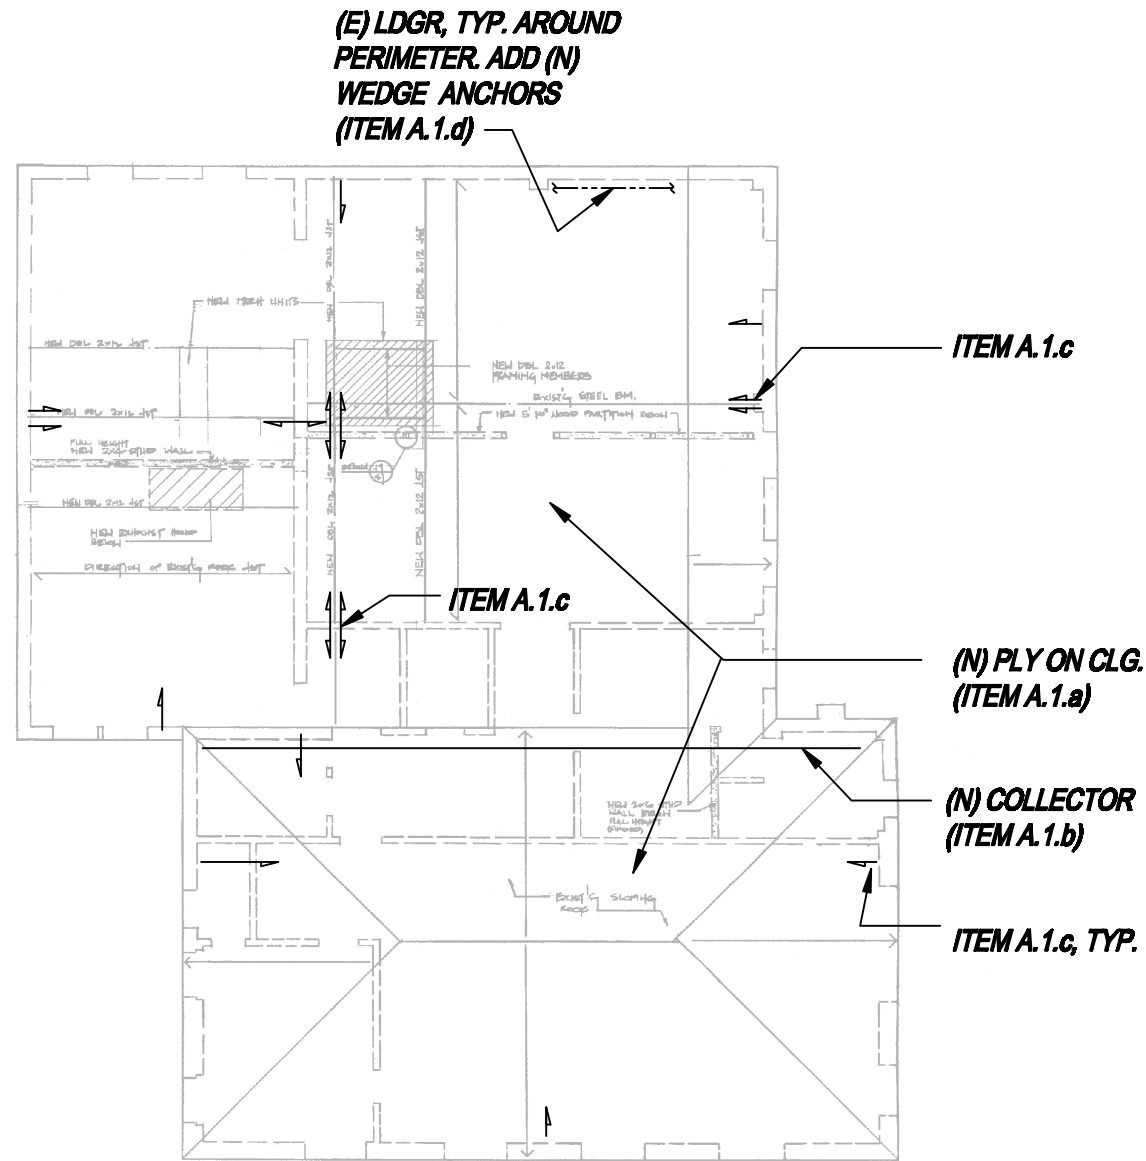
SECOND FLOOR FRAMING PLAN

rated as poor, given the age and construction material of the building. Older concrete wall buildings with wood framed floors and roofs are susceptible to significant structural damage during a strong earthquake. The possible damages to this building might include damage to the floor and roof as the concrete wall separates from those levels. This could result in a collapse or partial collapse of the floor or roof.

In addition, this building appears to have a minimal amount of concrete shear walls and the existing concrete shear walls have been modified. This could result in damages to the existing concrete shear walls.

1. Diaphragms
 - a. Addition of plywood to the ceiling above the apparatus room and on the ceiling above second floor.
 - b. Addition of new collector ties at the roof and second floor level.
 - c. Addition of new concrete wall and masonry wall ties and continuity ties at the second floor and roof levels. New ties to be spaced at 4'-0" cc.
 - d. Addition of new wedge anchors at roof and second floor ledgers.
2. Shear Walls
 - a. Add new concrete shear walls.
 - b. Add new plywood to the existing walls shown on the schematic plan.
 - c. Add new holdowns where shown.
 - d. Add new foundations where shown.

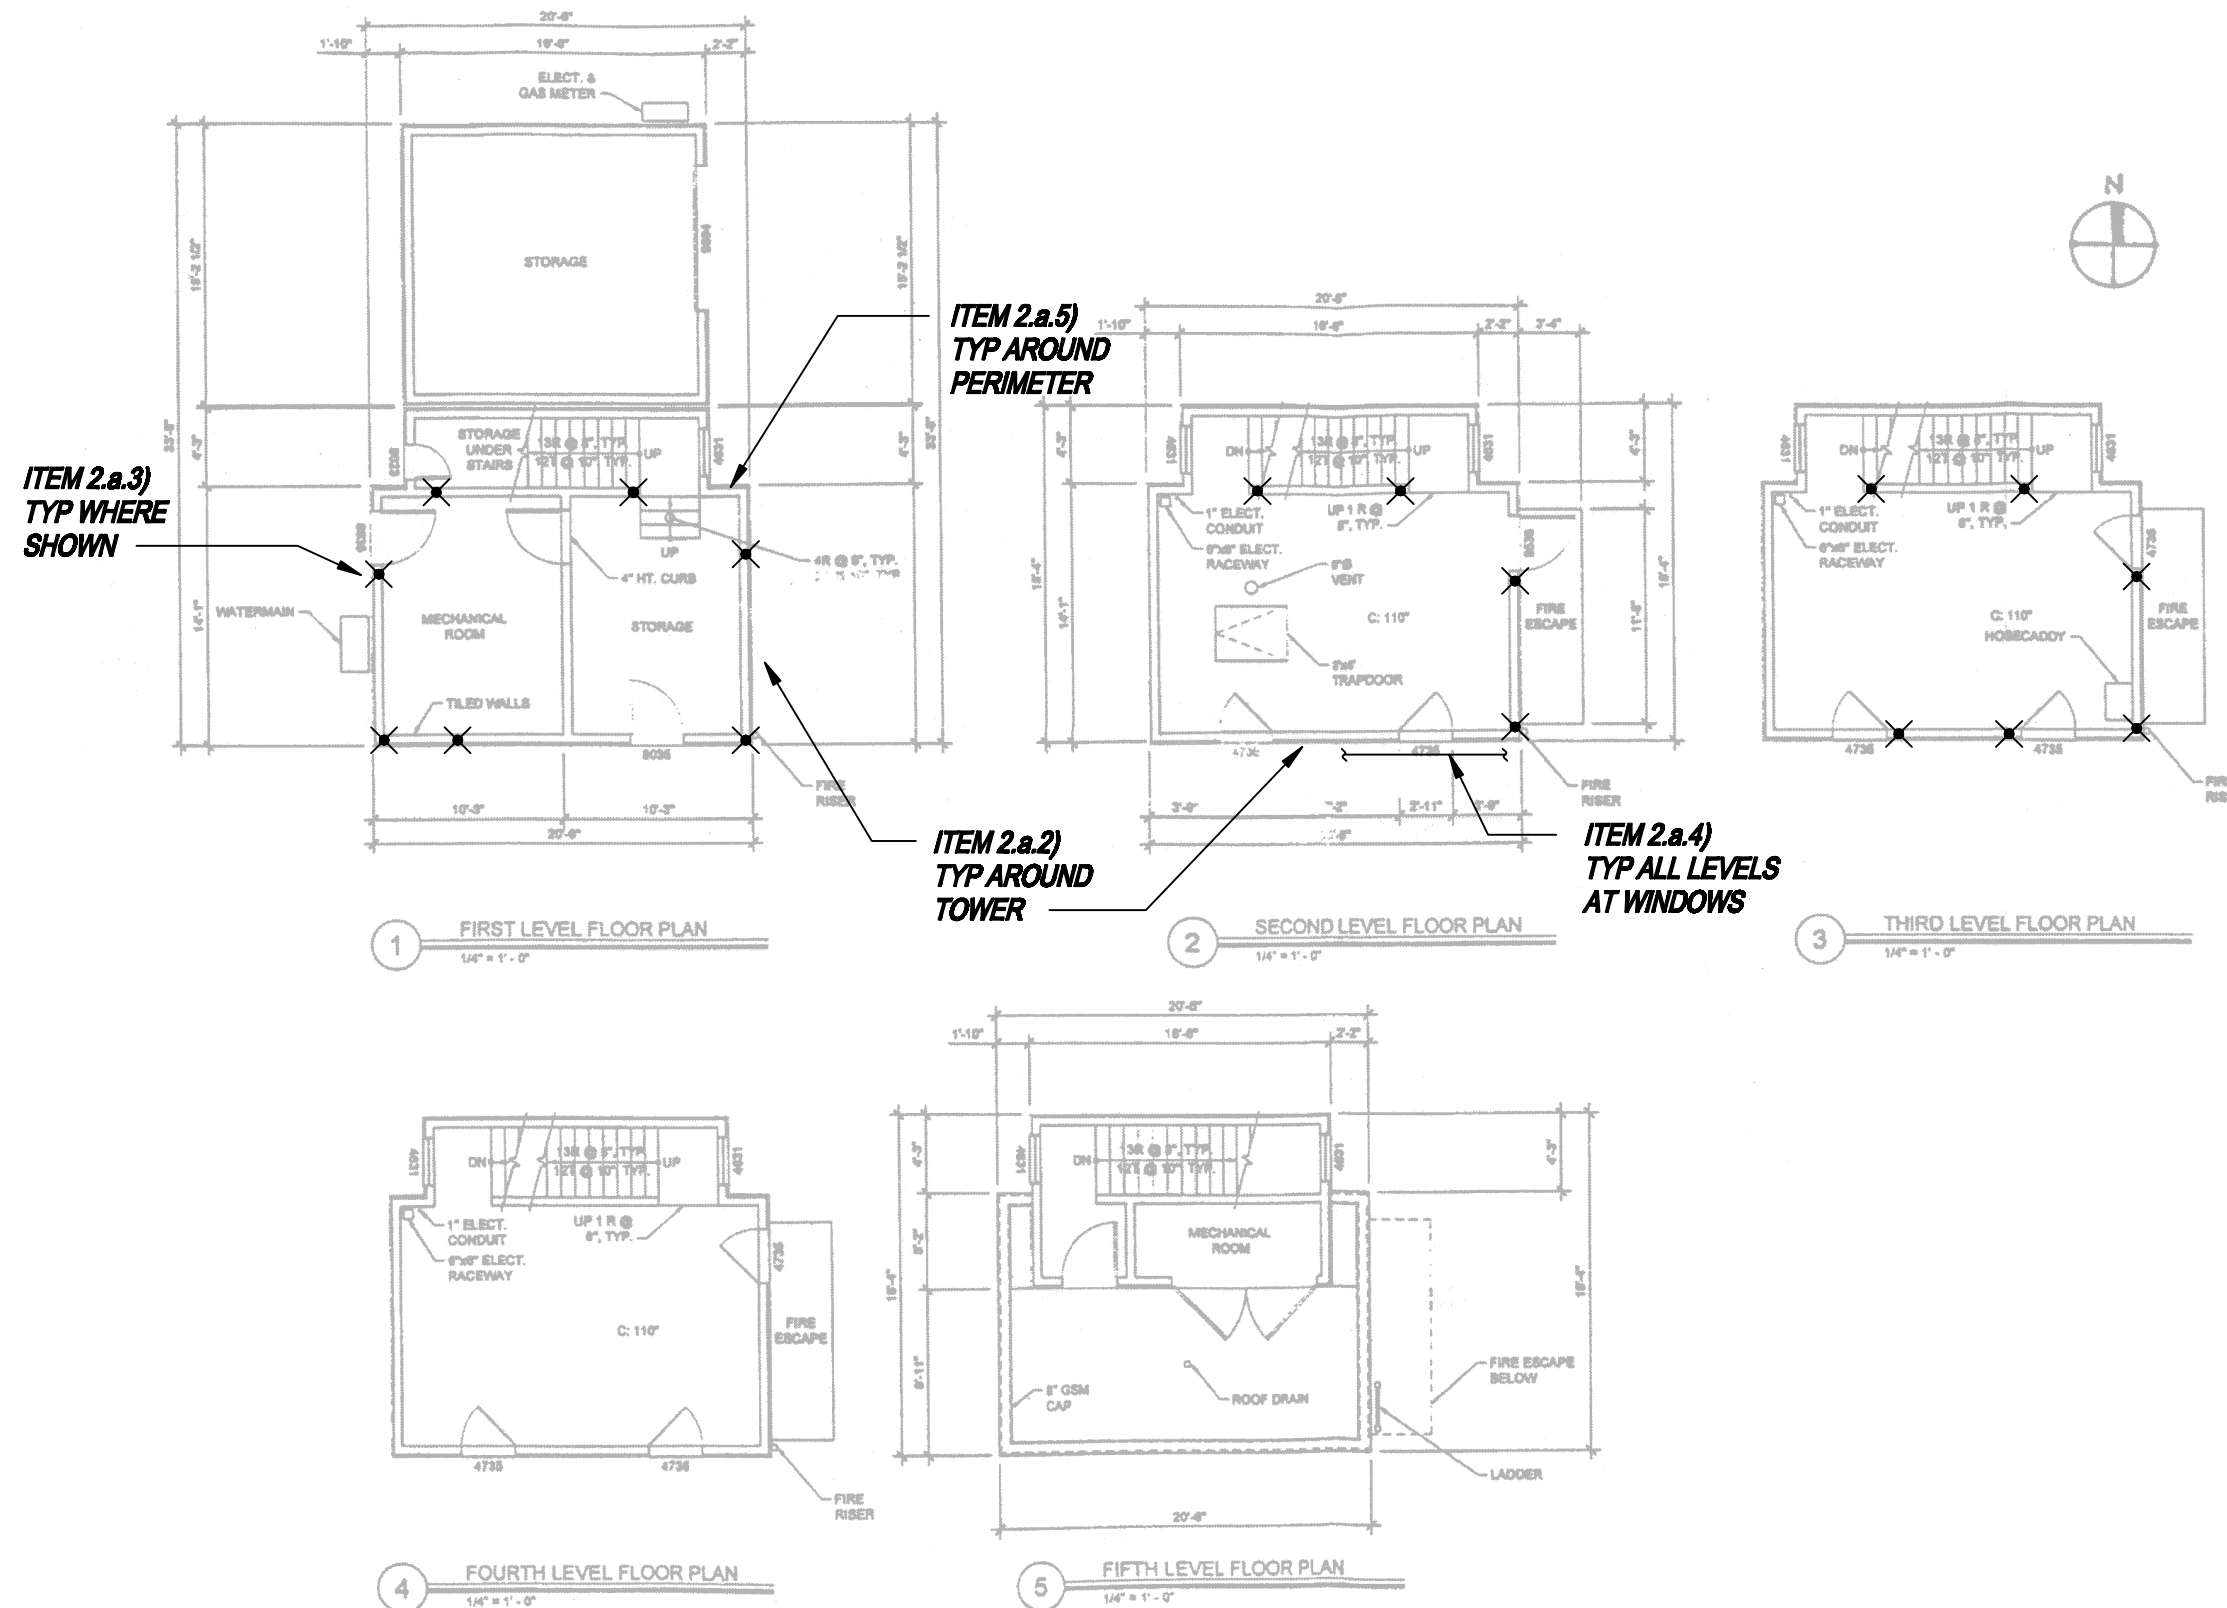
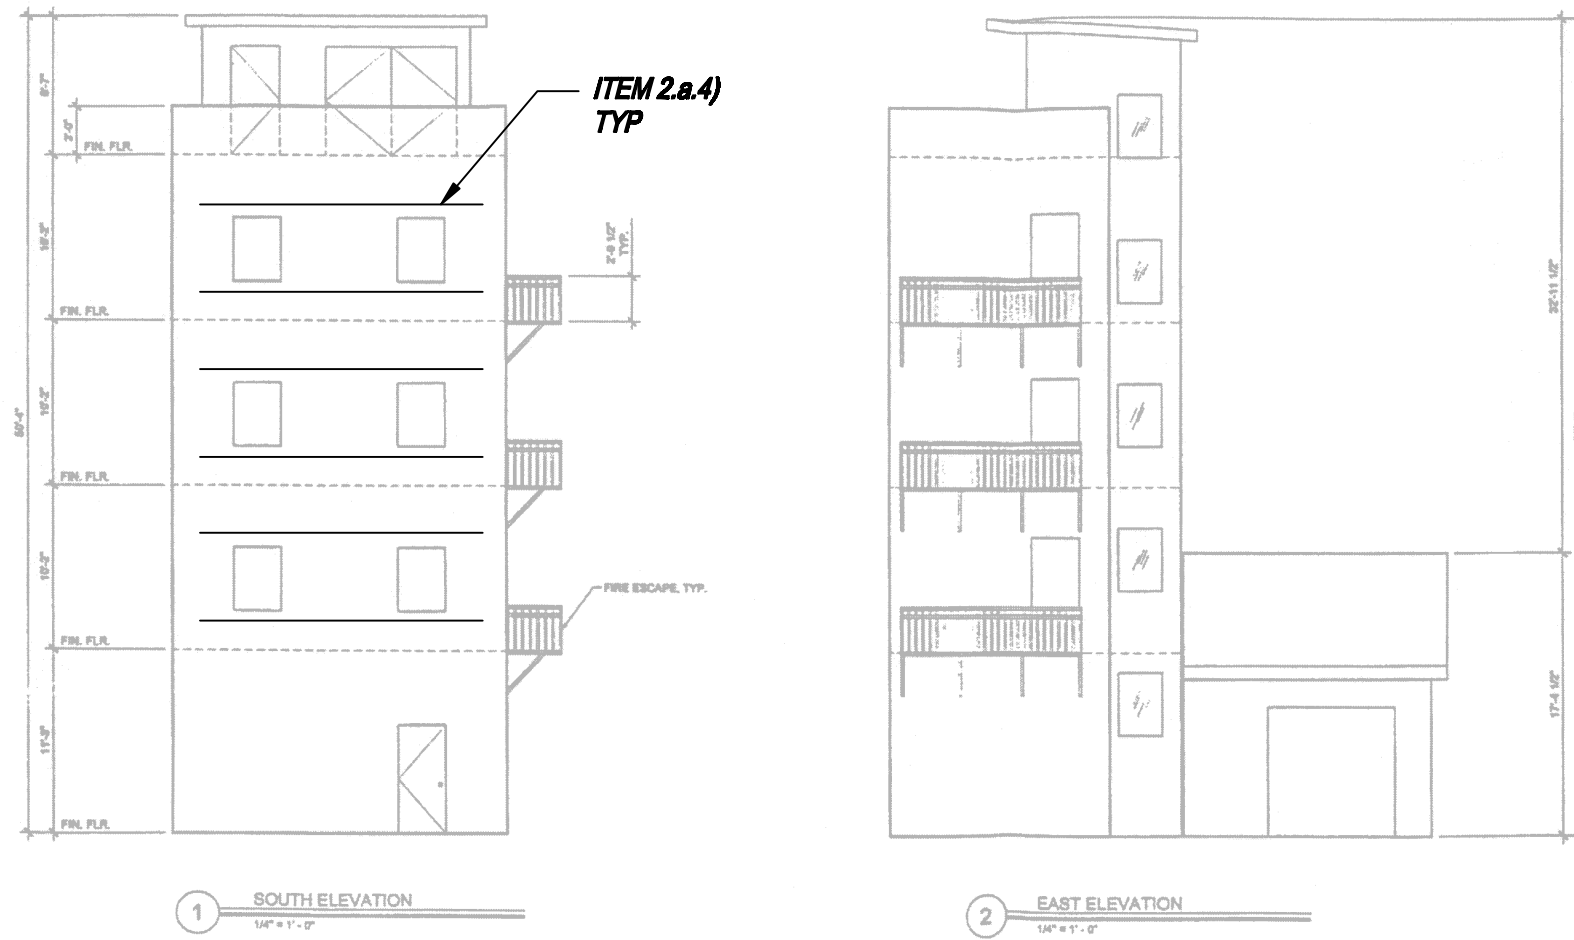
DRILL TOWER

- There appears to be some water-related damage to the training tower. Water damaged plywood floor and wall panels were found in areas throughout the tower.

- The exterior plaster around the training tower has been damaged in some areas by the infiltration of water behind the plaster.
- The floor slab of the training tower is lower than the exterior grade. There are no floor drains in the slab to drain water inside of the training tower.

- Some dry rot was found in the wood structure at the base of the training tower.

- 1) Replace water damaged plywood and framing.
- 2) Renail the existing interior and exterior wall plywood.

- 3) Add new holdowns at corners and edges of openings through the shear walls.
- 4) Reinforce around window openings with continuous horizontal straps placed above and below the openings over the plywood.
- 5) Increase the size of the existing building foundation.

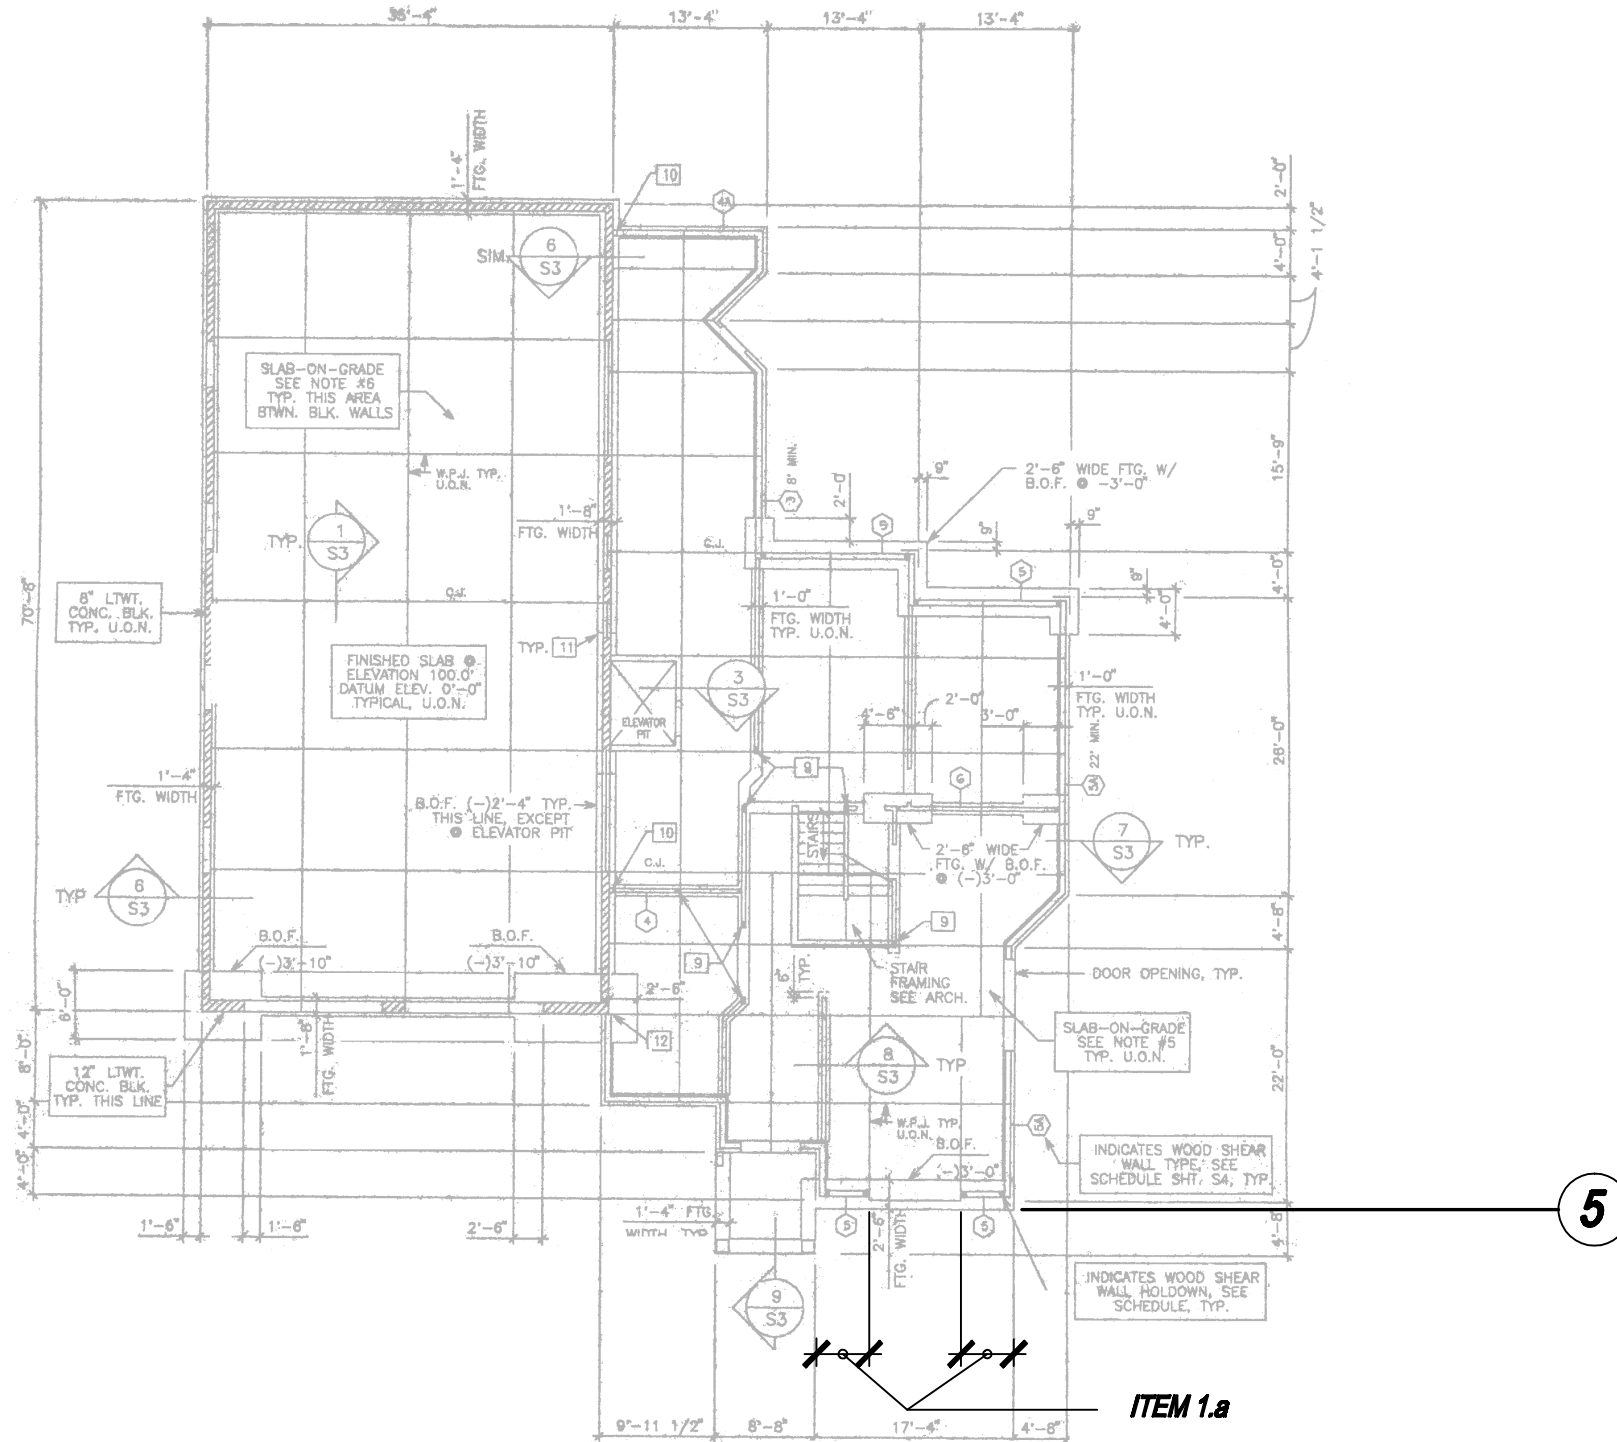
FOUNDATION PLAN

- a. The 1997 UBC requires the aspect ratio of the shear wall not be exceed 2:1 (height to width ratio). The shear walls at line 5 adjacent to the sliding glass door do not comply with this requirement
