**CITY OF SAN RAFAEL
ESSENTIAL FACILITIES**

FACILITY EVALUATION REPORT

APPENDIX TO STRATEGIC ANALYSIS REPORT

AUGUST 2003

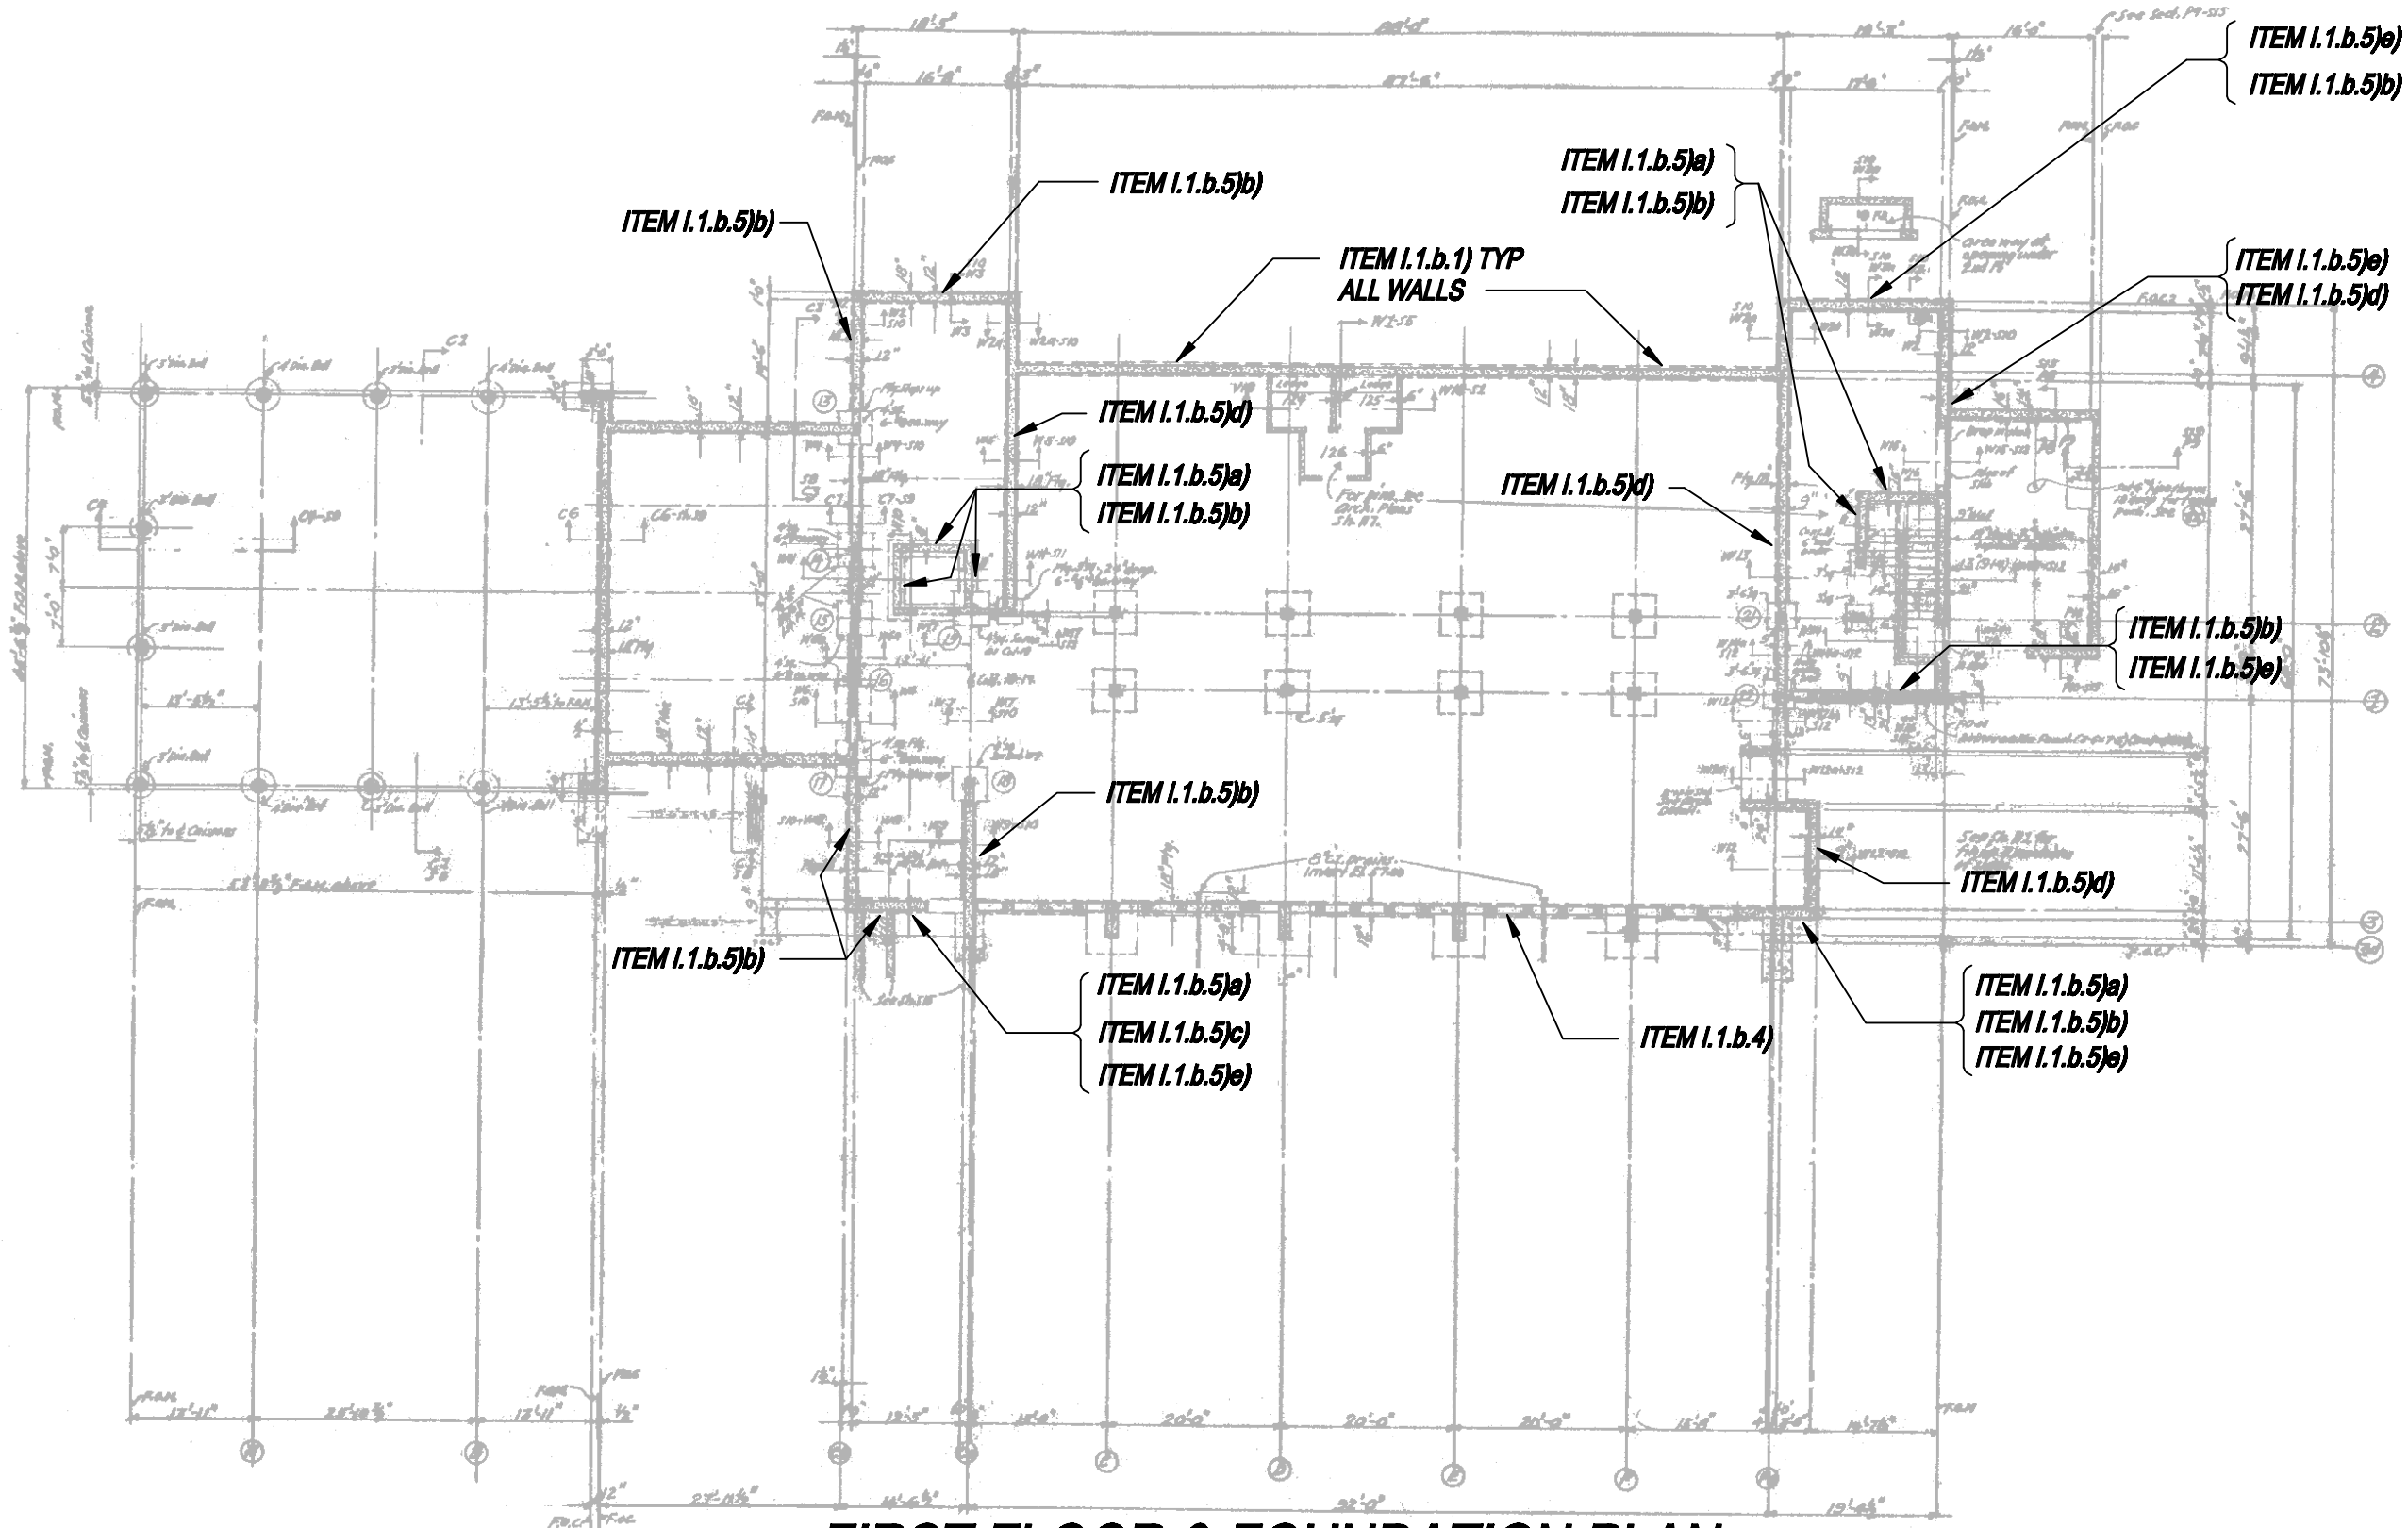
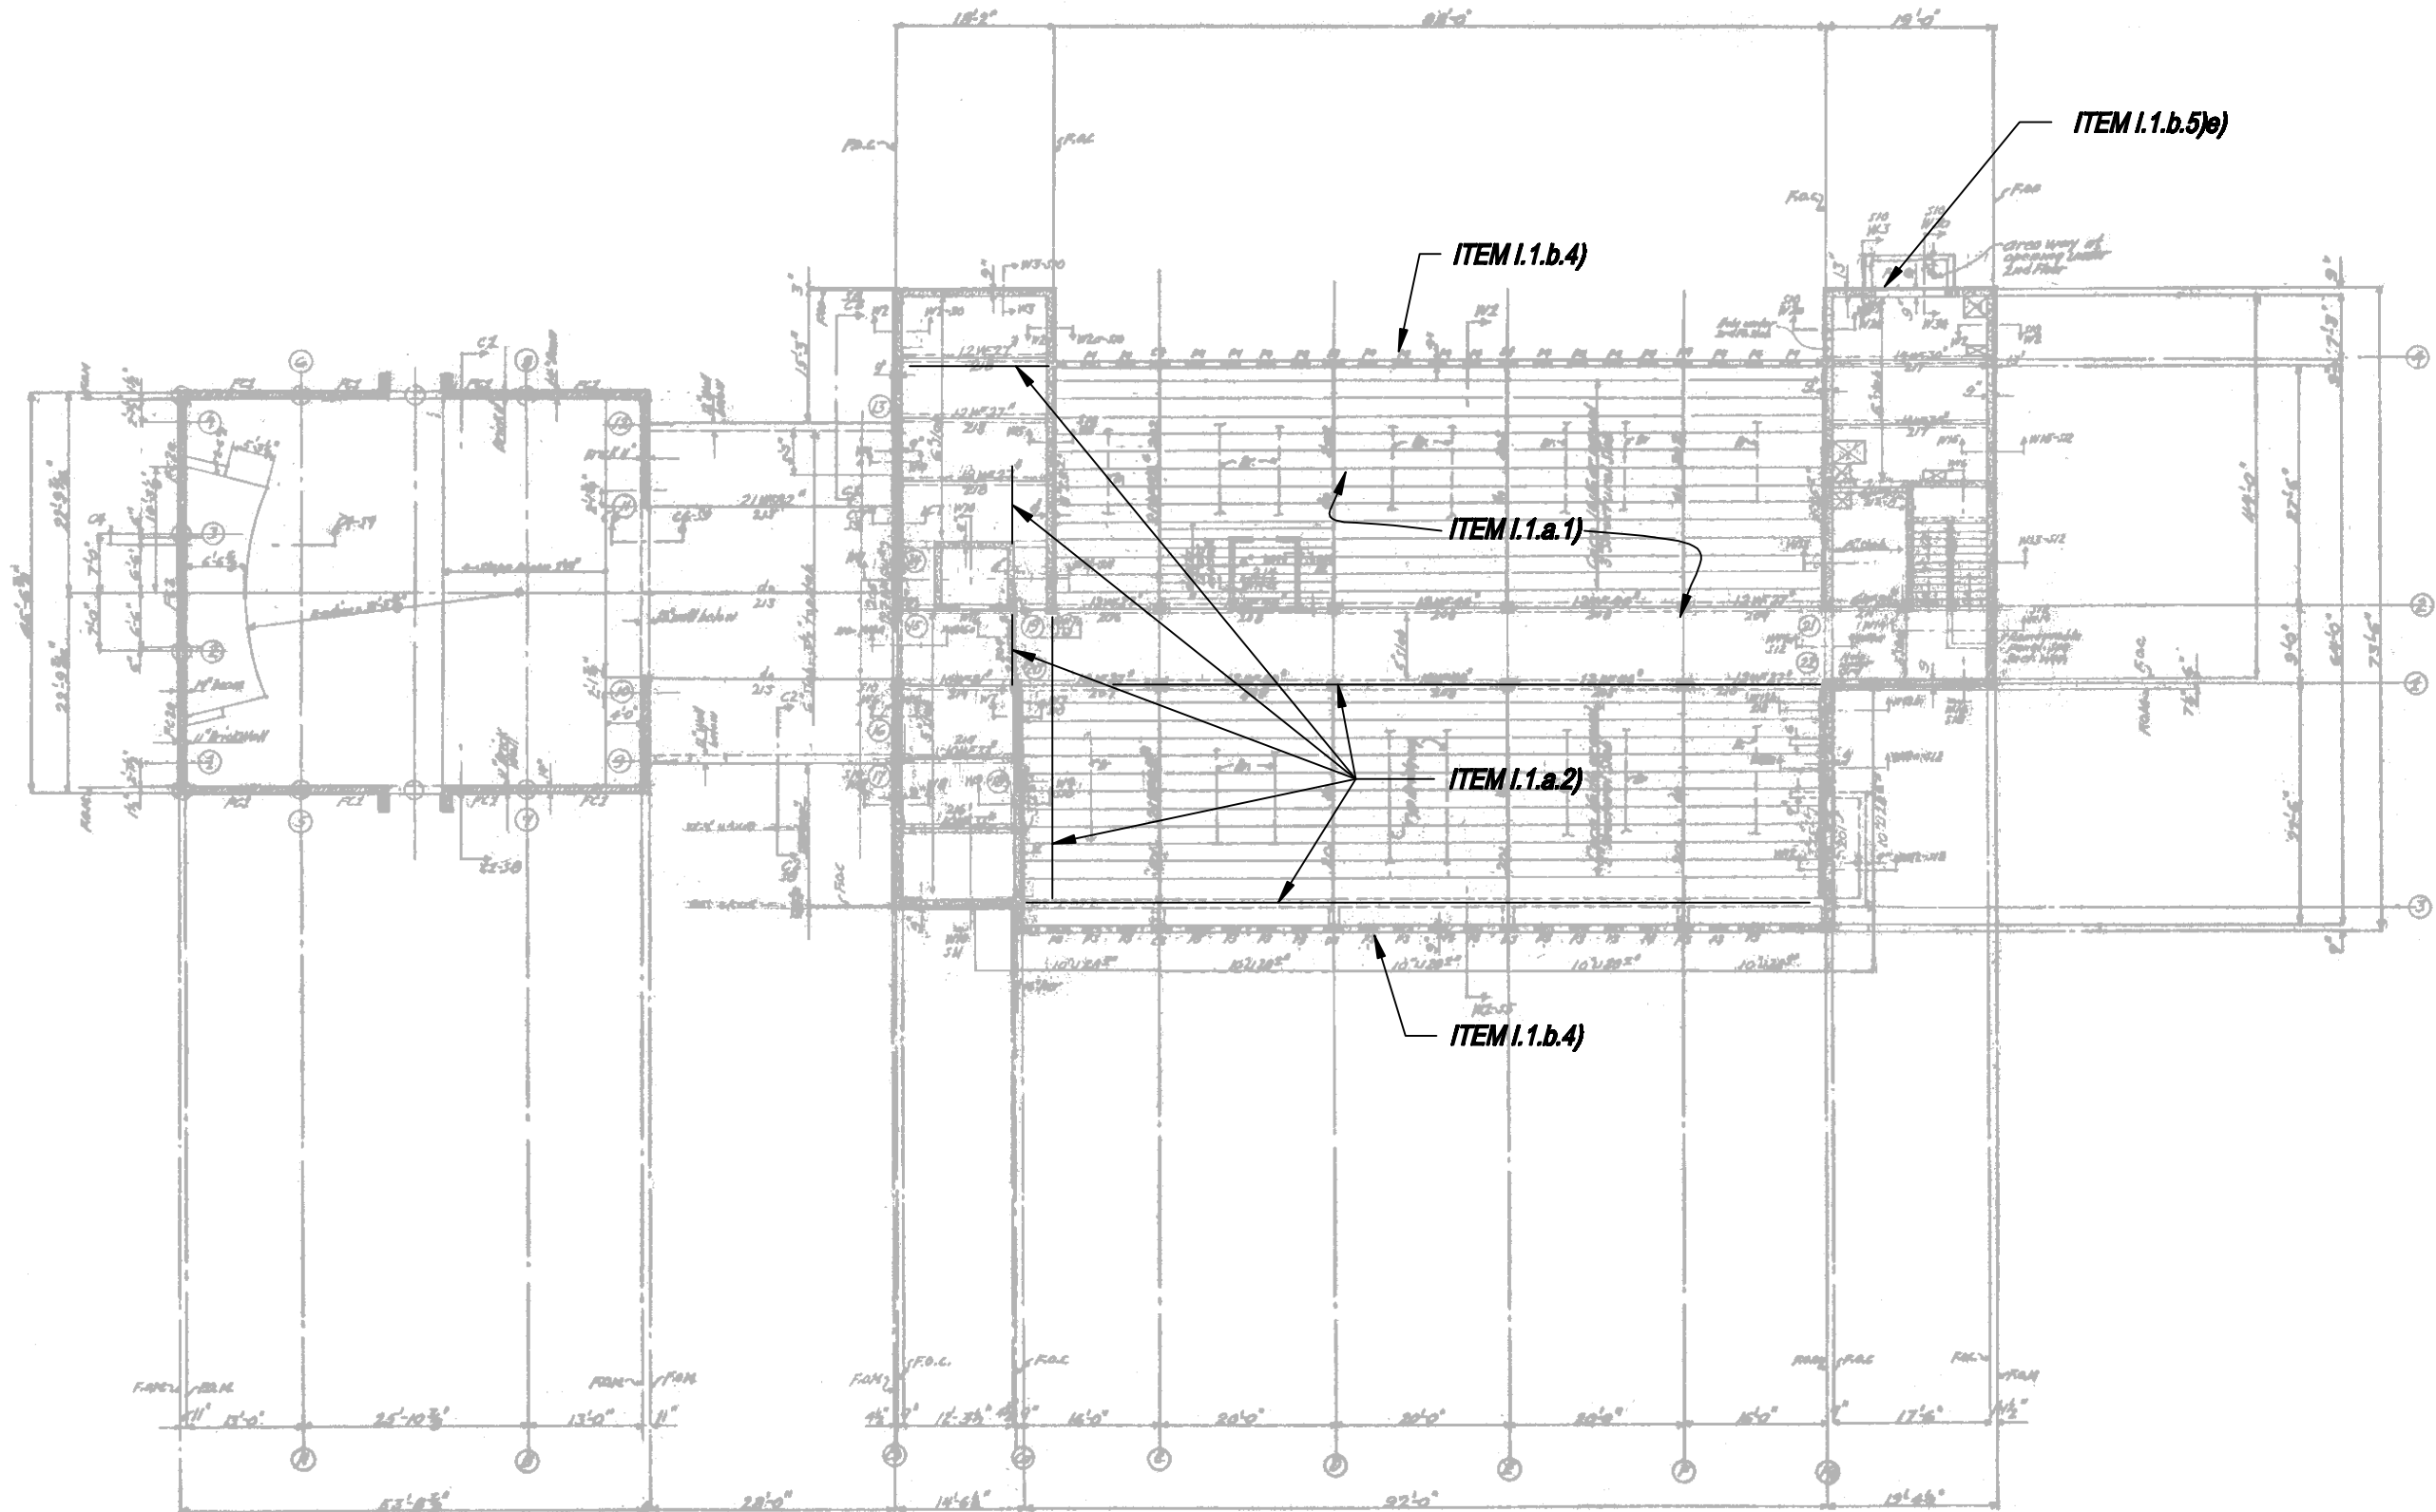
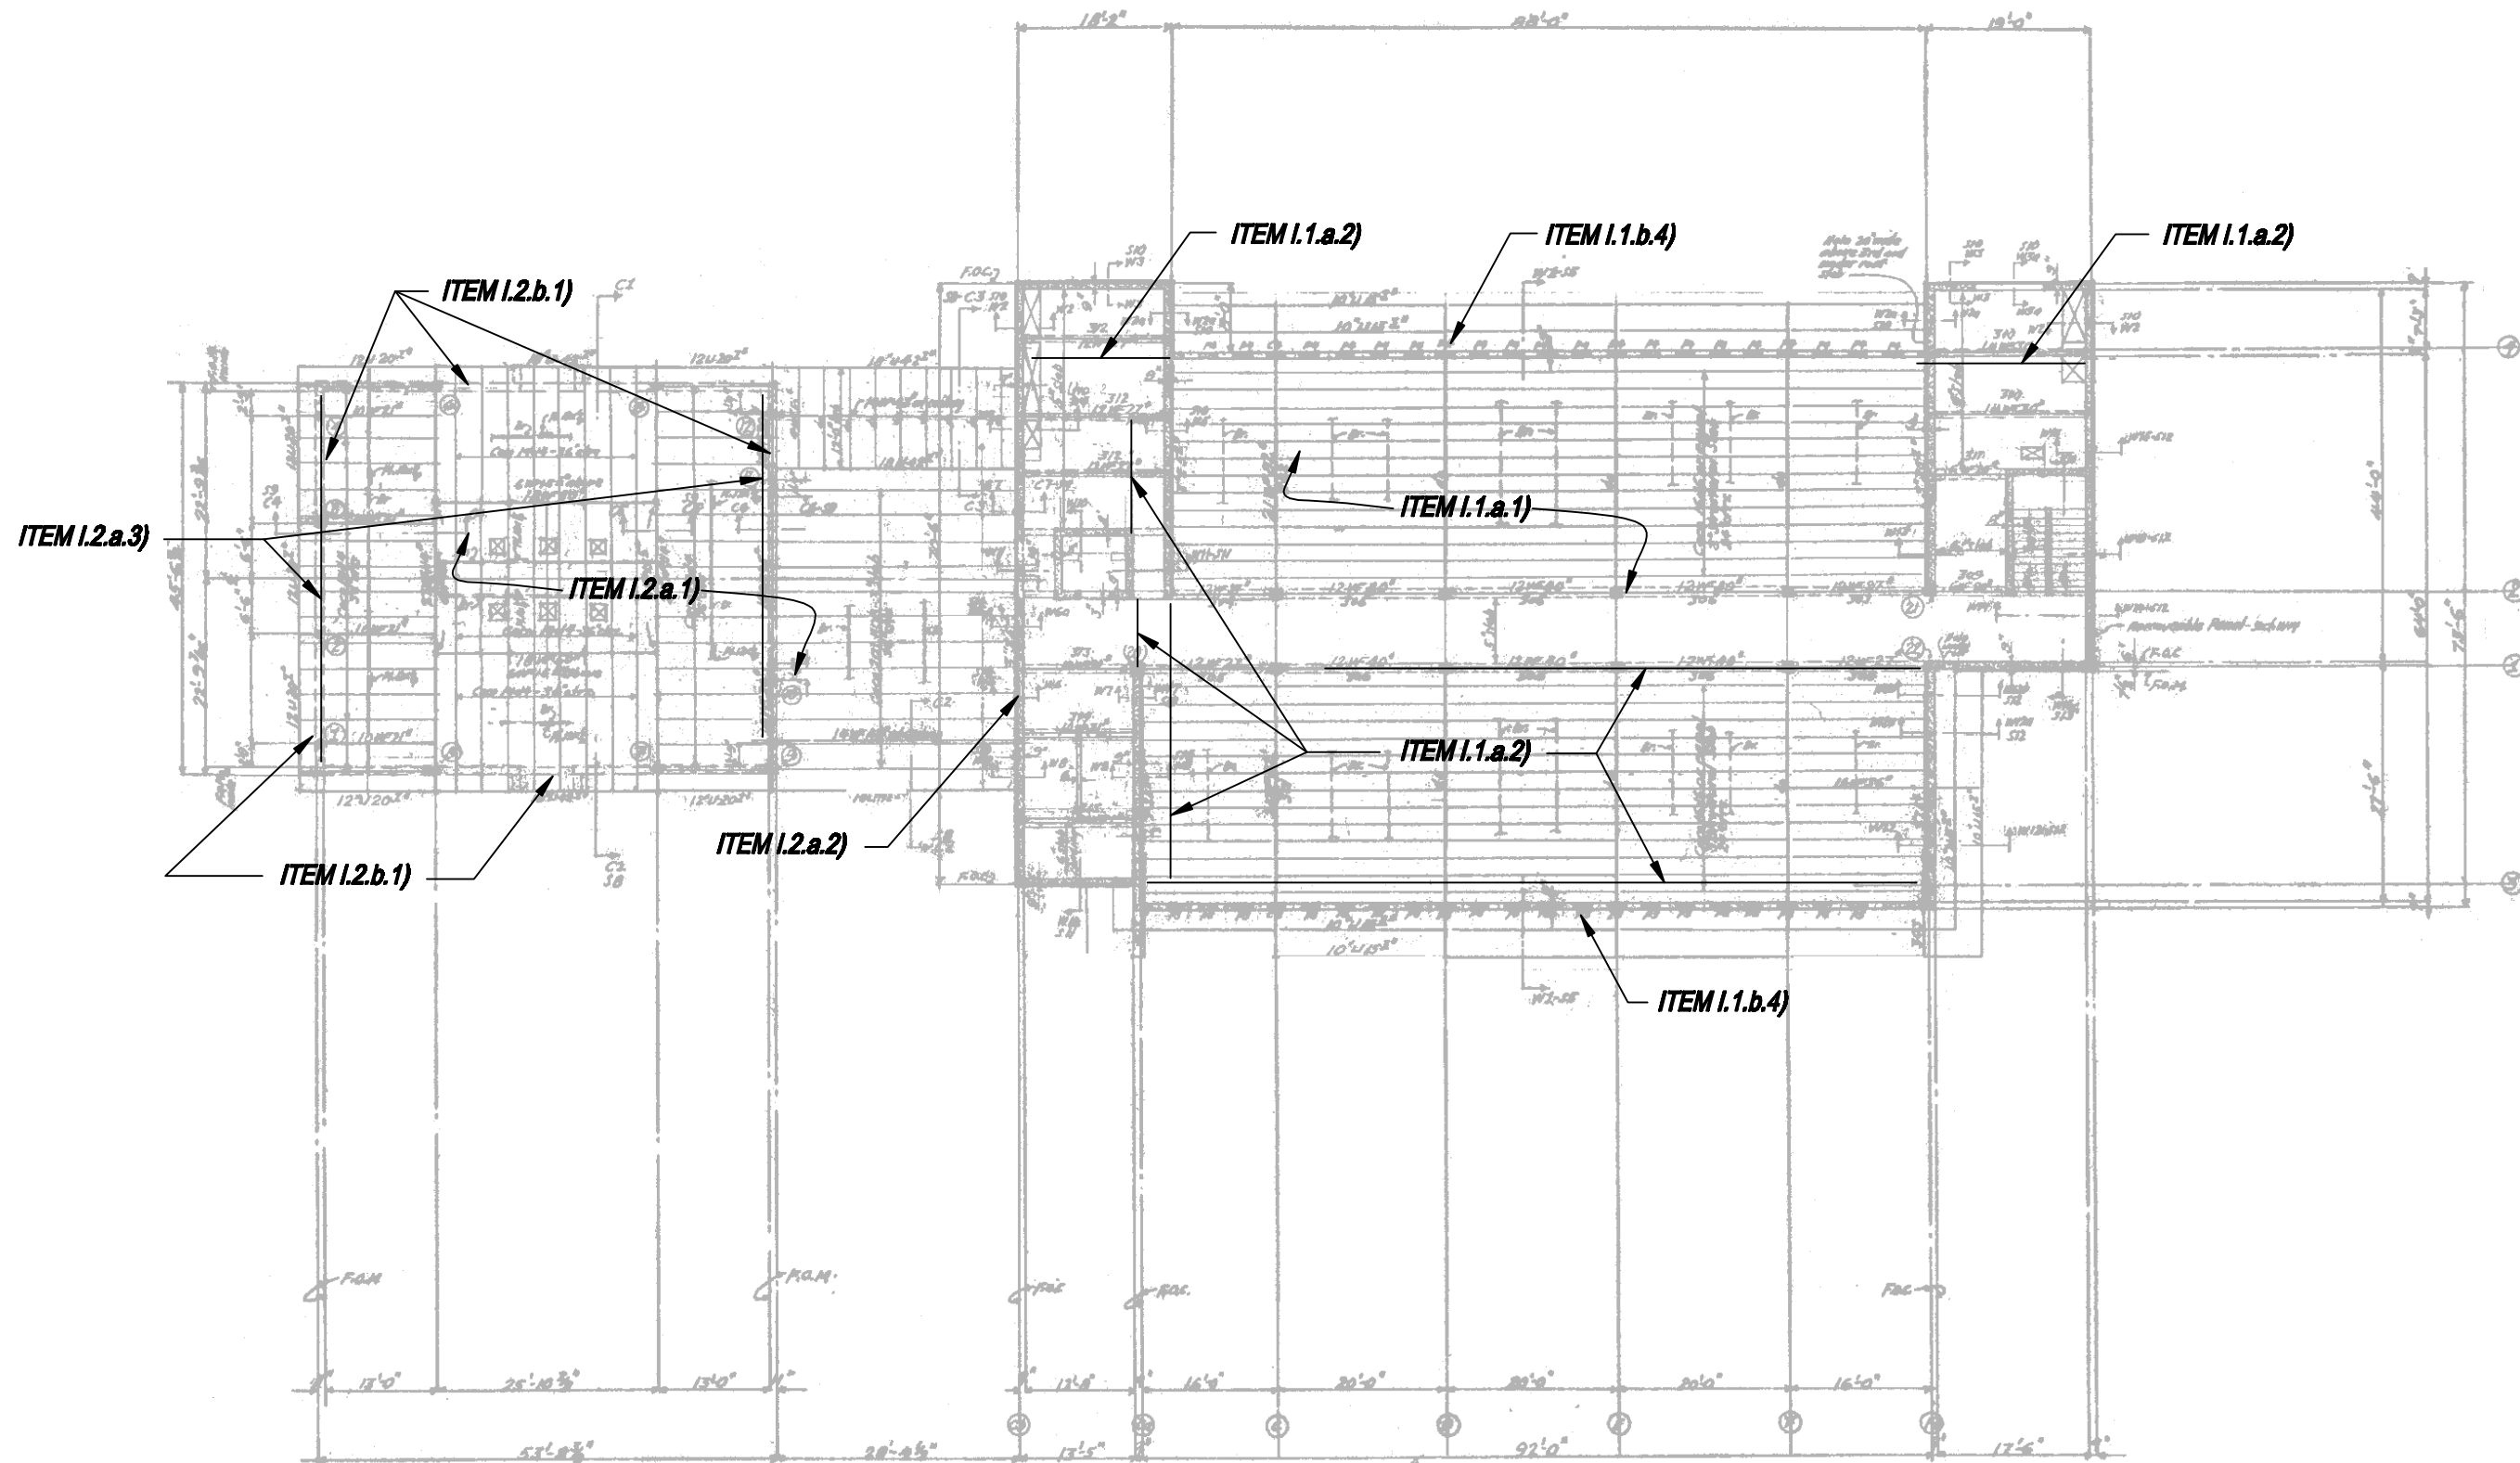
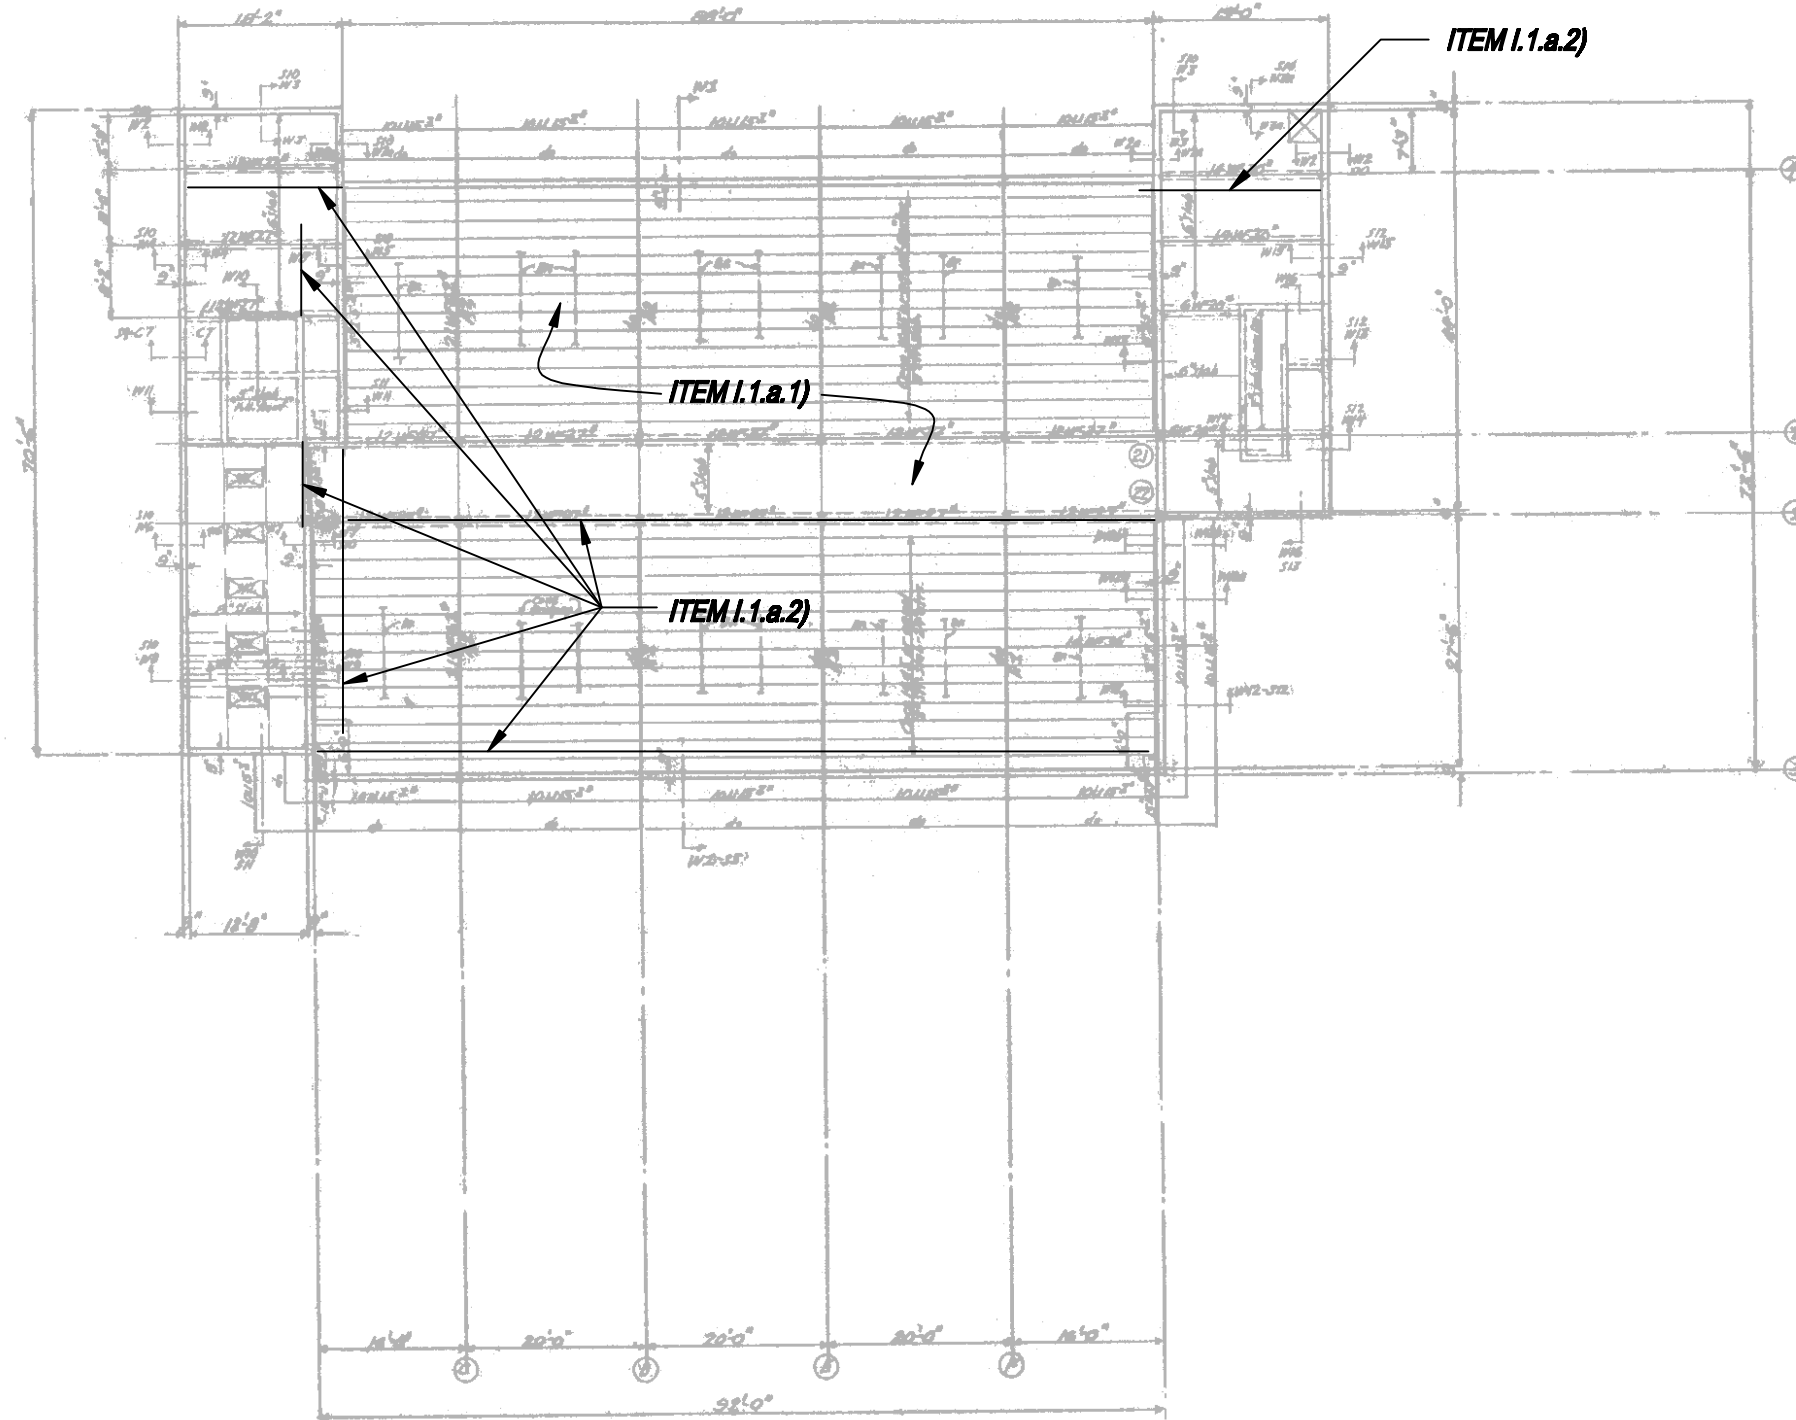
- 1) The reinforced brick masonry walls do not extend to the roof deck of the council chamber. Therefore, the top of the walls are not connected to the roof deck to transfer the in plane or out of plane lateral loads.
