**APPENDIX G**  
**ASBESTOS SURVEY REPORT**

September 25, 2023

**ASBESTOS SURVEY REPORT  
2101 AND 2109 EAST SANTA CLARA AVENUE  
SANTA ANA, CALIFORNIA 92705**

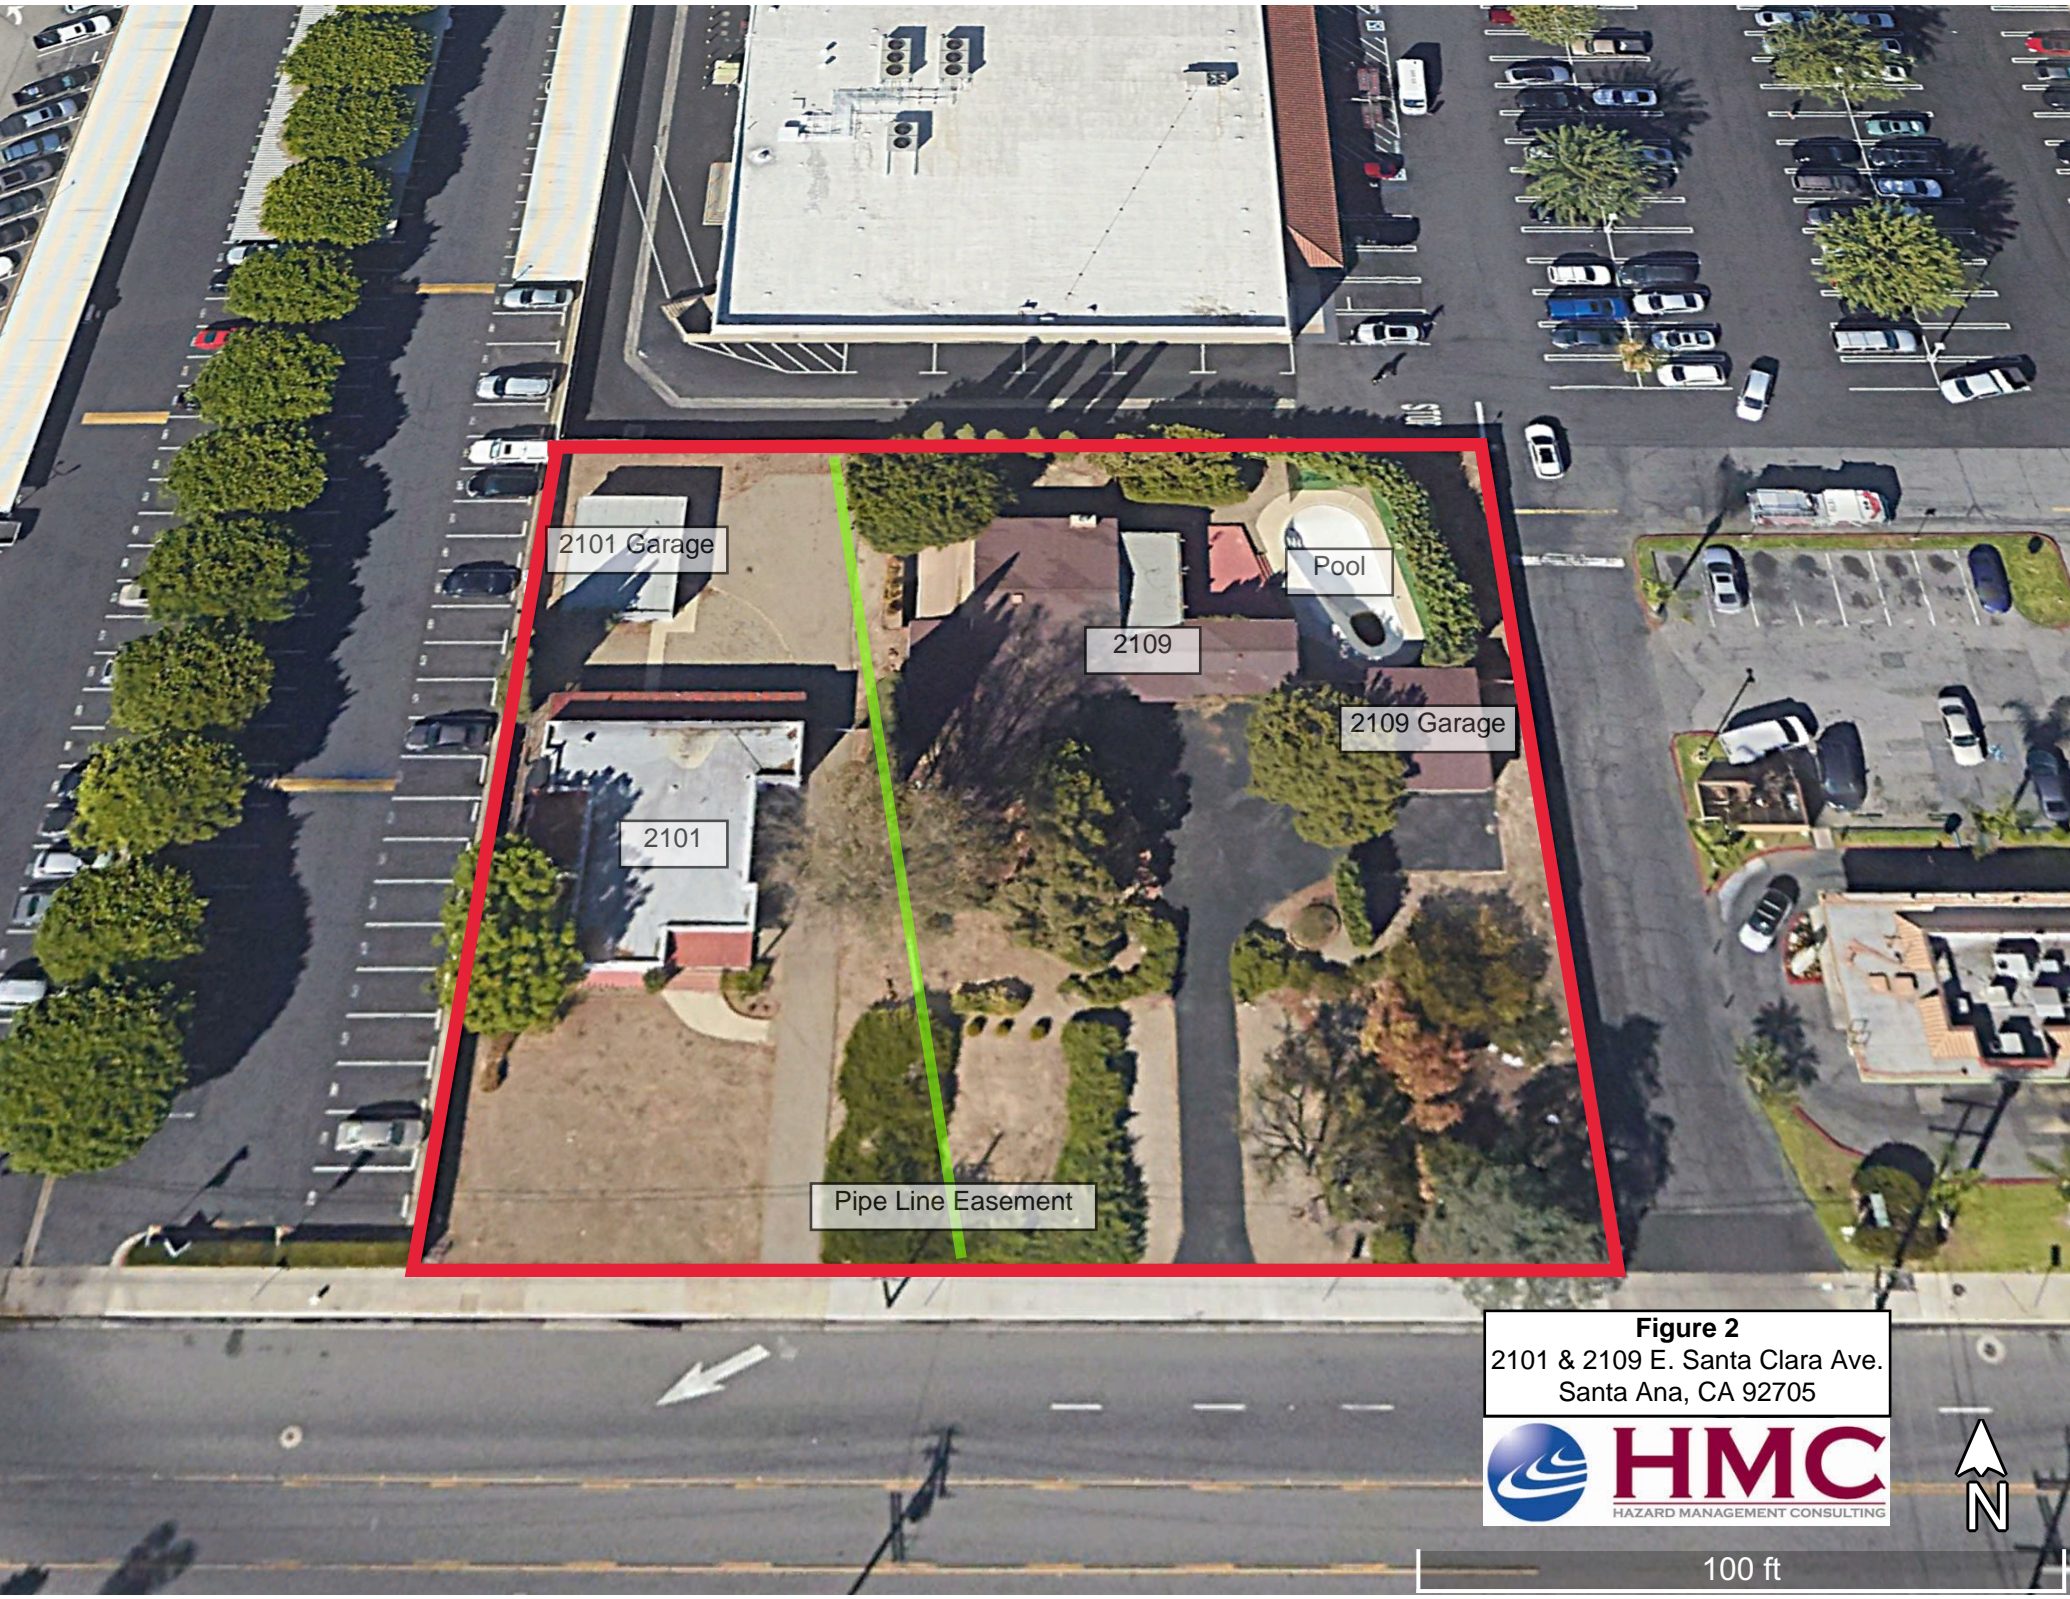
**Figure 2**  
2101 & 2109 E. Santa Clara Ave.  
Santa Ana, CA 92705

- Given the intact, non-friable conditions of positively identified ACM (Section 5.1), an asbestos abatement project would be required to be conducted under a South Coast Air Quality Management District Procedure 3 notice with the exception of the damage pipe located at the 2109 East Santa Clara Avenue address. Due to its classification as a subterranean pipe, as well as damaged condition, this material will need to be abated under a Procedure 5 notice. It should be noted that this pipe is believed to be located within in an easement that travels approximately 182 feet from at least the northern property line to the southern property line, depicted in Figure 2.
