**SOMERVILLE BOROUGH HALL &
PUBLIC LIBRARY**
PRESERVATION PLAN UPDATE

MARCH 2021

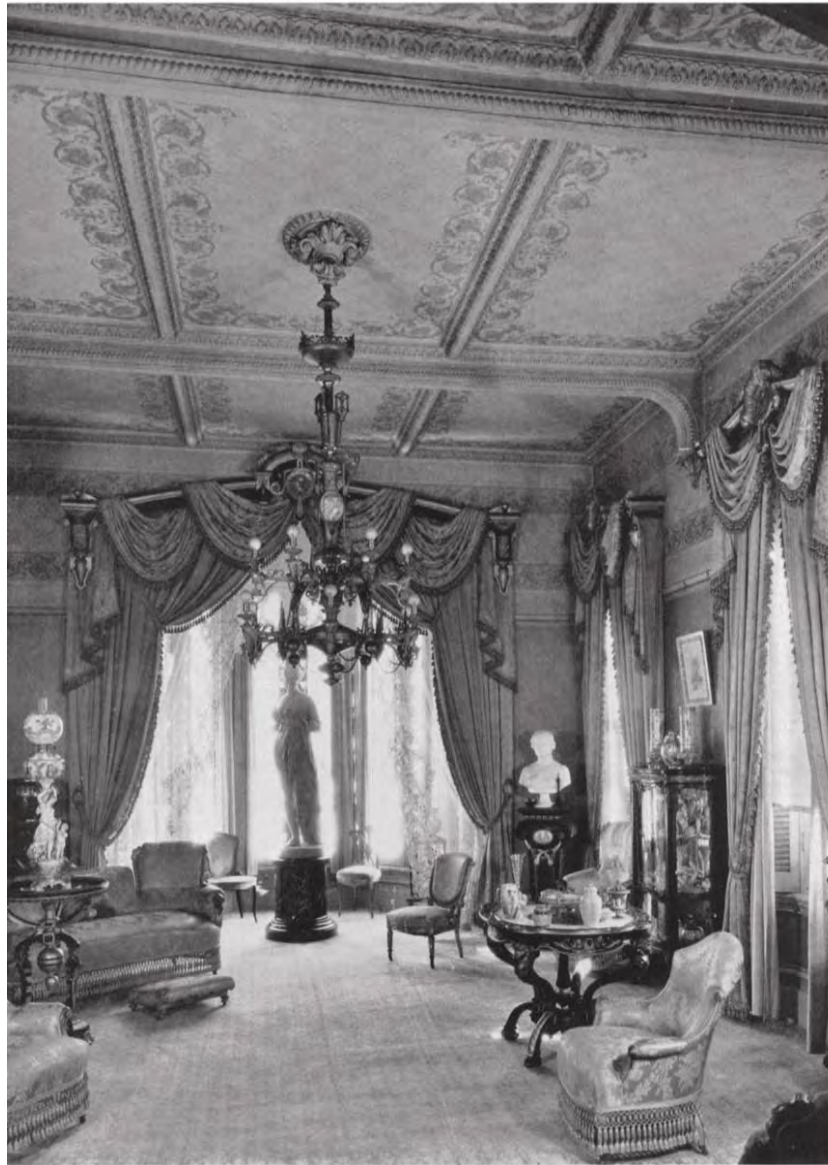
Figure 36: The blue parlor of the Harral House.
(From Edna Donnell, *A.J. Davis and the Gothic Revival*.)

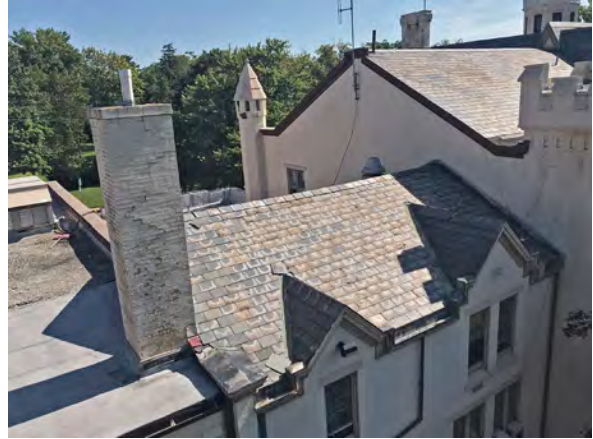
Photo 1: View from the east side of the building of slate roofs on Borough Hall, the sheet membrane roof on the rear addition, and membrane roof with ballast on the Library.

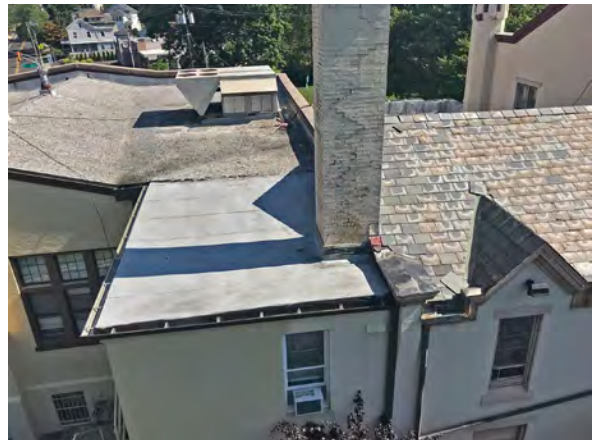
Photo 2: View from the east side of the building of slate roofs on Borough Hall, the sheet membrane roof on the rear addition, and membrane roof with ballast on the Library. Also note the step cracking on the square boiler chimney.

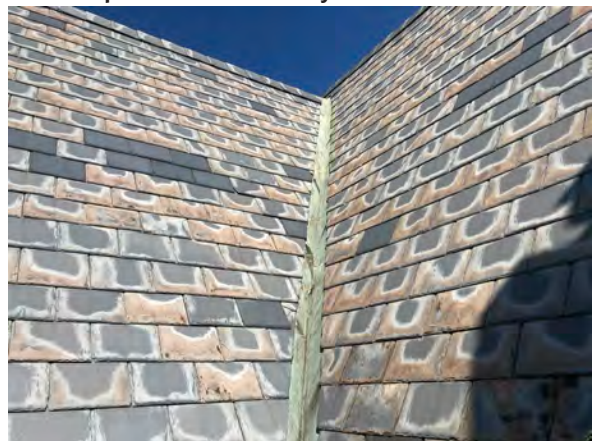
Photo 3: Valley between intersecting gable roofs on Borough Hall showing "gypsum smiles."

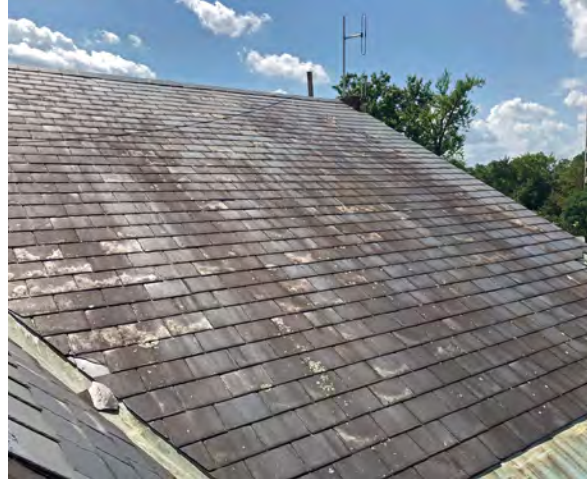
Photo 4: Black algae and lichen growth on west roof of Borough Hall. Taken from north elevation.

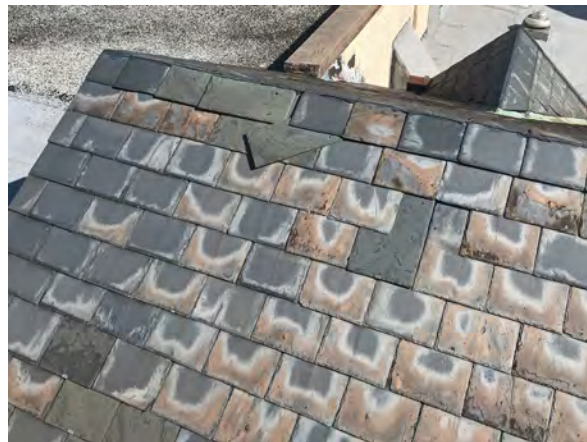
Photo 5: Replacement slates on west roof of Borough Hall. Taken from south elevation.

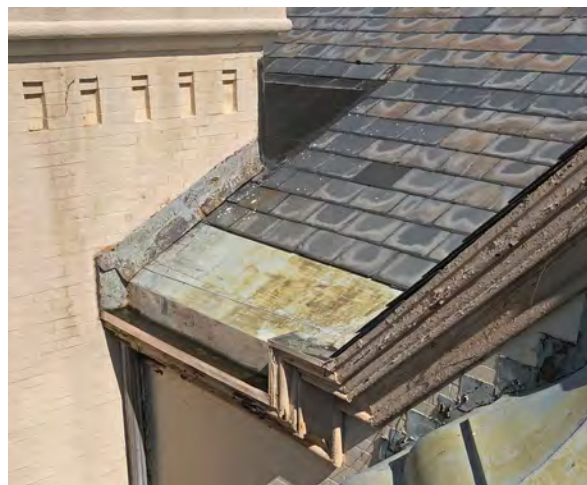
Photo 6: Black sheet membrane behind south tower. Deteriorated flashing on tower and oriel window roof. Slate shingles offset from edge of roof.

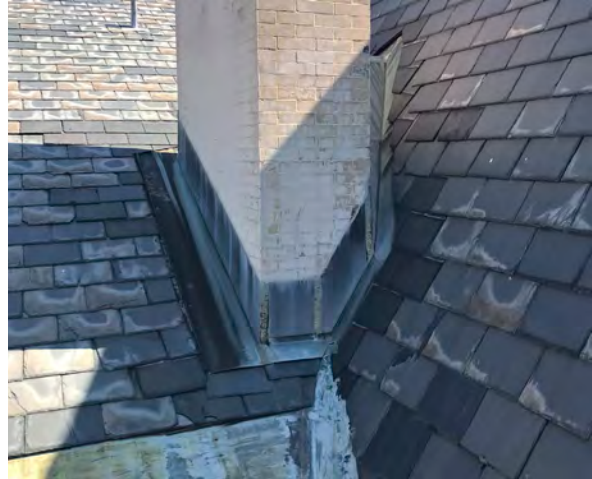
Photo 7: Copper flashing around chimney at south elevation.

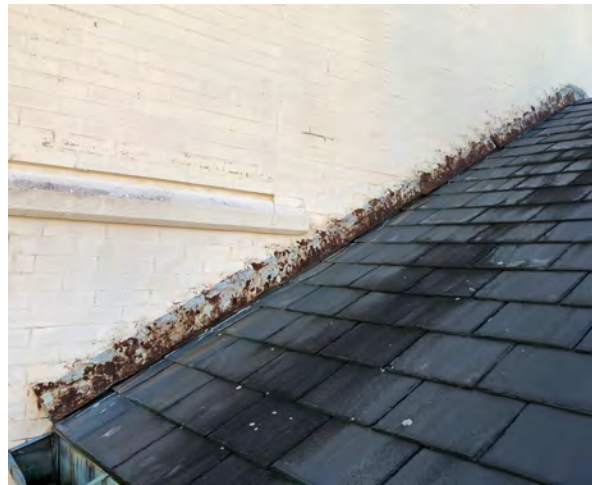
Photo 8: Typical condition of deteriorated flashing along brick walls of Borough Hall.

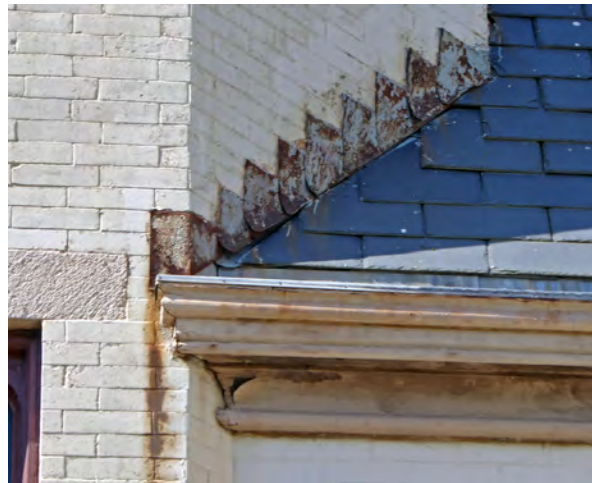
Photo 9: Typical condition of deteriorated flashing along brick walls of Borough Hall.

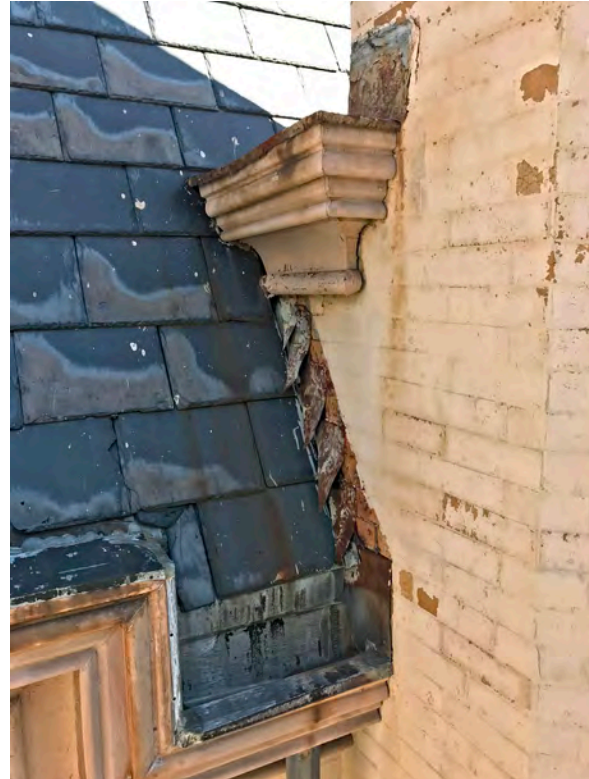
Photo 10: Example photo of deteriorated built-in gutter liner, wall flashing and cap flashing at Borough Hall. Taken from south elevation.

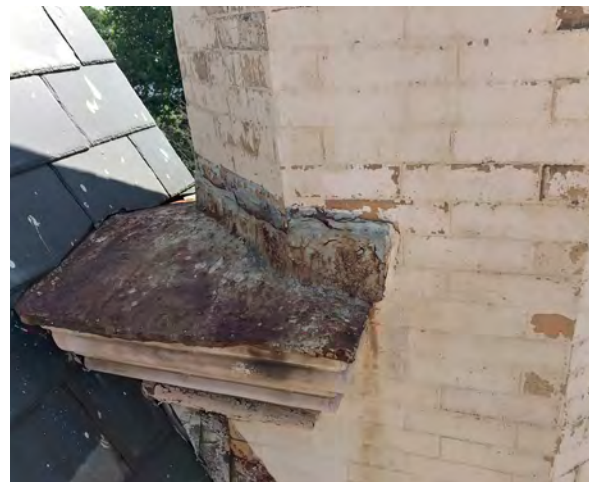
Photo 11: Typical condition of deteriorated flashing capping wall dormer steps on Borough Hall. Taken from south elevation.

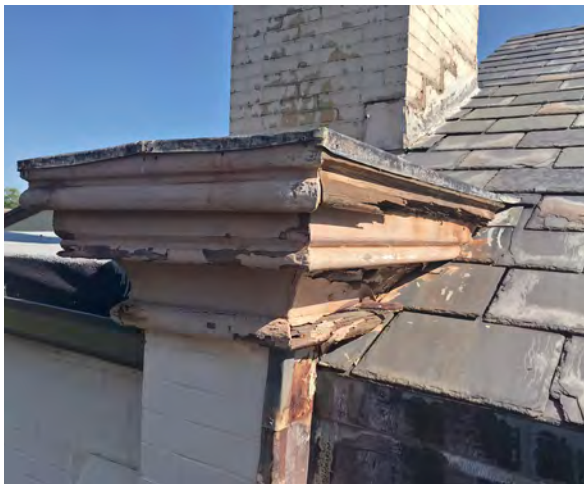
Photo 12: Deteriorated wall dormer step at southwest corner of Borough Hall.

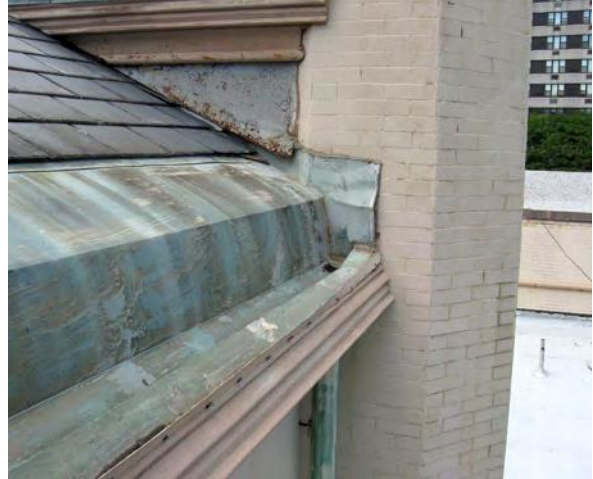
Photo 13: Typical view of built-in gutter at cornices of Borough Hall.

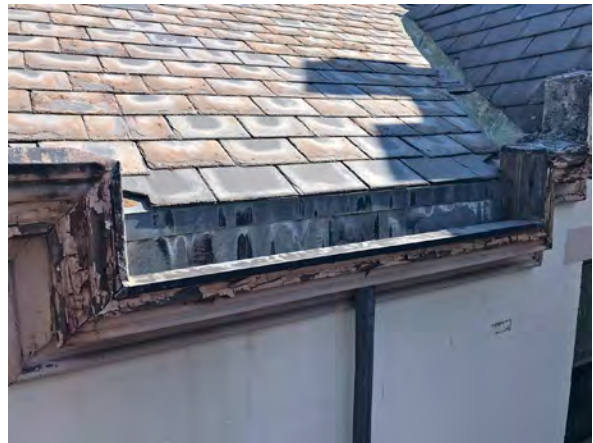
Photo 14: Typical condition of deteriorated wood cornices on Borough Hall.

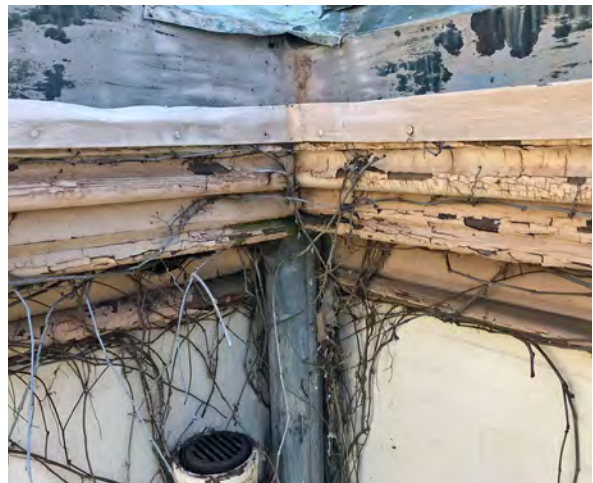
Photo 15: Detail view of deteriorated cornice on Borough Hall.

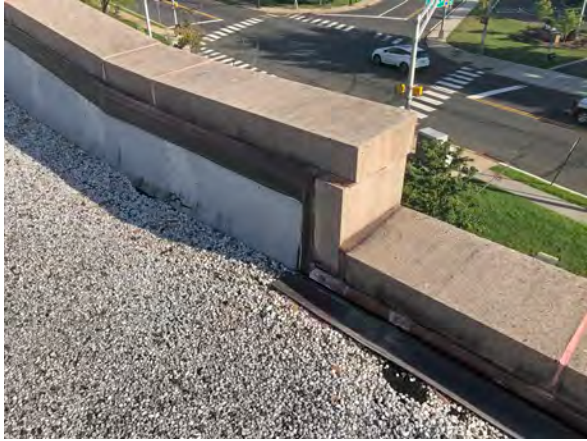
Photo 16: Parapet and cast stone coping units at north side of Library roof.

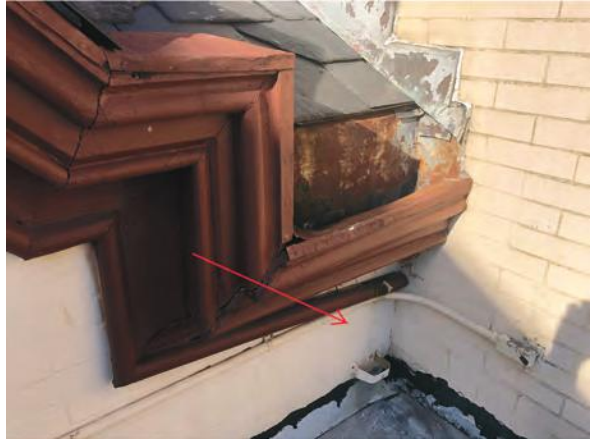
Photo 19: Missing Borough Hall downspout at Library Addition roof.

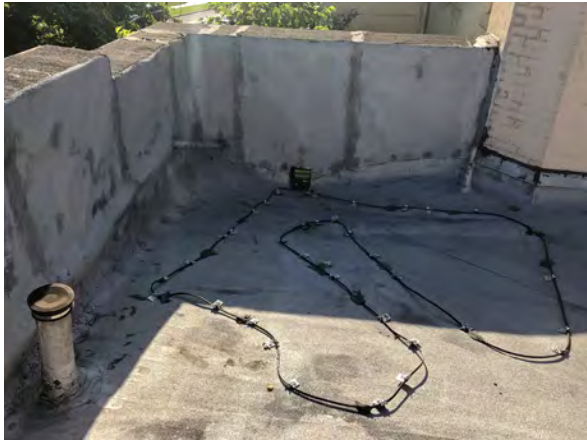
Photo 17: Roof of Library Addition with drain opening in its east parapet.

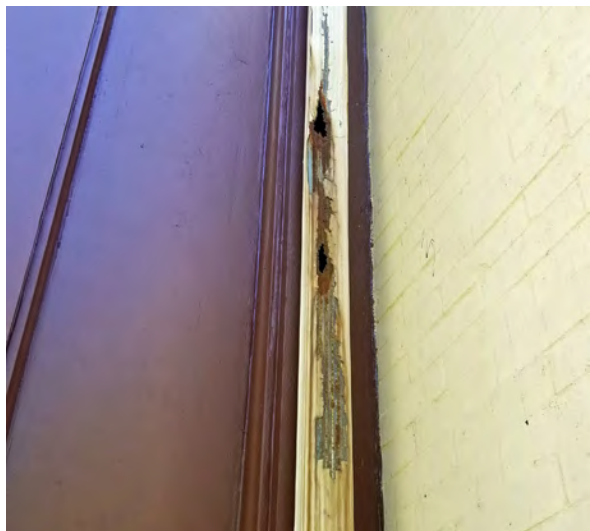
Photo 21: Rusted downspout at east end of north elevation

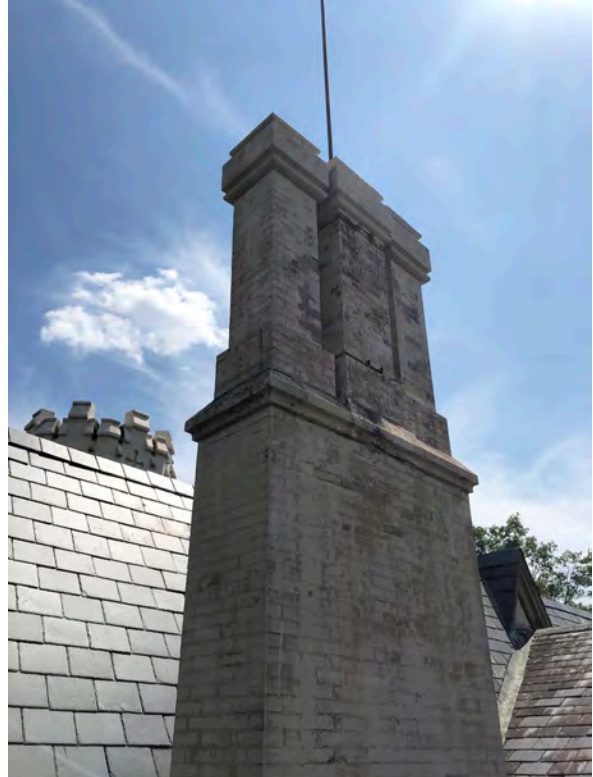
Photo 22: South chimney of Borough Hall.

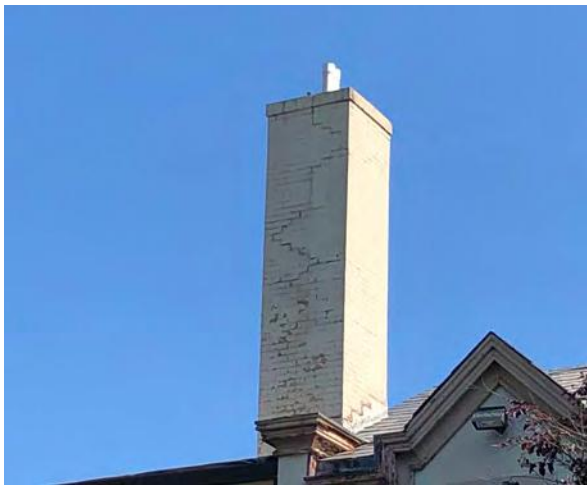
Photo 25: Extensive step cracking on boiler chimney at southwest corner of Borough Hall.

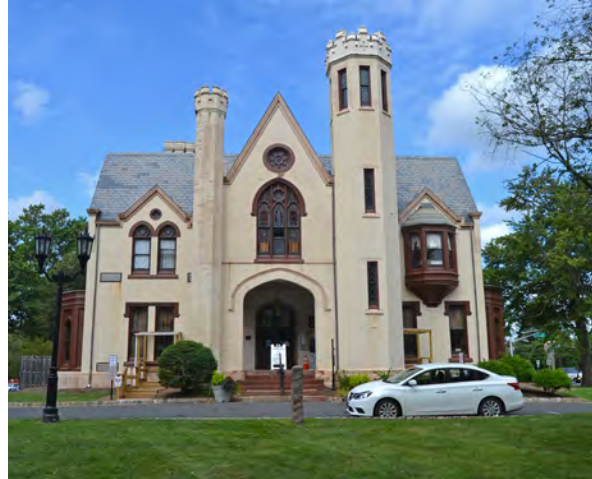
Photo 27: East elevation of Borough Hall.

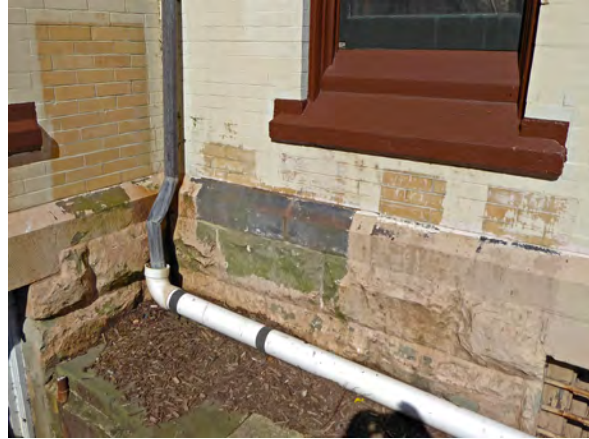
Photo 30: Finish removal tests at north side of east elevation.

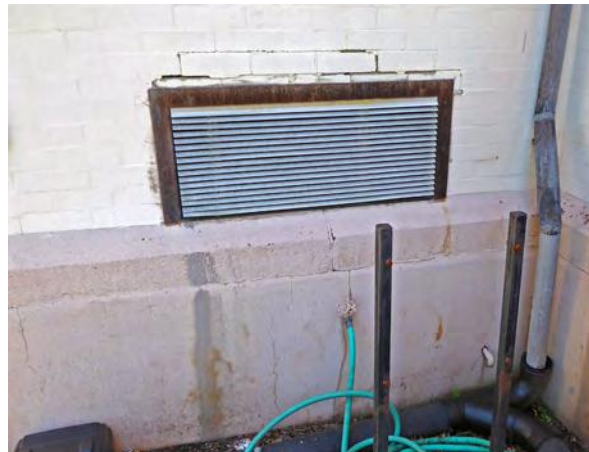
Photo 31: Rusted louver with deteriorated brick above on south side of east elevation.

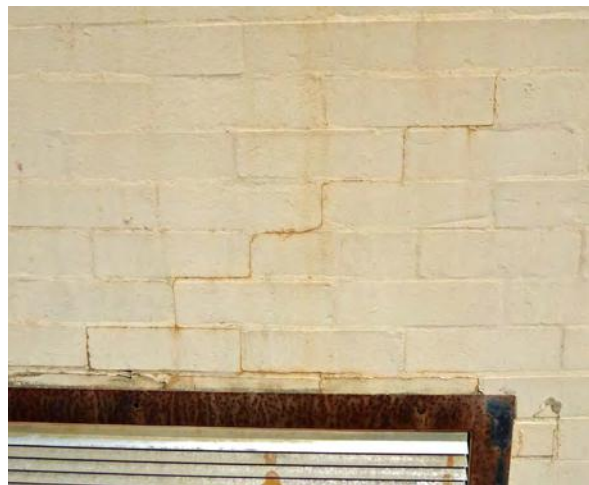
Photo 32: Rusted louver and step crack above on south side of east elevation.

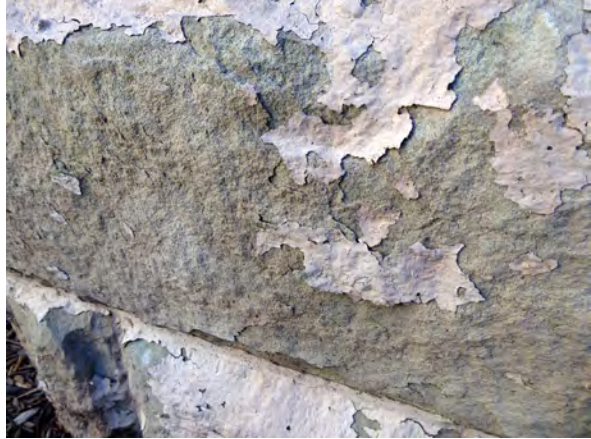
Photo 35: Delamination and subsequent paint loss on foundation stones on east elevation.

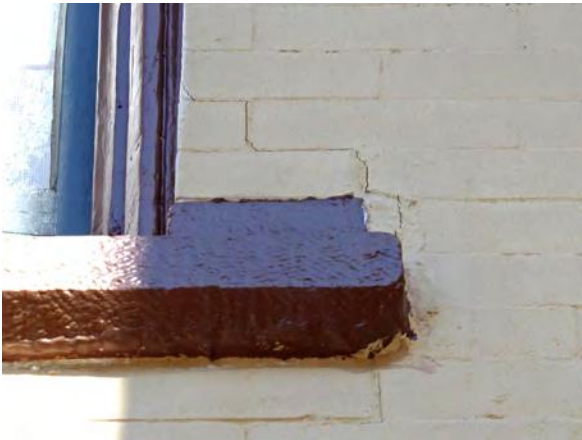
Photo 33: Example photo of cracking around sills on east elevation.

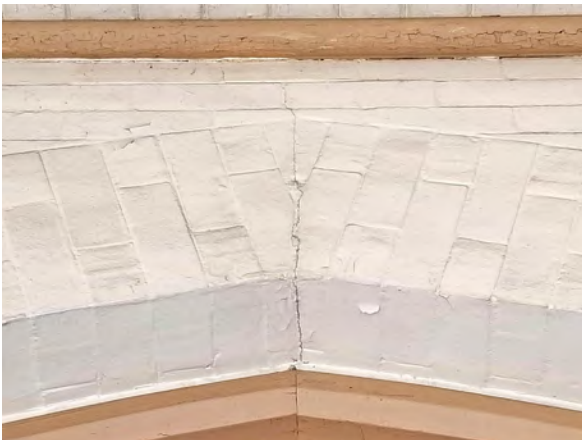
Photo 34: Small crack above main entry door.

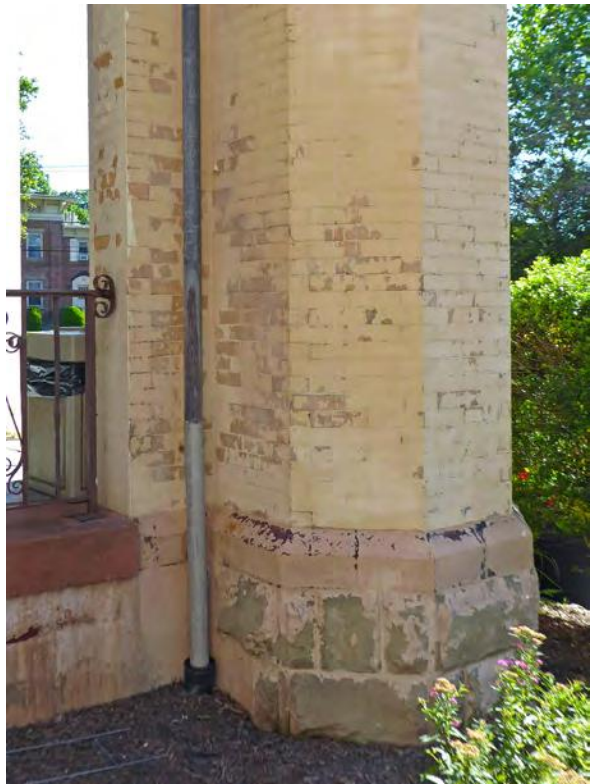
Photo 36: Paint loss at south tower of east elevation.

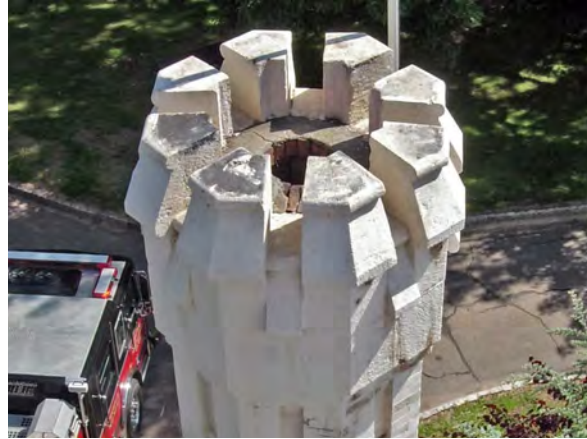
Photo 37: South tower roof with opening and cracked parging.

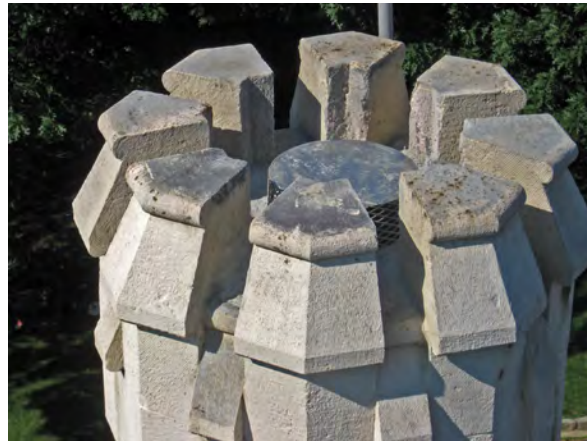
Photo 38: Positive slope and vented cap installed on south tower roof in 2008.

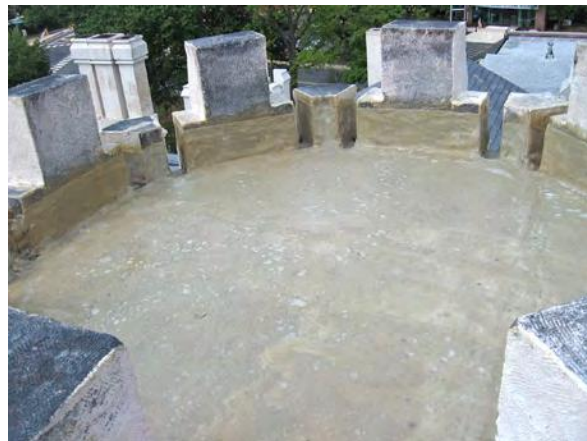
Photo 39: New membrane roof on north tower of east elevation installed in 2010.

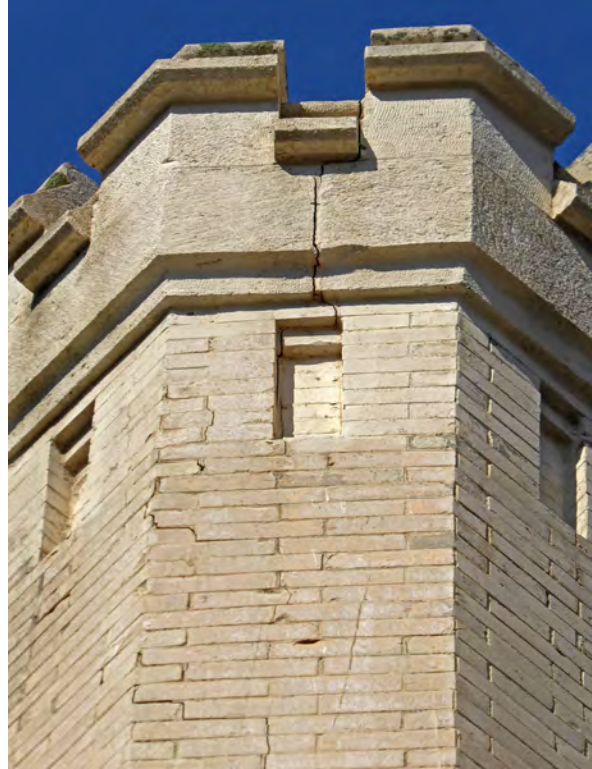
Photo 40: Long cracks on south tower of east elevation.

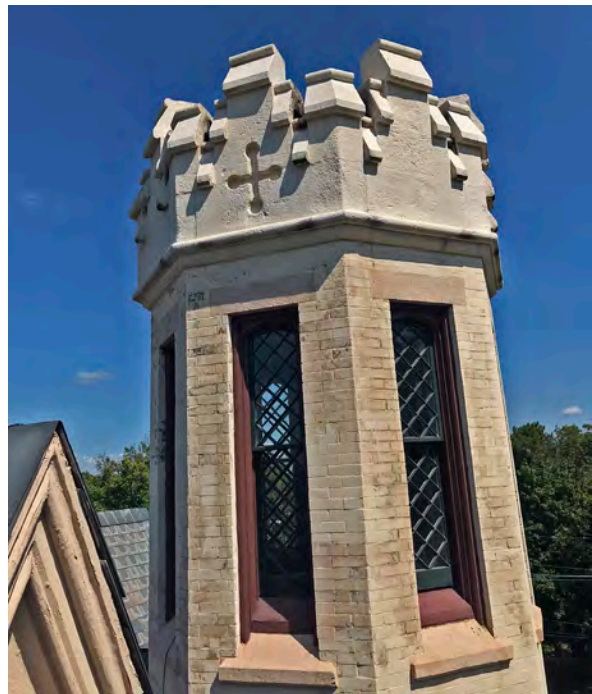
Photo 41: Diamon-pane wood windows on north tower of east elevation.

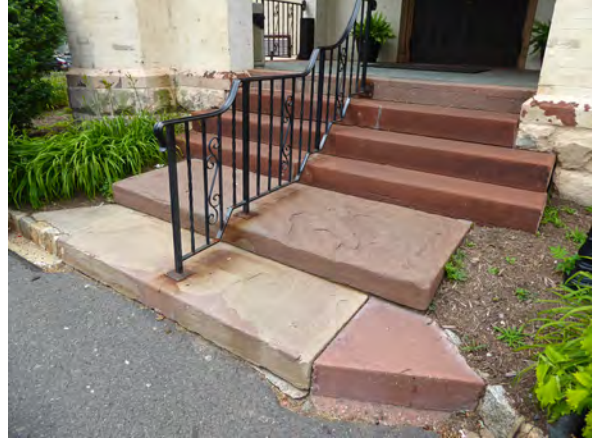
Photo 42: Deteriorated steps to entry porch at east elevation.

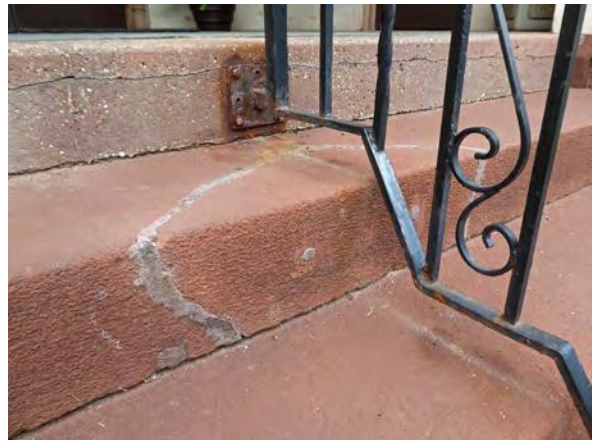
Photo 43: Rusting iron railing and extensive cracking on entry porch steps.

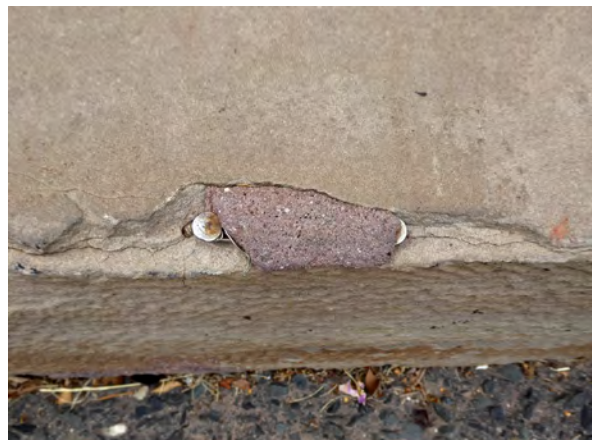
Photo 44: Cementitious patch anchored with nails at bottom step of entry porch.

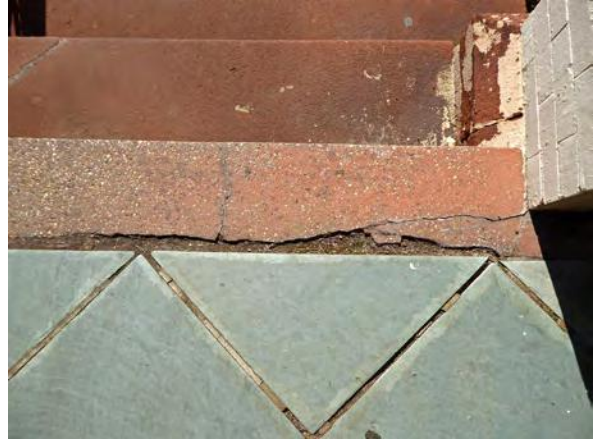
Photo 45: Deteriorated cast stone edging and slate paver joints at entry porch.

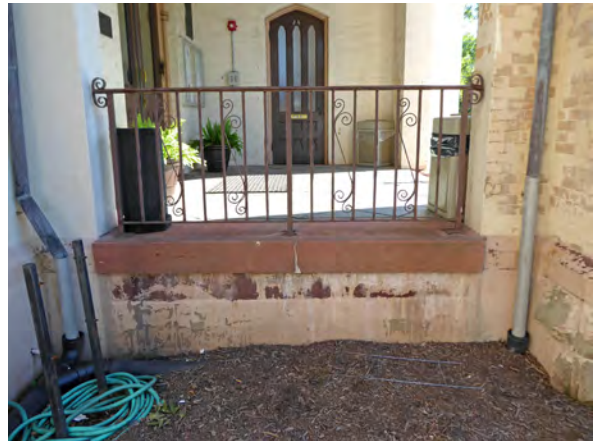
Photo 46: Wrought iron railing on south side of entry porch.

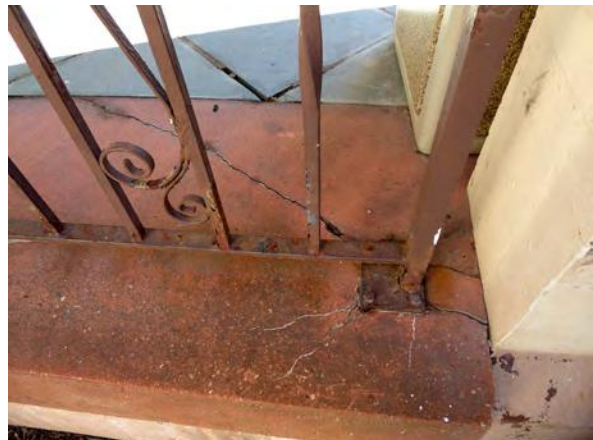
Photo 47: Star cracks caused by rusting rail posts.

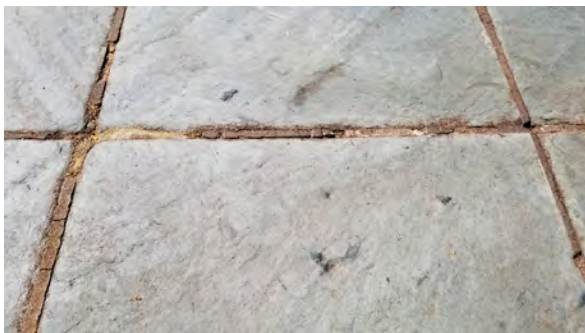
Photo 48: Deteriorated slate paver joints at entry porch floor.

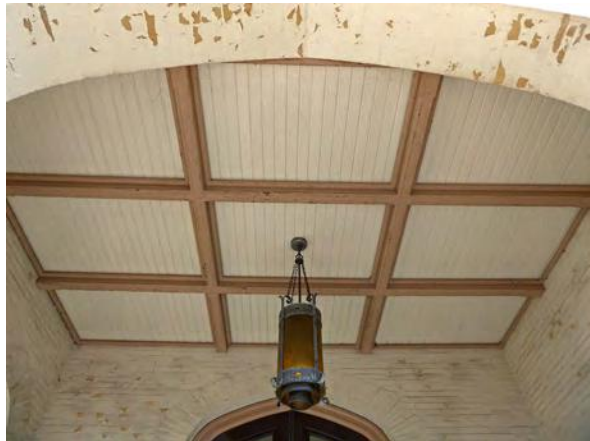
Photo 49: Deteriorated paint on entry porch ceiling.

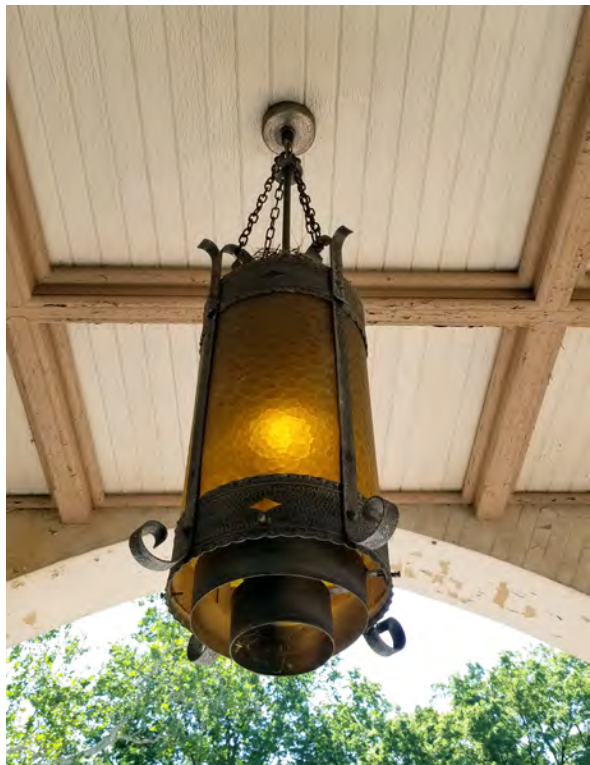
Photo 50: Historic pendant light at front entry porch.

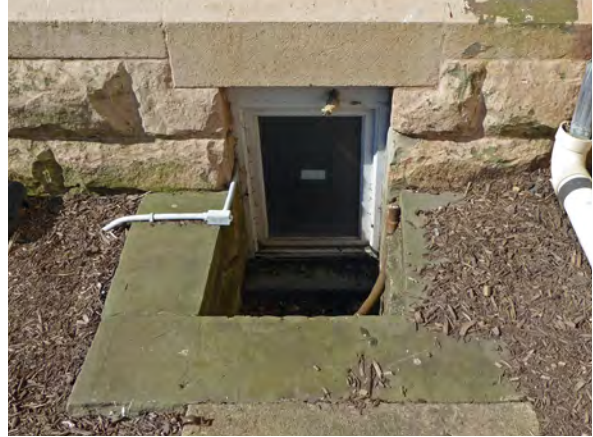
Photo 51: Foundation window (N001) at north wall of north tower.

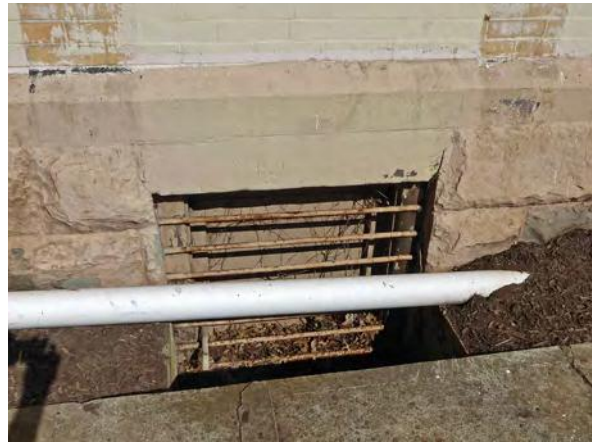
Photo 52: Foundation window (E001) at north side of east elevation.

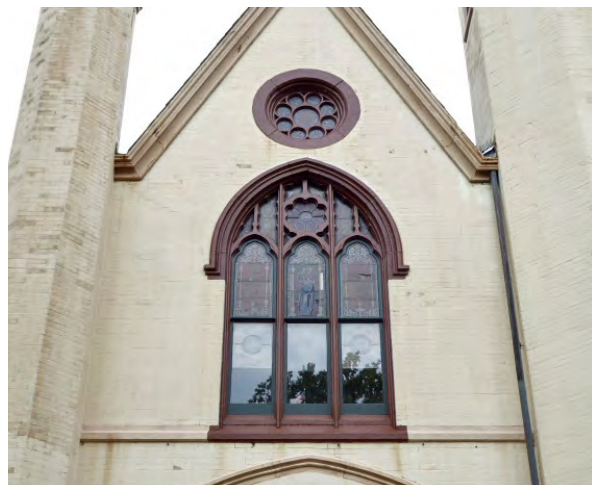
Photo 53: Arched stained glass window and rosette over entry porch on east elevation

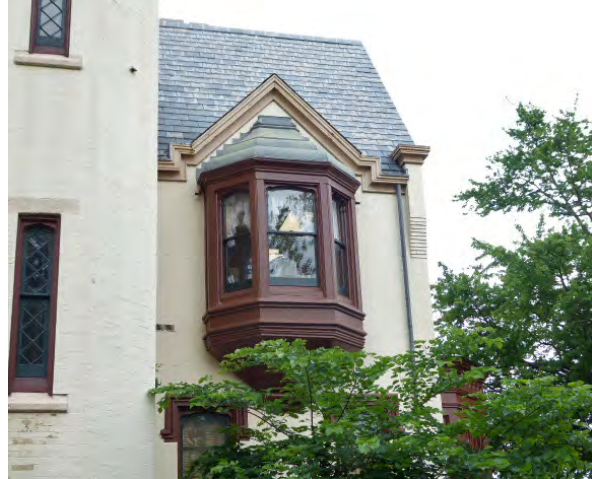
Photo 54: Second-floor oriel window on north side of east elevation.

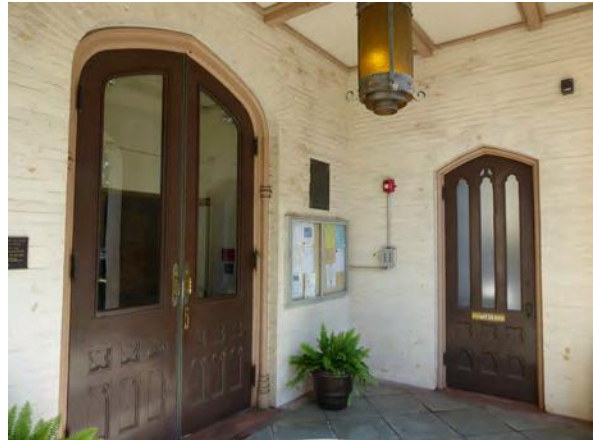
Photo 57: Main entry double doors and side tower door at entry porch.

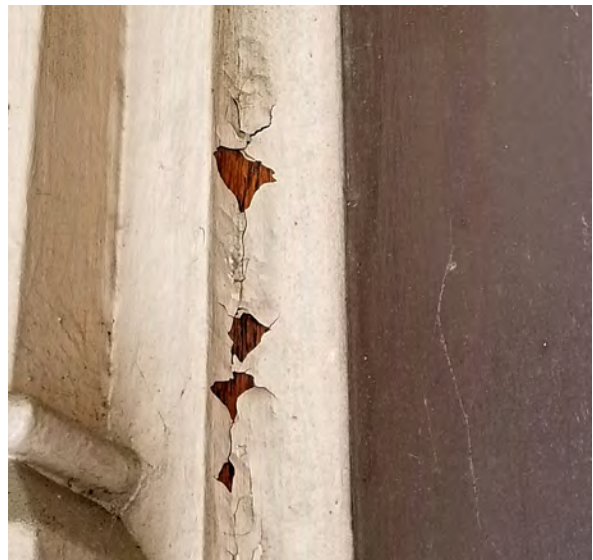
Photo 58: Paint loss at archway around entry door showing possible historic graining beneath.

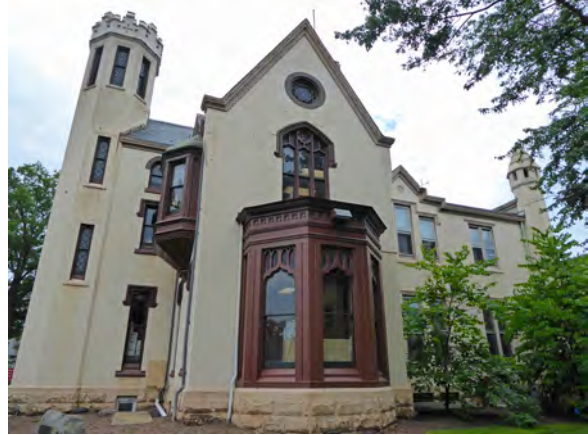
Photo 59: East end of north elevation of Borough Hall.

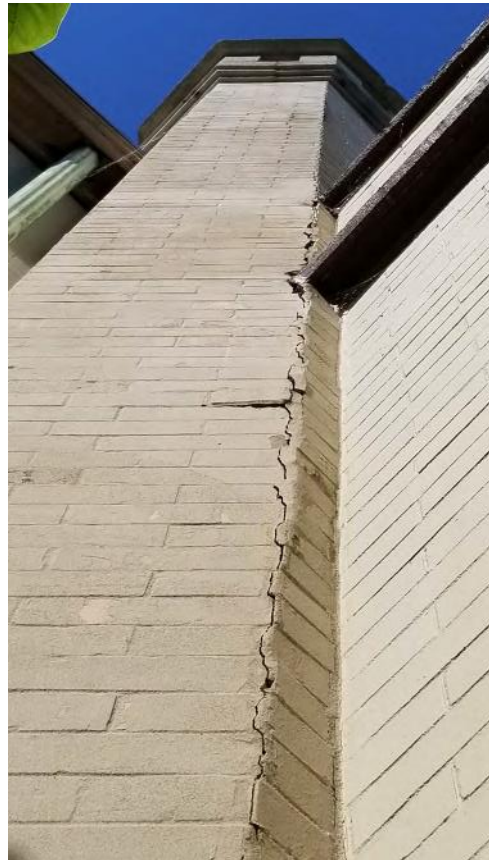
Photo 60: Crack along northwest chimney at intersection with Library addition.

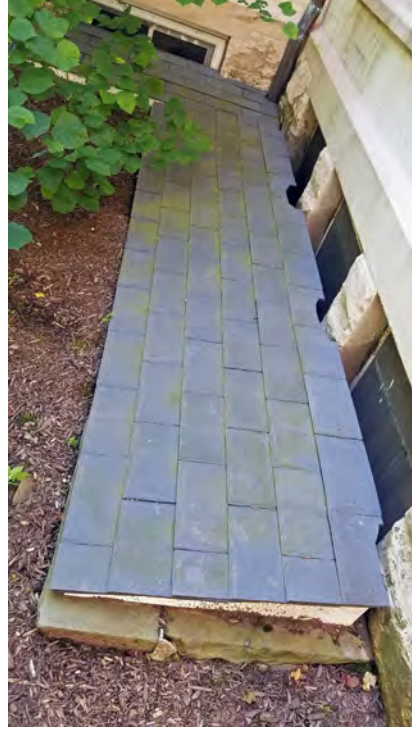
Photo 61: Cover over foundation windows on north elevation.

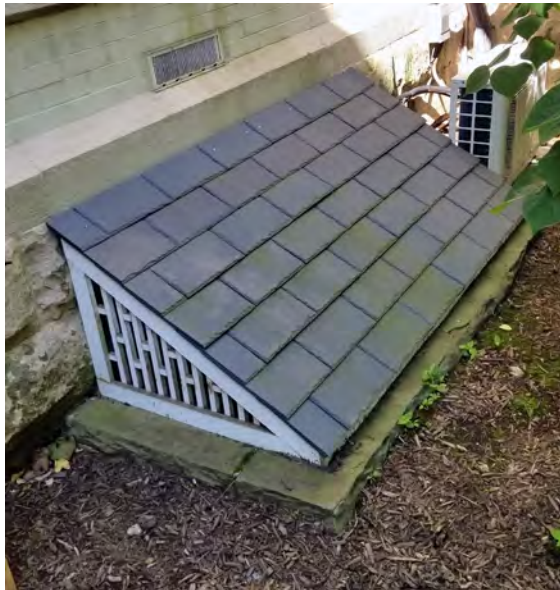
Photo 62: Cover over foundation window on north elevation.

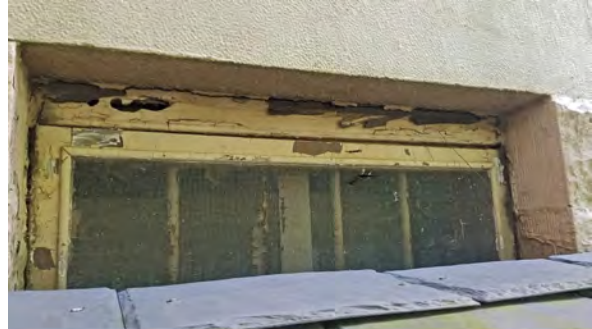
Photo 63: Typical condition of deteriorated foundation windows on north elevation of Borough Hall.

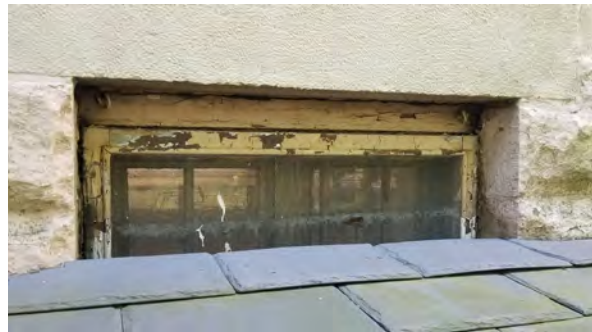
Photo 64: Typical condition of deteriorated foundation windows on north elevation of Borough Hall.

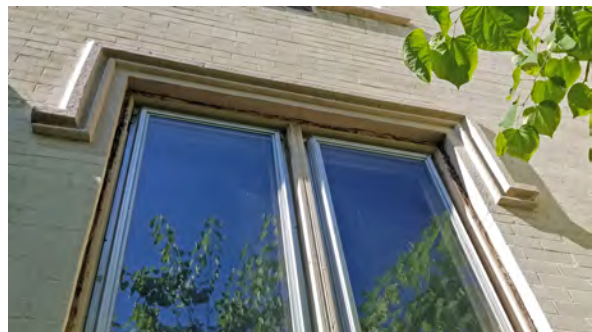
Photo 65: Deteriorated sealant around first floor window N108.

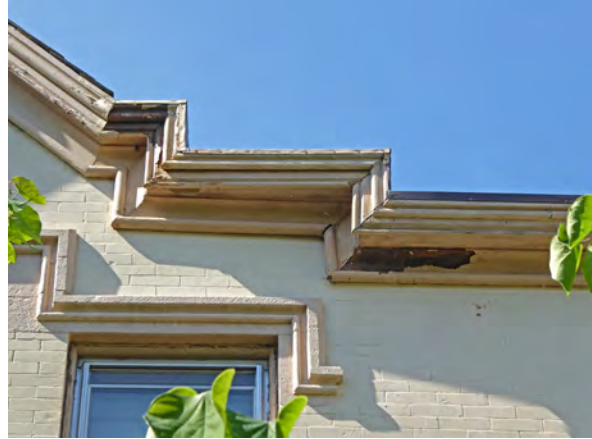
Photo 66: Deteriorated wood cornice at north elevation of Borough Hall.

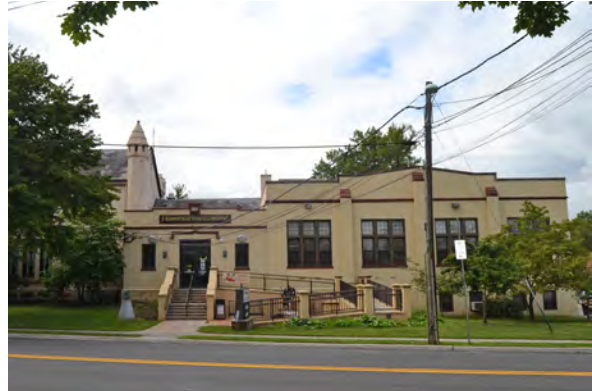
Photo 67: View of Library and entrance stairs and ramp from across street.

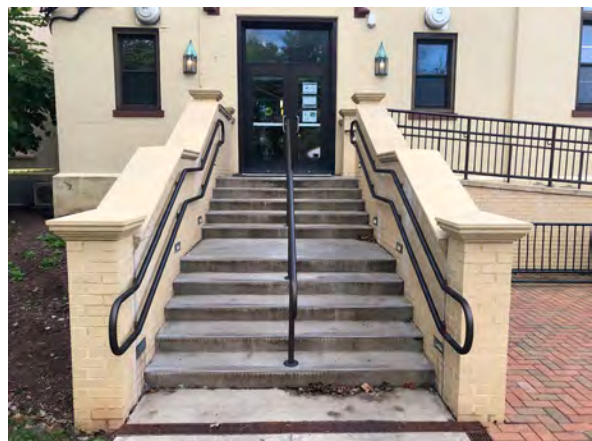
Photo 69: Recently constructed entrance stairs to Library.

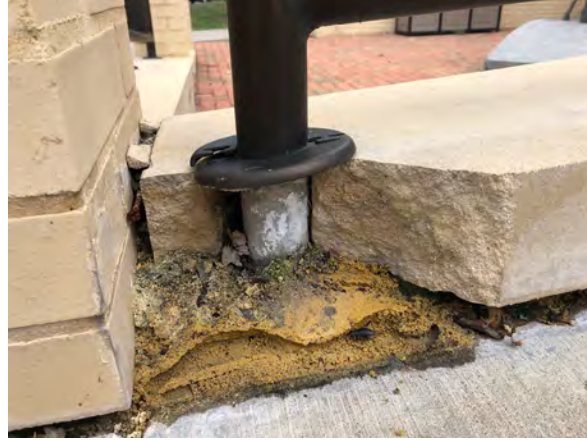
Photo 70: Total loss of portion of ramp coping.

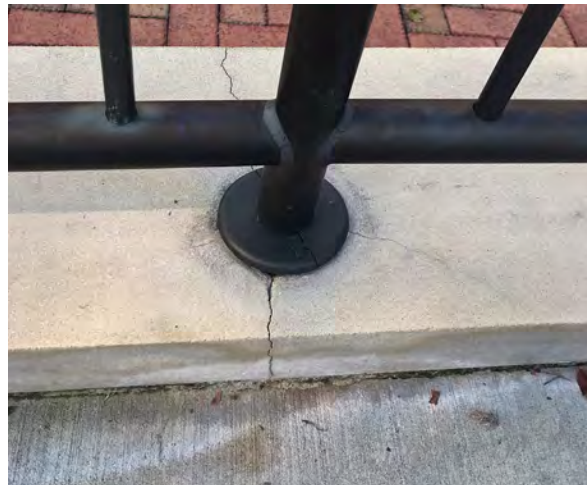
Photo 71: Crack on coping at railing post.

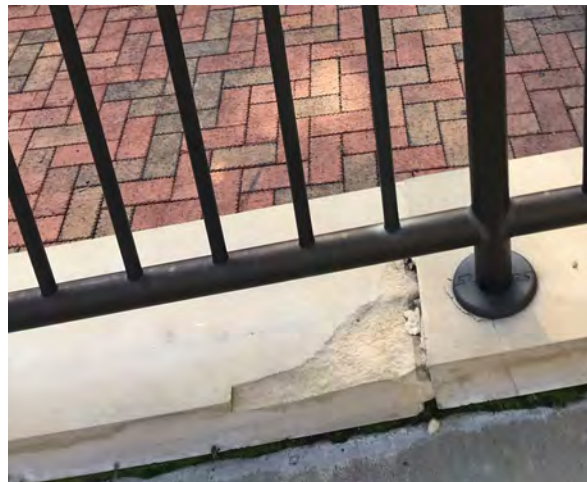
Photo 72: Spall on coping unit.

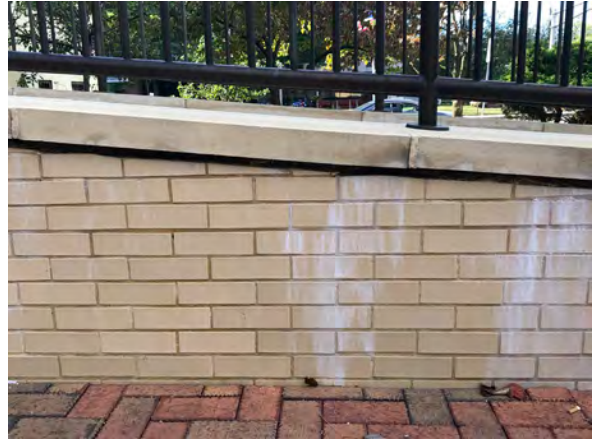
Photo 73: Salt efflorescence on brick wall of ramp.

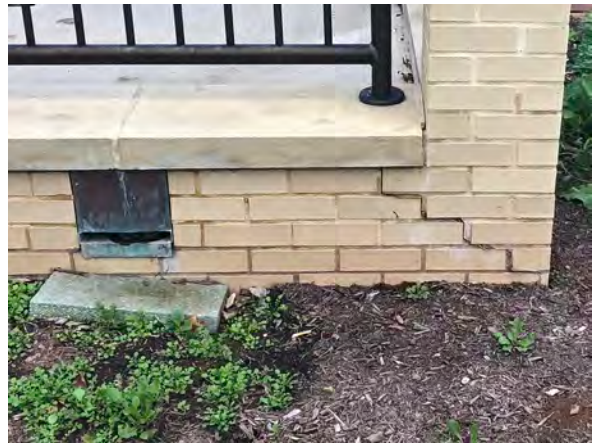
Photo 74: Step crack at base of ramp post (right) and poorly designed drainage of ramp (left).

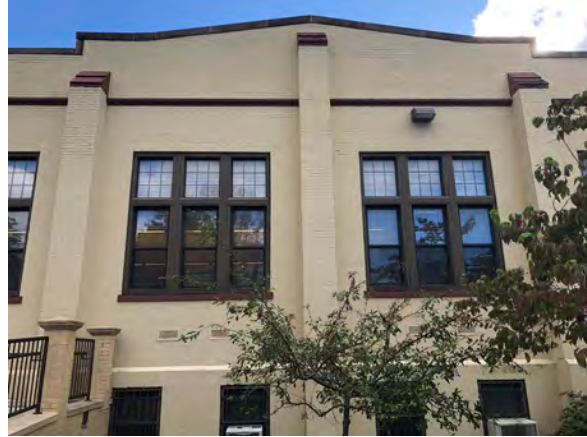
Photo 75: Typical first floor windows at north elevation of Library.

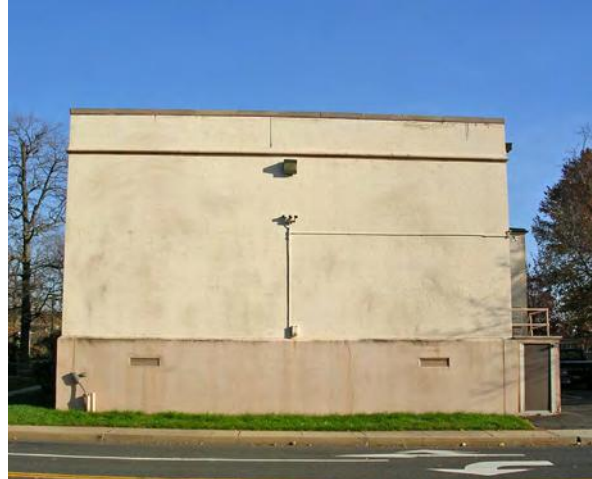
Photo 77: West elevation of Library.

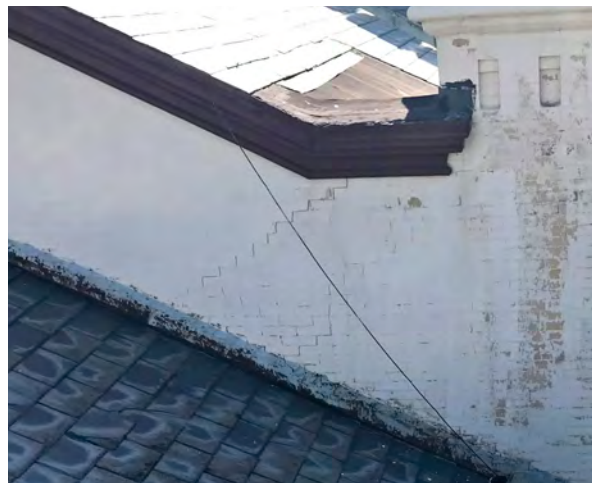
Photo 79: Step cracks and paint loss on west elevation of Borough Hall.

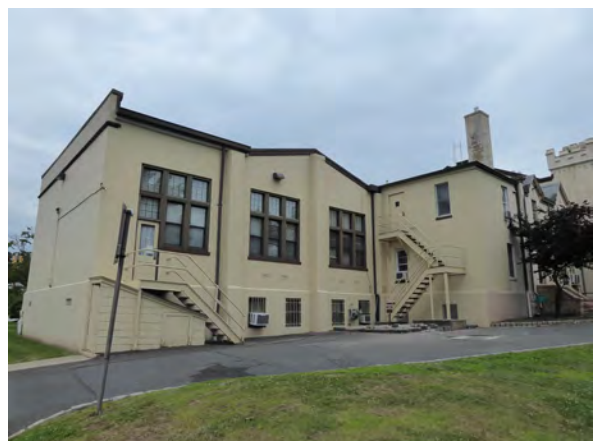
Photo 82: Library and rear addition of Borough Hall. Both fire escape stairways shown in photo.

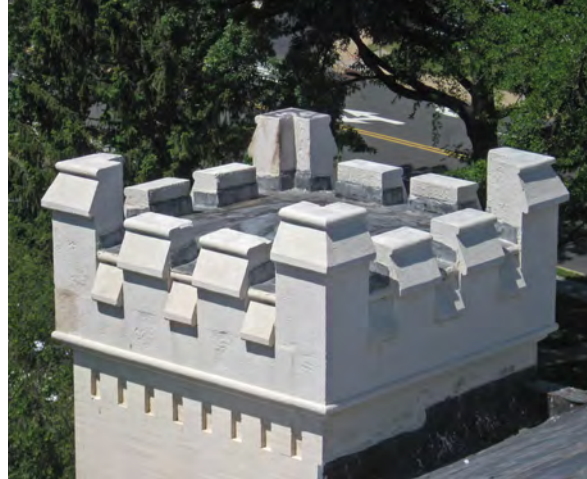
Photo 83: Sloped membrane roof on south tower.

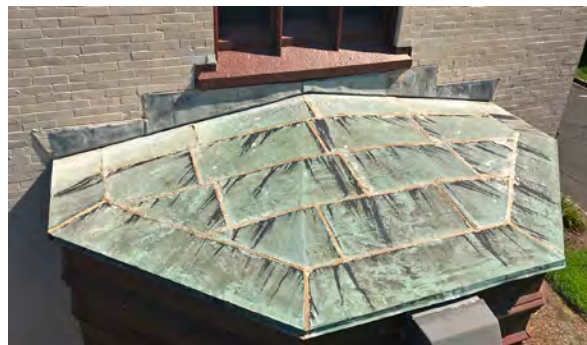
Photo 85: Copper roof on bay at east end of south elevation of Borough Hall.

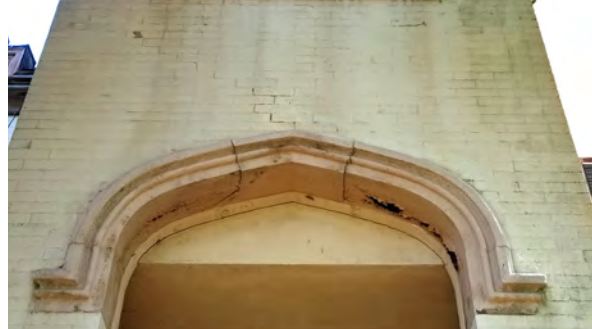
Photo 86: Cracks in stone archway and bricks above at tower porch.

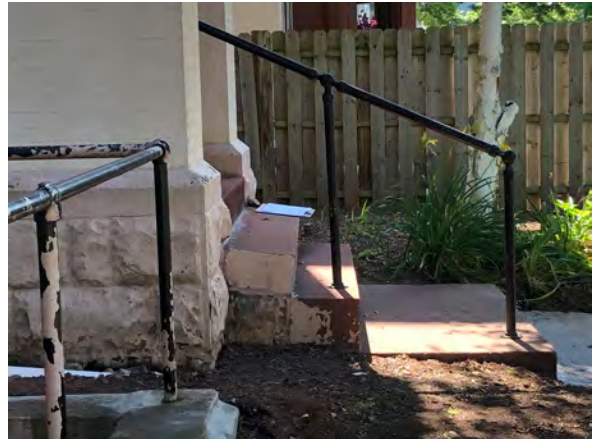
Photo 87: Displaced steps at tower porch.

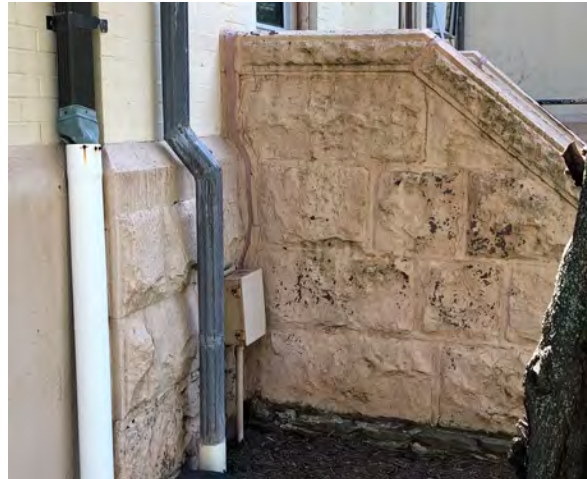
Photo 89: Separation of west entry stair side wall from building, filled in.
