**SOMERVILLE BOROUGH HALL &
PUBLIC LIBRARY**
PRESERVATION PLAN UPDATE

MARCH 2021

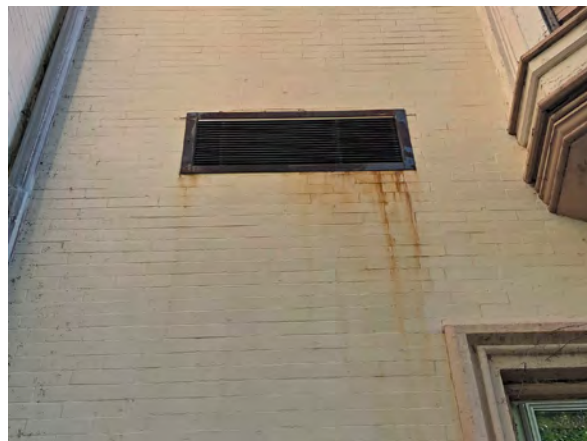
Photo 90: Rusted louver at second floor on east end of south elevation.

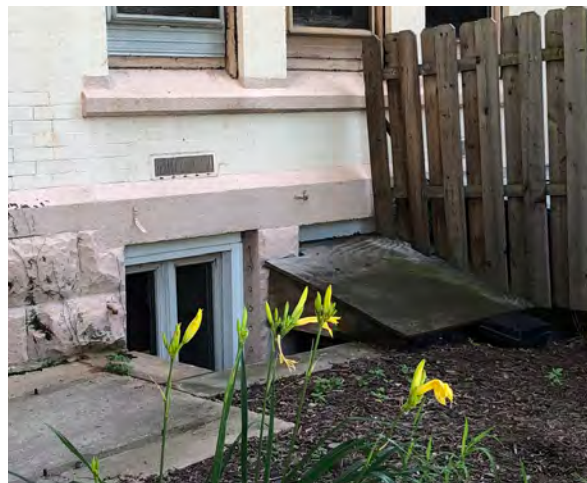
Photo 91: Foundation windows with light wells at east end of south elevation of Borough Hall.

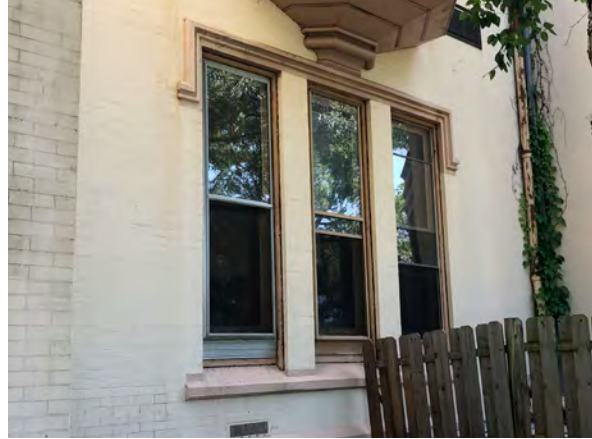
Photo 92: Set of three deteriorated windows at first floor of south elevation of Borough Hall.

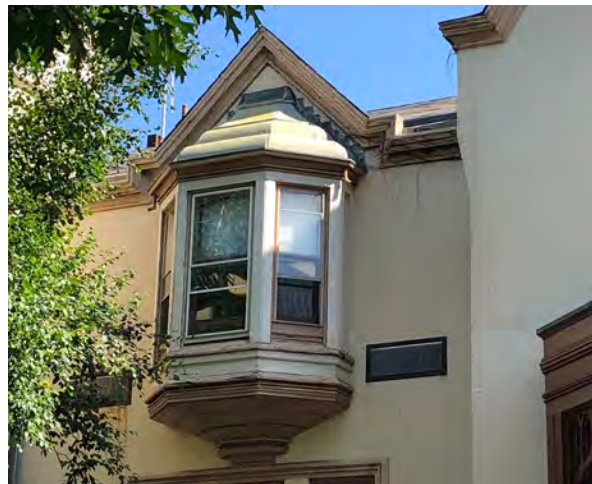
Photo 93: Deteriorated bay window with rolled copper roof on south elevation of Borough Hall.

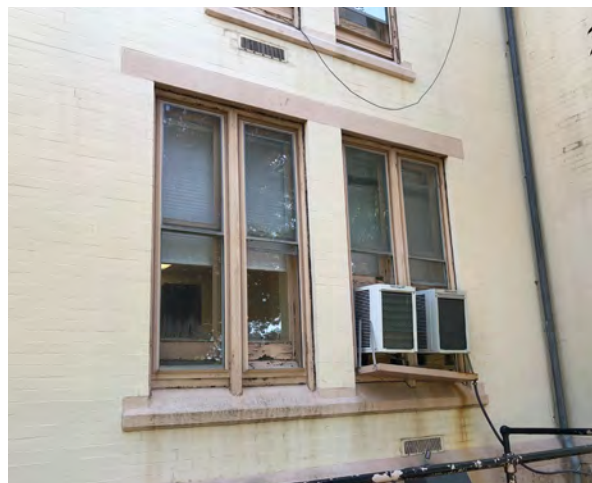
Photo 94: Deteriorated windows at west end of south elevation of Borough Hall.

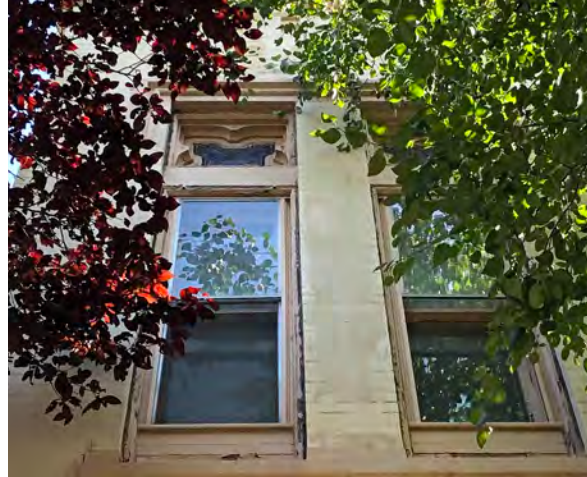
Photo 95: Deteriorated second floor windows with stained glass transoms at south tower.

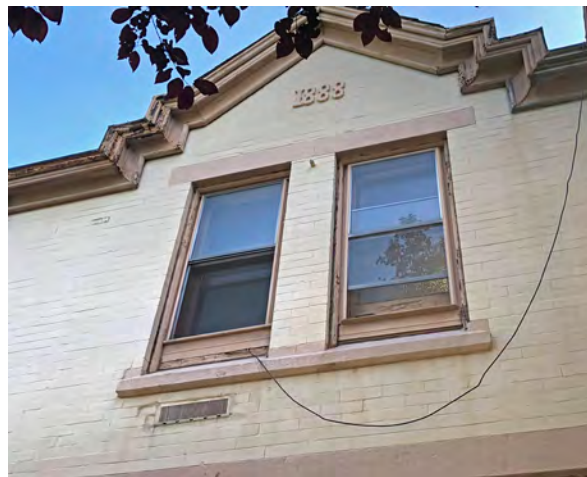
Photo 96: Deteriorated windows at west end of south elevation of Borough Hall.

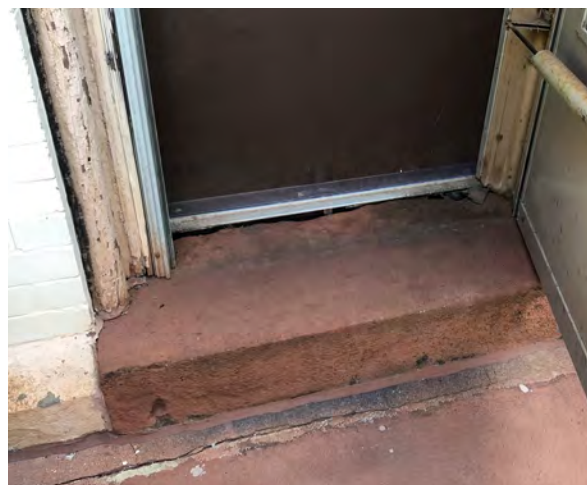
Photo 97: Void at west entry door sill.

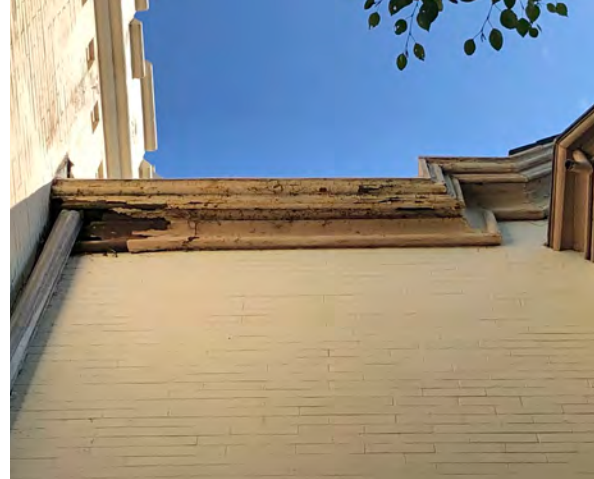
Photo 98: Deteriorated wood cornice at east end of south elevation of Borough Hall.

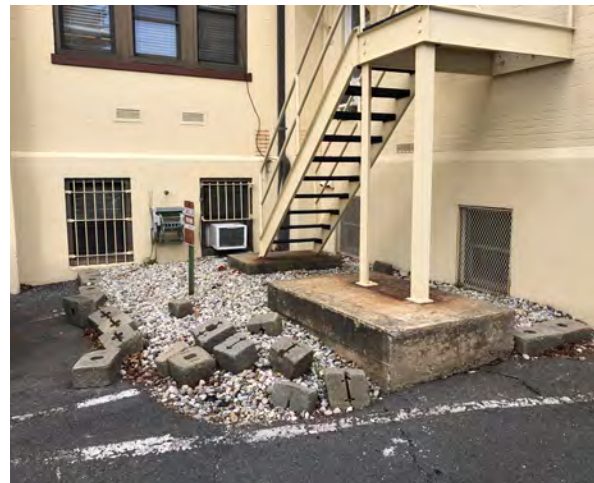
Photo 99: Base of fire escape stairway on rear addition of Borough Hall.

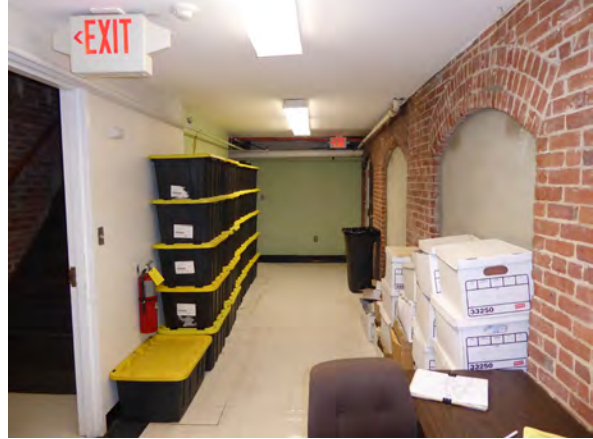
Photo 1: View west in Room 001.

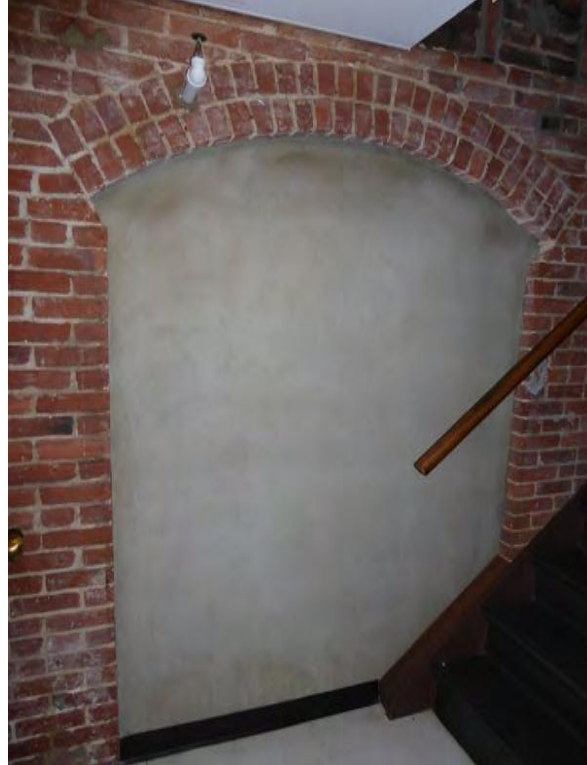
Photo 4: Filled in arched opening in brick interior foundation wall at bottom of basement stairs.

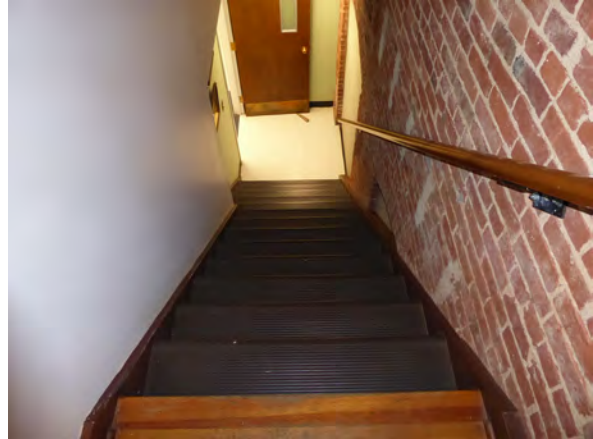
Photo 5: View of basement stairs from top landing.

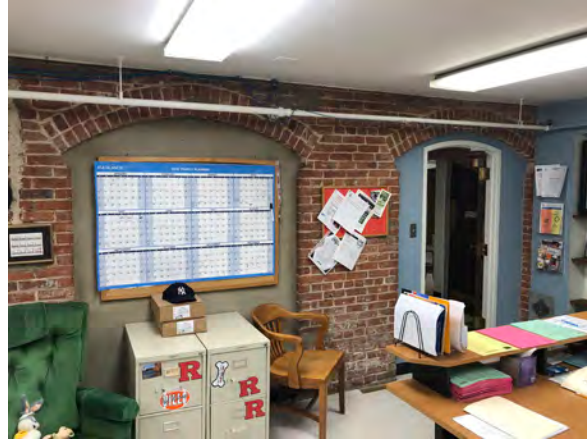
Photo 7: North wall in Room 002 showing brick foundations with filled in arched openings.

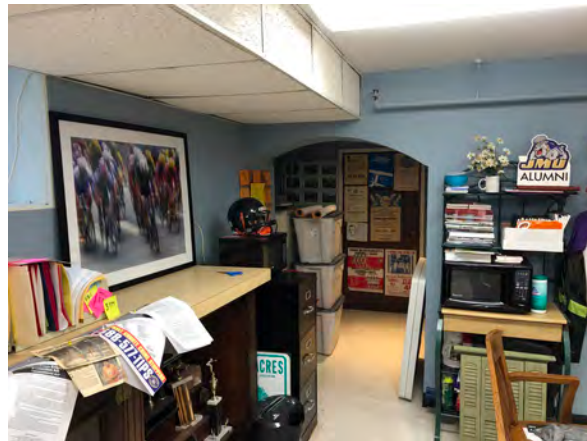
Photo 8: View southwest in Room 002, showing door to Room 011.

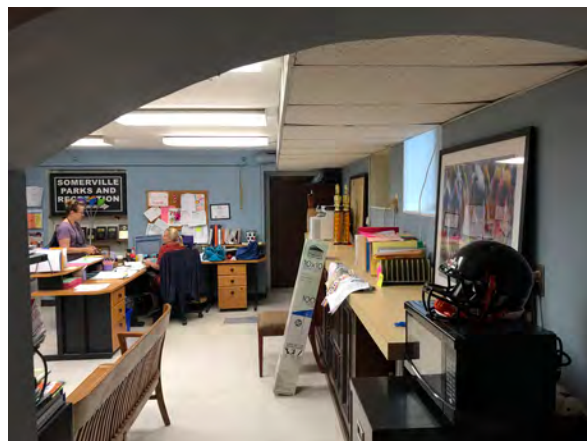
Photo 9: View east in Room 002, showing door to Room 003.

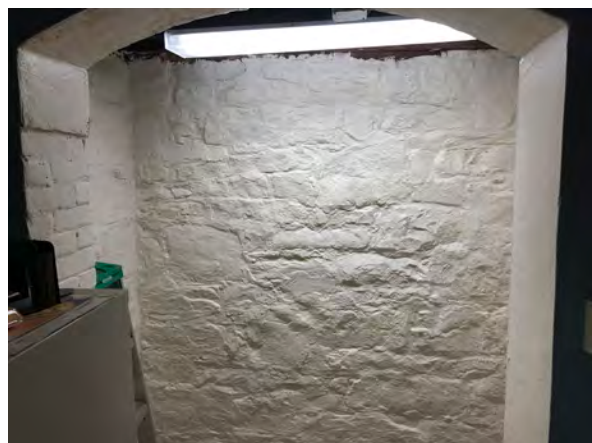
Photo 12: Painted exposed masonry foundation in closet of Room 002.

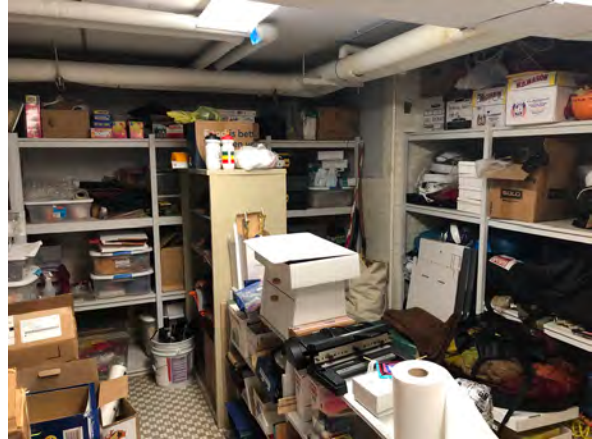
Photo 13: View southeast in Room 003.

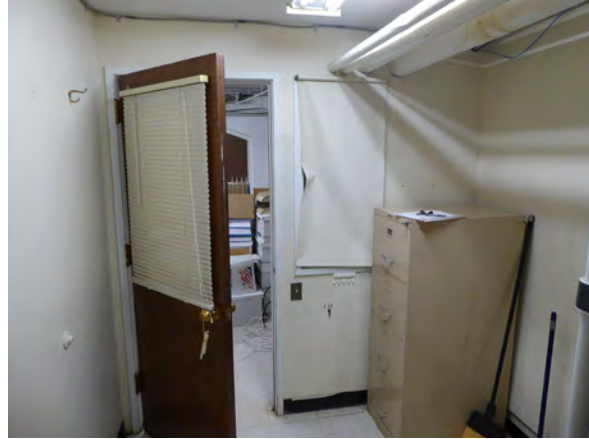
Photo 17: View north in Room 005.

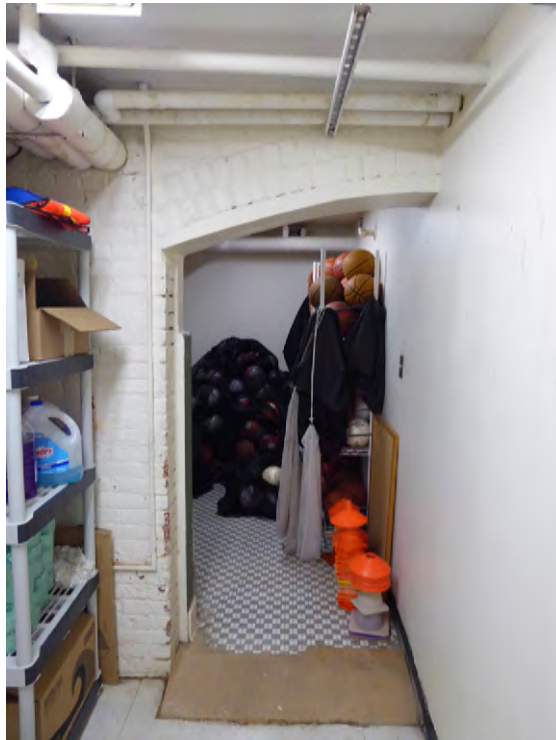
Photo 18: View south in Room 005, showing brick foundation dividing the room.

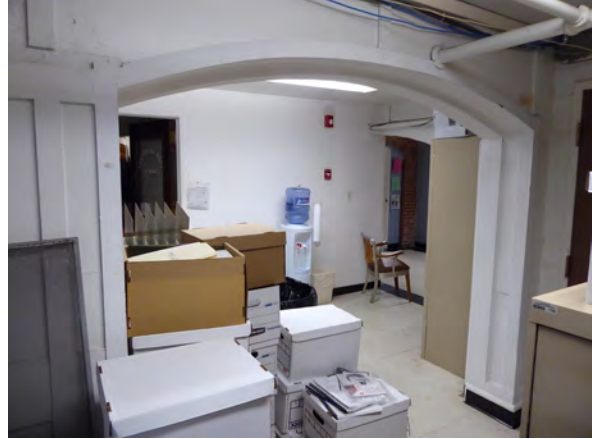
Photo 20: View southwest through central archway in Room 006, showing door to Room 005 and archway to room 001

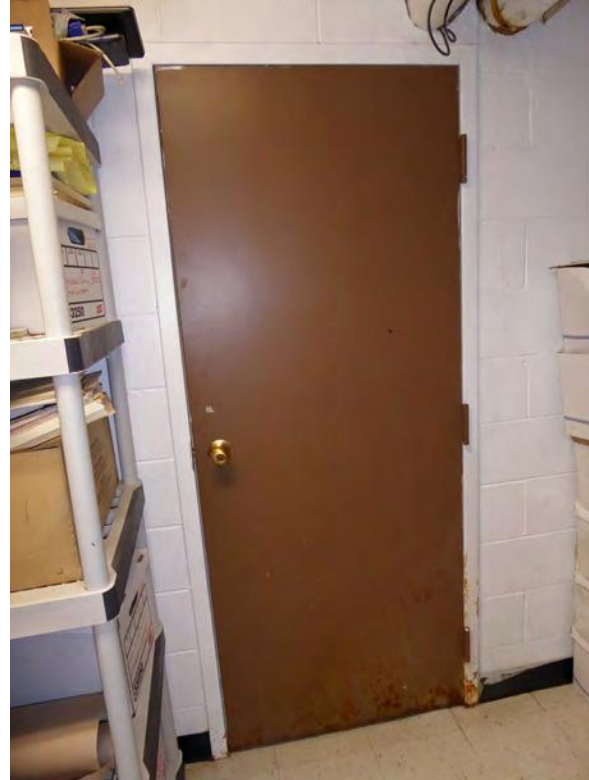
Photo 25: Door to Room 007.

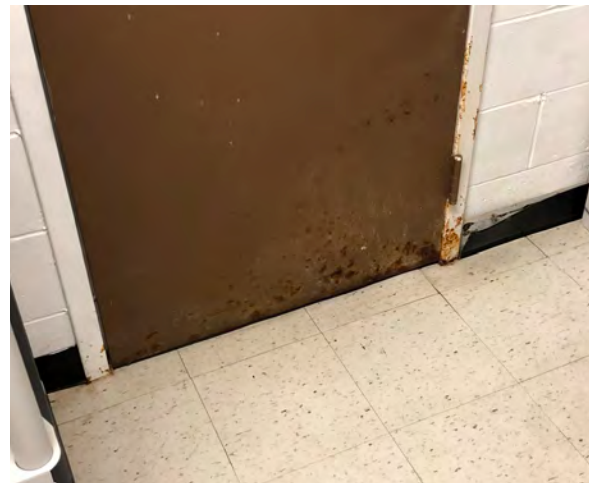
Photo 26: Rust along bottom of door to Room 007.

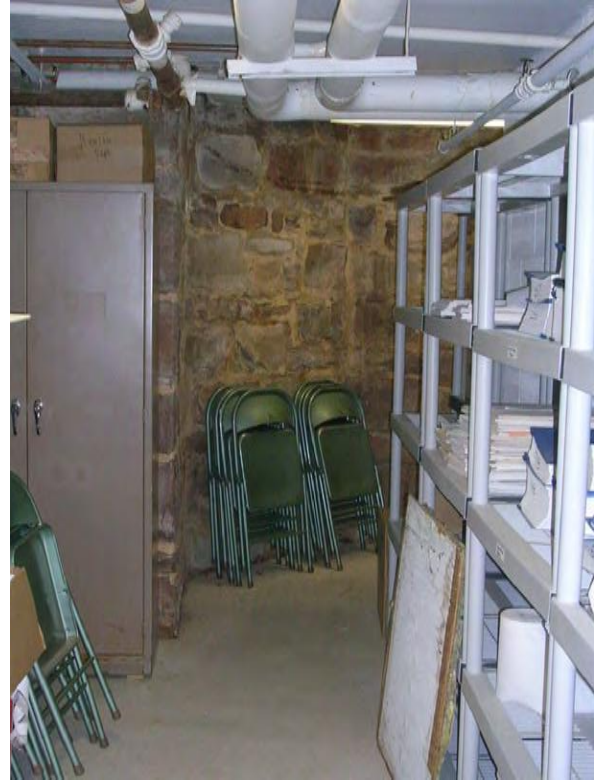
Photo 27: View north in Room 008. Photo taken in 2007.

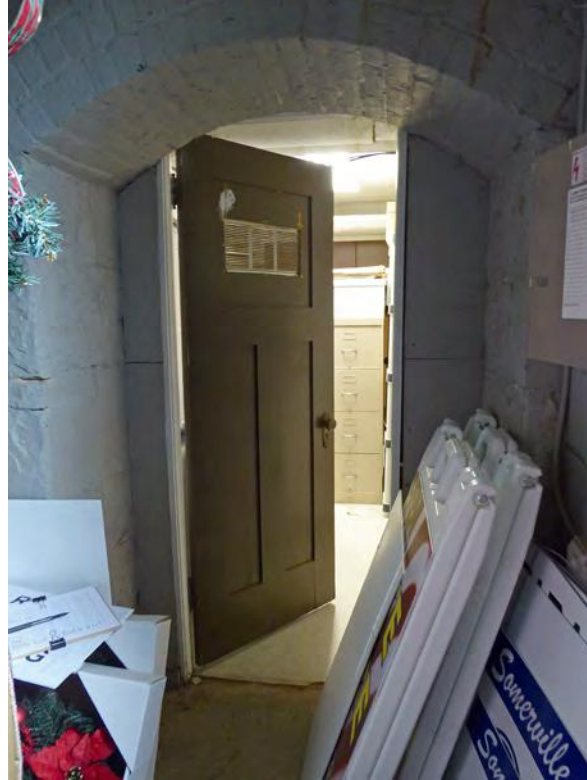
Photo 28: View west in Room OST-2 showing archway in brick foundation wall and door to Room 006.

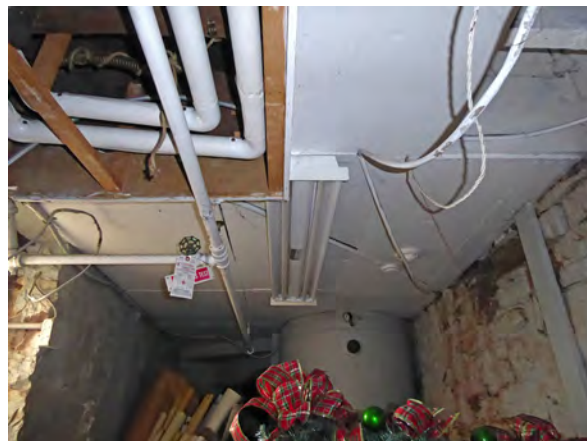
Photo 29: View east in Room OST-2.

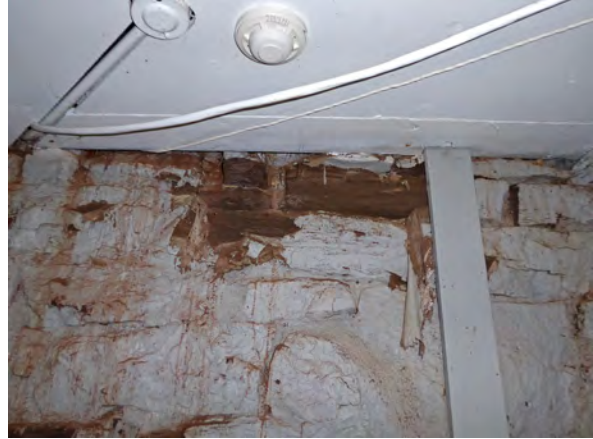
Photo 30: Delaminating stones on south wall in Room OST-2.

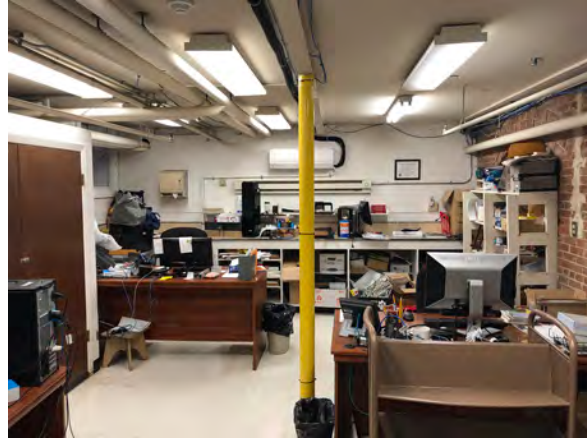
Photo 33: View east in Room 010.

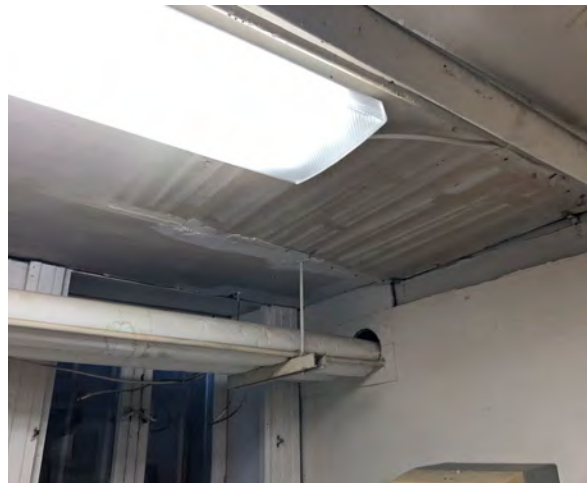
Photo 35: Water damage on the northeast corner of the ceiling.

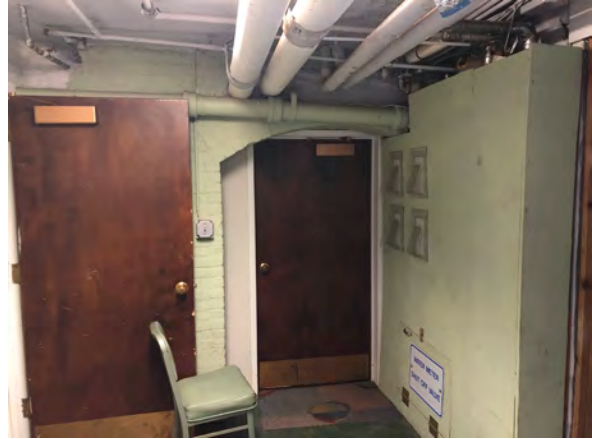
Photo 40: View east in Room 011.

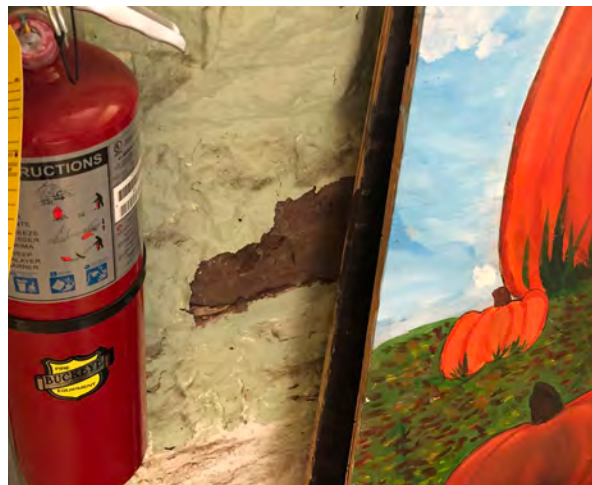
Photo 42: Delaminating stones on south foundation wall.

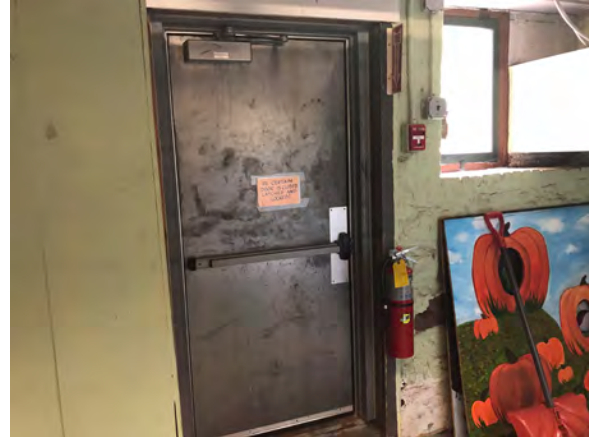
Photo 43: Exterior door on south wall in Room 011.

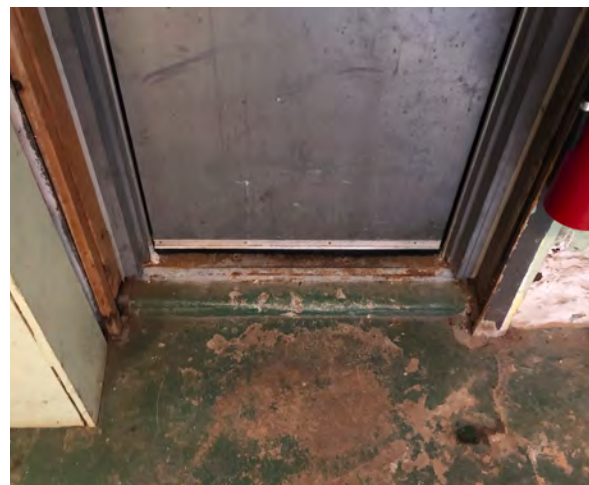
Photo 44: Rust on the exterior door threshold in Room 011.

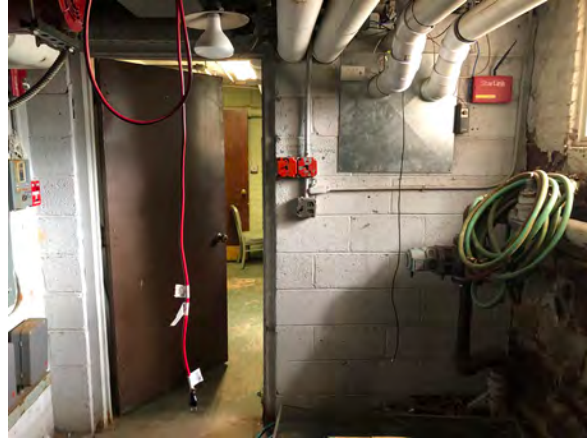
Photo 46: View east in Room 012.

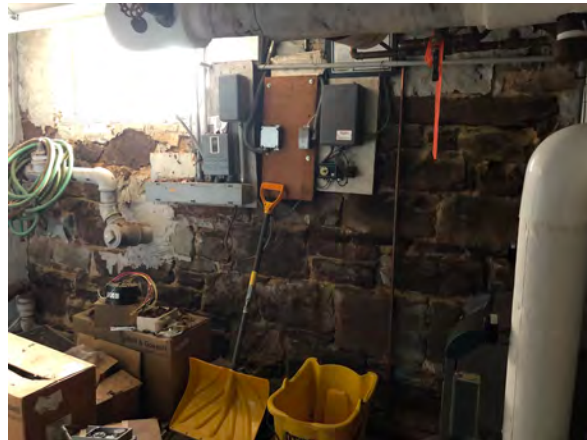
Photo 47: South foundation wall in Room 012.

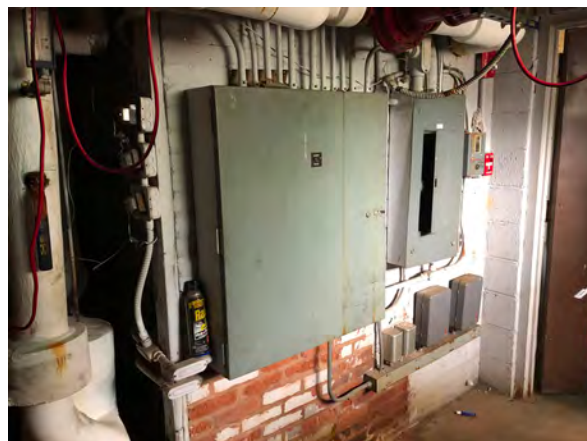
Photo 48: Portion of north wall with deteriorated lower brick courses.

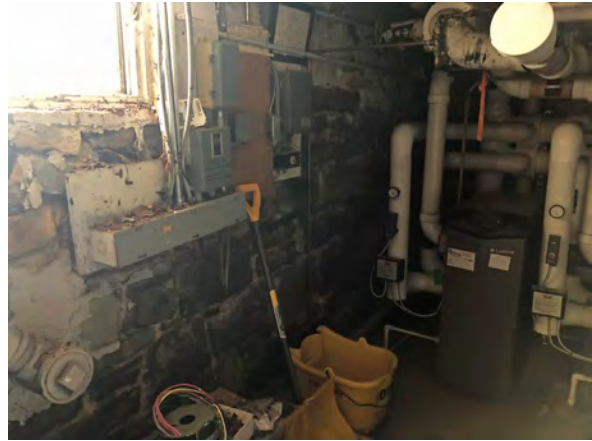
Photo 49: Southeast corner of Room 012 showing one boiler and associated piping.

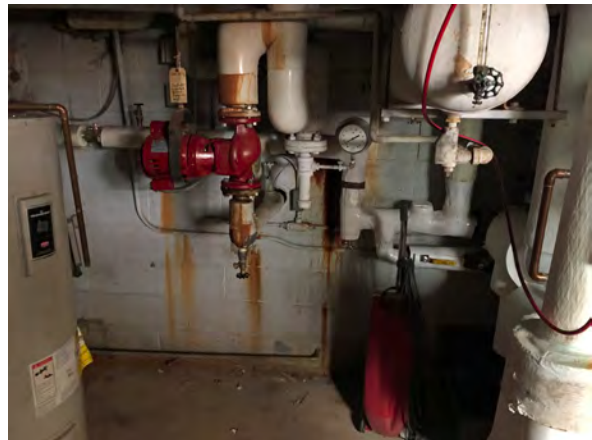
Photo 50: View north in Room 012 showing hot water heater and boiler piping.

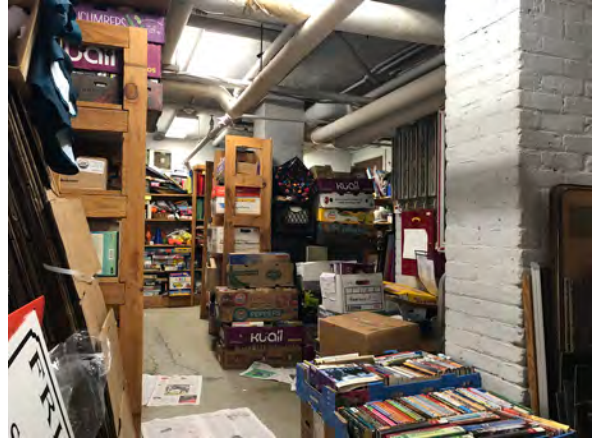
Photo 51: View southeast in Room 013 showing brick columns and exhaust fan on east wall.

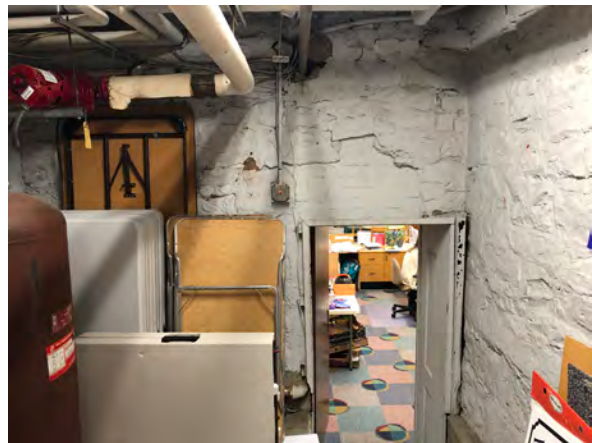
Photo 52: West wall in Room 013 with door to Room 015 and brick repair above.

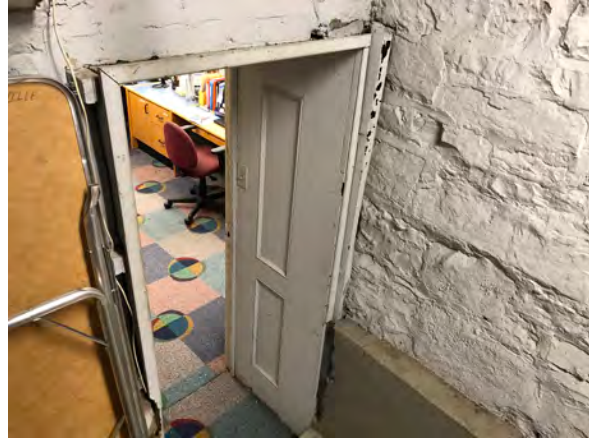
Photo 53: Paneled door jamb on doorway to Room 015 and concrete underpinning under north foundation wall.

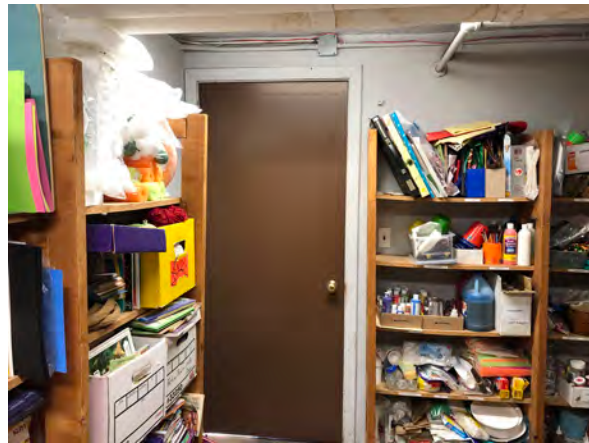
Photo 54: Door to Room 011 on the south wall in Room 013.

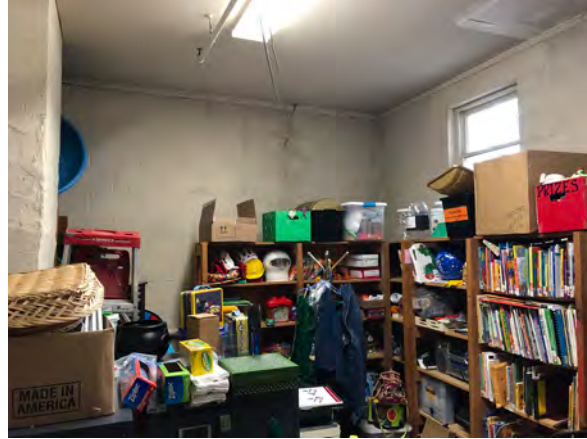
Photo 57: View south in Room 014. Note the water staining at the top of the wall.

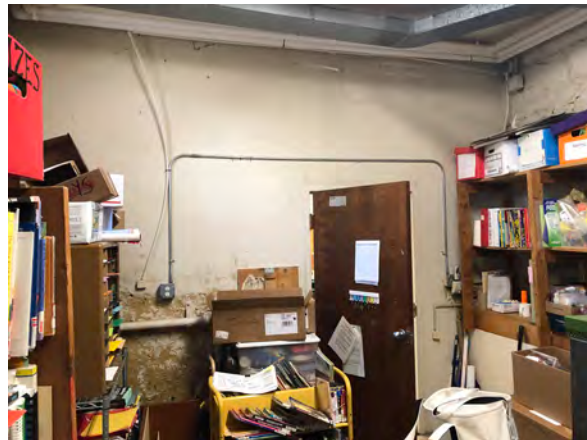
Photo 58: View north in Room 014 showing door to Room 015.

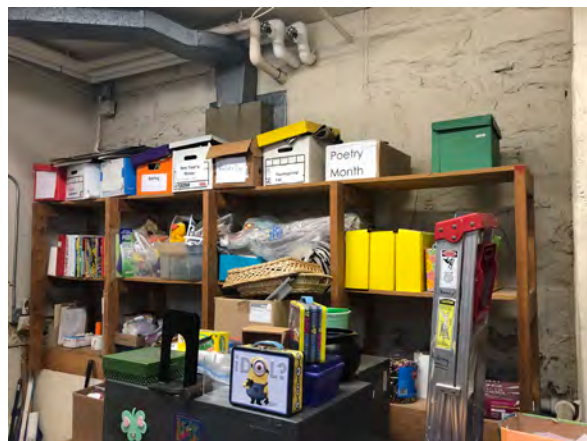
Photo 59: Exposed stone foundation of Borough Hall on east wall of Room 014.

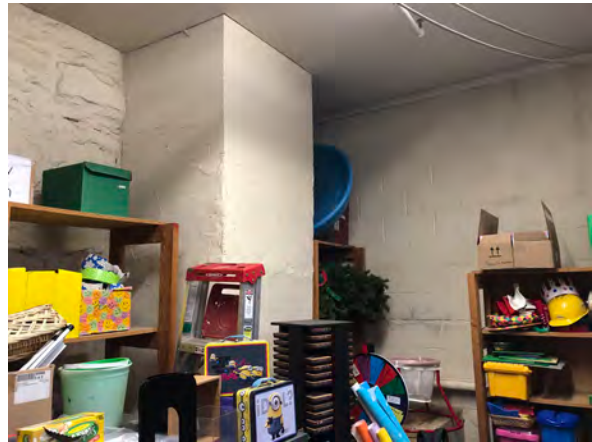
Photo 60: Chimney foundation on east wall in Room 014.

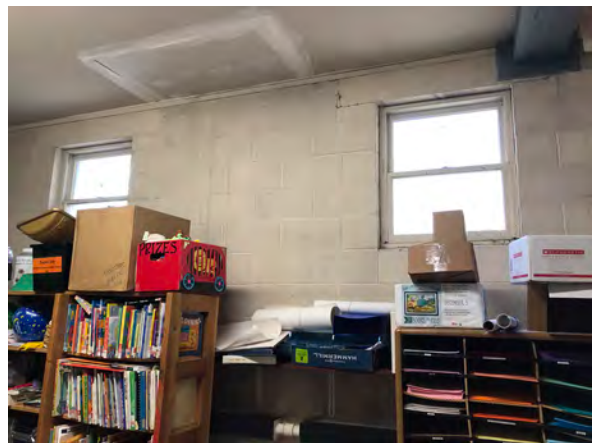
Photo 61: View west in Room 015, showing windows and cut out section of ceiling.

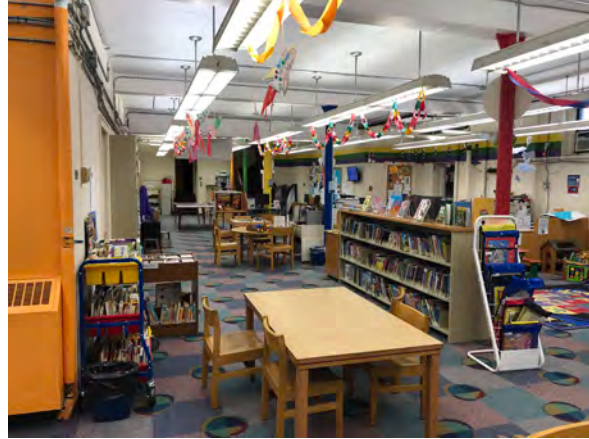
Photo 62: View east in Room 015.

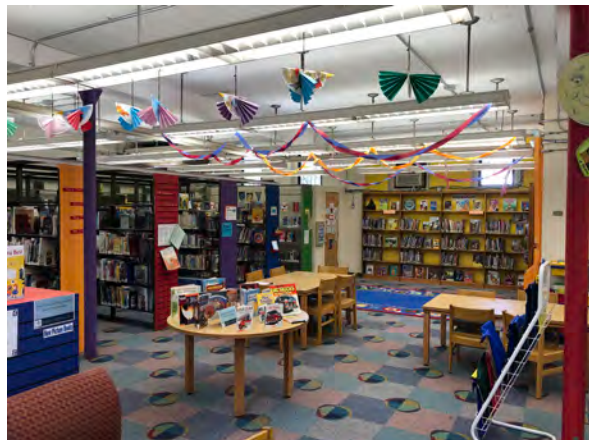
Photo 64: View northwest in Room 015.

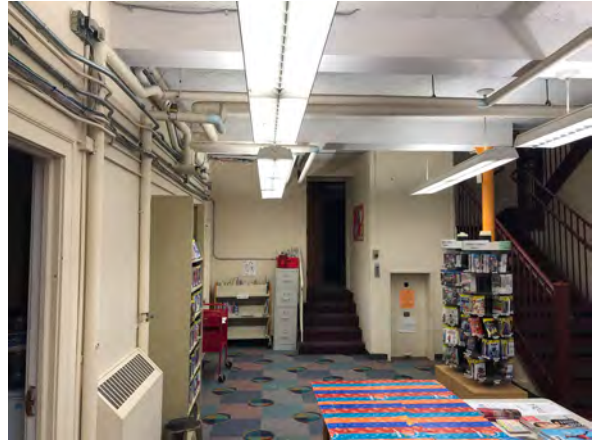
Photo 65: East side of Room 015 showing stairs, book lift and door to Room 010.

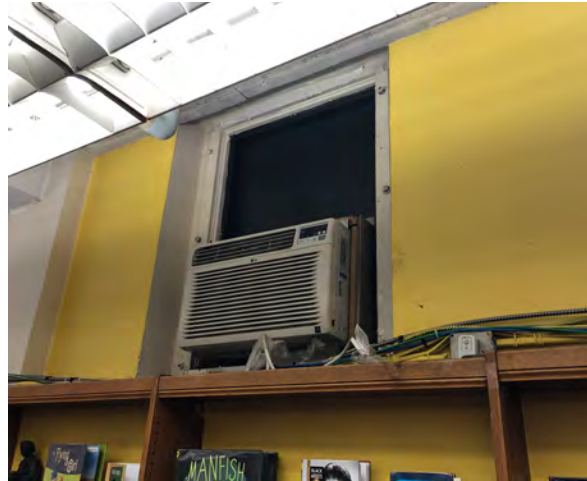
Photo 67: Window air conditioning unit on north wall in Room 015.

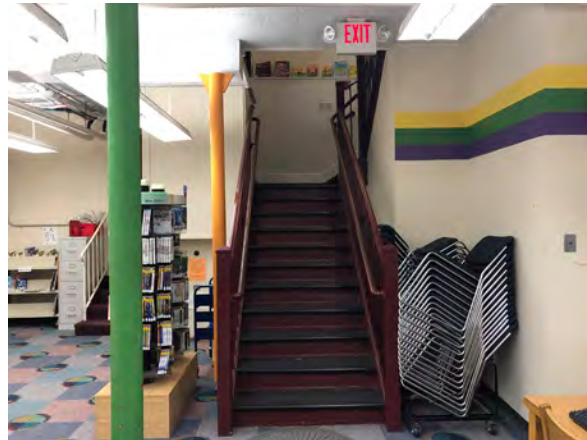
Photo 68: Stair to first floor at east end of Room 015.

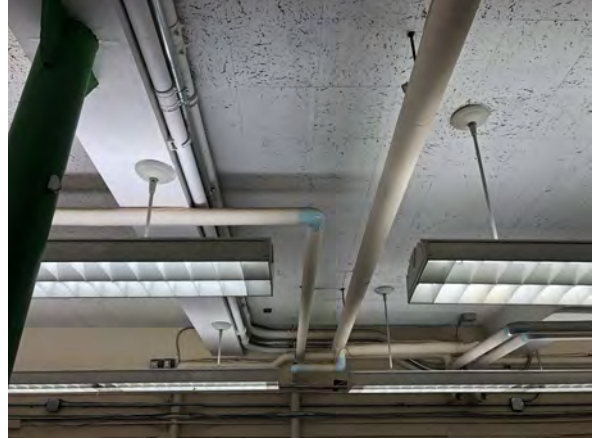
Photo 69: Piping and wiring below applied acoustical ceiling tile in Room 015.

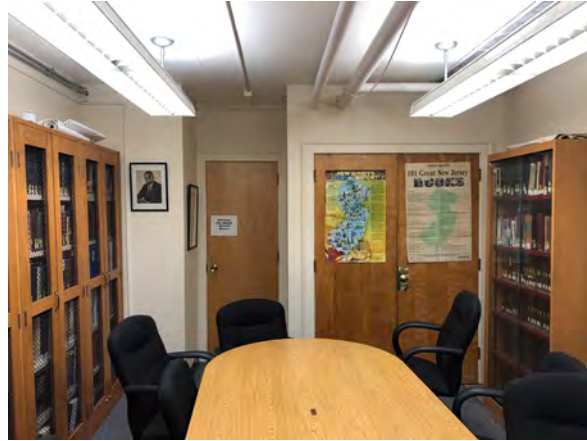
Photo 70: View west in Room 017, showing the closet and door to Room 016.

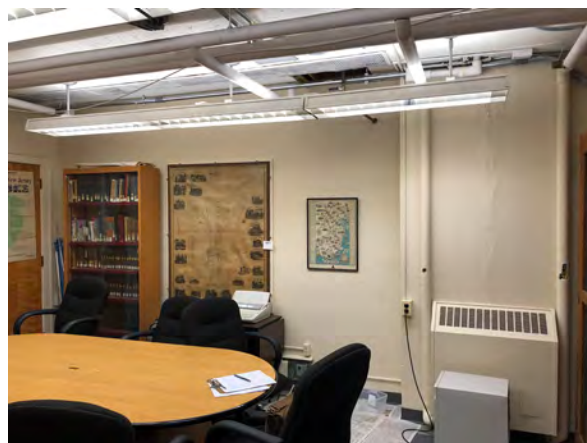
Photo 72: View north in Room 017. Note location of ceiling leak in center of photo.

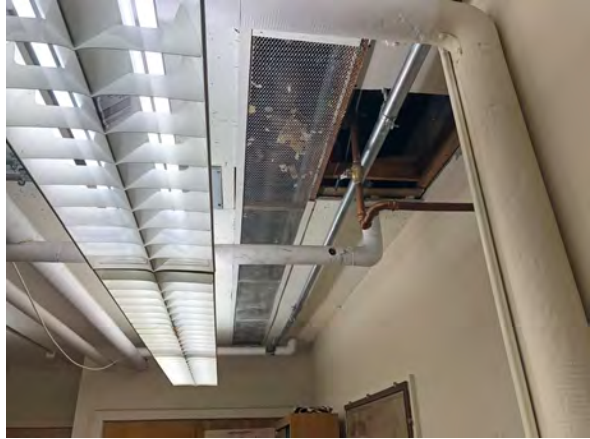
Photo 73: Wire mesh covering section of removed tiles at north end of ceiling. Source of leak at left.

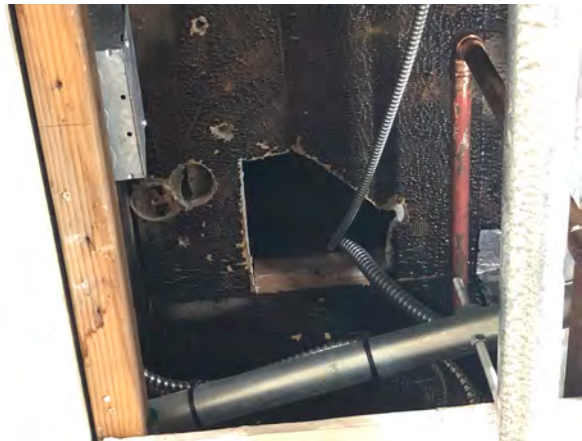
Photo 74: Gypsum wall board chase behind ceiling. Cut to allow conduit installation.

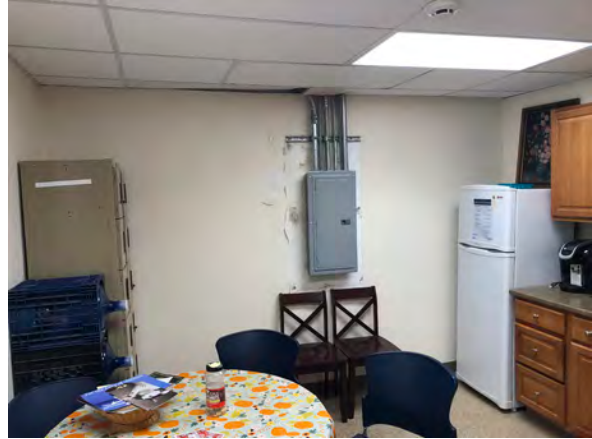
Photo 75: View north in Room 018.

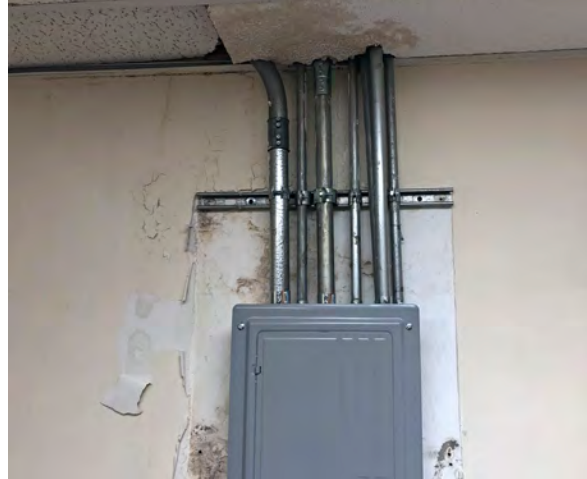
Photo 78: Water damage on north wall and staining on ceiling tile.

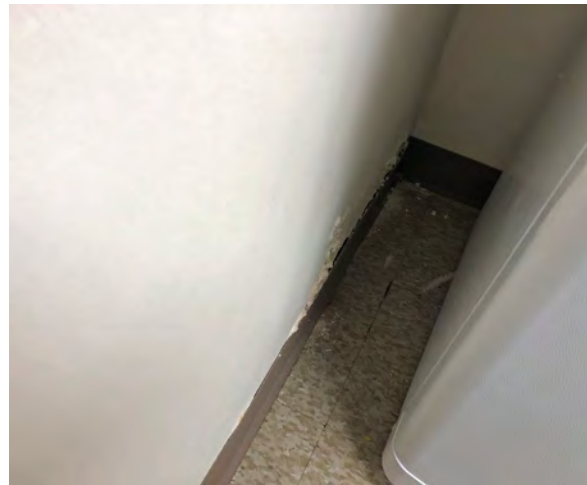
Photo 79: Water damage at bottom east corner of the north wall, by the refrigerator.

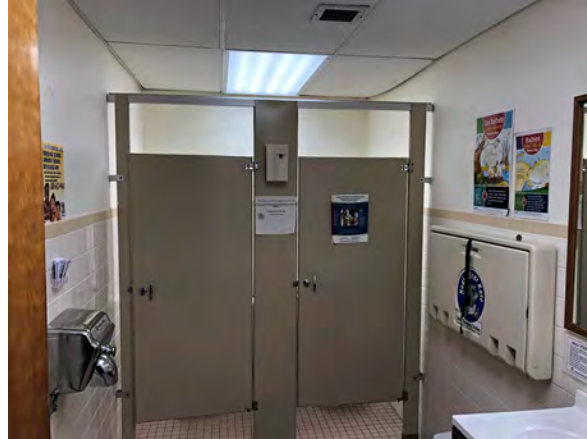
Photo 80: View north in Room 019.

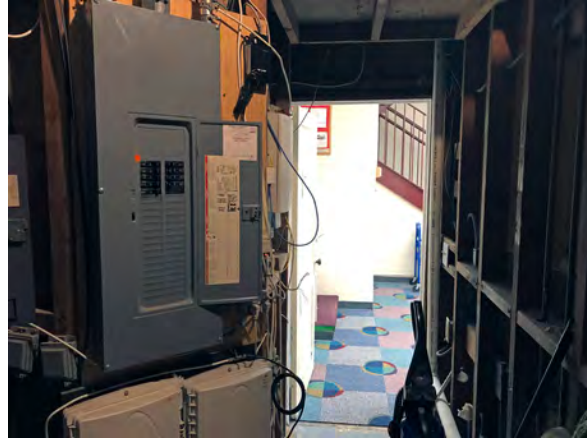
Photo 83: View south in Room 020, showing electrical service equipment at left and unfinished west wall to the right.

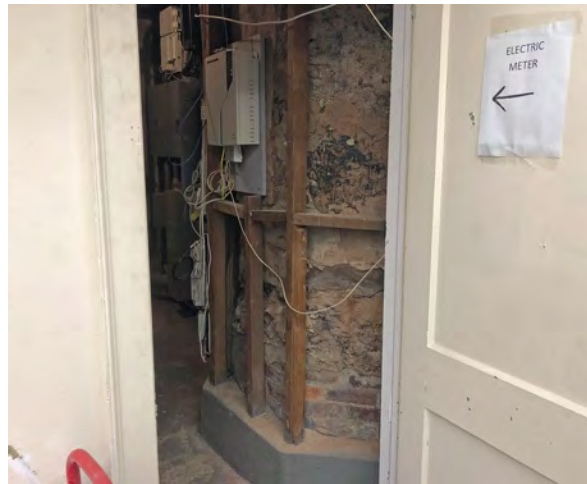
Photo 84: Masonry foundation of northwest tower of Borough Hall in southeast corner of room 020.

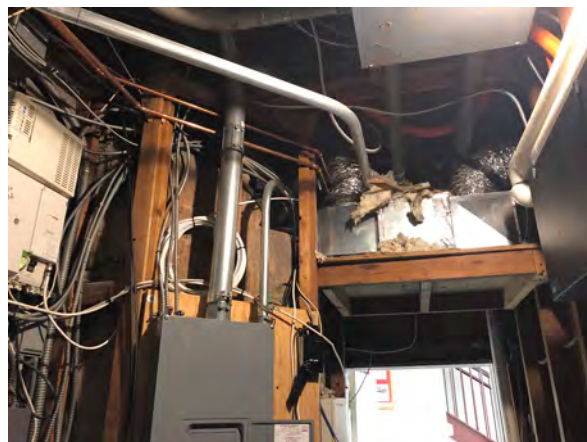
Photo 85: Wiring, piping, and duct at ceiling and walls in Room 020.

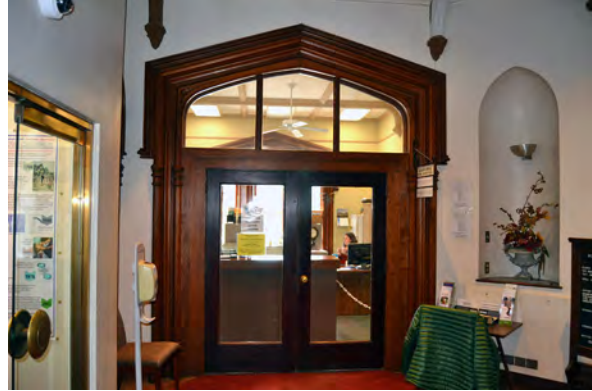
Photo 88: View south in Room 100 into Room 102.

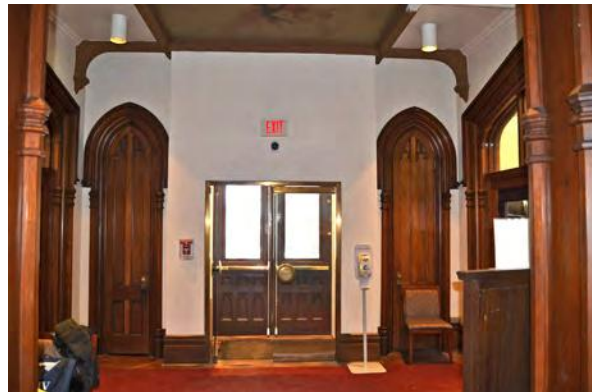
Photo 90: View east in Room 100 showing vestibule and flanking closets.

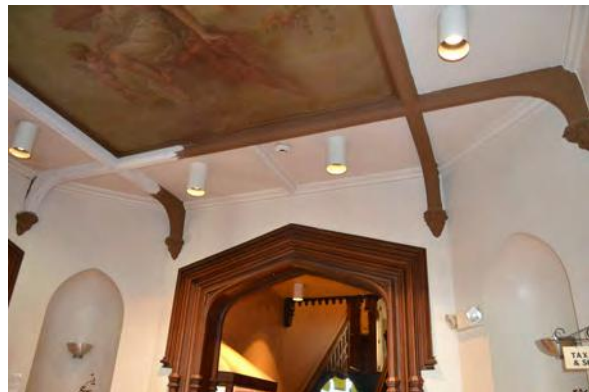
Photo 92: Alcoves on the west wall and ribbing and mural on the ceiling in Room 100.

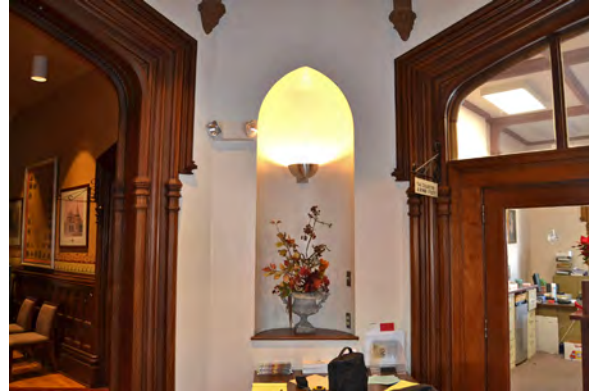
Photo 93: Arched alcove in northwest corner of Room 100.

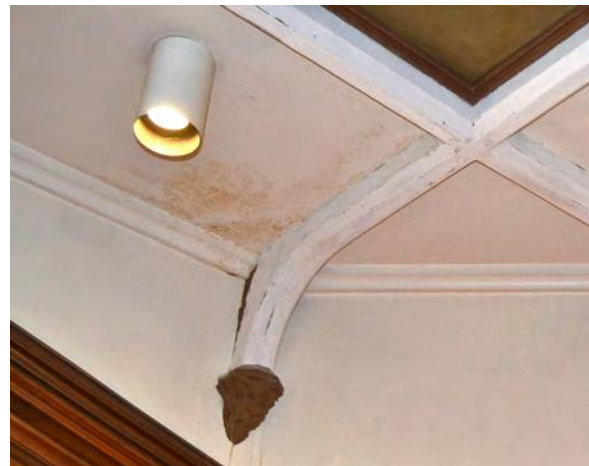
Photo 94: Staining on southwest corner of ceiling in Room 100.

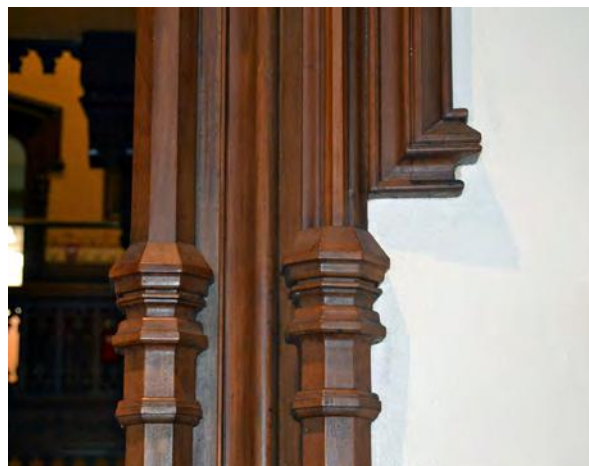
Photo 95: Detail of stained wood surround of pointed arched openings in Room 100.

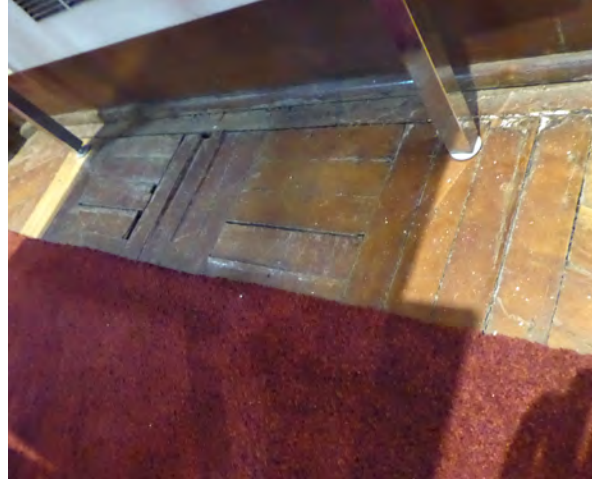
Photo 96: Shrunken boards in southwest corner of Room 100.

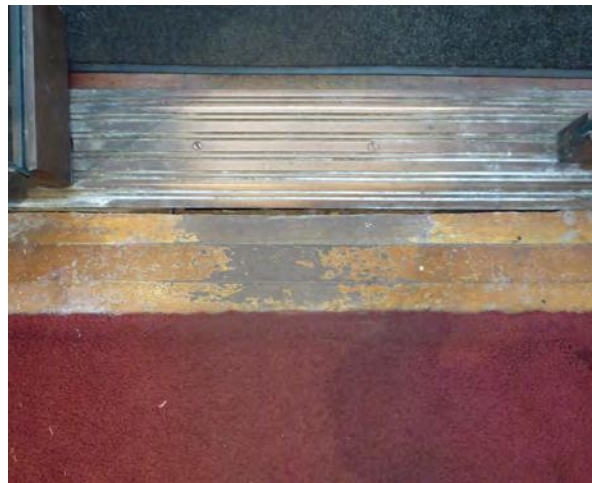
Photo 97: Worn floorboards at entry door in Room 100.

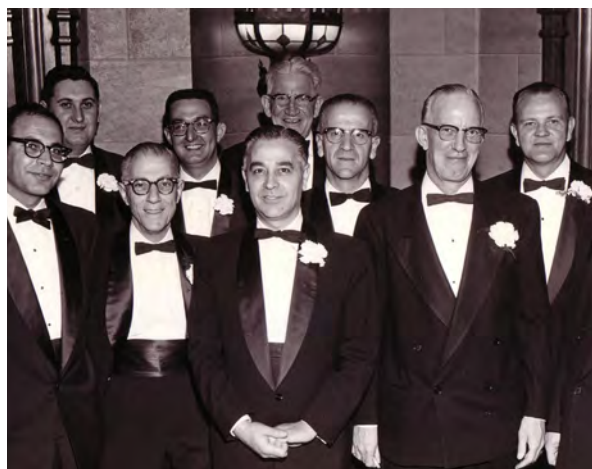
Photo 98: Historic photo showing stonework painted on walls and historic lamp in alcove in Room 100.

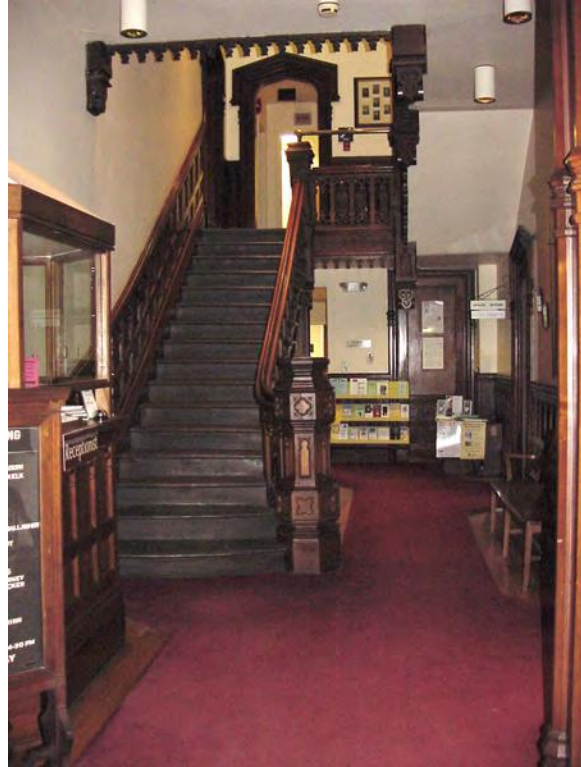
Photo 99: View west in Room 101 prior to 2014 restoration.

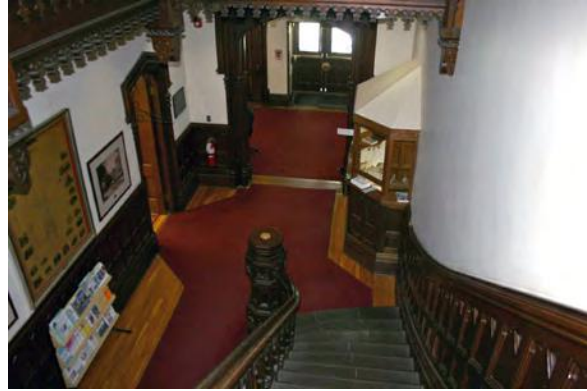
Photo 101: View of Room 100 from staircase landing prior to 2014 restoration.

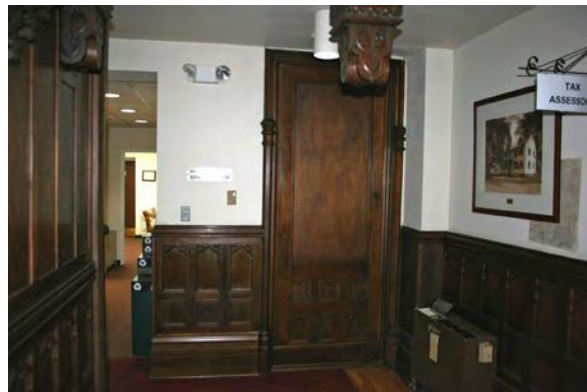
Photo 103: View west in Room 101, showing door which originally connected to the rear porch and hall to rear section of building.

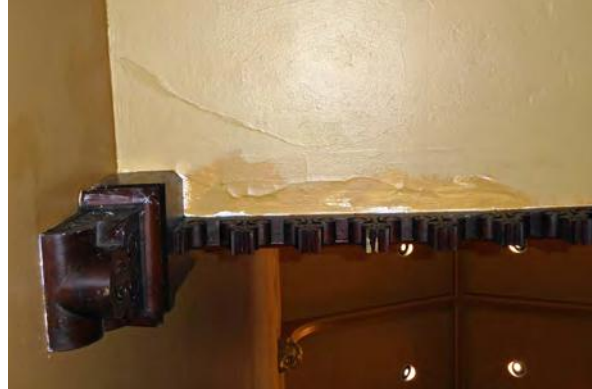
Photo 104: Cracks on ceiling at stair opening in Room 101.

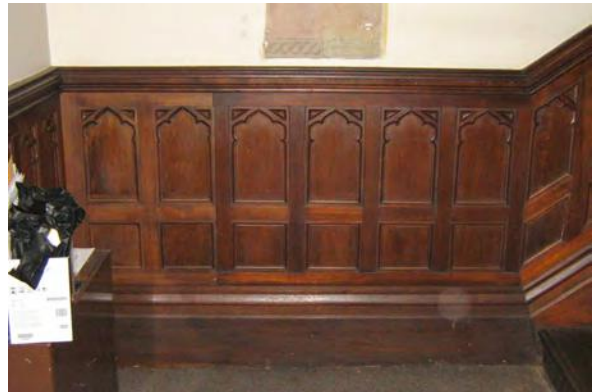
Photo 105: Typical wainscot in Room 101 and along staircase.
