**SOMERVILLE BOROUGH HALL &
PUBLIC LIBRARY**
PRESERVATION PLAN UPDATE

MARCH 2021

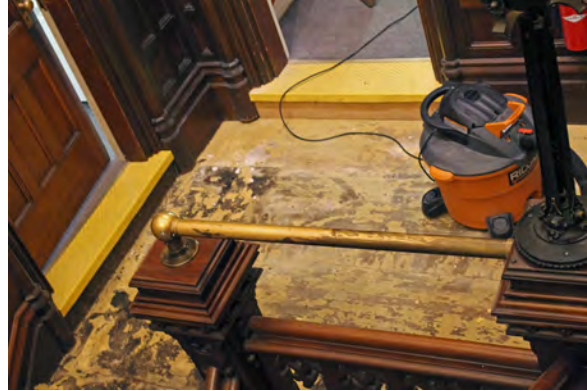
Photo 107: Wood floor of landing exposed during carpet installation in 2014.

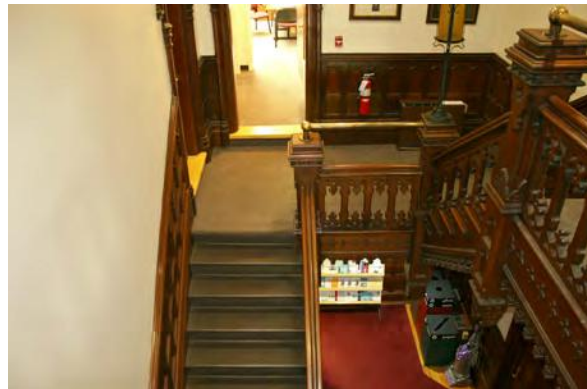
Photo 109: View of staircase flights and connecting landing from Room 201.

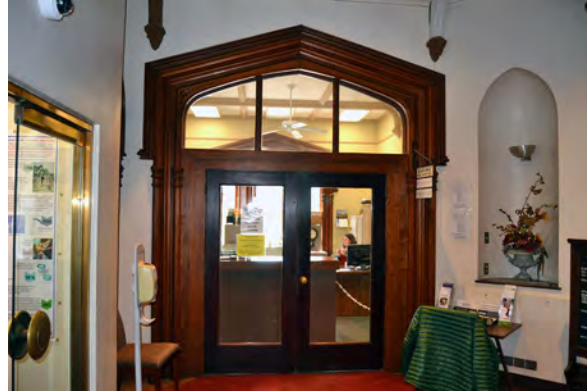
Photo 112: View into Room 102 from Room 100.

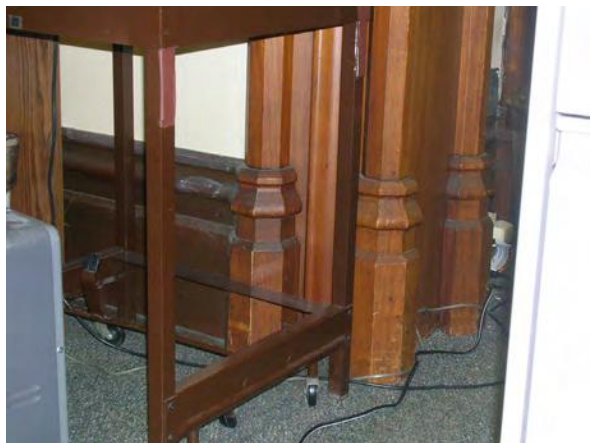
Photo 117: Baseboard and base of trim around south archway in Room 102.

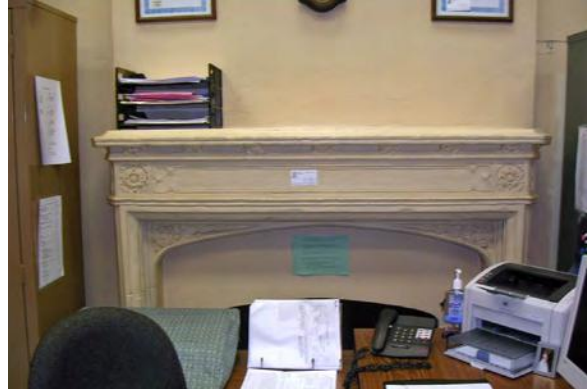
Photo 118: Fireplace on west wall in Room 102.

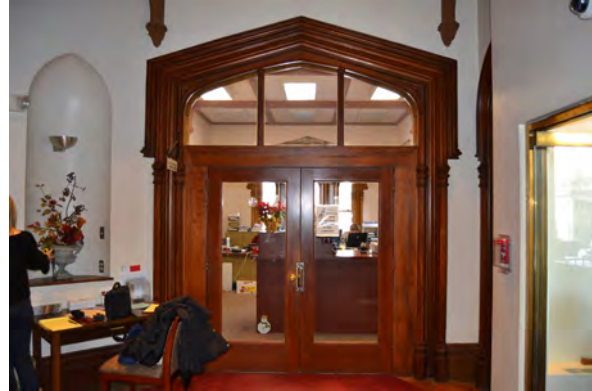
Photo 120: View into Room 103 from Room 100.

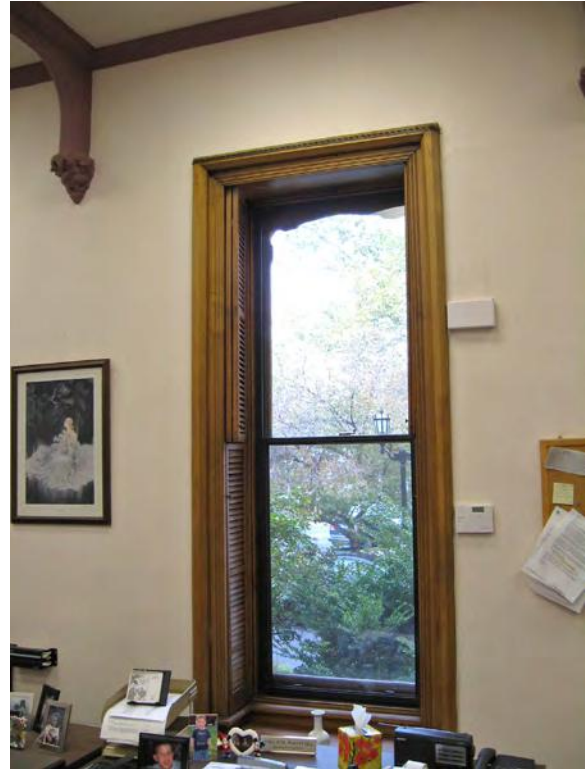
Photo 123: Window and interior shutters on east wall in Room 103.

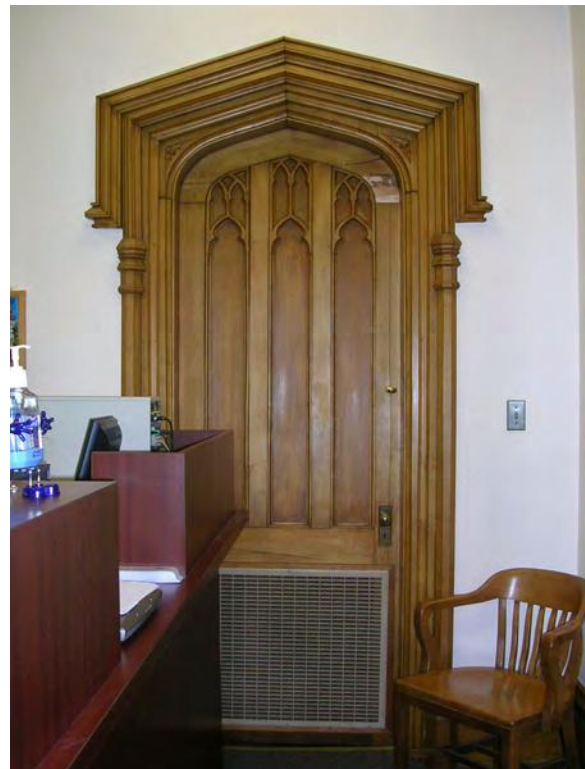
Photo 124: White maple door and trim on east wall connecting to stair tower in Room 103.

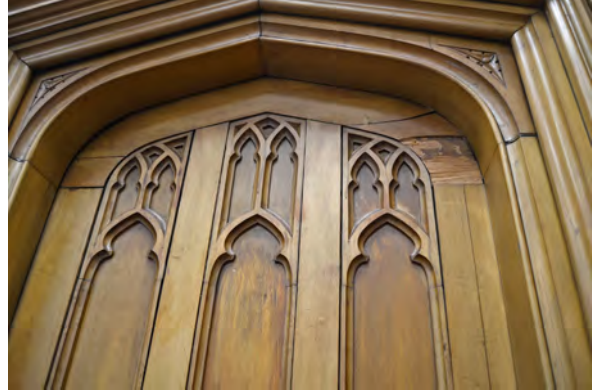
Photo 125: Cracks and area of loss on top wood veneer of door stair tower in Room 103.

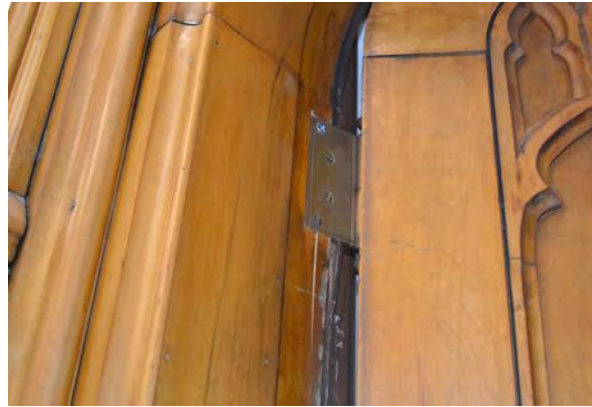
Photo 126: Hinge pulled away from jamb, causing a crack on door to stair tower in Room 103.

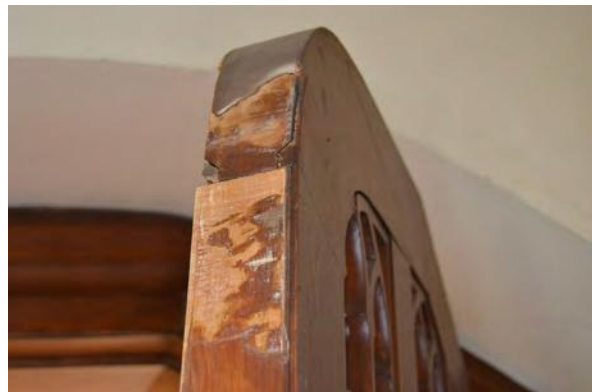
Photo 127: Abrasion and detached top wood veneer on door to stair tower in Room 103.

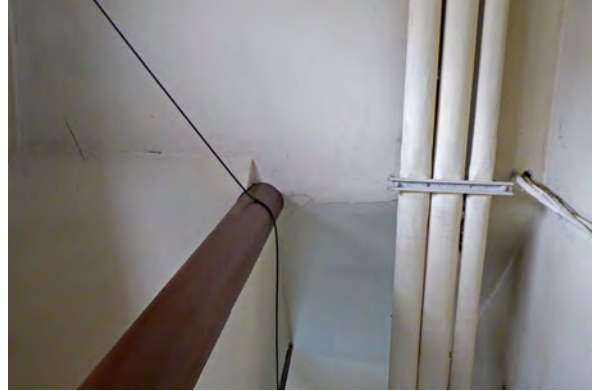
Photo 128: Cracks on ceiling at transition between flat and sloped sections at staircase.

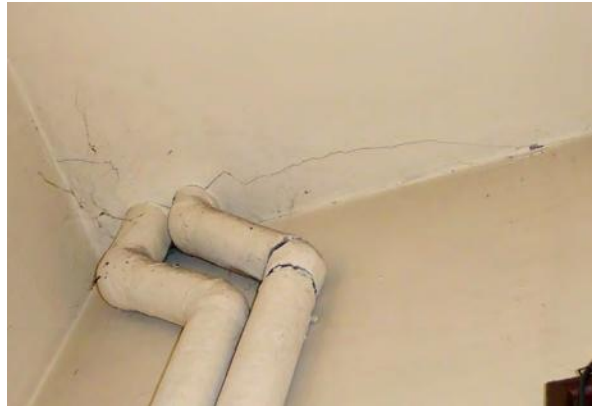
Photo 129: Cracks in ceiling around pipes.

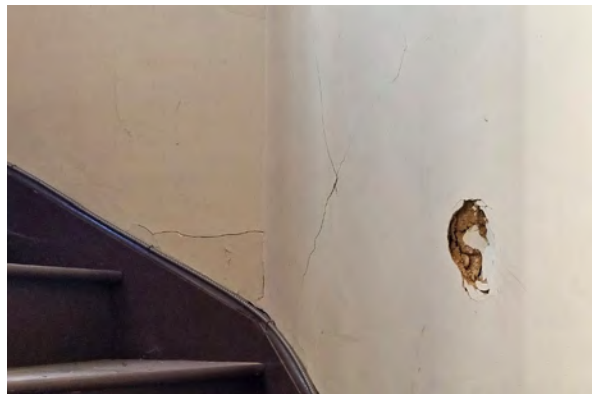
Photo 130: Cracks and loss on wall at staircase.

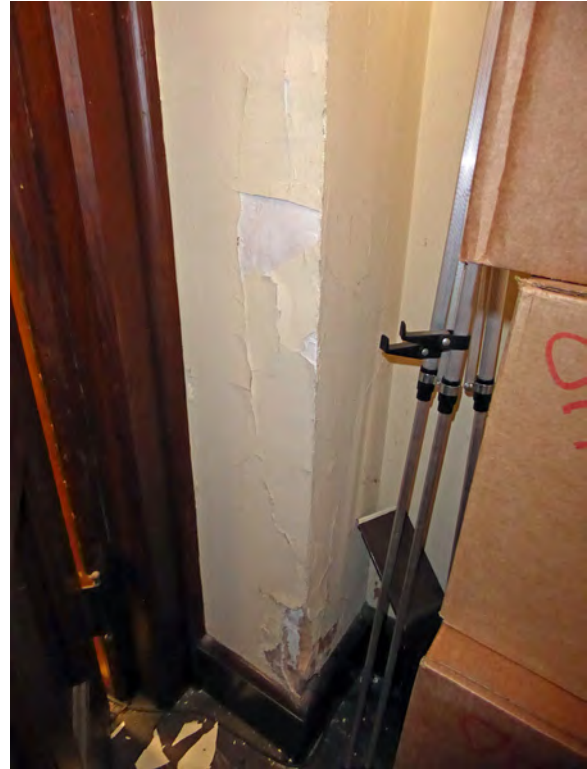
Photo 131: Cracks and areas of loss on wall behind door connecting to Room 103.

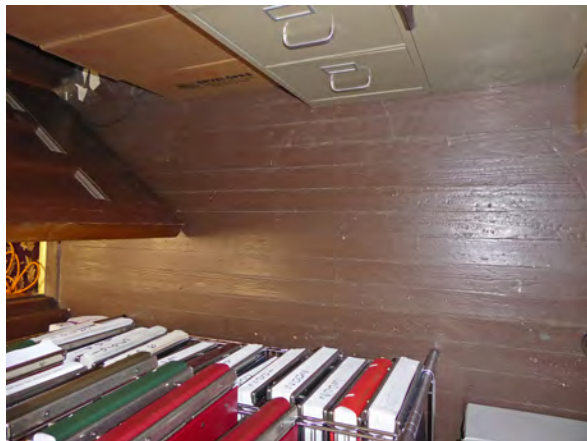
Photo 132: Painted wood floor.

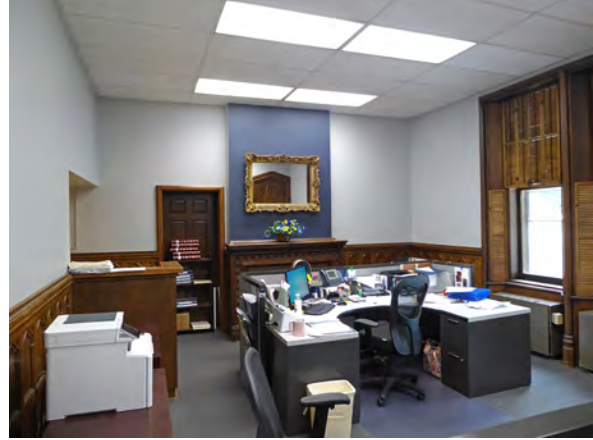
Photo 135: View east in Room 104.

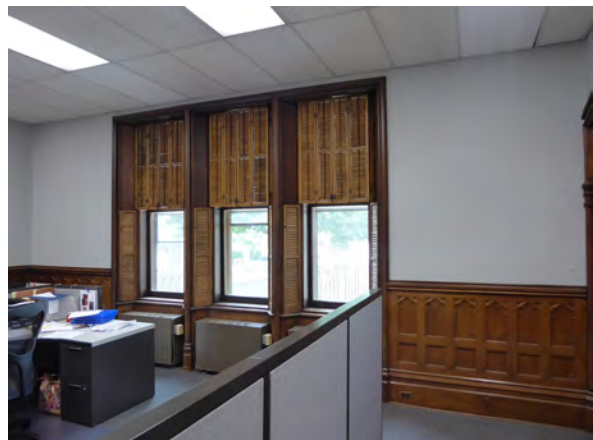
Photo 137: Windows on south wall in Room 104.

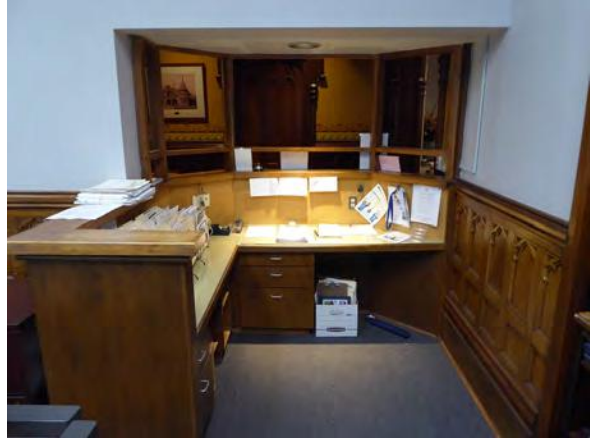
Photo 138: Reception desk in northeast corner of Room 104.

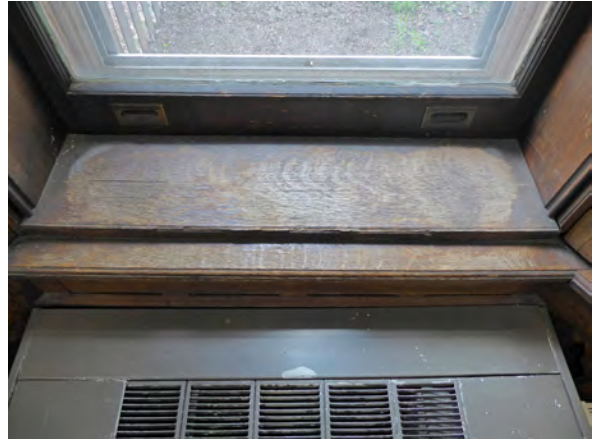
Photo 141: Degraded finish on window sill in Room 104.

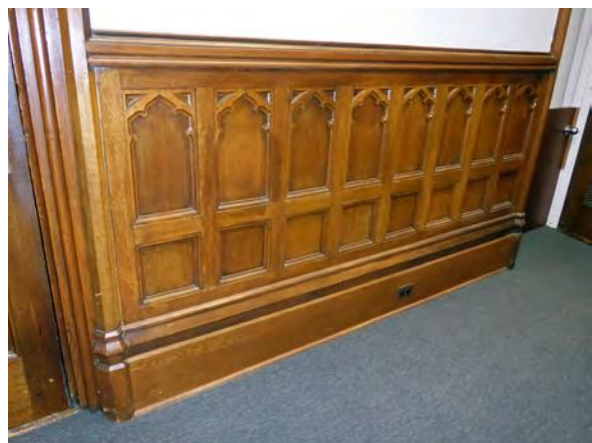
Photo 142: Section of wainscoting on the west wall in Room 104.

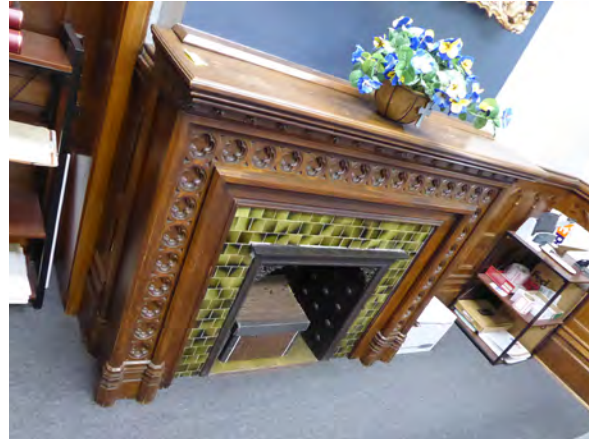
Photo 143: Fireplace on the east wall in Room 104.

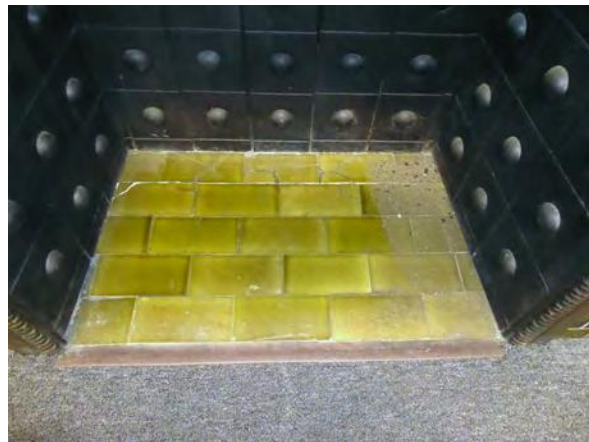
Photo 144: Ceramic tile floor with some cracking at fireplace.

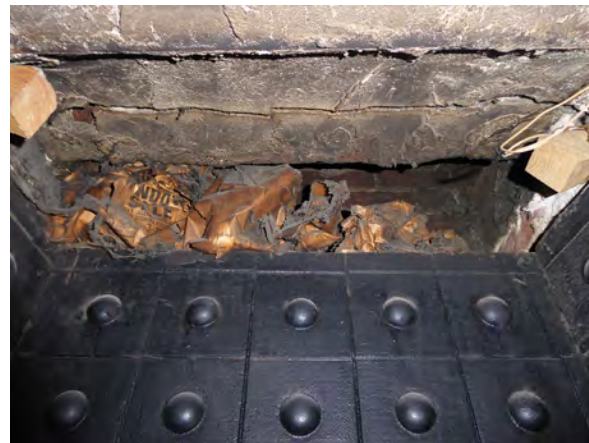
Photo 145: Firebox interior showing open flue, shims under support beam and crack in plaster on beam.

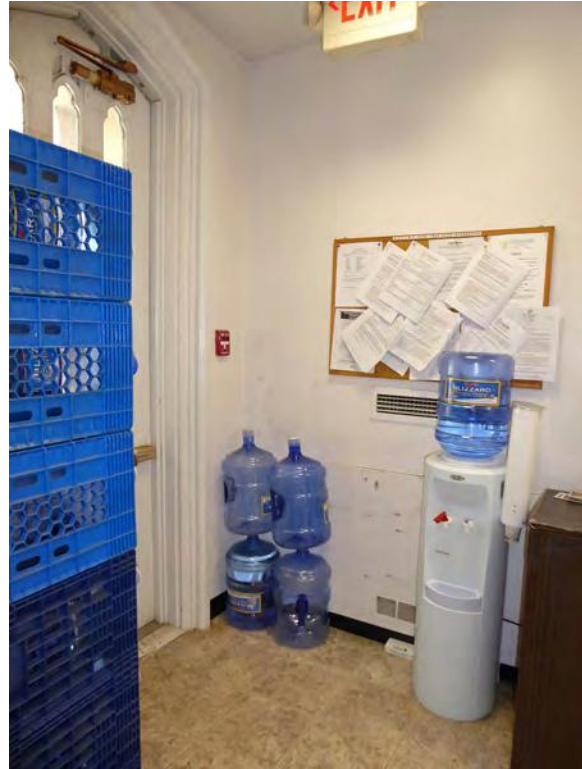
Photo 146: View west in Room 105.

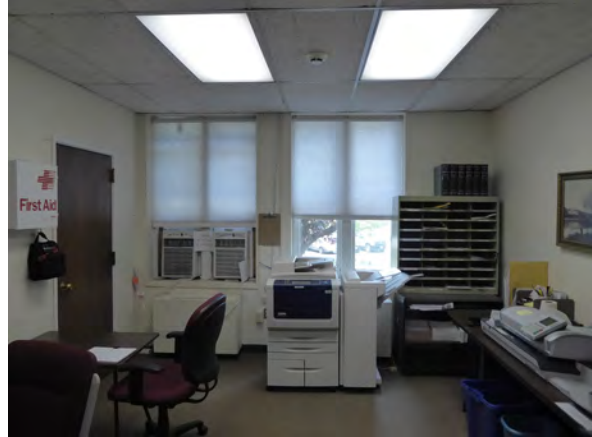
Photo 152: View south in Room 108.

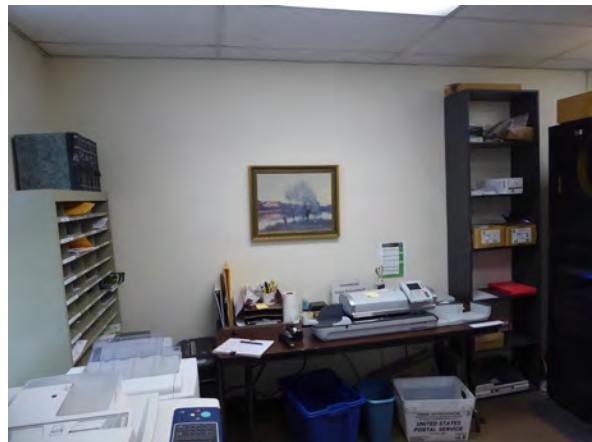
Photo 154: View west in Room 108.

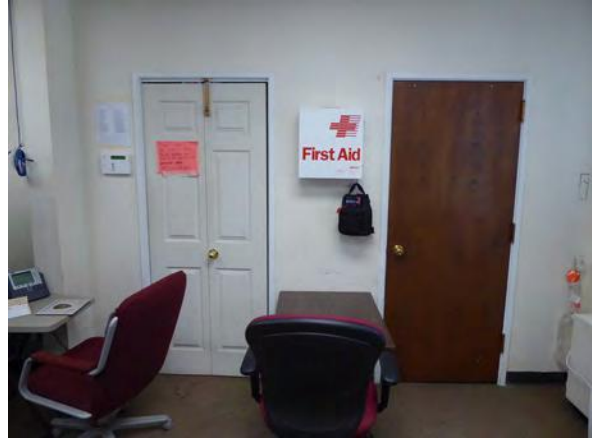
Photo 155: View east in Room 108.

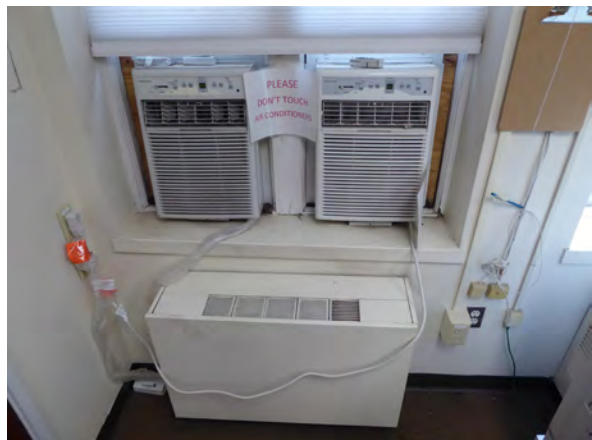
Photo 157: East pair of windows in Room 108 with air conditioning units.

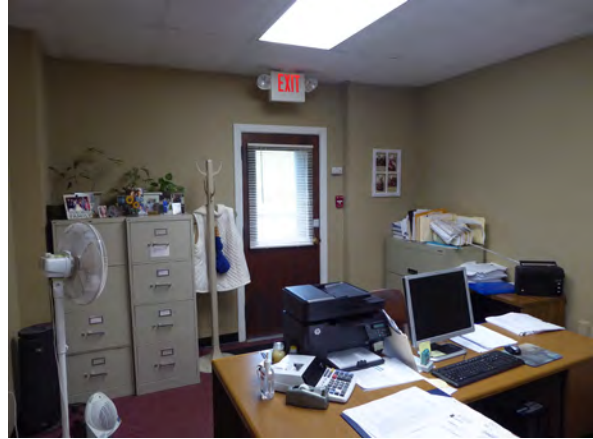
Photo 158: View south in Room 109 showing exterior door.

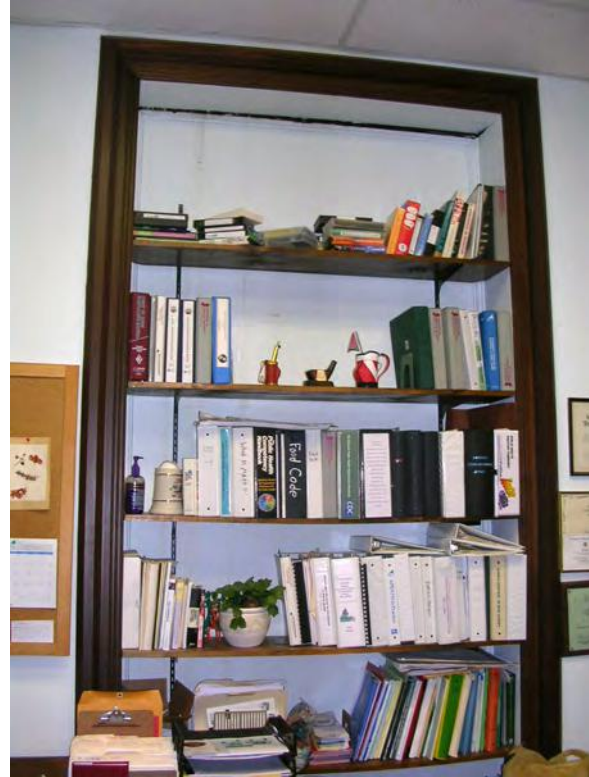
Photo 162: Shelves installed in a historic window opening on the west wall in Room 112.

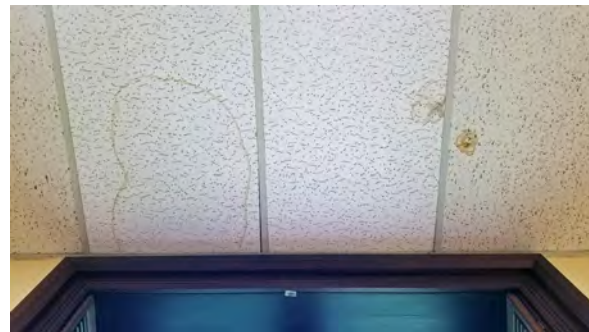
Photo 163: Water stains on drop ceiling tiles at windows of Room 112.

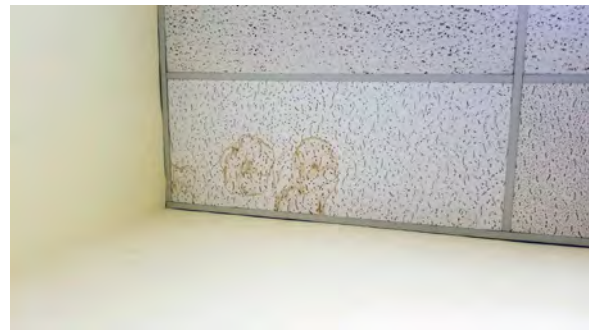
Photo 164: Water stains on drop ceiling tile at southwest corner of Room 112.

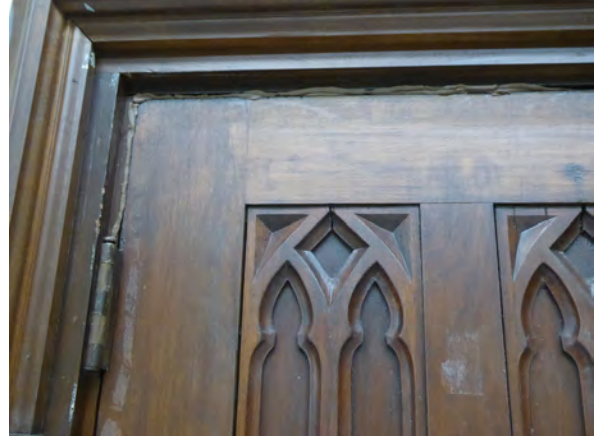
Photo 165: Sealant on top of door connecting to Room 113.

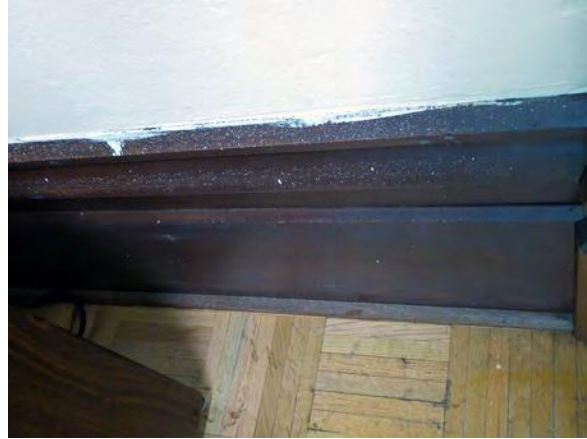
Photo 167: Overpainting and paint flecks on baseboard in Room 112.

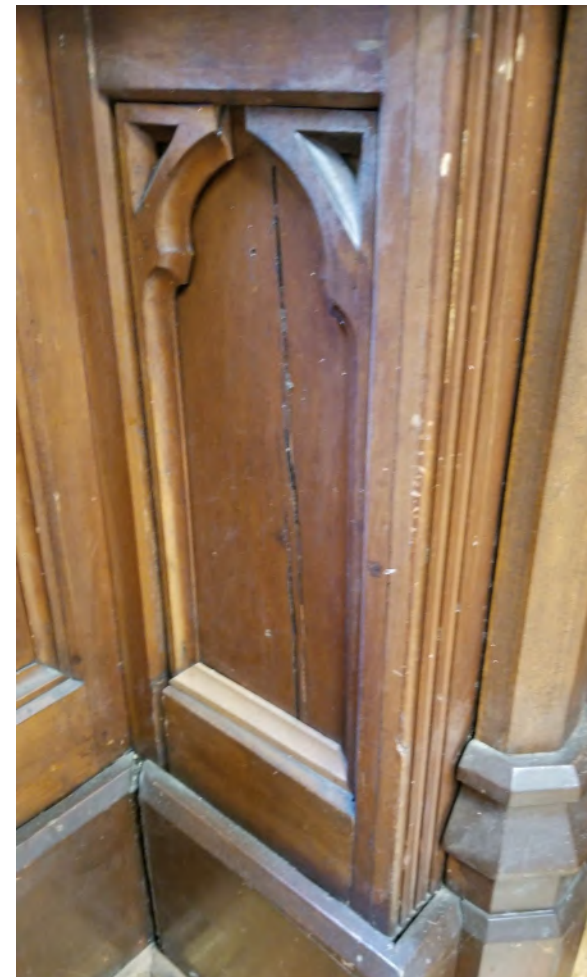
Photo 168: Crack and small loss on wood panel below windows in Room 112.

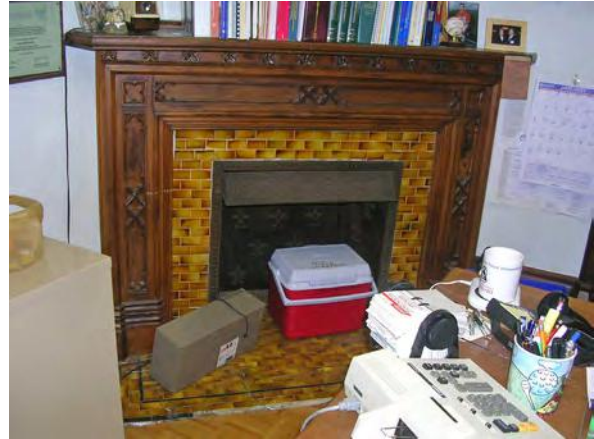
Photo 169: Fireplace in northwest corner of Room 112.

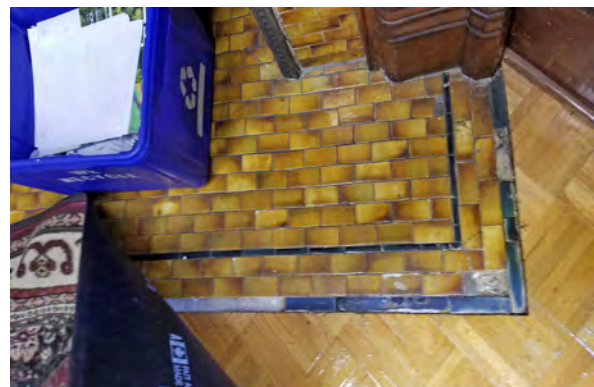
Photo 171: Missing ceramic tiles on fireplace hearth.

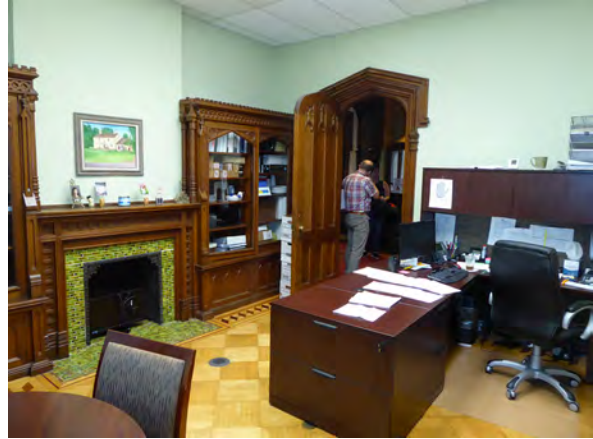
Photo 172: View southeast in Room 113 showing door to Room 101, cabinet and fireplace.

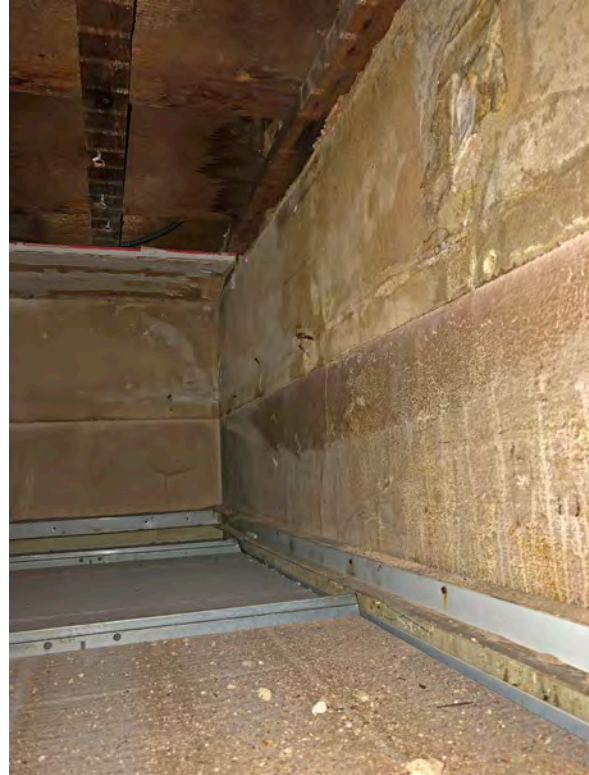
Photo 175: View above drop ceiling showing that historic plaster ceiling has been removed.

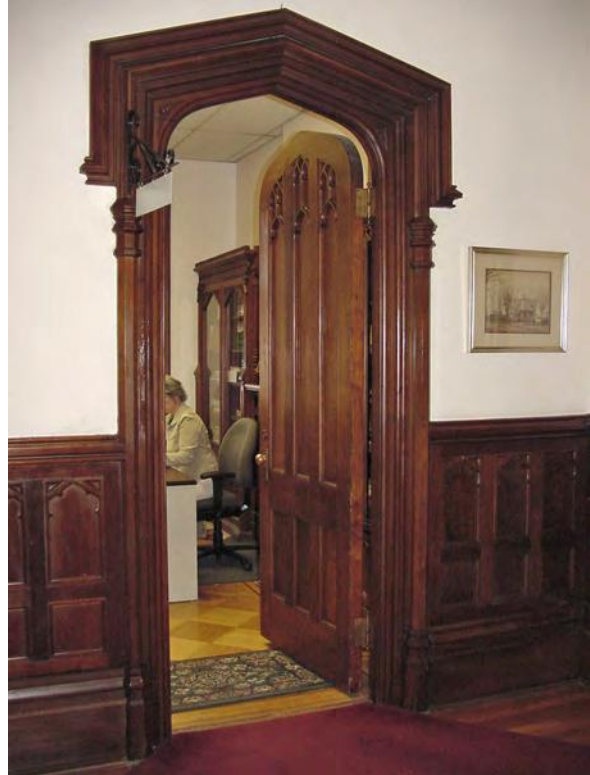
Photo 177: View of door into Room 113 from Room 101.

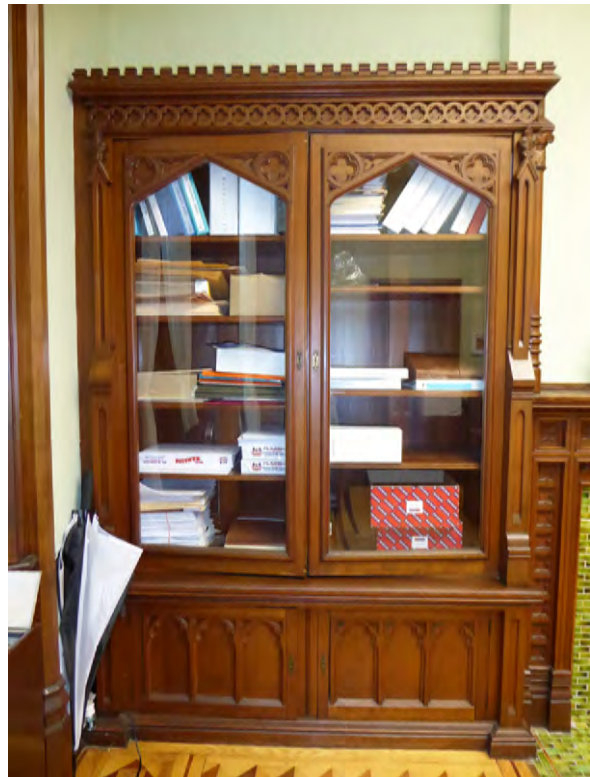
Photo 178: Cherry wood cabinet on east wall in Room 113.

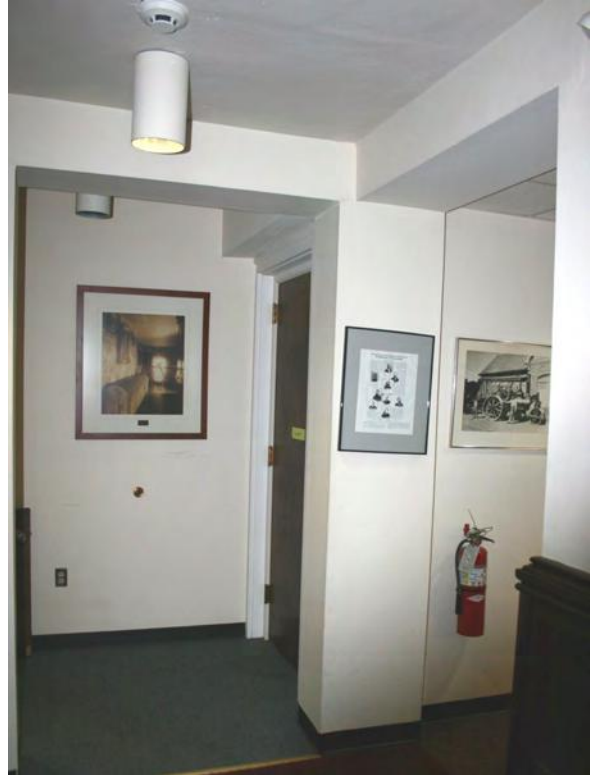
Photo 182: View of Room 114 and Room 107 from Room 101.

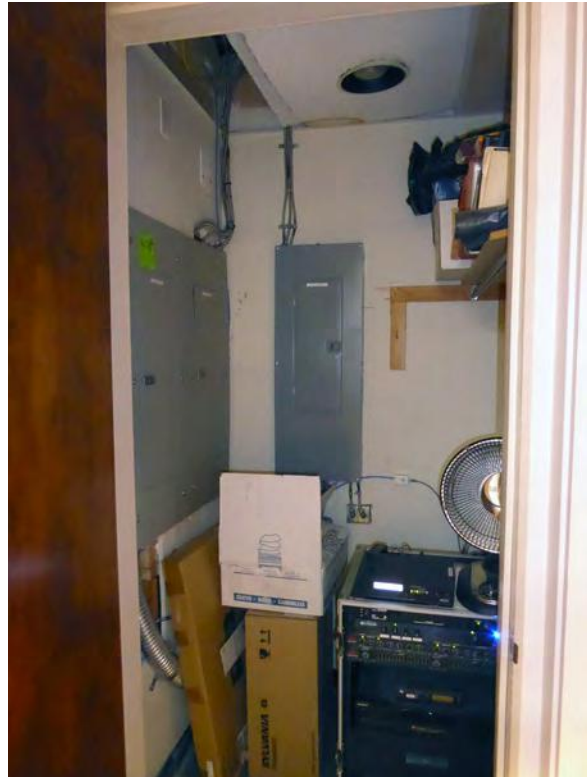
Photo 184: View inside closet of Room 114.

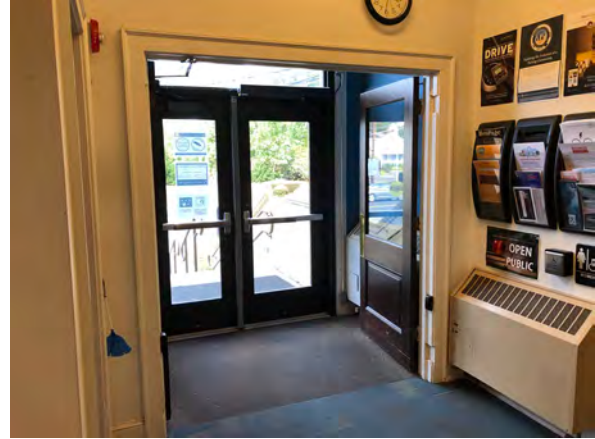
Photo 192: View of entrance vestibule on north side of Room 116.

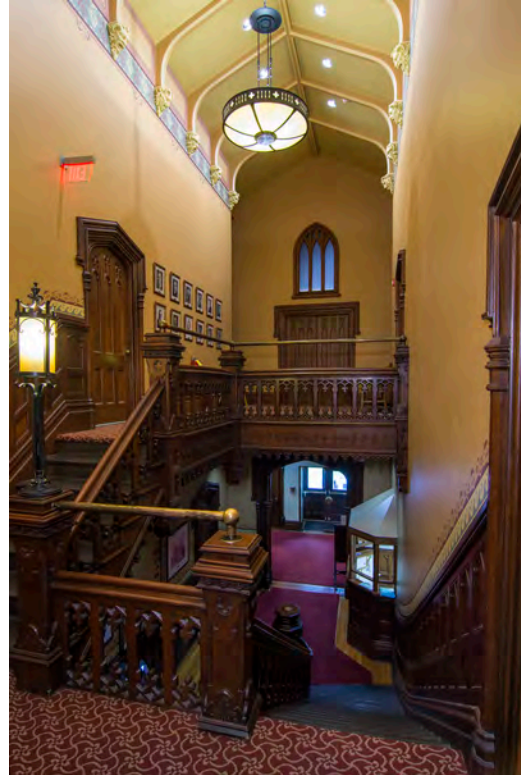
Photo 194: View east in stair hall from intermediate landing of staircase.

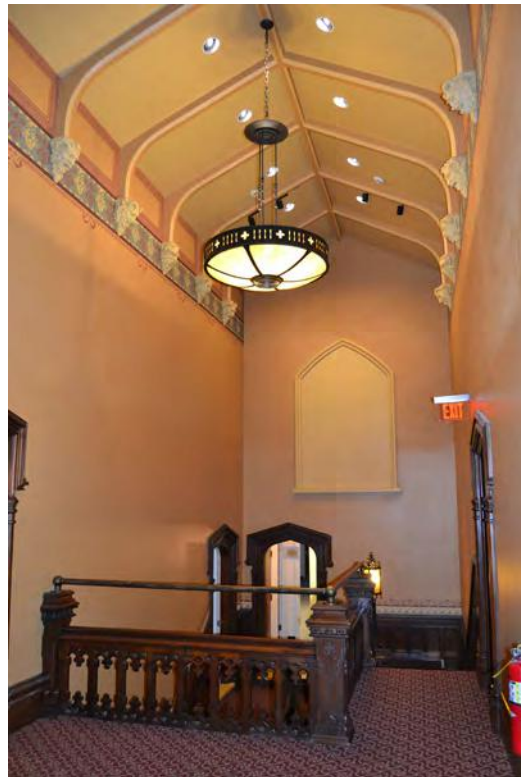
Photo 195: View west in stair hall.

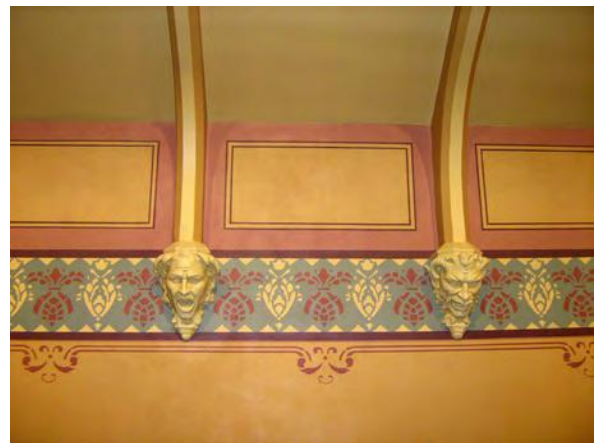
Photo 198: Grotesques at end of vaulted ceiling ribbing with reproduced historic paint scheme.

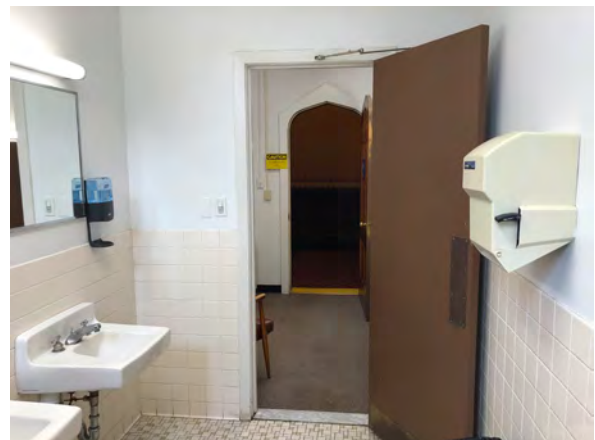
Photo 203: View north in Room 202 from south section.

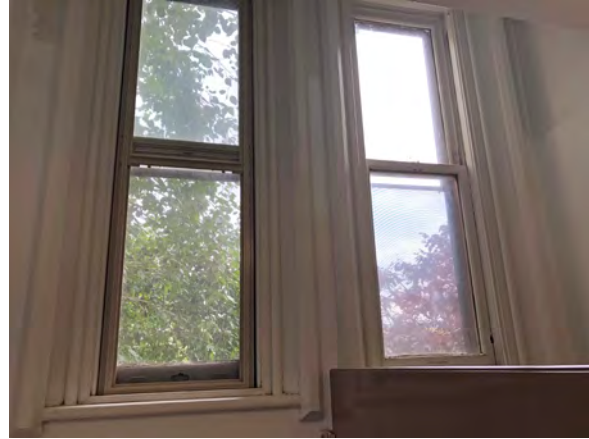
Photo 204: Windows on south wall in Room 202.

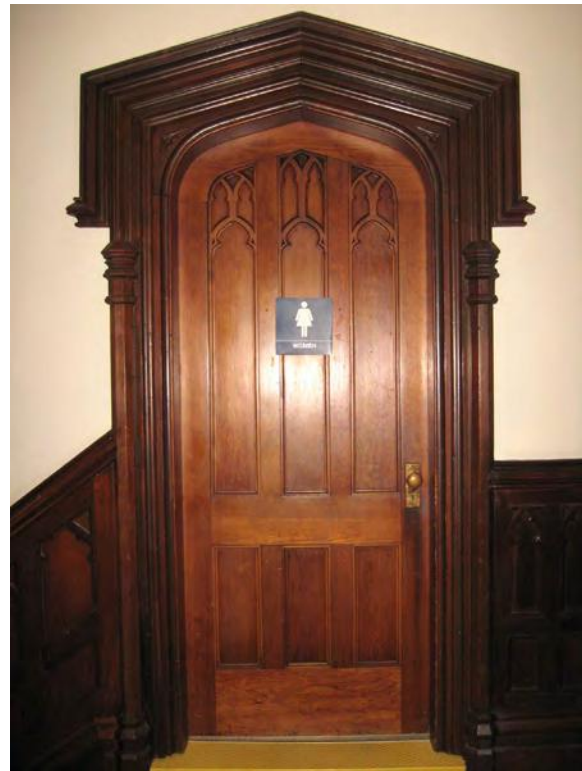
Photo 205: View of door into Room 202 from staircase landing.

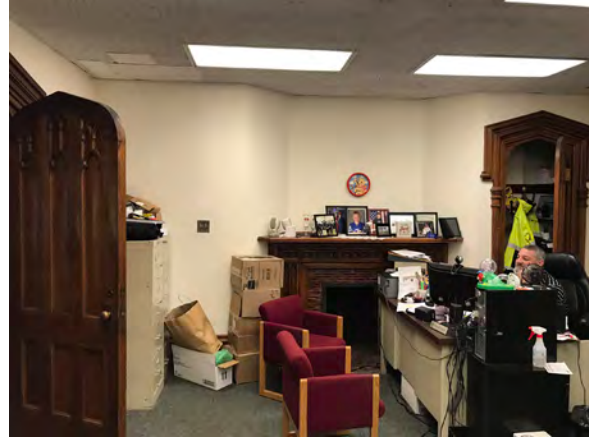
Photo 206: View east in Room 203 showing fireplace and closet.

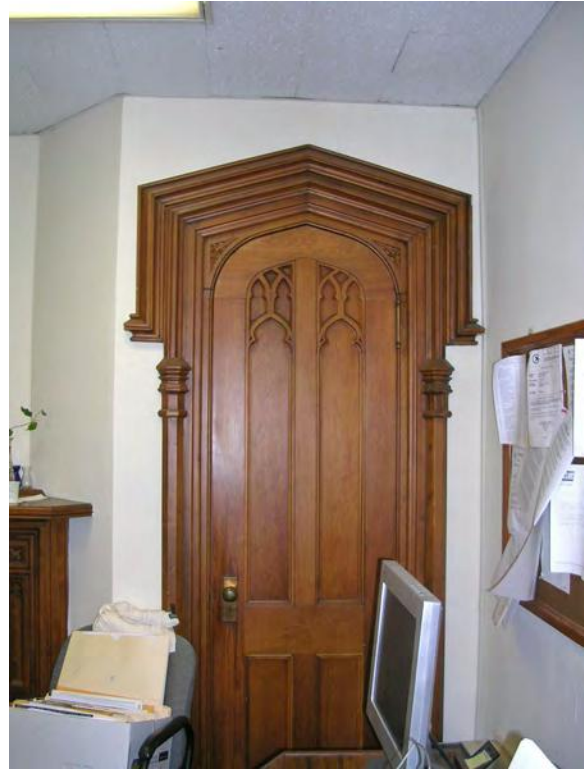
Photo 209: Closet on south side of fireplace at the east wall in Room 203.

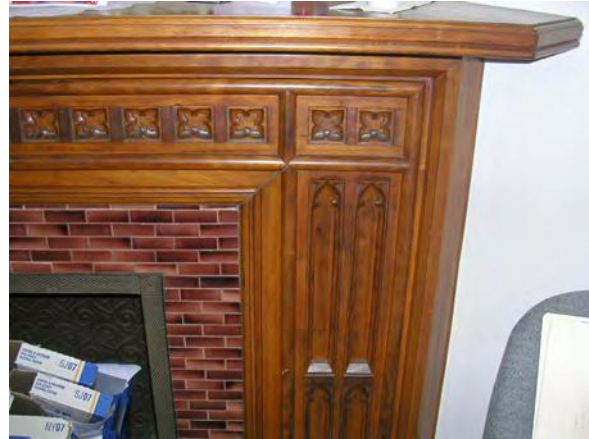
Photo 210: Detail view of fireplace mantel and surround on east wall in Room 203.

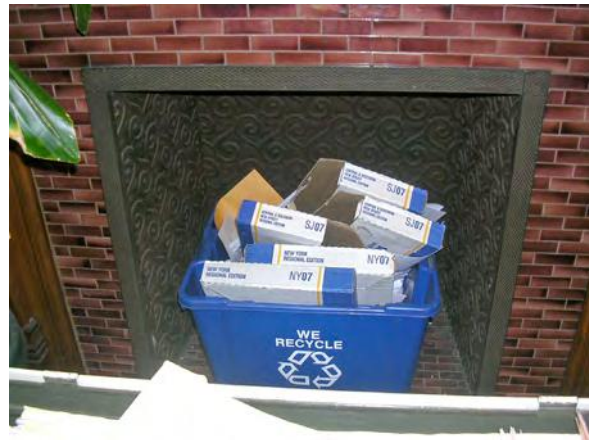
Photo 211: Decorative cast iron firebox insert at fireplace in Room 203.

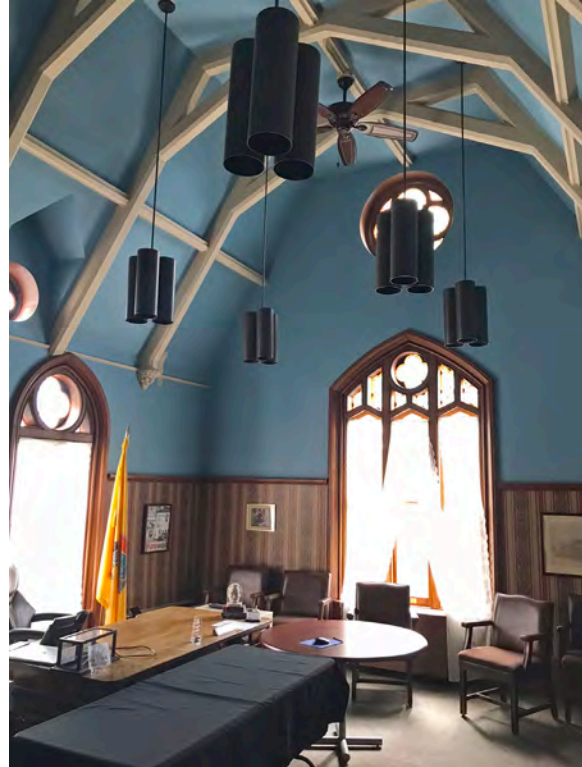
Photo 212: View southeast in Room 204..

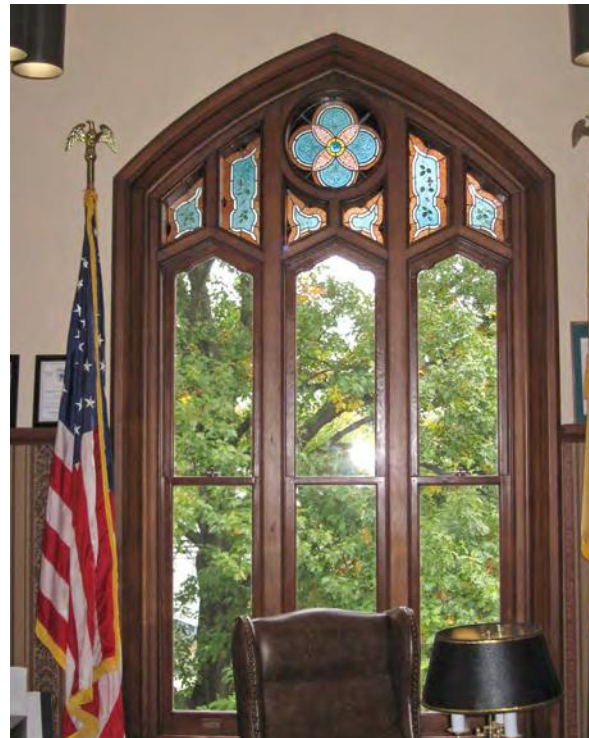
Photo 213: Windows on south wall in Room 204.

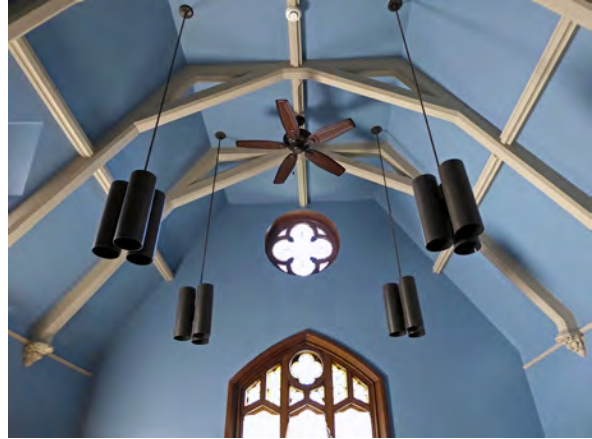
Photo 214: Vaulted ceiling with painted wood framing in Room 204..

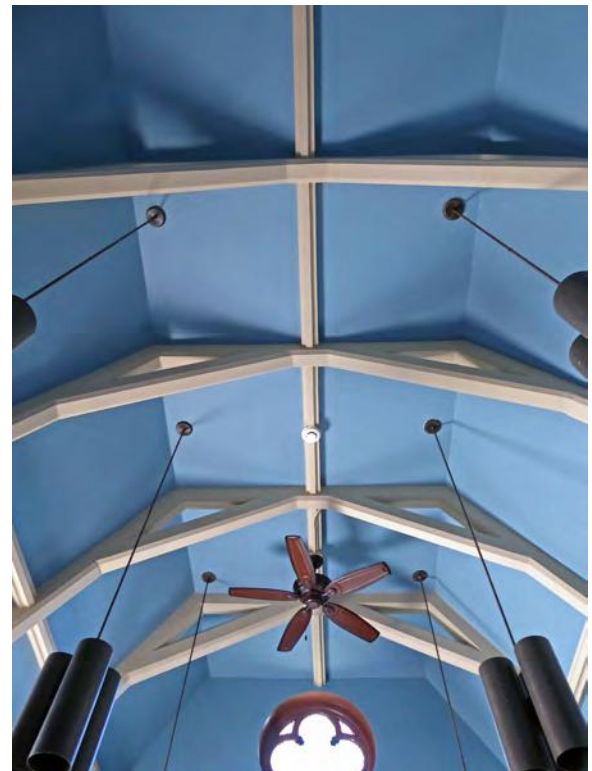
Photo 215: Vaulted ceiling with painted wood framing in Room 204.

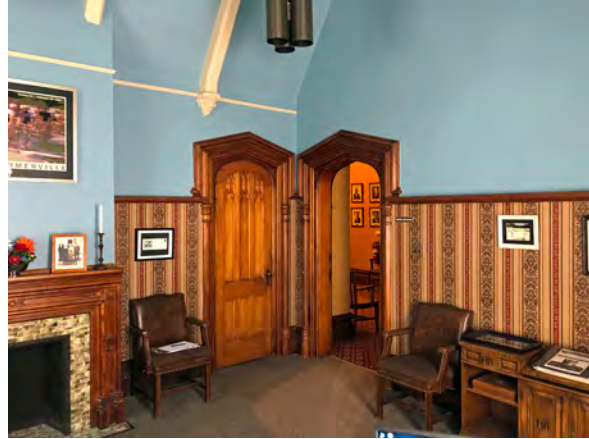
Photo 216: View northwest in Room 203 showing closet and door to Room 201.

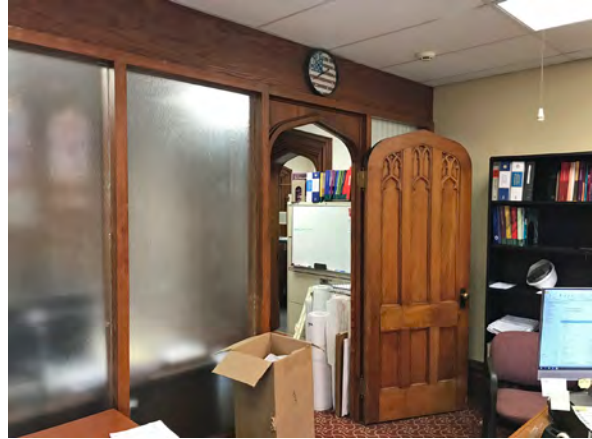
Photo 221: Partition wall between Rooms 205 & 206.

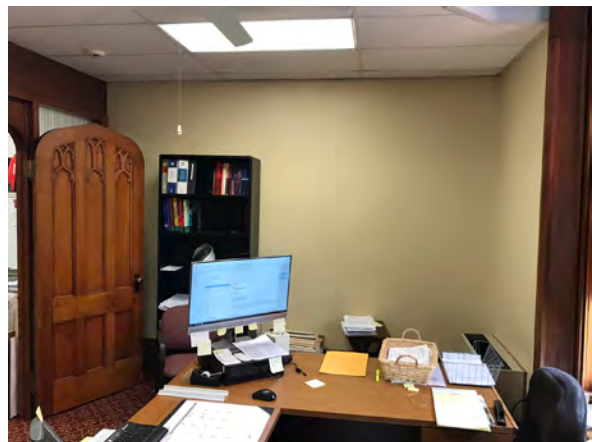
Photo 223: View north in Room 206.

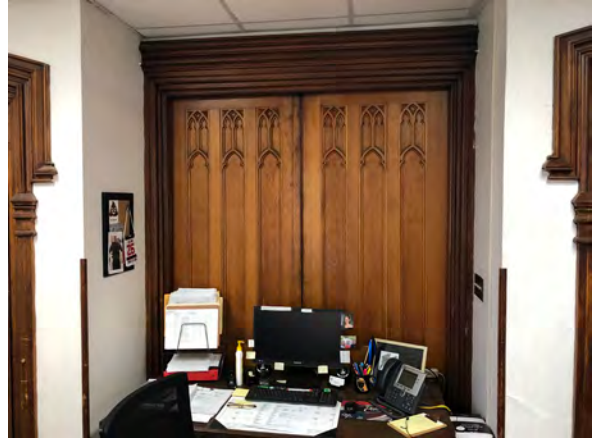
Photo 224: Pocket doors on west wall in Room 205.

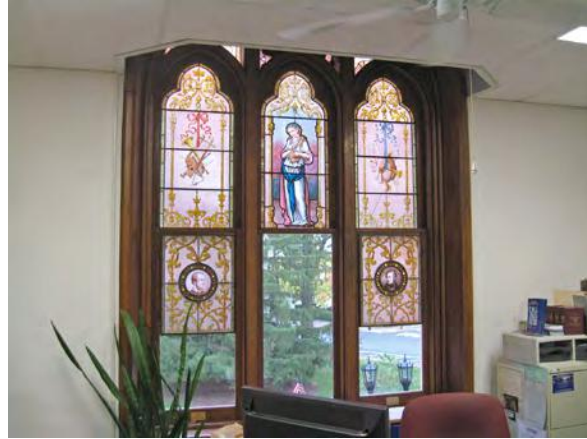
Photo 225: Large, Gothic-arched window on east wall in Room 206.

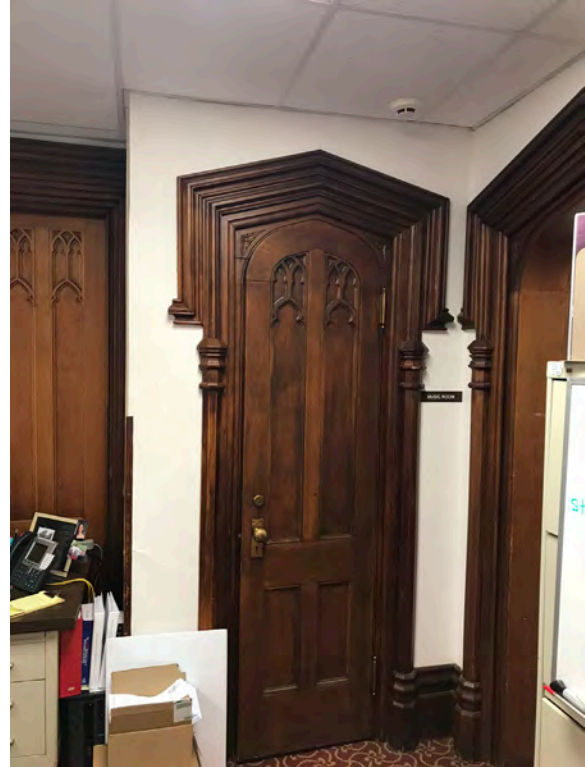
Photo 227: North closet in Room 205.

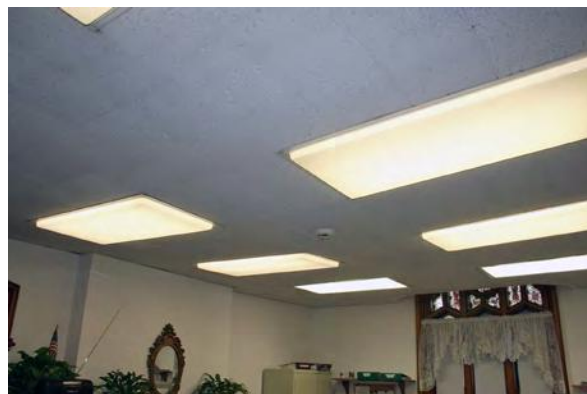
Photo 231: Dropped ceiling in Room 207.

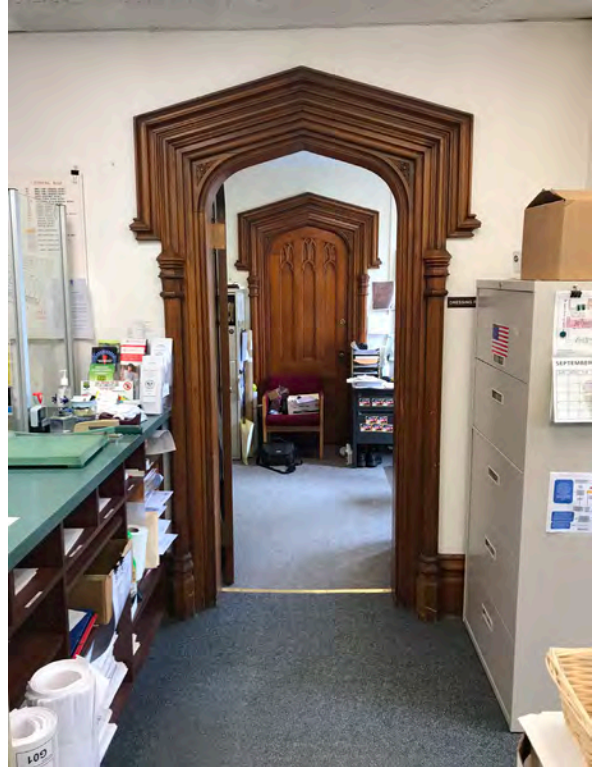
Photo 232: Door into Room 208 on west wall.

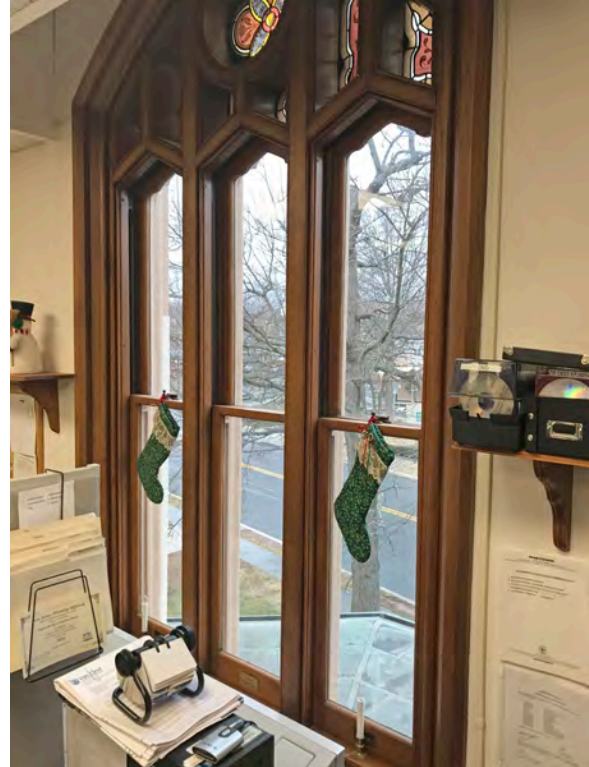
Photo 234: Arched window opening on north wall in Room 207.

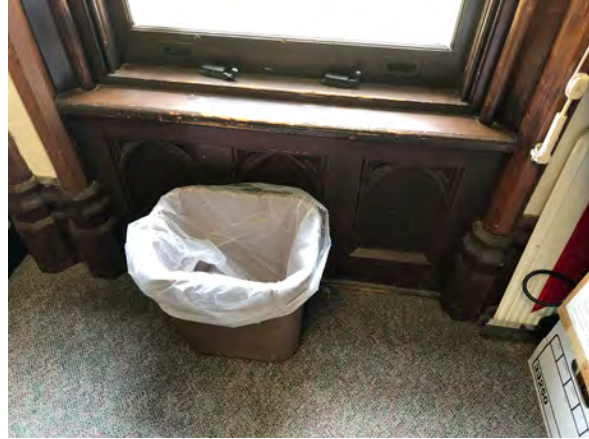
Photo 238: Panels below north window in Room 208.

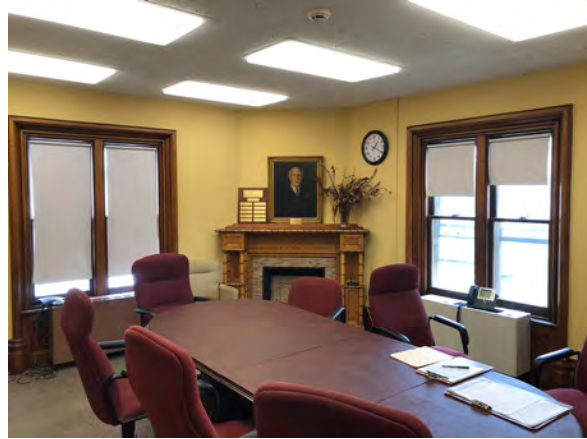
Photo 239: View northwest in Room 209.

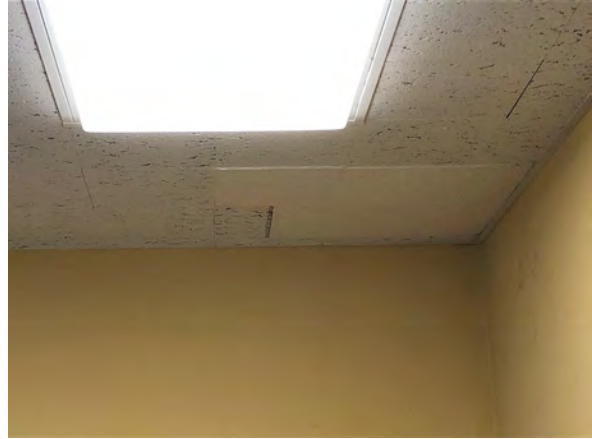
Photo 242: Patched area of acoustical tile ceiling in southeast corner of Room 209.
