**SOMERVILLE BOROUGH HALL &
PUBLIC LIBRARY**
PRESERVATION PLAN UPDATE

MARCH 2021

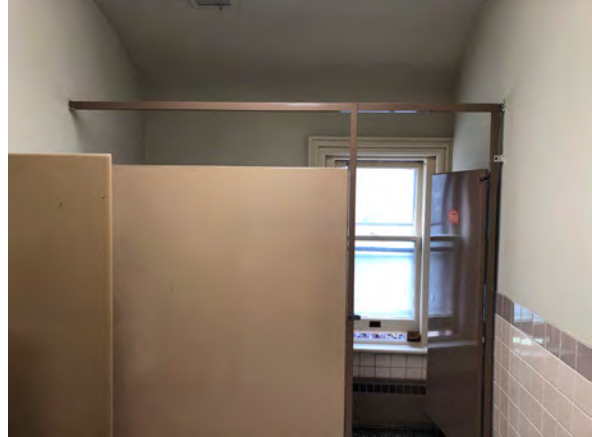
Photo 245: View south in Room 210.

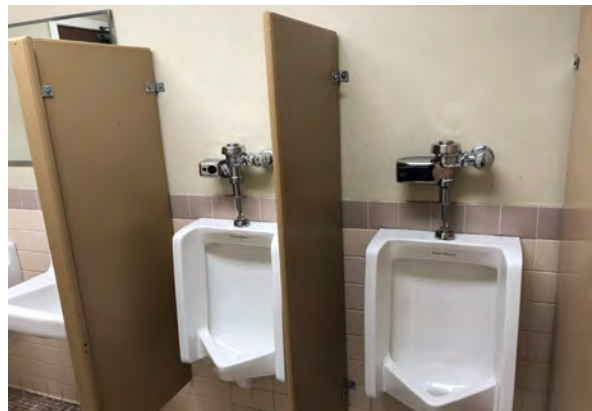
Photo 247: Urinals on east wall in Room 210.

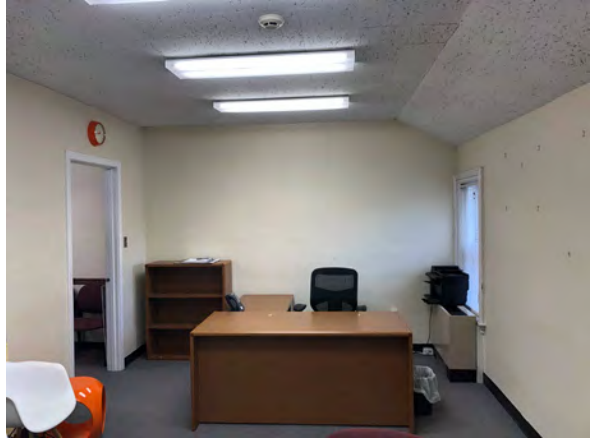
Photo 251: View east in Room 212.

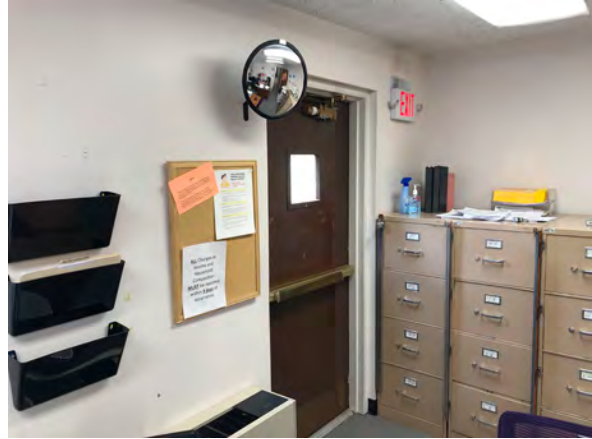
Photo 255: Exit door on west wall in Room 213.

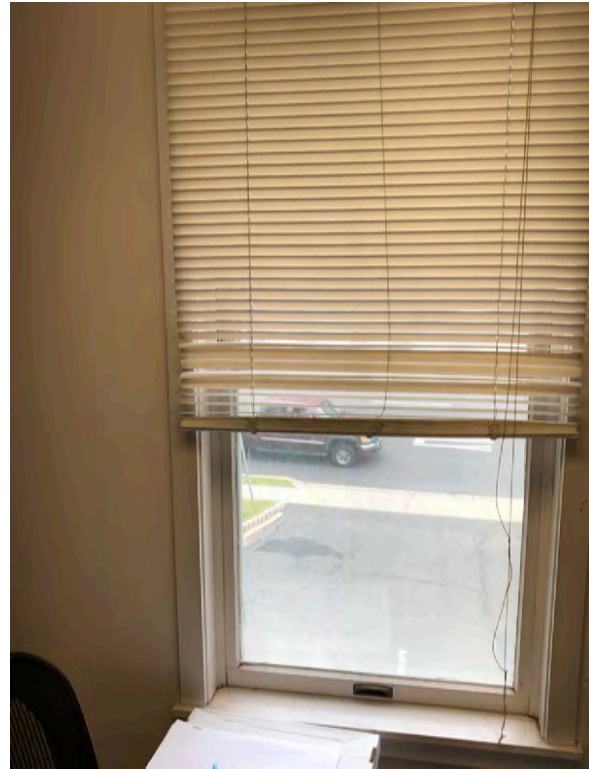
Photo 257: Typical window in Room 213.

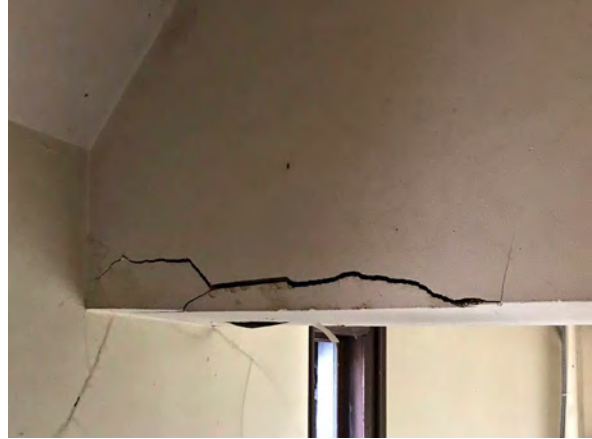
Photo 258: Crack and associated detachment of plaster on beam at third level of northeast stair tower.

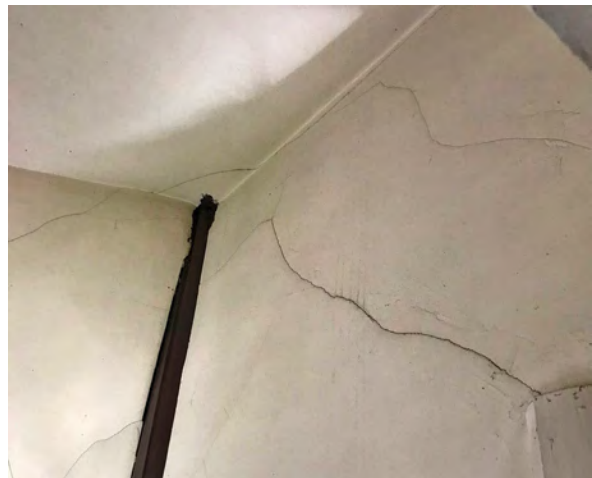
Photo 259: Cracks on wall at third level of northeast stair tower.

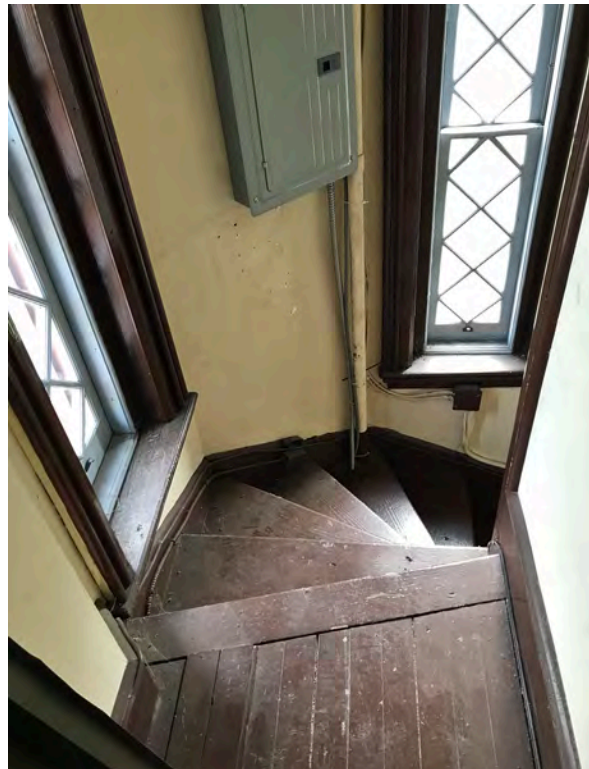
Photo 261: View of landing and spiral stair at third level of northeast stair tower.

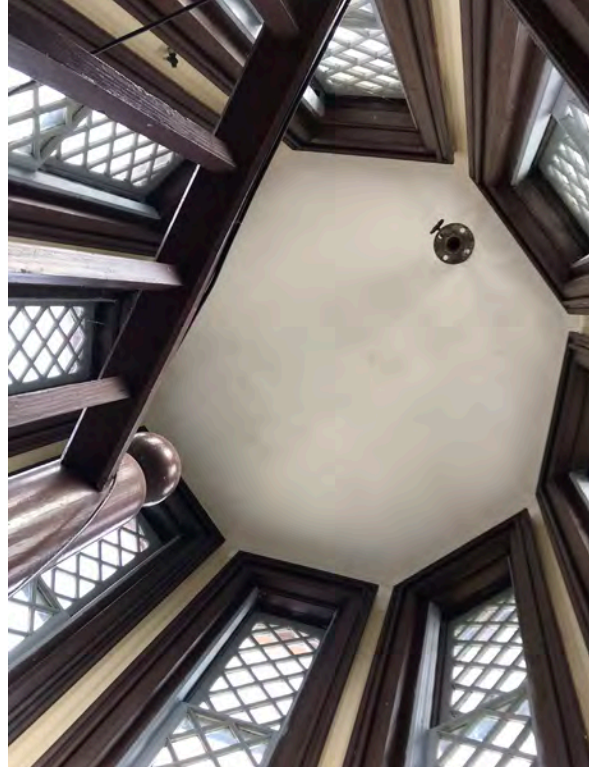
Photo 263: Repaired ceiling of top room in northeast stair tower.

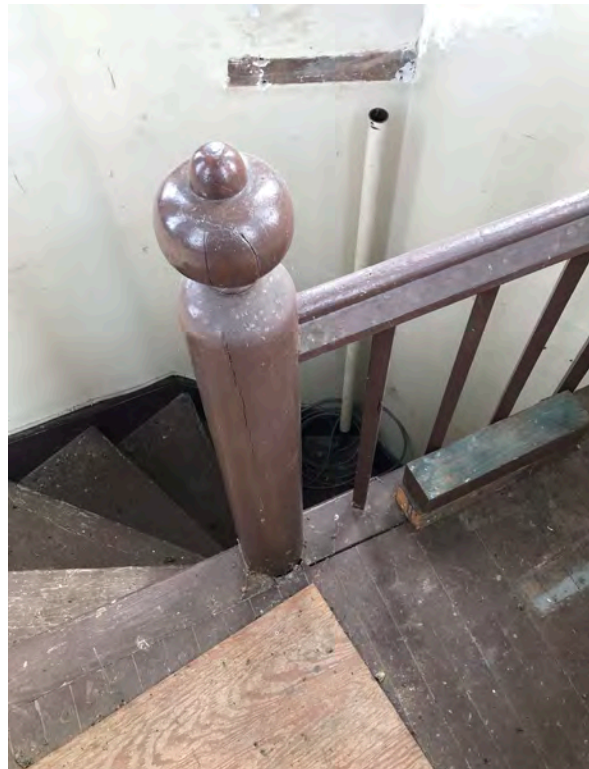
Photo 264: Wood post and guardrail at landing in top room in northeast stair tower.

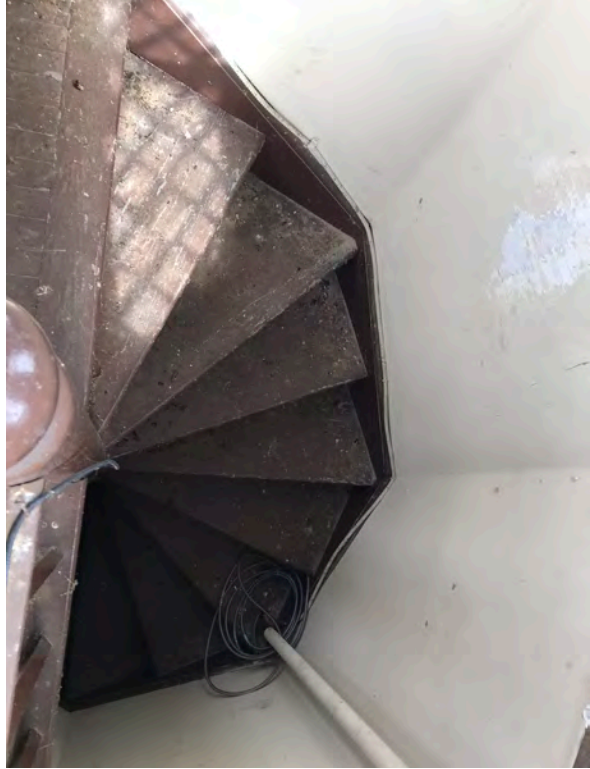
Photo 266: Spiral stair in top room of northeast stair tower.

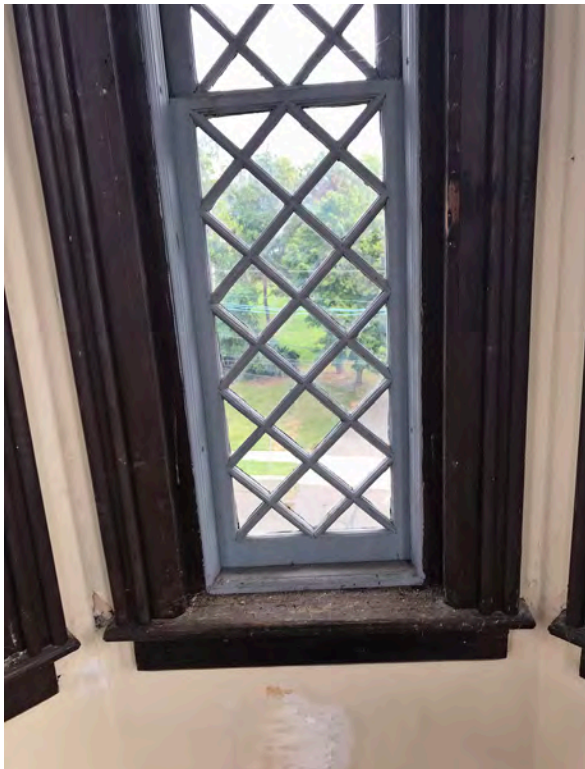
Photo 269: Typical wood window in northeast stair tower.

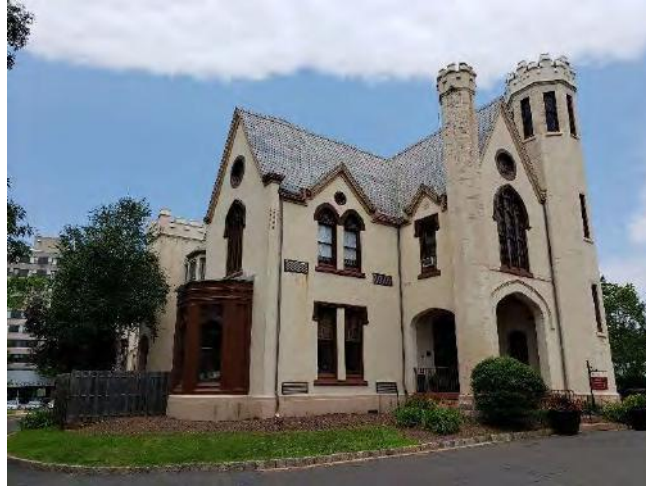
35 WEST END AVE, SOMERVILLE, NJ 08876

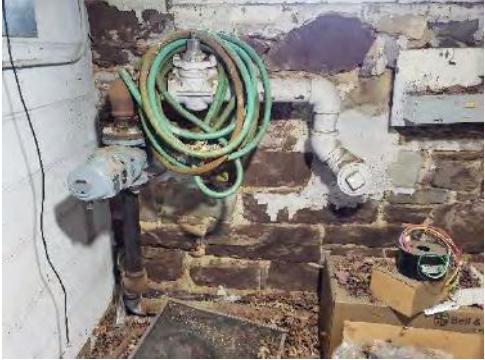
<p>4. Domestic electric water heater. This unit was made by Bradford White and is rated for 7 KW and has a 50 gallon storage capacity. The unit appears to be in acceptable condition. However, the overflow pipe should be extended to 6" AFF.</p>

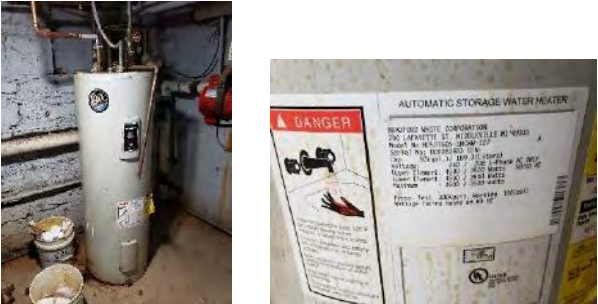
5. It is recommended to relocate either the janitor's closet or the electrical service equipment. The janitor's sink is located within the working space clearance of the electrical equipment. There is water piping within this room routed directly above the electrical panels. This piping should be relocated to reduce the risk of fire caused by a leak.

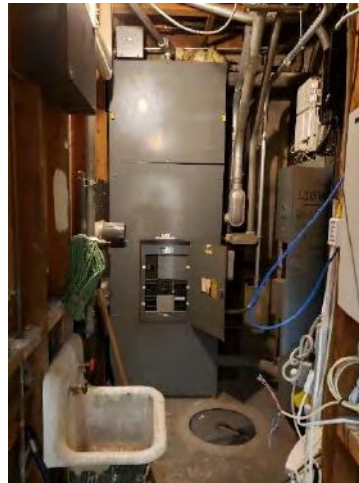
6. Janitor's closet, the plumbing fixtures appears to be in acceptable condition.

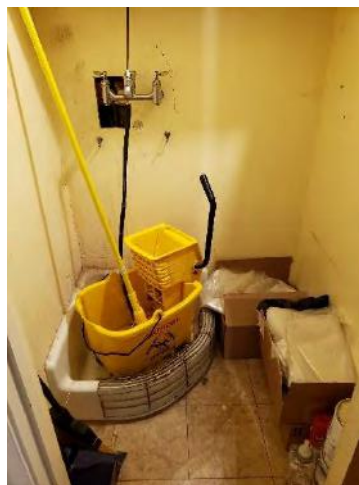
7. Fire sprinkler service arrangement. The fire sprinkler main shut off valve has recently been replaced and the detector check valve appear to be in good condition. The backflow preventor should be serviced regularly to assure proper protection of the municipal water system.

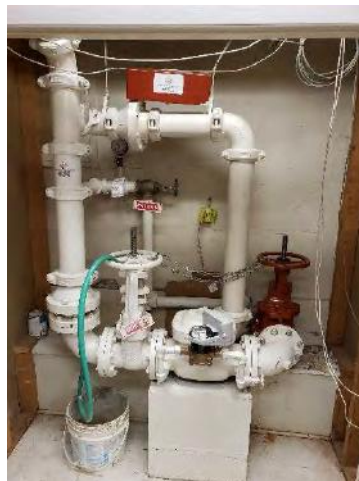
8. Fire service main shutoff valve recently replaced.

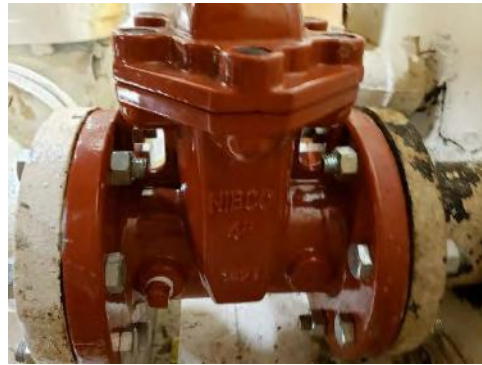
9. Lochinvar Knight XL boilers, two separate units each rated for 500 MBH at 90%. The boilers were not running at the time of our summer survey. However, they are in relatively new condition and believed to be fully functional. Typical maintenance in accordance with the manufacturer's written directions should be performed.

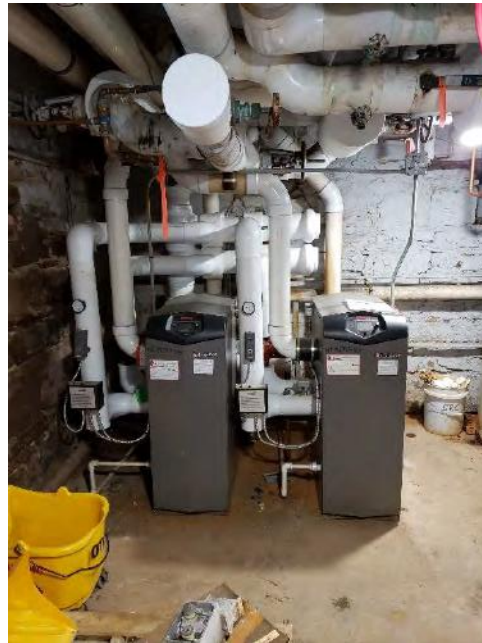
10. Outdoor grade mounted 20 ton chiller recently replaced. It is our understanding that this unit is in good operational condition. General maintenance should be provided in accordance with the manufacturer's written directions.

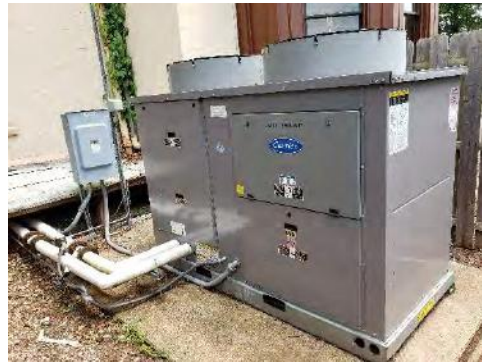
11. Mechanical room dual water distribution piping. At the time the chiller and boilers were upgraded the piping in the immediate area was also replaced. Other than that, the piping appears to be very old. Due to oxidation, over time pipe corrodes and loses strength. If this old piping ruptures it could cause server damage to the historic structure. It is recommended to replace it in the near term.

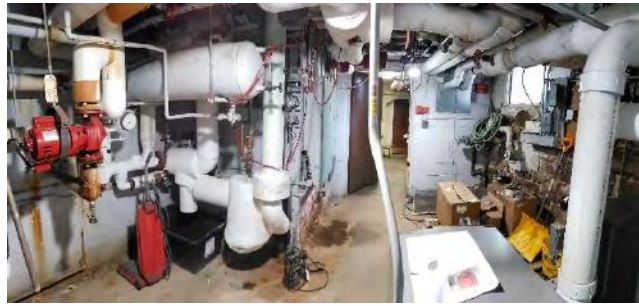
12. Fan coil unit partially blocked by filing cabinet.

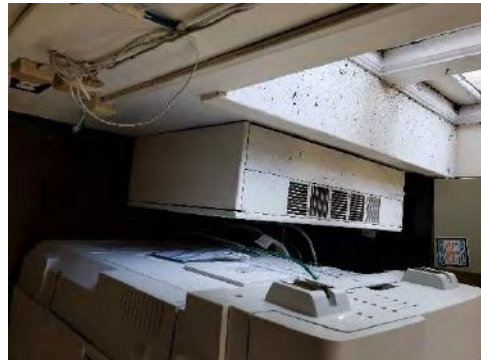
17. The outside air louvers are in poor condition and aestically displeasing. Each louver is connected to an indoor mechanical unit serving the respective space. The louvers are rust staining the exterior wall. It is unclear if this rust is from rain water or condensate drain water. It is recommended to replace the louvers when the fan coil units are upgraded and provide proper condensate drainage.

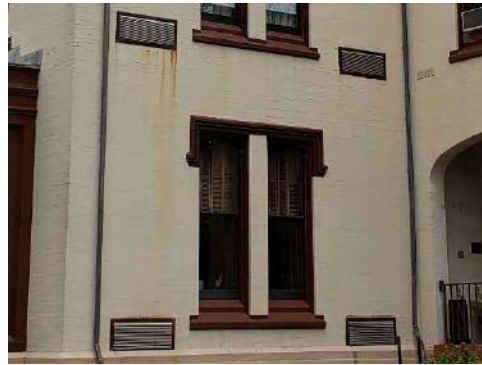
18. Janitor's closet exhaust fan appears to old and in need of replacement.

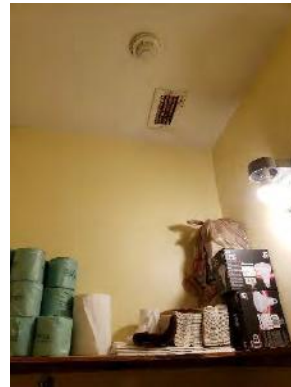
19. HVAC control panel located in the basement mechanical room. The controls are old and at the end of their life cycle. It is recommended to upgrade the existing HVAC control system throughout the building.

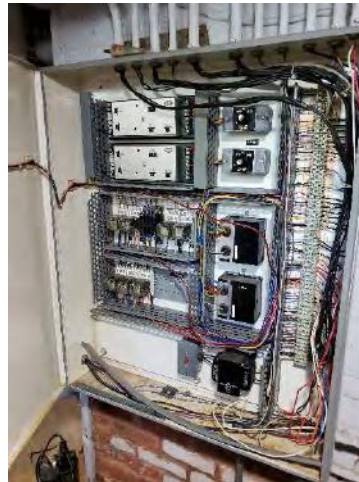
20. Main electrical services is a 120/208V, 3P, 4W rated for 600A. Janitor wall mounted sink is within the working space clearance of the electrical equipment. It is recommended to relocate the janitor's closet or when the electrical service is upgraded, the new electrical service be relocated.

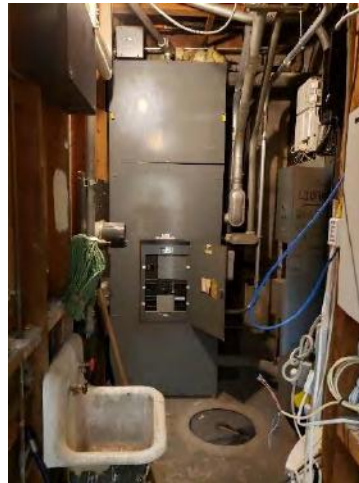
21. Main electrical PSE&G meter located at the point of service. Meter No. 9197435D. This meter has exposed unprotected wiring and should be upgraded to a full enclosed type of meter enclosure.

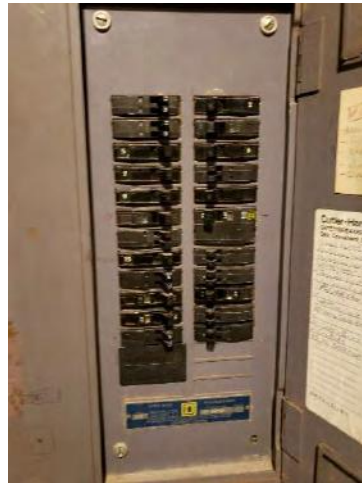
25. Existing B-K branch panelboard in basement mechanical room. This panel should be replaced.

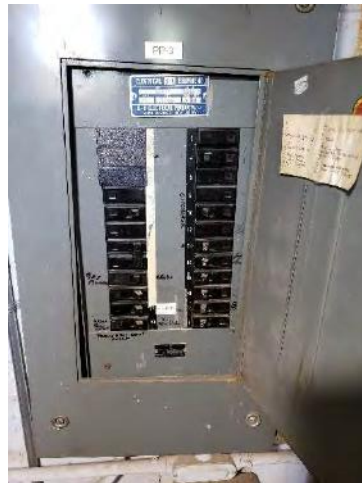
26. Existing branch panelboard in basement mechanical room. This panel appears to be in good condition.

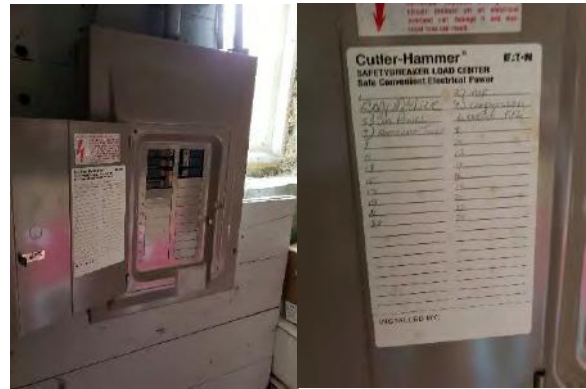
27. Existing branch panelboards on first floor. These panels appear to be in functional equipment.

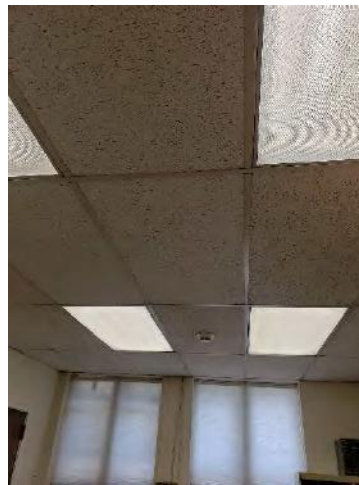
31. Old Simplex conventional zoned fire alarm system. This system is anticipated to be over 40 years old and is way beyond the end of its service life. It is recommended to replace the fire alarm system with a new addressable system.

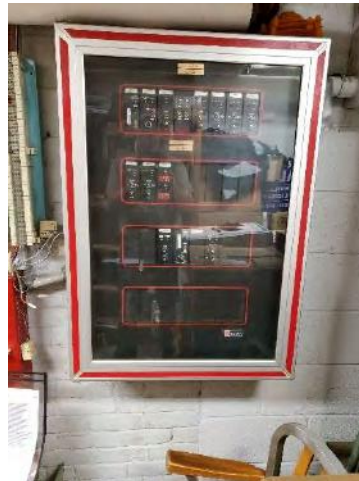
32. Fire sprinkler service valves are not monitored via tamper switches interconnected with the fire alarm system. They valves are chain locked. Proper monitoring of the sprinkler system should to be provided.

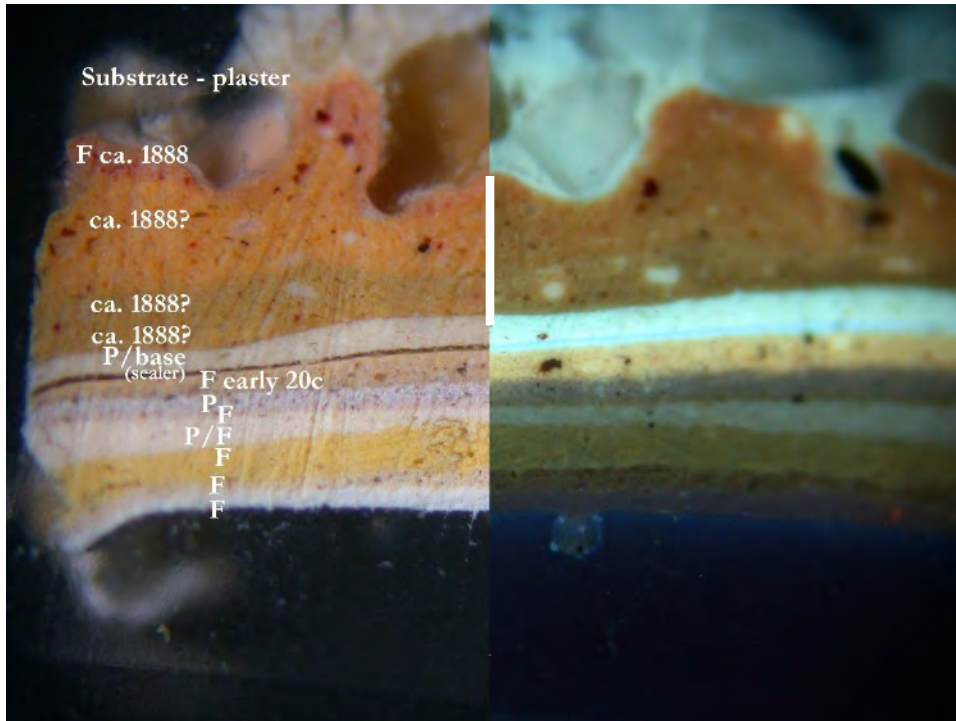
Figure 3. Sample 100-11 (Upper wall from Room 100 Entrance Hall; 100x magnification in color-corrected reflected visible light (left) and longwave ultraviolet light (right)). Evidence of comprehensive chromachronology from ca. 1888 original construction (line) through current finishes.

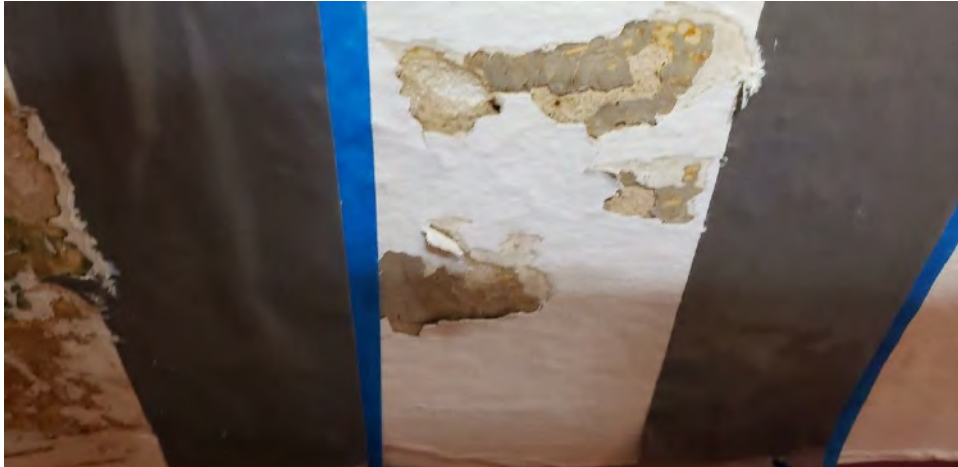
Figure 14. Pre-existing conditions and detachment between paint layers at ceiling level in Room 100; difficulty in installing exposure windows.

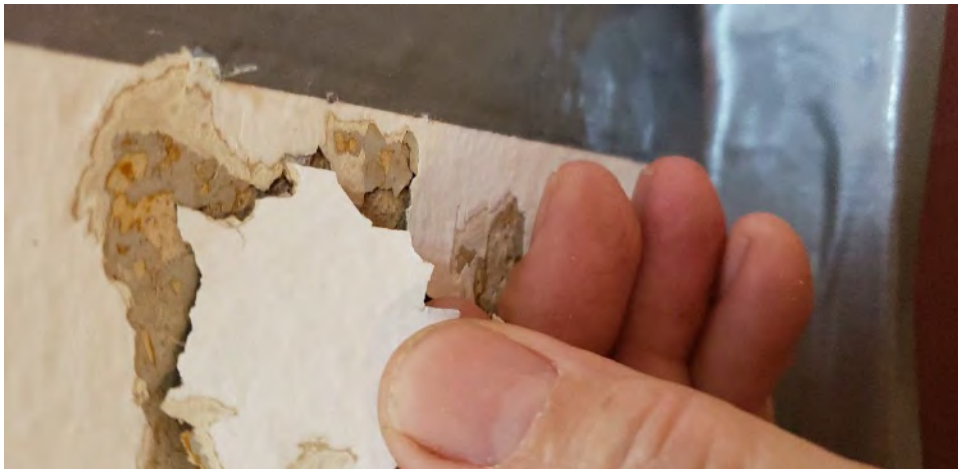
Figure 15. Pre-existing conditions and detachment between paint layers at ceiling level in Room 101; difficulty in installing exposure windows.

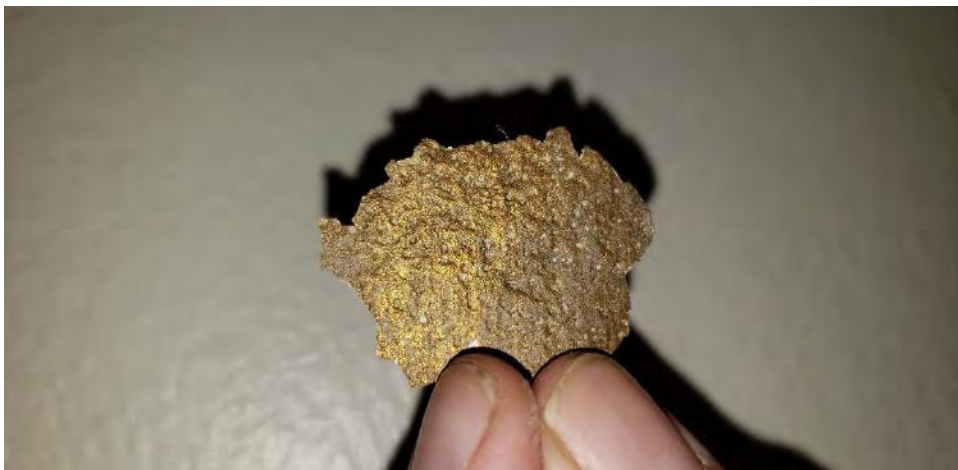
Figure 16. Pre-existing conditions and detachment between paint layers at ceiling level in Room 100; difficulty in installing exposure windows. Reverse side of detachment exposes metallic powder from early/original finish.

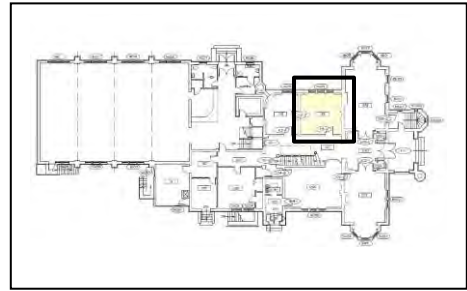
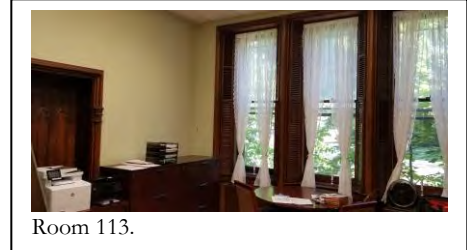
Room 204: Mayor's Office

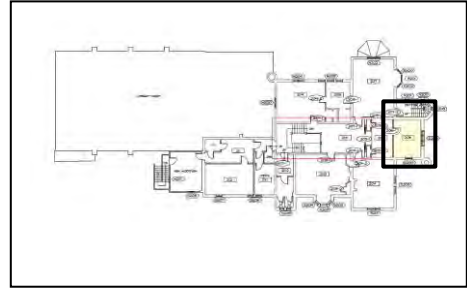
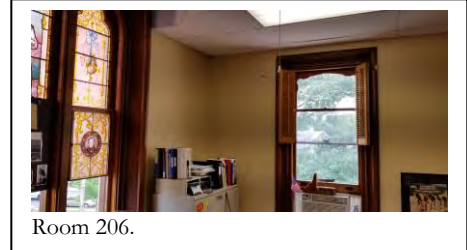
Analysis completed to date suggests neither polychrome nor ornament in this space. However, to confirm, or to rule out the presence of decoration, additional sampling, with the possibility of exposure windows being completed, would be required.

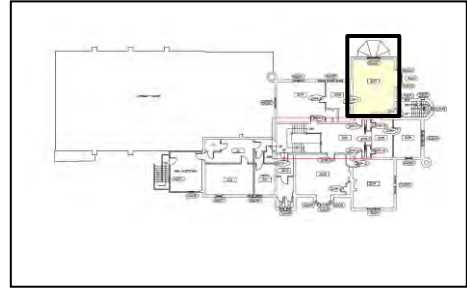
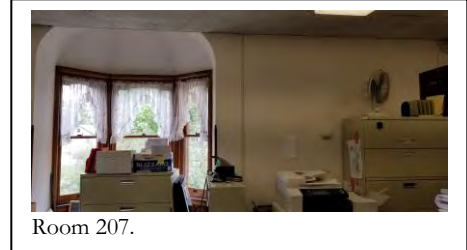
Analysis completed to date is inconclusive with respect to both ca. 1888 colors and early 20th century colors. Additional sampling, with the possibility of exposure windows being completed, would be required to fully understand this space.

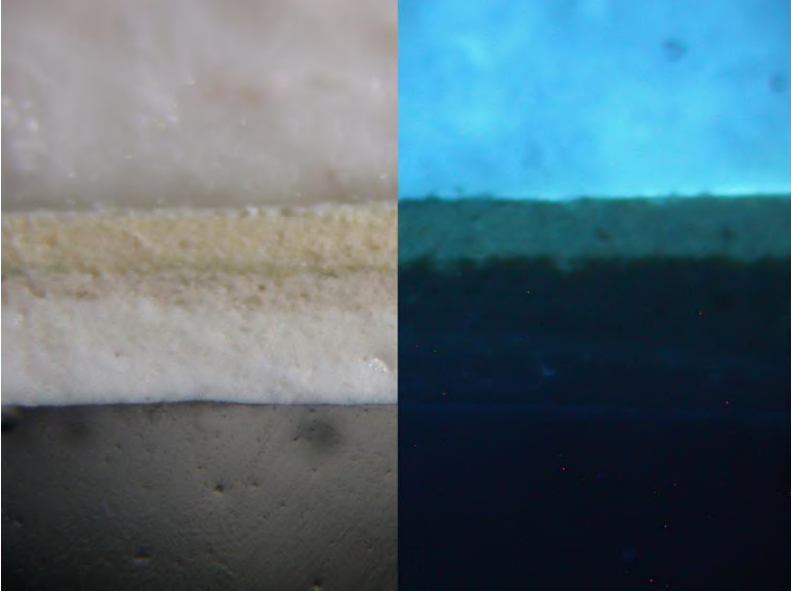
Chromachronology:			
Observations: Modern plaster or repair with no historic layers

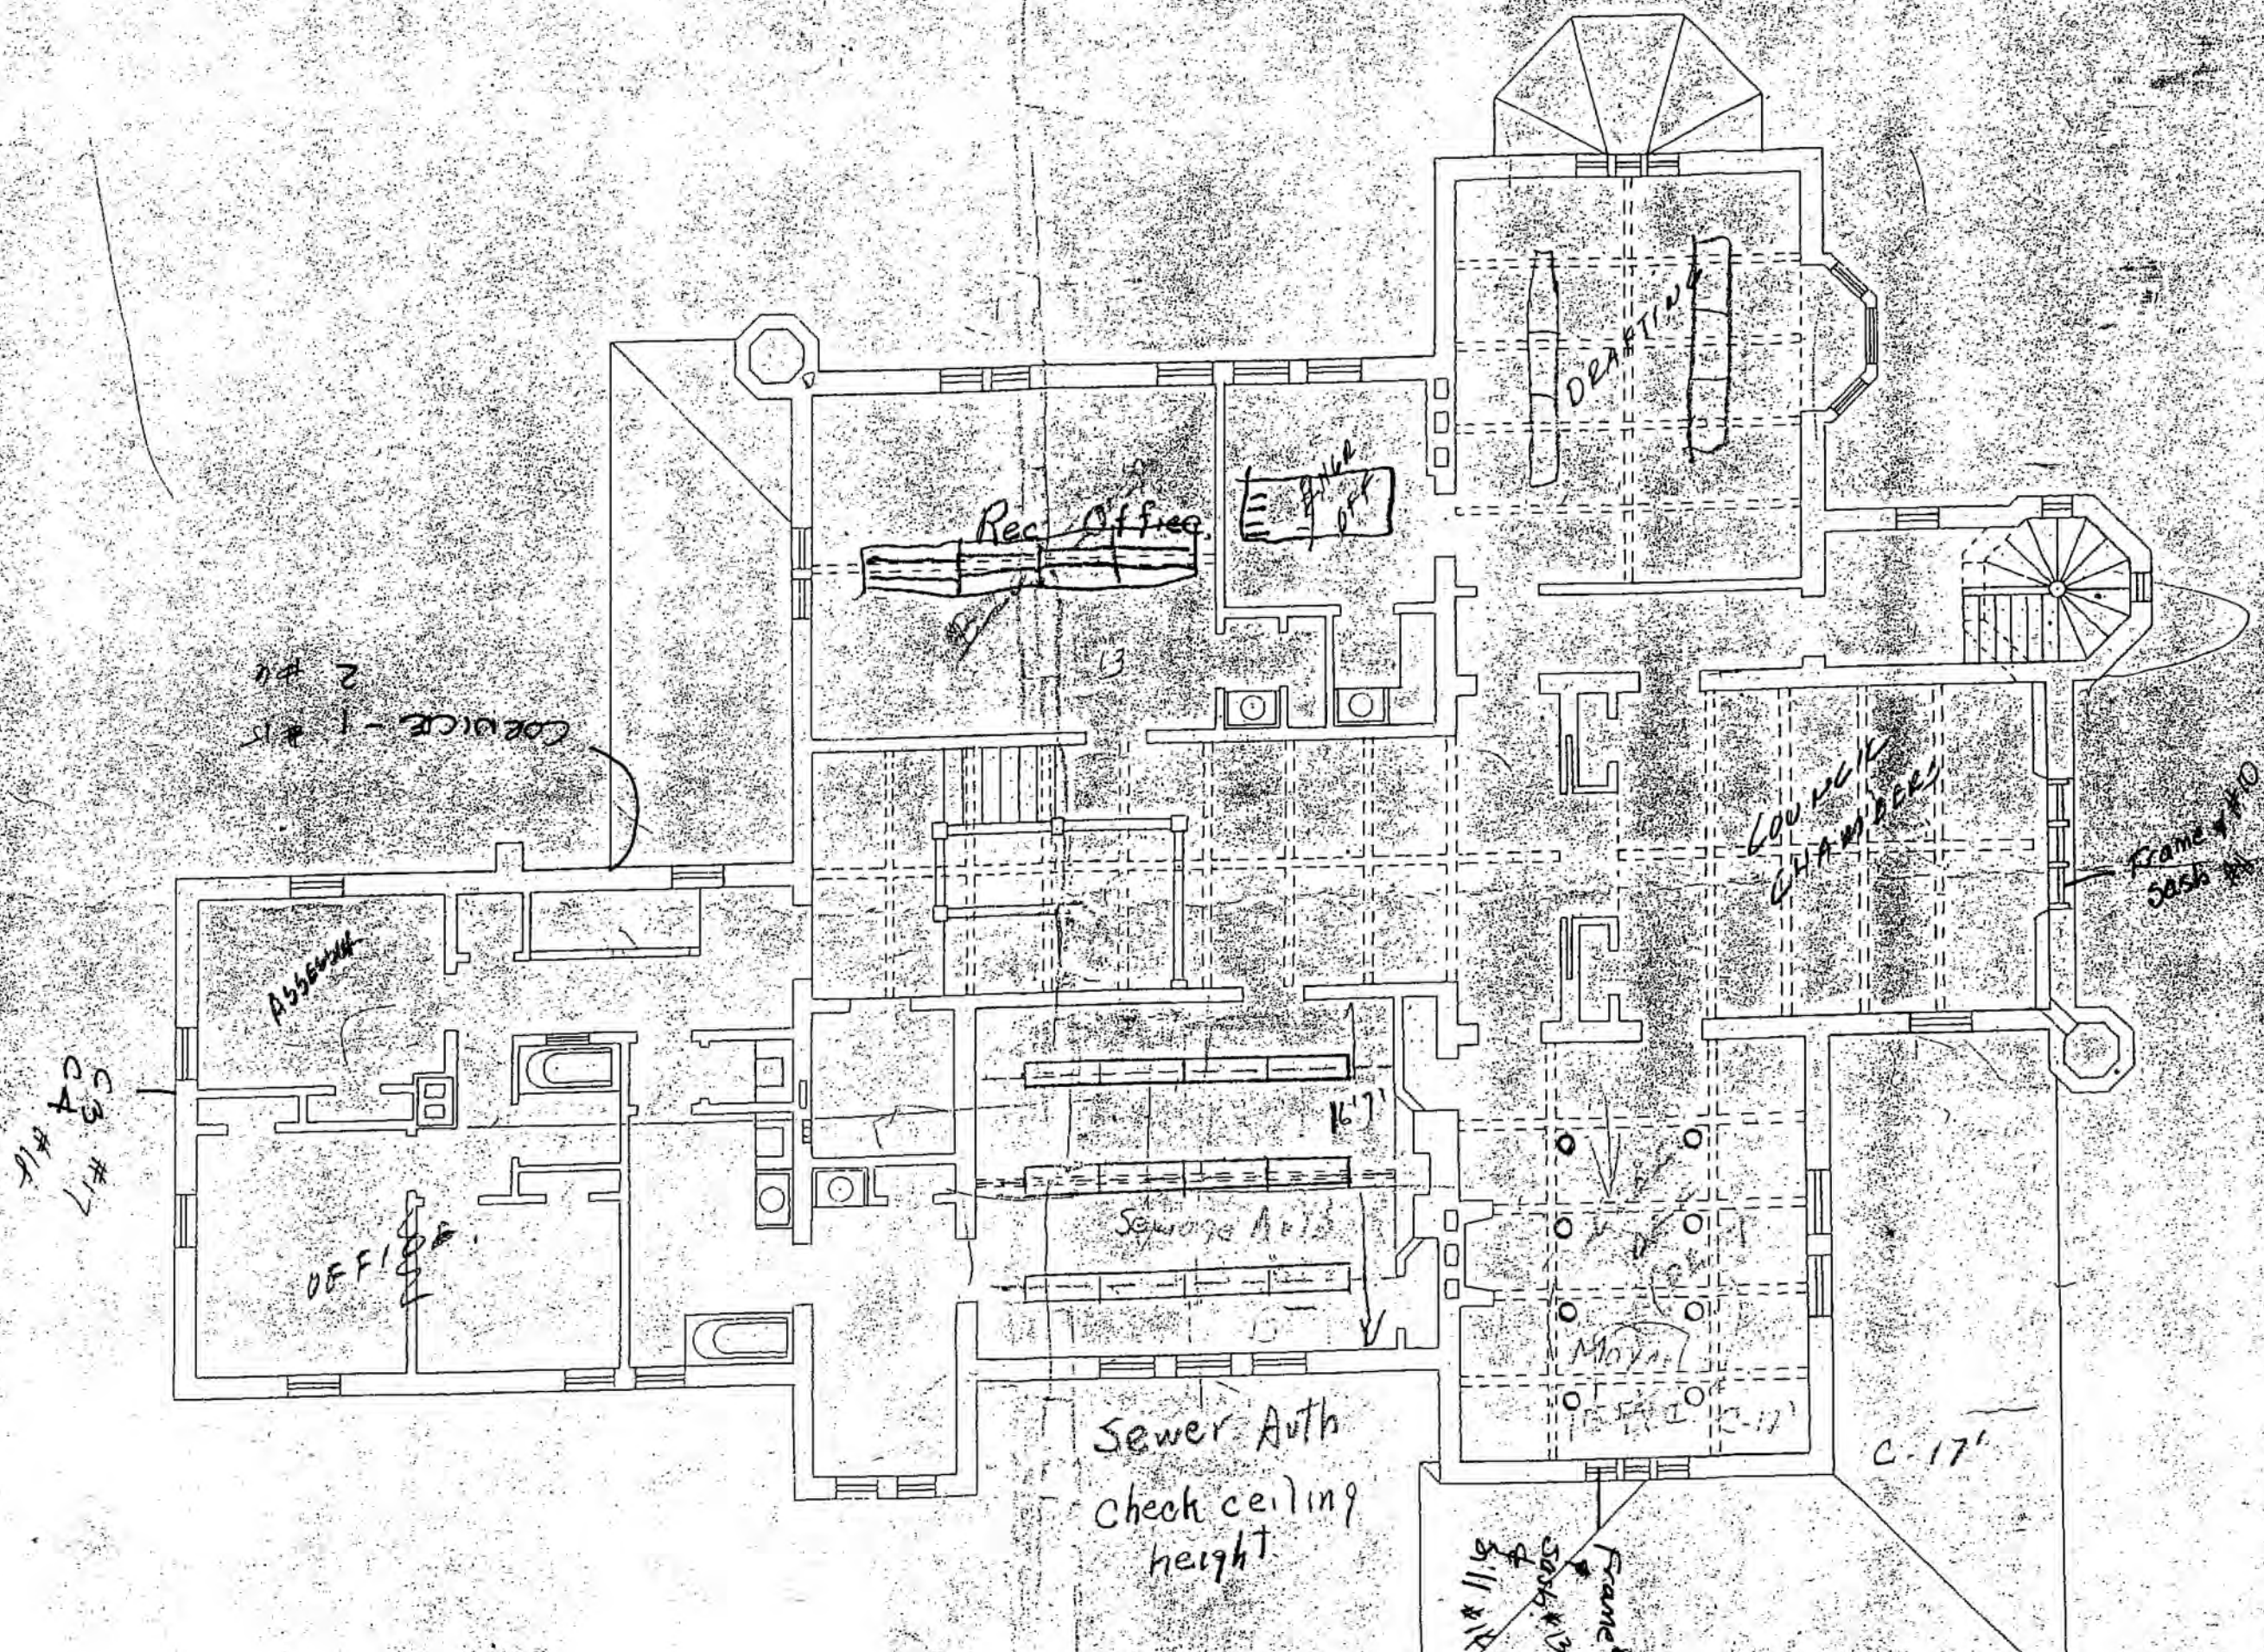
Appendix A: Bunnell and Lambert Architects Original Drawings

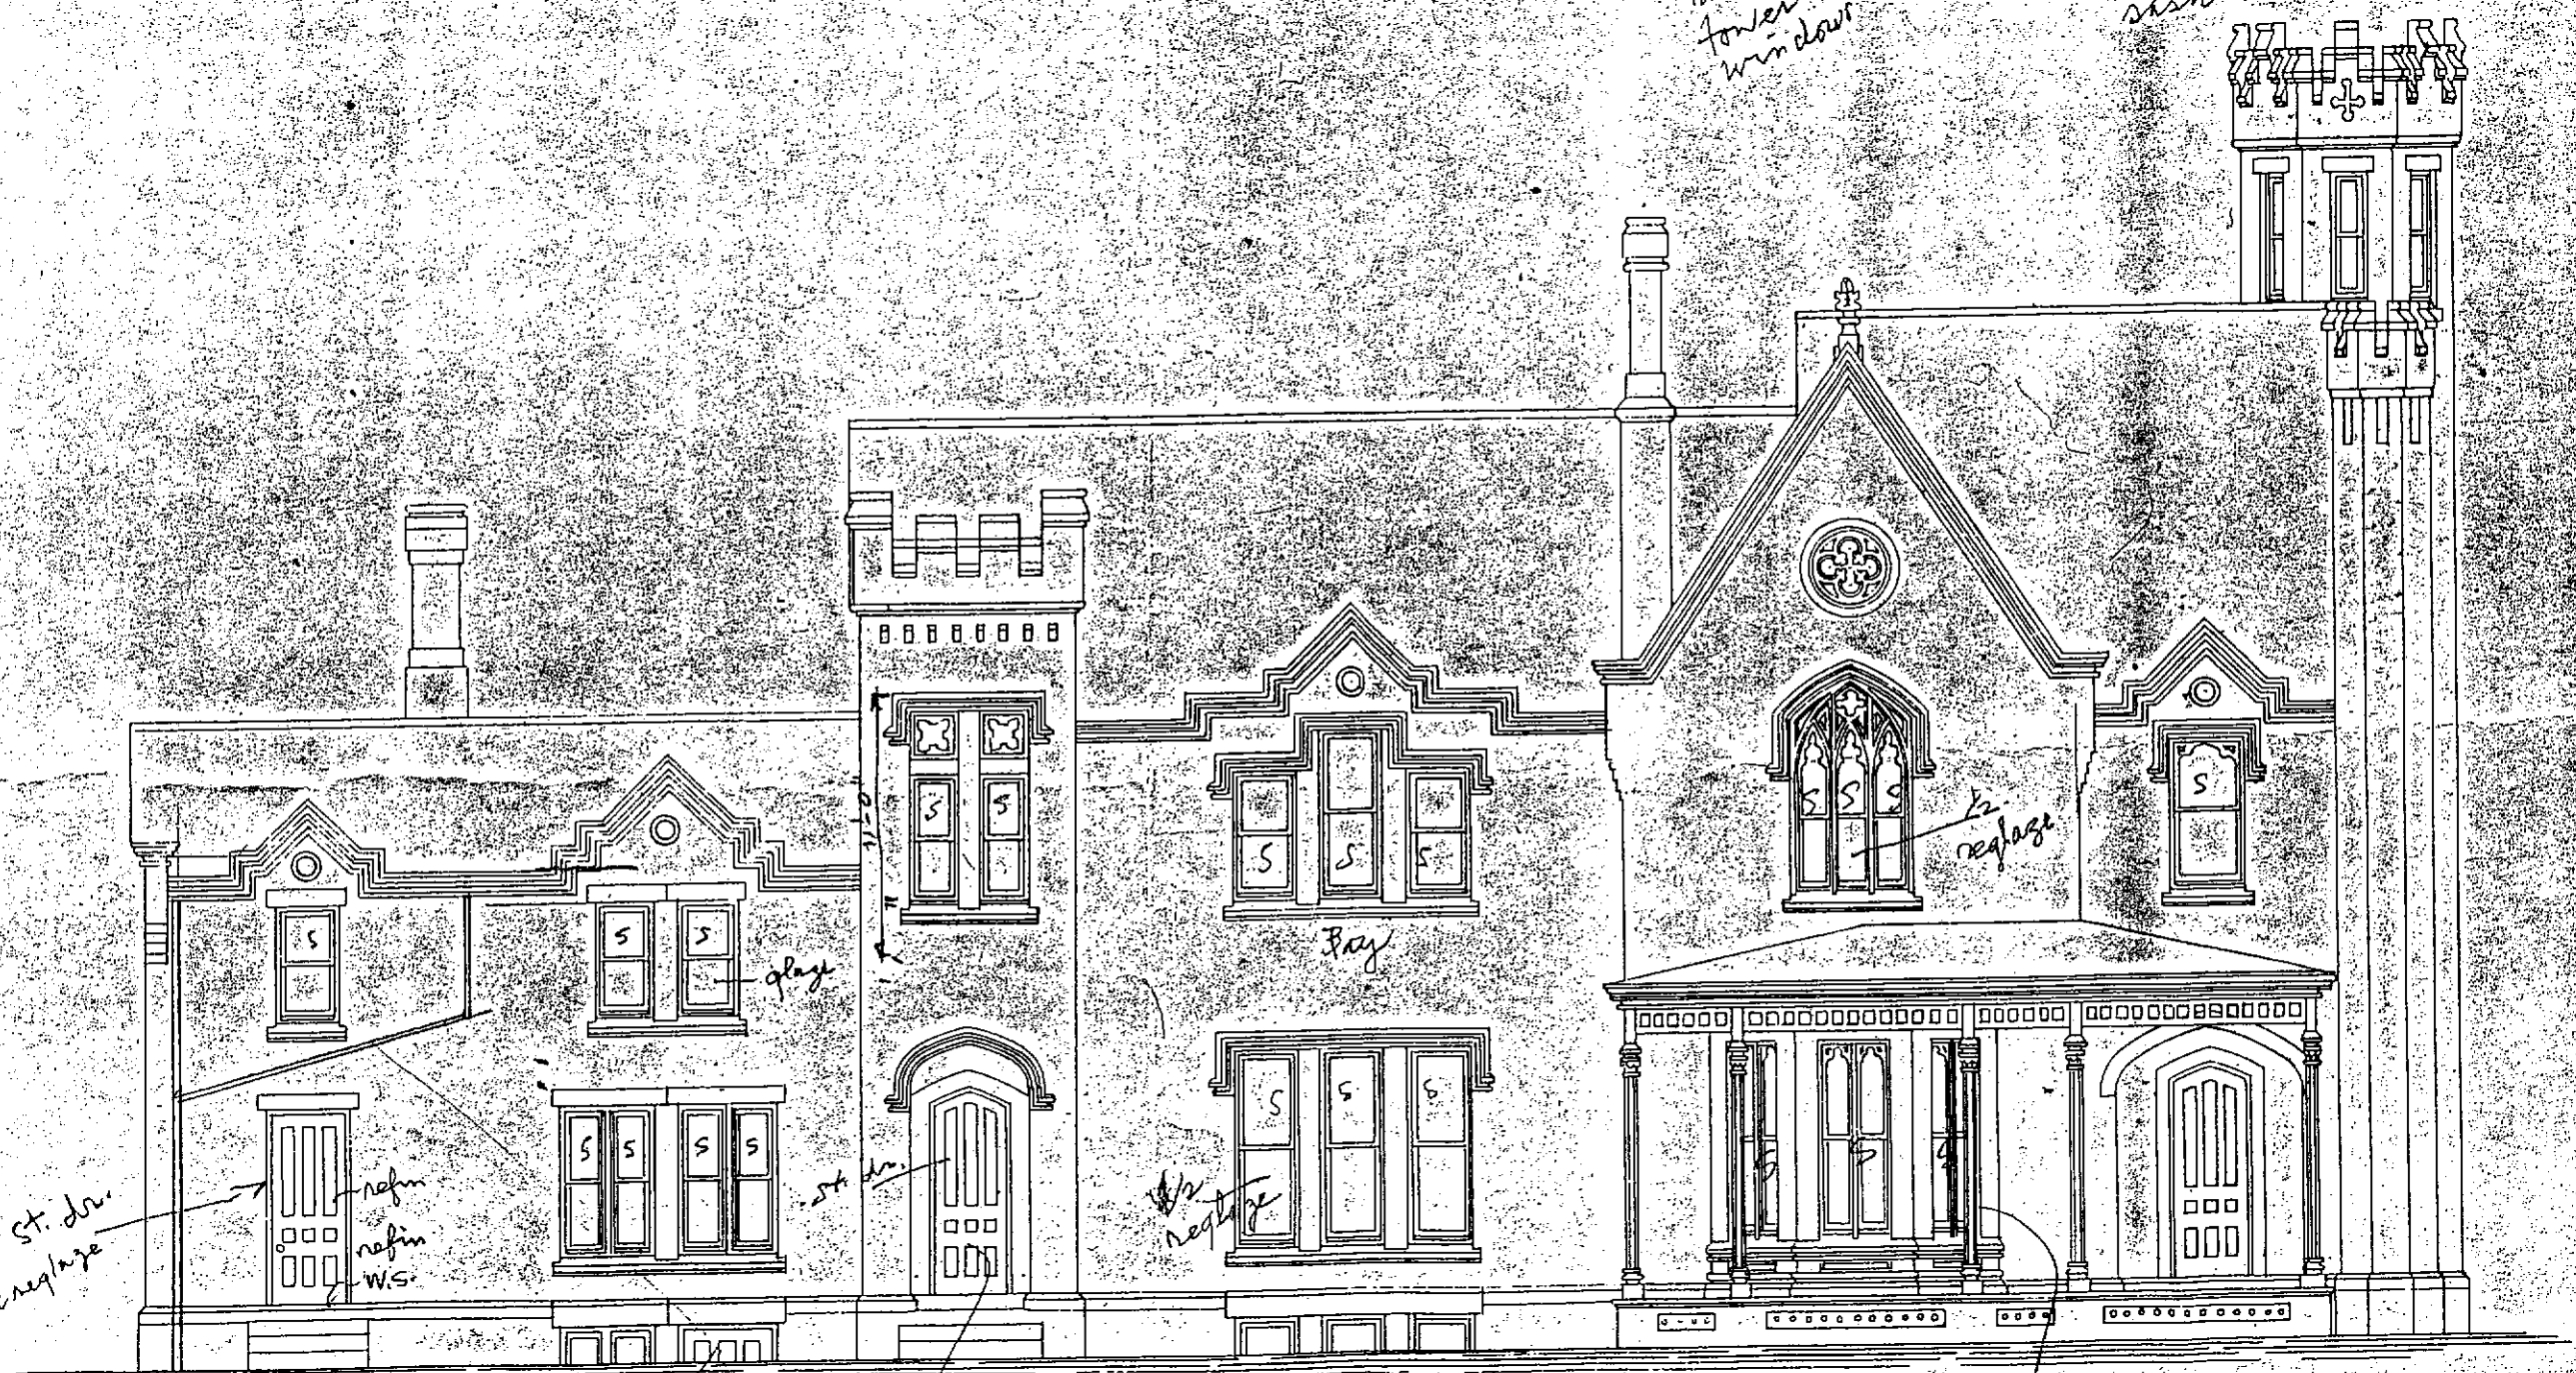
remove 2 lower sash & replace clear over stained
