## **Arborists Report and Tree Impact Summary**

**Pritchard Farm  
196 E Spain Street  
Sonoma, CA  
Parcel #018-171-011 & 018-171-012**

**March 25, 2024**

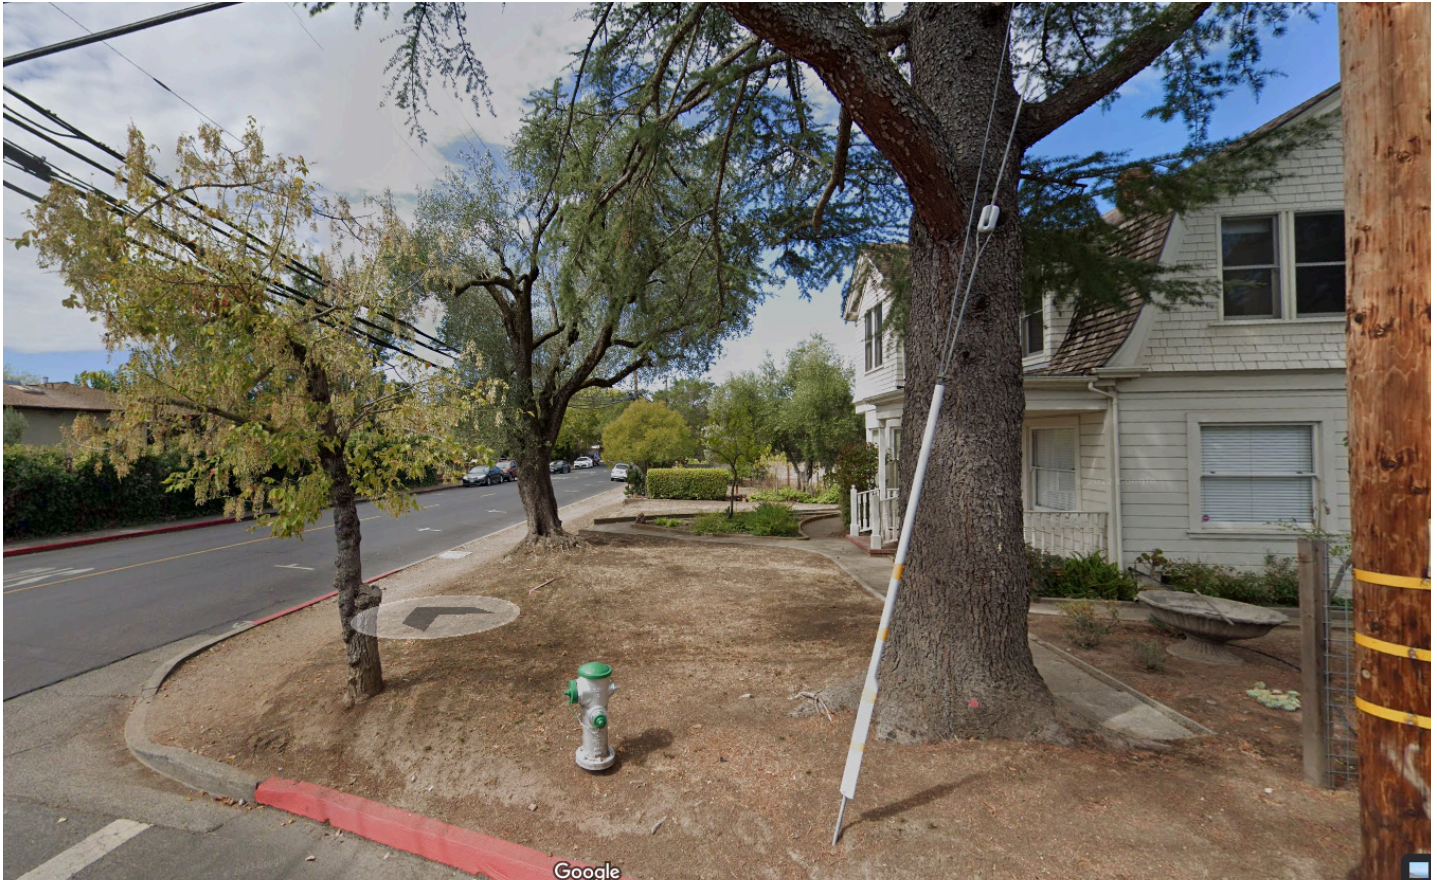
Looking Approximately West. Historical Google imagery. Trees 7946, 7945, and 7947 (left to right). Tree 7946 is proposed for removal and 7945, 47 are proposed for retention with impacts. Tree 7946 has been utility pruned and as of October 2022 has 50% dead bark on base and trunk. large decayed flush cut north at 3', and weak attachment of the canopy.

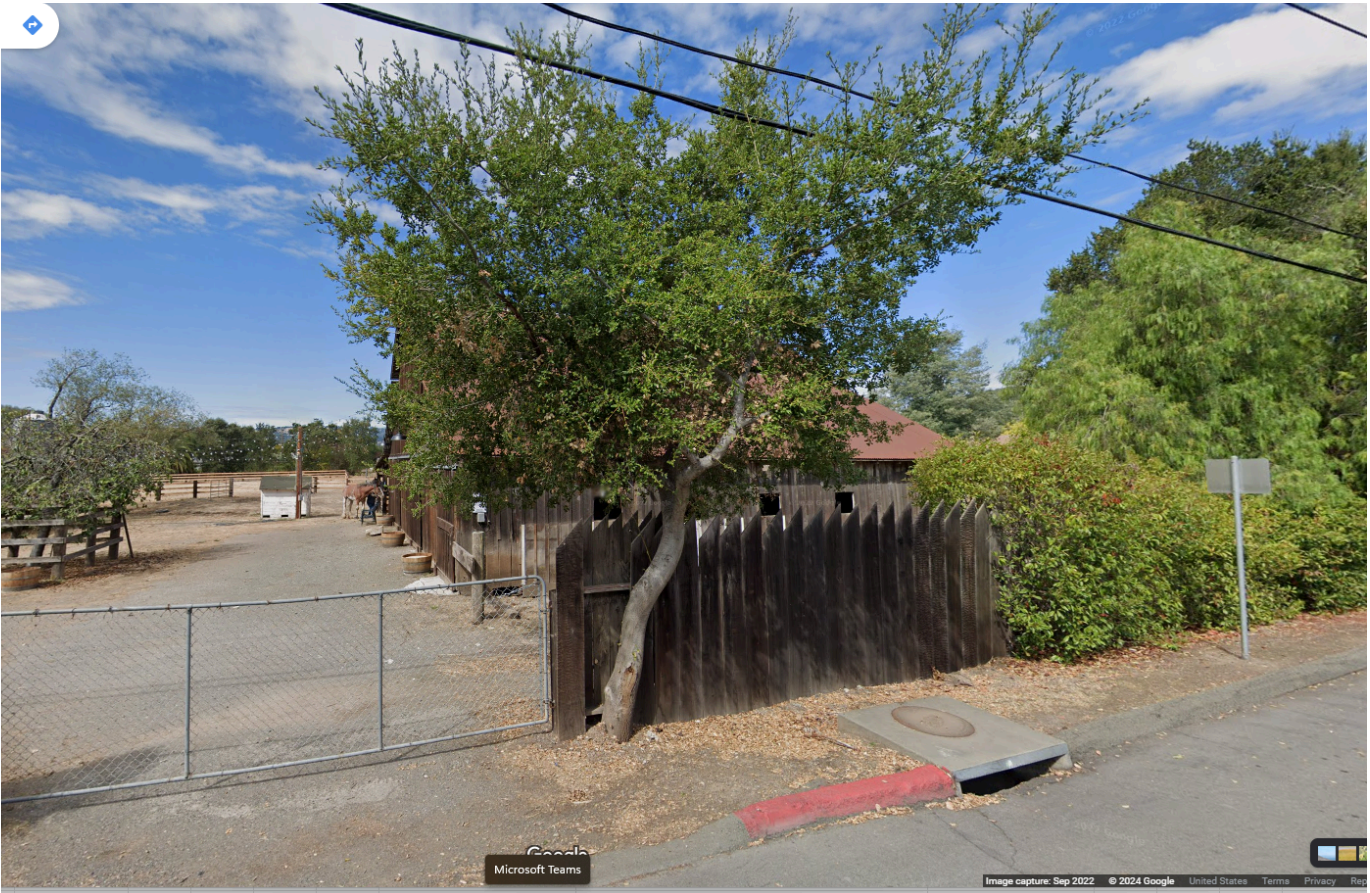
Looking Approximately West. Historical Google imagery. Tree 200. Compacted gravel driveway and curb to be reconstructed. Protection of the existing roots will be determined during the development process.
