Water Quality Report

City of Streetsboro and Portage County Water Resources

10/7/2019

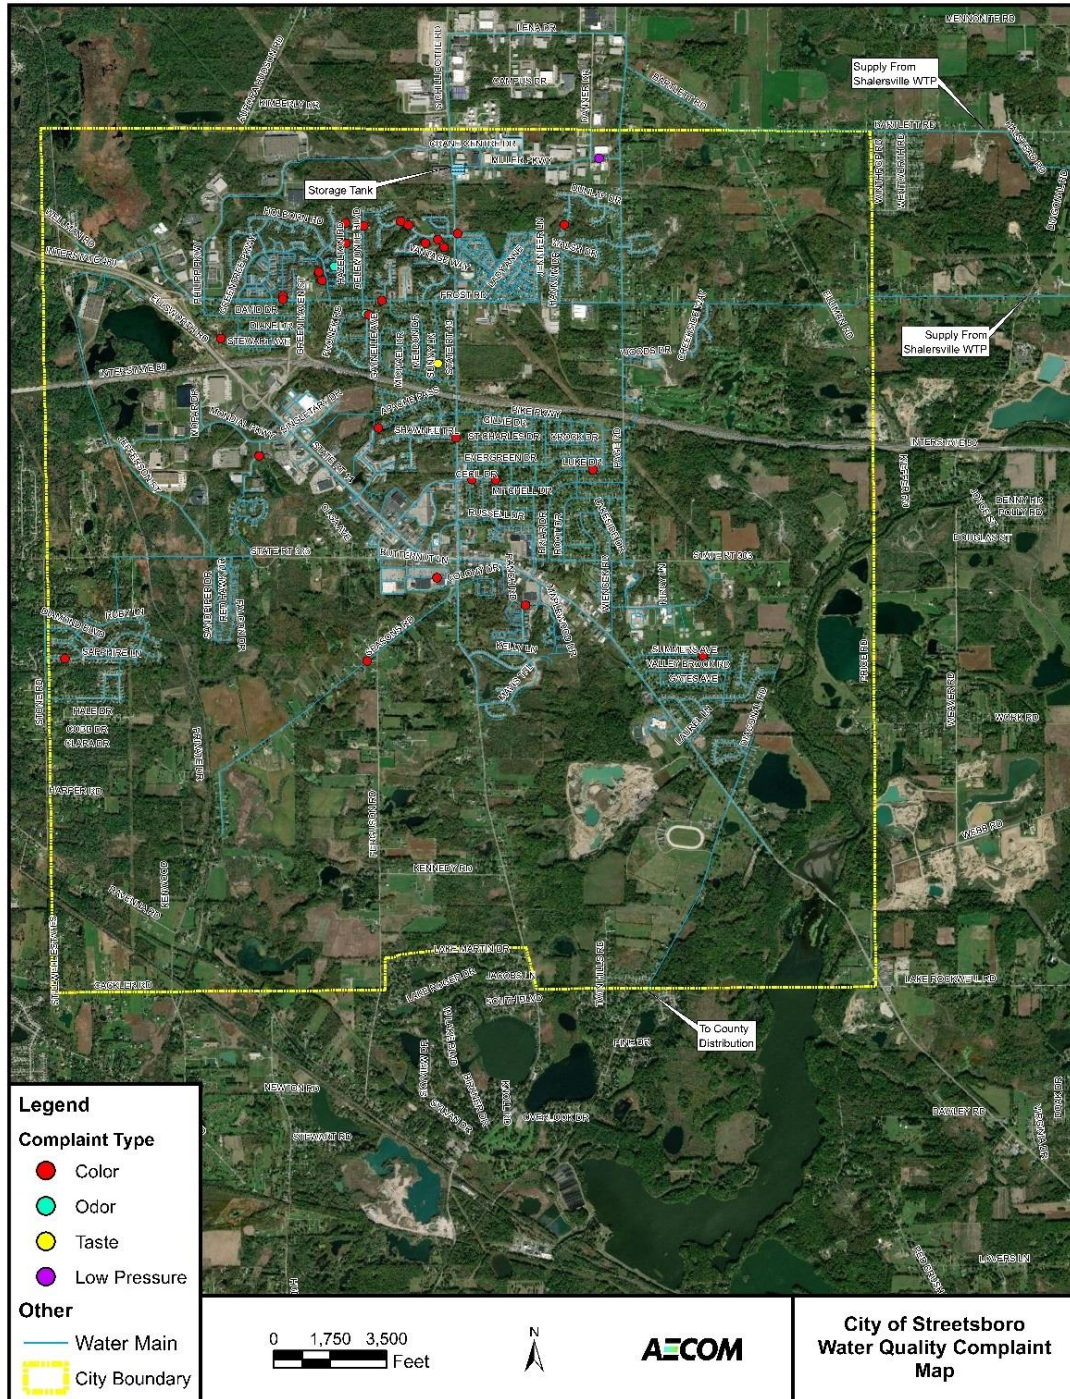
Figure 3-1 Map of Water Quality Complaints of Unknown Cause

The complaints of unknown causes are distributed throughout the City without much of a clear pattern, although there are increased complaints in the northern quadrant. One area that stands out is the Tinker’s Green subdivision (which is this north central area), and numerous complaints were logged here in the fall of 2017. This area is actually a separate pressure zone of about 150 homes served by a booster station on Tinker’s Green Drive. Booster stations feeding small pressure zones without elevated storage

or pressure tanks can have issues relating to reverse flow and hammer, which can cause sediment to stir. Additionally, rather than pressure reducing valves, the zone is isolated by check valves. It is possible that one of these check valves could have temporarily stuck open while the booster station was running. Depending on the controls of the station, a check valve temporarily stuck opened could cause the pumps to run out on their curves, resulting in high velocity in the 8-inch waterlines and stirring sediment. Although these complaints appear to be an isolated event, the City may want to consider replacing one of these check valves with a pressure reducing valve or adding a hydro-pneumatic pressure tank in this zone. Doing so could reduce the number of pump starts and stops per day and mitigate issues such as hammer or short duration occurrences of high velocity. An 8-inch pressure reducing valve costs about \$6,000 and can be installed in one of the check valve manholes.

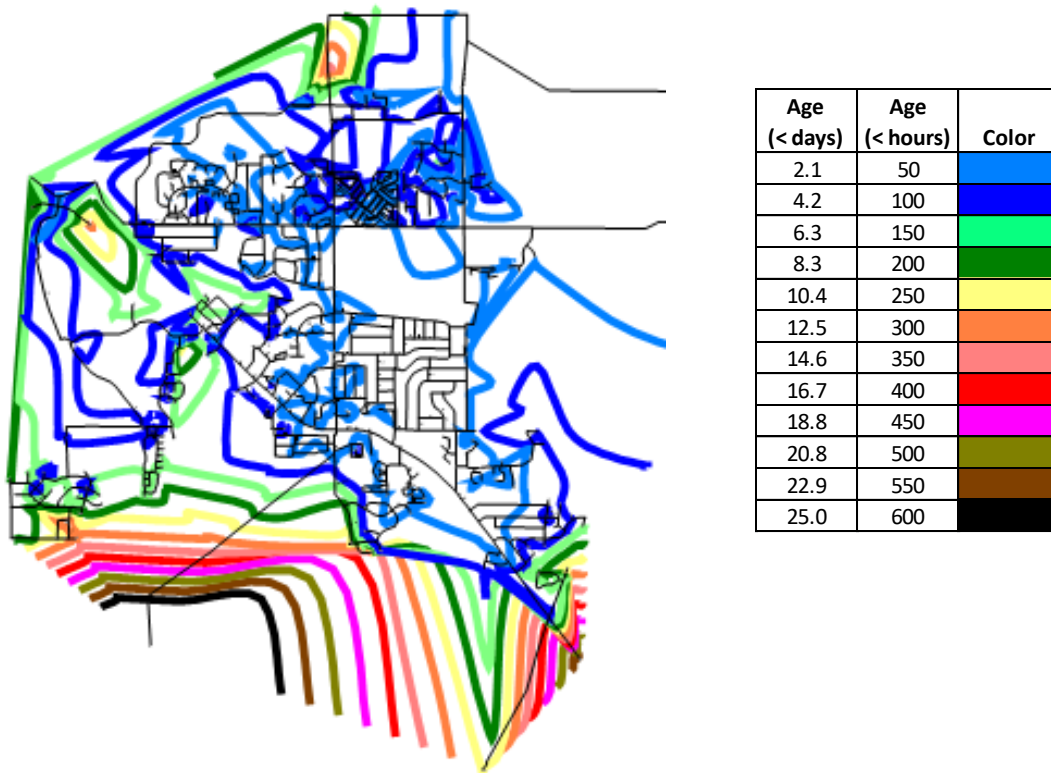
Figure 3-2 Water Age Simulation (No Flushing)

As seen in the figure, problematic areas occur in the extremities of the dead end waterline branches in the southern portions of town. Distribution systems of this size commonly experience excessive age in dead-end waterlines, as it is not often financially feasible to loop such lines. Note the area to the southeast on Diagonal Road which appears to be a dead end branch is an extension beyond City limits servicing other PCWR customers. This connection is metered and experiences a typical flow about 5,000 gallons per day and was simulated in the model. There is also one small area to the north on Route 43 which is modelled as a somewhat high age. However, this may be a nuance of the model as this line has bidirectional flow between Streetsboro and Aurora. Modelling the Aurora water system and demand is outside the scope of this study, resulting in the actual demand and water age in this area being misrepresented. However, the net difference in flow direction is minimal (typically <90,000 gal/day into Streetsboro), and may have little impact. However, since this could not be accurately modelled, it is suggested that the City check chlorine residual in this area to verify whether or not it is a concern.

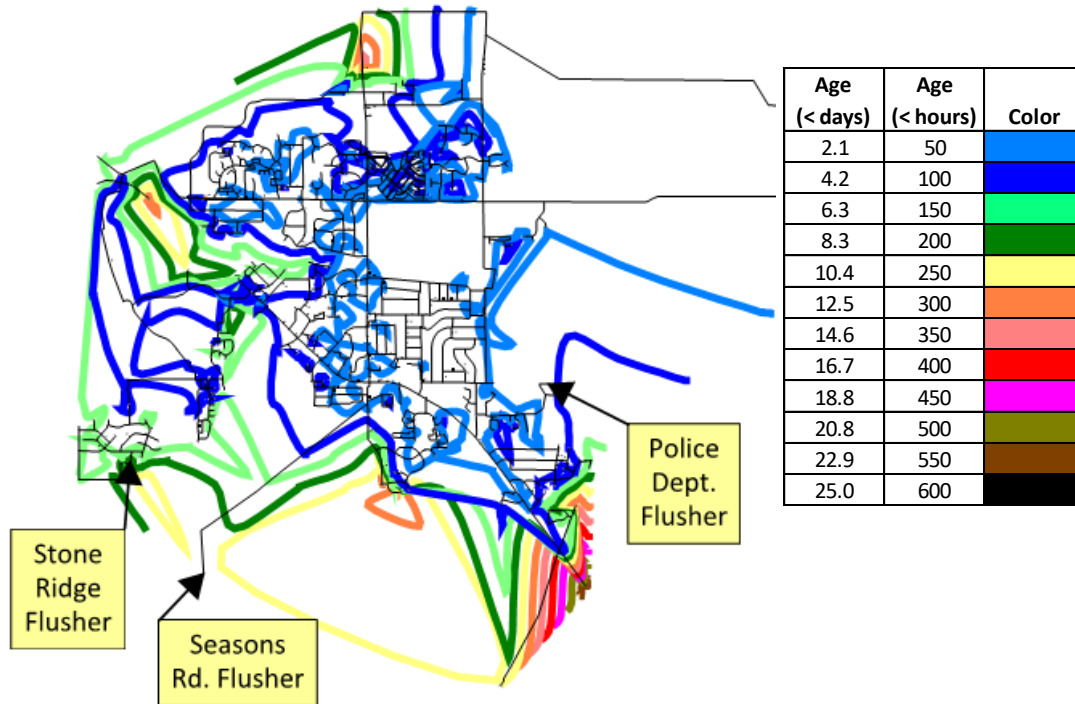
Figure 3-3 Water Age Simulation (with Flushing)

Implementation of the automatic flushers has reduced water age considerably in their installed locations. Modelling results indicate the following:

- Seasons Road: Age reduced from the initial 830 hours (34.5 days) to a range of 225 to 250 hours (9.3 to 10.4 days).
- Stone Ridge: Age reduced from the initial 360 hours (15 days) to a range of 180 to 230 hours (7.5 to 9.6 days).
- Police Department: Age reduced from an initial 150 hours (6.3 days) to 48 hours (2 days) immediately following a flush.

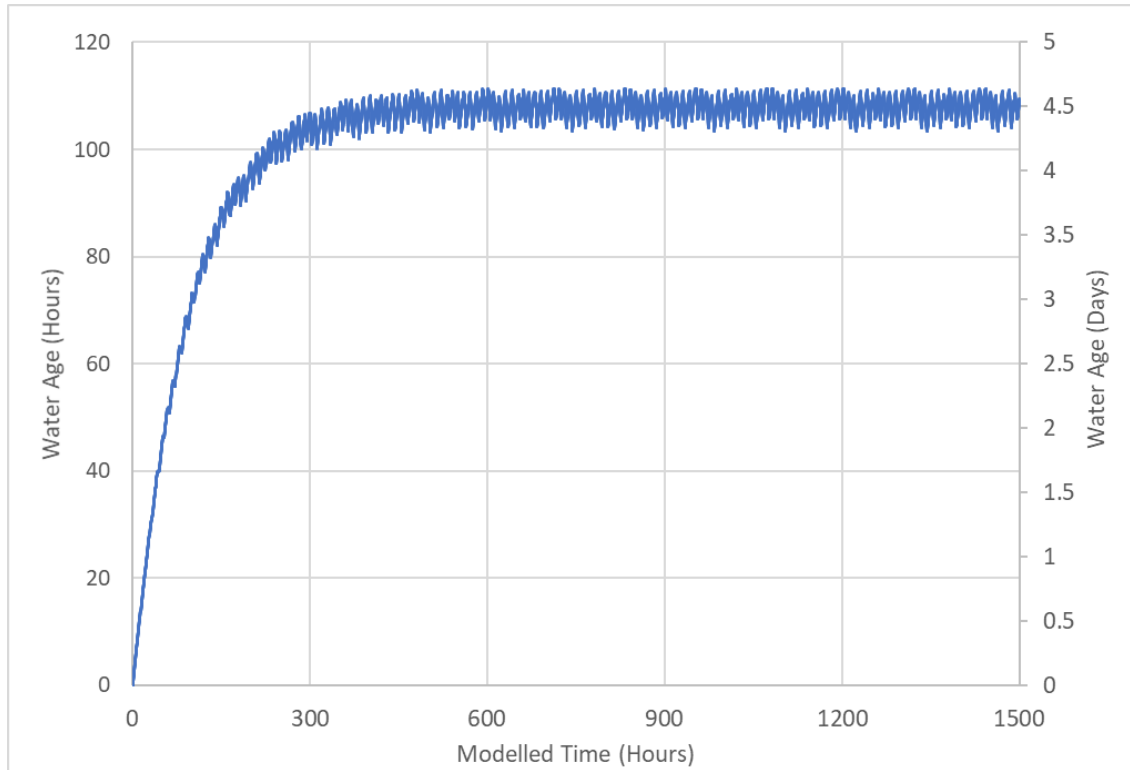
Figure 3-5 Modelled Water Age in Elevated Tank

The original design of the storage tank featured a 100 gpm circulation pump and spray nozzles intended for reduction of disinfection byproducts including total trihalomethanes (TTHMs). Spray aeration creates water droplets which then allow vitalization of TTHMs to the atmosphere, and these have shown to be effective. However, the plastic piping between the spray header and pump failed in March of 2019, which caused flooding in the base of the tank and destroyed over \$50,000 in City assets. The City had previously collected TTHM samples upstream of the water tank and from the water tank in 2015 and 2016. This was prior to running the aerator, and results are presented in Table 3-2.

As evident by this data, TTHM formation does appear to be occurring in the tank, which would warrant use of the spray aeration system. A replacement pump has recently been purchased and the plastic segments of piping are planned to be replaced with stainless steel material. However, a spray aeration system also requires continuous air changes inside the reservoir using forced or induced

ventilation to remove volatilized TTHM. Without this, volatilized TTHMs will primarily dissolve back into the water. An active ventilation system was not installed on the original tank and without one, the spray aerator may not be adding much benefit. It is recommended that the City install an active ventilator on the existing tank vent or reservoir access hatch and proceed with installing the recently purchased replacement pump and new stainless steel piping. Once the system is fully operational, it is recommended the City monitor TTHM removal performance in the summer of 2020. If low TTHM removal (< 20%) is occurring, it is recommended to install a larger pump (up to 200 gpm capacity) and additional spray nozzles to accommodate higher flows. Since the City already has the 100 gpm pump, it is not recommended to install a larger one at this time. The pump should be run continuously during warmer summer and fall months and does not need to be utilized in the winter or much of the spring. 24-hour operation should initially be implemented and can be scaled back if TTHM removal is shown to be effective.

City should installing and active tank ventilation system and replace circulation pump and piping. Monitor TTHM removal and consider installing a larger pump capacity if removal rates remain low.

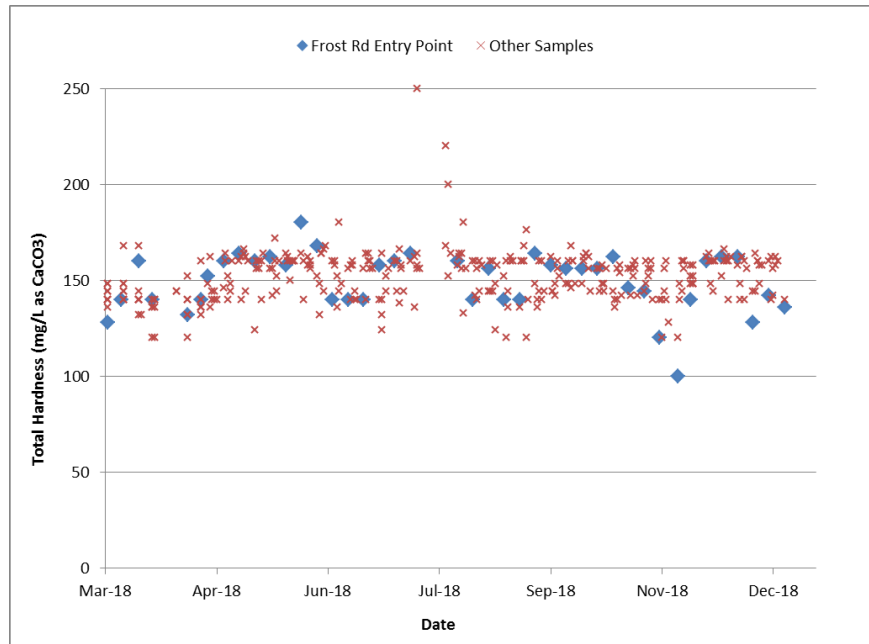
Figure 3-6 Water Hardness throughout Distribution System

Values for hardness reported by the City consistently appear to be slightly higher than those reported by PCWR, and it is suggested that the City calibrate and verify the accuracy of their analytical equipment. This could be performed in conjunction with checking the City's chlorine analyzers (discussed in the next section, "Chlorine Residual"). Magnesium hardness was sampled (by lab analysis) as part of this study at the plant and within the City and was observed to be 36 to 40 mg/L as CaCO₃. The observed values for magnesium hardness are approaching the suggested limit of 40 mg/L as CaCO₃, and lowering the plant finished water target between 130 and 140 mg/L as CaCO₃ could help alleviate scaling issues. Of course, operating at a lower hardness is an added cost for PCWR. Furthermore, a lower hardness may not even be achievable with the Shalersville WTP ion exchange system, as the spent regeneration brine is sent to the Streetsboro wastewater treatment plant. Increasing the total dissolved solids load at this plant would likely result in a discharge permit violation. To mitigate dissolved solids, the Shalersville

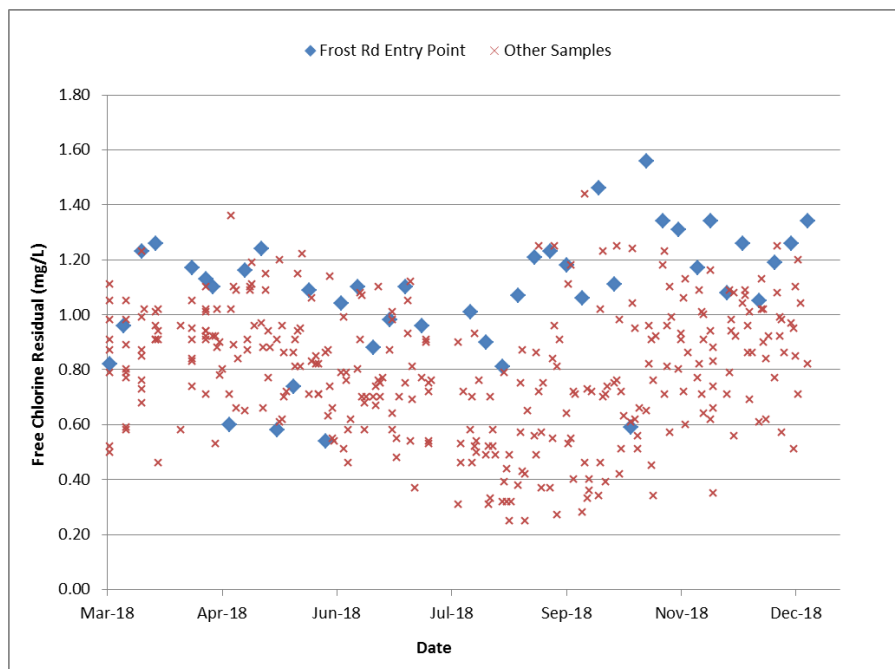
Figure 3-7 Free Chlorine Residual Sampling Results

According to City-collected data from 2018, free chlorine residual at the entry point is often observed several tenths below the Shalersville WTP residual of 1.5 mg/L. This indicates chlorine decay could be occurring prior to entering the system. However, the contact time between the Shalersville supply and City entry point is only 5 to 8 hours based on normal flow

conditions, and such a decrease in residual is unusual. It is possible that the City's chlorine analyzers require calibration and it is suggested that PCWR perform a secondary sampling event along with the City to verify accurate readings. If the same decay is observed, PCWR is encouraged to perform sampling along the waterline which supplies the City in order to identify the location of any in chlorine residual sink.

Recommendation:
 City should continue to calibrate chlorine analyzers, and PCWR should perform secondary sampling to verify accuracy. PCWR should investigate the cause of residual decay prior to entering the City if this condition is verified.

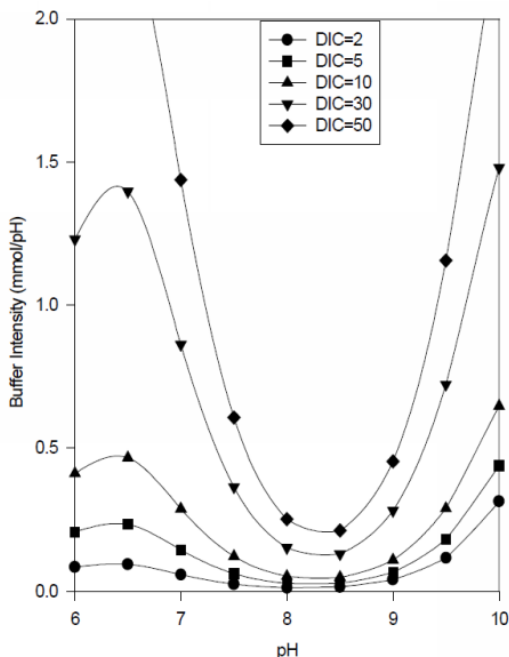
Figure 3-8 Buffer Intensity as a Function of pH and DIC

relating to maintaining a low corrosion and metal release rate). A graph of buffer intensity as a function of pH and DIC is shown in Figure 3-8 which illustrates minimum intensity between pH of 8 and 8.5. Note that this figure was taken from the 2016 US EPA Guidance Manual for Corrosion Control, which actually recommends not operating water systems at a pH between 8 and 8.5.

In summary, adding sodium hydroxide to raise pH between 8.2 and 8.3 is causing more negative impacts than positive. It costs the County unnecessary expenses, increases TTHM formation potential, produces a high scaling potential water, limits the effectiveness of phosphate chemicals, and minimizes the buffer intensity. Unfortunately, this pH target is an Ohio EPA mandated operation. PCWR has previously attempted to negotiate lowering the pH with Ohio EPA without success. It is recommended that the County continue to pursue negotiations to propose a finished water pH requirement of 7.6 ± 0.2 . This situation is not unique to PCWR and many utilities throughout Ohio have similar requirements with similar impacts. Fortunately, Ohio EPA has recently begun to acknowledge the negative impacts of high pH on water systems, and the current requirement may have been a kneejerk reaction to recent corrosion control publicity. On April 19, 2019, the EPA released a formal response to comments document regarding optimal corrosion control guidelines. Within this document, similar arguments were made and the EPA is acknowledging the negative impacts which will likely lead to changes in the guidelines.

The current pH of 8.3 is causing numerous issues, and it is recommended that PCWR continue to negotiate with Ohio EPA to reduce this to a pH of 7.6 ± 0.2 .

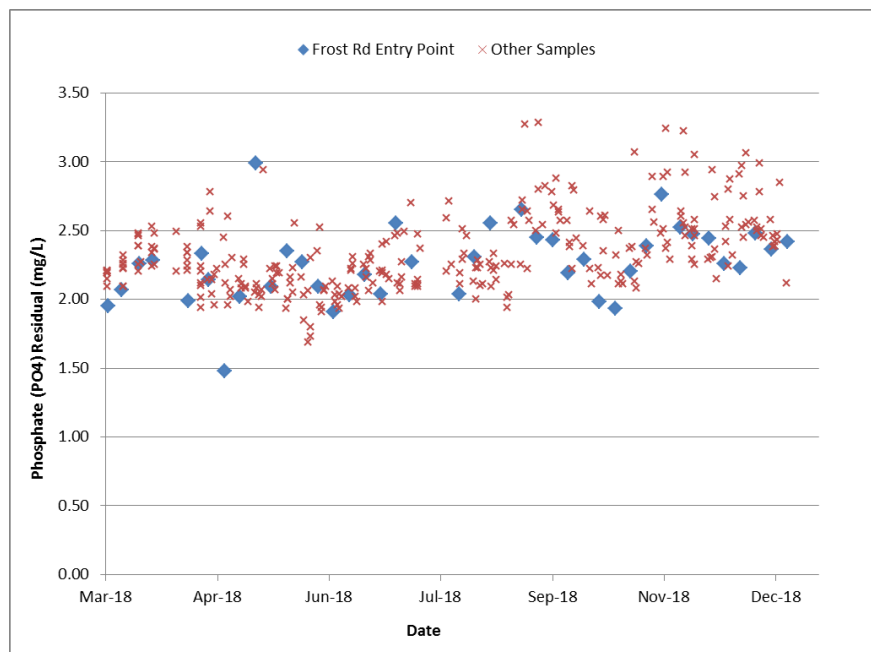
Figure 3-9 Residual Phosphate (as PO_4) Sampling Results

As seen in the figure, phosphate residual remains relatively constant throughout the year and at different locations in the system. It is often observed as slightly higher than the average concentration reported at the Shalersville WTP MORs, but this is likely due to the sampling technique employed by the City, which is not required to be reported. Regardless, given the consistency of the results, it is evident that little consumption of phosphate is occurring within

the distribution system, which is expected for a system that has established a coating. However, as discussed, orthophosphate for lead control is optimal at a pH between 7.2 and 7.8, and higher values give preference to binding with other cations (such as calcium and magnesium) over lead. Since Shalersville operates at a pH of 8.2 to 8.3, the addition of orthophosphate is effectively doing little for prevention of lead corrosion. This is not, however, to suggest that lead corrosion is occurring, as higher pH will effectively mitigate corrosion. Similarly, polyphosphates are optimal below a pH of 8.0 for other metal sequestration. Once again, operating at a lower pH would be recommended in order to effectively utilize the currently fed corrosion inhibitor.

The corrosion inhibitor is less effective at the elevated pH, and pH should be lowered to realize its benefit.

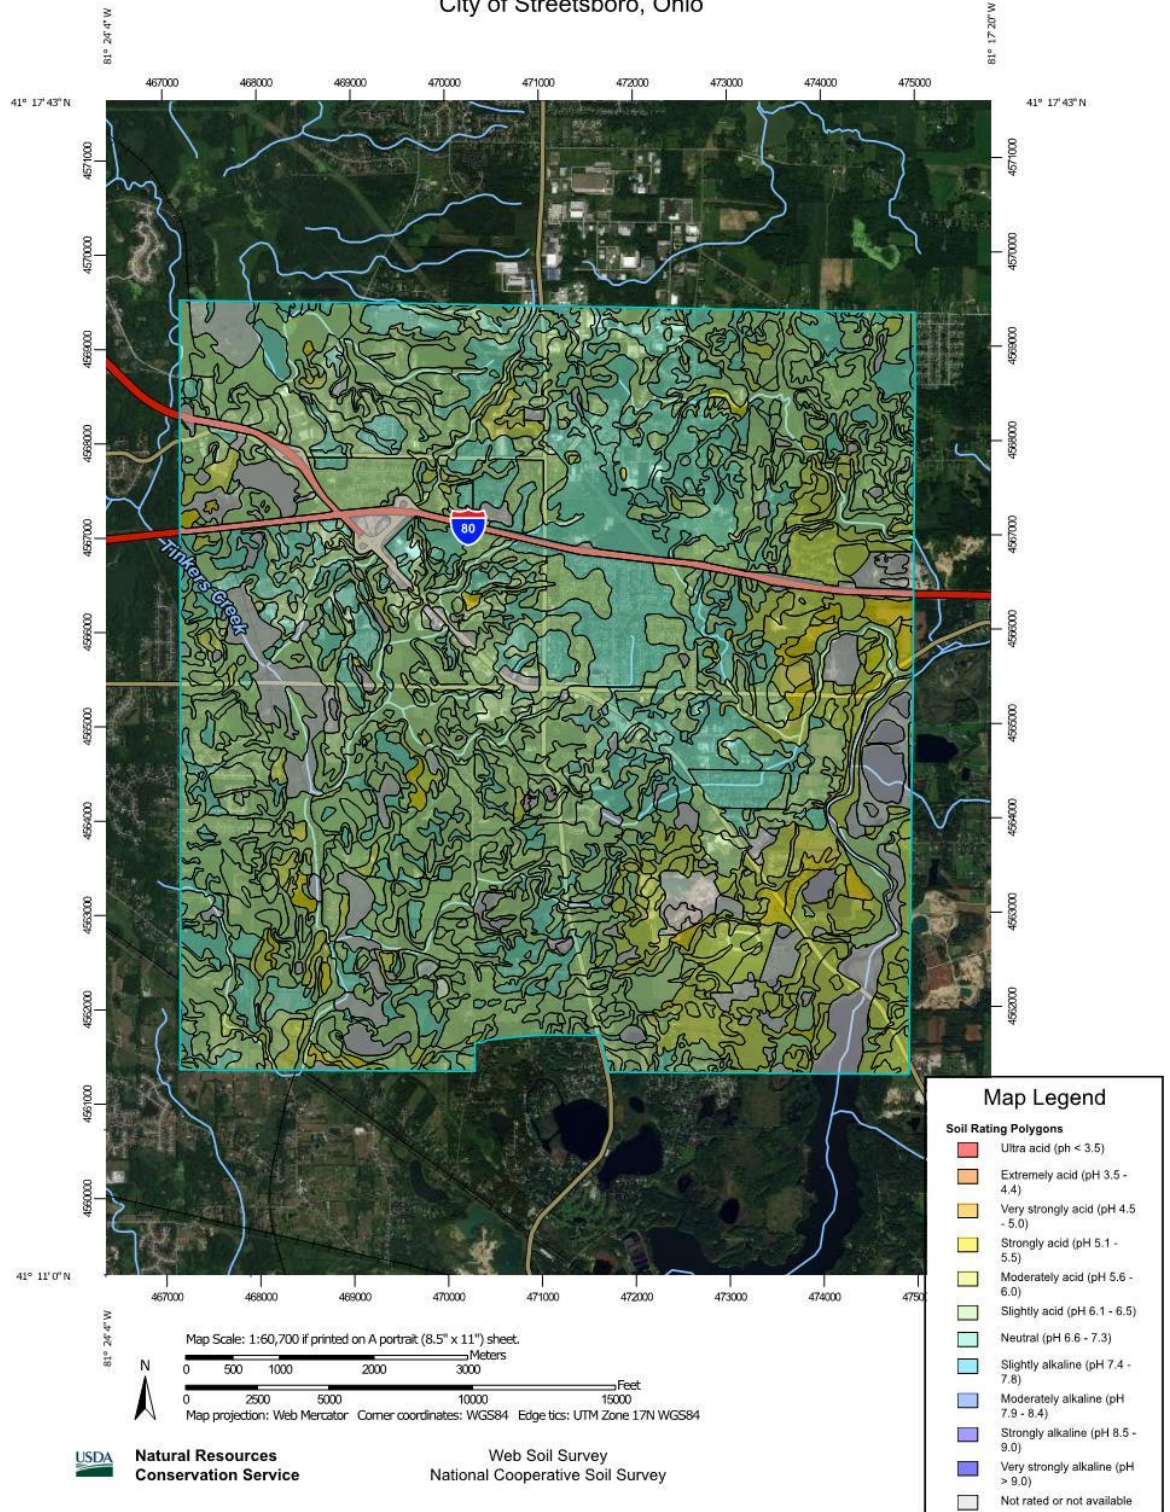
Figure 3-10 Soil Acidity Map (1973 Study)

Although changes in water chemistry can be implemented to help prevent corrosion inside of pipes, there is also the possibility or risk of pipes (or bolts / fittings) corroding from the outside due to corrosive soils or backfill conditions. AECOM contacted the Natural Resources Conservation Service to obtain 2018 soil survey data, and subsequently generated a soil acidity map for Streetsboro using the NRCS Web Soil Survey application tool. This map is presented as Figure 3-10 on the following page. City-wide soil acidity is generally neutral with some pockets of moderately alkaline (pH 7.9 to 8.4) and moderately acidic (pH 5.6 to 6) soils. However, there are areas of strongly and very strongly acidic soils (pH 4.5 to 5.5). These predominantly exist in the (largely undeveloped) eastern and southeastern regions of the City limits, although some pockets are found in other areas.

The City also noted that certain areas have waterlines where limestone backfill was used during construction. As limestone dissolves in groundwater, it can produce alkali water which can be corrosive to metals. These areas include the Interstate Commerce Center industrial park area and Seasons Road. Specifically, the City has noted that the nuts/bolts on the fittings of this piping experience severe corrosion. The cast or ductile iron pipes in these areas would be the material most susceptible to accelerated corrosion due to pH, and a map of the City waterlines by pipe material is provided in Appendix A as Figure 2.

When performing spot-repairs of cast or ductile iron pipes, the City should install cathodic protection. Larger-scale repair of cast or ductile iron pipe should involve replacement with PVC.

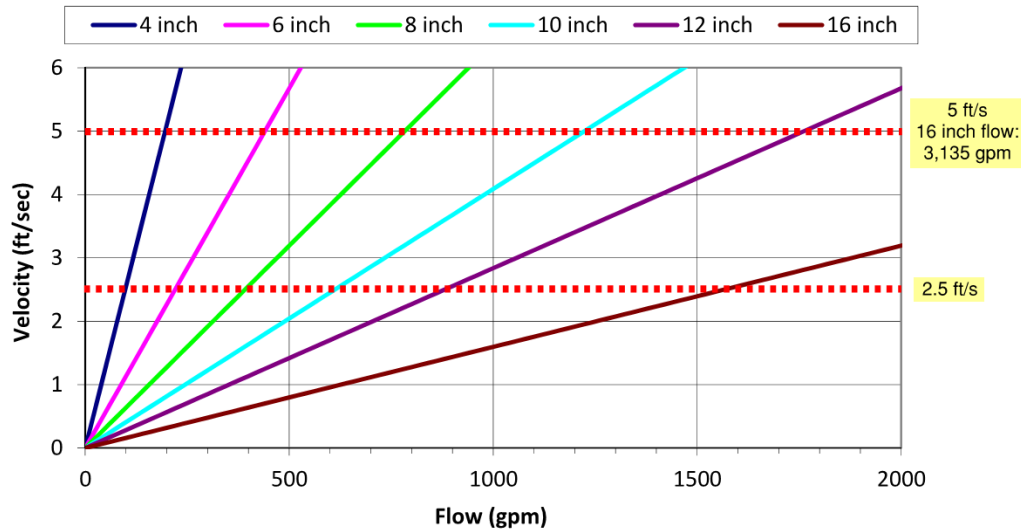
Figure 3-11 Pipe Velocity and Flow

The graph provides a reference for the hydrant flow needed to achieve minimum velocities in a single pipe / direction of flow. Since the City individually flushes all 929 of their hydrants and many privately-owned hydrants, it is doing an excellent job of achieving single-direction flow. The City has noted that a flushing event costs nearly \$50,000 in labor (including overtime), water use, and miscellaneous repairs. With customer complaints having ceased since completion of the recent flushes, there may be an opportunity to dial back the flushing efforts. During the upcoming flush (fourth event in the now-biannual protocol), the City should conduct visual sediment tests by collecting water from the hydrants in a white container. If water is running clear after the first few seconds, a flush is likely not needed. If little or no sediment is observed throughout the system, the majority of the lines should be able to be reduced to flushing once per year.
