# FACILITY CONDITION ASSESSMENT

SACRAMENTO CITY UNIFIED SCHOOL DISTRICT  
5735 47<sup>th</sup> Avenue  
Sacramento, California 95824

CHARLES A. JONES CAREER AND EDUCATION CENTER  
5451 Lemon Hill Avenue  
Sacramento, California 95824

June 4, 2020

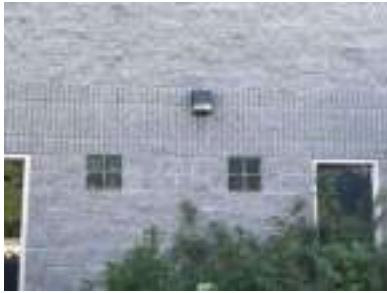
**Light Fixture in Poor condition.**

any type w/ LED Replacement, 400 W  
00A - Building 100/200 Building exterior

Client reported lighting needs improvement - AssetCALC ID: 1455844

Uniformat Code: D5022  
Recommendation: **Replace in 2020**

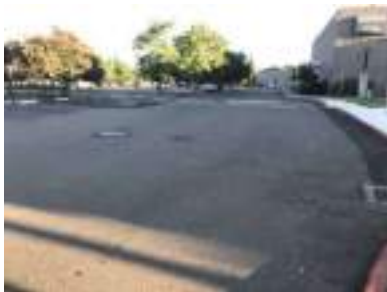
**Parking Lots in Poor condition.**

Asphalt Pavement  
Site

Striping faded - AssetCALC ID: 1456052

Uniformat Code: G2022  
Recommendation: **Seal & Stripe in 2020**

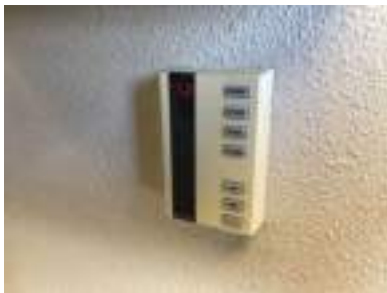
**BAS/HVAC Controls in Poor condition.**

Extensive/Robust BMS or Smart Building  
System  
00A - Building 100/200 Throughout all buildings

Client reported system not fully functional - AssetCALC ID: 1455801

Uniformat Code: D3068  
Recommendation: **Upgrade in 2020**

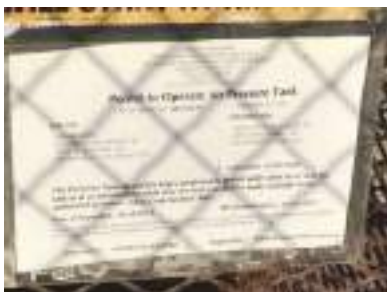
**Air Compressor in Poor condition.**

5 HP  
00B - Building 300 Building exterior

Unit appears to be non-functional or near - AssetCALC ID: 1455911

Uniformat Code: D2091  
Recommendation: **Replace in 2020**

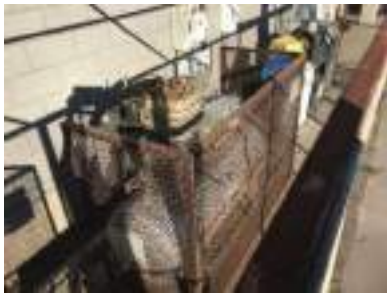
**Air Compressor in Poor condition.**

10 HP  
00B - Building 300 Building exterior

Unit appears to be non-functional or near - AssetCALC ID: 1455895

Uniformat Code: D2091  
Recommendation: **Replace in 2020**

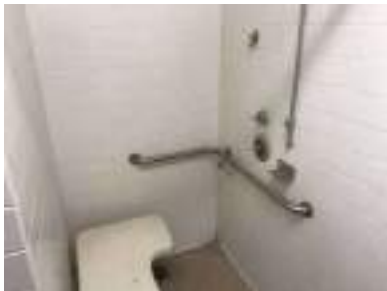
**Shower in Failed condition.**

Ceramic Tile  
00B - Building 300 Restrooms

Non-functional hardware - AssetCALC ID: 1455906

Uniformat Code: D2017  
Recommendation: **Replace in 2019**

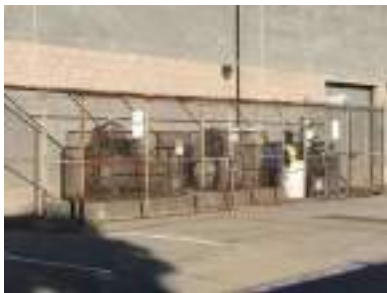
**Fences & Gates in Poor condition.**

Chain Link, 6' High  
00B - Building 300 Site

Rusted and deteriorating - AssetCALC ID: 1455917

Uniformat Code: G2041  
Recommendation: **Replace in 2020**

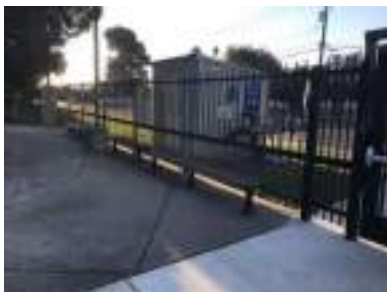
**Fences & Gates in Poor condition.**

any Painted Surface  
Site

Painted major peeling - AssetCALC ID: 1456056

Uniformat Code: G2041  
Recommendation: **Prep & Paint in 2020**

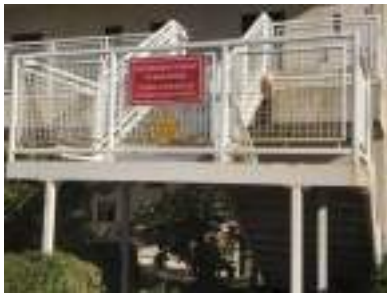
### Fences & Gates in Poor condition.

any Painted Surface  
00E - Building 500 Site

Significant exposed metal/rust - AssetCALC ID: 1456002

Uniformat Code: G2041  
Recommendation: **Prep & Paint in 2020**

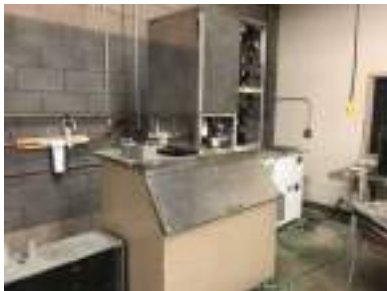
### Commercial Kitchen in Poor condition.

Icemaker, Freestanding  
00B - Building 300 O305 - HVAC Shop

Not functional - AssetCALC ID: 1455866

Uniformat Code: E1093  
Recommendation: **Replace in 2019**

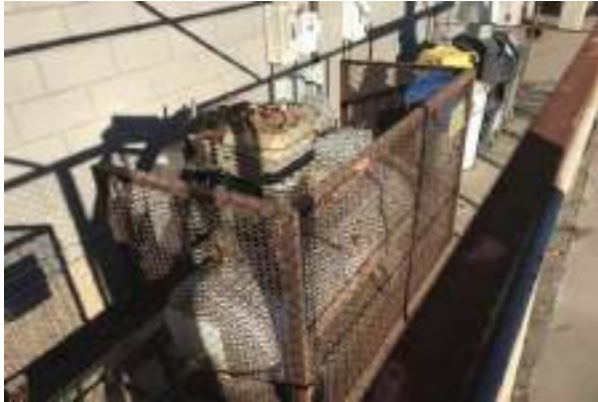
#1	DEFICIENCY AIR COMPRESSOR
----	---------------------------

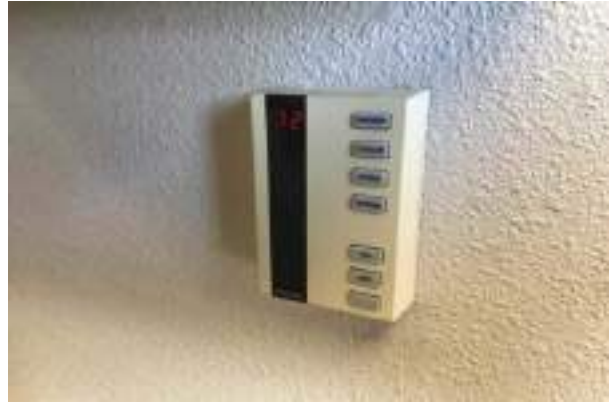
#2	DEFICIENCY EMS/BAS CONTROLS
----	-----------------------------

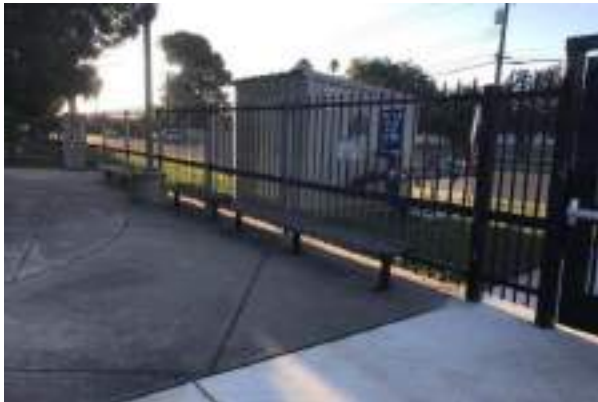
#3	DEFICIENCY FENCES & GATES, PAINTED SURFACE
----	--

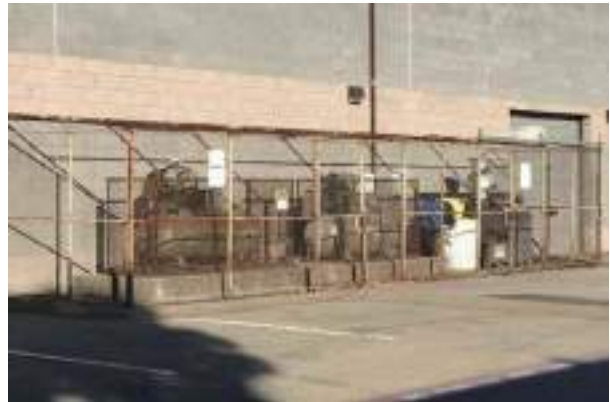
#4	DEFICIENCY FENCES & GATES, CHAIN LINK
----	---------------------------------------

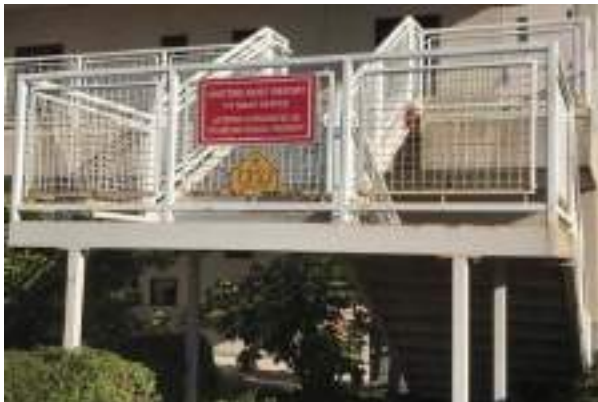
#5	DEFICIENCY G20 FENCES & GATES, PAINTED SURFACE
----	--

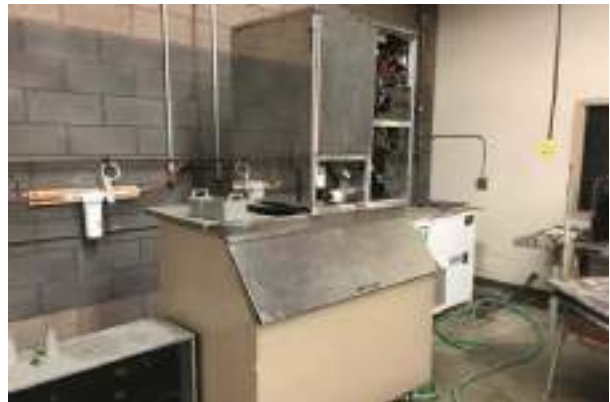
#6	DEFICIENCY ICEMAKER
----	---------------------

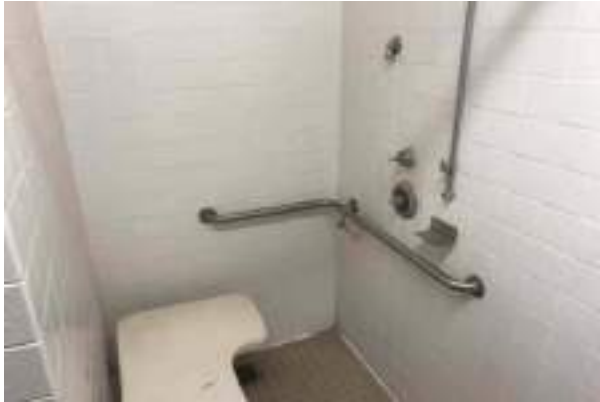
#7	DEFICIENCY SHOWER FIXTURES
----	----------------------------
