FACILITY CONDITION ASSESSMENT

SACRAMENTO CITY UNIFIED SCHOOL DISTRICT
5735 47th Avenue
Sacramento, California 95824

PACIFIC ELEMENTARY SCHOOL
6201 41st Street
Sacramento, California 95824

June 10, 2020

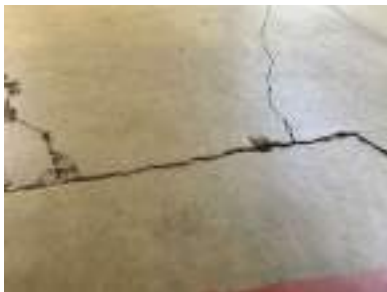
Sidewalk, Concrete Sections/Small Areas
SITE Site

Pedestrian Pavement in Failed condition.

Cracked pedestrian pavement observed near admin area 002 - AssetCALC ID: 1373705

Uniformat Code: G2031
Recommendation: **Replace in 2019**

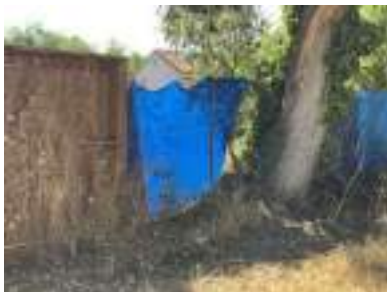
Chain Link, 6' High
SITE Site

Fences & Gates in Failed condition.

Gap in fencing at southern most part of playfields. - AssetCALC ID: 1371757

Uniformat Code: G2041
Recommendation: **Replace in 2019**

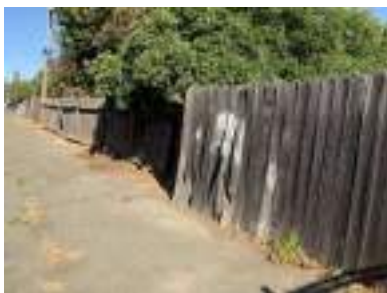
Wood Board, 6' High
SITE Site

Fences & Gates in Poor condition.

Wood fence is deteriorated and will need replacement. - AssetCALC ID: 1371694

Uniformat Code: G2041
Recommendation: **Replace in 2021**

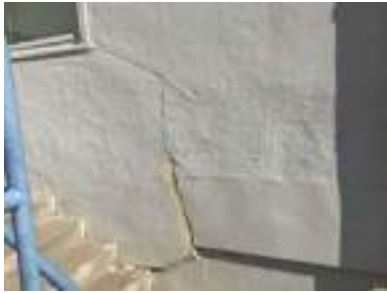
Structural, Superstructure
001 Cafeteria/Kitchen Building exterior

Cracking was noted at the southeast corner of the 001 building (Auditorium). A professional engineer must be retained to analyze the existing condition, provide recommendations and, if necessary, estimate the scope and cost of any required repairs. The cost of this study is included in the cost tables. Due to the ambiguity of the required repair scope at the time of this assessment, the cost for any possible subsequent repairs is not included.

East side of building - AssetCALC ID: 1364734

**Recommended Follow-up Study:
Structural, Superstructure**

Uniformat Code: P000X
Recommendation: **Evaluate/Report in 2019**

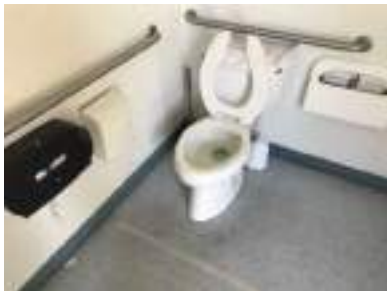
Commercial Water Closet
P10 Portable Classroom Restrooms

Toilet in Fair condition.

Uniformat Code: D2011
Recommendation: **Replace in 2034**

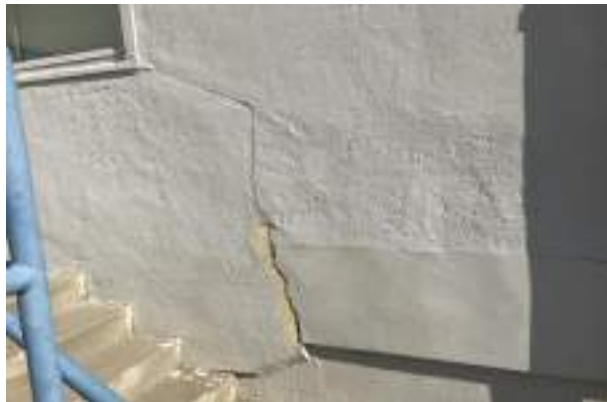
#36	ENGINEER, STRUCTURAL, SUPERSTRUCTURE, EVALUATE/REPORT. CRACKING NOTED AT 001 BUILDING (AU
-----	---
