FACILITY CONDITION ASSESSMENT

SACRAMENTO CITY UNIFIED SCHOOL DISTRICT
5735 47th Avenue
Sacramento, California 95824

JOHN STILL MIDDLE (EAST CAMPUS)
2250 John Still Drive
Sacramento, California 95832

June 11, 2020

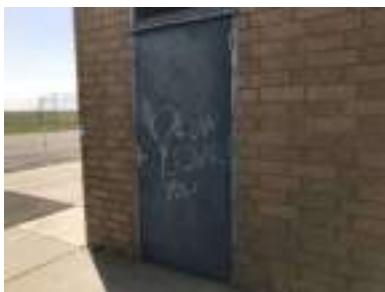
Exterior Door in Poor condition.

Wood Solid-Core
00D Gymnasium East mechanical room

Wood is damaged and delaminating. - AssetCALC ID: 1479366

Uniformat Code: B2032
Recommendation: **Replace in 2021**

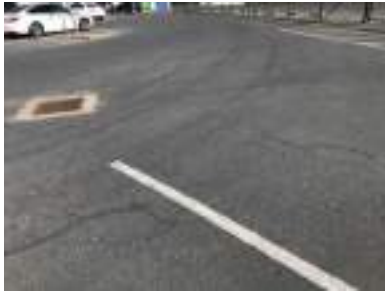
Parking Lots in Poor condition.

Asphalt Pavement
Site West parking lot

Has been seal coated recently, but about 25% has alligator cracking. Would require an extensive cut and patch, so recommend replace all. - AssetCALC ID: 1479149

Uniformat Code: G2022
Recommendation: **Mill & Overlay in 2021**

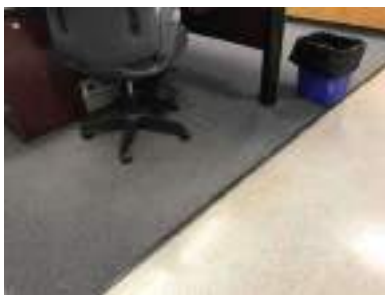
Interior Floor Finish in Poor condition.

Carpet Commercial Standard
00B Office, Classrooms Office - reception

Wrinkled, threadbare, trip hazard - AssetCALC ID: 1479369

Uniformat Code: C3025
Recommendation: **Replace in 2019**

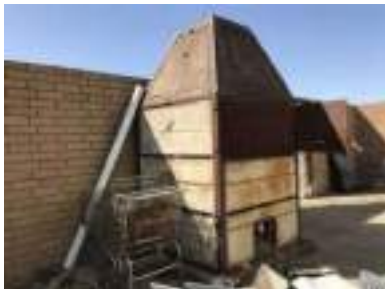
Kiln in Failed condition.

5 kW
Site, yard next to E

Kiln is deteriorated and no longer in use. - AssetCALC ID: 1479123

Uniformat Code: E1029
Recommendation: **Remove in 2019**

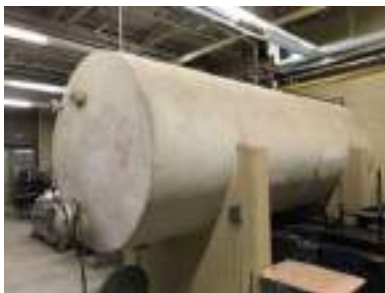
Water Storage Tank

3700 GAL
00E Classrooms Boiler room-B001

No longer in use - AssetCALC ID: 1479350

Uniformat Code: D2023
Recommendation: **Remove in 2019**

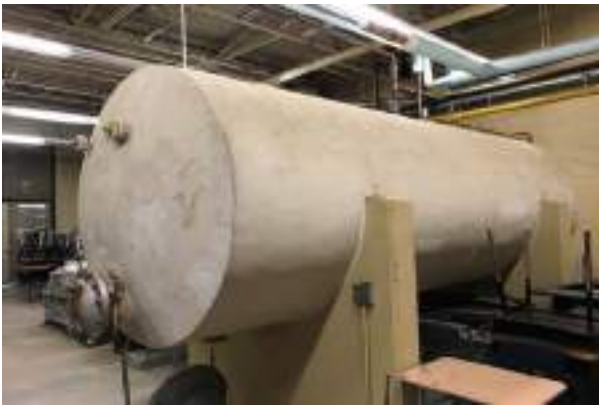
#27	ABANDONED TANK, TO BE REMOVED
-----	-------------------------------

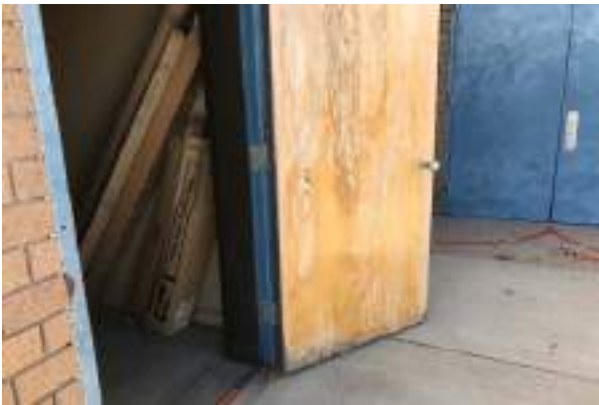
#45	DAMAGED DOOR AT GYM WATER HEATER ROOM
-----	--

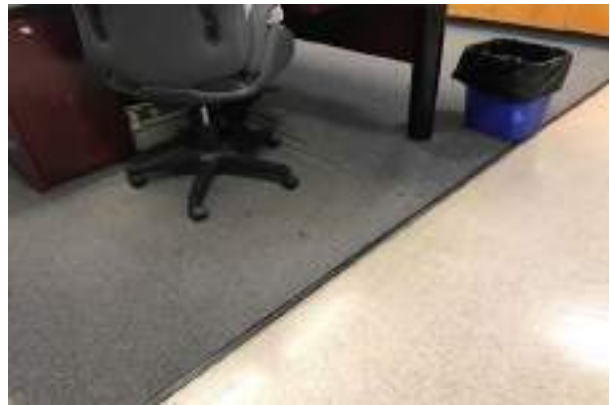
#46	OLD CARPET AT RECEPTION/OFFICE
-----	-----------------------------------

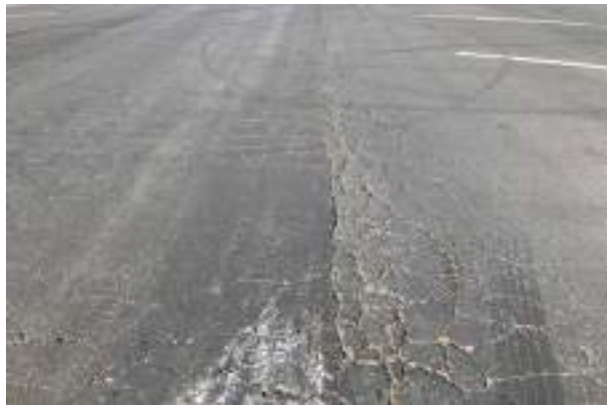
#52	DETERIORATED ASPHALT AT WEST PARKING LOT
-----	--

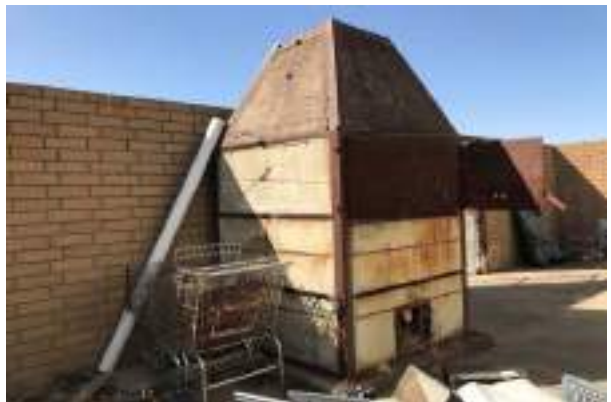
#54	KILN, TO BE REMOVED
-----	---------------------
