FACILITY CONDITION ASSESSMENT

SACRAMENTO CITY UNIFIED SCHOOL DISTRICT
5735 47th Avenue
Sacramento, California 95824

ALBERT EINSTEIN MIDDLE SCHOOL
9325 Mirandy Drive
Sacramento, California 95826

June 10, 2020

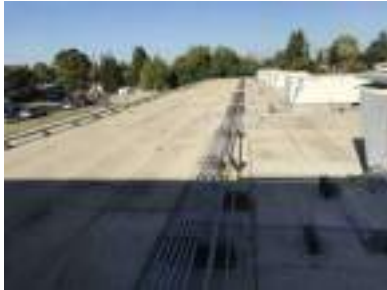
Modified Bituminous
00A Classrooms 4 - 14 00A-Roof

Roof in Poor condition.

Roof has problems with seals cracking and blisters in the bituminous material. - AssetCALC ID: 1482944

Uniformat Code: B3011
Recommendation: **Replace in 2020**

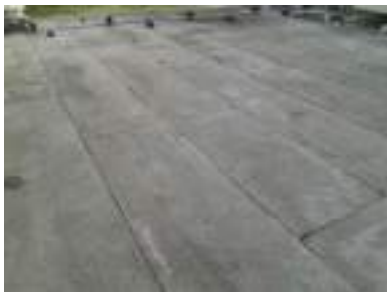
Asphalt Shingle 20-Year
00D Gymnasium 00D-Roof

Roof in Poor condition.

Cracking and bubbling with sealant failure observed throughout the roof system. - AssetCALC ID: 1420758

Uniformat Code: B3011
Recommendation: **Replace in 2021**

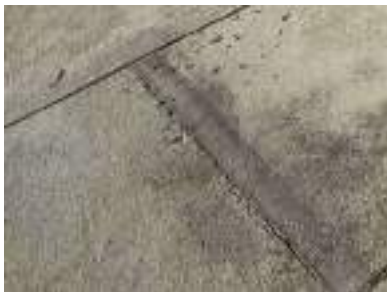
Modified Bituminous
00E Classrooms 22 - 26 00E-Roof

Roof in Poor condition.

Cracking and bubbling and sealant failure throughout the roof system - AssetCALC ID: 1420766

Uniformat Code: B3011
Recommendation: **Replace in 2021**

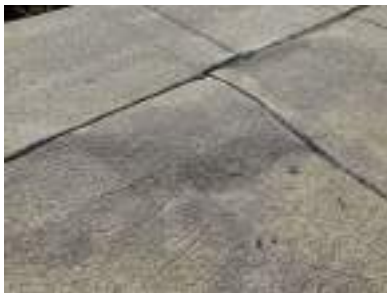
Modified Bituminous
00B Office, Classrooms 1-3, 15-17, 52-60 00B-Roof

Roof in Poor condition.

Bubbling and cracking throughout roof system, failing seals - AssetCALC ID: 1420793

Uniformat Code: B3011
Recommendation: **Replace in 2021**

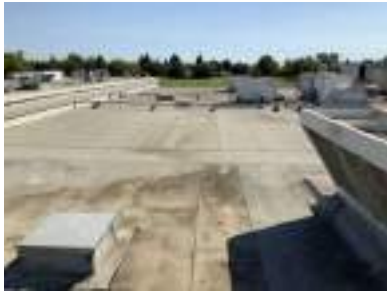
Modified Bituminous
00F Kitchen, Multipurpose 00F-Roof

Roof in Poor condition.

Cracking and bubbling across whole roof system. Sealer has cracking and possible failure. - AssetCALC ID: 1420731

Uniformat Code: B3011
Recommendation: **Replace in 2021**

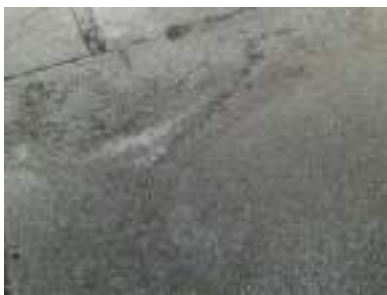
Modified Bituminous
00D Gymnasium 00D-Roof

Roof in Poor condition.

Cracking and bubbling and seal failure throughout roof system - AssetCALC ID: 1420711

Uniformat Code: B3011
Recommendation: **Replace in 2021**

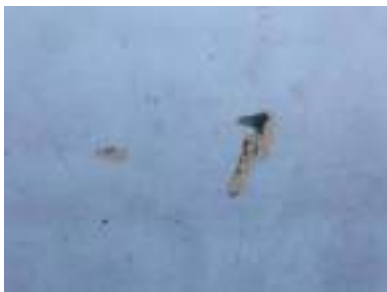
any Painted Surface, 1-2 Stories
00E Classrooms 22 - 26 00E-Building exterior

Exterior Wall in Poor condition.

Uniformat Code: B2011
Recommendation: **Prep & Paint in 2020**
