Inspection Details	
Year	2019
Make	Bobcat
Model	T590
Date of Inspection	03/05/2024
Location of Inspection	5875 State Street , Bettendorf, IA, 52722, USA
Serial Number	ALJU30285
Cylinders	See Notes
Engine Hours	2,352
EMS Warning Lights	No Active Warnings
Travel Control	No Damages Observed
Operator's Seat	See Notes
Mirrors	N/A
Radio	No
A/C	No
Steering Wheel	N/A

Aspen Field Services

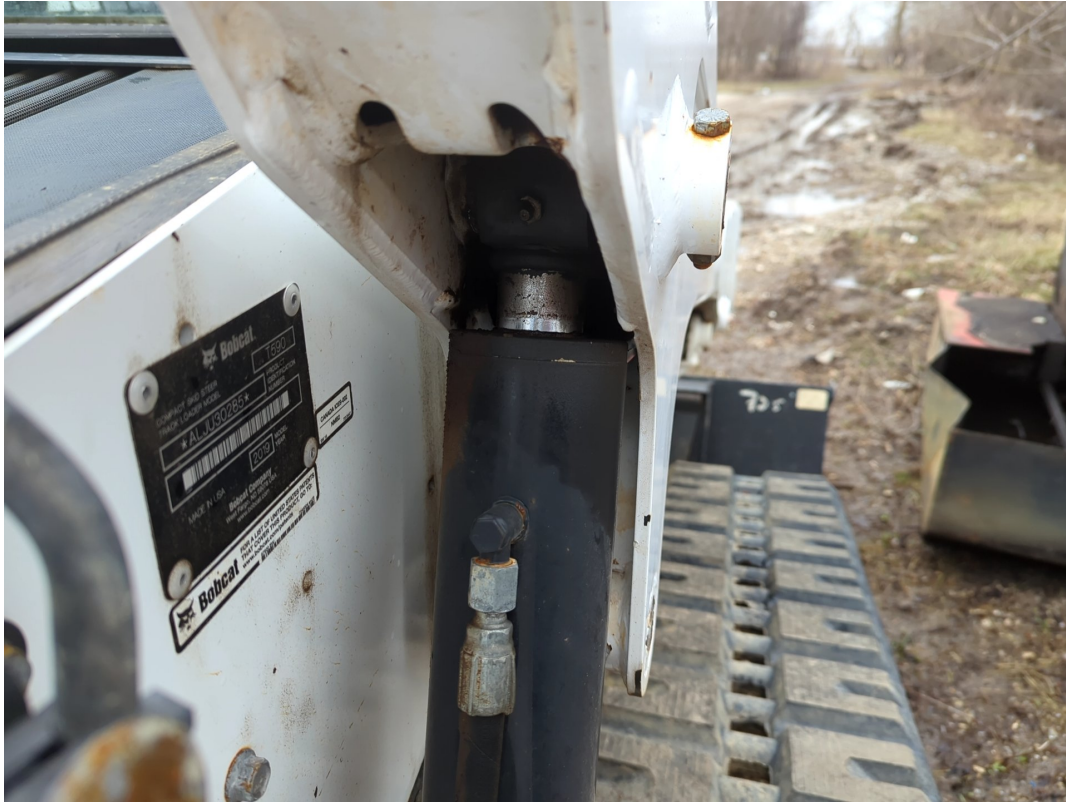
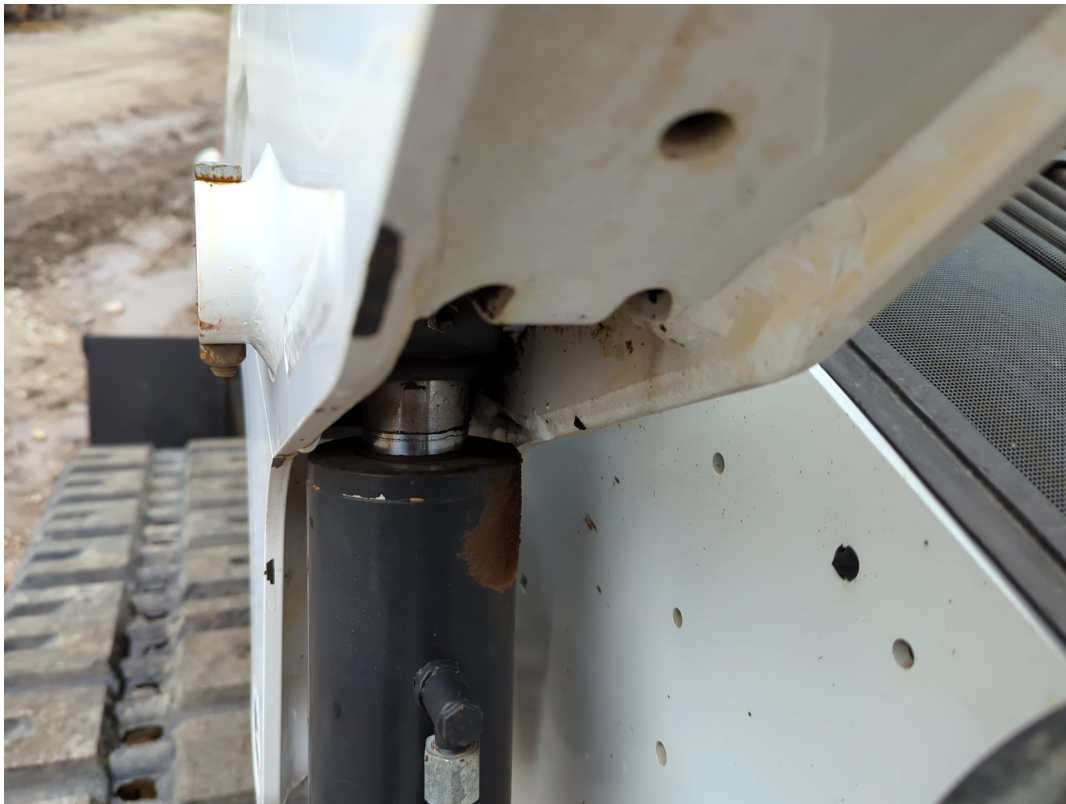
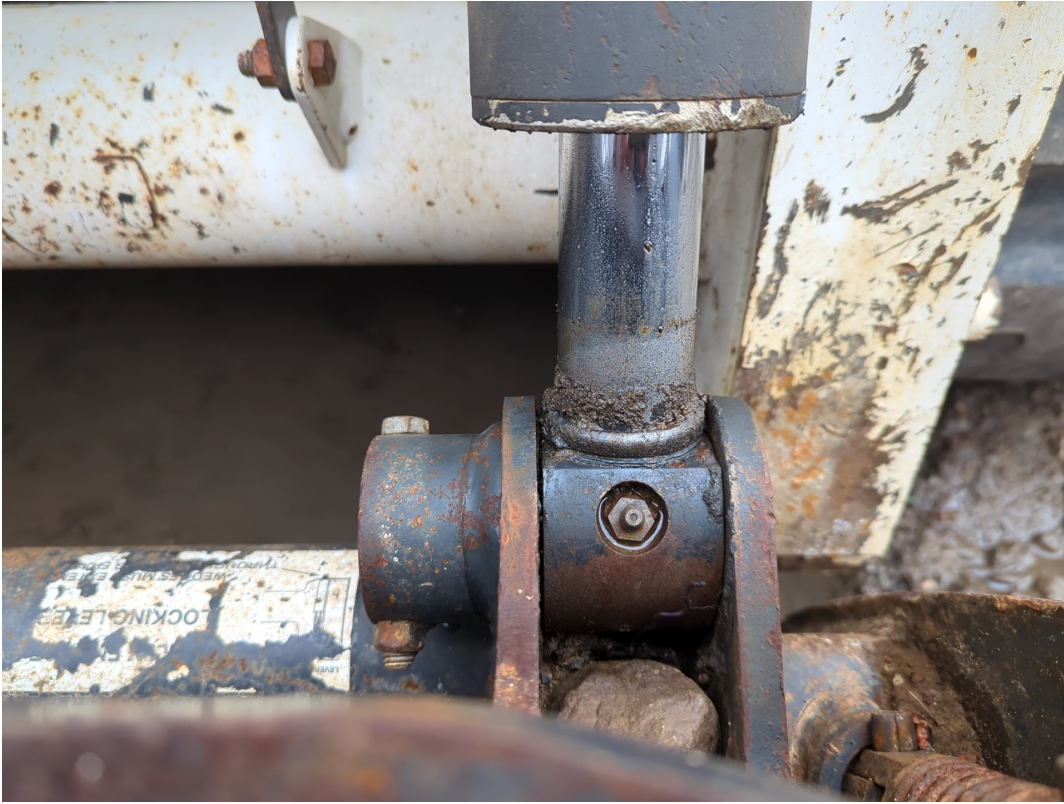
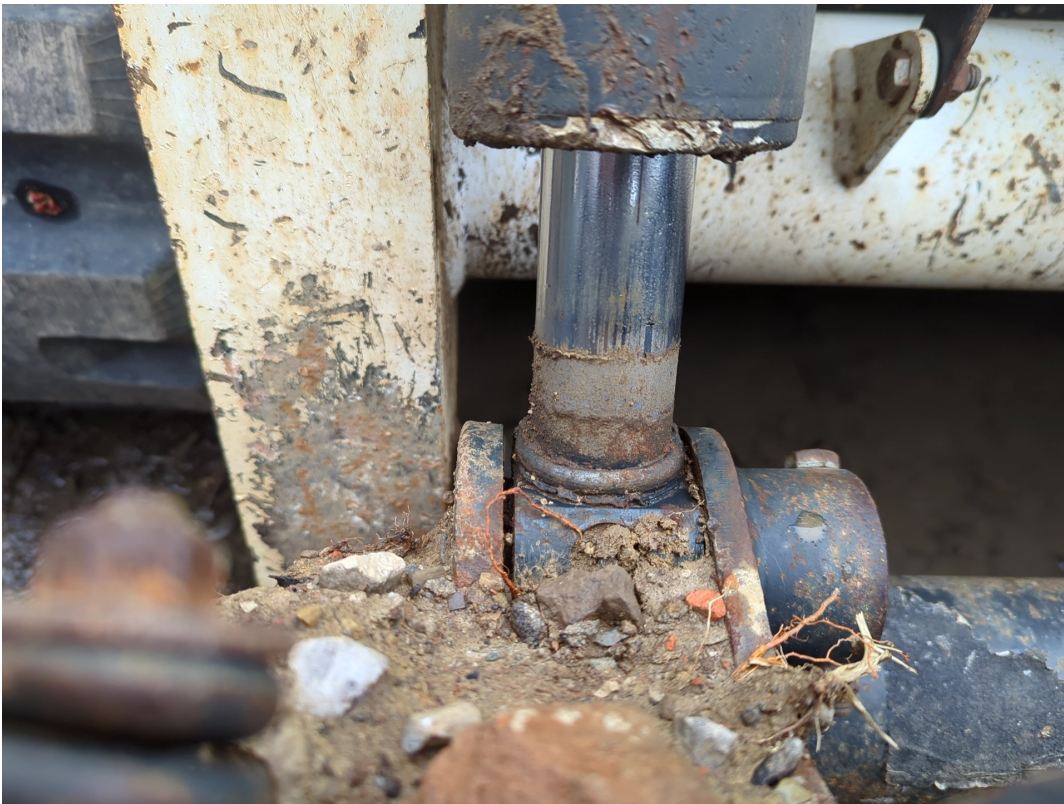
Cylinders / 03-05-2024

Inspection Details Cont'd	
Pedals	No Damages Observed
Floorboard	No Damages Observed
Power Mirrors	No
Heated Mirrors	No
Switches and Controls	No Damages Observed
Steps	See Notes
Handrails	No Damages Observed
Oil Dipstick	Good Level / Dark Color
Engine Compartment	See Notes
Exhaust	No Damages Observed
Axles	N/A
Deluxe Instrumentation	No
Backup Camera	No
ROPS	No Damages Observed
Front Lights	No Damages Observed
Rear Lights	See Notes
Left Track Condition	See Notes
Left Track Brand	Could Not Be Located
Left Track Size	Could Not Be Located
Left Track Tread Depth Measurement	1"
Right Track Condition	See Notes
Right Track Brand	Could Not Be Located
Right Track Size	Could Not Be Located
Right Track Tread Depth Measurement	1"
Attachments - Bucket	No Damages Observed
Comments	The unit runs and drives. The site confirmed that the lights are operational. The left taillight lens is damaged at the bottom. The rear work lights are absent. The headliner in the cab seems to be drooping at the rear. The material on the operator's seat is torn. The upper engine enclosure at the rear appears to be bent and has a dent in the screen. The engine oil is dark in color. The bucket steps are bent. The left track appears to be loose. The sprockets on both sides are worn out. The lift cylinder is leaking. The right sprocket appears to be oily, indicating a leak from the final drive. The tilt cylinders appear to be oily and possibly leaking.
