Inspection Details	
Year	2015
Make	Bobcat
Model	T770
Date of Inspection	04/26/2024
Location of Inspection	700 E Temperance St, Ellettsville, IN, 47429
Serial Number	A3P814504
Cylinders	See Notes
Engine Hours	2,589
EMS Warning Lights	Active Warnings
Travel Control	No Damages Observed
Operator's Seat	No Damages Observed
Mirrors	N/A
Radio	Yes - See Notes
A/C	Yes
Steering Wheel	N/A

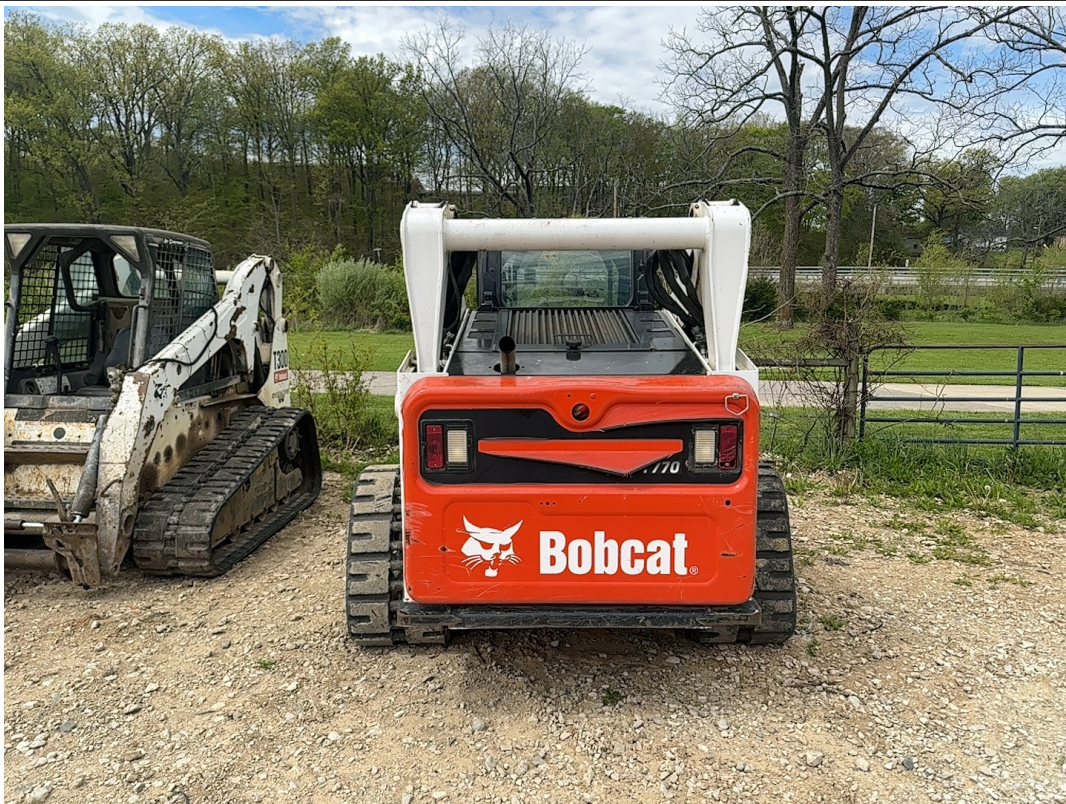
Rear / Rear Lights / ROPS / 04-26-2024

exhaust tip is bent on the bottom of the outlet. The engine oil is dark in color. The rear door latch could possibly not be operational; the rear door appears to be held shut using a hitch pin and hairpin. The backup on the rear door is missing a bolt that attaches the alarm to the door. The decals on the rear door are peeling off. Both of the lift cylinders appear to be oily at the head of the cylinder and possibly leaking. The pins on the ends of the tilt cylinders and coupler housing are worn; there is a gap between the pin and the coupler housing. The bob tach cylinder appears to be oily and possibly leaking. Sprockets are showing wear. The right track has cuts in the rubber and the lugs. The left track has some small cuts in the rubber lugs. The backup alarm is not operational. The rear work lights and tail lights are not operational. The front left arm auxiliary hydraulic fittings appear to have been leaking, leaving an oil stain on the lift arm. The rear outside part of the left and right lift arms have paint scratches, and the metal is showing rust.

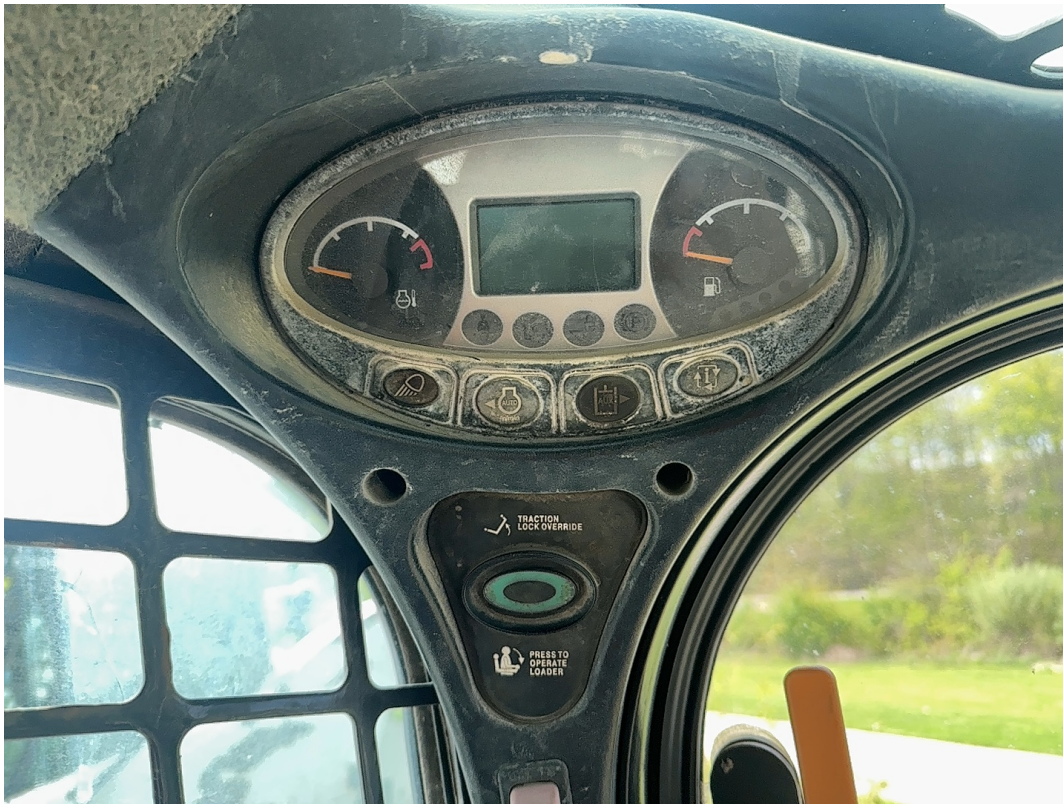
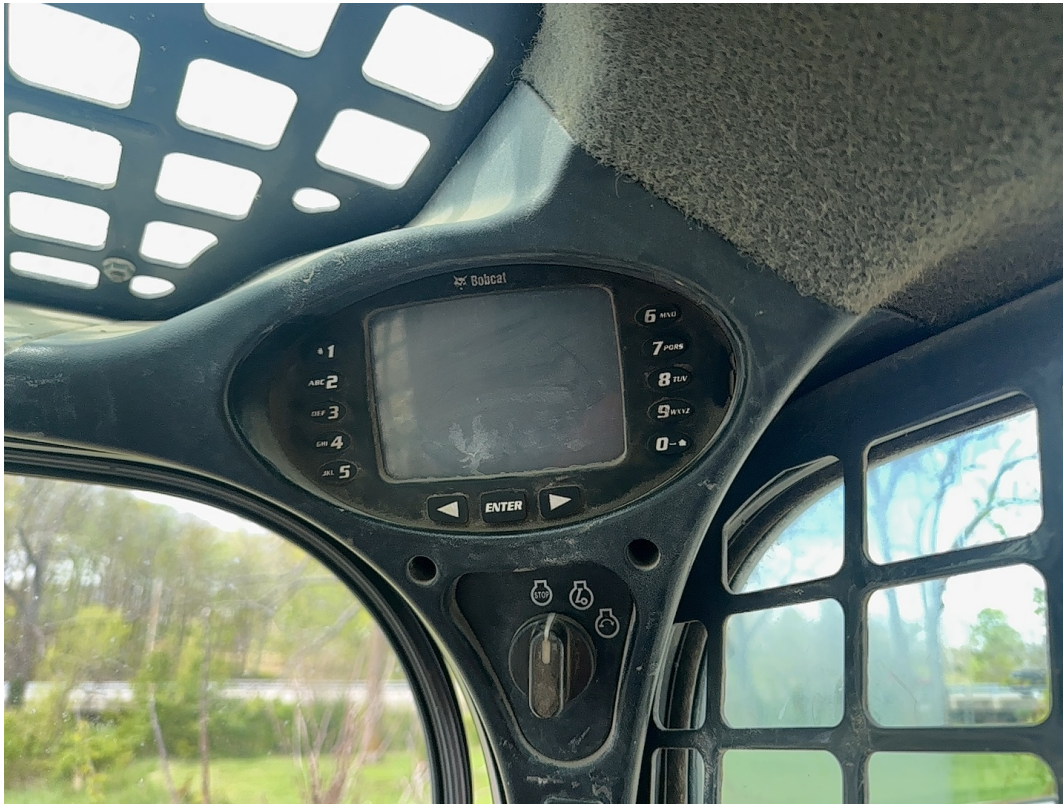
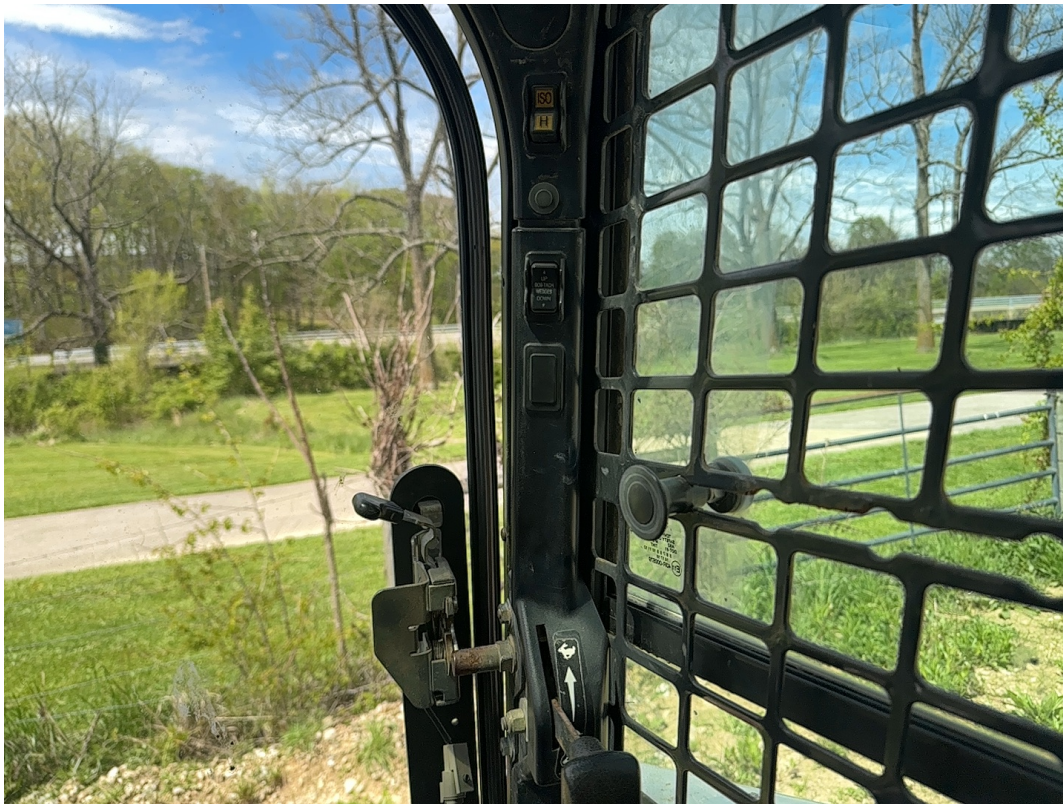
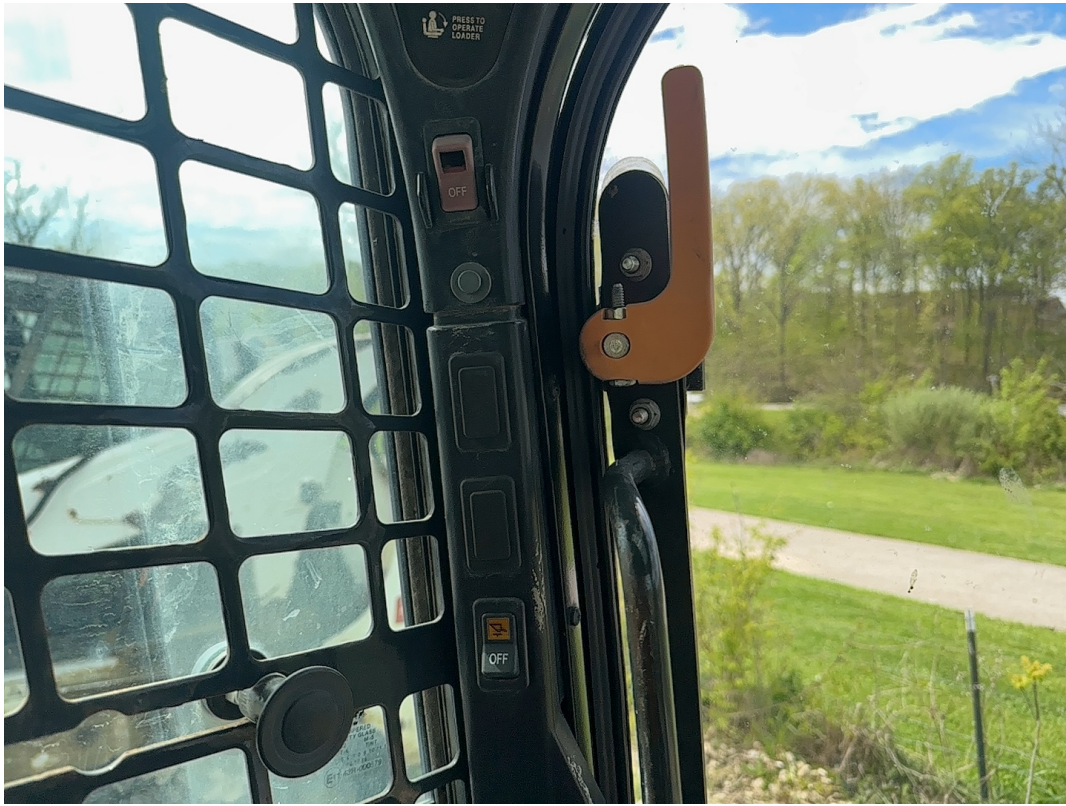
Switches and Controls / 04-26-2024

Inspection Details Cont'd	
Pedals	No Damages Observed
Floorboard	No Damages Observed
Power Mirrors	No
Heated Mirrors	No
Switches and Controls	See Notes
Steps	See Notes
Handrails	No Damages Observed
Oil Dipstick	Good Level / Dark Color
Engine Compartment	See Notes
Exhaust	Single Stack - See Notes
Axles	N/A
Deluxe Instrumentation	No
Backup Camera	No
ROPS	No Damages Observed
Front Lights	See Notes
Rear Lights	See Notes
Left Track Condition	See Notes
Left Track Brand	Bridgestone
Left Track Size	6678749
Left Track Tread Depth Measurement	26/32"
Right Track Condition	See Notes
Right Track Brand	Bridgestone
Right Track Size	6678749
Right Track Tread Depth Measurement	1"
Attachments - Bucket	See Notes
Comments	Unit runs and drives. The site confirmed that the horn does not work. The bucket cutting edge is missing, and the bucket is worn down to the bolt holes. Additionally, the edge of the bucket appears to be bent and cracked on the lip. The rear door has paint damage. The radio antenna is missing on the rear of the cab. The left track appears to be loose. The light housing over the left light is dented. The bucket step is bent. The front lower platform below the entry door is rusty. The front door is missing the wiper arm and blade. The entry step is bent to the right and missing bolts. The dash is displaying a low fuel warning at the time of inspection. The door shock is missing for the front door. The traction tape is worn off at the entry of the cab. The front door latch cover is missing. The park brake rocker switch light lens is broken out of the switch. The
