Inspection Detail

Client:	CloudStore		
	Inspected by:			
	Location of Inspection:	1116 MN-23, Pipestone, MN 56164		
	Phone No / Email:	+1 507 820 1720 / nonapplicable@gmail.com		
	Date of Inspection:	6/19/2024	Job#:	8688u58jk
	Year:	2019	Make:	Komatsu
	Model:	PC138US	VIN:	KMTPC261JJA052547

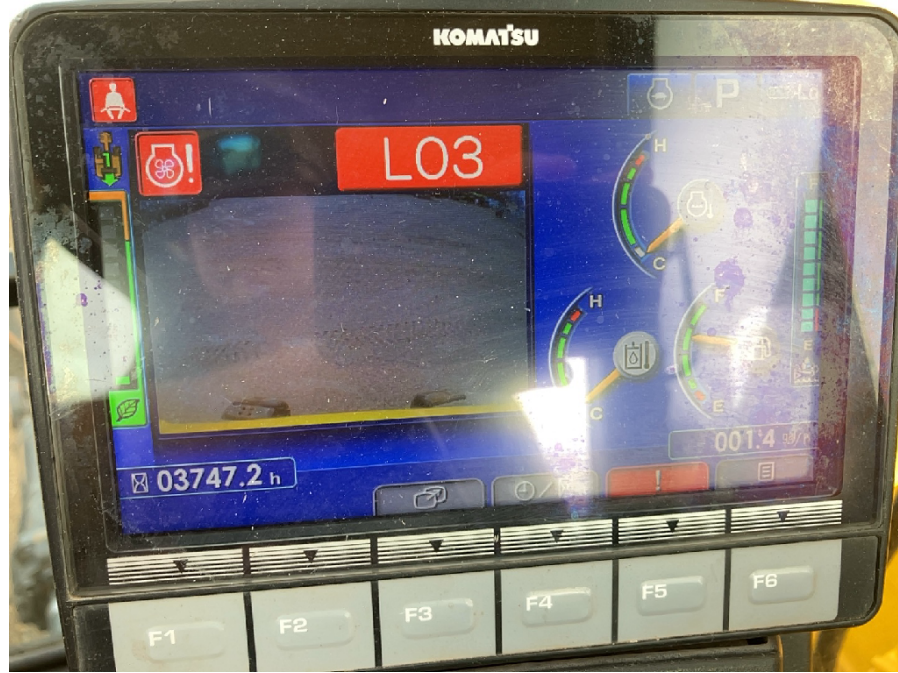
Engine Hours: 3,747 / EMS Warning Lights / Backup Camera

The Front and Rear Lights are not operational. The bucket is missing. The rear counterweight has paint scratches on it. Both of the tracks appear to be loose. The unit is showing a warning for the fan control system abnormality on the dash at the time of inspection. The headliner and roof panel are stained. The armrests on the operator seat are worn. The bottom aftermarket seat cover is coming off. The left foot pedal pad cover is missing. The front right sheet metal panel is dented and the paint is missing. The right center sheet metal cover is bent and dented. The rear right compartment door panel is bent and dented. The front right step is bent. The engine coolers appear to be dirty. The tie-down loops on the sides of the blade appear to be broken off. The blade lift cylinder shields appear to be missing on top of the cylinders. The rubber track shoes have cuts and gouges in them. Some of the track link pins are starting to show wear. The coolant is low in the reservoir. The front right grab handle appears to be bent. The front left lower sheet metal below the cab appears to be bent.
