NESHAP Demolition Survey

For Asbestos Containing Building Materials

Sunset Motel
1401 South 2nd Avenue
Sheldon, IA

Re: NESHAP Demolition Survey for Asbestos Containing Building Materials
Alloy Specialty Project Number 19033

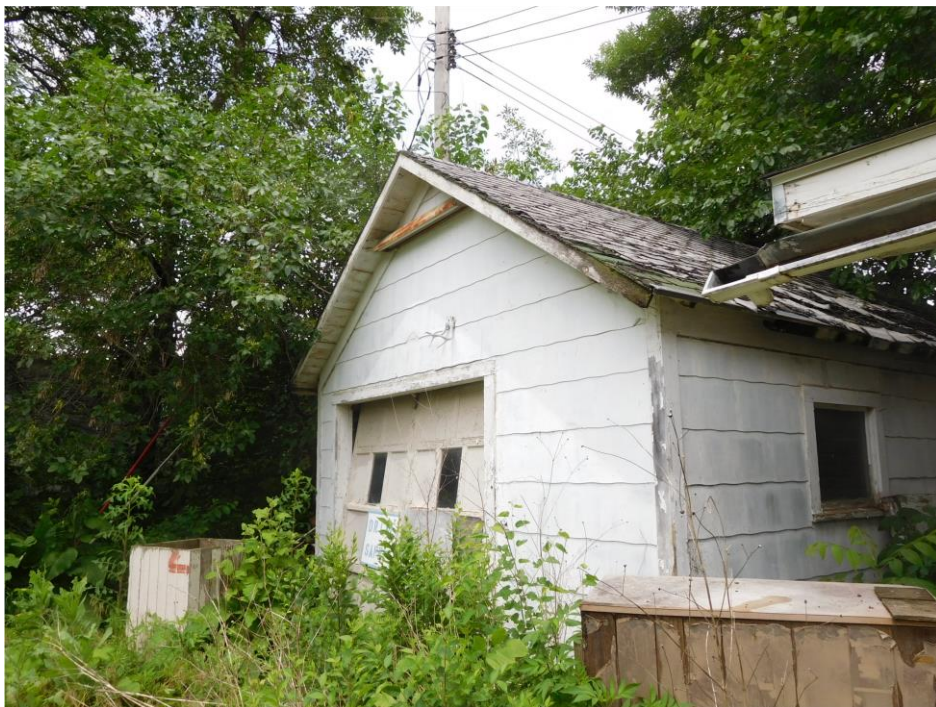
PHOTO 4:
Western garage with **asbestos containing transite** siding on the exterior.

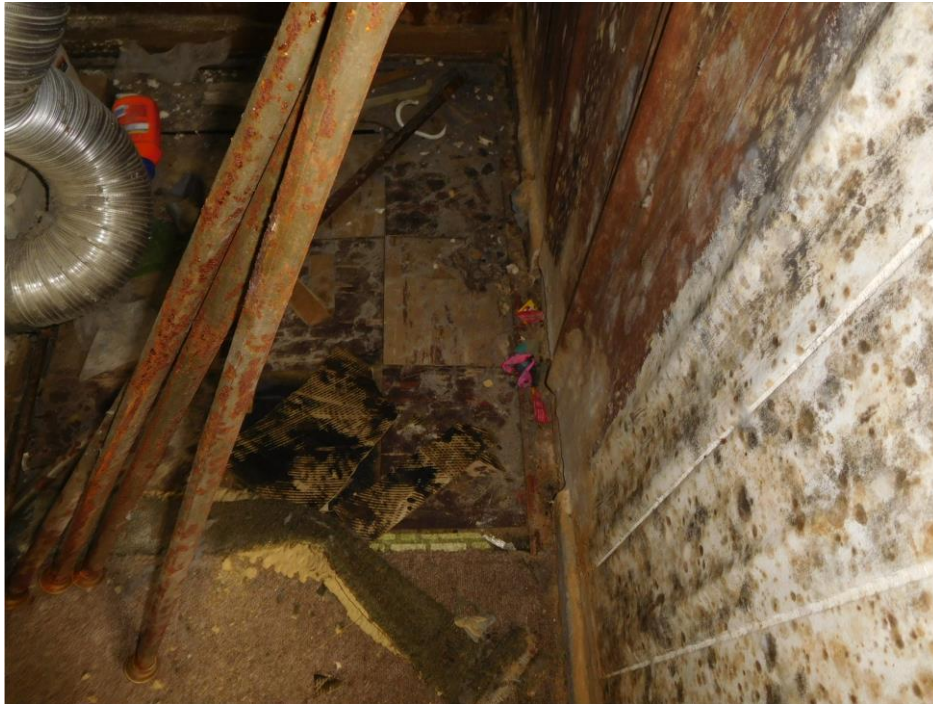
PHOTO 5: Laundry room in the Southern row units. This **asbestos containing**, 9" x 9", resilient tile and black mastic are consistent throughout the units. Tile is under carpets, flooring and ceramic tiles.

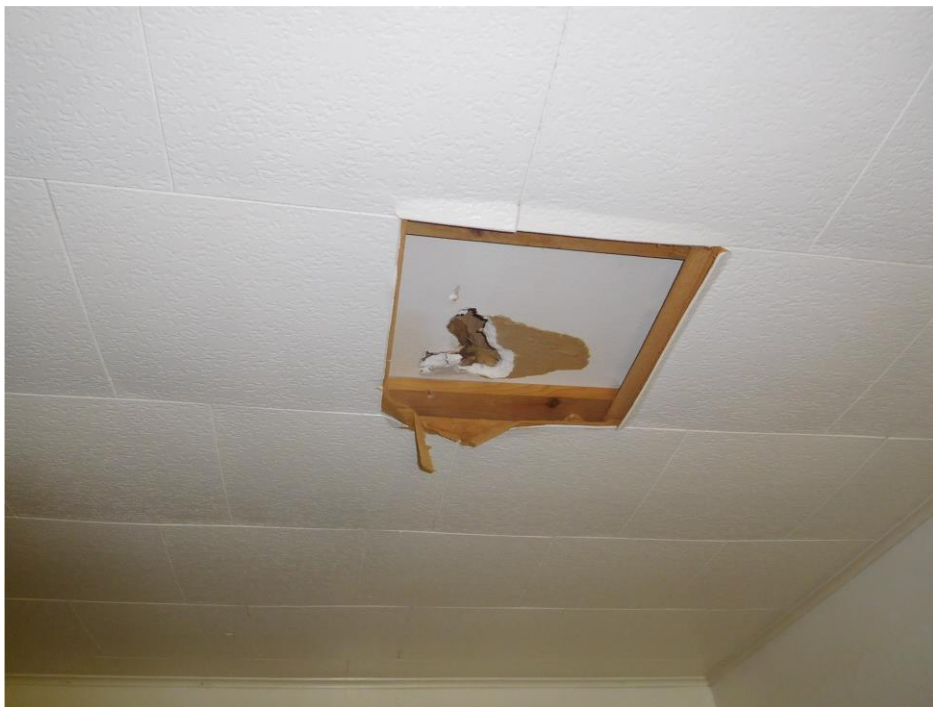
PHOTO 6: Interior of Unit #1, ceiling system. Non-asbestos ceiling tile with **asbestos containing** drywall materials (**asbestos** found in the joint compound).

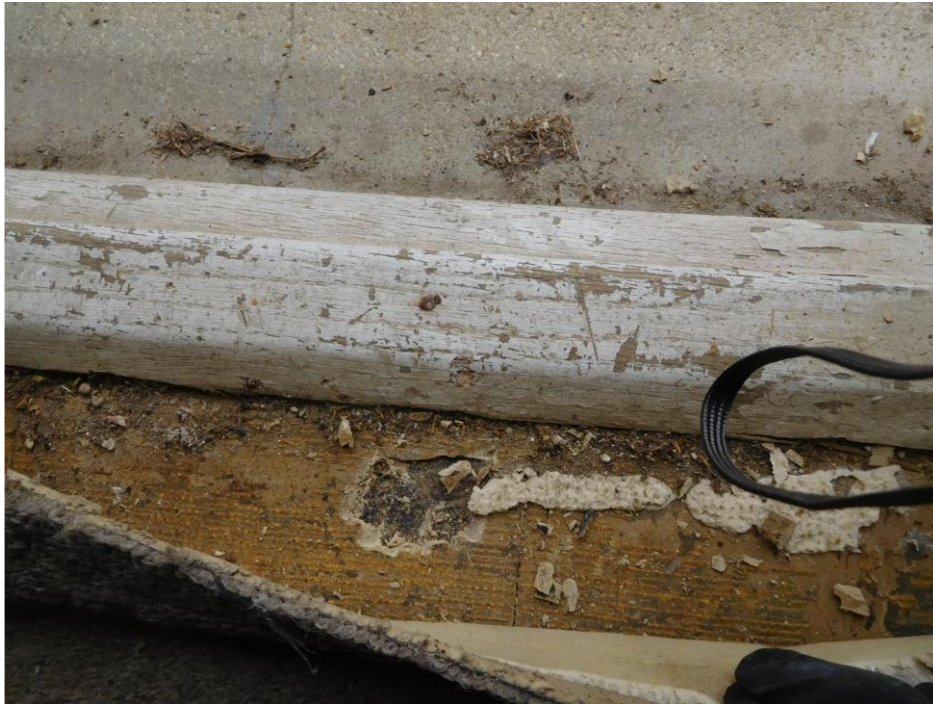
PHOTO 9:
Unit 9, under carpet, **Asbestos Containing** Floor Tile and Mastic adhesive.

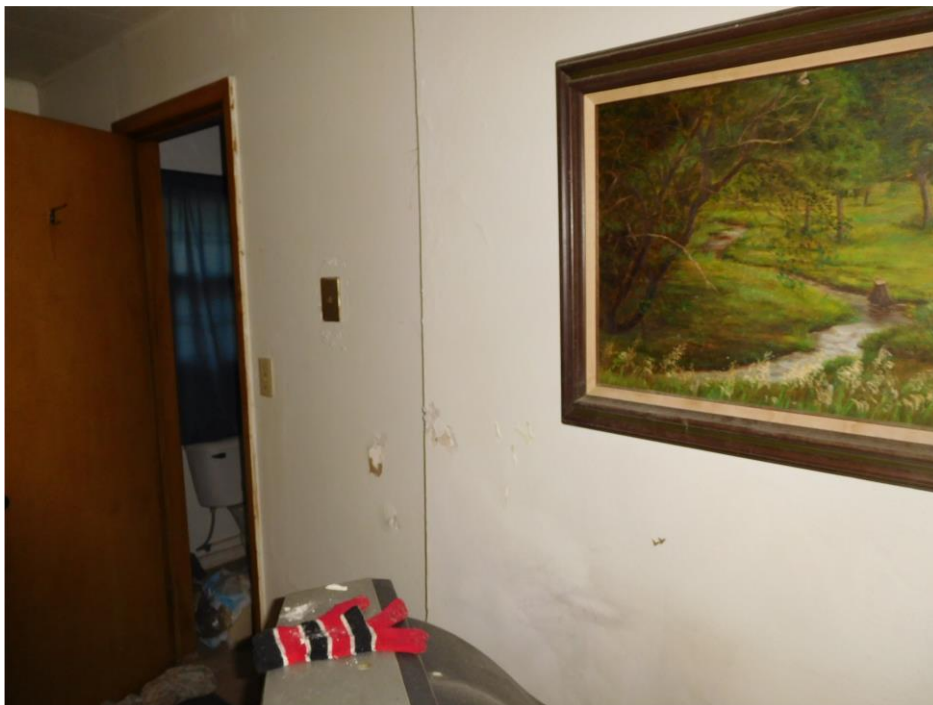
PHOTO 10:
Interior Unit #12, **asbestos containing** wall materials.

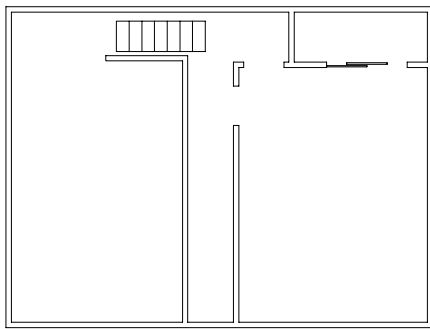
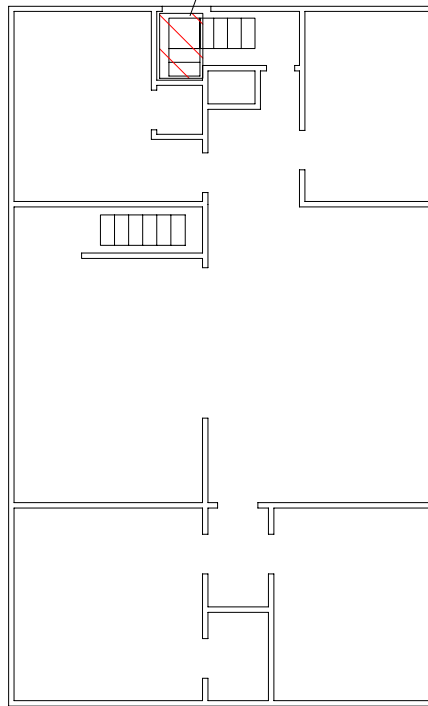
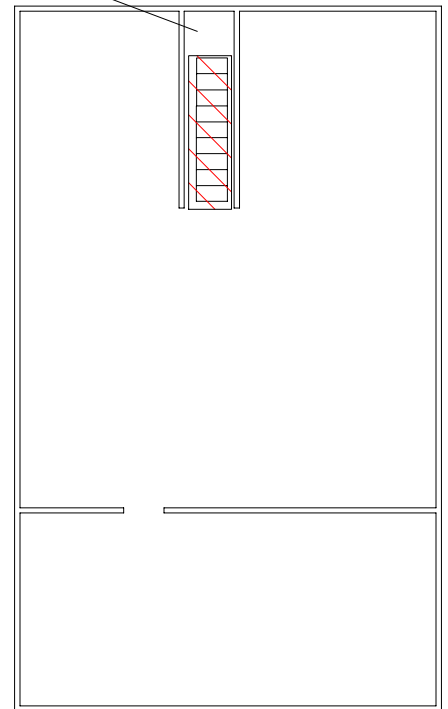
SHEET Asbestos Materials
Office
DWG NO 4

Asbestos Containing, Resilient
Sheet Flooring on Stairs to
Basement

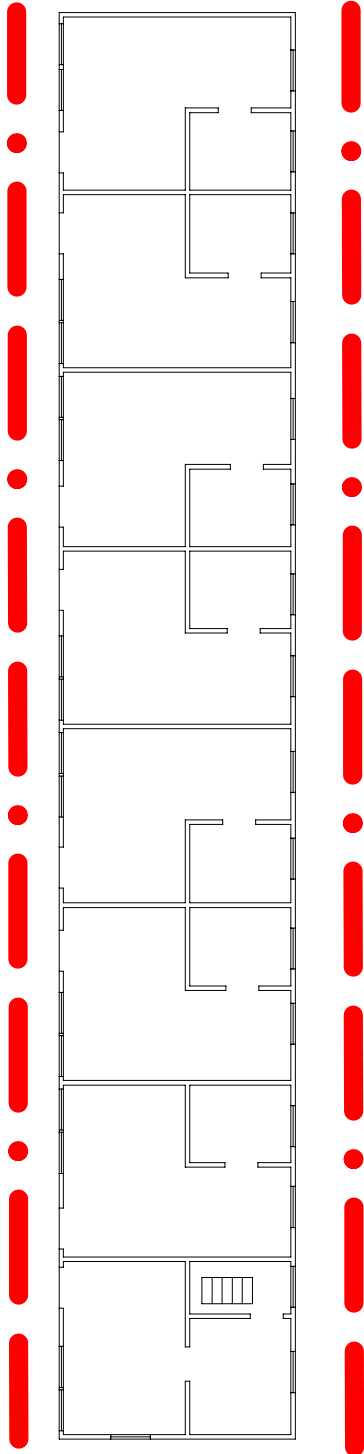
SHEET Asbestos Materials
 Exterior -- South Units

Asbestos Containing Window Glazing on All Windows

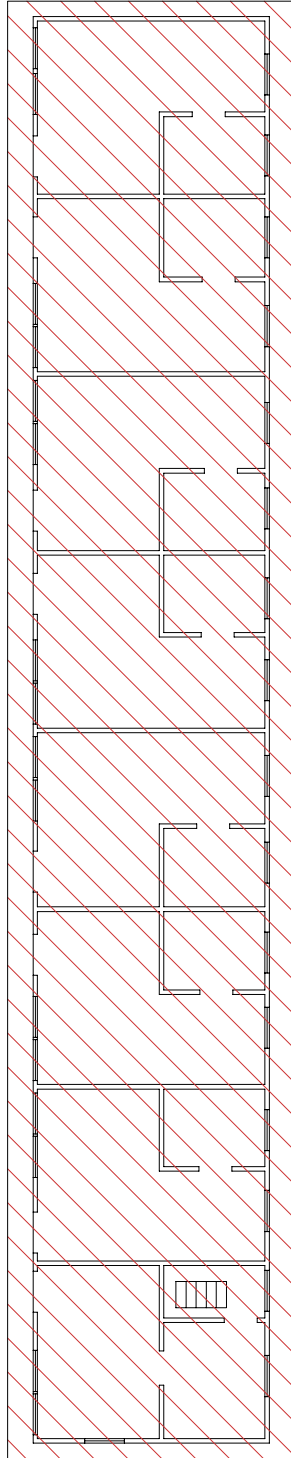
SHEET
Asbestos Materials
Interior -- South Units
DWG NO
6

Asbestos Containing Drywall
Joint Compound on Walls and Ceilings

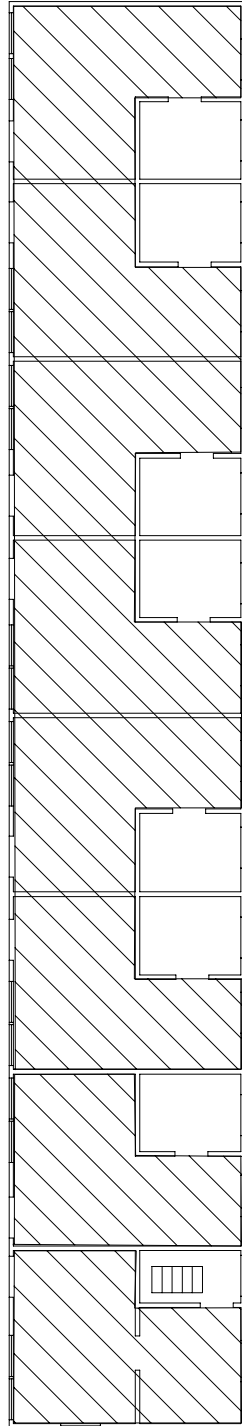
SHEET
Asbestos Materials
Interior -- South Units
DWG NO
7

Asbestos Containing Resilient
Floor Tile Under Linoleum, Carpet
or Faux Wood Flooring

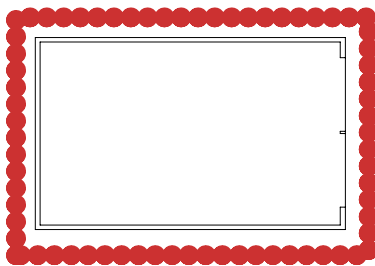
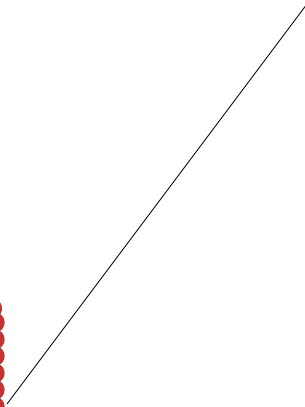
SHEET	Asbestos Materials Exterior North Units
DWG NO	9

Asbestos Containing Siding Panels
aka Transite

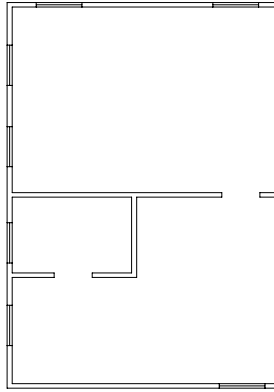
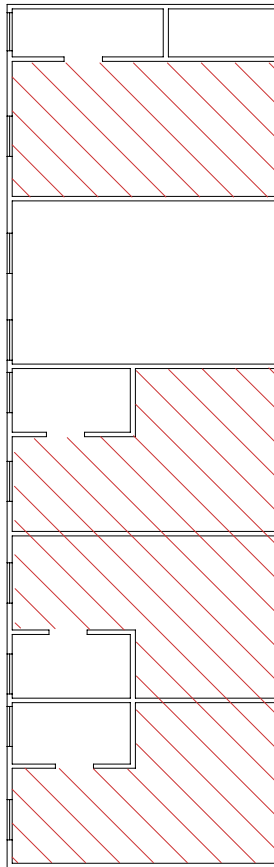
Asbestos Materials
Exterior North Units

Asbestos Containing Floor Tiles
Under Carpet
