NESHAP Demolition Survey

For Asbestos Containing Building Materials

*DJ's Redemption Services
428 West Park Street
Sheldon, IA*

Re: NESHAP Demolition Survey for Asbestos Containing Building Materials
Alloy Specialty Project Number 19034

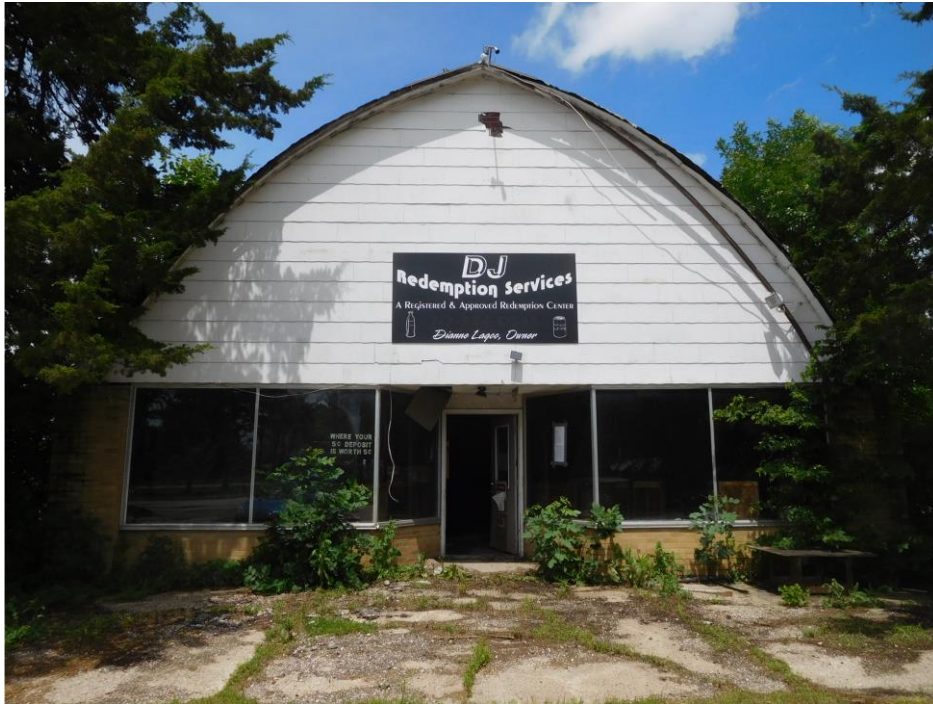
PHOTO 1:
Address side of the former DJ Redemption Services Building. Note: **asbestos containing siding** on building.

The property **has** identified non-friable materials. The identified materials must be removed prior to demolition, because of their composition. All materials must be removed in accordance to regulatory laws of the EPA, State of Iowa, and OSHA.

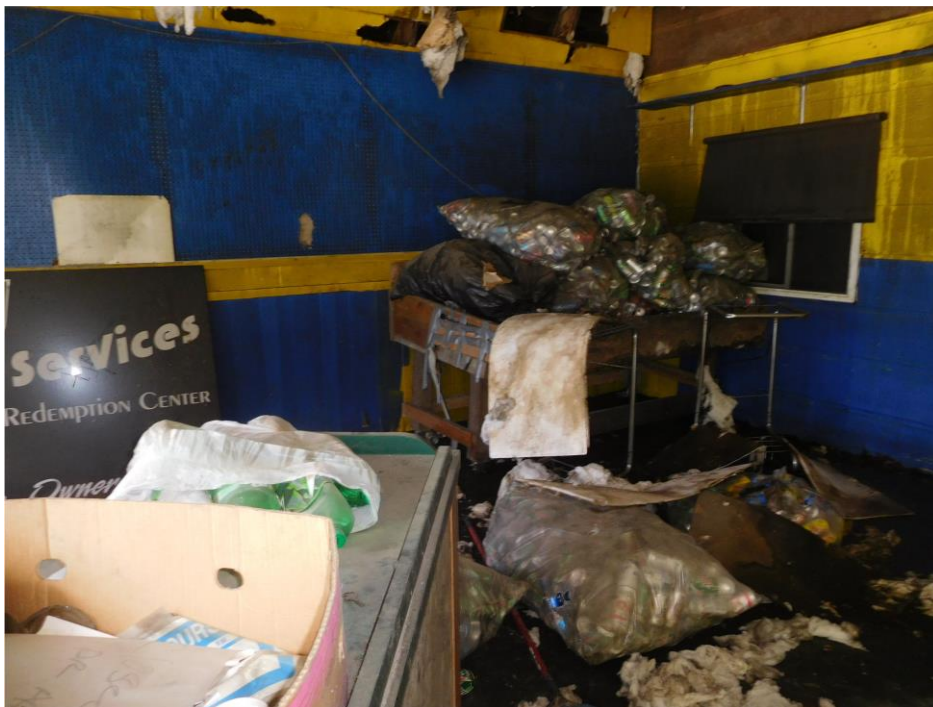
PHOTO 2:
Interior of office area of property. Building has aluminum cans and assorted metals.

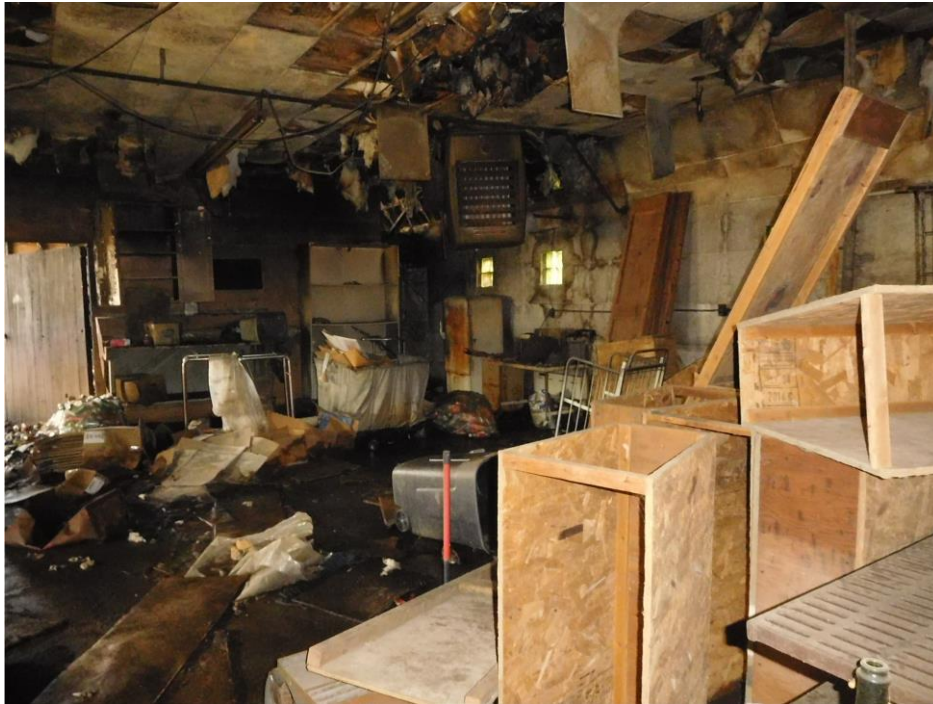
PHOTO 3:
Interior center section of main building. Overview of separation boxes, fallen ceiling tile and exposed insulation.

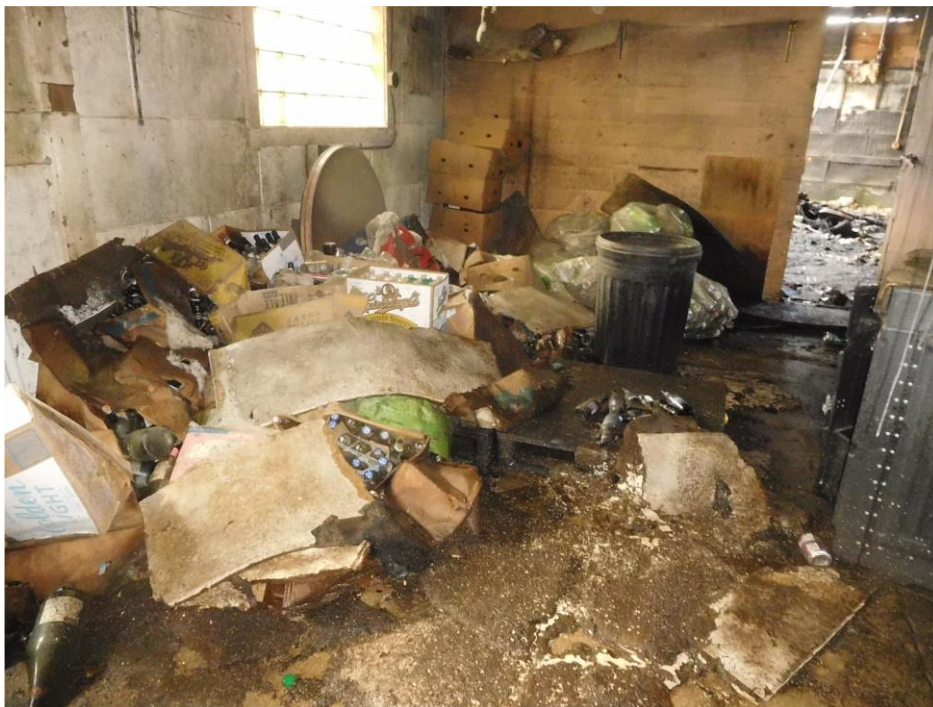
PHOTO 4:
Interior center section of main building. Overview of separation boxes, fallen ceiling tile and exposed insulation.

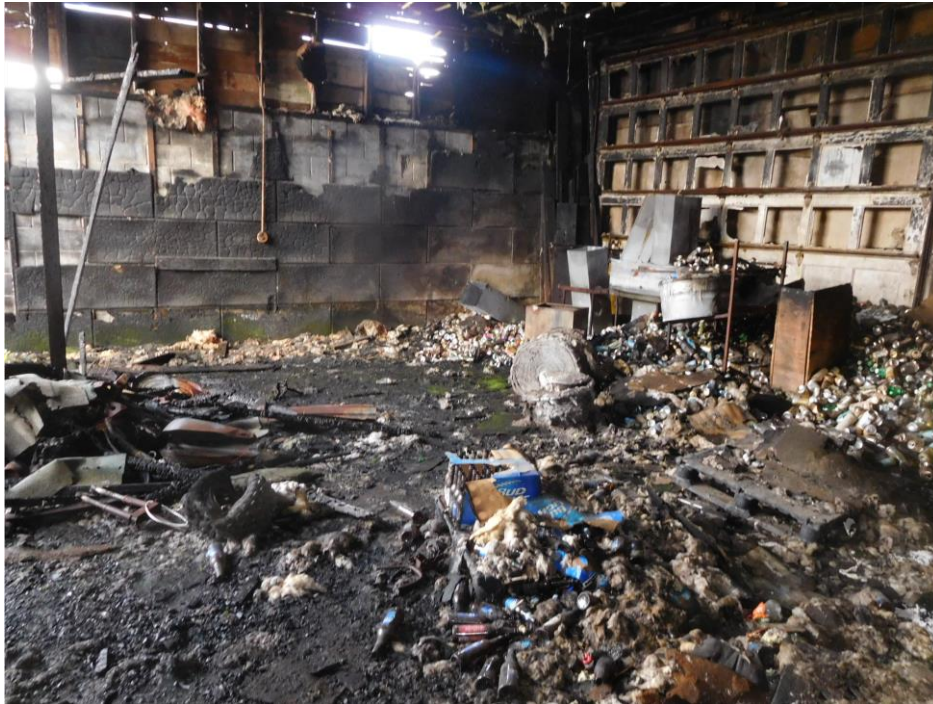
PHOTO 5:
North section of main building. Extensive fire damage to structure. Assorted debris and aluminum cans.

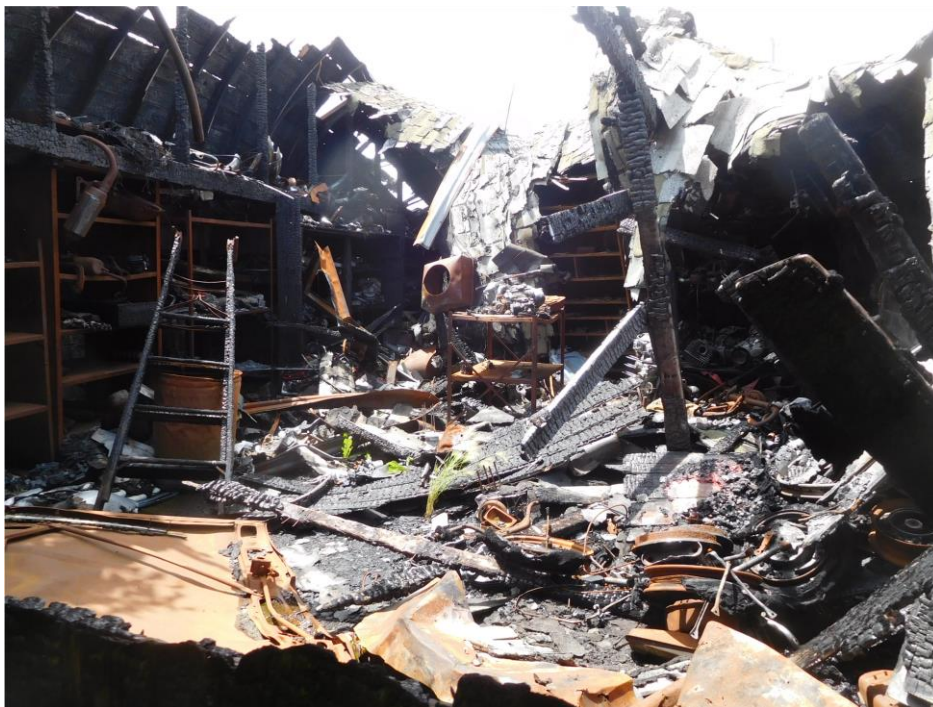
PHOTO 6:
West building, East end. Extensive fire damage. Motorcycle engines and parts. No salvage.

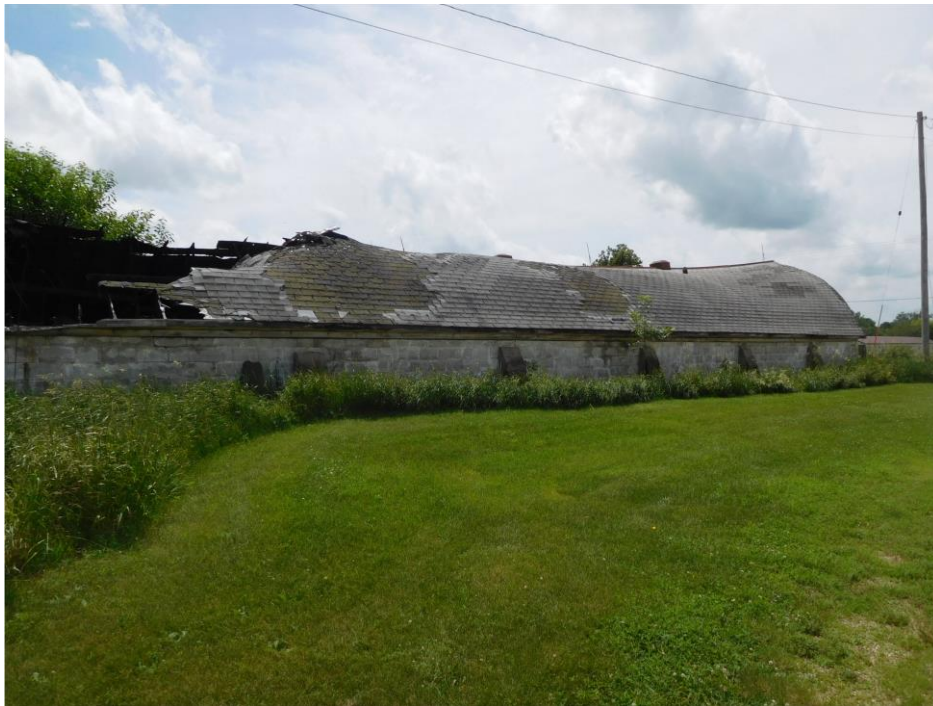
PHOTO 7:
Overview of West building with East end having the fire. Non-asbestos roofing on West building.

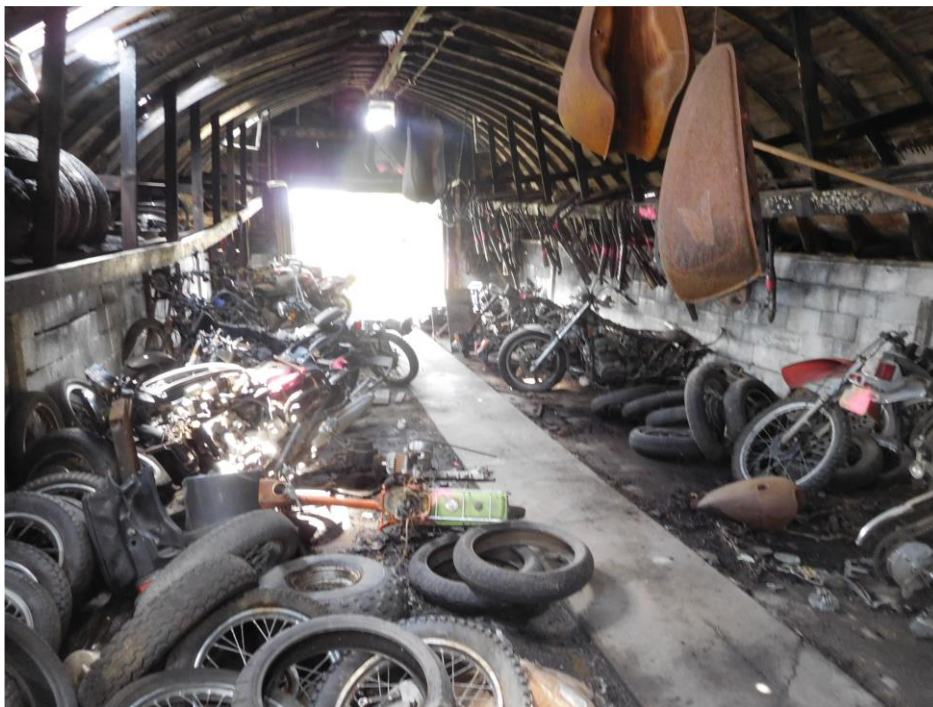
PHOTO 8:
Interior of West building, West end. Overview of tires, parts and motorcycles.

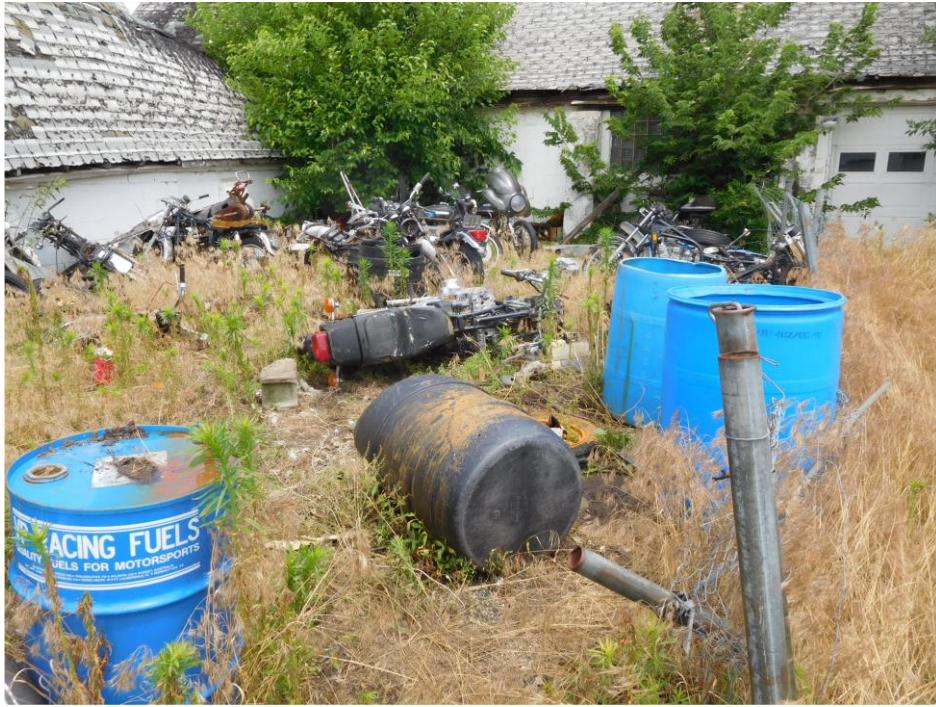
PHOTO 9: South exterior side of West building. Laydown area for motorcycles and parts. Note: drum marked racing fuels. Note: top layer of roofing on Main building is **asbestos containing**.

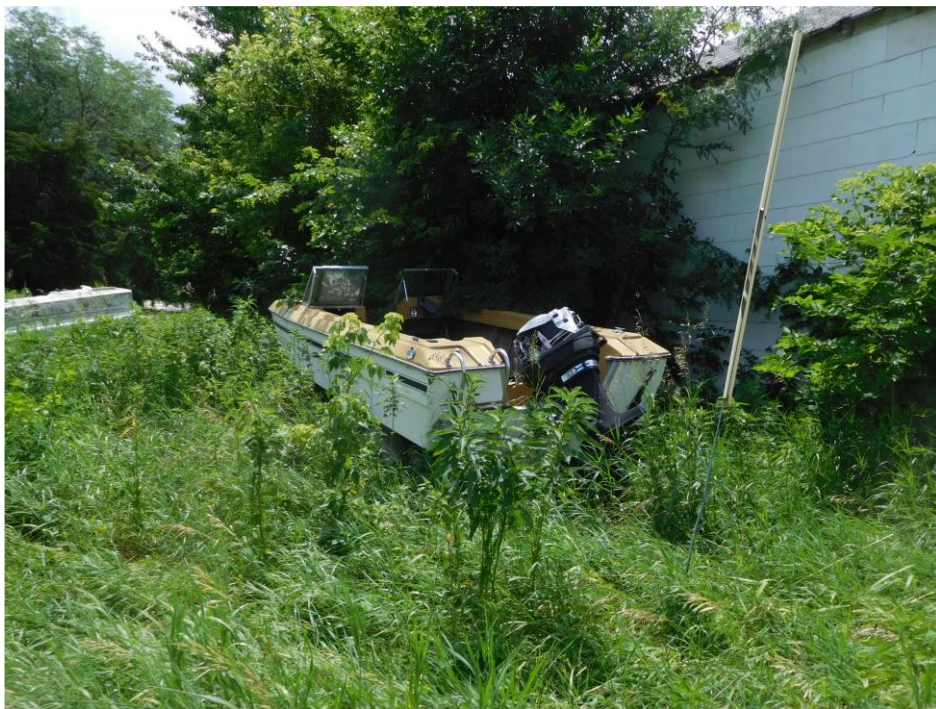
PHOTO 10: East yard area of main building. Overgrown vegetation covers boat, household furniture, windows, awnings, etc. Note: **asbestos containing siding** on East exposure north end of main building.
